WIRE DRAG

DESCRIPTIVE REPORT

Type of Survey ... Wire Drag

Sublocality Approach to Tampa Bay

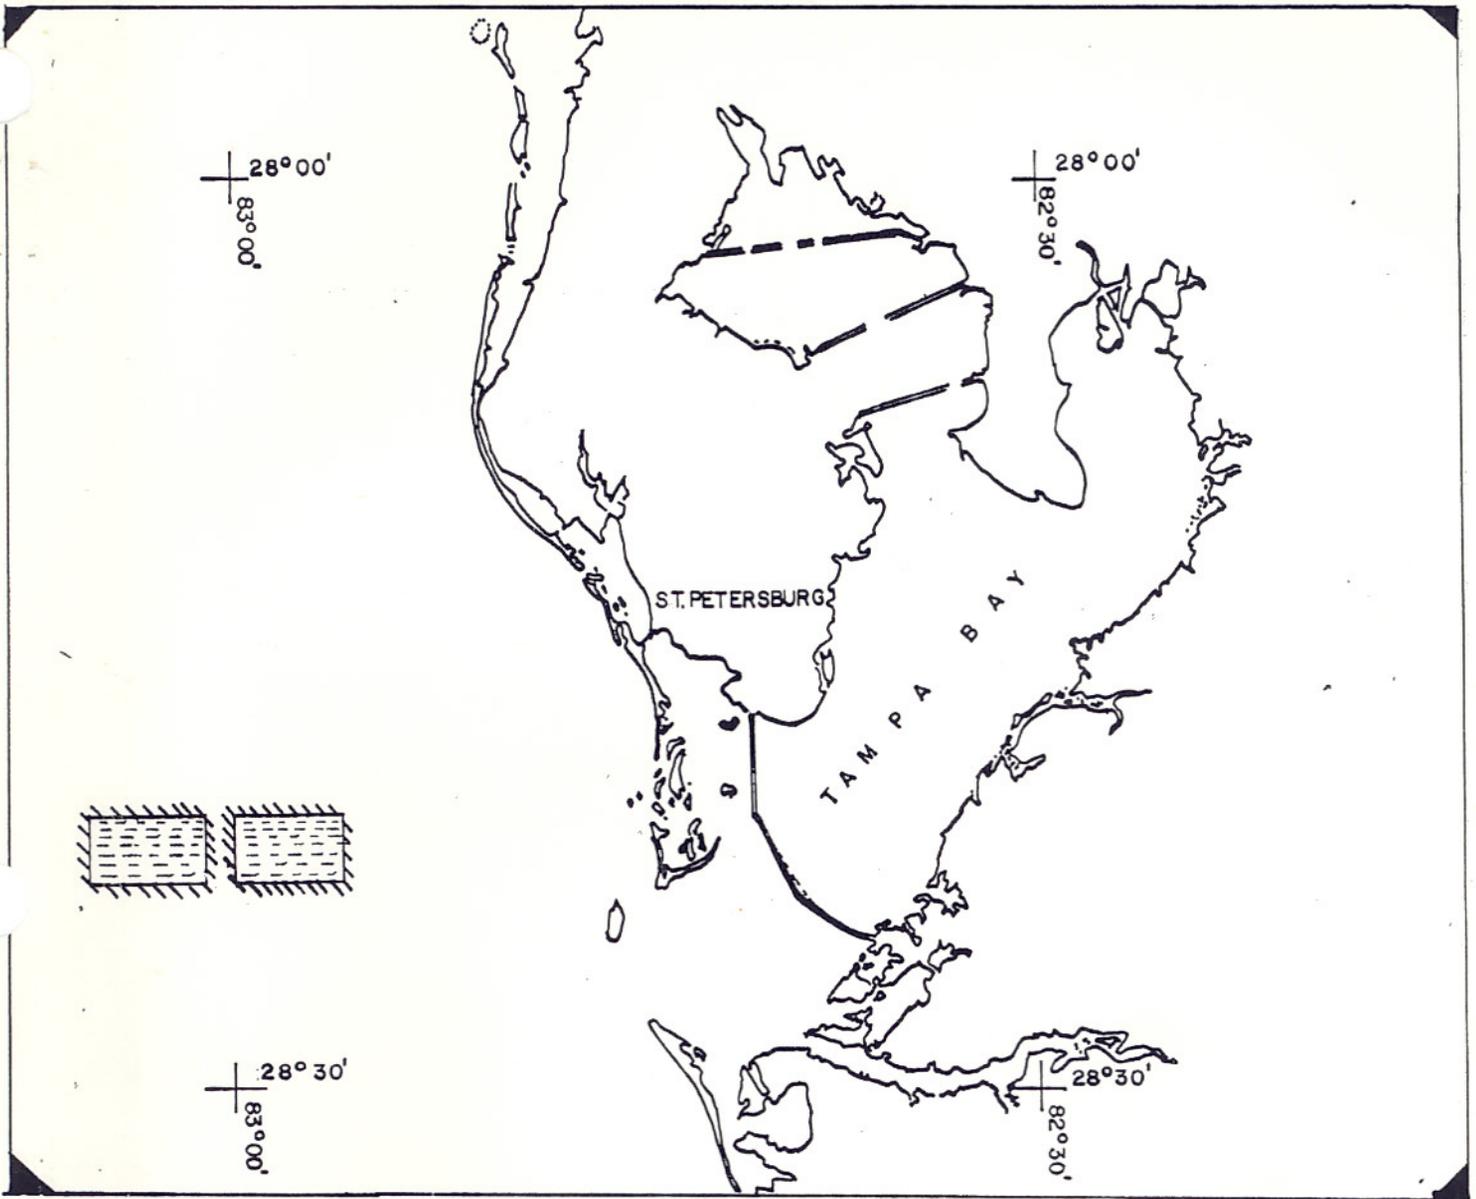
P R O G R E S S S K E T C H

OPR-J657-RU/HE-86

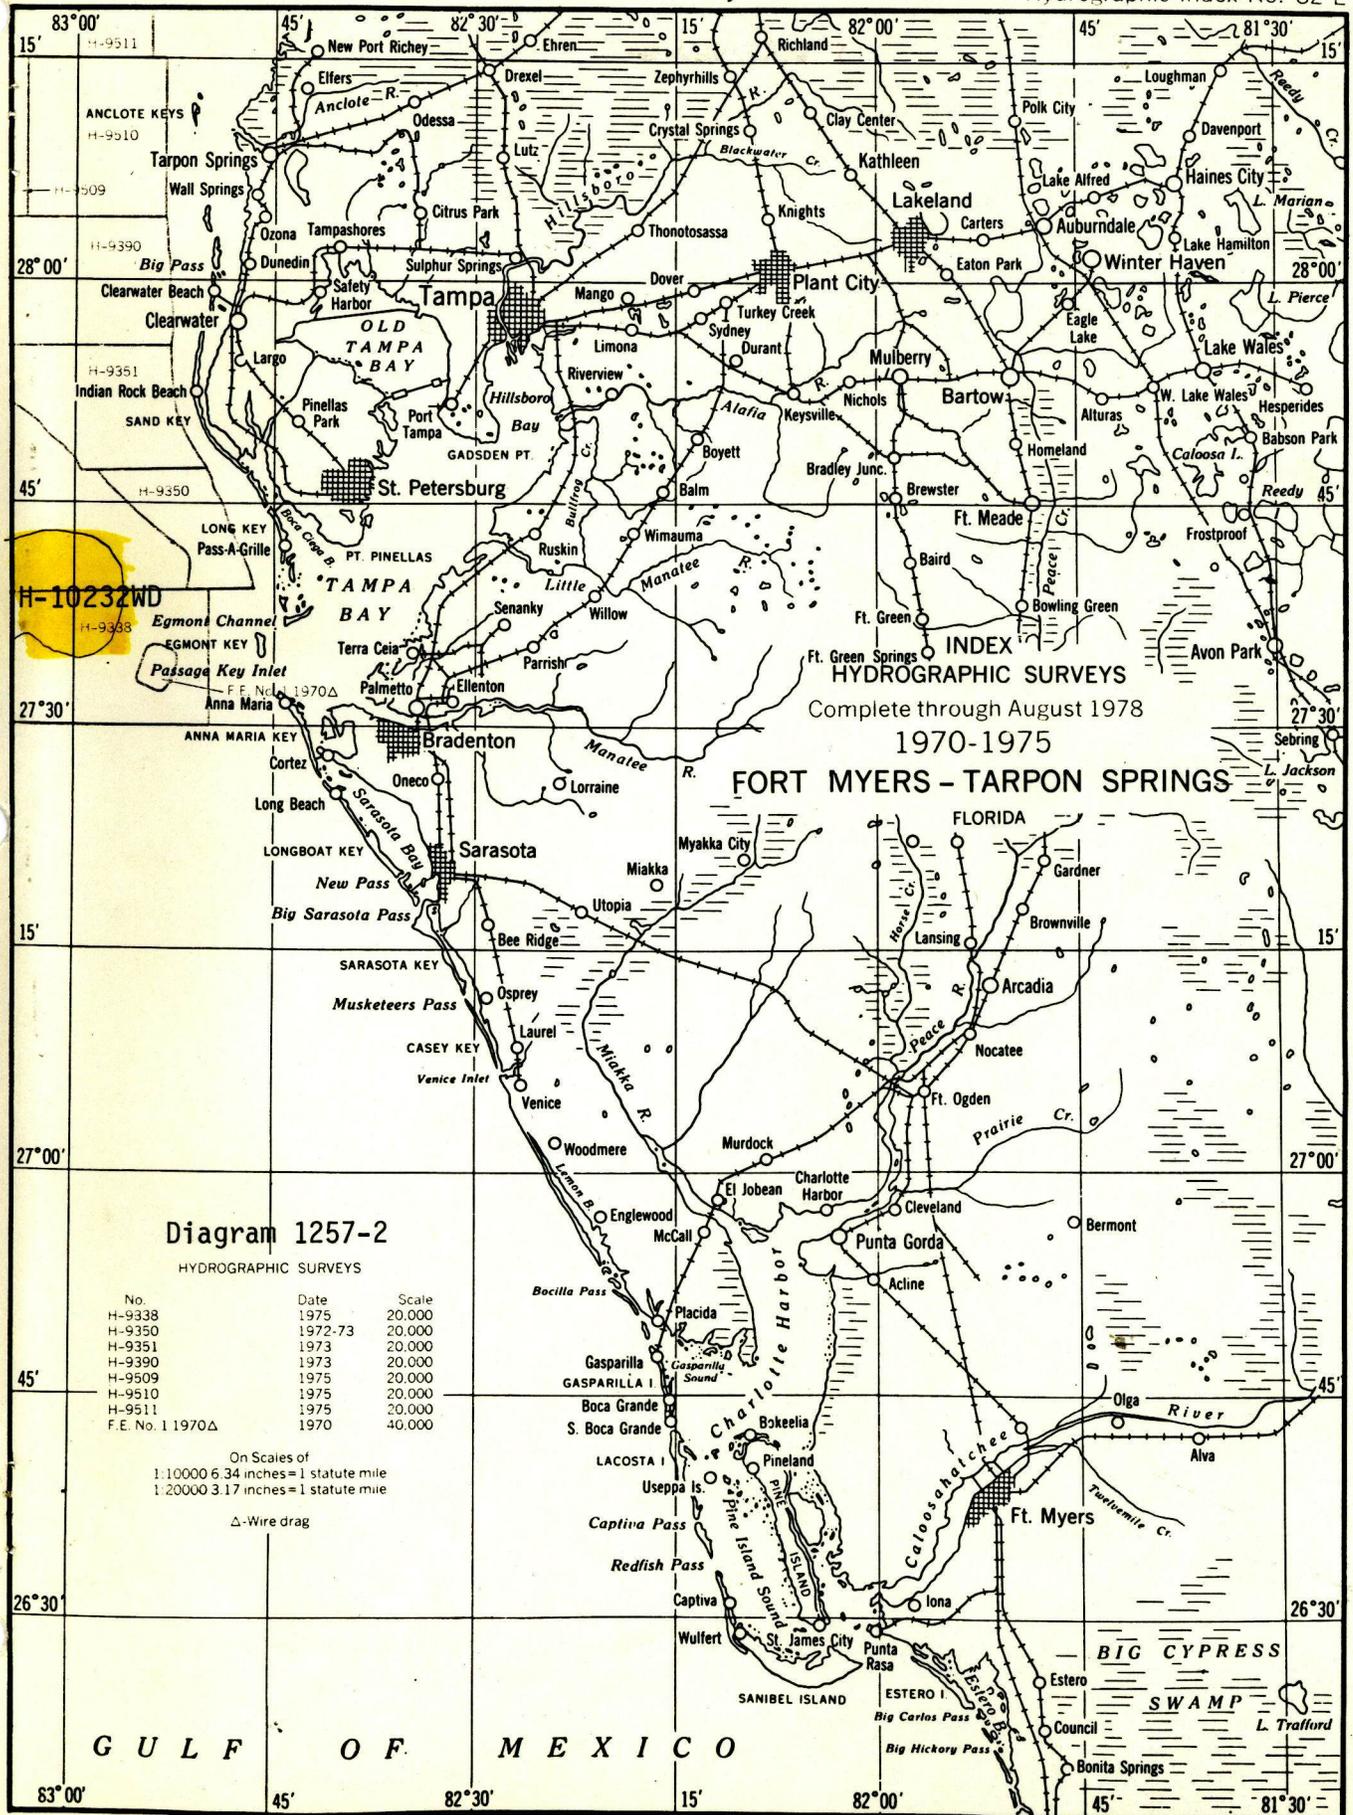
Hydrographic Index No. 82 E

DEPARTMENT OF COMMERCE
 National Oceanic and Atmospheric Administration
 National Ocean Survey
 Rockville, Maryland
