DESCRIPTIVE REPORT

Type of Survey ... Hydrographic.....

Registry No. H-10263.....

General Locality ... Bristol Bay.....

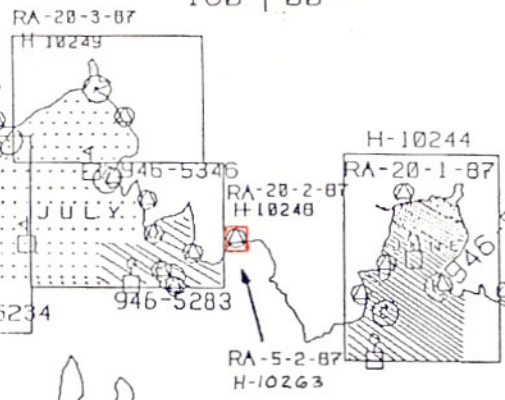
PROGRESS SKETCH
 OPR-R184-RA-87
 HYDROGRAPHIC SURVEY
 TOGIAK BAY, ALASKA
 JUNE 7 - JULY 31

NOAA SHIP RAINIER
 CARL W. FISHER, CAPT. NOAA
 COMMANDING
