DESCRIPTIVE REPORT

H11295

General Locality: York River

Sub-locality: Indian Field Creek to the Entrance to the York River

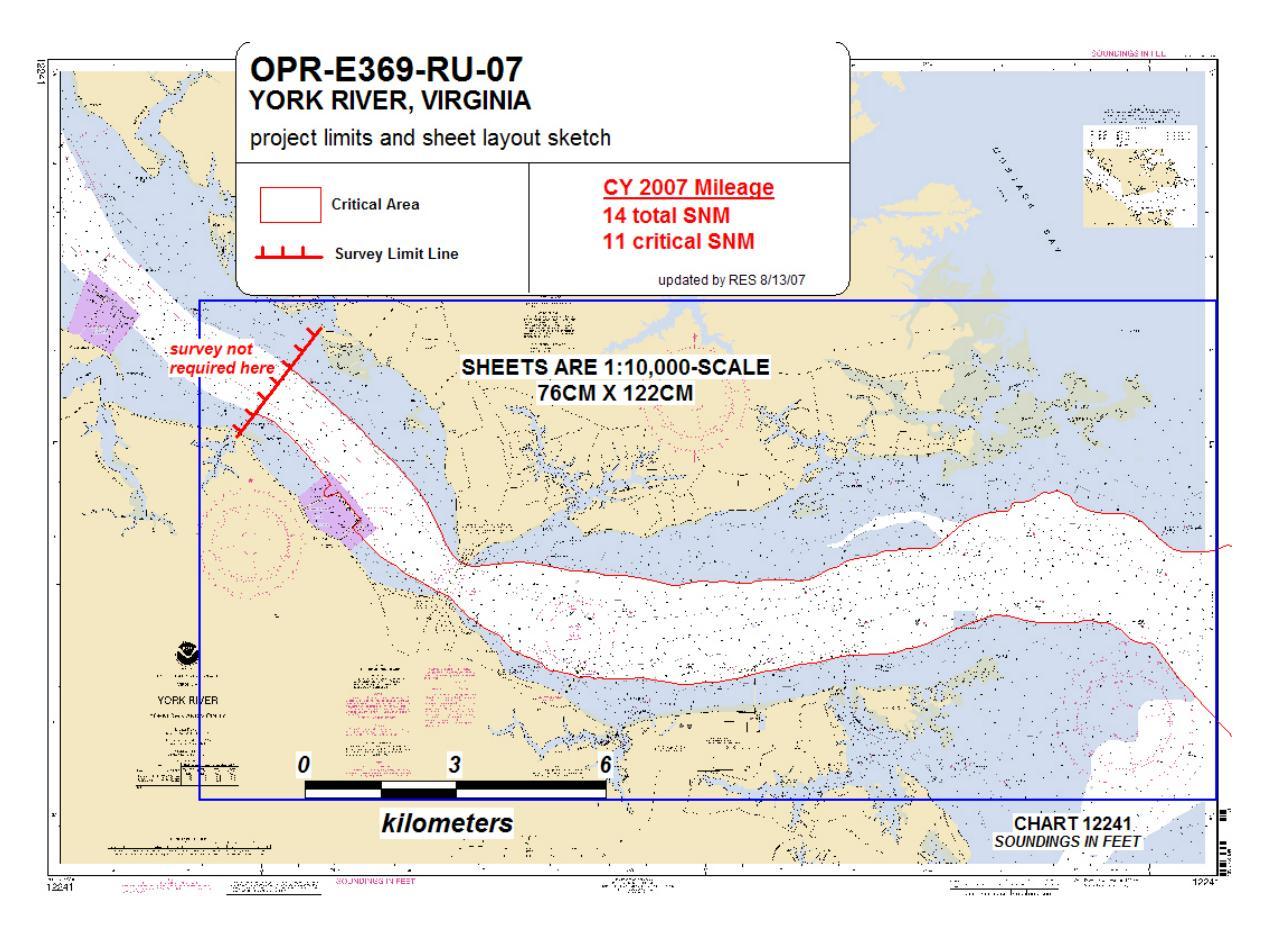
Figure 1. H11295 Survey Limits (Chart 12241).

Survey limits of H11295 are shown in Figure 1.

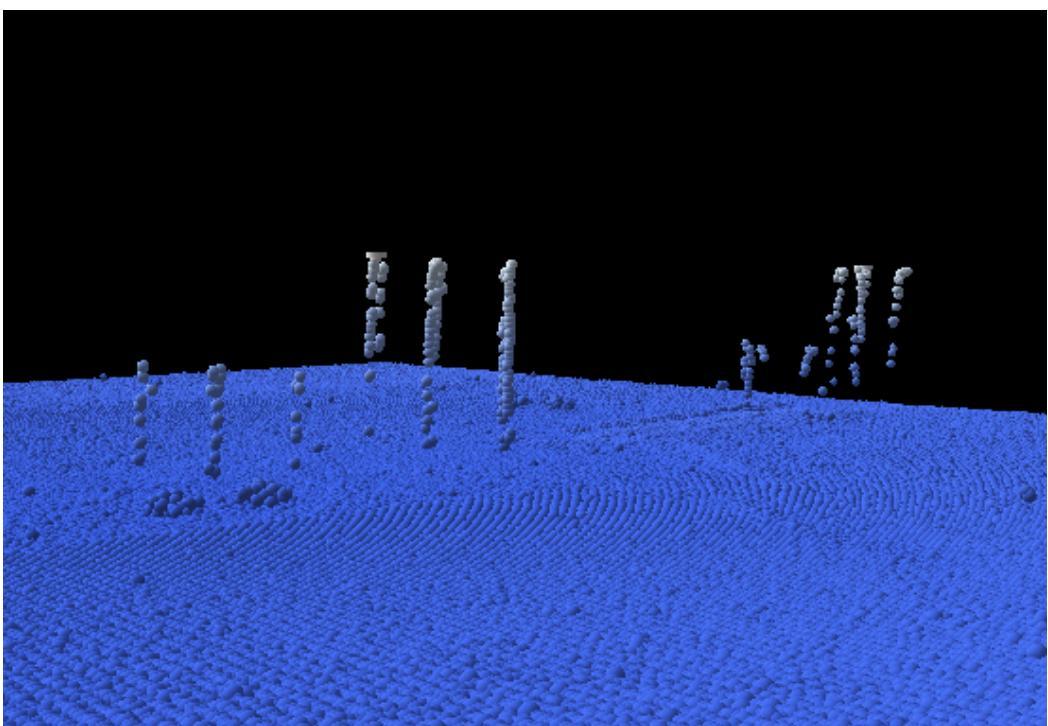
Figure 2. Three images of each object, one image from each line run over the area.

All data acquired during H11295 met IHO S-44 Order 1 specifications. A large numbers of submerged piles were found in the York River. These piles proved to be excellent tools for checking for systematic errors. While the side scan data would show only a single pile at a given geographic position, a review of the MBES development data showed, what would appear to be two or three piles at this same location (Figure 2). Further investigation revealed that each of these MBES piles was from a different survey line. Subsequent diver investigations proved the existence of only a single pile. After extensive review of our POS/MV configuration, offset measurements, CARIS vessel configuration files, and patch test data, it was determined that these offsets were produced by uncertainties in the GPS positioning. *Concur with clarification. The finalized CARIS BASE Surface was tested in CARIS to determine whether the grid met INO Order 1 specification. It was determined that 99.65% of all nodes in the grid meet IHO Order 1. This is adequate for charting.*

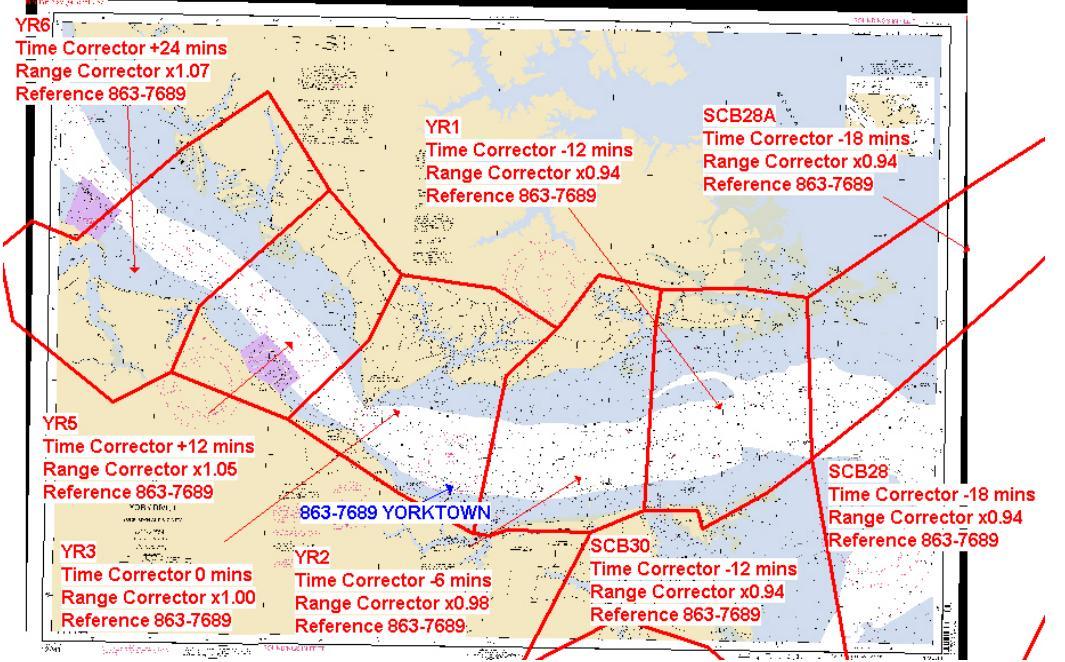
Figure 3. Tidal zoning assigned in Project instructions.

All sounding data were reduced to mean lower-low water (MLLW). The operating National Water Level Observation Network (NWLON) station at Yorktown, VA (863-7689) served as datum control for H11295 as specified in the Letter Instructions* and illustrated in Figure 3.

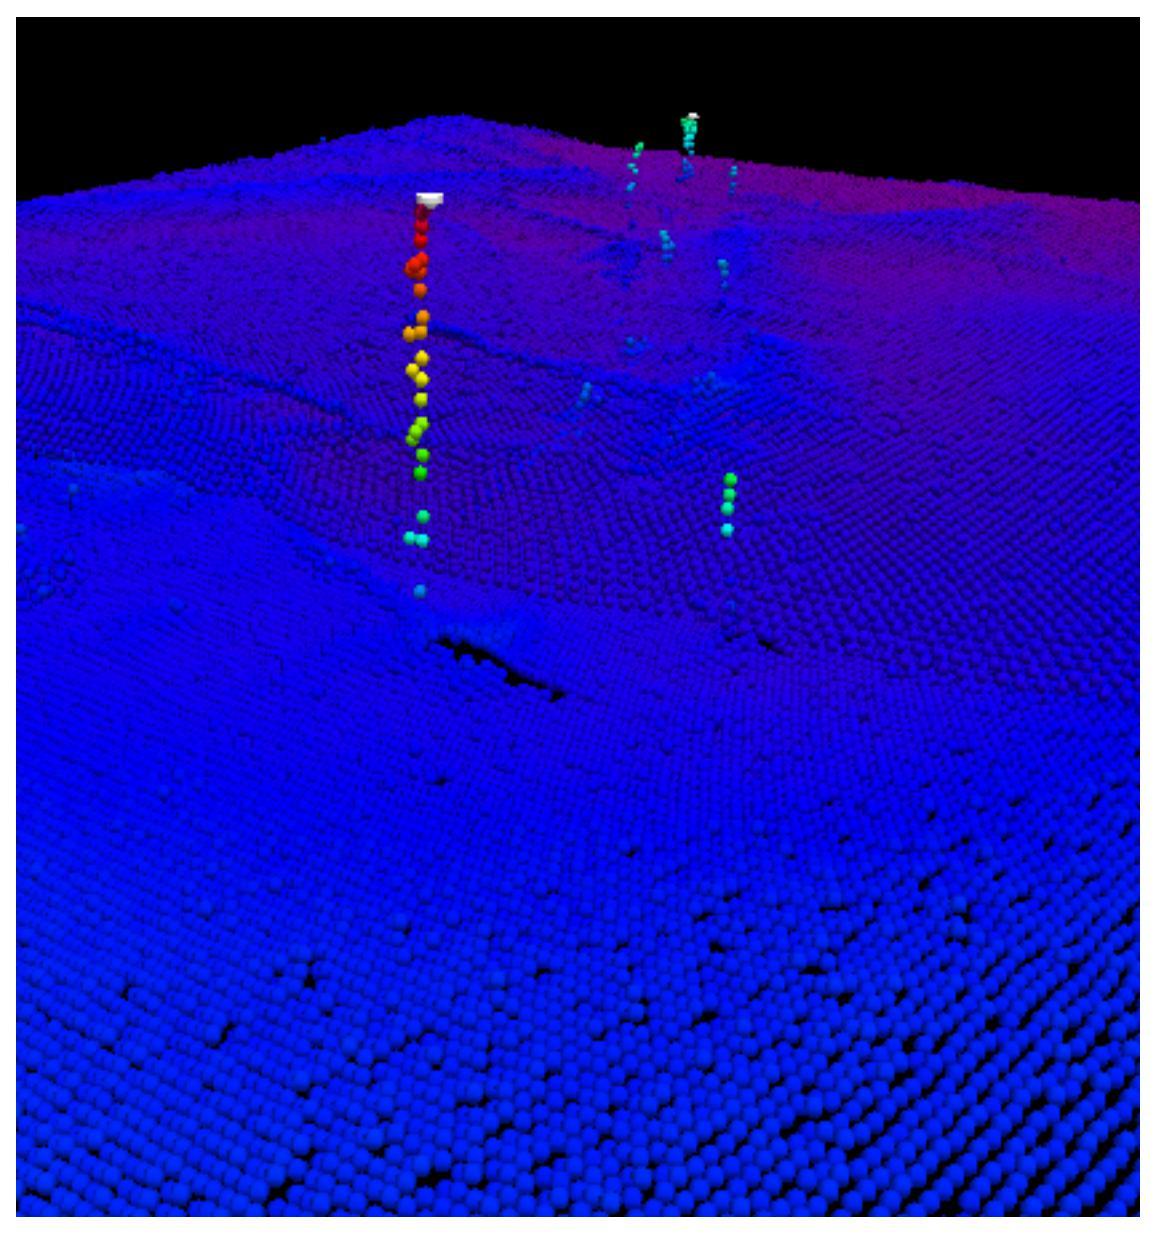
Figure 1.2.1

Uncharted area of dangerous obstructions located during H11295 survey operations. Objects appear to be piles from remains of fish traps with more piles laying on the sea floor. Items were initially located using 200% SSS and developed using a Reson 8125 multibeam echosounder. The least depth on this collection of features was found to be 22.20ft (6.77m) relative to the Chart datum. Surrounding water depths were 36.16ft (11.89m). Soundings were adjusted to the MLLW datum using verified water levels and final discrete tide zones.

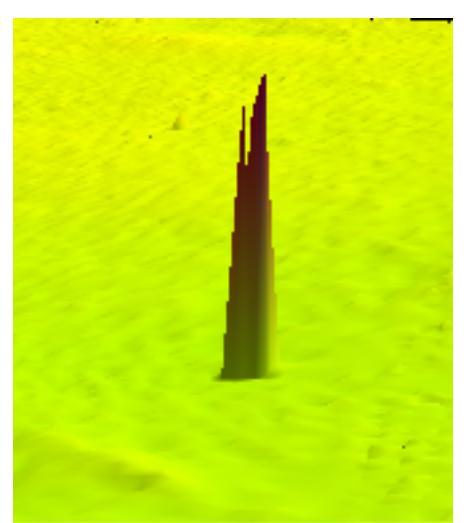
Figure 1.3.1

Uncharted area of dangerous obstructions located during H11295 survey operations. Objects appear to be piles from remains of fish traps with more piles laying on the sea floor. Items were initially located using 200% SSS and developed using a Reson 8125 multibeam echosounder. The least depth on this collection of features was found to be 22.05ft (6.72m) relative to the Chart datum. Surrounding water depths were 32.42ft (9.88m). Soundings were adjusted to the MLLW datum using verified water levels and final discrete tide zones.

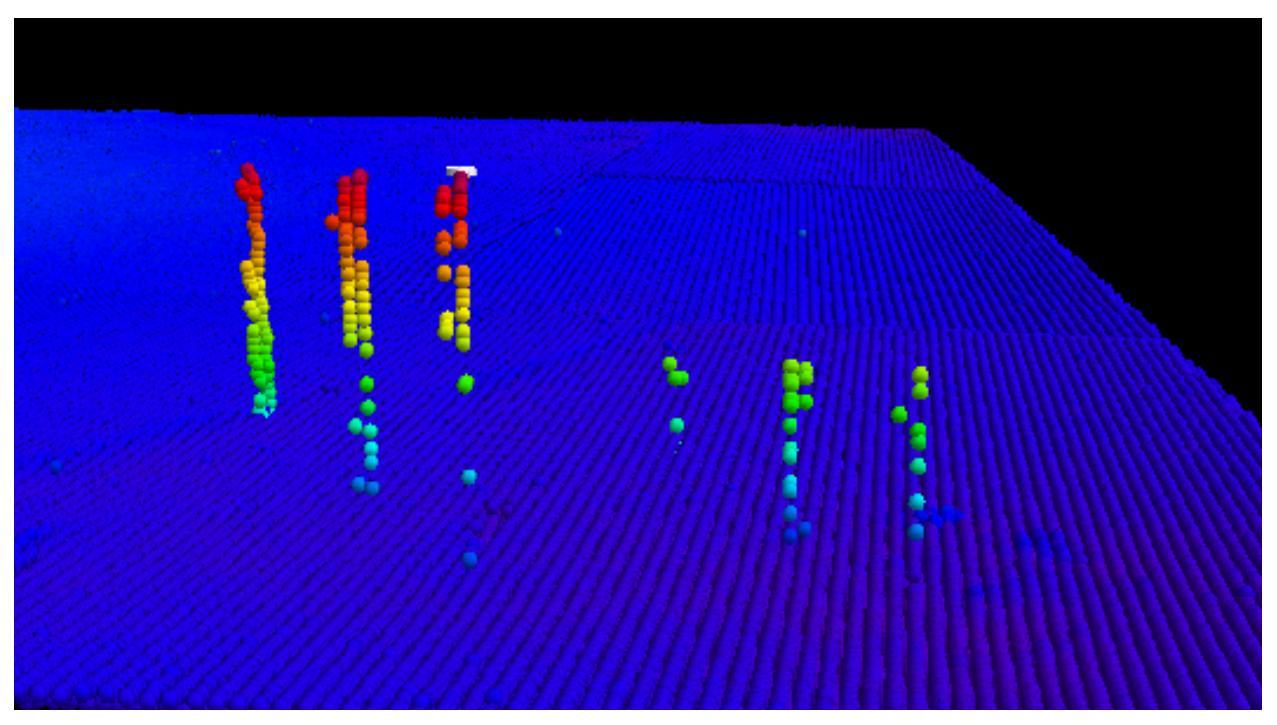
Figure 1.4.1

Uncharted area of dangerous obstructions located during H11295 survey operations. Objects appear to be piles from remains of fish traps with more piles laying on the sea floor. Items were initially located using 200% SSS and developed using a Reson 8125 multibeam echosounder. The least depth on this collection of features was found to be 17.64ft (5.38m) relative to the Chart datum. Surrounding water depths were 31.04ft (9.46m). Soundings were adjusted to the MLLW datum using verified water levels and final discrete tide zones.

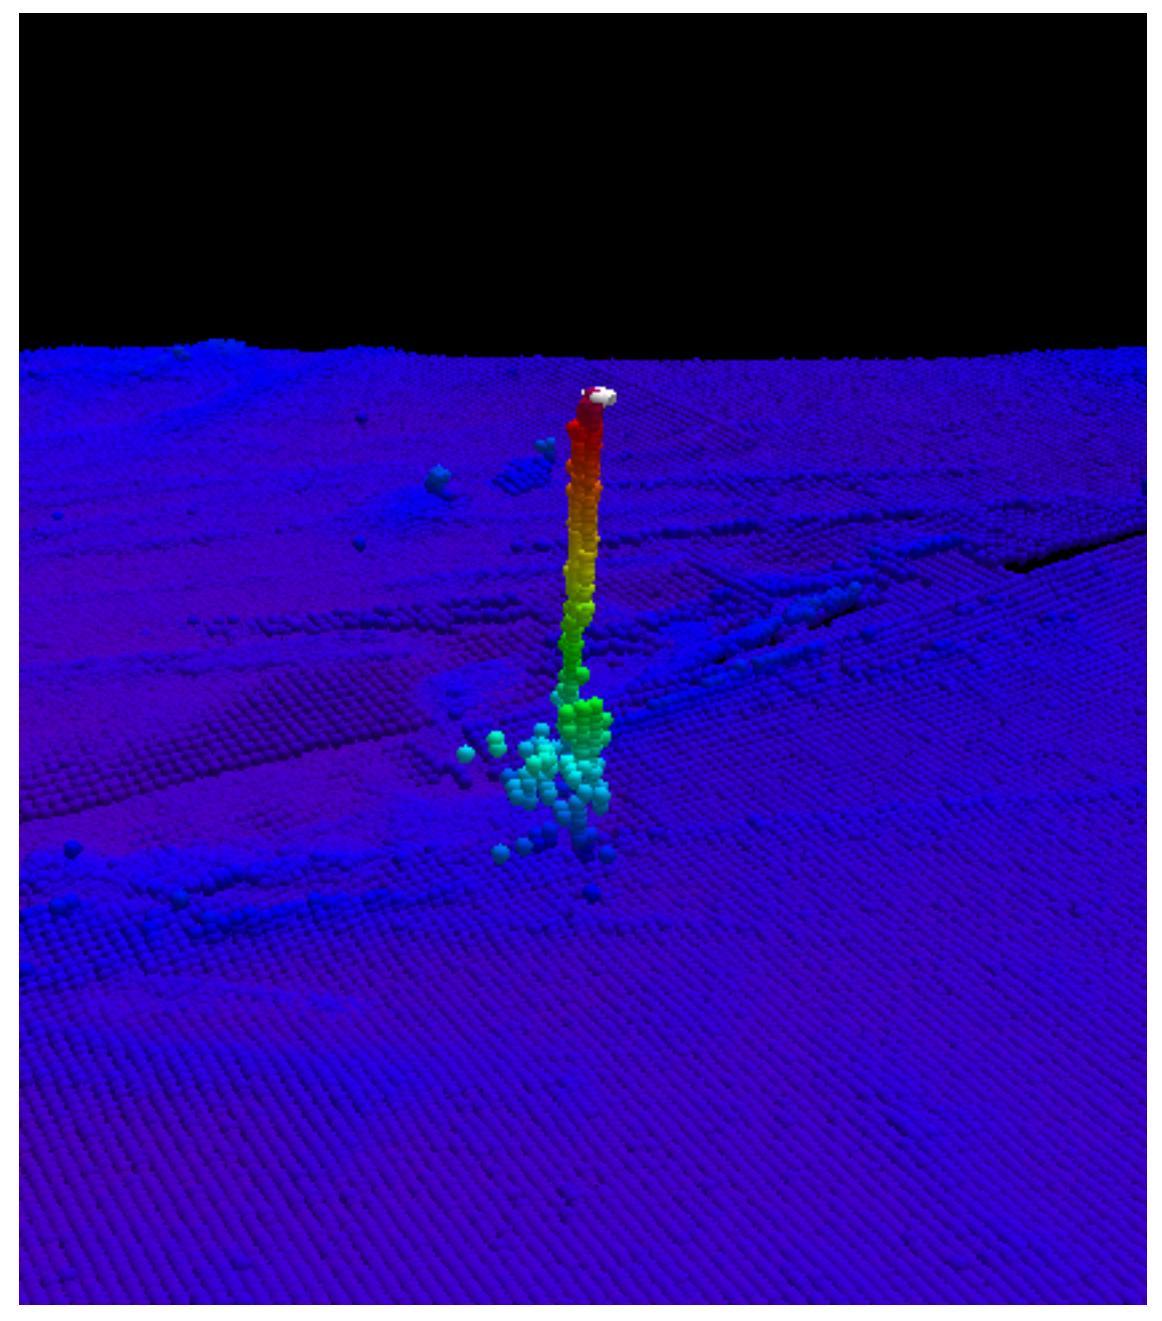
Figure 1.5.1
1.6) Obstruction 643/188

Uncharted area of dangerous obstructions located during H11295 survey operations. Objects appear to be piles from remains of fish traps with more piles laying on the sea floor. Items were initially located using 200% SSS and developed using a Reson 8125 multibeam echosounder. The least depth on this collection of features was found to be 12.06ft (3.68m) relative to the Chart datum. Surrounding water depths were 35.64ft (10.86m). Soundings were adjusted to the MLLW datum using verified water levels and final discrete tide zones.

Geo object 1: Obstruction (OBSTRN) Attributes: CATOBS - 6:foul area QUASOU - 6:least depth known SORDAT - 20071011 TECSOU - 2,3:found by side scan sonar,found by multi-beam VALSOU - 3.677 m VERDAT - 12:Mean lower low water WATLEV - 3:always under water/submerged

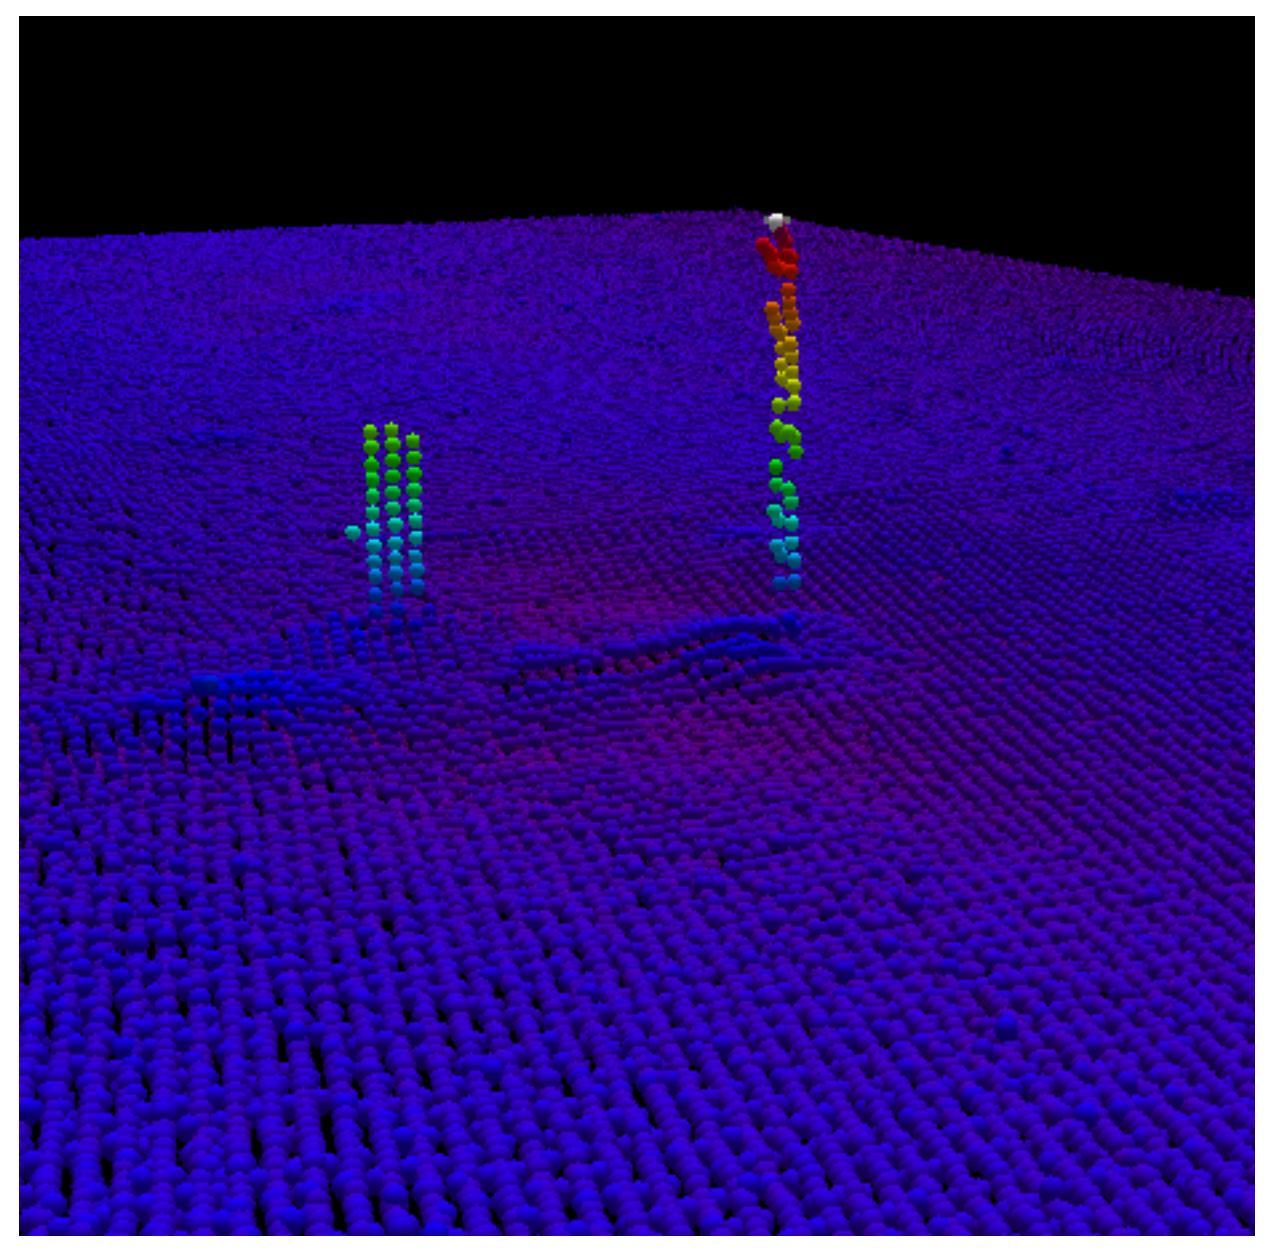
Figure 1.6.1

Uncharted dangerous obstruction located during H11295 survey operations. Object appears to be a pile with a few other smaller piles within 5m of surveyed position. Item was initially located using 200% SSS and developed using a Reson 8125 multibeam echosounder. The least depth on this feature was found to be 19.65ft (5.99m) relative to the Chart datum. Surrounding water depths were 29.53ft (9.00m). Soundings were adjusted to the MLLW datum using verified water levels and final discrete tide zones.

QUASOU - 1:depth known SORDAT - 20071011 TECSOU - 2,3:found by side scan sonar,found by multi-beam VALSOU - 5.989 m VERDAT - 12:Mean lower low water WATLEV - 3:always under water/submerged

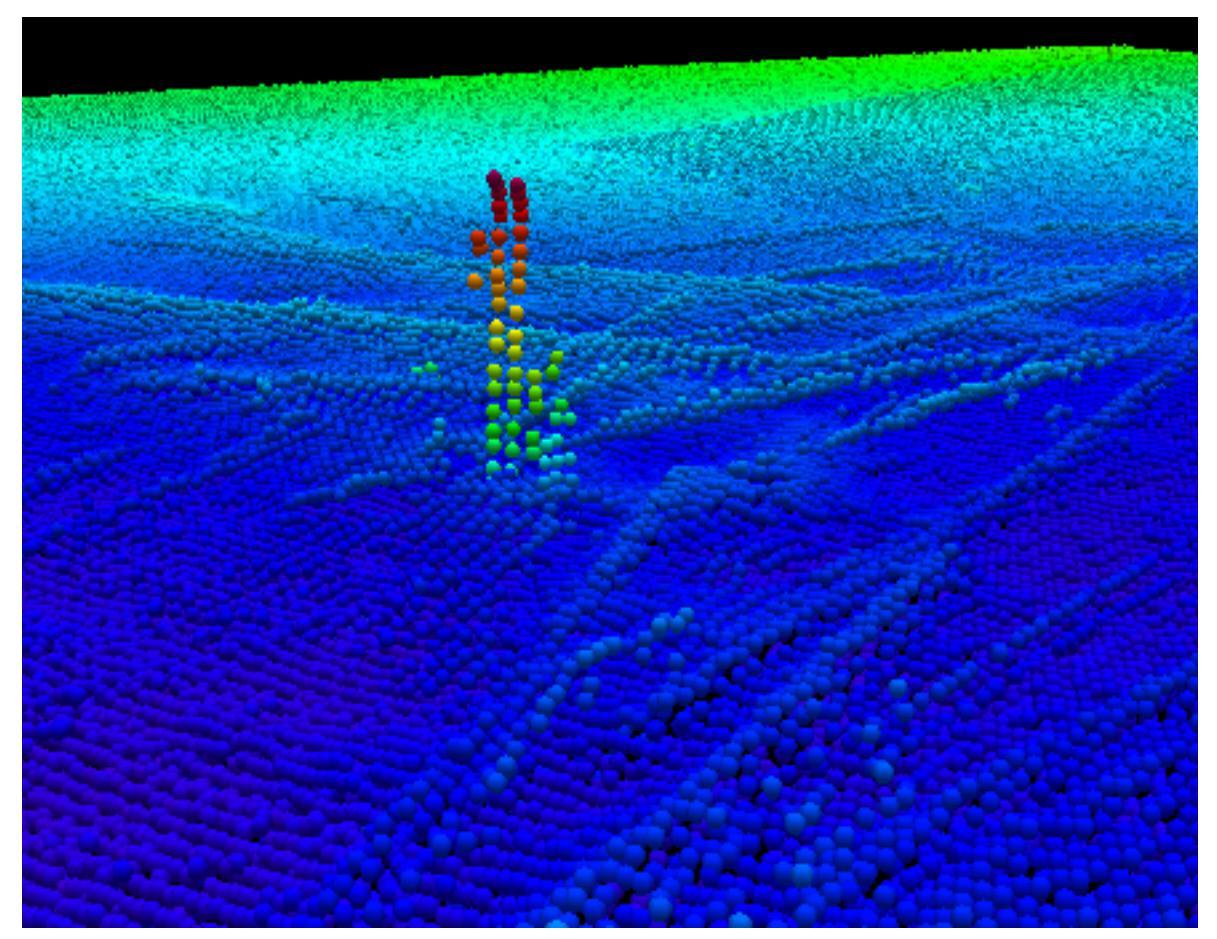
Figure 1.7.1

Uncharted area of dangerous obstructions located during H11295 survey operations. Objects appear to be piles from remains of fish traps with more piles laying on the sea floor. Items were initially located using 200% SSS and developed using a Reson 8125 multibeam echosounder. The least depth on this collection of features was found to be 23.15ft (7.06m) relative to the Chart datum. Surrounding water depths were 30.61ft (9.33m). Soundings were adjusted to the MLLW datum using verified water levels and final discrete tide zones.

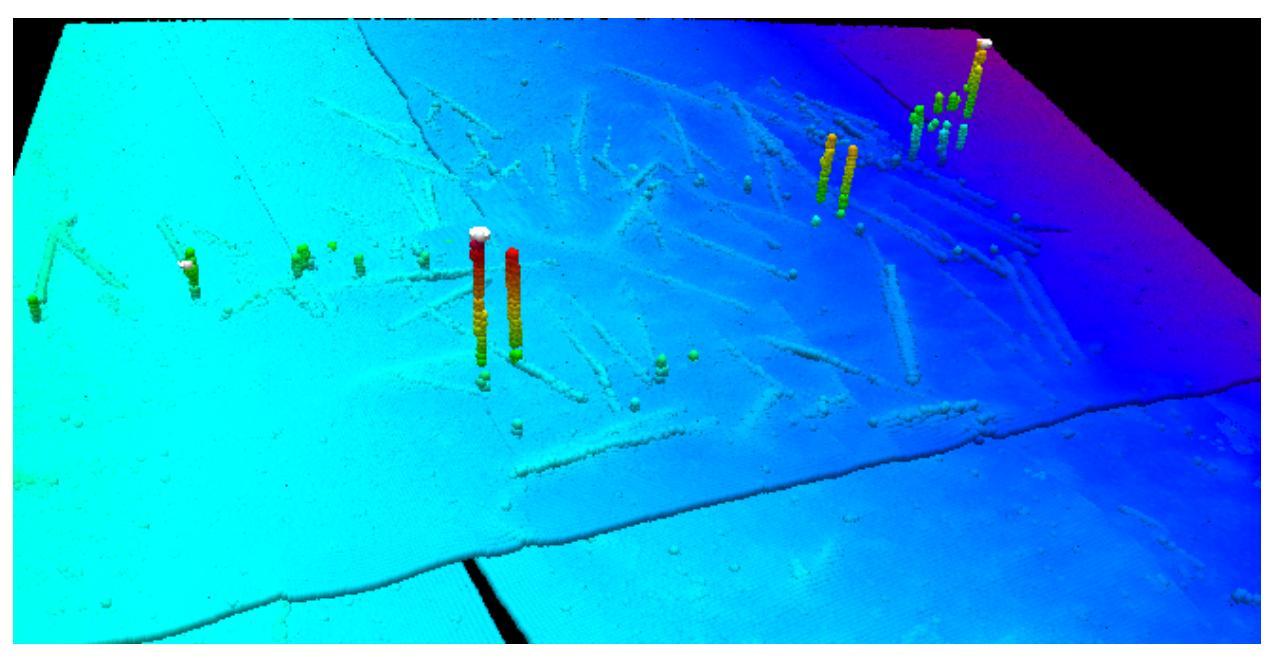
Figure 1.8.1

Uncharted area of dangerous obstructions located during H11295 survey operations. Objects appear to be piles from remains of fish traps with more piles laying on the sea floor. Items were initially located using 200% SSS and developed using a Reson 8125 multibeam echosounder. The least depth on this collection of features was found to be 14.61ft (4.45m) relative to the Chart datum. Surrounding water depths were 32.78 (9.99m). Soundings were adjusted to the MLLW datum using verified water levels and final discrete tide zones.

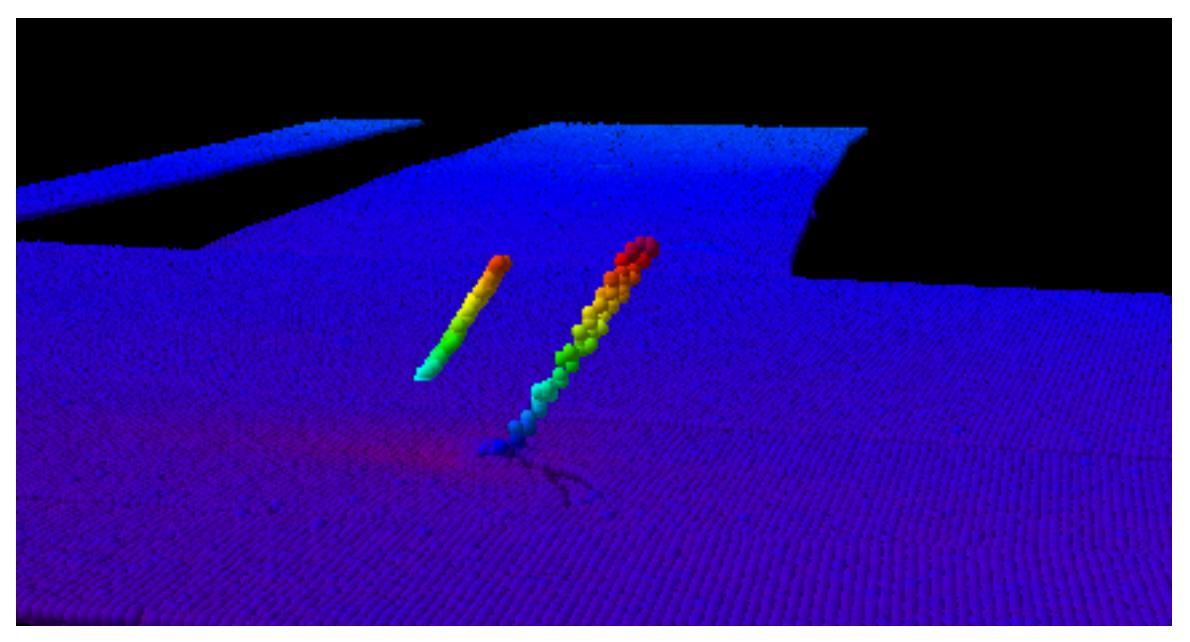
Figure 1.9.1

AWOIS 12191 was reported as a wrecked crane barge that originally had part of its boom above the surface. The area was surveyed with 200% SSS and developed with MBES. A light contact in SSS was found to be a pile or pipe sticking up off the bottom at 60° from horizontal with the MBES least depth of 10 feet (3.10 meters). Divers report the item to be a steel pipe approximately eight inches in diameter with no other wreckage apparent above the seafloor within a 50 foot radius. This item was reported as a DTON on 12/7/07. Hydrographer recommended removing charted wreck awash, position approximate, and charting a dangerous wreck in the surveyed location with a least depth of 10 feet in the DTON report. *Concur.*

LNM38/96-- (9/17/96); VIRGINIA-YORK RIVER-HAZARD TO NAVIGATION; A CRANE BARGE IS REPORTED SUNK IN THE YORK RIVER 1 NM SOUTHWEST OF SARAH'S CREEK IN APPROXIMATE POSITION LAT. 37-14.5N, LONG. 76-29.3W DOWNSTREAM FROM THE COLEMAN BRIDGE. IT IS REPORTED THAT ONLY A PORTION OF THE BOOM REMAINS VISIBLE ABOVE THE WATER. MARINERS ARE ADVISED TO TRANSIT THE AREA WITH EXTREME CAUTION. (ENT 2/2/04, SJV)

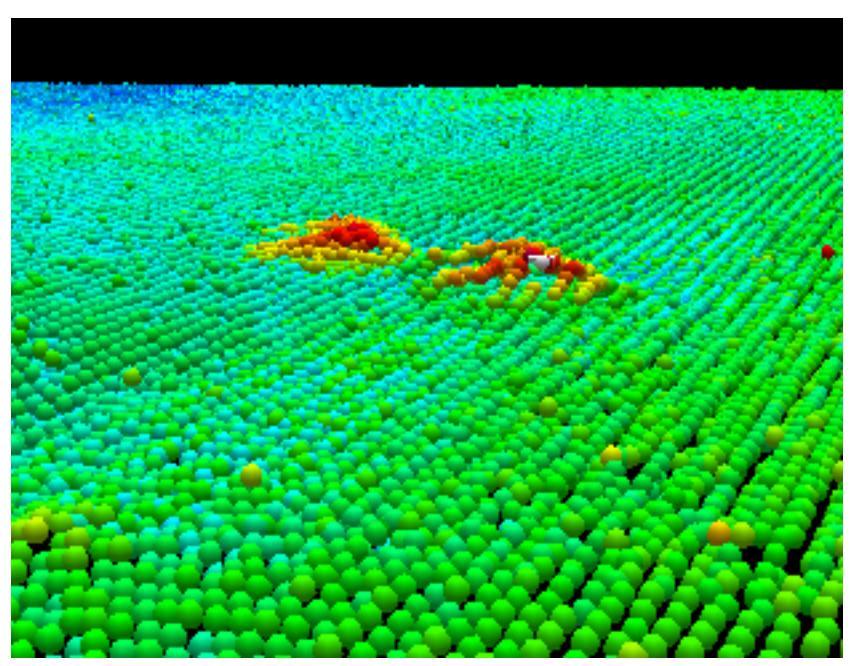
Figure 1.6.1

AWOIS 12141 was investigated with 200% SSS and MBES development. Nothing significant was seen in SSS. MBES development showed minimal structure on the bottom with a least depth of 36 feet (10.90 meters). Hydrographer recommends removing 27 foot obstruction and chart as 36 foot obstruction. *Concur.*

Concur with clarification. Chart an obstruction, least depth 36 feet (10.9m) in the present survey position. [Image file S:/Pydro_Proj/E-369_York_River/H11295 Sheet A/PSS/Images/549_0830_443-207.jpg does not exist.]

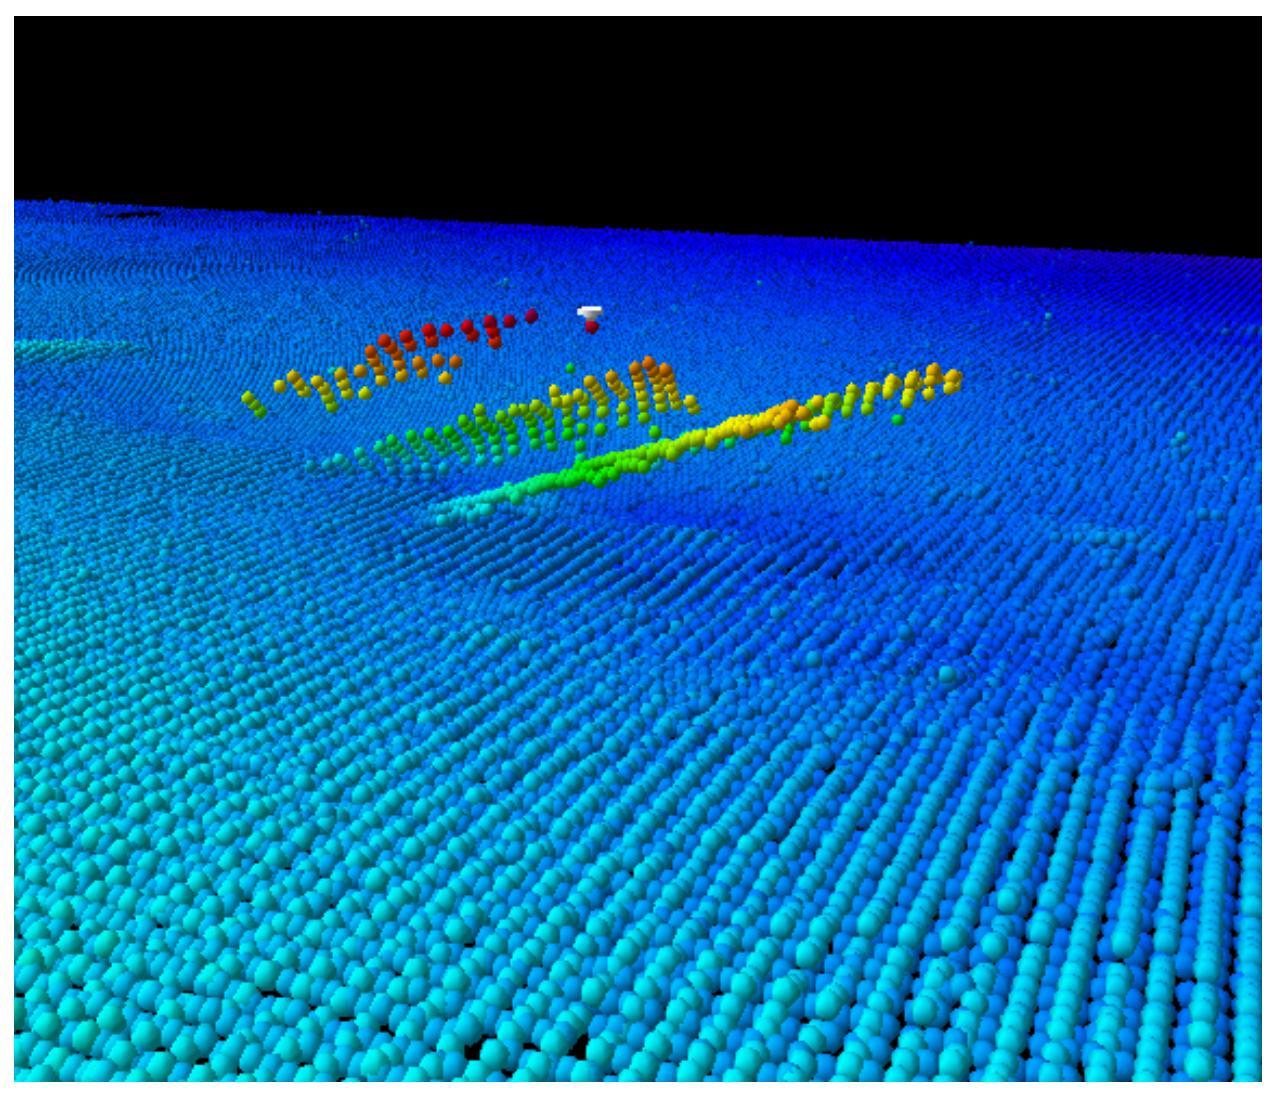
Figure 1.7.1

AWOIS 12142 was investigated with 200% SSS and MBES development. Nothing significant was seen in SSS imagery. MBES development measured a least depth of 30 feet (9.12 meters) on a pile that was 4m long and approximately 30 degrees from horizontal in the previously charted position. The hydrographer recommends retaining this item as charted. *Do not concur. Chart an obstruction as described in Appendix II of this report. Refer to Appendix II for detailed description of this item.*

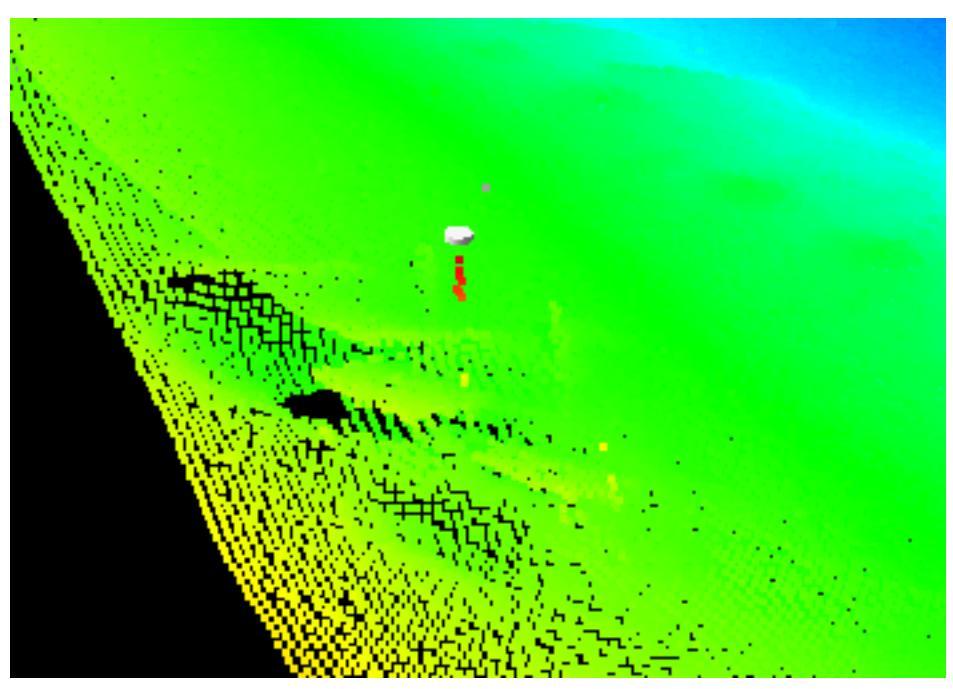
Figure 1.8.1

AWOIS 12195 was apparently a group of submerged piles from 1952. 200% SSS imagery showed no features. MBES development of the area measured a few piles which were designated as contacts and recommended for charting. No other significant contacts were found. *Concur.*

Concur. Chart an obstruction, least depth 19 feet (5.95m), in the present survey position. Delete charted piles at 37°14'04.090" N, 76°30'00.290" W and 37°14'03.905" N, 76°30'01.675" W.

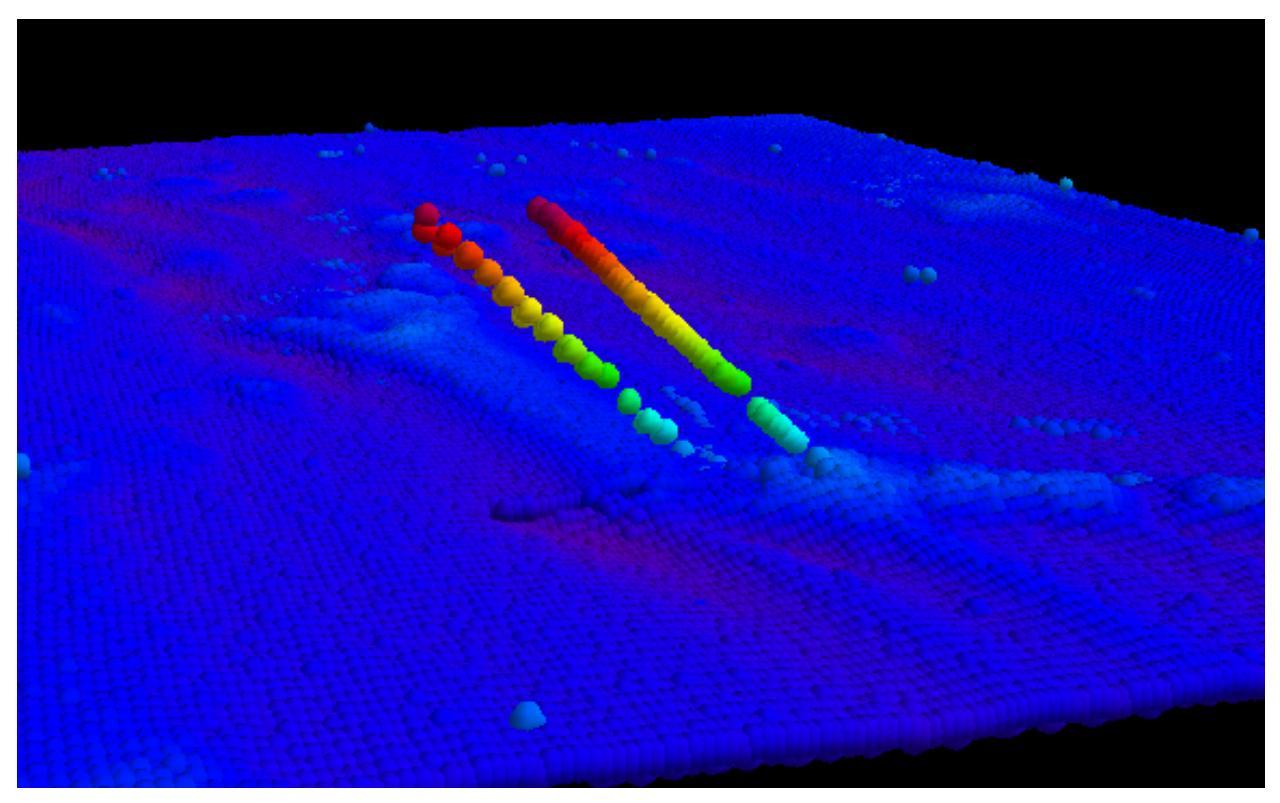
Figure 1.9.1

AWOIS 12390 was found with SSS. 200% SSS imagery shows a dark mass on the seafloor with no vertical structure. Multibeam development measures a least depth of 48.60 feet (14.81 meters) on a pile like item that is at 45° from horizontal. The hydrographer recommends to retain this item as charted. *Do not concur. The surveyed least depth is shoaler than the charted least depth. Chart an obstruction as described in Appendix II of this report. Refer to Appendix II for detailed description of this object.*

Concur. Retain obstruction as charted.

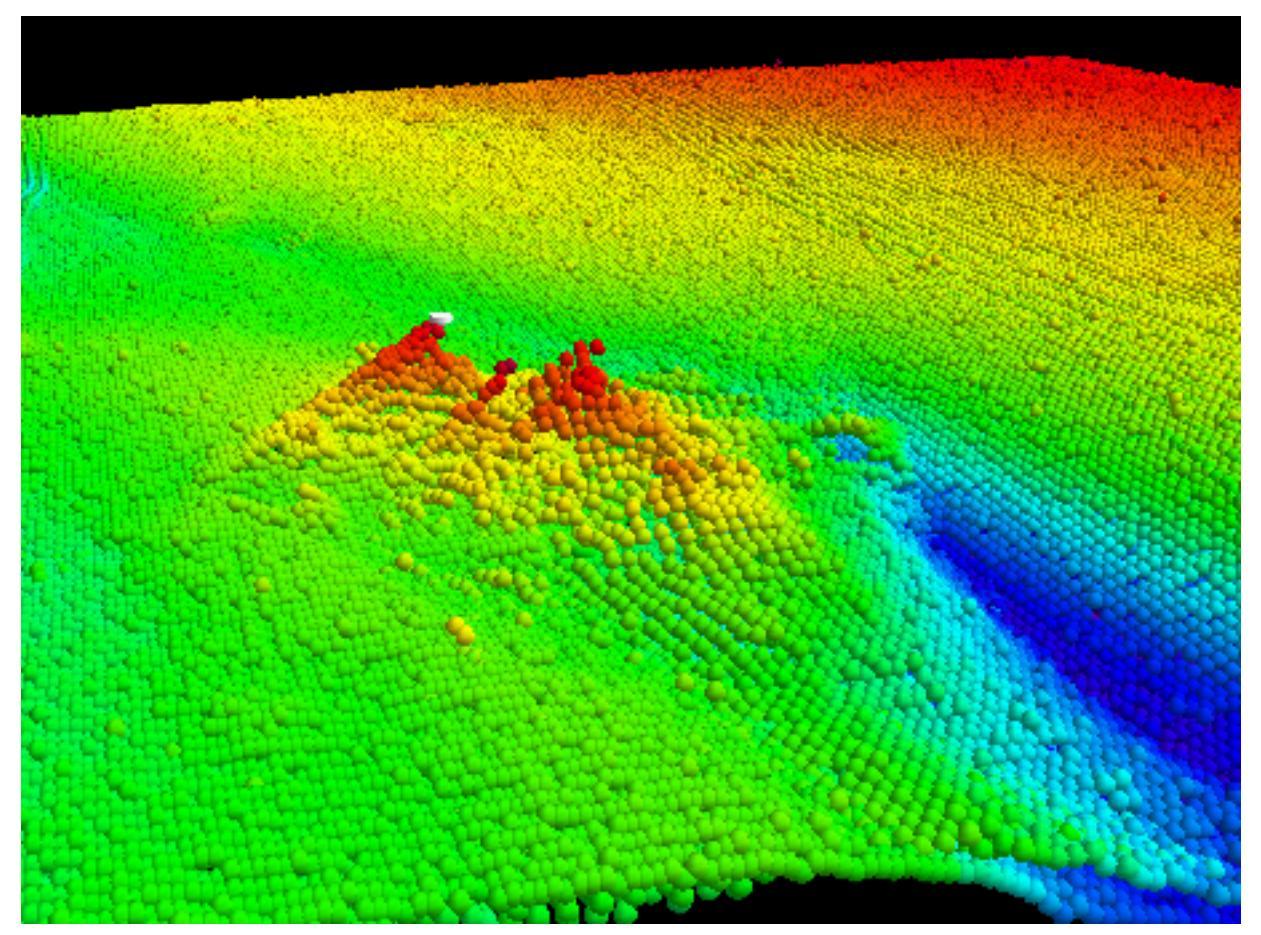
Figure 1.10.1

AWOIS 12393 was a wreck found on SSS with a least depth of 47 feet from MBES. Current 200% SSS was unable to find evidence of this wreck. MBES development measures a least depth of 47.74 feet (14.55 meters) with a height of 2.23 feet (0.68 meters) above the surrounding seafloor. The hydrographer recommends to retain this feature as charted. *Concur.*

Concur. Retain wreck as charted.

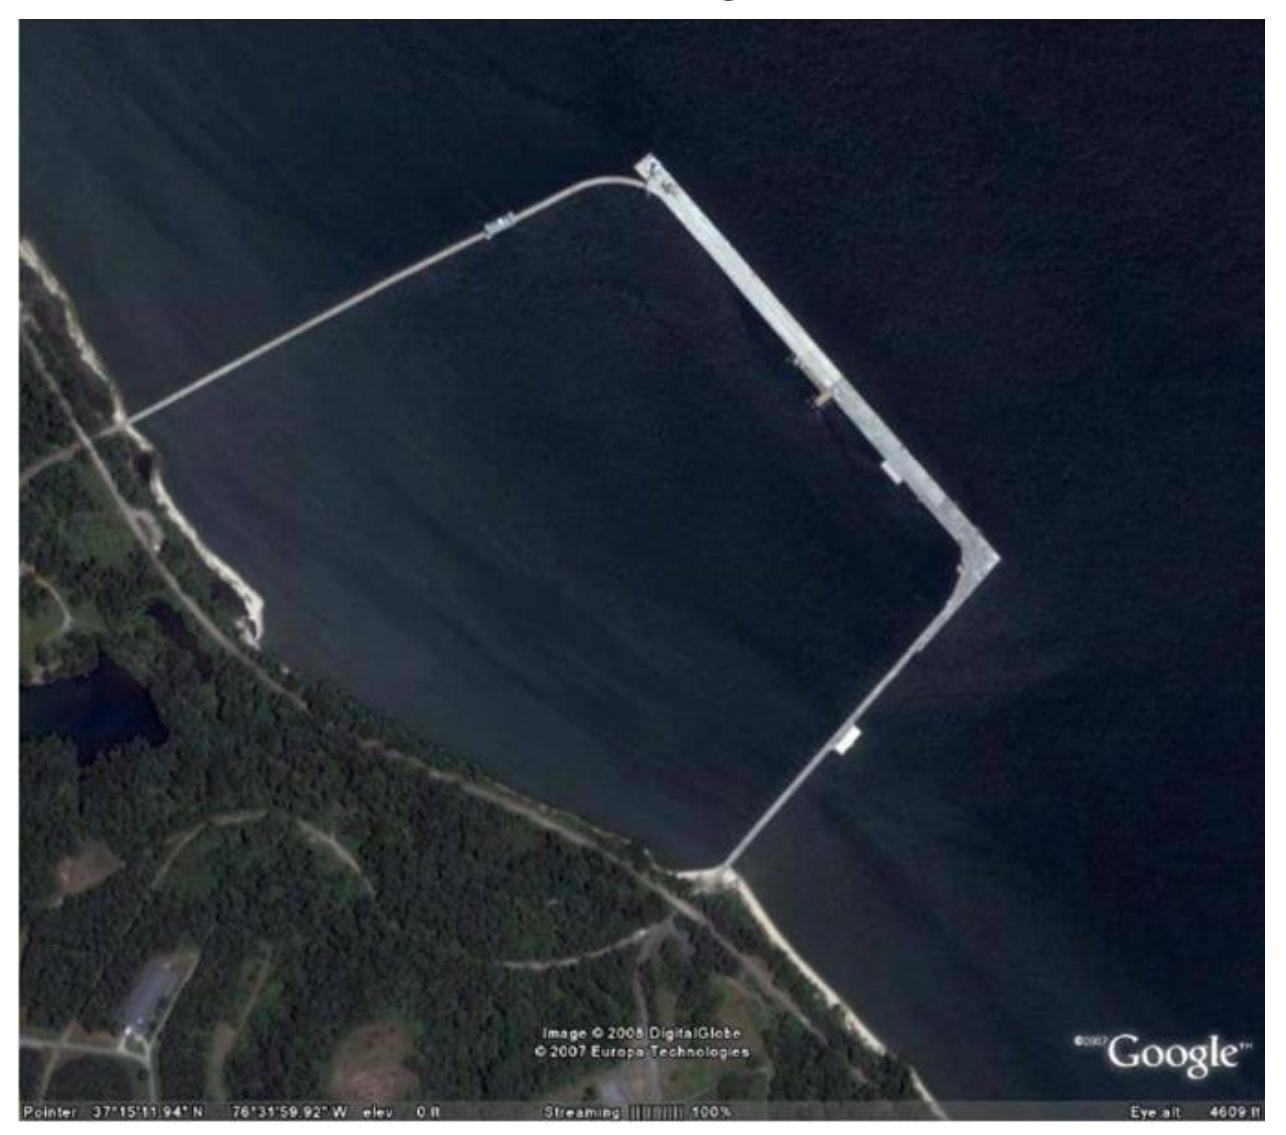
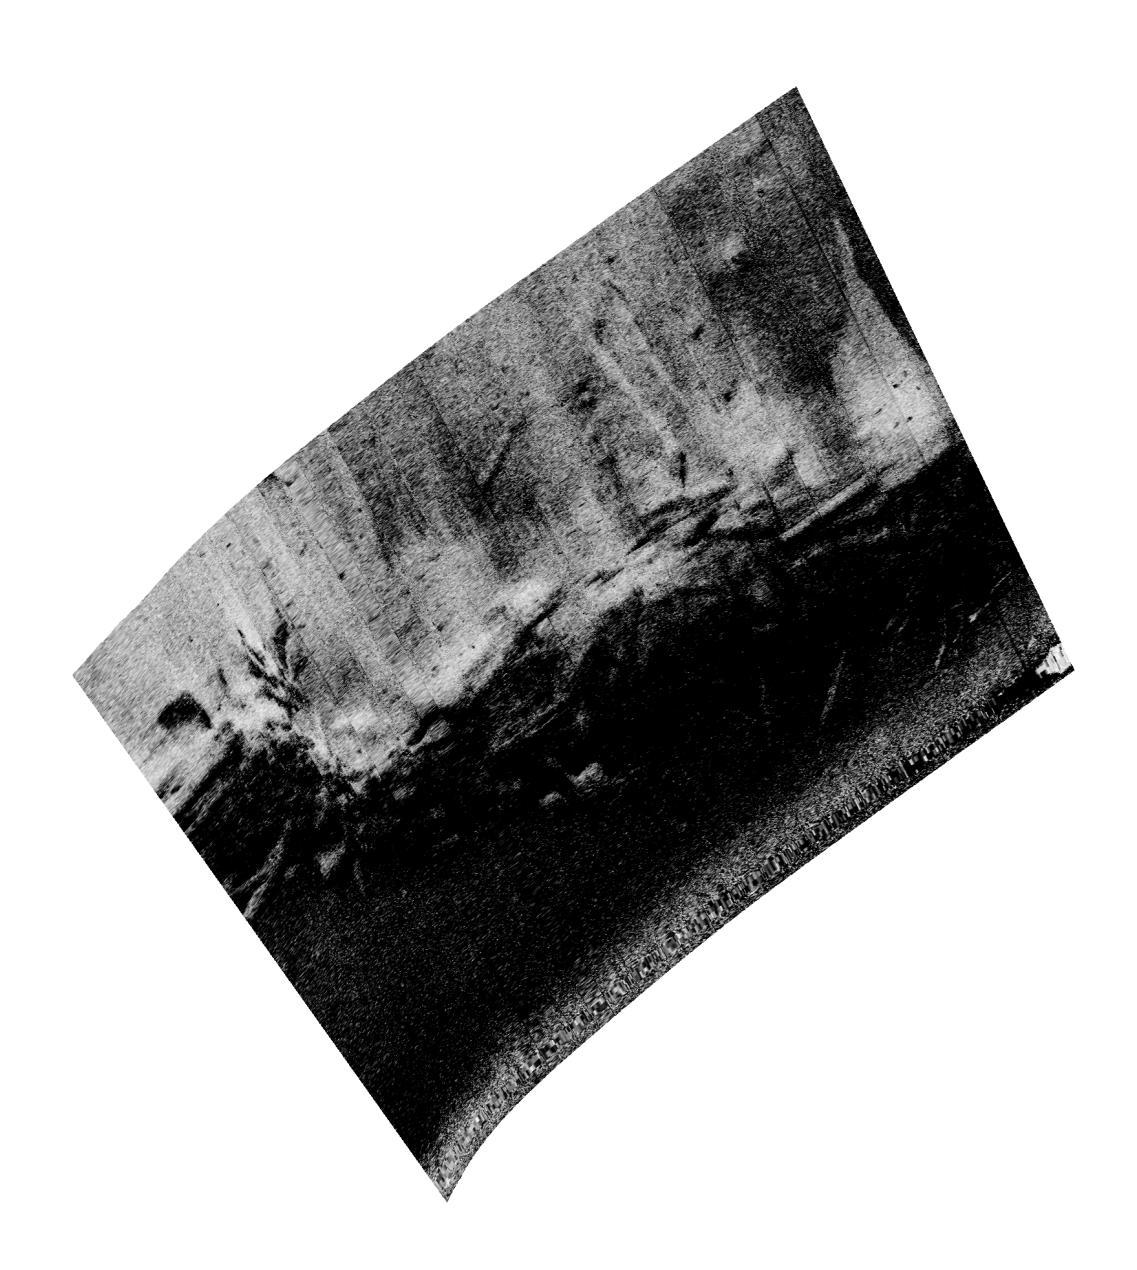
Figure 1.2.1

There was one charted feature of interest that was not covered under the AWOIS or other section of this report. The remains of a pier awash charted off Stony Point at the Yorktown Naval Weapons Station were not seen above the surface. SSS of the area showed remains of the pier were still present in the area charted. MBES coverage of the area was deemed too dangerous to acquire. The hydrographer recommends deleting the pier awash and charting submerged pier ruins at the currently charted location. All other features in Table 4 are located as charted and their representation on the chart is adequate. *See Evaluation Report.*

Concur with clarification. Part of this feature is shown on chart 12241 as a pier and part as a pier submerged. Google Earth imagery indicates no above water features. See Blue Notes for feature position. Recommend MCD reference photogrametry of area for final charting disposition of above water portion of pier.
