DESCRIPTIVE REPORT

H11295

General Locality: York River

Sub-locality: Indian Field Creek to the Entrance to the York River

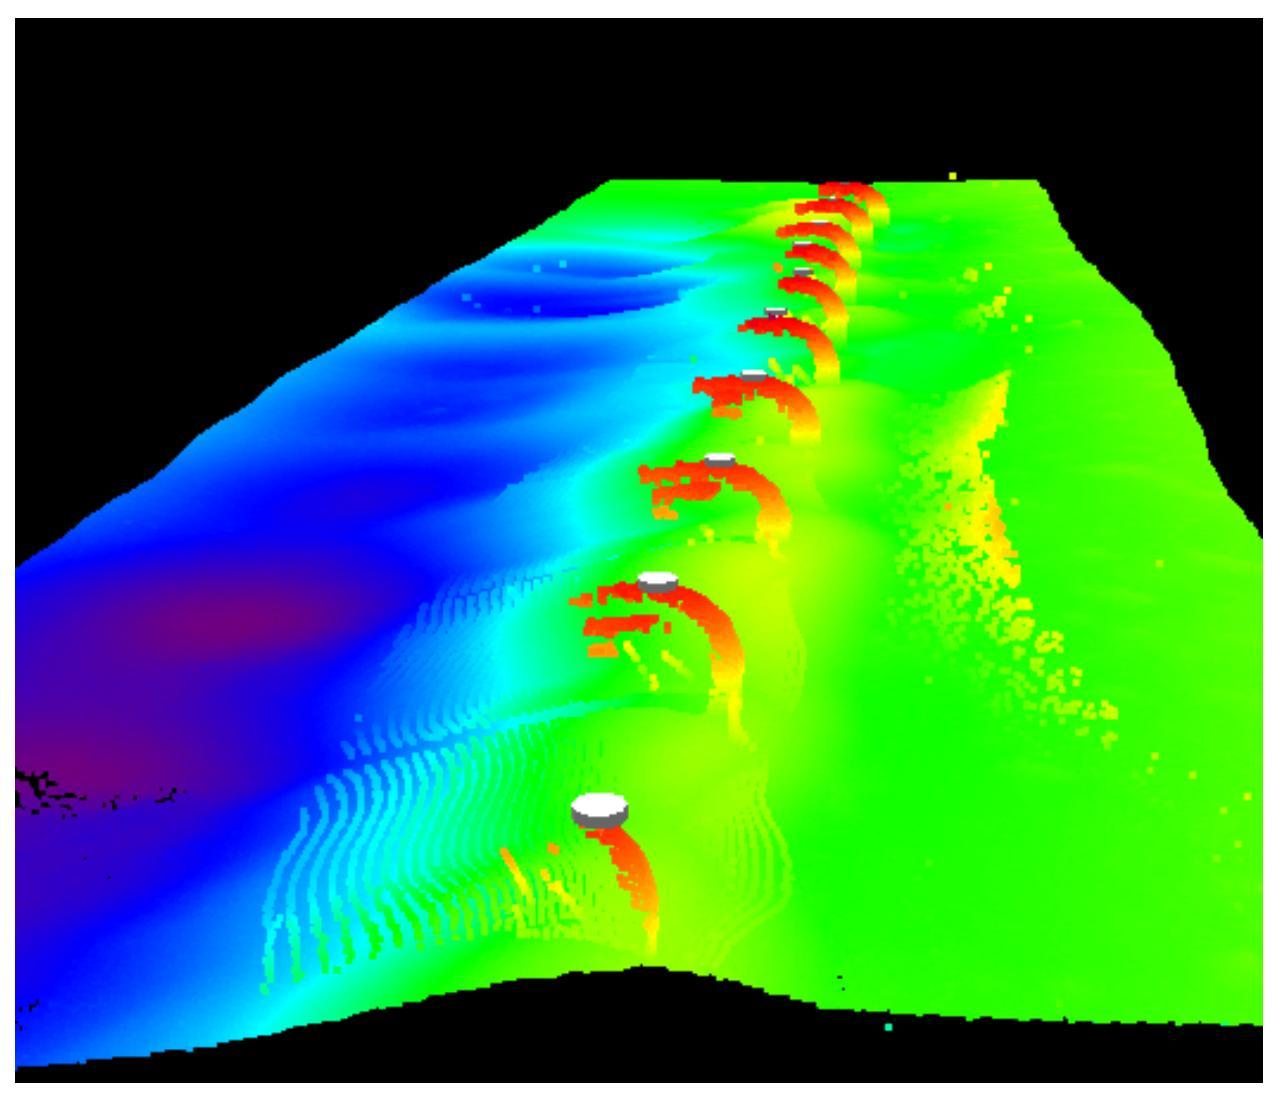
Figure 1.3.1

The sewer pipe west of Goodwin Neck was surveyed and is not charted properly. Charting recommendation are deferred to the Marine Chart Division as this is a permitted feature. Further information on this feature is included in the Pydro Survey Feature Report in Appendix II*. Concur. The field unit did not address a charted pipe and cable area in the vicinity of the Coleman Memorial Bridge. Side scan sonar imagery from the area was examined by the office processor. No visible pipes or cables were found. Recommend retaining this notation as charted.

As this item is located well outside the shipping channel and is marked by a light, the office processor does not feel that this items requires submission as a DTON.
