NOAA FORM 76-35A
	U.S. DEPARTMENT OF COMMERCE NATIONAL OCEANIC AND ATMOSPHERIC ADMINISTRATION NATIONAL OCEAN SERVICE
	DESCRIPTIVE REPORT
CC	Type of Survey Hydrographic Survey Field No. N/A Registry No. H11551
	LOCALITY         State       Washington         General Locality       Colvos Passage and Vicinity         Sublocality       Quartermaster Harbor         2007       CHIEF OF PARTY         Commander Guy T. Noll, NOAA
	LIBRARY & ARCHIVES

# **Descriptive Report to Accompany Hydrographic Survey H11551**

Project OPR-N395-RA-07 Colvos Passage and Vicinity, Washington Vicinity of Quartermaster Harbor Scale 1:10,000 April, 2007 **NOAA Ship RAINIER (s221)** Chief of Party: Commander Guy T. Noll, NOAA

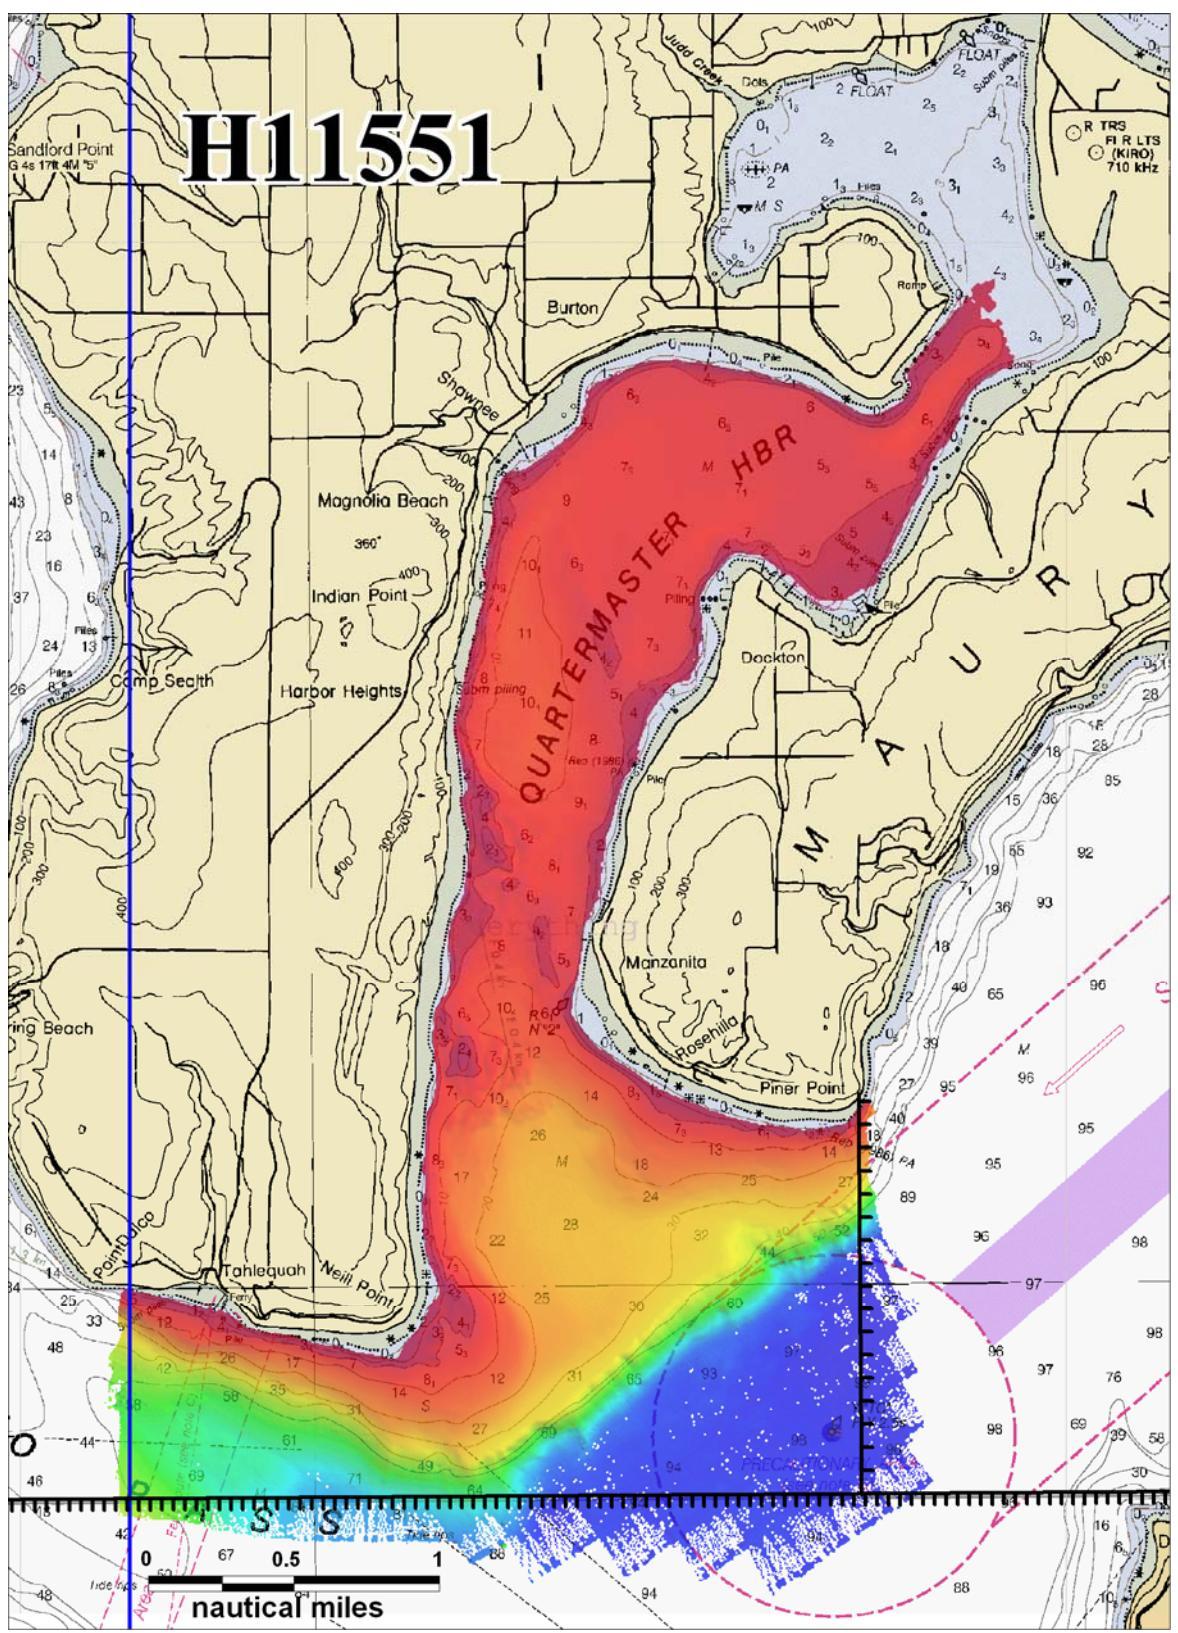
Figure 1. H11551 bathymetric data displayed on chart 18474.

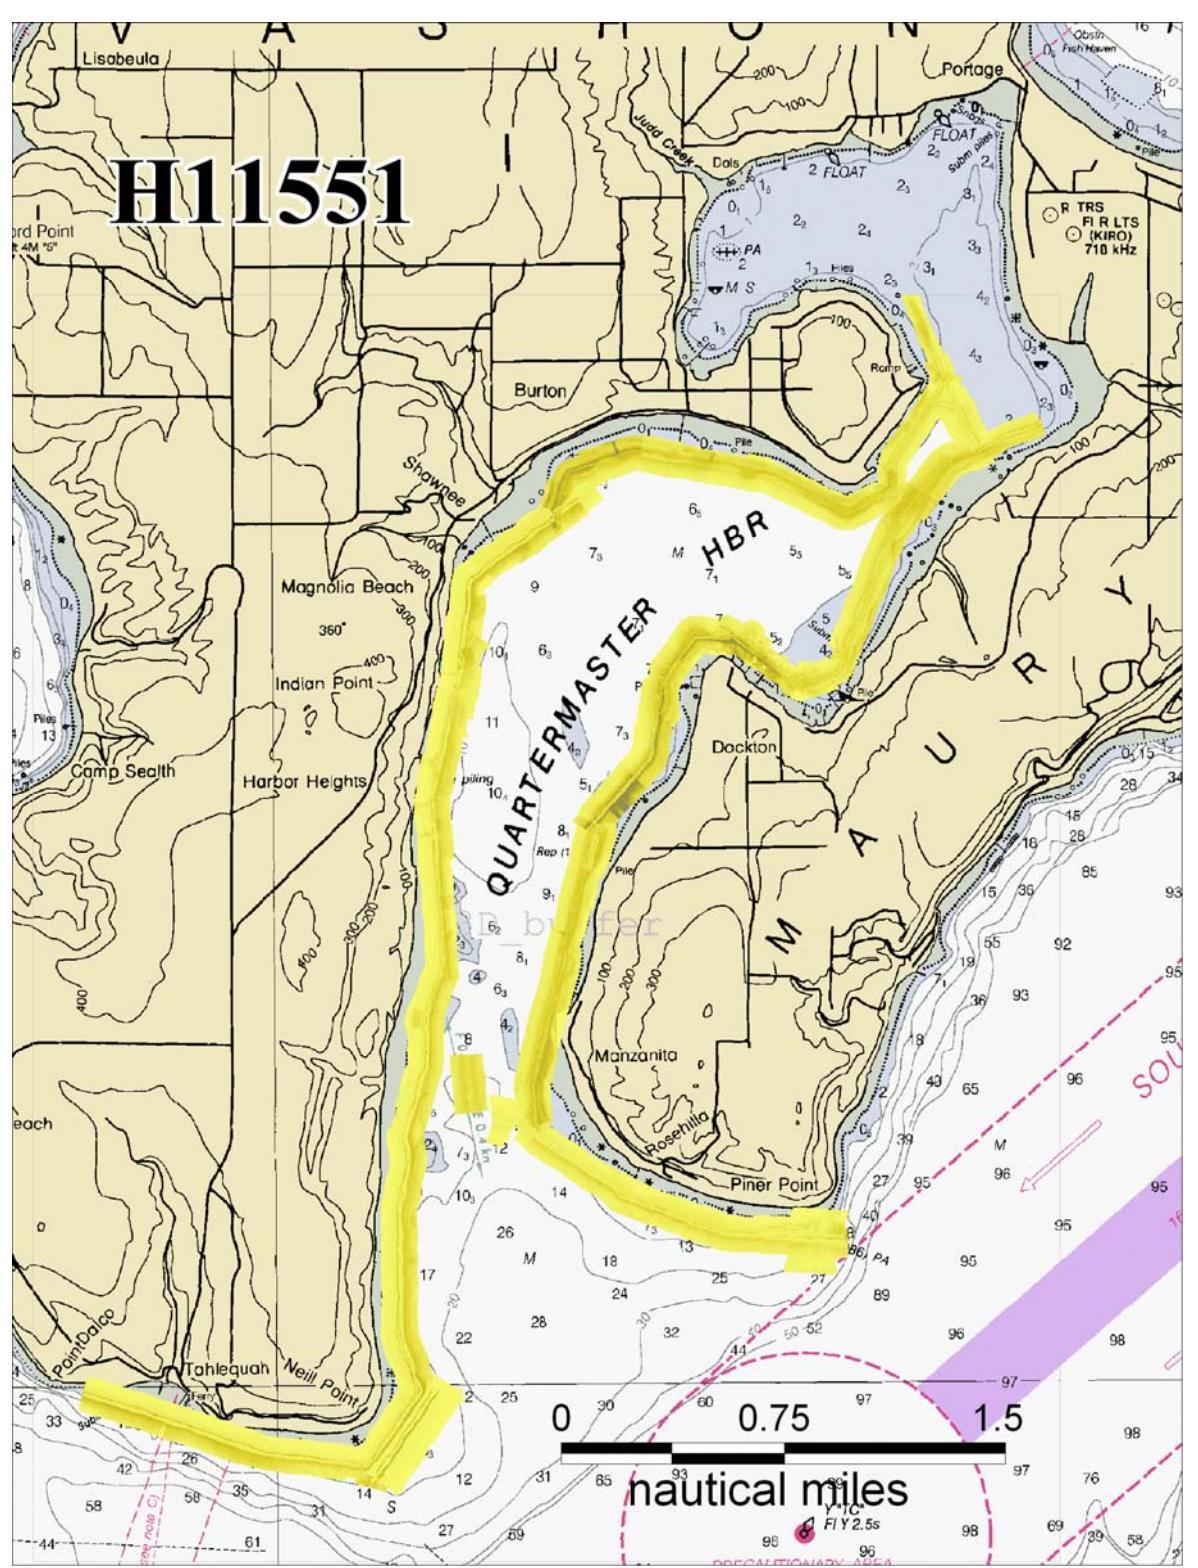
Figure 2. H11551 Side Scan Sonar mosaic from the Teledyne Benthos C3D Interferometric sonar displayed on chart 18474.

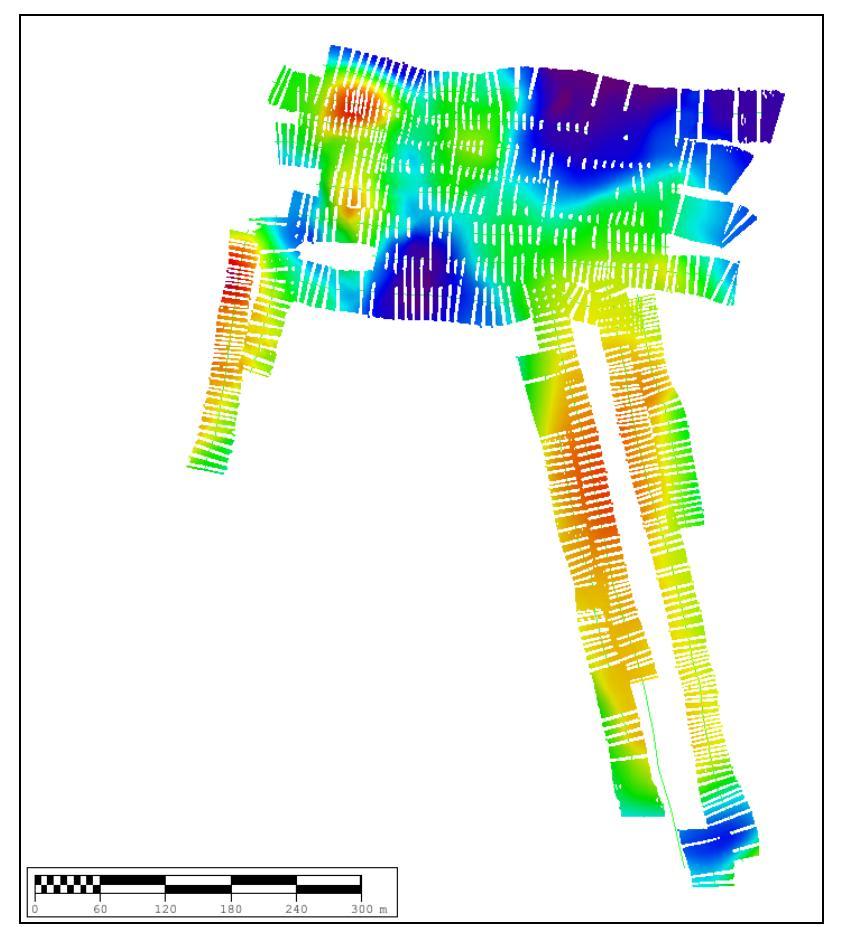
Intermittent data was acquired from launch 1016 on the first day of acquisition (DN100) in Quartermaster Harbor (see Figure 3). Subsequent trouble shooting traced the problem to a new version of the Triton Isis data acquisition software (ver 7.1.428.53) installed during the 2006-2007 winter import. This version of ISIS features a "True 3D" window displaying three-dimensional bathymetry as it is acquired. When this display is enabled, load on the acquisition computer increases to the point that Ethernet packets from the Reson processor are dropped. Disabling the "True 3D" and returning to the traditional "Scroll 3D" view eliminated the problem. The affected lines were rerun, but the data from DN100 was determined to be otherwise acceptable and retained as well.

Figure 3: Data acquired by launch 1016 on day number 100.

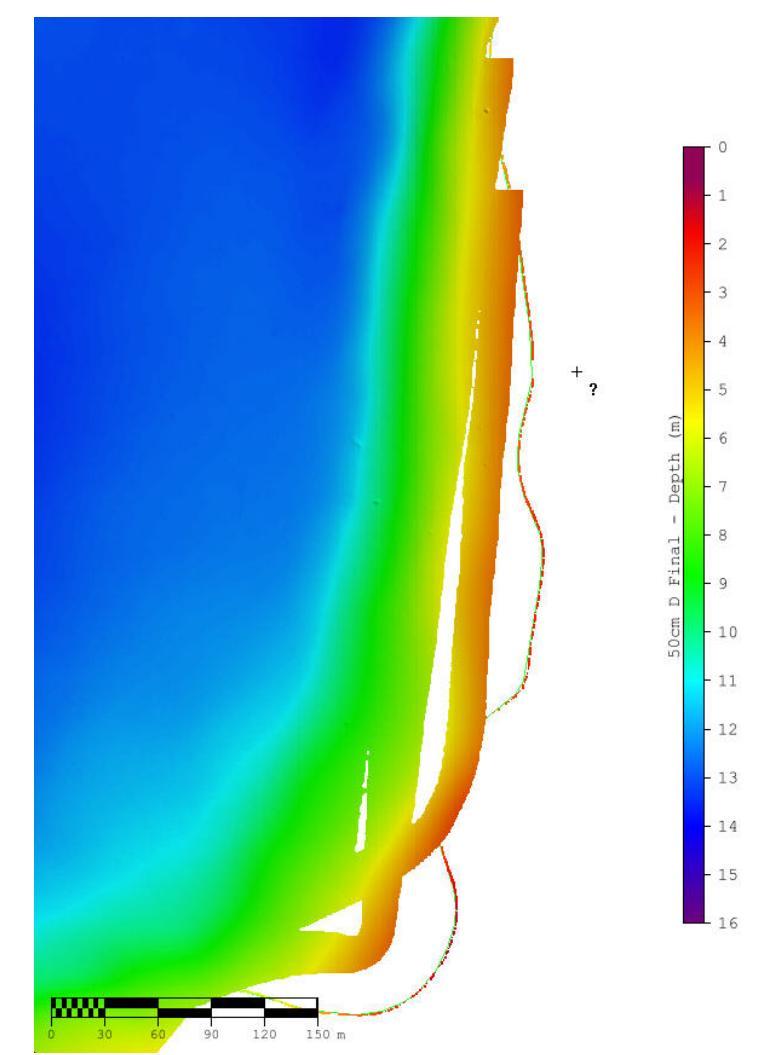
- In some areas, complete multibeam echsounder coverage was not achieved in waters between 8 meters depth and the inshore limit of the survey (see Figure 4). However, in all cases these gaps were covered by 200% side scan sonar, and are free of significant features. The hydrographer recommends that coverage be considered complete across these gaps, and that the survey supersede all prior survey and charted data in the common area.<sup>8</sup>

Figure 4: Holidays on the edge of the sheet. 200% SSS was acquired around the perimeter and covered these holiday areas.

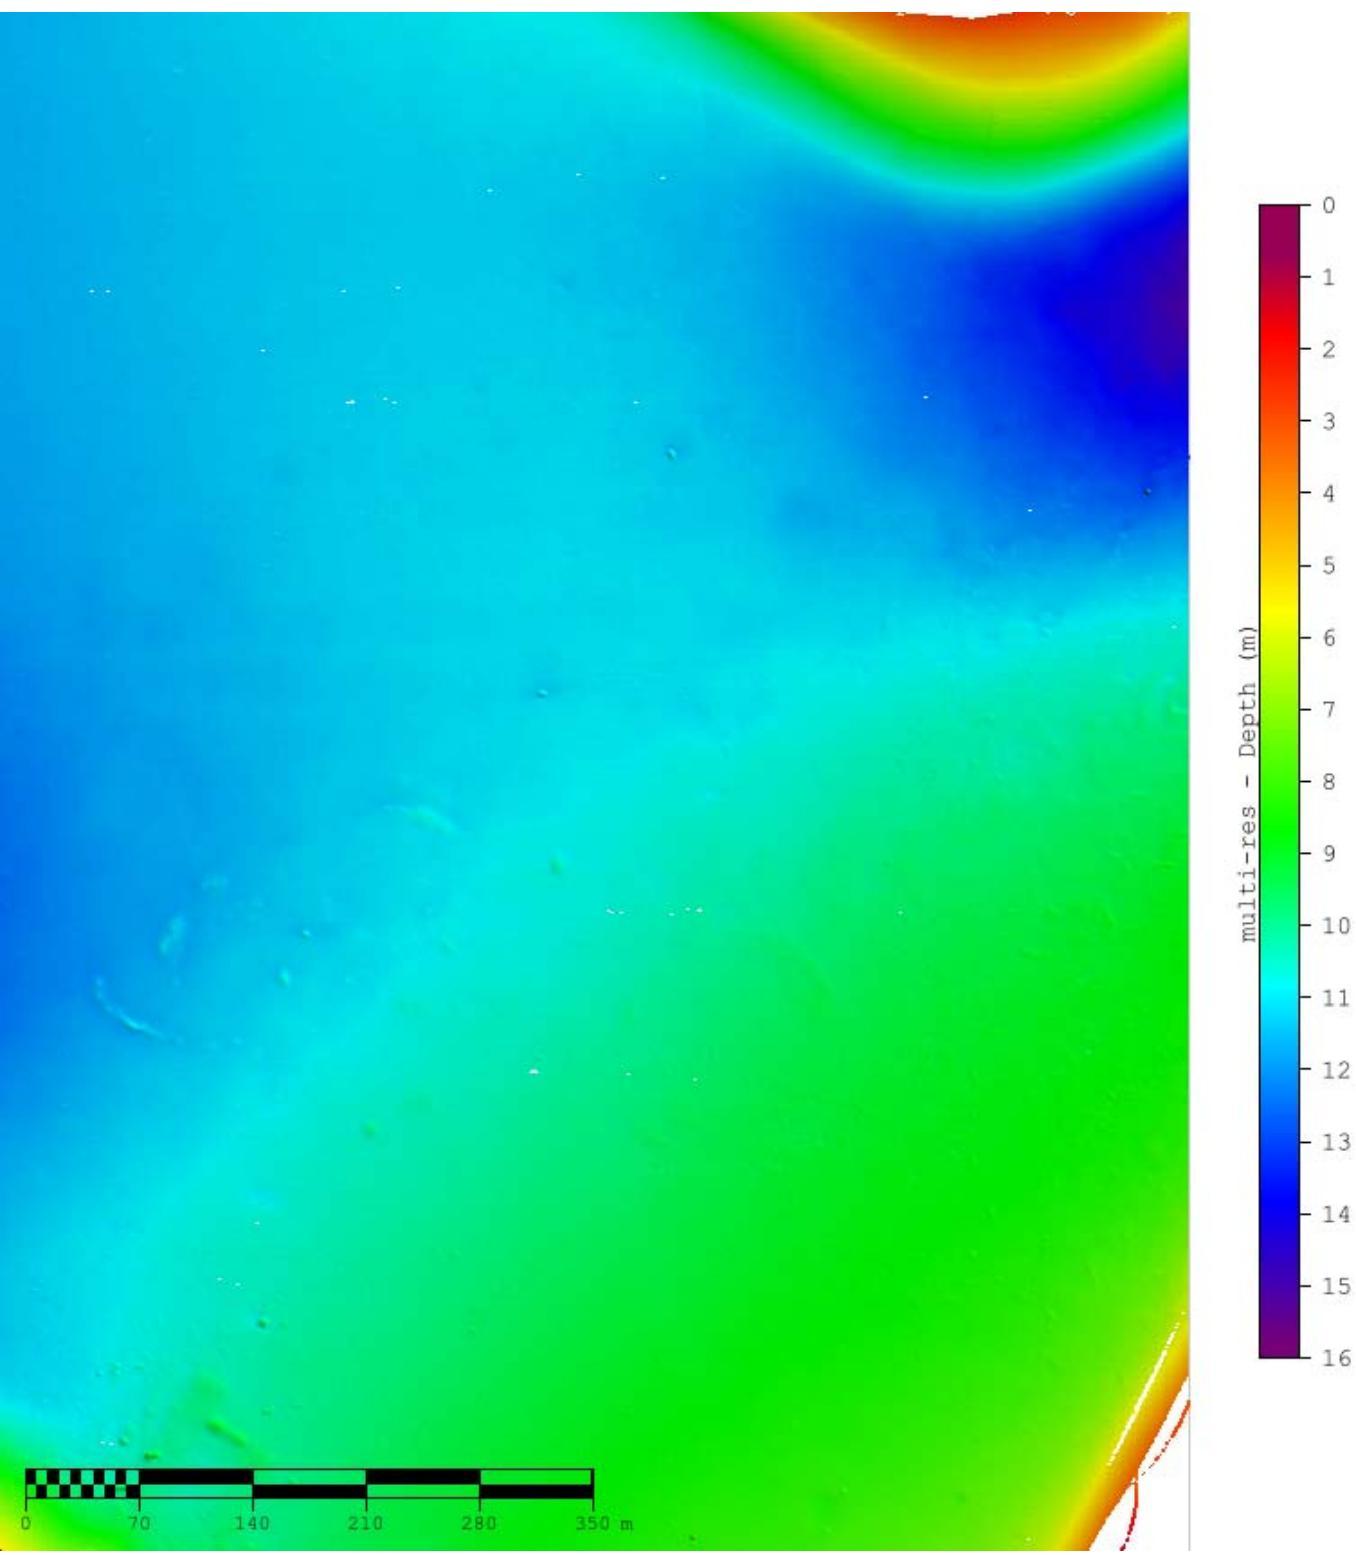
Figure 5: No apparent holidays appear in the multi-resolution BASE surface.

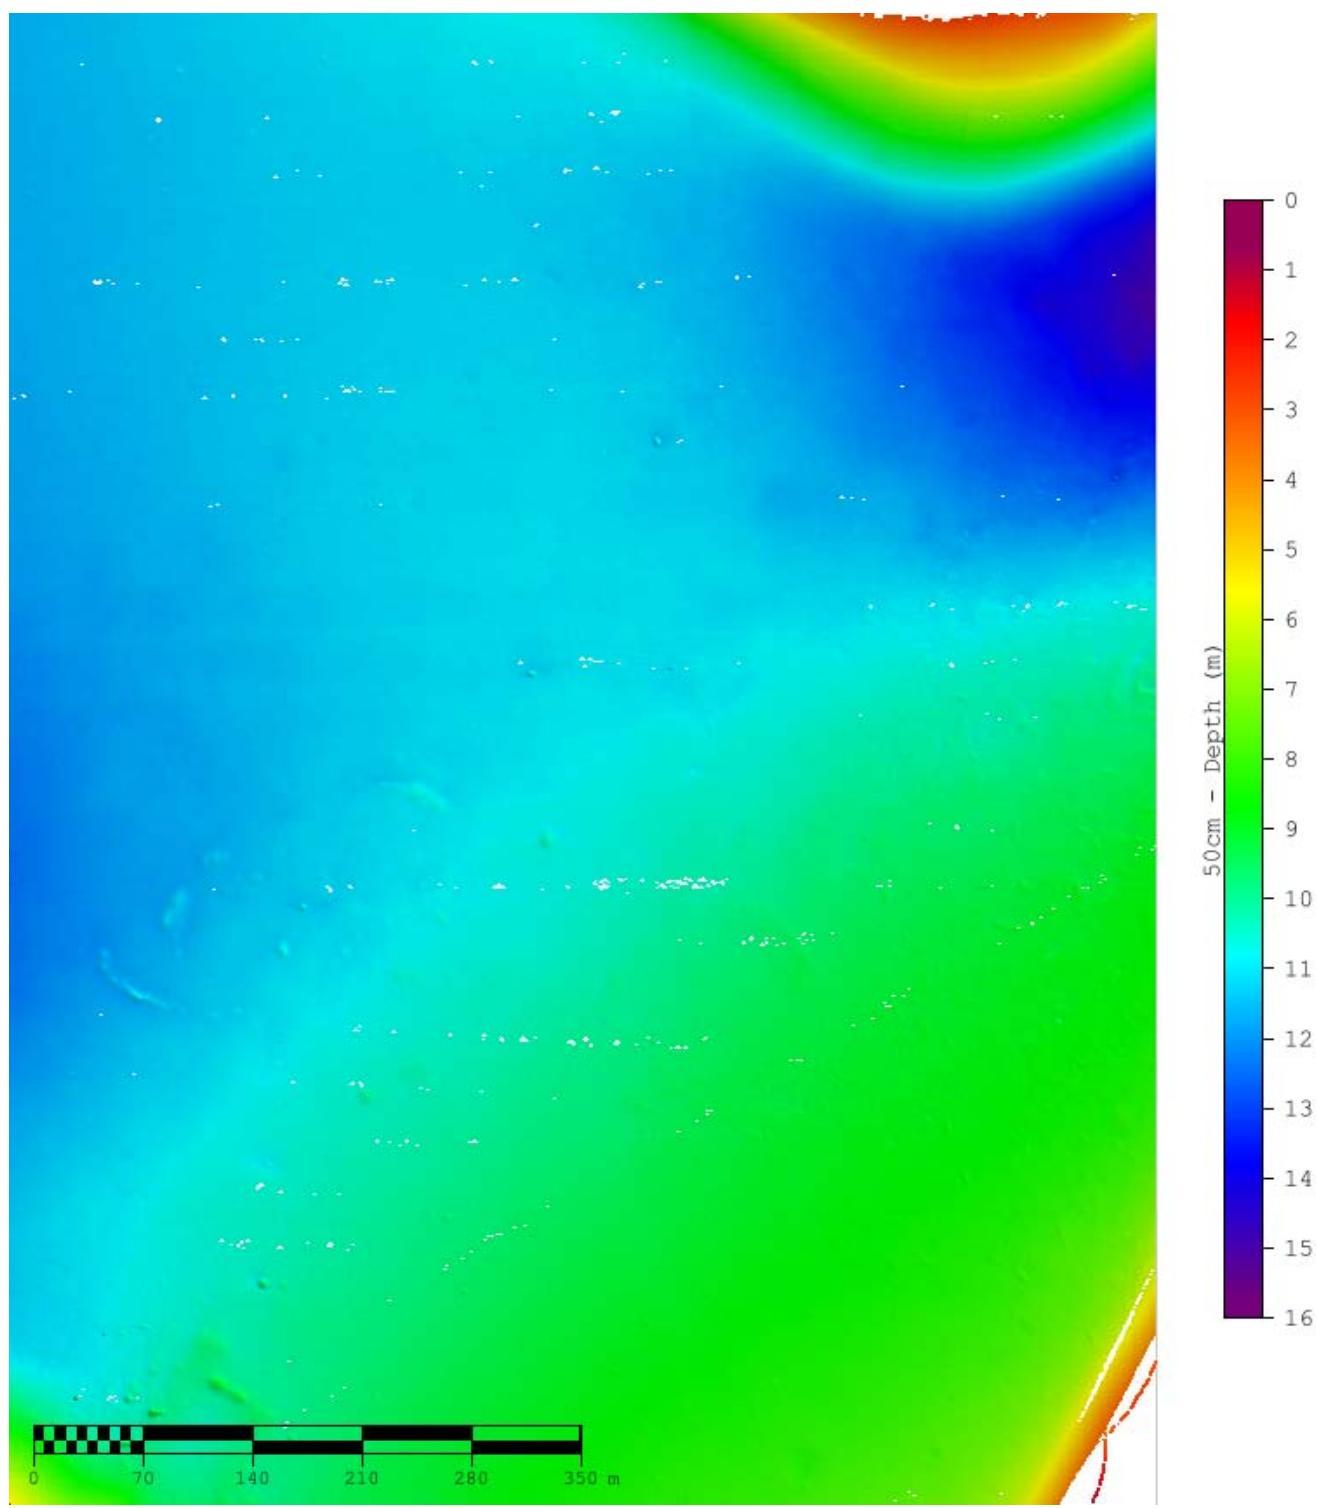
- Multiple resolution BASE surfaces were used for daily processing and coverage assessment of this survey, as described in the *OPR-N395-RA-07 Data Acquisition and Processing Report.* After RAINIER had left the survey area, it was discovered that CARIS HIPS 6.1 was not honoring the selected CUBE parameters for multiple resolution grids. Although RAINIER personnel selected the "Shallow" CUBE parameters, HIPS applied the default parameters. This resulted in small gaps in the final, single resolution BASE surfaces created after the survey was complete (See Figure 6). These areas had been free of holidays in the multiple resolution grids (See Figure 5). Although many of the gaps are larger than the 3 node maximum allowed under the NOS Hydrographic Surveys Specifications and Deliverables, the hydrographer considers the coverage adequate and recommends that H11551 supersede all prior survey and charted data in the common area. As of this writing, CARIS has issued a preliminary fix for this issue, and an official software update is expected soon.<sup>9</sup>

Figure 6: Holidays apparent in a single resolution BASE surface of the same area.

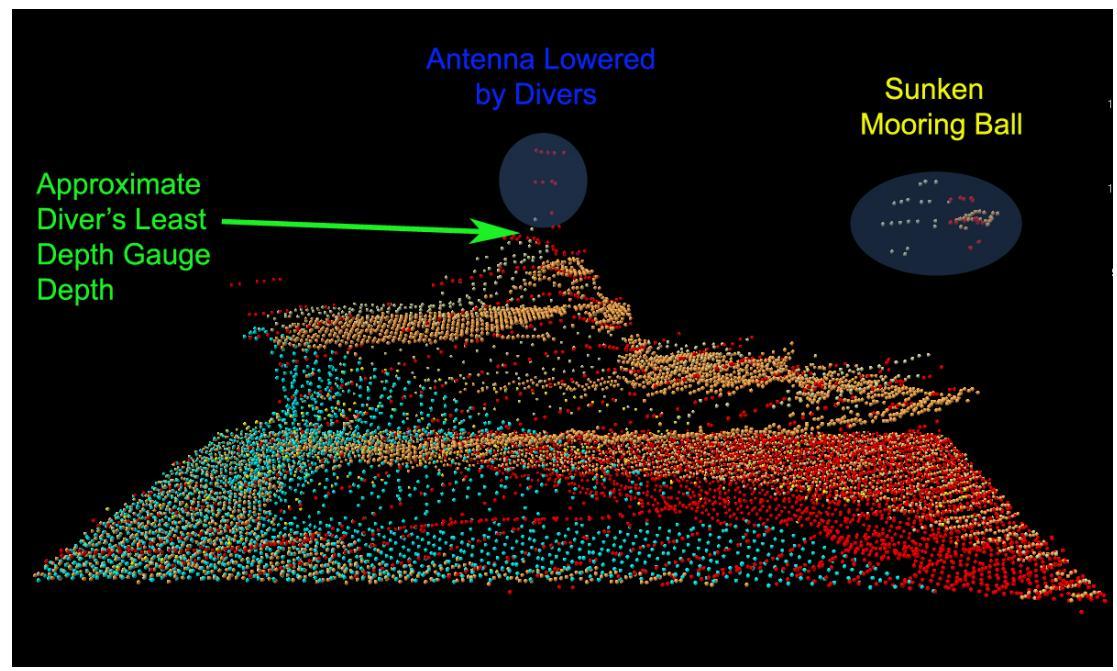
The DTON report submitted for feature "522/1" was based on a preliminary least depth which should be revised when this survey is compiled. The feature is a wreck in position 47° 22' 24" N, 122° 27' 23" W. Although the wreck was investigated by divers, the Diver's Least Depth Gauge (DLDG) data could not be immediately processed due to a problem with the Velociwin software. In the interest of notifying mariners of the hazard as quickly as possible, the DTON was submitted with the multibeam least depth. Subsequent processing of the DLDG data and reassessment of the MBES bathymetry revealed that the MBES depth was a sounding on an antenna on the wreck which was lowered by the divers during the investigation. The DLDG reading was taken at the highest point on the sunken vessel itself (see Figure 11). The hydrographer recommends that the MBES least depth submitted with the DTON be superseded by the deeper DLDG depth when the survey is compiled.<sup>16</sup>

*Figure 11: The antenna was lowered by divers and a diver's least depth gauge depth was taken on the highest point of the sunken vessel. The soundings in the bubbles have been rejected in the data.*

<sup>16</sup> Concur. The diver's least depth gauge depth is reflected in the HCell.

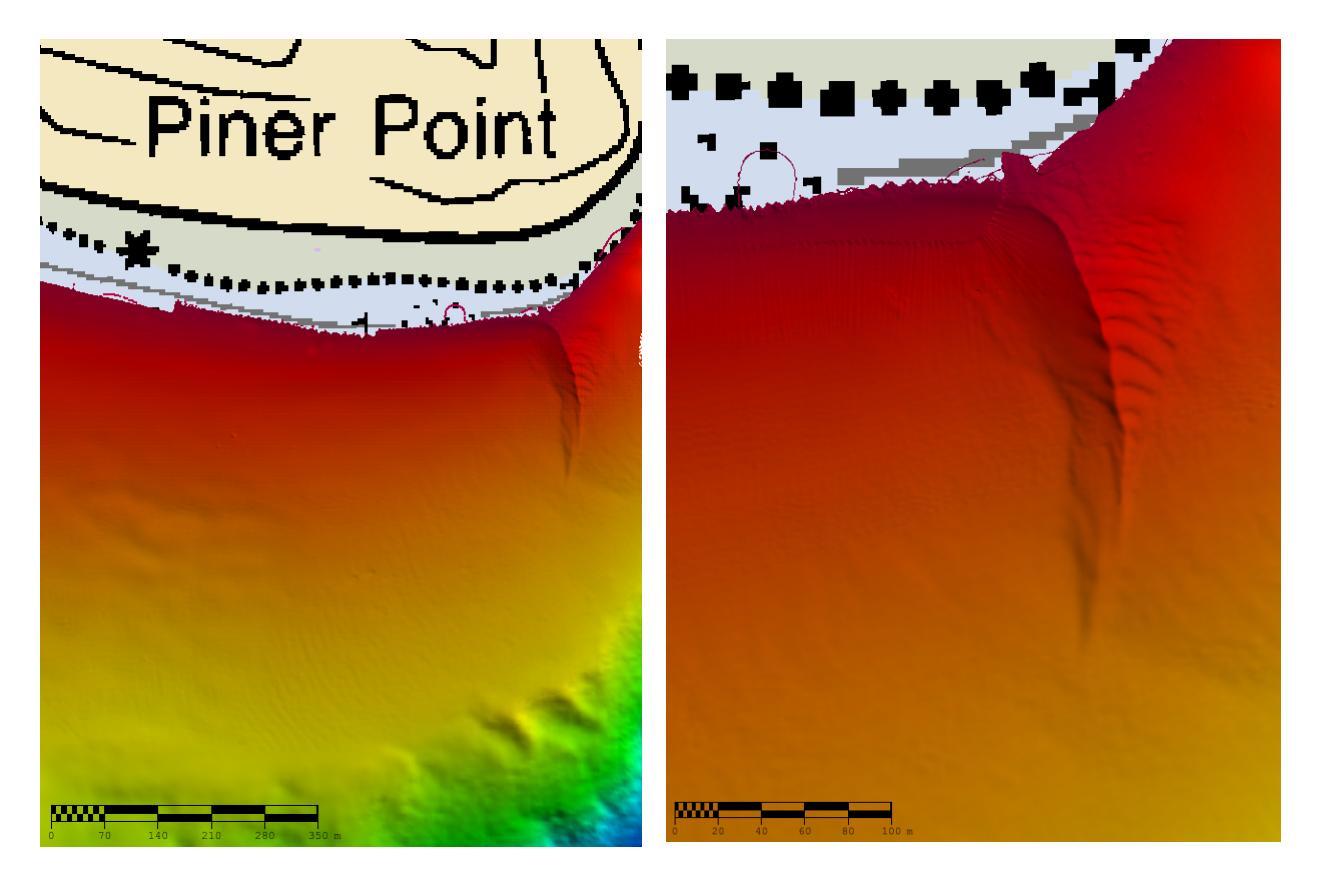
A sand ridge was found in the southeast corner of H11551 extending 200 meters off Piner Point (see Figure 12). The ridge suggests the occurrence of long shore transport moving sediments south, towards the traffic lanes and may be of geological interest in the area.

Figure 12: Sand ridge located in the Southeast corner of survey H11551 off of Piner Point.

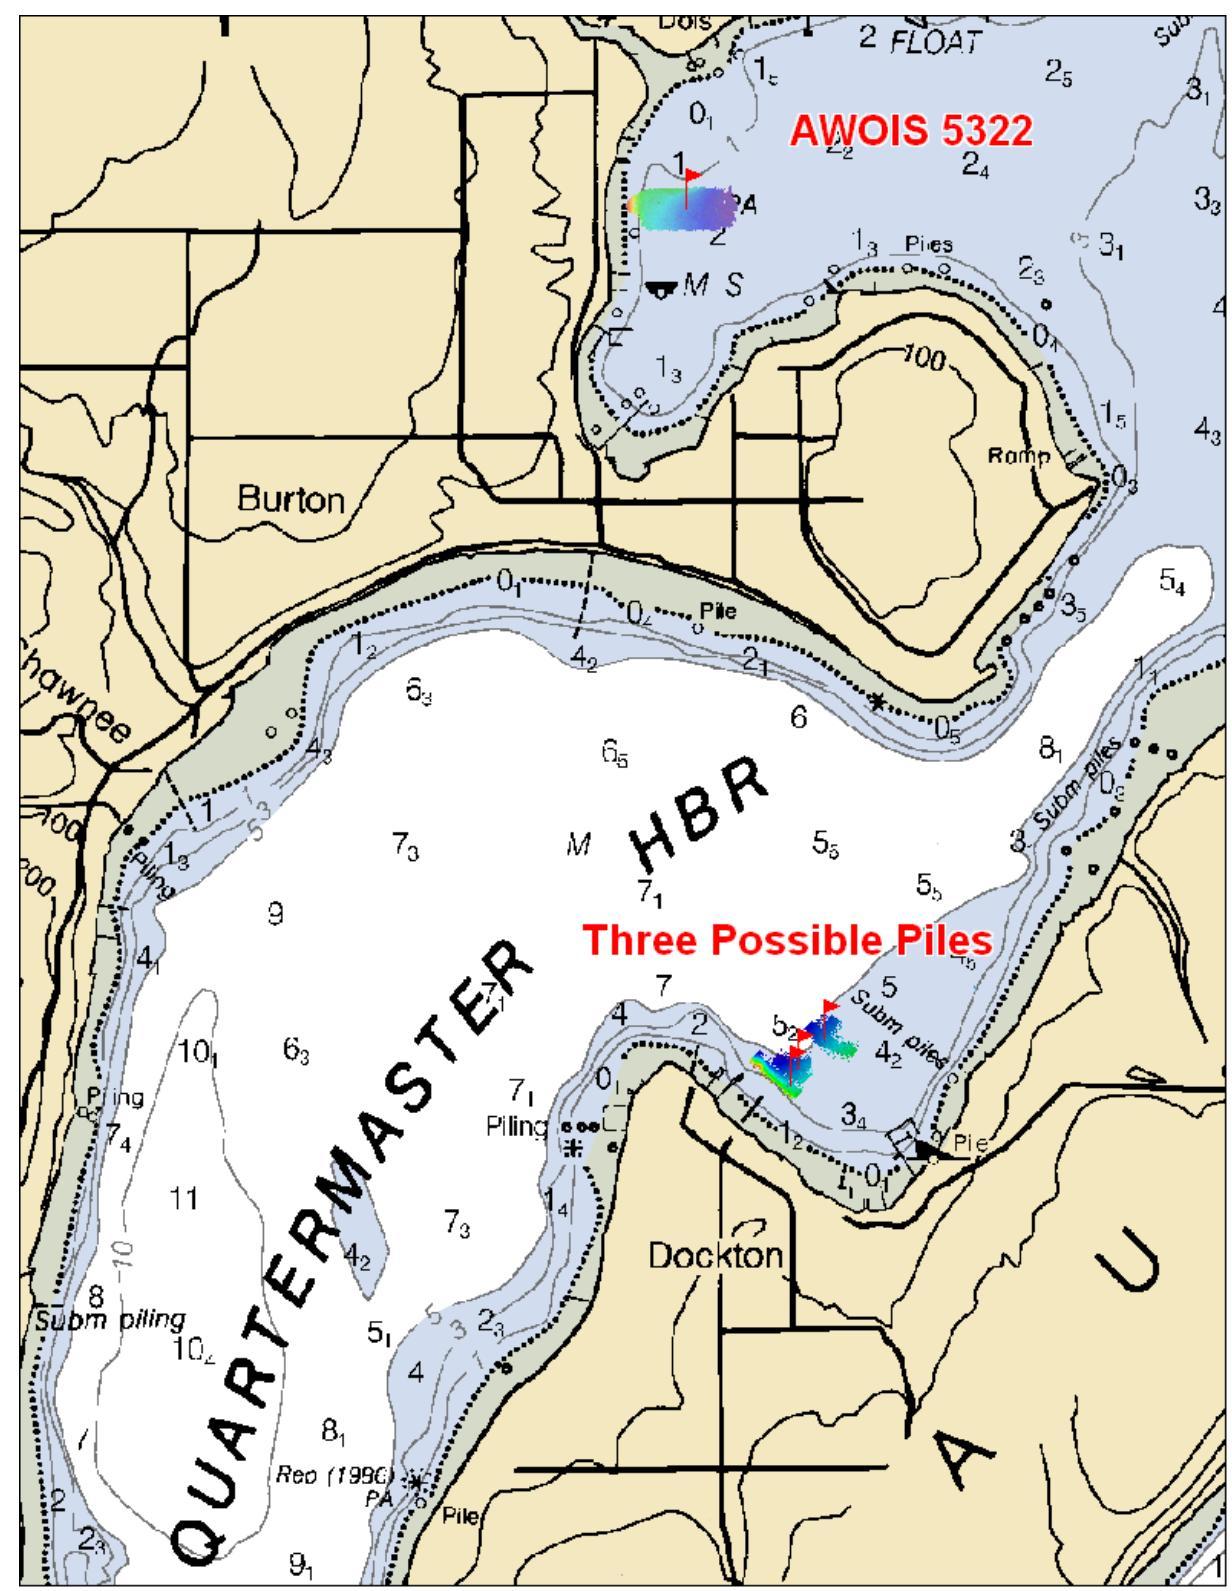
Upon review of the previously submitted hydrographic survey H11551, the Pacific Hydrographic Branch recommended four items for further field investigation. Specifically, 3 multibeam contacts were identified during the survey review that the reviewer felt could be possible piles. All three contacts are in the vicinity of a mooring field and the reviewer indicated that although the contacts are probably returns from a mooring buoy anchor line, they could not be discounted without further investigation. Additionally, during survey acquisition of H11551, AWOIS item 53322 was not fully investigated due to its location outside completed survey area. Due to fueling logistics, RAINIER was near the H11551 survey area on October 24, 2007 and was able to use a survey launch to carry out field investigations on these items as requested by the processing branch. See figure 1 for an overview of the items investigated.<sup>30</sup>

Figure 1. H11551 Addendum items overview displayed on chart 18474.

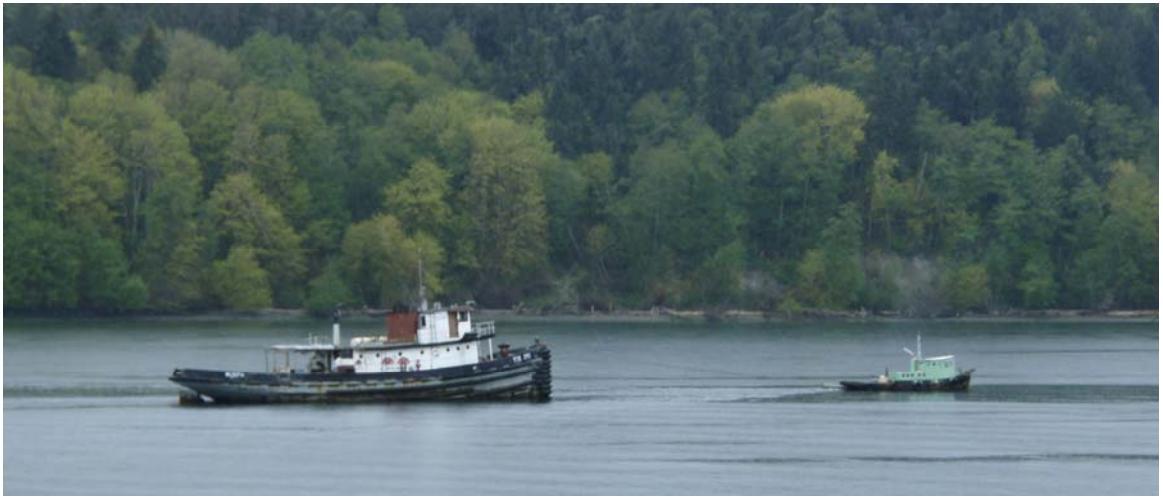
<sup>17</sup> During the 2007 field season, RAINIER surveyed Quartermaster Harbor. When departing the project area a derelict tug, strongly suspected of being this wreck, was observed being towed into the harbor (Figure 1). When anchored in Quartermaster Harbor to continue the project for the 2008 field season, this new wreck was observed by passing launches. On DN 104, launch 1101 made several passes around this wreck using her tilted Reson 8125 system and obtained complete overage.

Figure 1: A derelict tugboat in tow to Quartermaster Harbor.

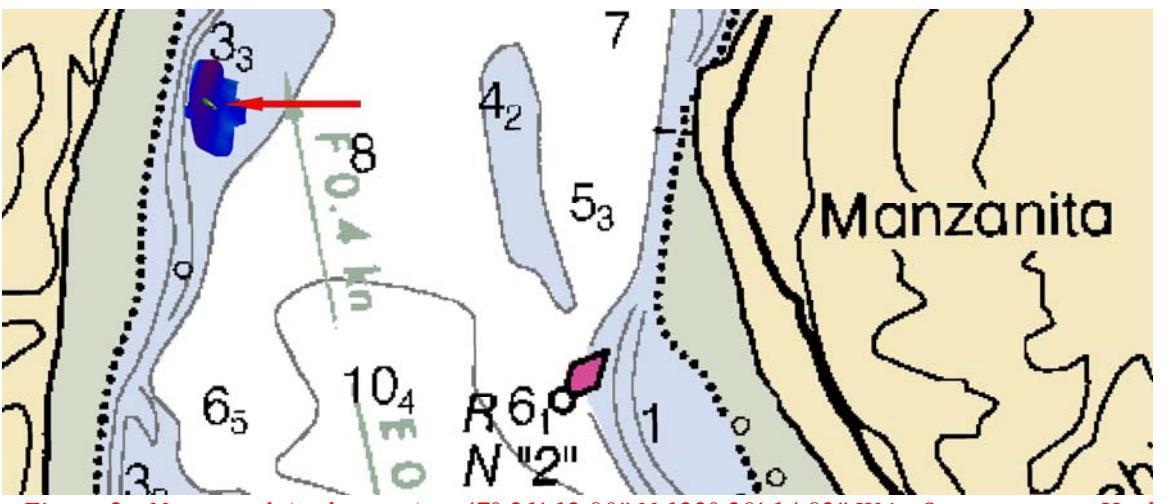
The wreck is located at 47-21-12.90 N, 122-29-14.92 W and has a least depth of -0.098 fathoms. The cartographer used the SORIND and SORDAT from the survey from 2008 (H11550) because the data was collected in junction with that data. Additional information about this wreck is attached to this document in the "Wreck Report" (See below).

Figure 2: New wreck (red arrow) at 47° 21′ 12.90″ N 122° 29′ 14.92″ W in Quartermaster Harbor.

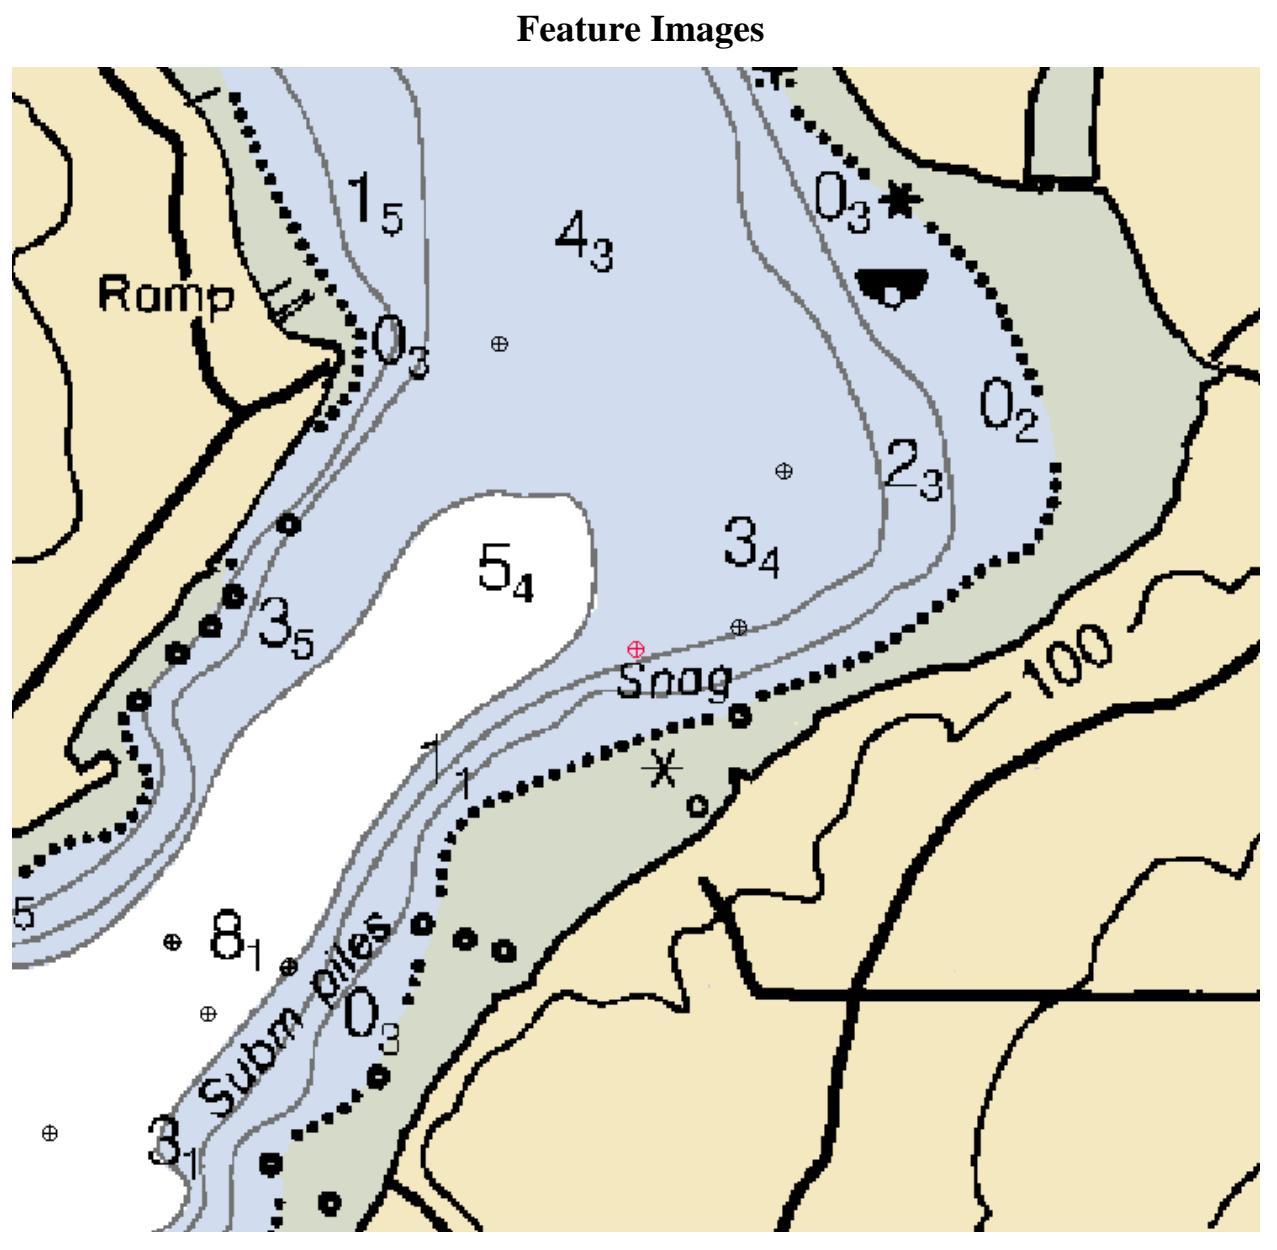
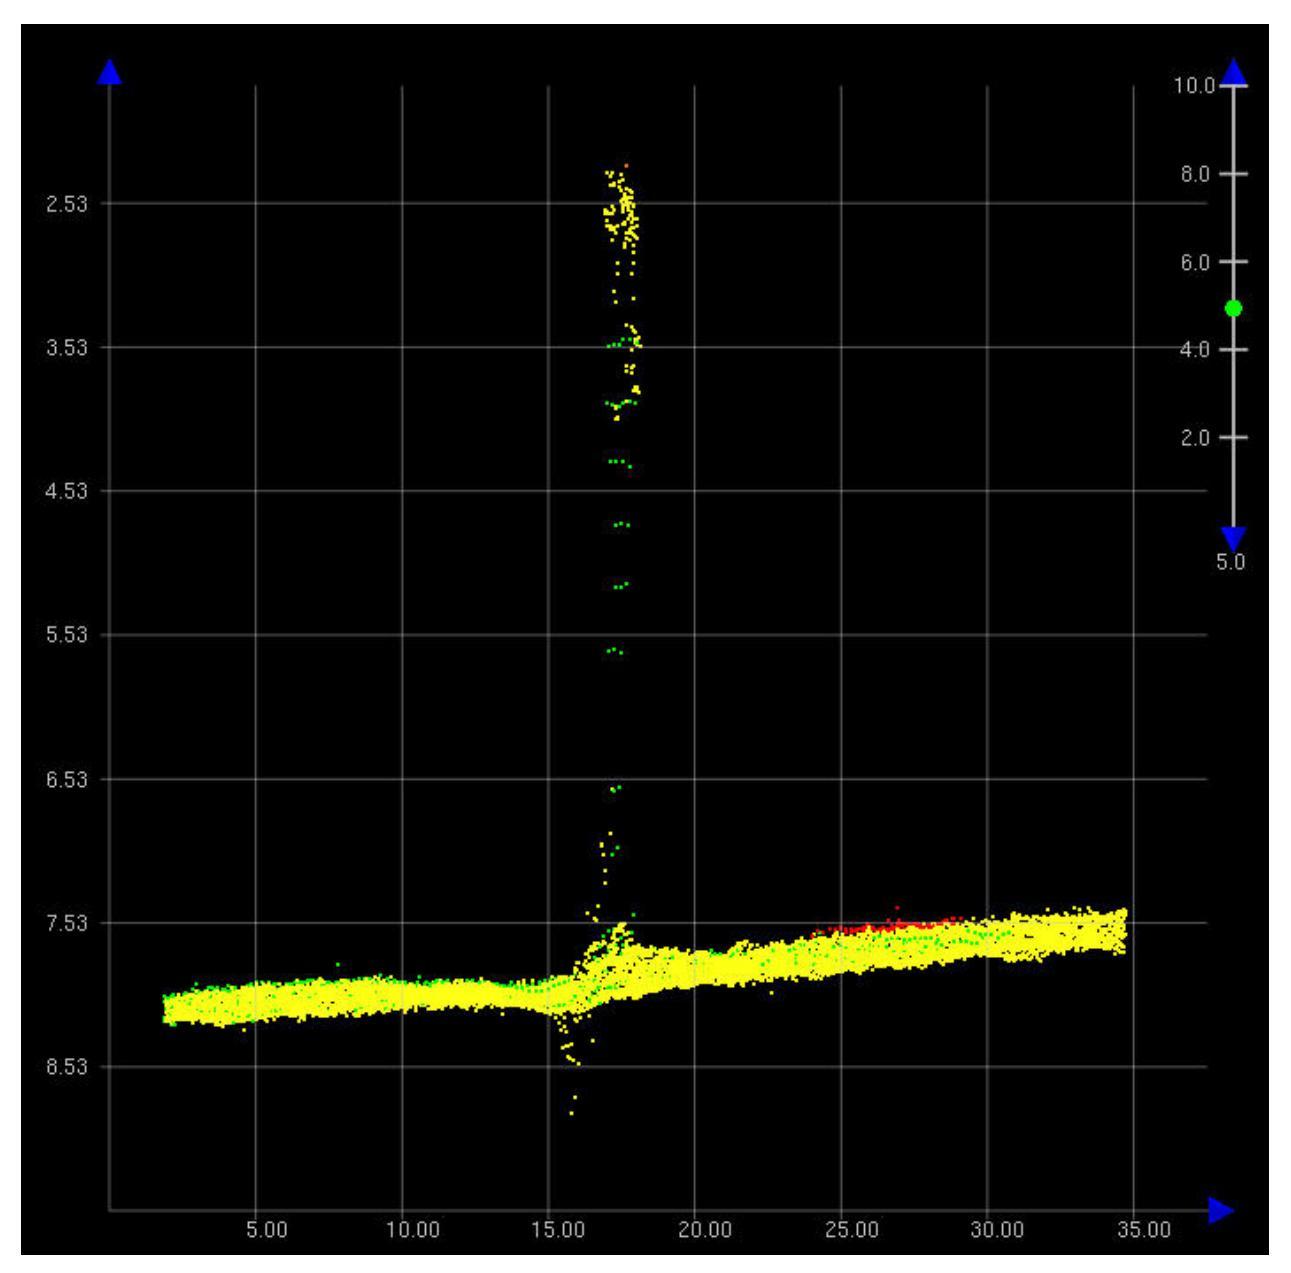
Geo object 1: Obstruction (OBSTRN) Attributes: CATOBS - 1:snag / stump QUASOU - 1:depth known TECSOU - 3:found by multi-beam VALSOU - 2.238 m
WATLEV - 3:always under water/submerged

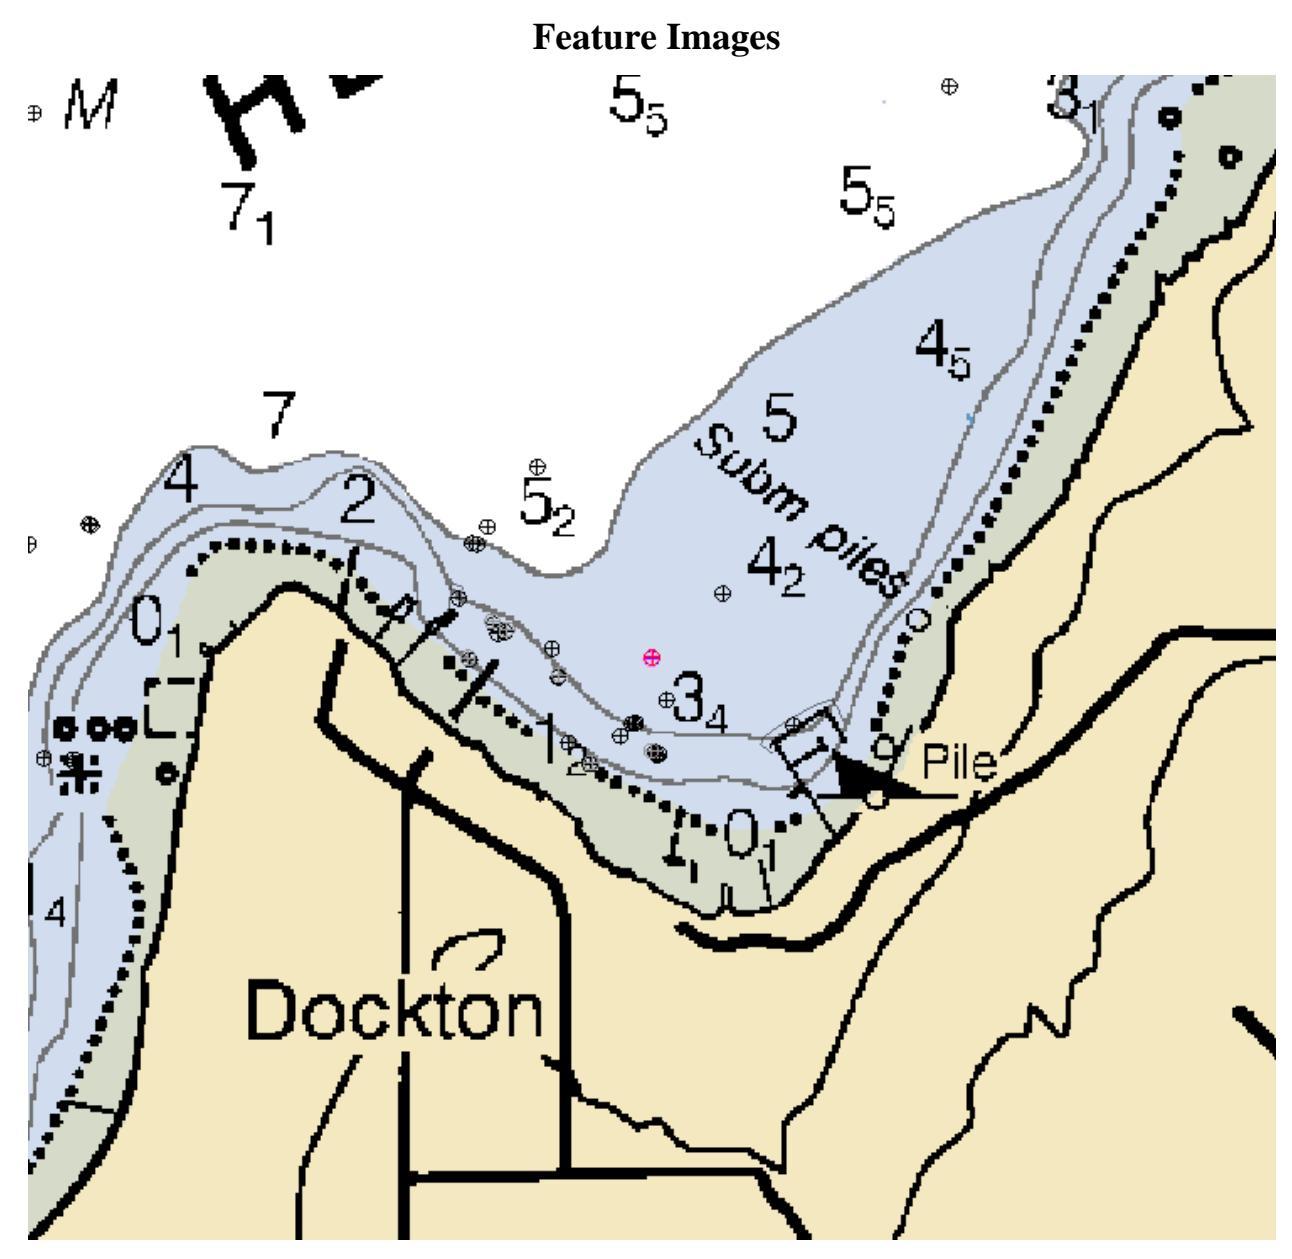
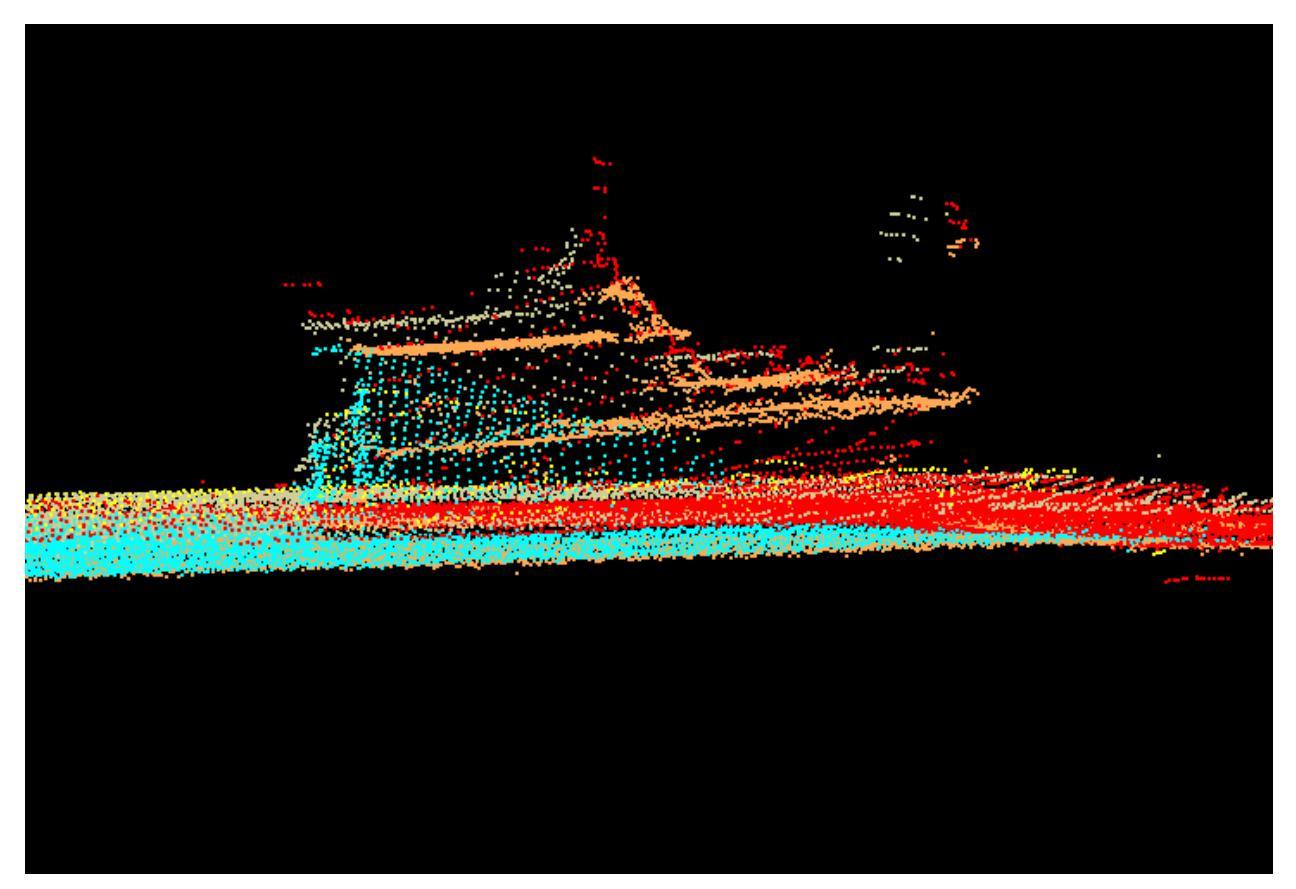
MBES least depth on wreck of ~35' power yacht. Dive report: ~35 foot power yacht sunk on its mooring. The vessel's superstructure was of wood construction. The age of the electronic equipment aboard and relatively light marine growth suggests that the vessel sank relatively recently (within the last 5 years). No identifying markings were found. Depth will be revised with diver least depth gauge depth when available.

Attributes: CATWRK - 2:dangerous wreck TECSOU - 3:found by multi-beam VALSOU - 2.530 m WATLEV - 3:always under water/submerged
