NOAA FORM 76-35A
	U.S. DEPARTMENT OF COMMERCE NATIONAL OCEANIC AND ATMOSPHERIC ADMINISTRATION NATIONAL OCEAN SERVICE
	DESCRIPTIVE REPORT
CC	Type of Survey Hydrographic Survey Field No. N/A Registry No. H11551
	LOCALITY         State       Washington         General Locality       Colvos Passage and Vicinity         Sublocality       Quartermaster Harbor         2007       CHIEF OF PARTY         Commander Guy T. Noll, NOAA
	LIBRARY & ARCHIVES

# **Descriptive Report to Accompany Hydrographic Survey H11551**

Project OPR-N395-RA-07 Colvos Passage and Vicinity, Washington Vicinity of Quartermaster Harbor Scale 1:10,000 April, 2007 **NOAA Ship RAINIER (s221)** Chief of Party: Commander Guy T. Noll, NOAA

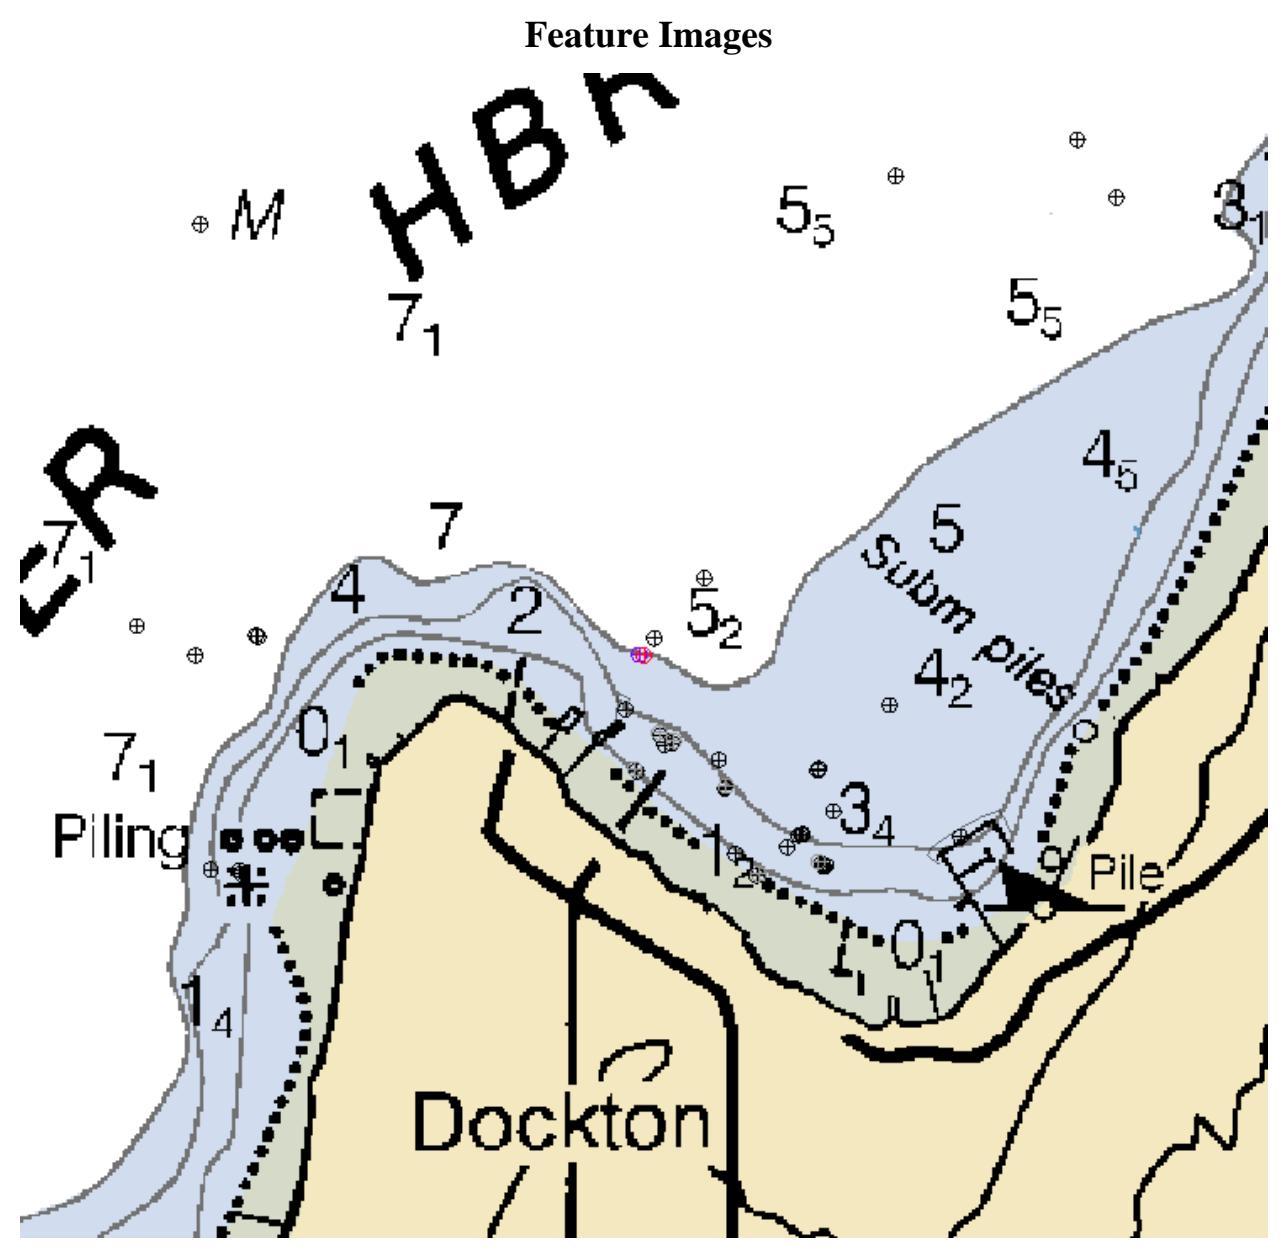
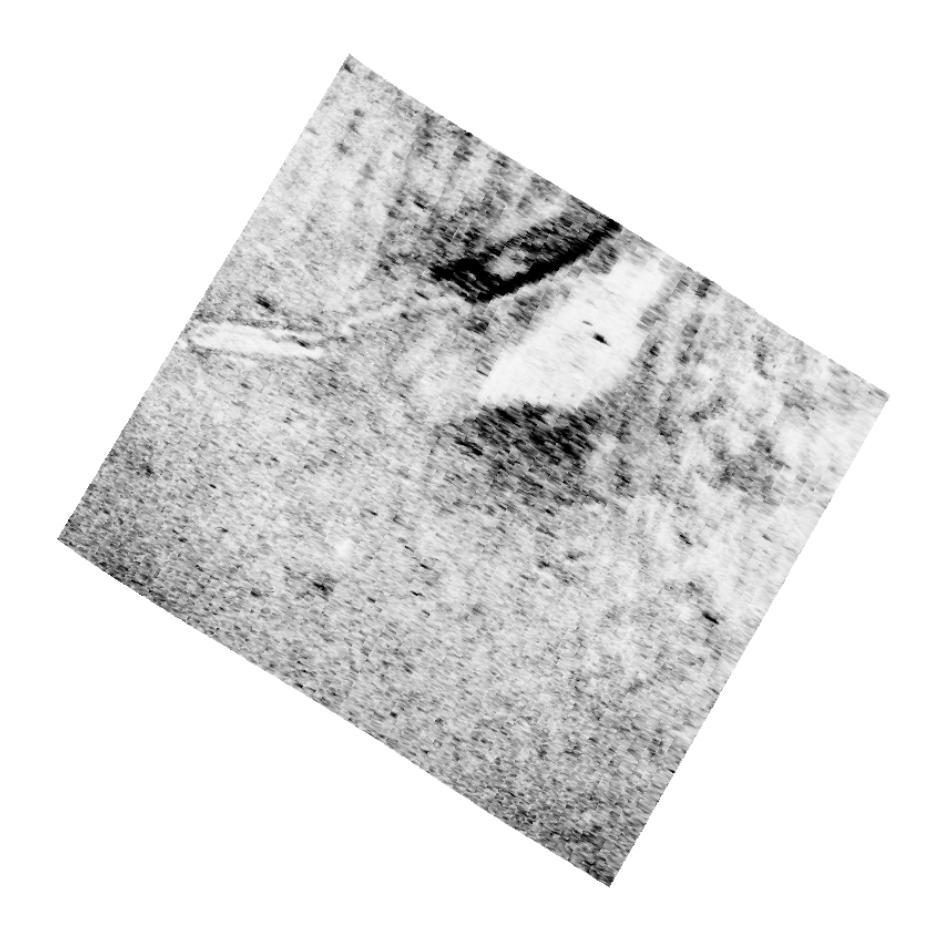
SORIND - US,US,surve,H11551 TECSOU - 3:found by multi-beam VALSOU - 6.440 m WATLEV - 3:always under water/submerged

DtoN was not charted but replaced by a shoaler obstruction.

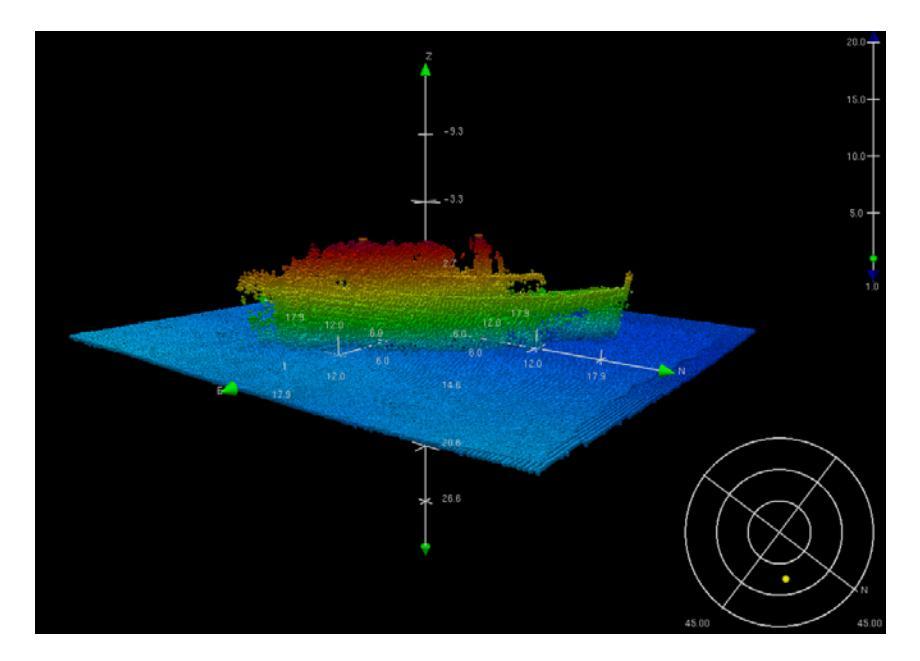
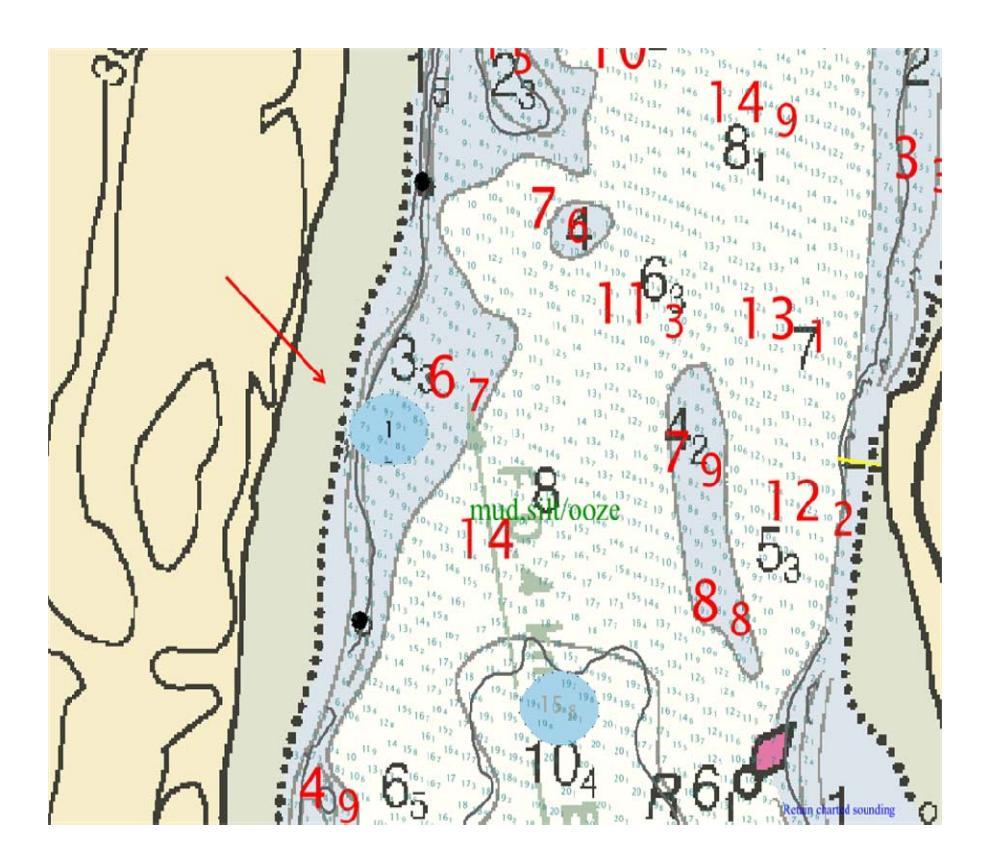
Survey Position:	47-21-12.90N, 122-29-14.92 W
Least Depth:	-0.18 m
S-57 Attributes:	Wreck (WRECKS)
Attributes:	CATWRK: 2:dangerous wreck
TECSOU:	3:found by multibeam
WATLEV:	5: awash
SORDAT:	20080428
SORIND:	US,US,graph,H11550

Remarks:MBES least depth on wreck of ~36 meter tug. Sunken vessel is the "Murph" USCG<br/>document number 960287, formally the Navy's tug "Wingina" YTM 395.

**Office Notes:** Charted wreck. Wreck is should be added to the AWOIS database.
