U.S. Department of Commerce National Oceanic and Atmospheric Administration National Ocean Survey		
	DESCRIPTIVE REPORT	
Type of Survey:	Navigable Area	
Registry Number:	H12568	
	LOCALITY	
State(s):	New Jersey	
General Locality:	Delaware Bay	
Sub-locality:	Cape May Point	
	2013	
CHIEF OF PARTY CAPT Lawrence T. Krepp, NOAA		
	LIBRARY & ARCHIVES	
Date:

## **Descriptive Report to Accompany Survey H12568**

Project: OPR-D332-TJ-13 Locality: Delaware Bay Sublocality: Cape May Point Scale: 1:20000 June 2013 - August 2013 NOAA Ship Thomas Jefferson

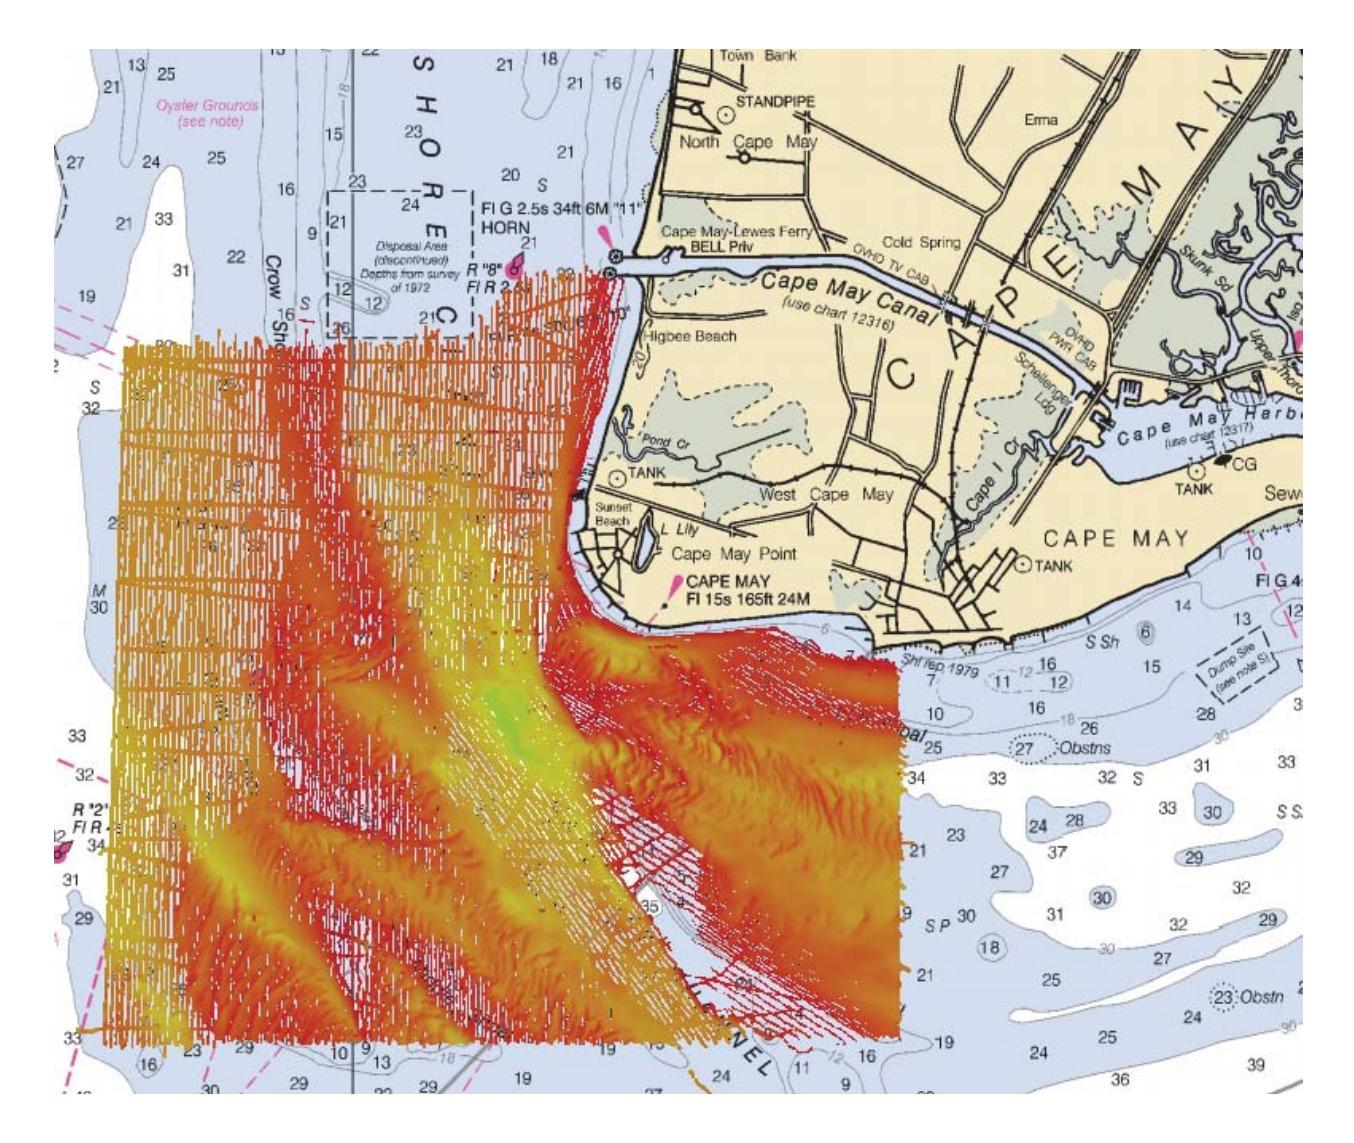
Figure 1: Survey H12568 coverage area.

Certain areas of survey H12568 did not meet coverage requirements listed in the project instructions. Areas of Prissy Wicks shoal, and Middle shoal were developed using only 100% Side Scan Sonar coverage, with concurrent Multibeam Echo Sounder (MBES) coverage. The Command deemed the depths found on the initial coverage of sections of Middle and Prissy Wicks Shoals too shoal for further safe development. Instead, the shoals were developed up to, and in some cases, beyond the 4 meter curve. A DtoN Report pertaining to Prissy Wicks Shoal was submitted 29 September 2013. For a full discussion of the DtoN report, see Appendix II of this report.

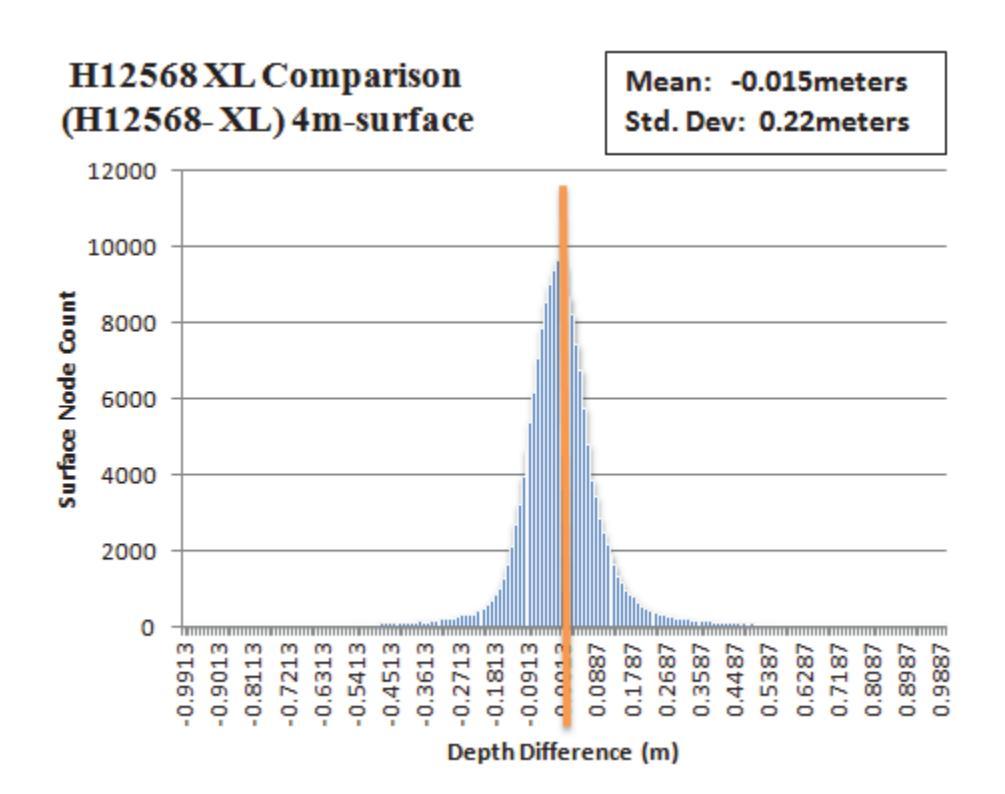
Multibeam crosslines were acquired by survey launches 3101 and 3102 on the first day of survey. Collectively, 57.18 linear nautical miles of MBES crosslines were acquired equating to 8.25% of mainscheme MBES data. Separate CUBE surfaces were created comprising only mainscheme and crossline hydrography respectively from which difference surfaces were generated at a 4m grid resolution. Summary statistics are presented in Figure 2. Crosslines compared to corresponding mainscheme lines with a mean difference of -0.015 m and standard deviation of 0.22 m. Survey H12568 complies with section 5.2.4.3 of the HSSD (2013 ed).

Despite overall agreement, multiple localized sources of disagreement were discovered in the survey area. In areas of high bathymetric relief, such as sandwaves, different depths were chosen by the gridding algorithm for the crosslines, resulting in depth differences in the 4m surface greater than allowable IHO Order 1 error. No significant differences were observed over local least depths.

Figure 2: H12568 Mainscheme to crossline comparison.

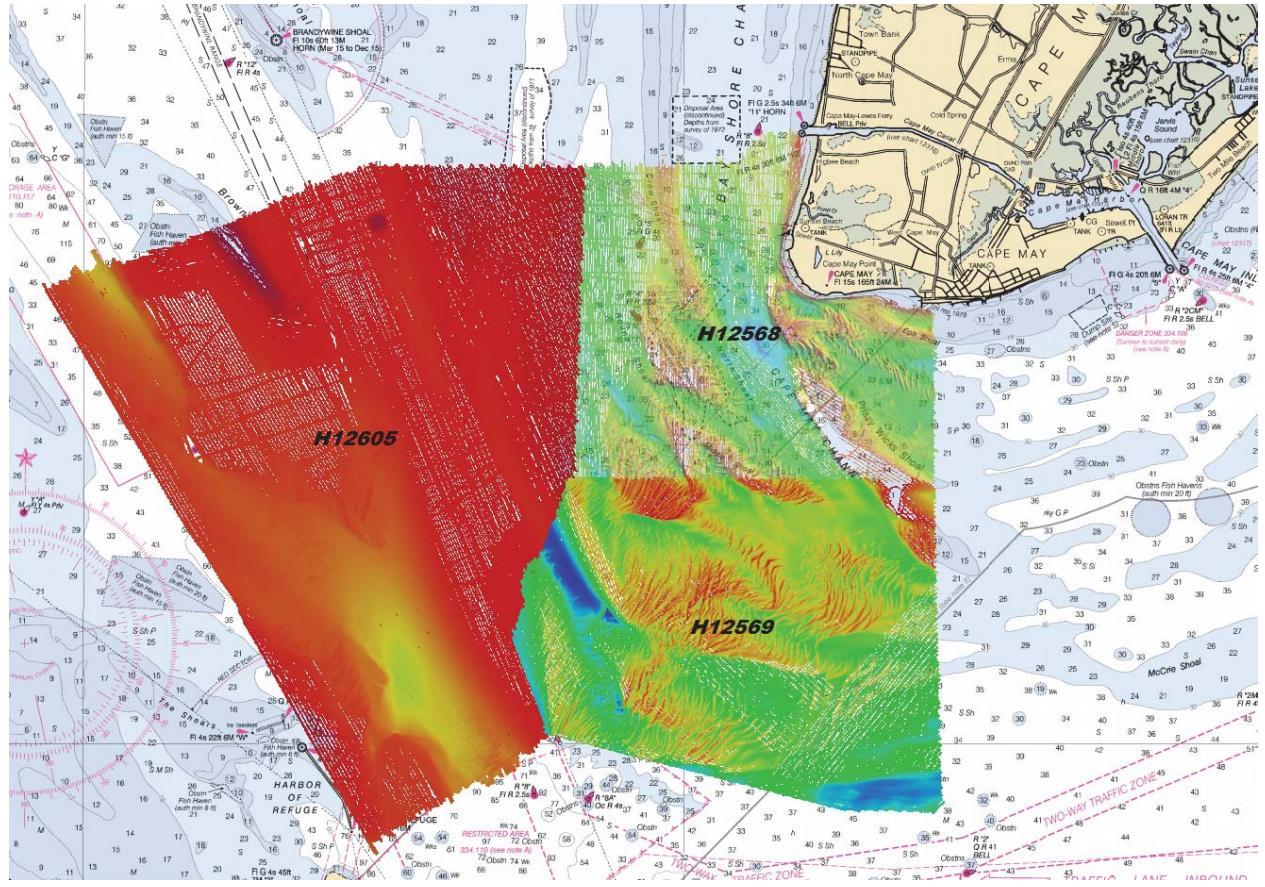
There were a total of two contemporary surveys that junction with Survey H12568: H12605 and H12569.

Figure 3: Junction Surveys to H12568.

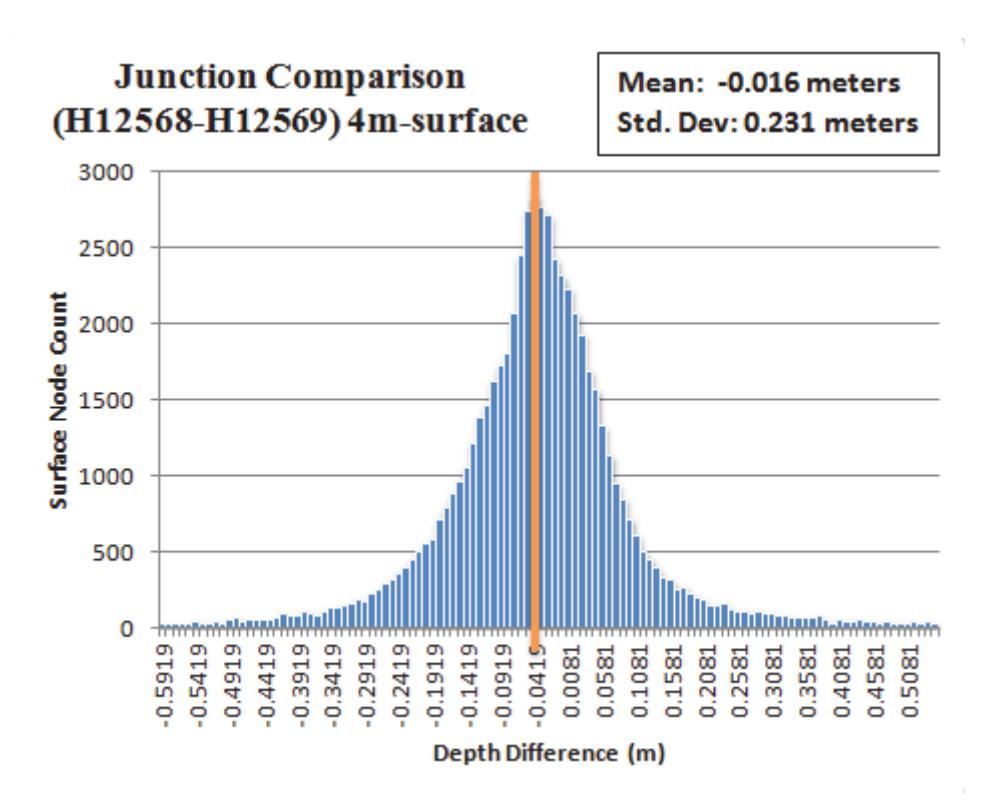
The difference between survey H12568 and junction H12569 ranged from -4.576 m to 5.032 m. The mean was -0.0160 m, and the standard deviation was 0.231 m. 61,966 of 62,648 nodes, or 98.9%, were within 1

meter. The extremes of the range were caused by slight horizontal offsets along the slopes of sand waves along both Middle and Prissy Wicks Shoals, which comprise the majority of the junction overlap between H12568 and junction H12569.

Figure 4: Survey H12568 and junction H12569 in meters.

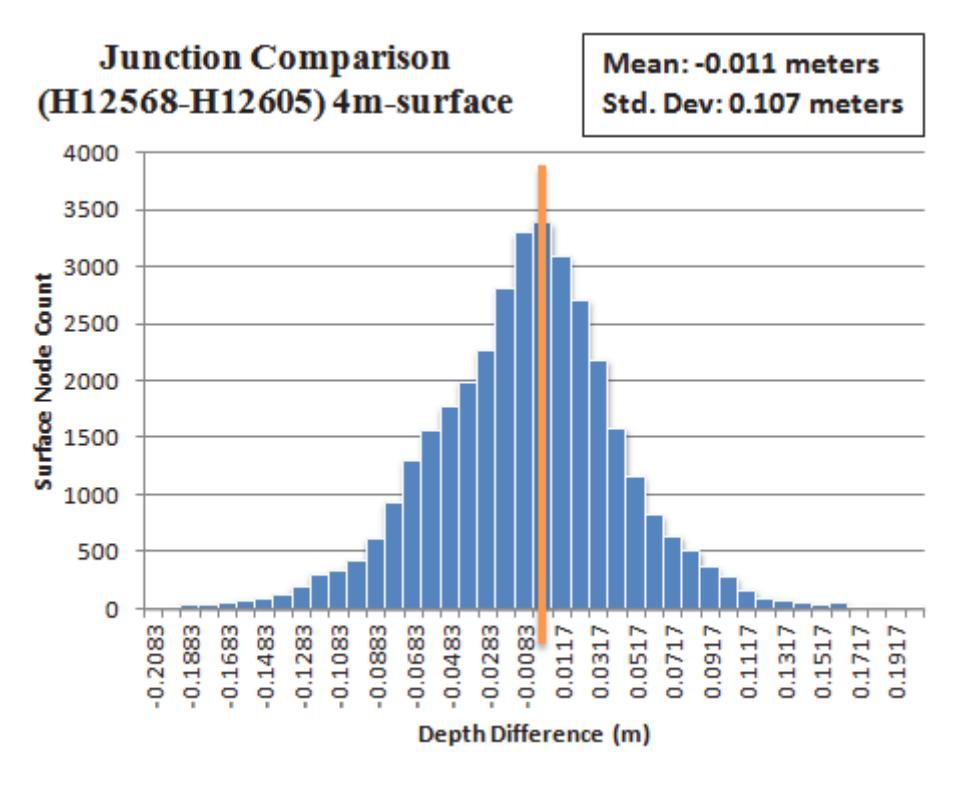
The difference between survey H12568 and H12605 ranged from 4.06 m to -0.893 m. The mean was -0.011 m, and the standard deviation was 0.107 m. 35,784 of 35,840 nodes, or 99.8%, were within 1 meter. The range was affected by the shifting shoals on the western portion of survey H12568. The steep slopes of the shoals effected the algorithm selection of surface depths.

Figure 5: Survey H12568 and junction H12605 in meters.

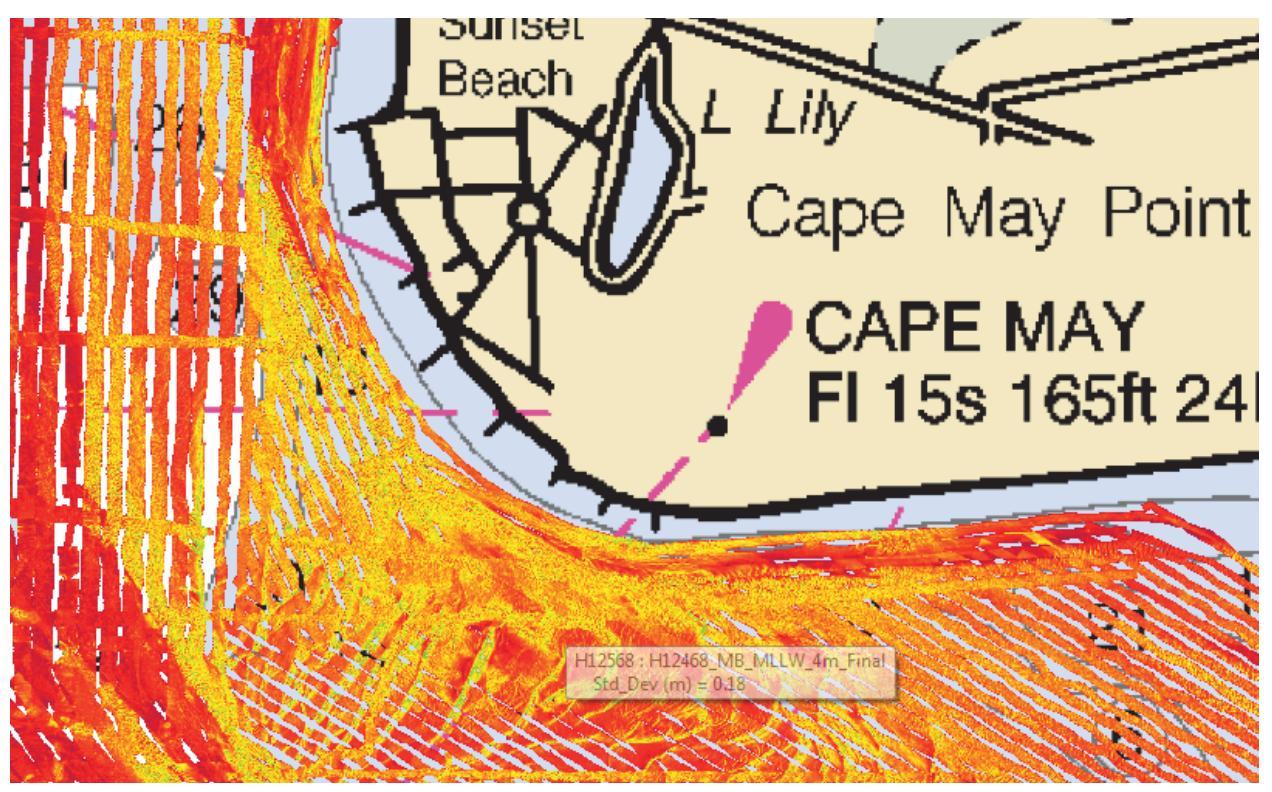
Strong currents and turbidity around Cape May Point negatively affected the ability of the SV71 to correctly steer the sonar beams. The Reson 7125 sonars on HSL launches 3101 and 3102 could not resolve the true depth in several areas due to interference of air bubbles around the sound velocity probe. The currents also caused the vessels to experience a settlement that was not resolved by the dynamic draft table input in the vessels CARIS HVF. The resulting vertical offset can be seen in the surface, but does not exceed IHO Order 1 specifications. This error was not correlated to a specific vessel nor day.

Side Scan Sonar data was also negatively affected by the turbidity and current in the area of Cape May Point. Some outer beam pings were lost due to conditions during survey, however, the area was fully covered by 200% SSS data.

Figure 6: Turbidity negatively affecting standard deviation around Cape May Point.

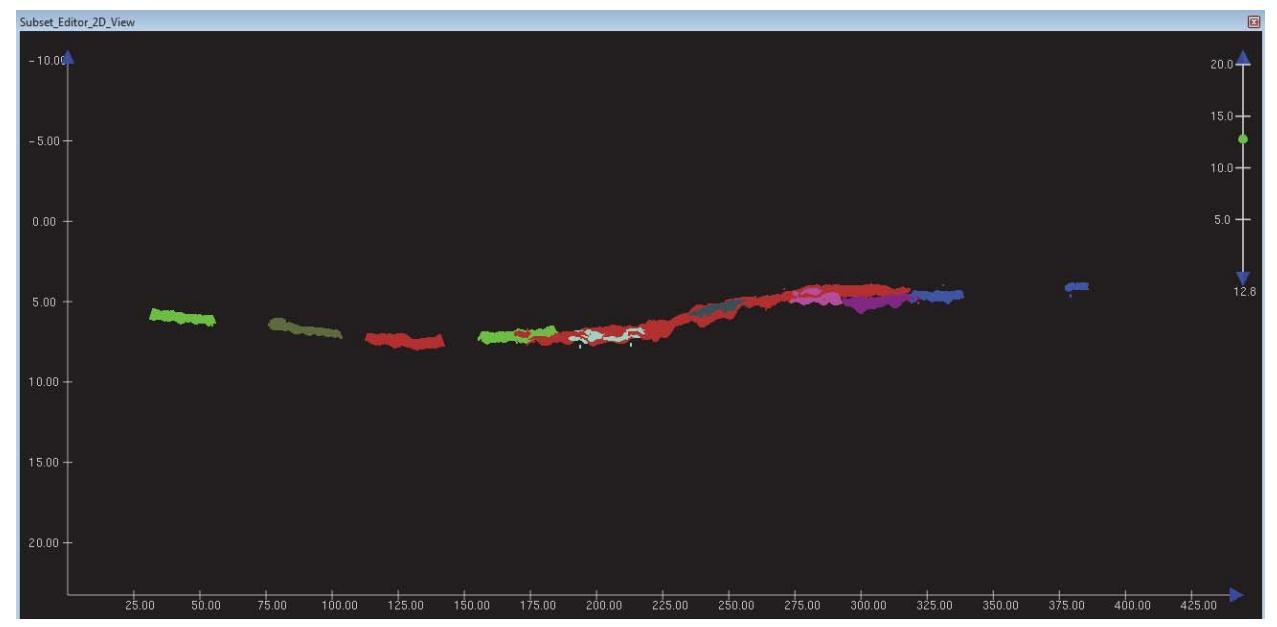
Figure 8: Thoroughly processed data.

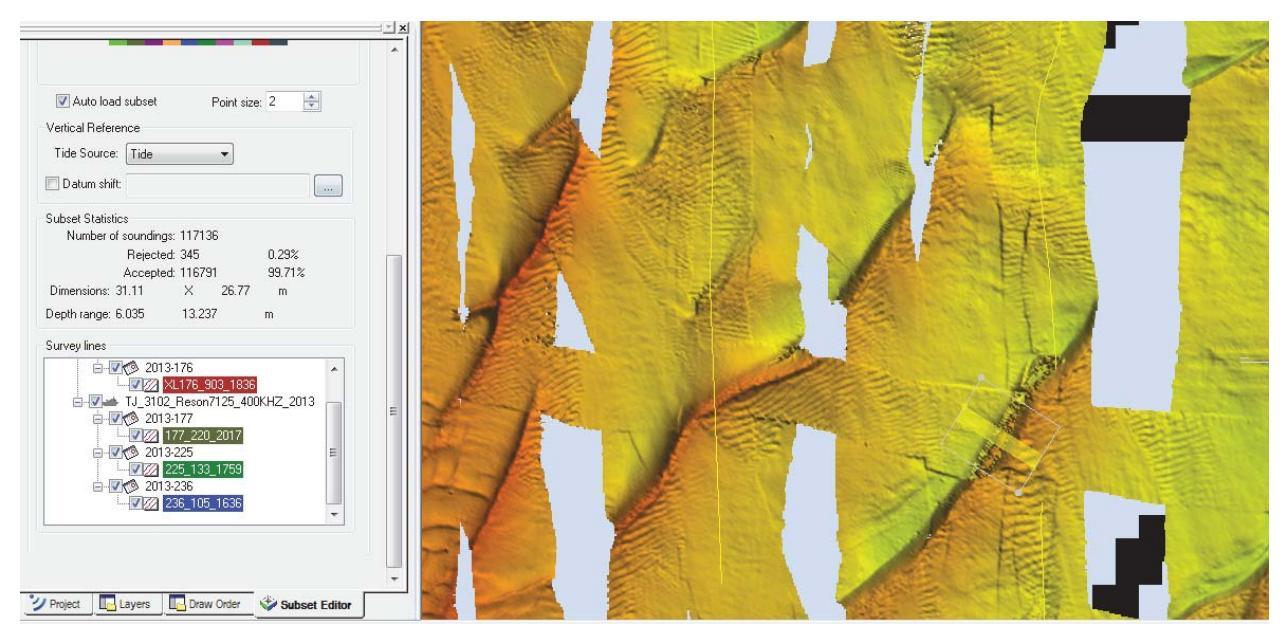
Between 20130629 and 20130813 no data was collected on survey H12568. Temporal gaps in data acquisition produced higher uncertainty in areas of sandwaves. It is believed the sandwaves are migrating. There are several examples of this shift throughout the survey, but one of the clearest is found in the vicinity of the 20 and 21 ft soundings charted on the western edge of Crow and Middle Shoals, approximate location 38-56-22.5 N 074-59-48.8 W.

Figure 9: Evidence of shifting sand waves.

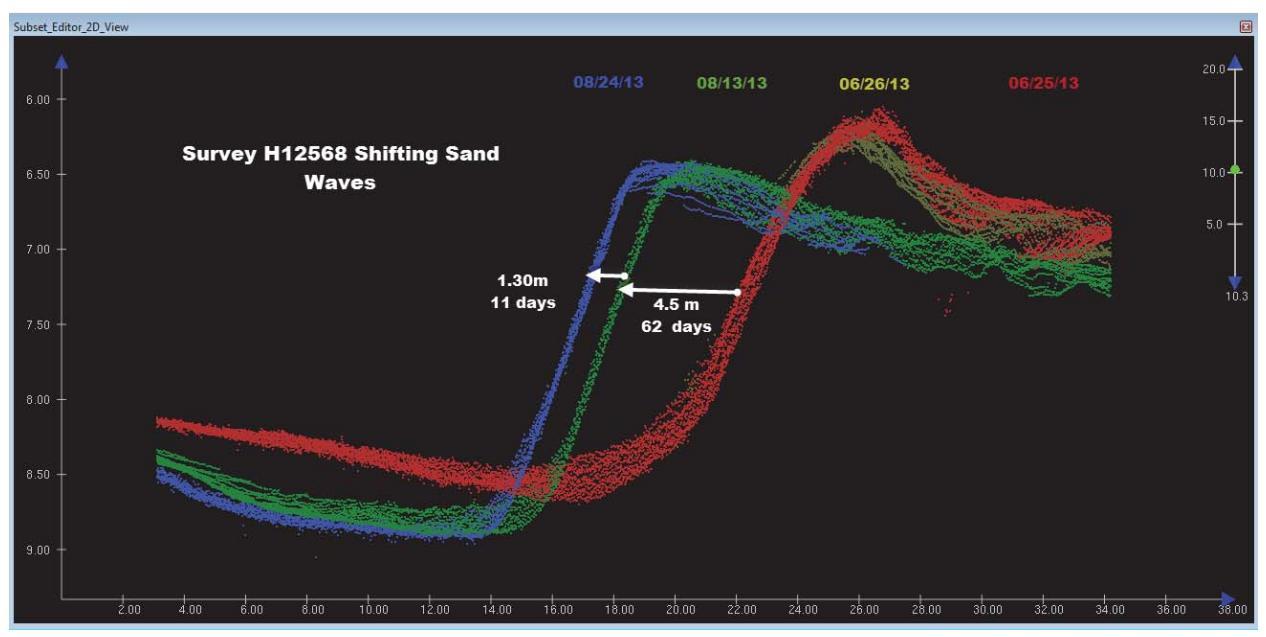
Figure 10: Temporal shift of sand waves.

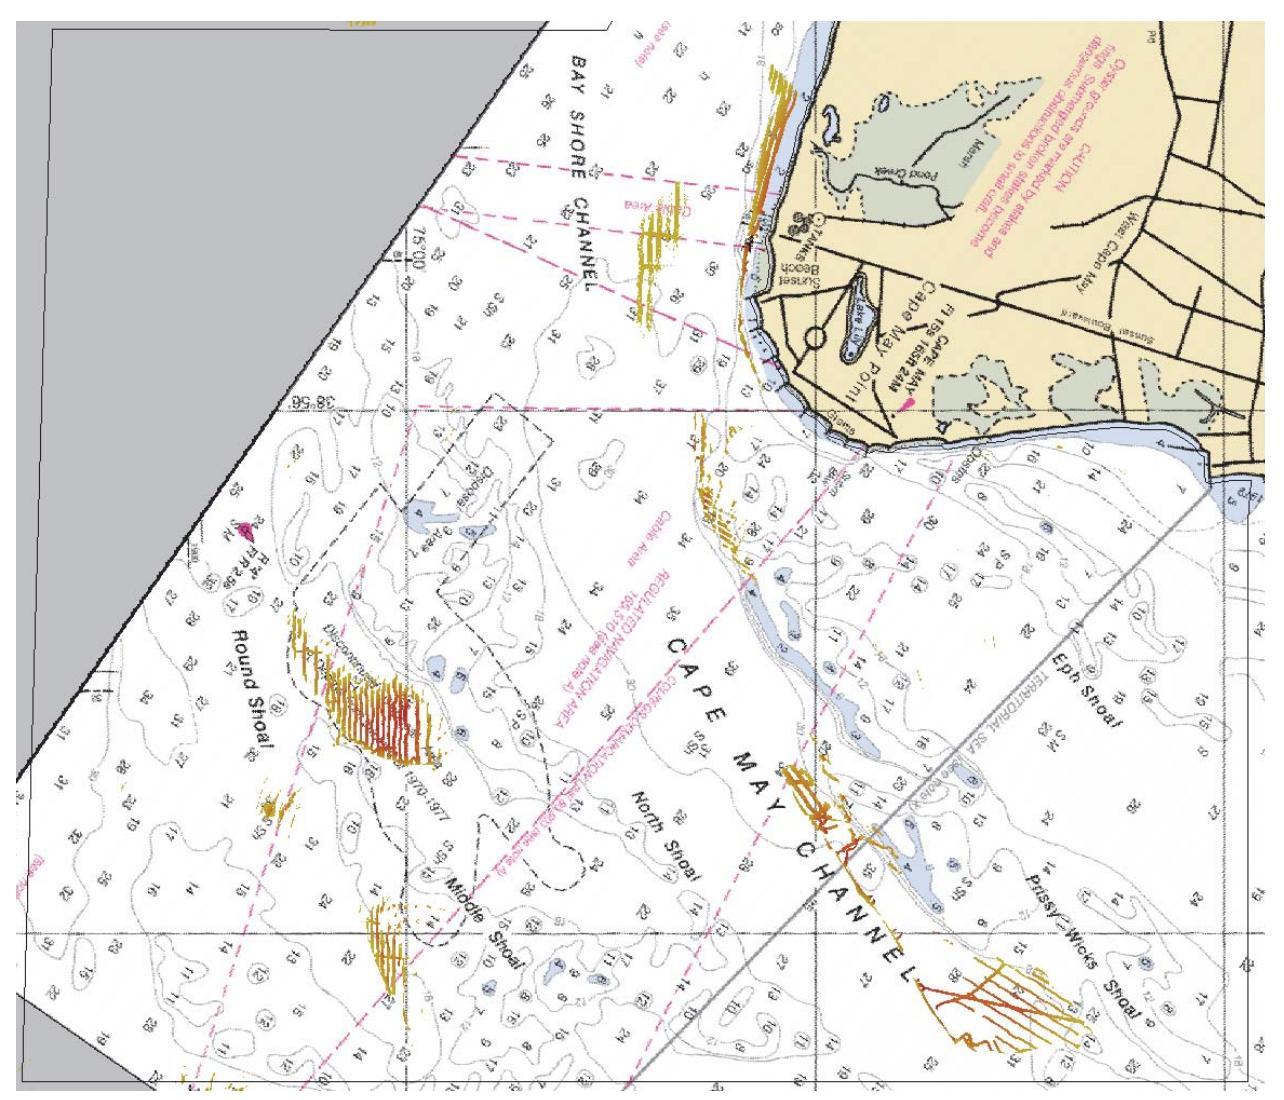
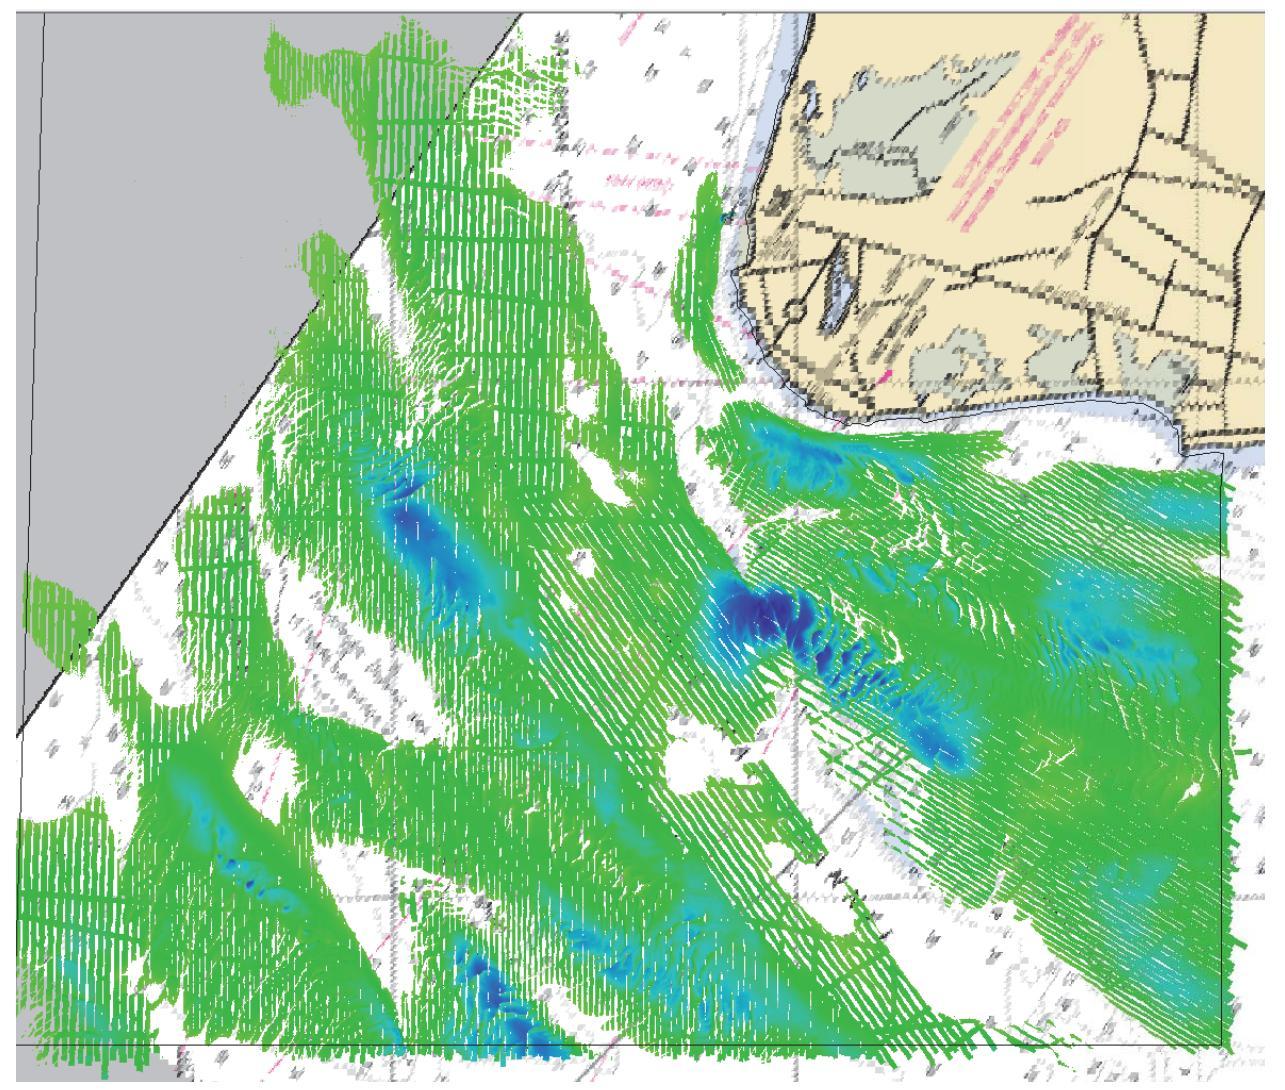
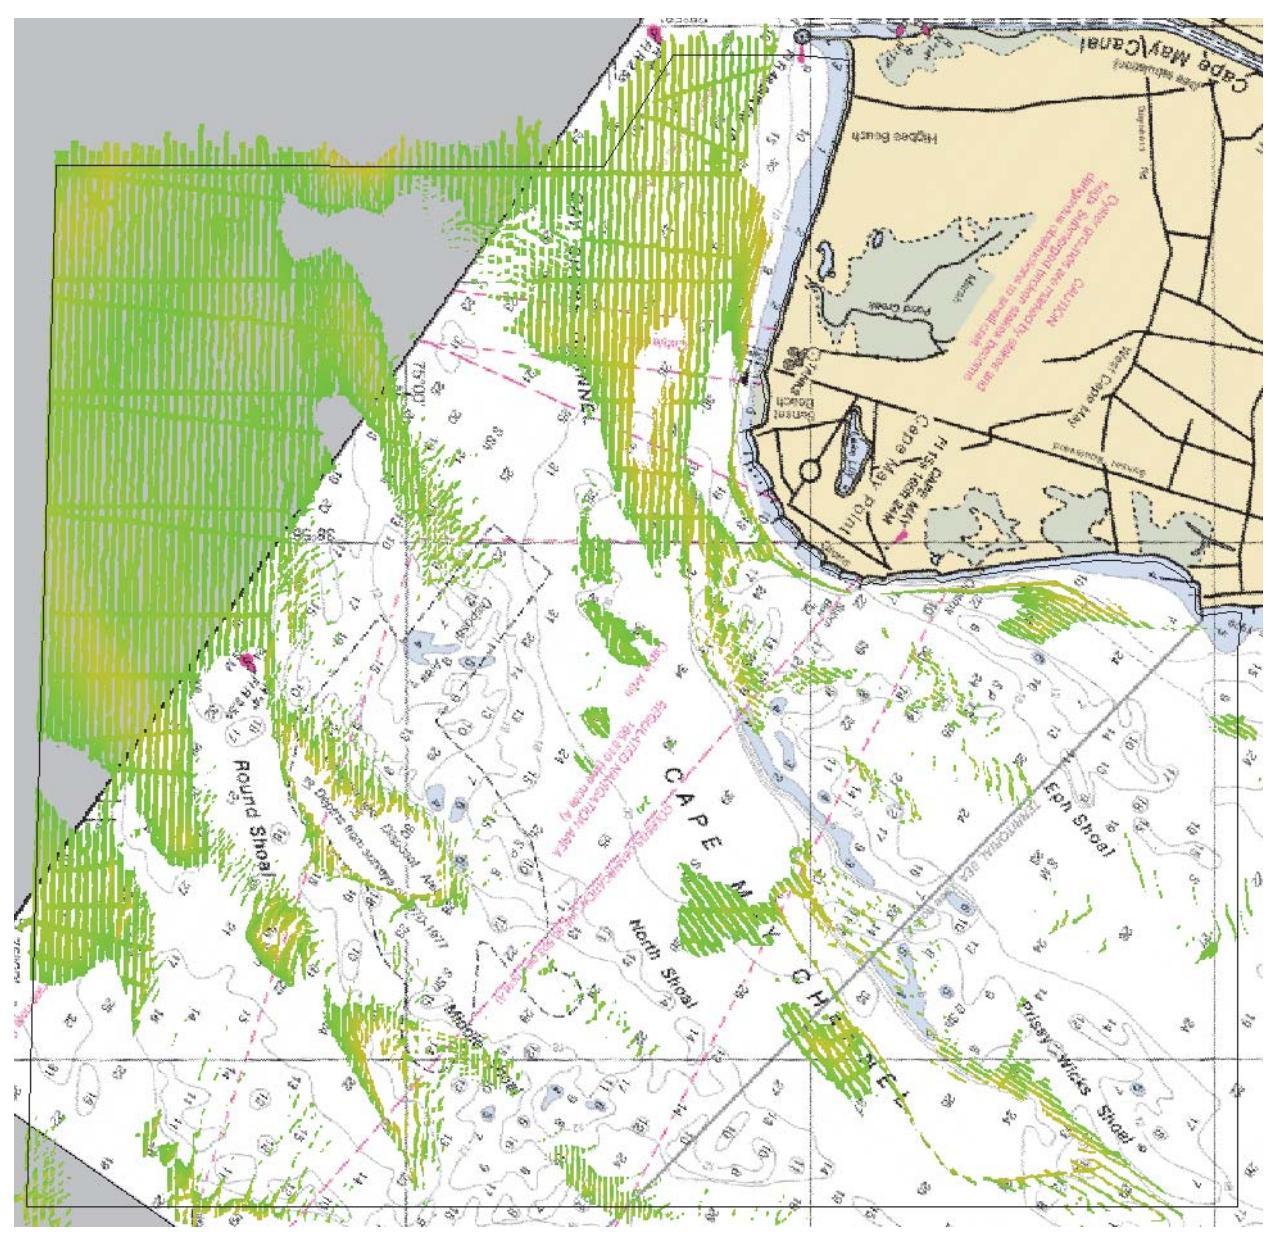
Chart 12316 is the largest scale chart for survey H12568. Alongshore currents have caused a westerly migration of shoal areas denoted on chart 12316. Prissy Wicks, North, and Middle Shoals have experienced the greatest amount of movement. Description of feature investigations are included in the Final Feature File. It is recommended that survey H12568 data supersede all charted depths on chart 12316.

Figure 11: Surveyed depths at least 1ft shoal to charted depths on chart 12316.

Figure 12: Surveyed depths at least 1ft deeper than charted on chart 12316.

Figure 13: Surveyed depths within 1ft of charted soundings on chart 12316.

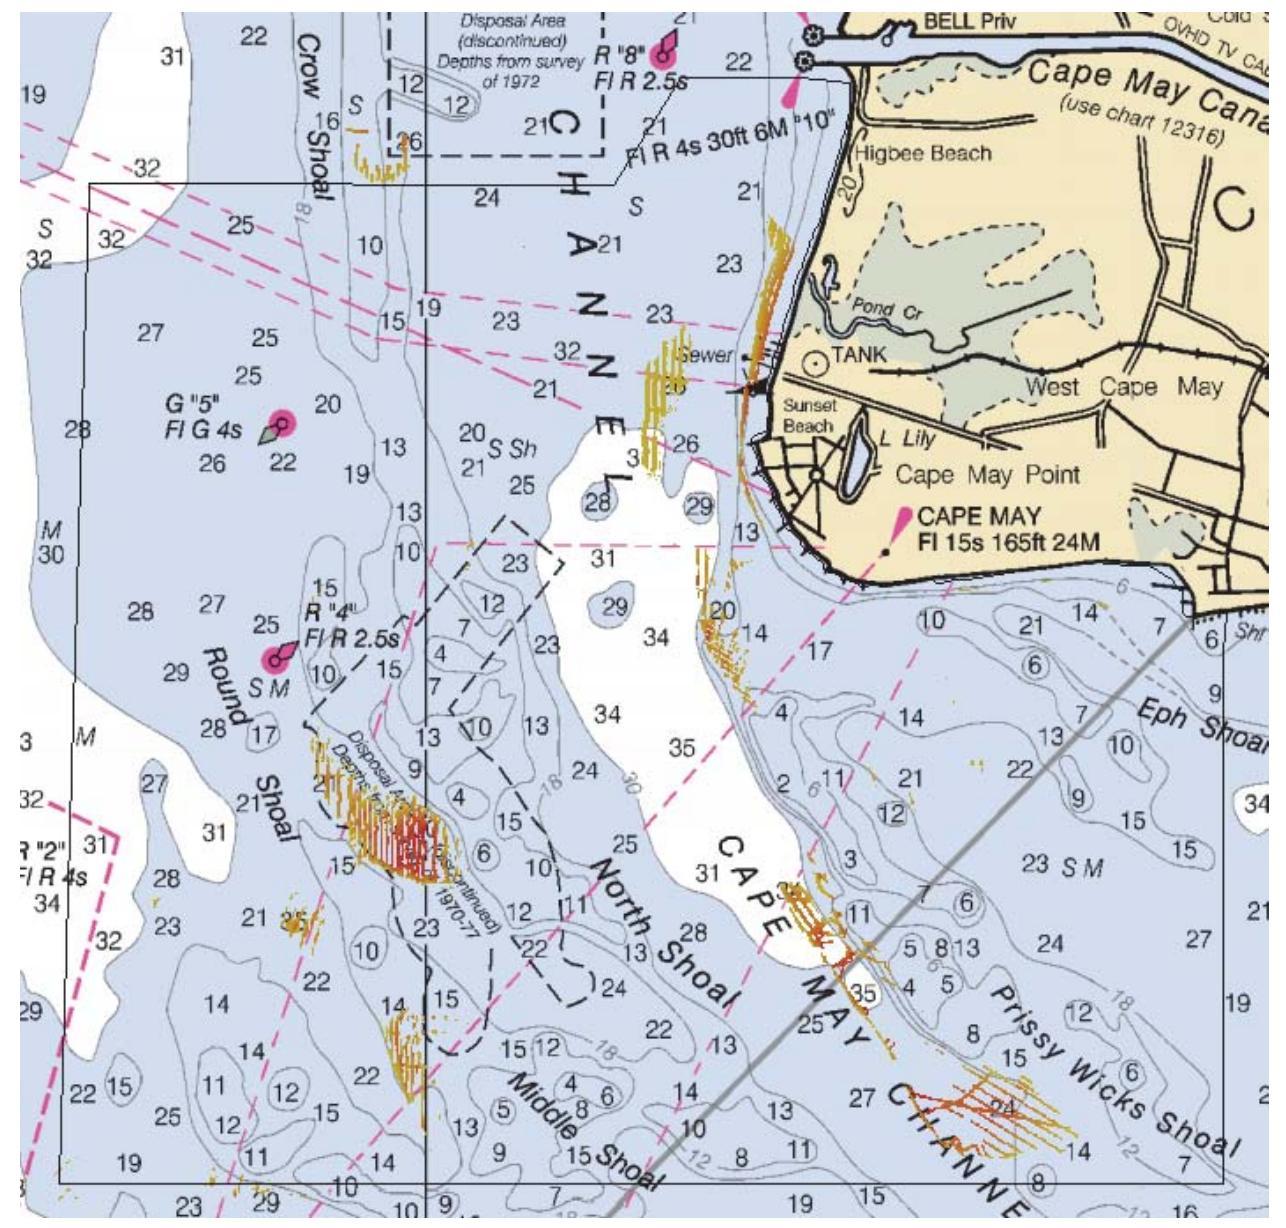
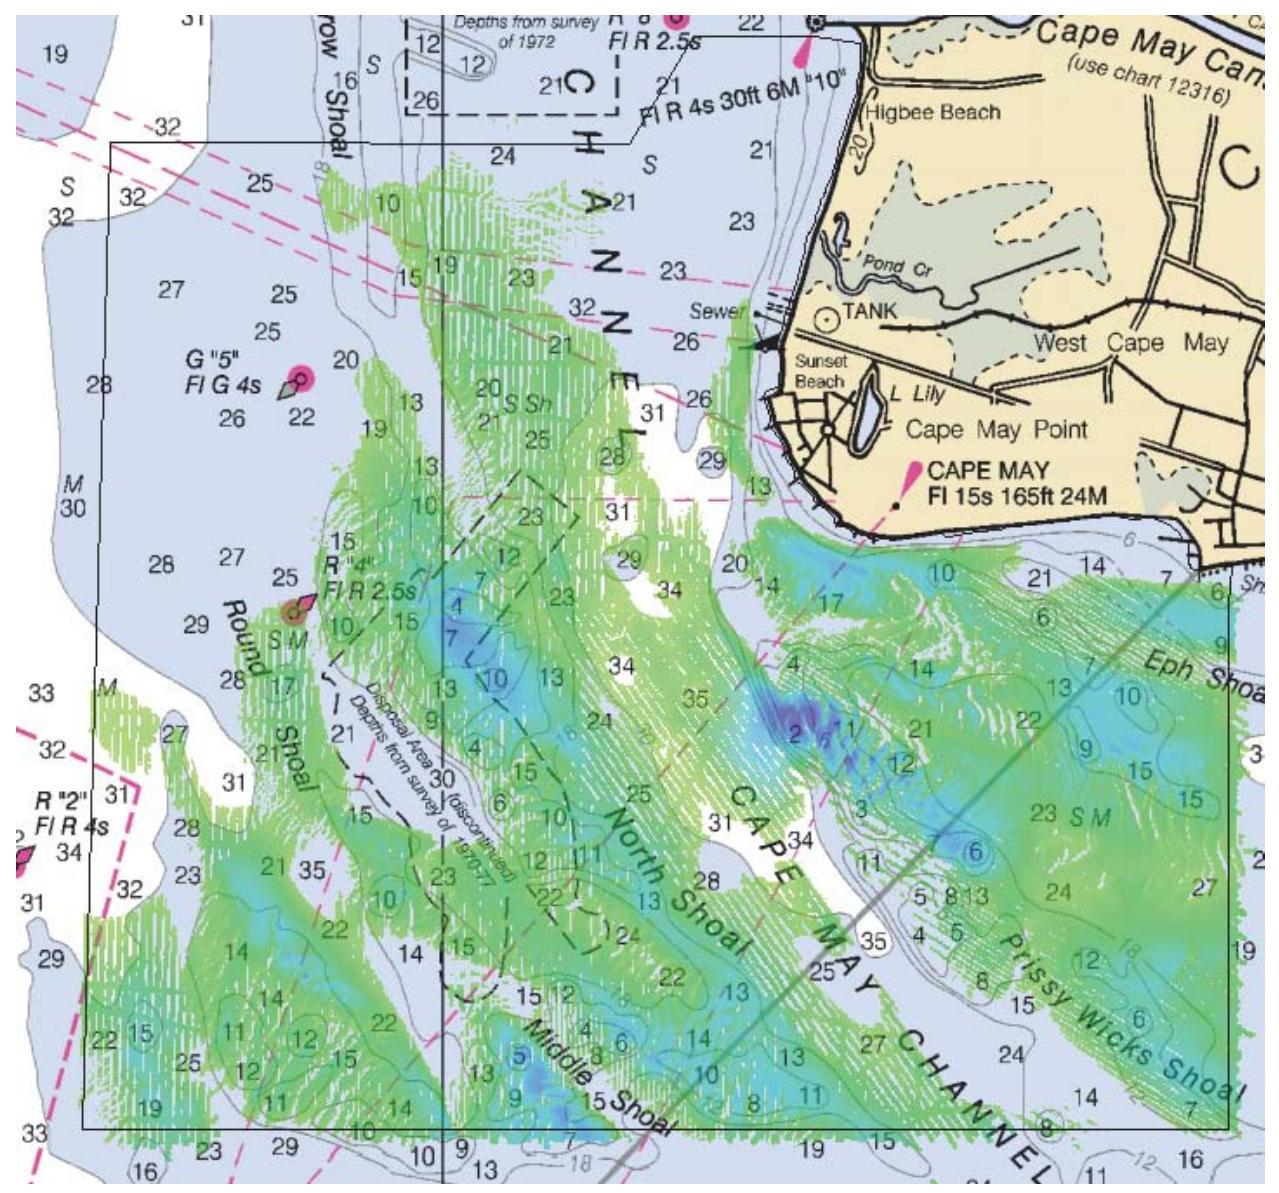
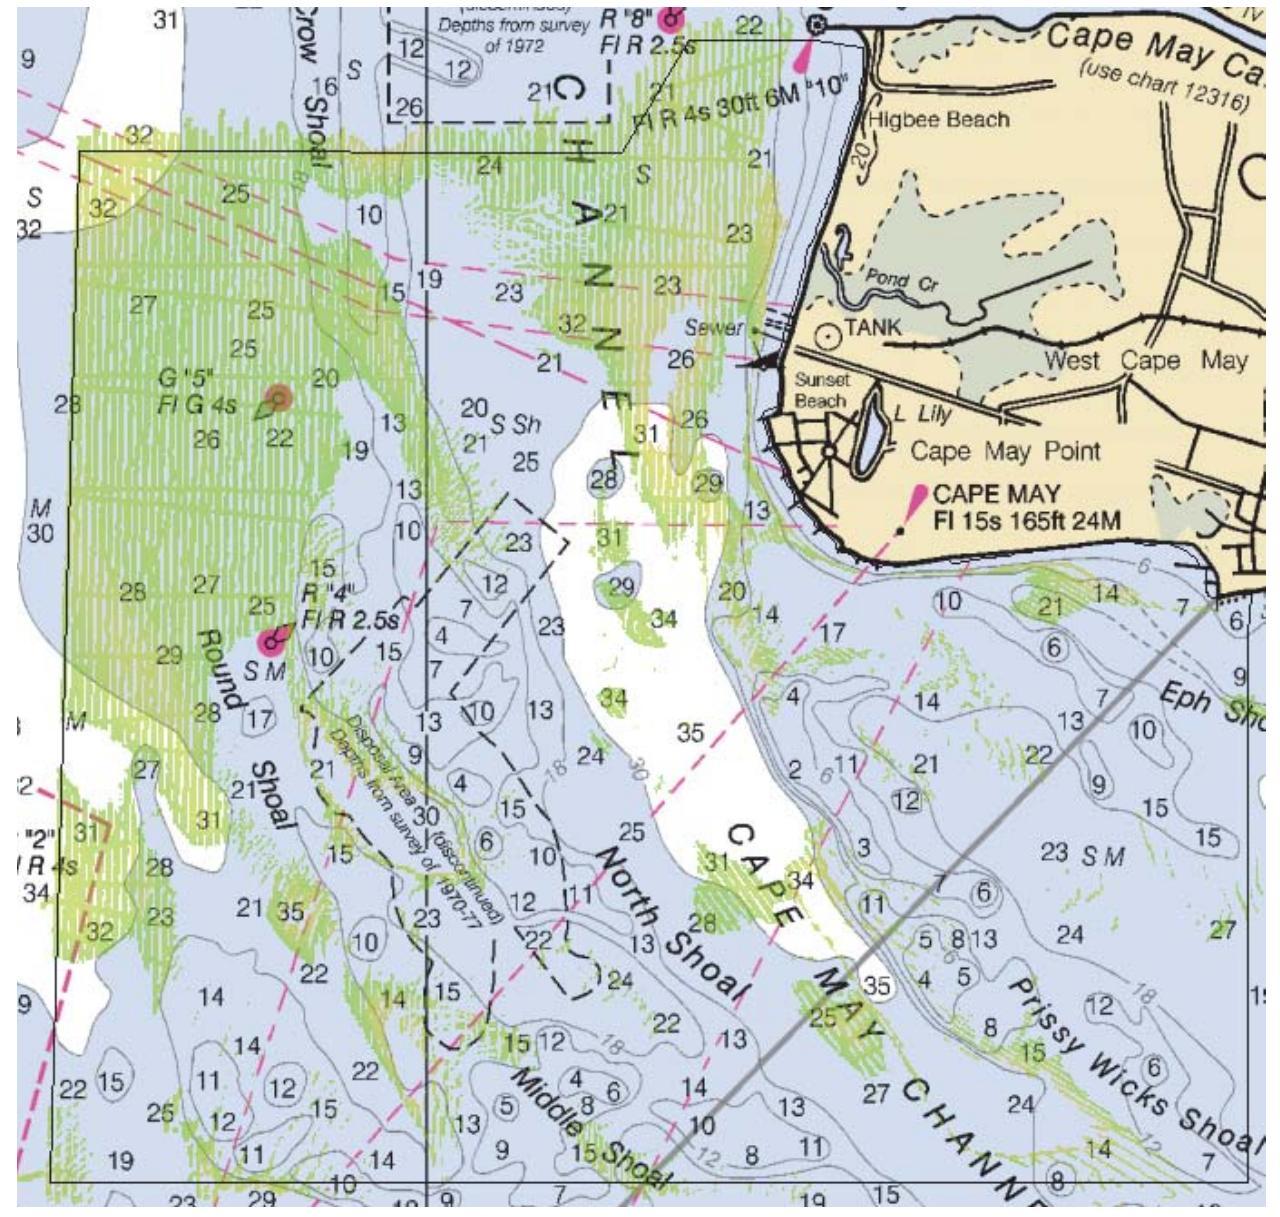
Alongshore currents have caused a westerly migration of shoal areas denoted on chart 12214. Prissy Wicks, North, and Middle Shoals have experienced the greatest amount of movement. Description of feature investigations are included in the Final Feature File. It is recommended that survey H12568 data supersede all charted depths on chart 12214.

Figure 14: Surveyed depths at least 1ft shoal to charted depths on chart 12214.

Figure 15: Surveyed depths at least 1ft deeper than charted on chart 12214.

Figure 16: Surveyed depths within 1ft of charted soundings on chart 12214.
