U.S. Department of Commerce National Oceanic and Atmospheric Administration National Ocean Survey		
	DESCRIPTIVE REPORT	
Type of Survey:	Navigable Area	
Registry Number:	H12568	
	LOCALITY	
State(s):	New Jersey	
General Locality:	Delaware Bay	
Sub-locality:	Cape May Point	
	2013	
CHIEF OF PARTY CAPT Lawrence T. Krepp, NOAA		
	LIBRARY & ARCHIVES	
Date:

## **Descriptive Report to Accompany Survey H12568**

Project: OPR-D332-TJ-13 Locality: Delaware Bay Sublocality: Cape May Point Scale: 1:20000 June 2013 - August 2013 NOAA Ship Thomas Jefferson

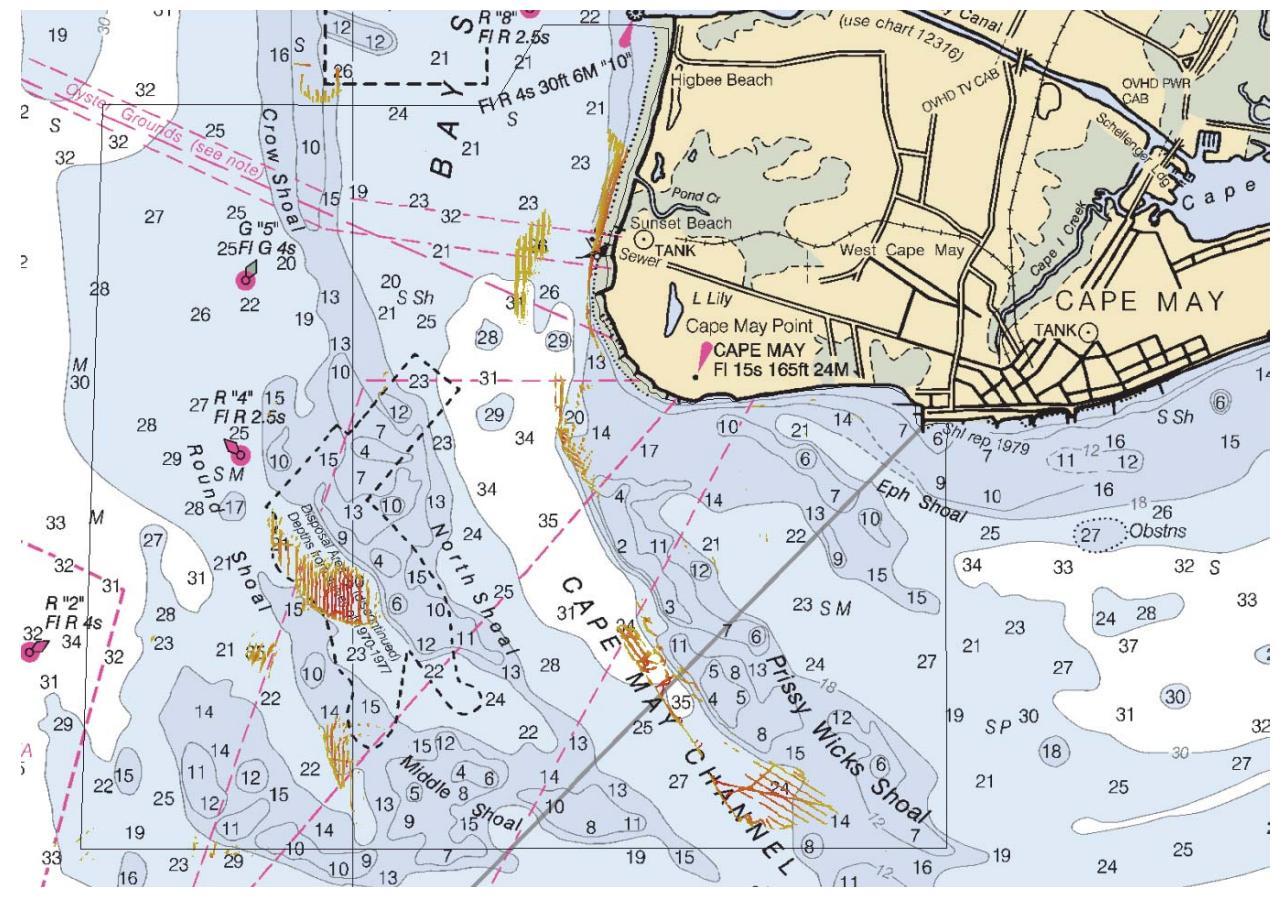
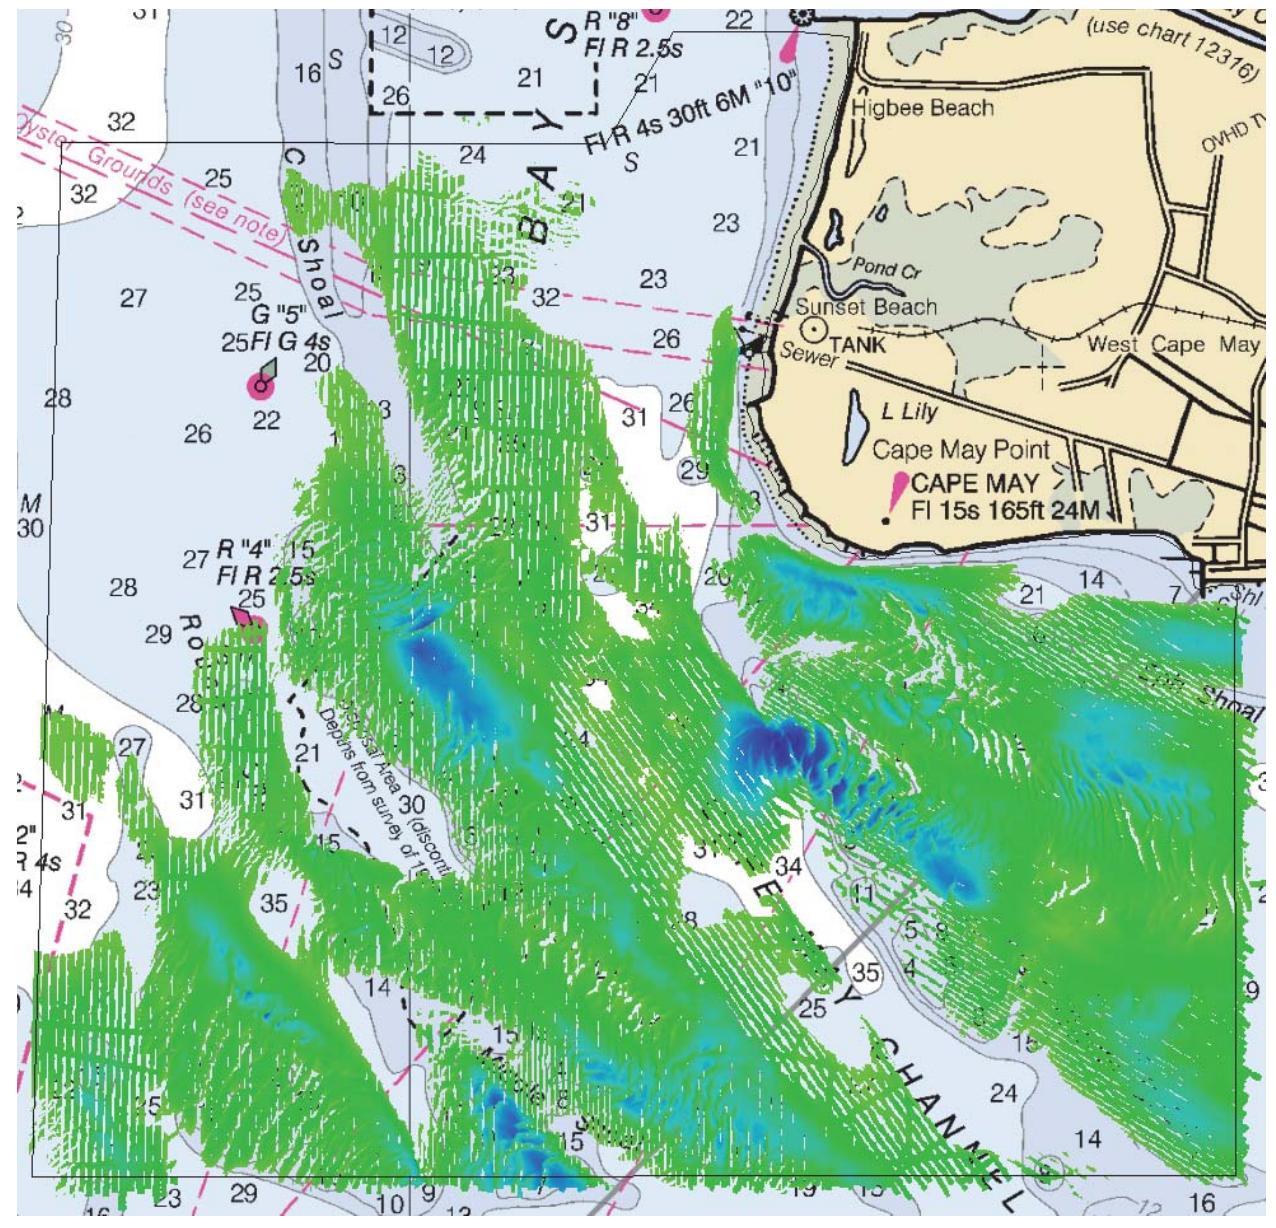
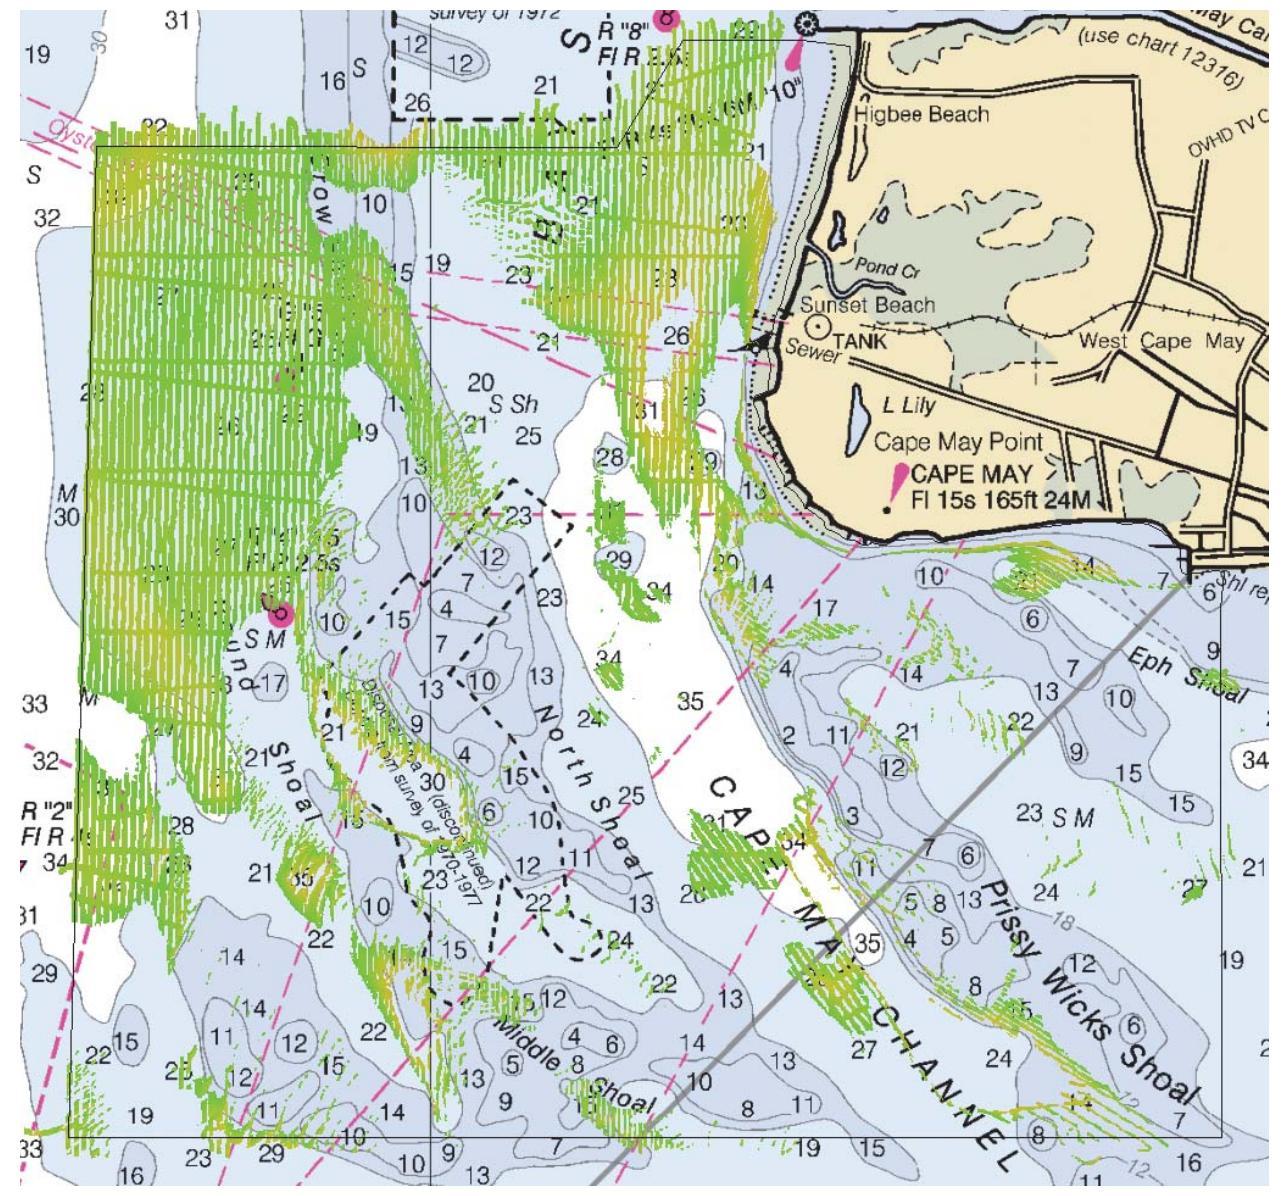
Alongshore currents have caused a westerly migration of shoal areas denoted on chart 12304. Prissy Wicks, North, and Middle Shoals have experienced the greatest amount of movement. Description of feature investigations are included in the Final Feature File. It is recommended that survey H12568 data supersede all charted depths on chart 12304.

Figure 17: Areas that were surveyed to be at least 1ft shoal of charted depths.

Figure 18: Areas surveyed to be at least 1ft deeper than charted depths.

Figure 19: Areas surveyed to be within 1ft of charted depths.

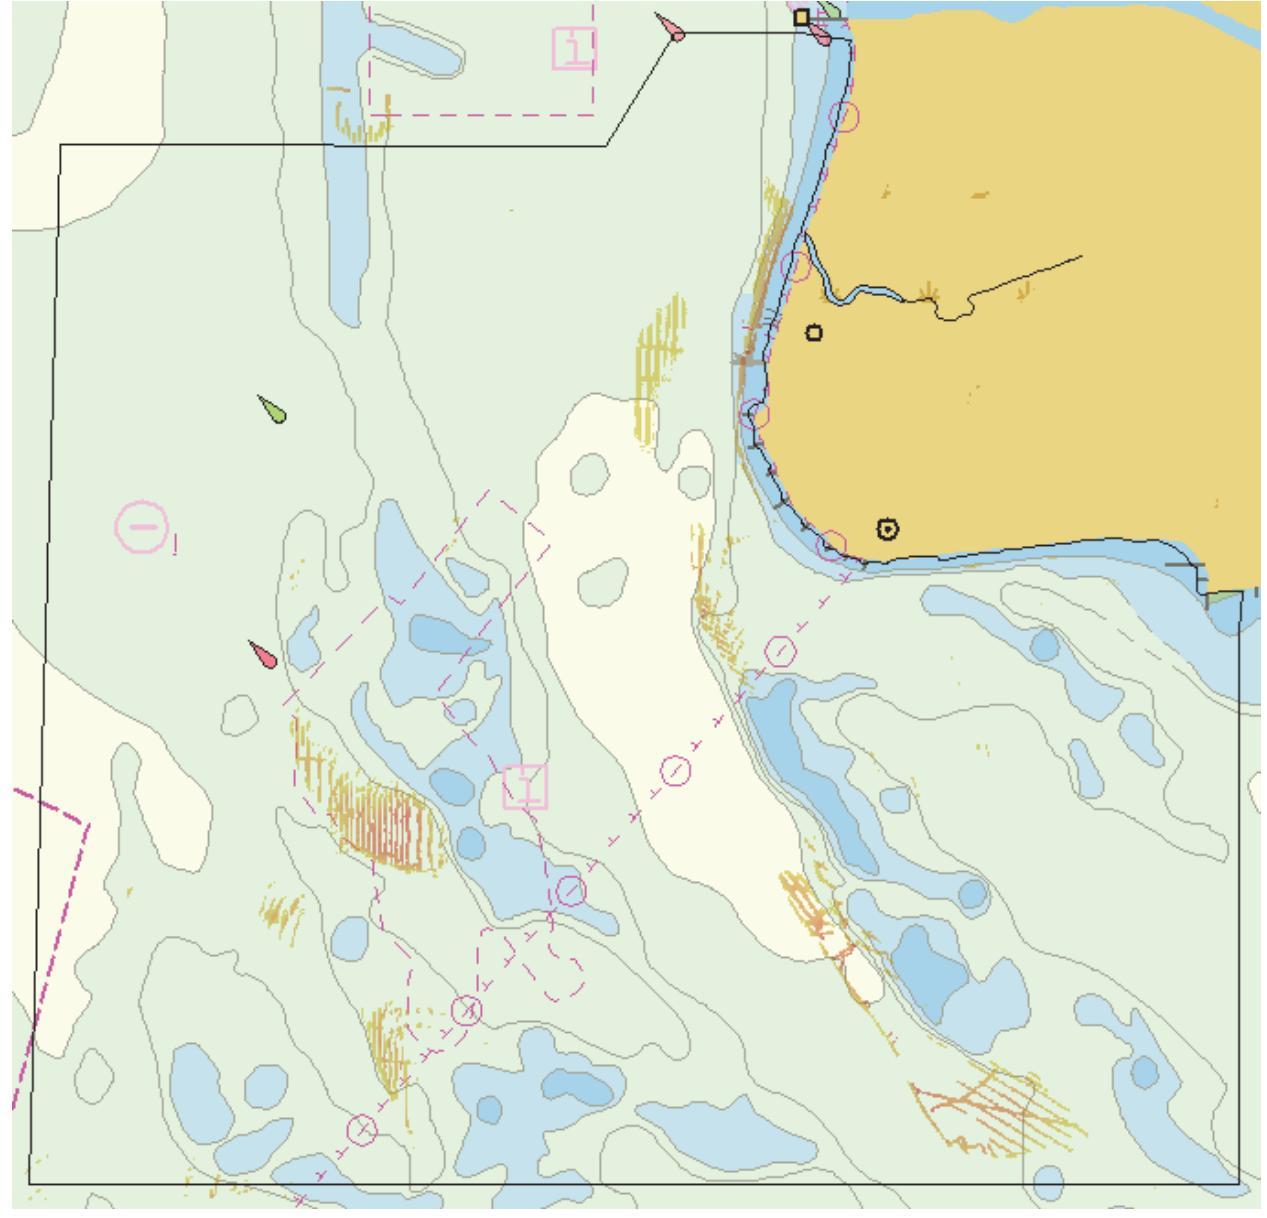
Figure 20: Areas of surveyed soundings shoal to charted depths. ENC US4DE11M shown.

Comparison of ENC US4DE11M agrees with raster chart analysis for the area of survey H12568. It is recommended that survey H12568 data supersede all charted depths on ENC US4DE11M.

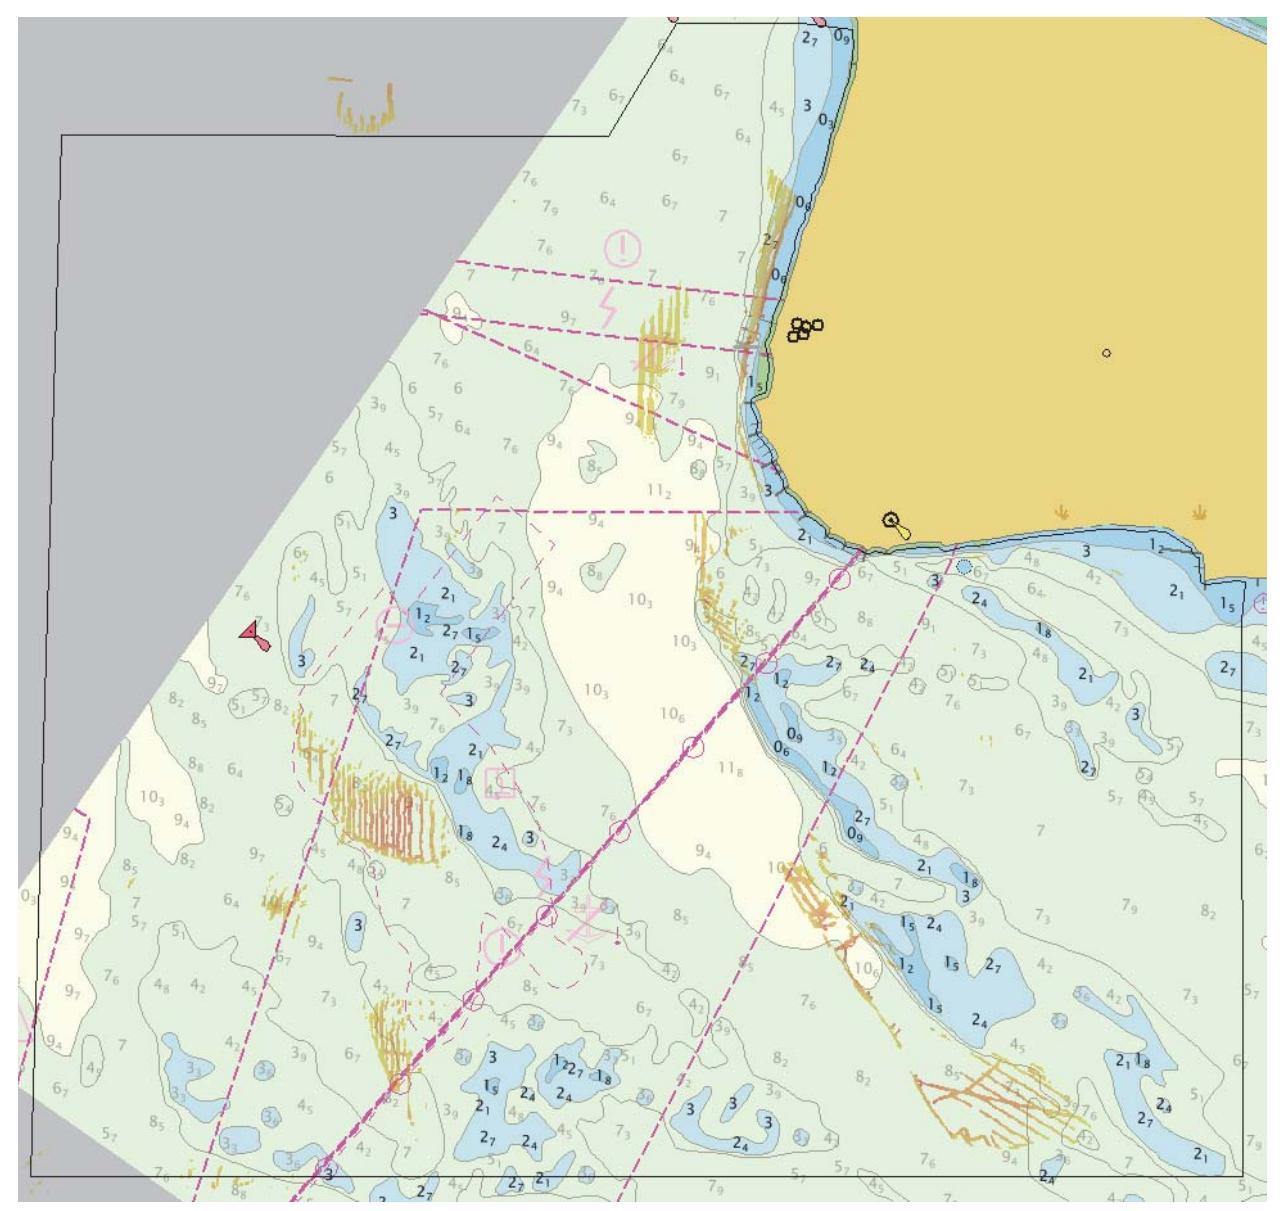
Figure 21: Areas of surveyed soundings shoal to charted depths. ENC US5NJ24M shown.

Comparison of ENC US5NJ24M agrees with raster chart analysis for the area of survey H12568. It is recommended that survey H12568 data supersede all charted depths on ENC US5NJ24M.

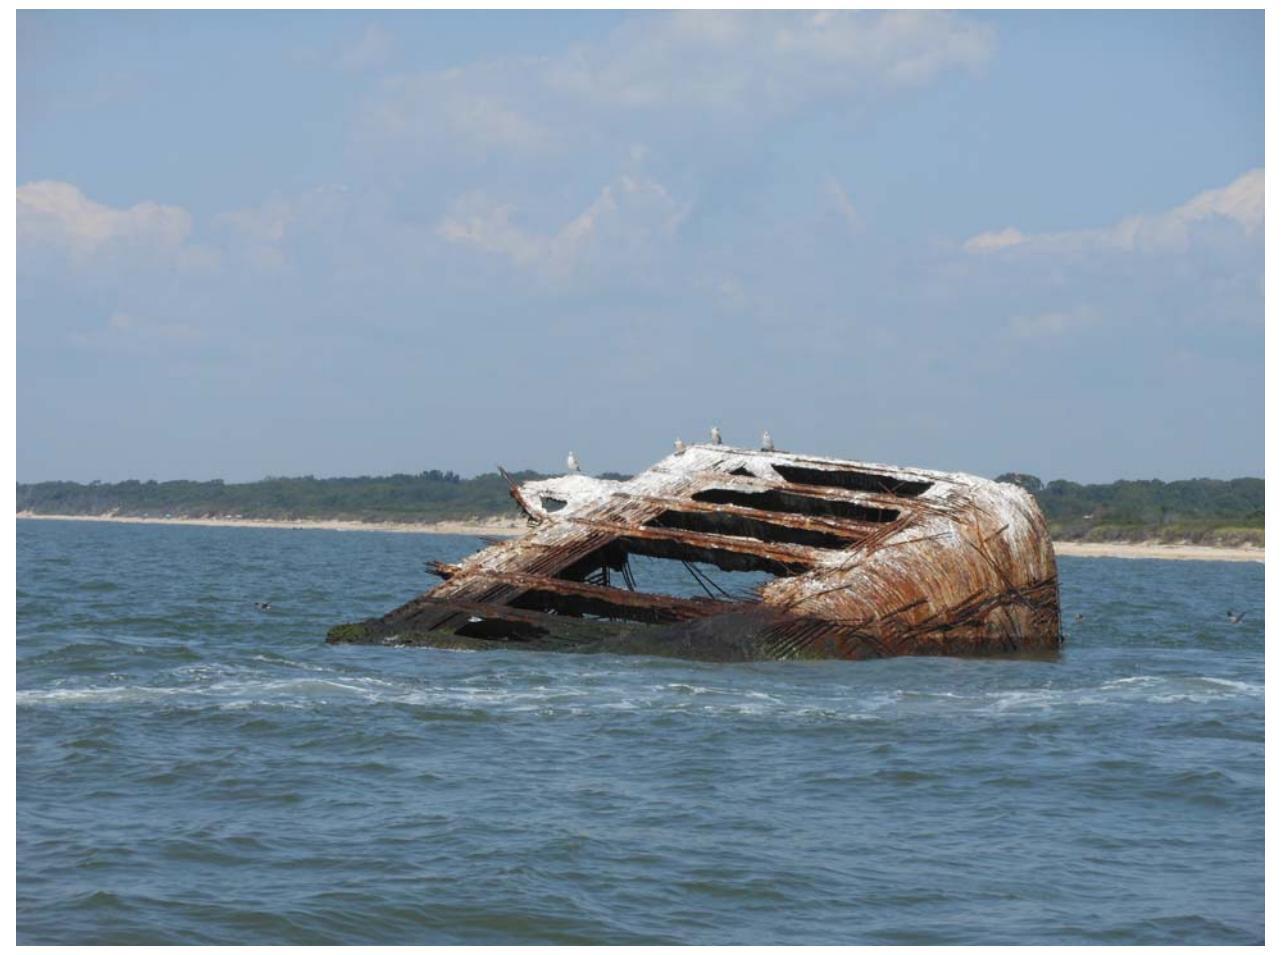
Survey H12568 contains one AWOIS item, the wreck of the U.S.S. Atlantus. The wreck remains accurately charted, but the search radius was not extended inshore of safe operational limits. Refer to the Final Feature File for a full discussion.

Figure 24: U.S.S. Atlantus, Cape May, NJ. 2013

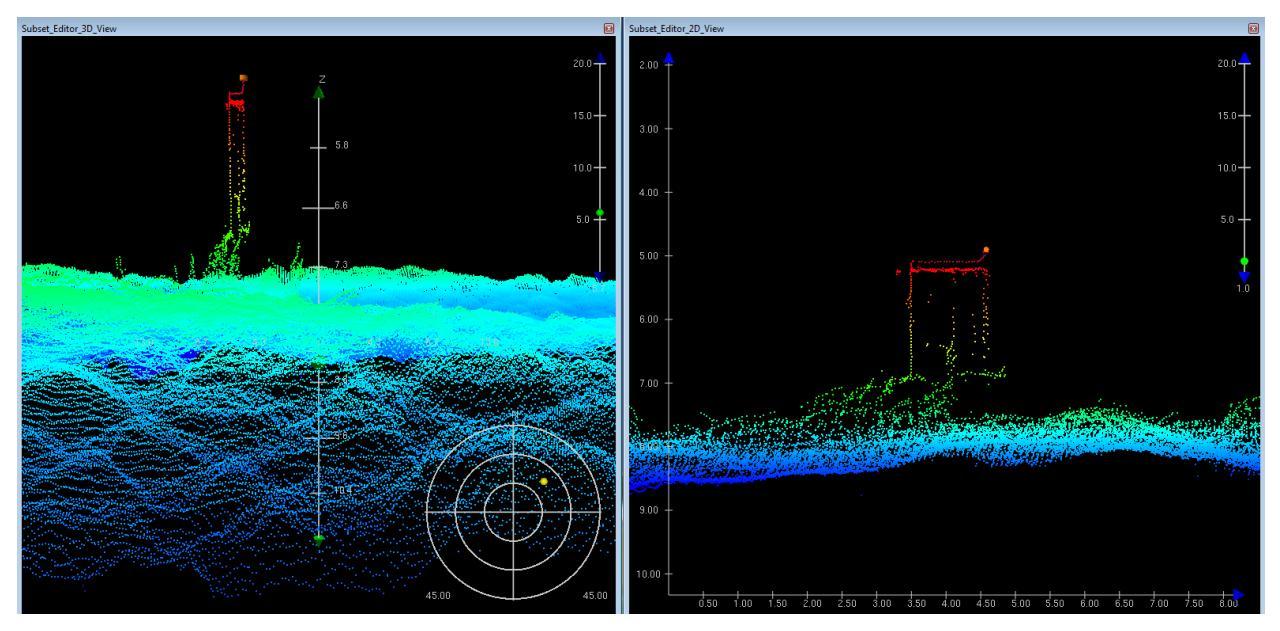
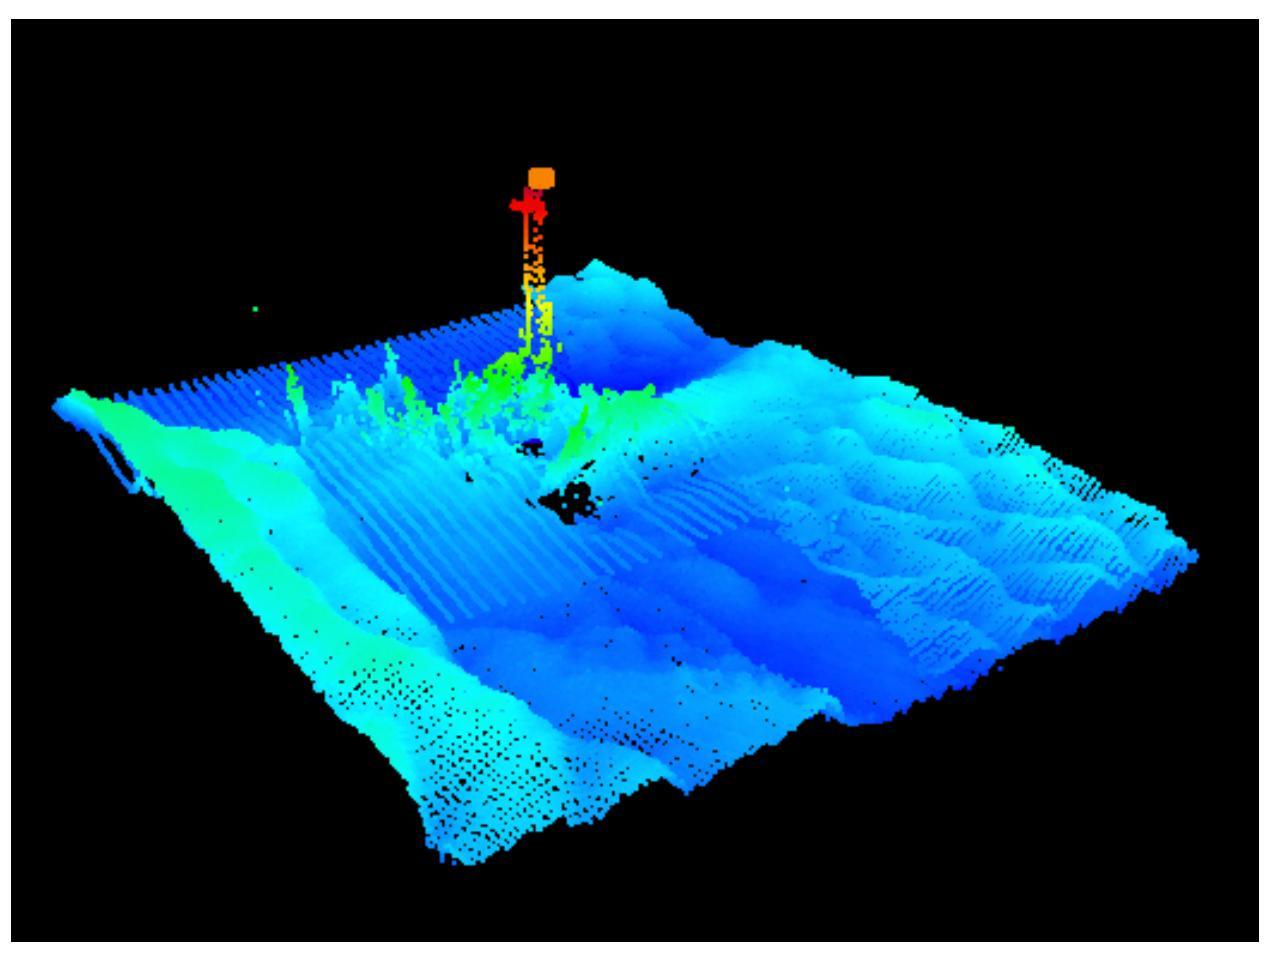
Figure 1.1.1

OBSTRN/remrks: Uncharted obstruction found using 200% SSS and ODMB. Reduced to MLLW via final tidal zoning and verified water levels. DtoN #2 for H12568.

TECSOU - 3,2:found by multi-beam,found by side scan sonar VALSOU - 4.870 m WATLEV - 3:always under water/submerged

Compile: Add Obstruction.

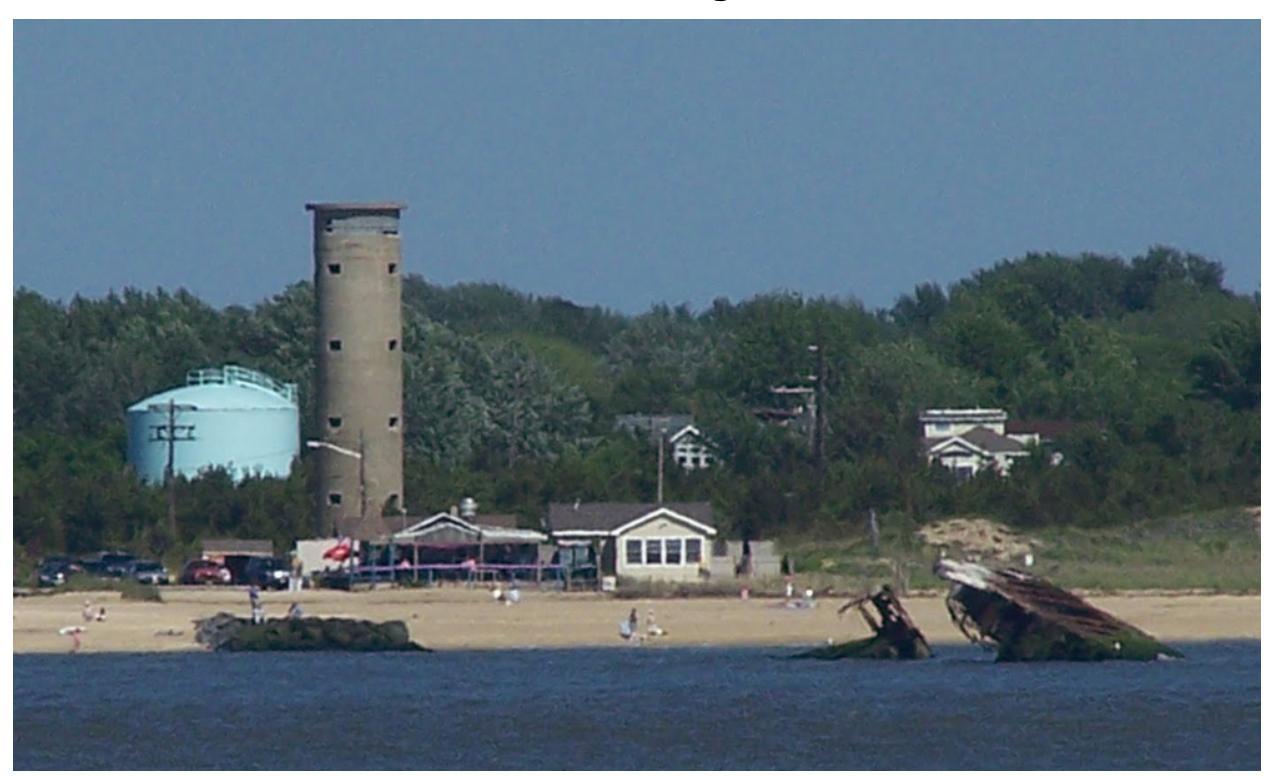
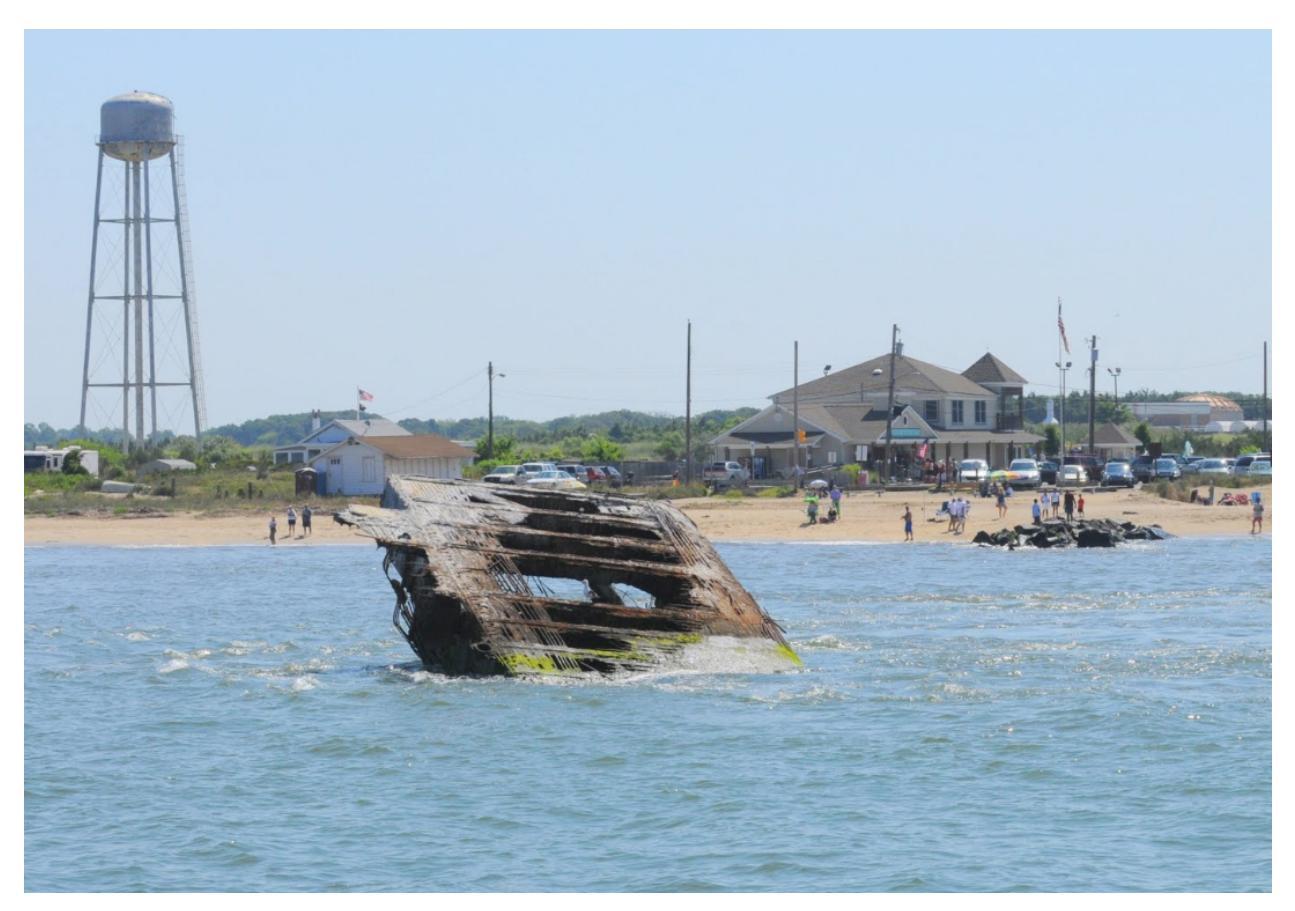
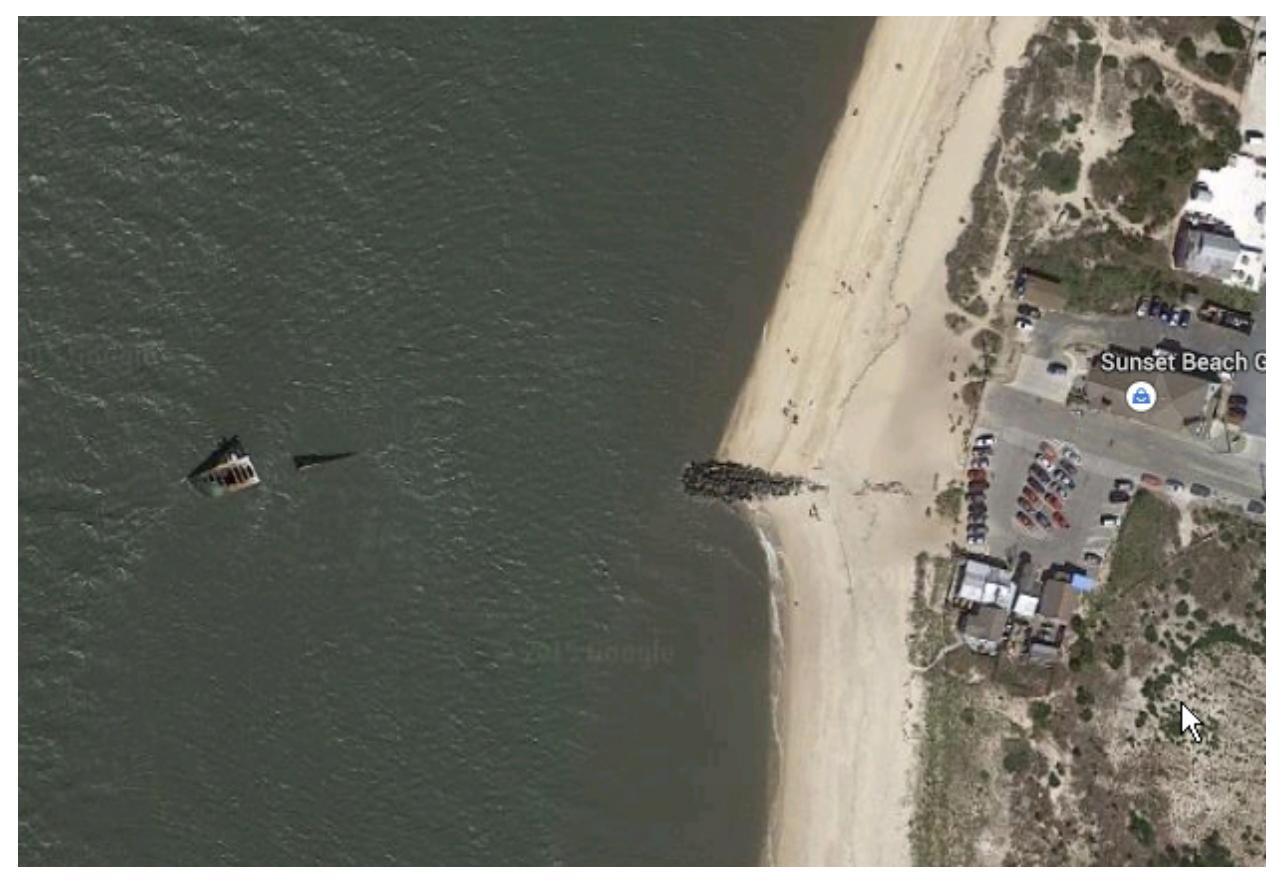
Figure 1.2.1

Attributes:CATWRK - 5:wreck showing any portion of hull or superstructure<br/>NINFOM - retain (note discrepancy between enc's and raster)<br/>QUASOU - 2,6:depth unknown,least depth known<br/>SORDAT - 20051200<br/>SORIND - US,US,graph,Chart 12316<br/>TECSOU - 2,3:found by side scan sonar,found by multi-beam<br/>WATLEV - 2:always dry

Compile: AWOIS 1210 is present, retain as charted (update positioning from project PRF)

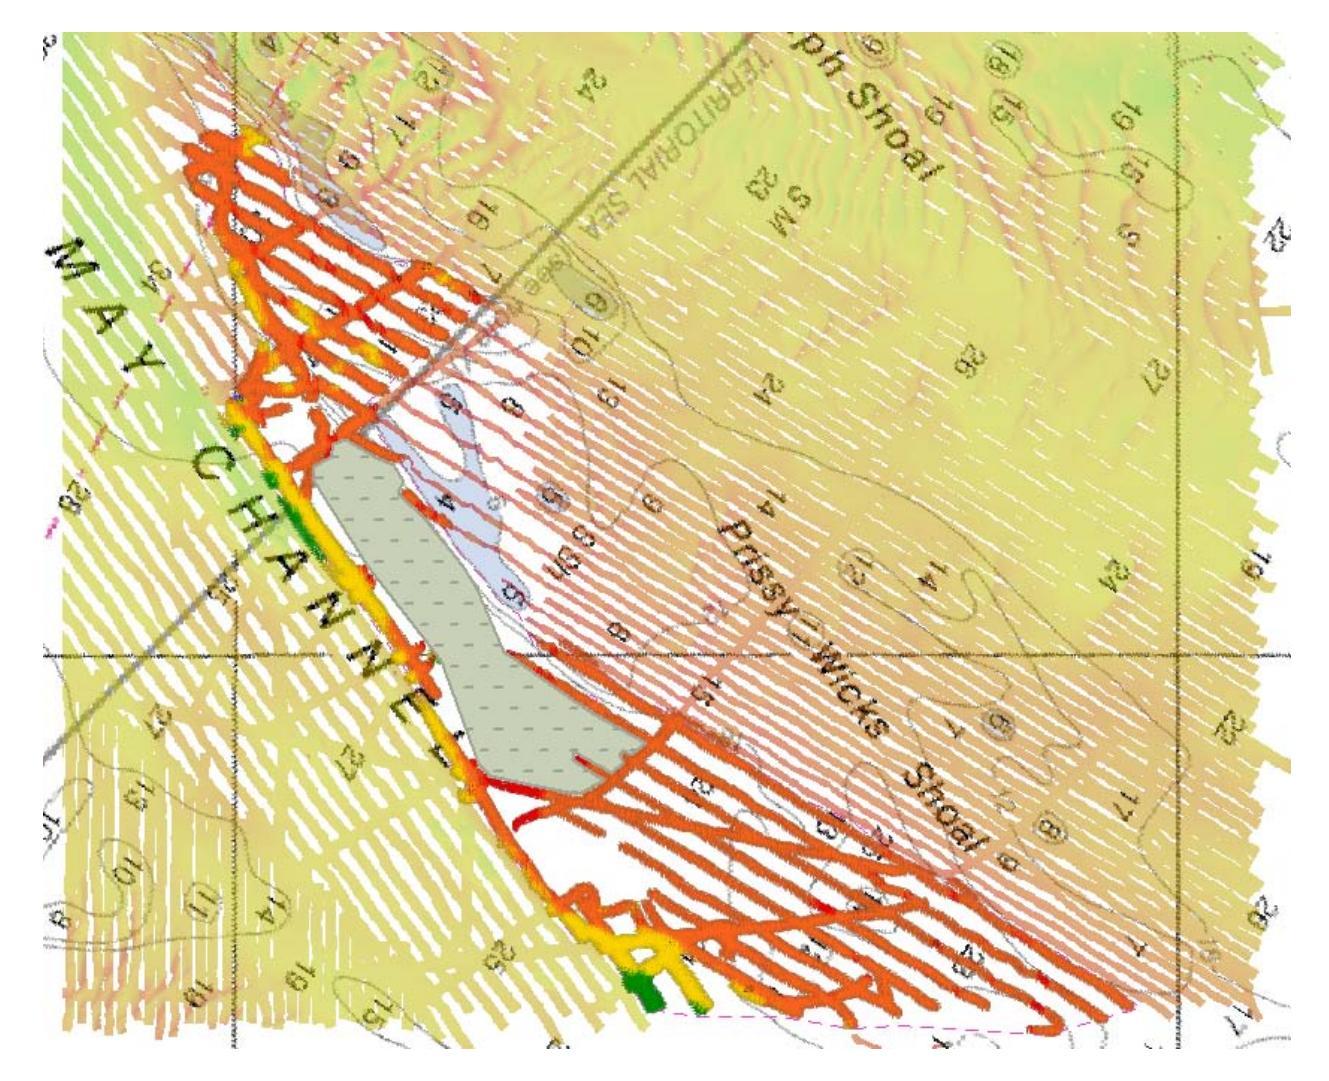
During field acquisition, the channel was initially investigated using 100% side scan coverage with concurrent set line spacing multibeam. At the time of acquisition the Operations Officer instructed the HIC's to stop data acquisition at the draft corrected 4m curve. After review of the 100% coverage the command deemed the area too shoal for further investigation (sub-4m depths), acquisition ceased at the observed 4m curve, and approximately 0.10 sq nm was left unsurveyed. A survey scale sounding plot was generated, and is included in this report along with a digitization of the unsurveyed area.

Figure 1: Survey scale soundings of the DToN shoal are colored by depth, and laid over a semi-transparent DTM. The background chart is 12316.

Update charts 12214 and 12316 to reflect current survey data.
