Descriptive Report to Accompany Survey H12750

Project: OPR-O322-RA-15 Locality: Chatham Strait, AK Sublocality: Security Bay Scale: 1:20000 May 2015 - May 2015

NOAA Ship Rainier

Chief of Party: Edward J. Van Den Ameele, CDR/NOAA

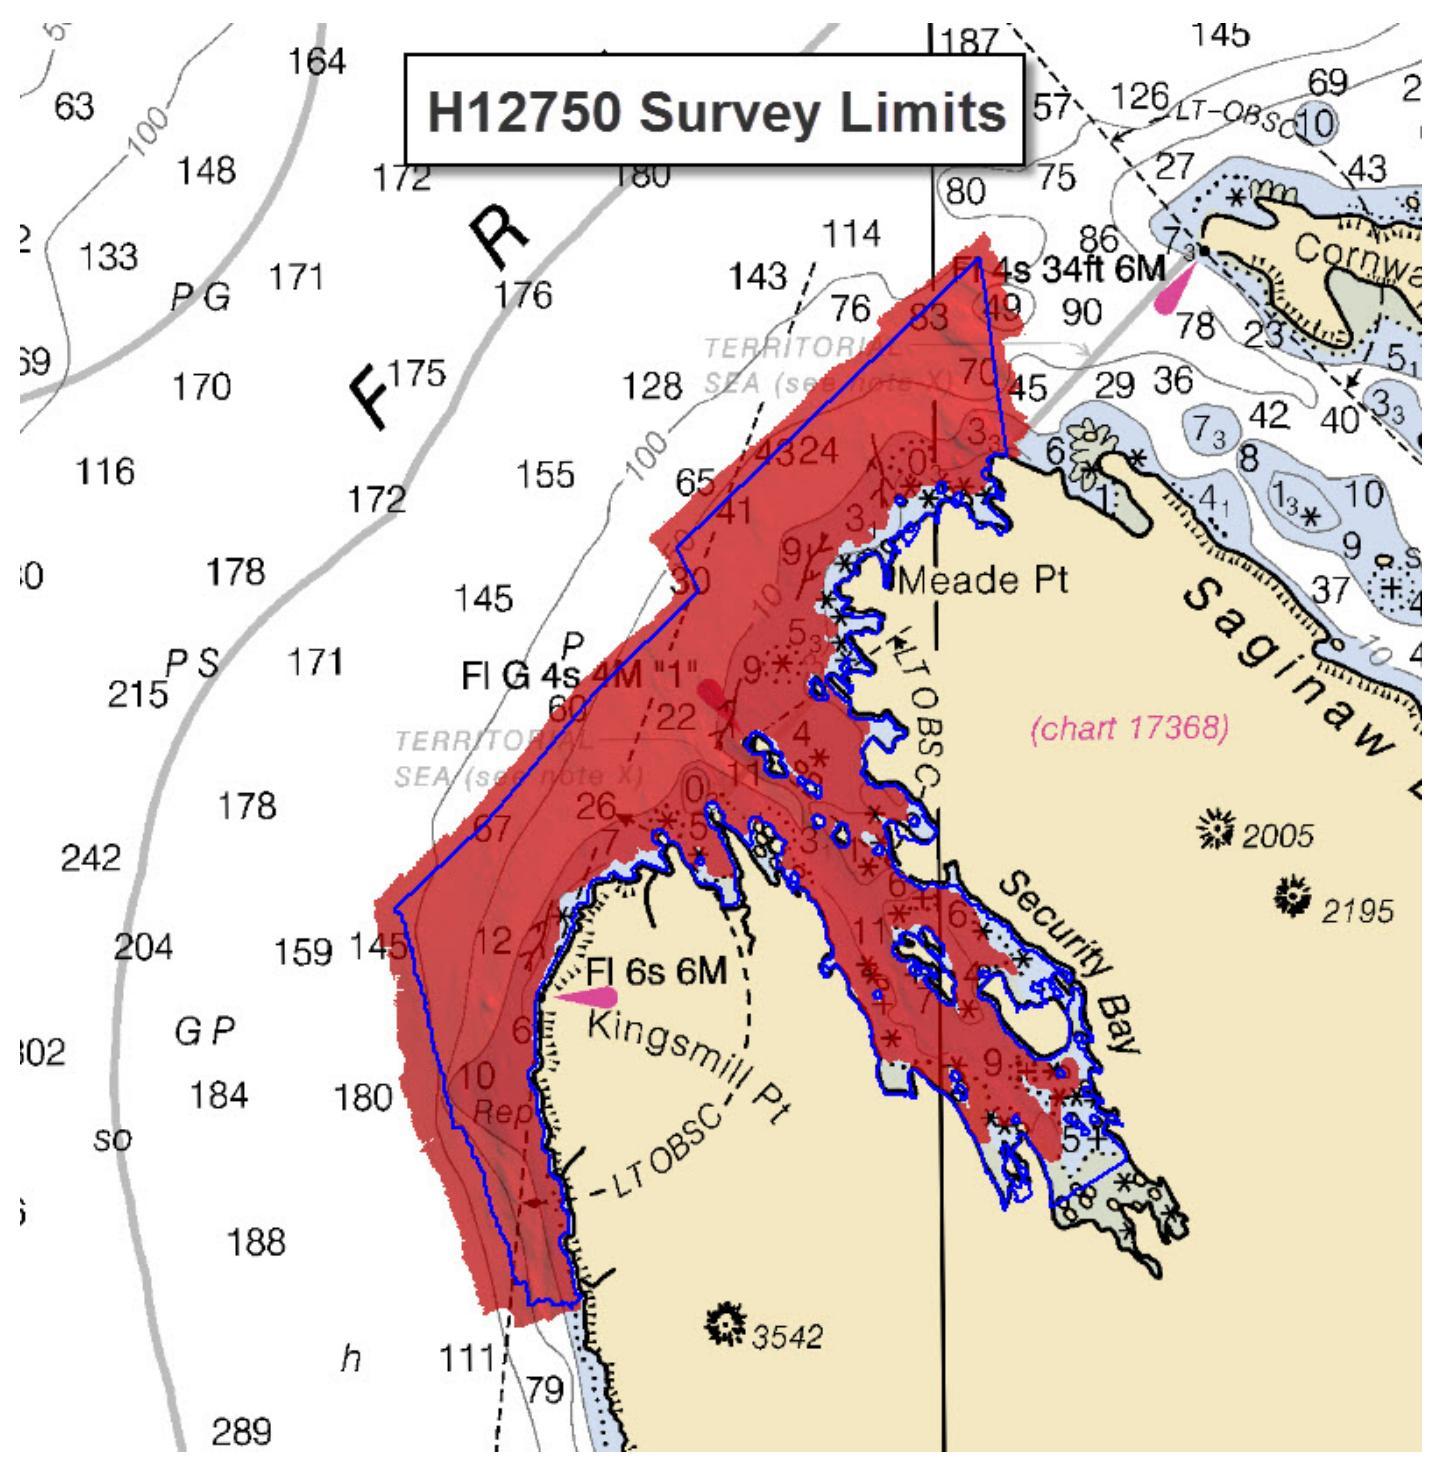
Figure 1: Overlay of H12750 sheet limits (blue) and the acquired survey coverage (red) on Chart 17320. Multibeam coverage did not reach the survey limits due to the unnavigable nature of shoreline areas.

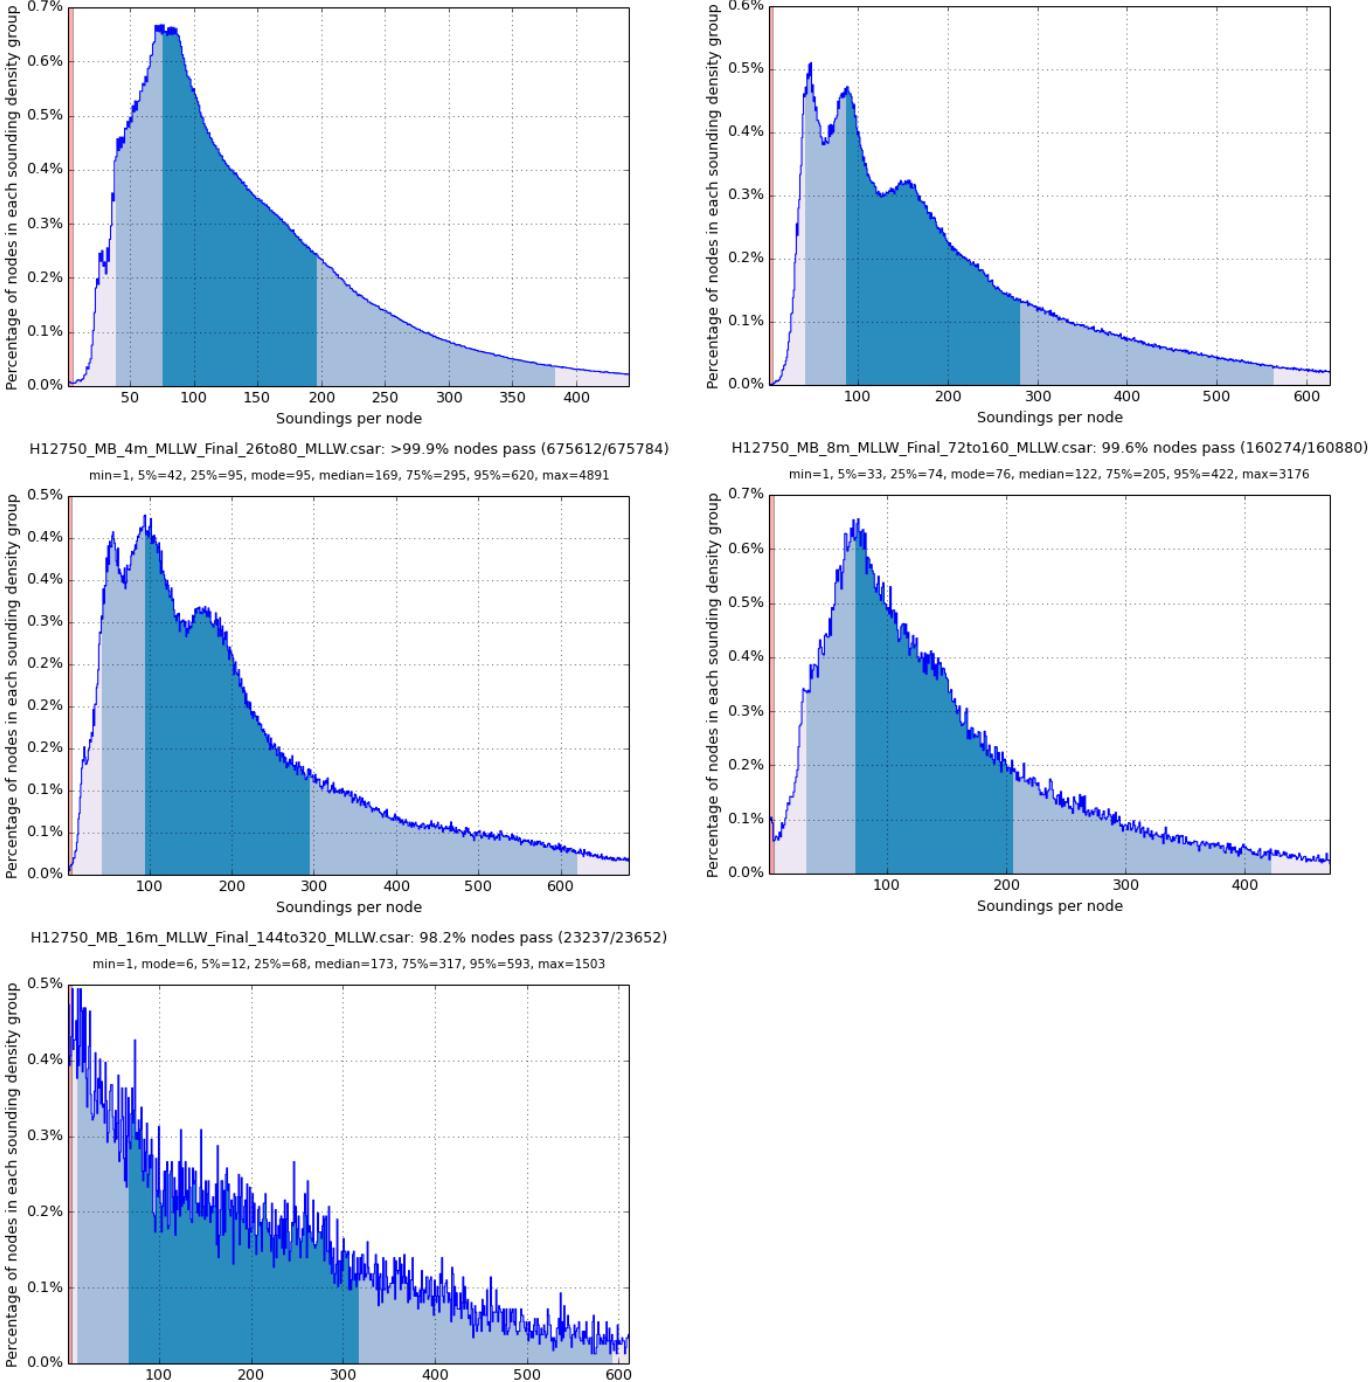
H12750_MB_2m_MLLW_Final_12to40_MLLW.csar: >99.9% nodes pass (2824760/2824855) min=1, 5%=42, mode=48, 25%=88, median=160, 75%=281, 95%=563, max=5442

H12750_MB_1m_MLLW_Final_0to20_MLLW.csar: >99.9% nodes pass (14421775/14425975) min=1, 5%=39, mode=74, 25%=76, median=121, 75%=196, 95%=383, max=9110

Figure 2: Density statistics for H12750

Data acquired on survey H12750 met complete multibeam echosounder (MBES) coverage requirements outlined in Section 5.2.2.2 of the HSSD, including data density requirements. Overall, the required data density was achieved in 99.97% of nodes. This was determined using the Pydro Finalized CSAR Surface Density Tool.

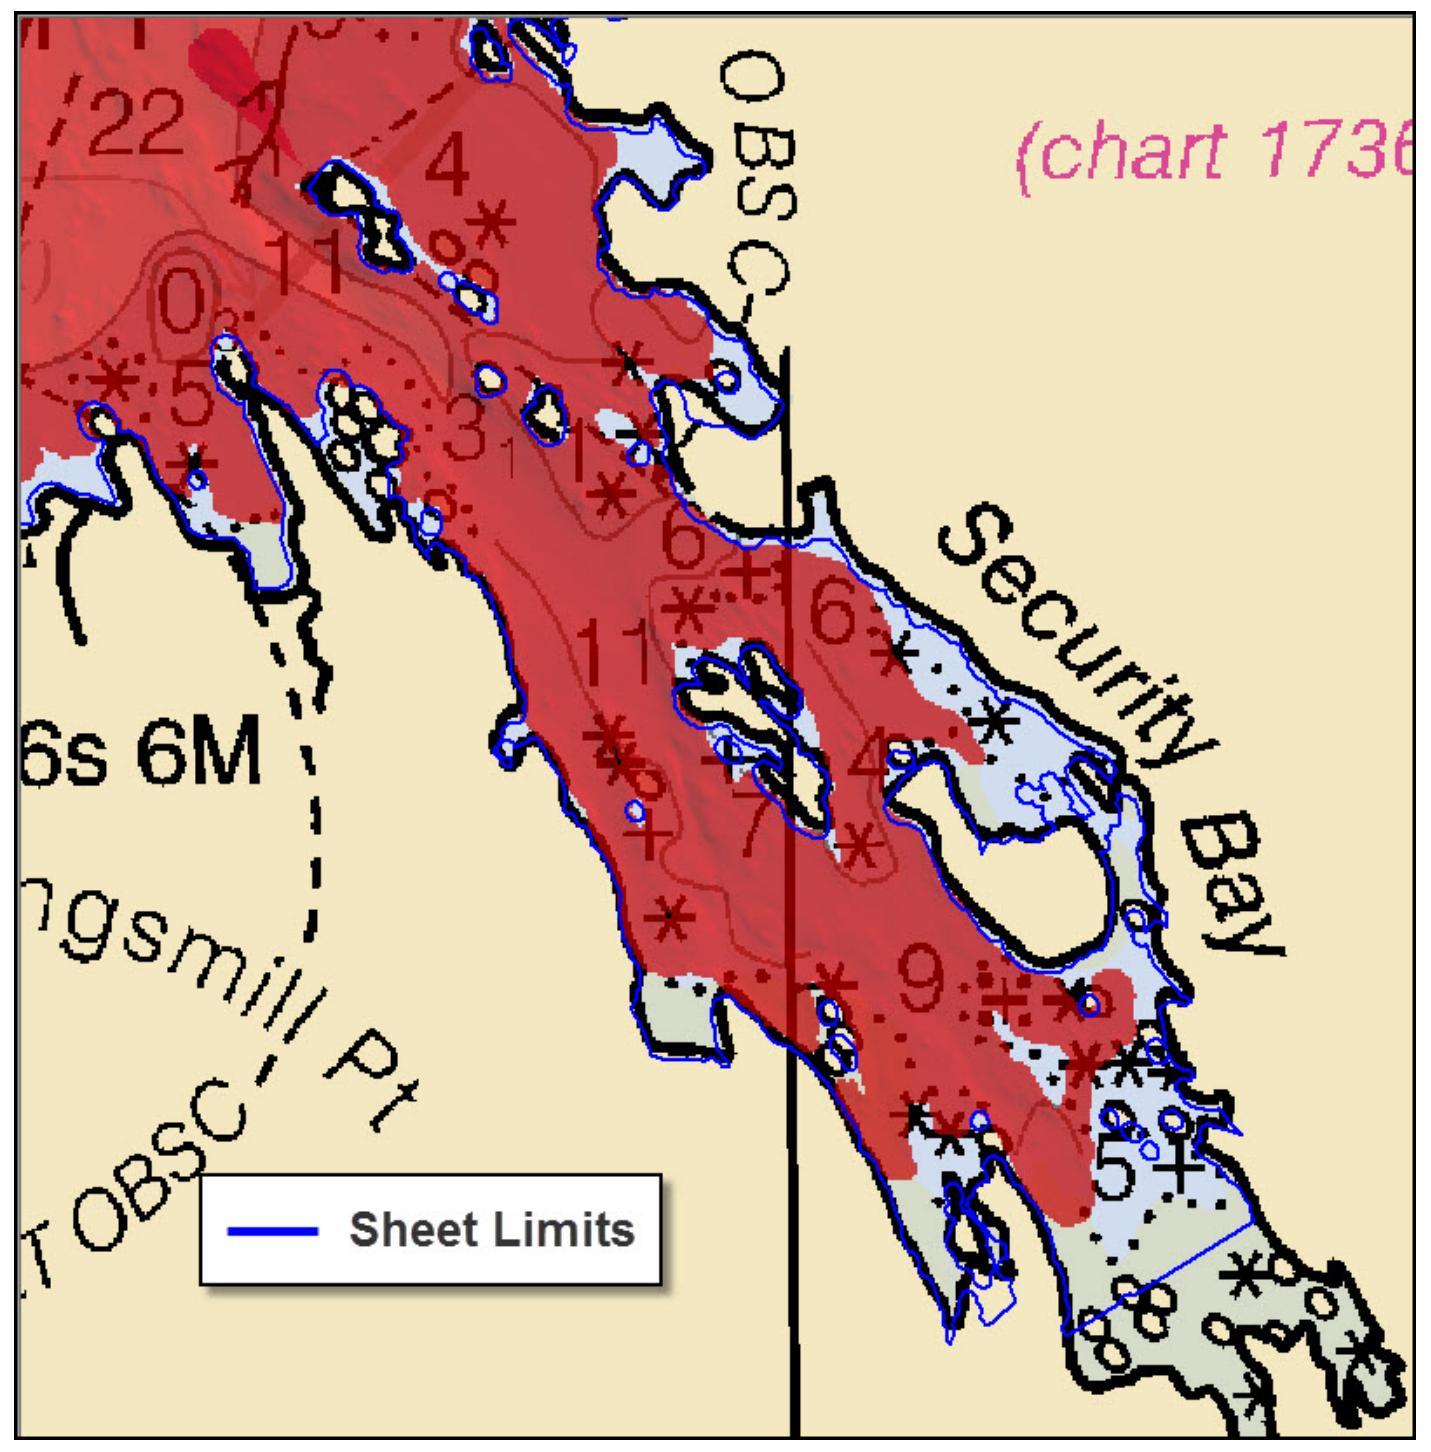
Figure 3: Overlay of H12750 sheet limits (blue) and the acquired survey coverage (red) on Chart 17320. Multibeam coverage did not reach the survey limits due to the unnavigable nature of shoreline areas.

Survey coverage did not meet the sheet limits along many portions near the shoreline and islets; these areas were considered unnavigable due to fouling with kelp and rocks (Figure 4). These areas are delineated and attributed in the Final Feature File.

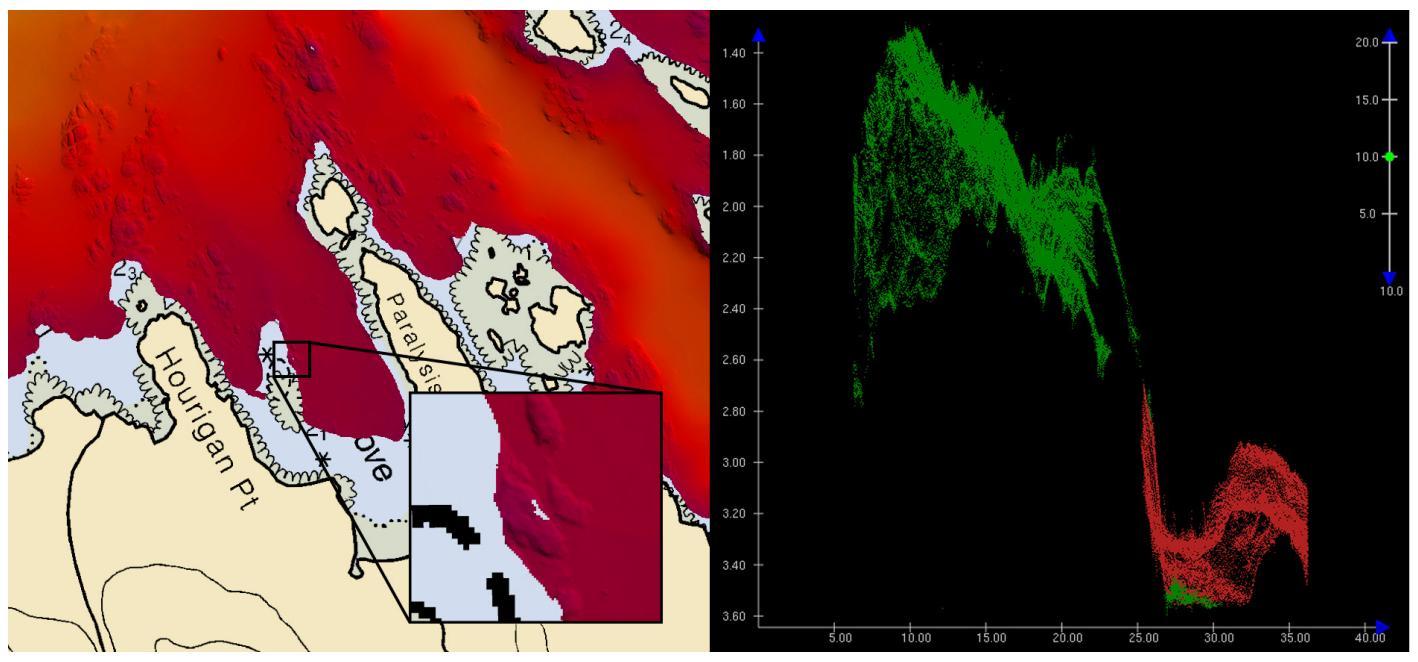
Figure 4: *Holiday in survey coverage measures approximately 4 x 12 meters.*

Additional Holidays: Five small holidays resulting from inadequate line spacing exist in H12750 survey coverage. An overview of these holidays is shown in Figures 5-9. The largest holiday measures approximately 4 x 12 meters. All holidays were examined to ensure that no navigationally significant features were evident in the surrounding data.

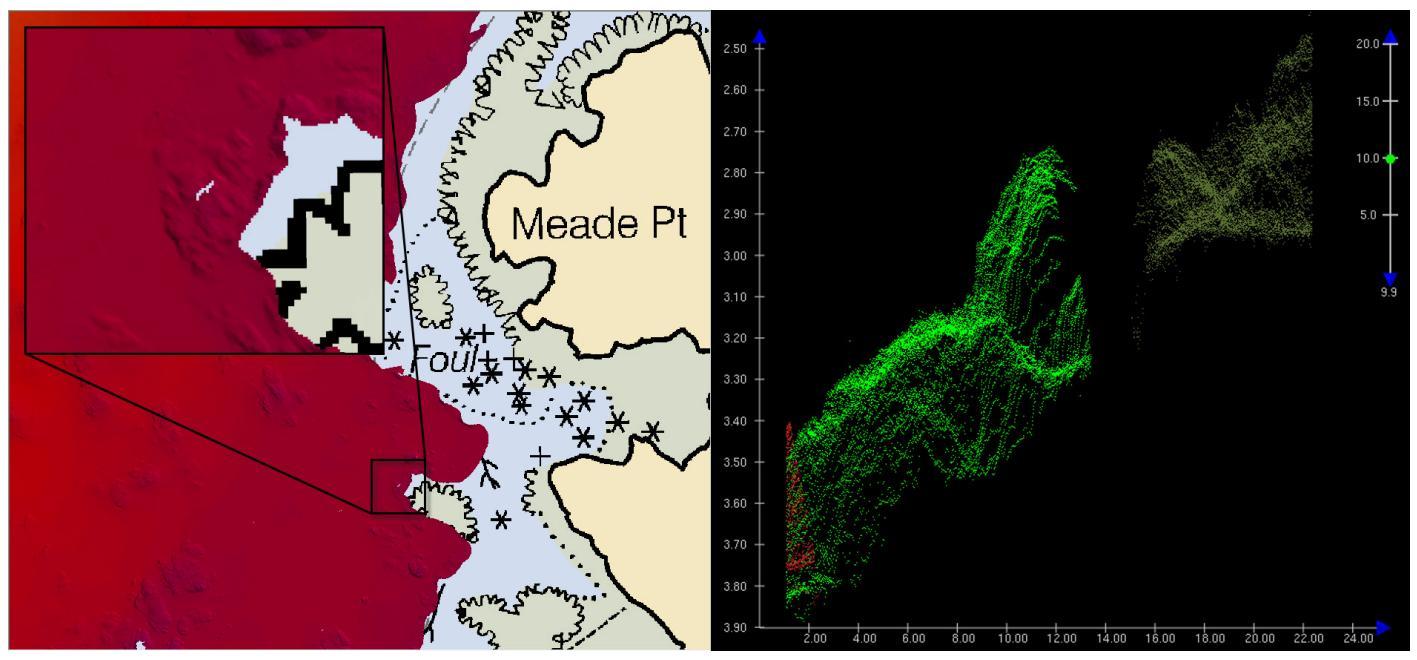
Figure 5: Holiday in survey coverage measures approximately 4 x 11 meters.

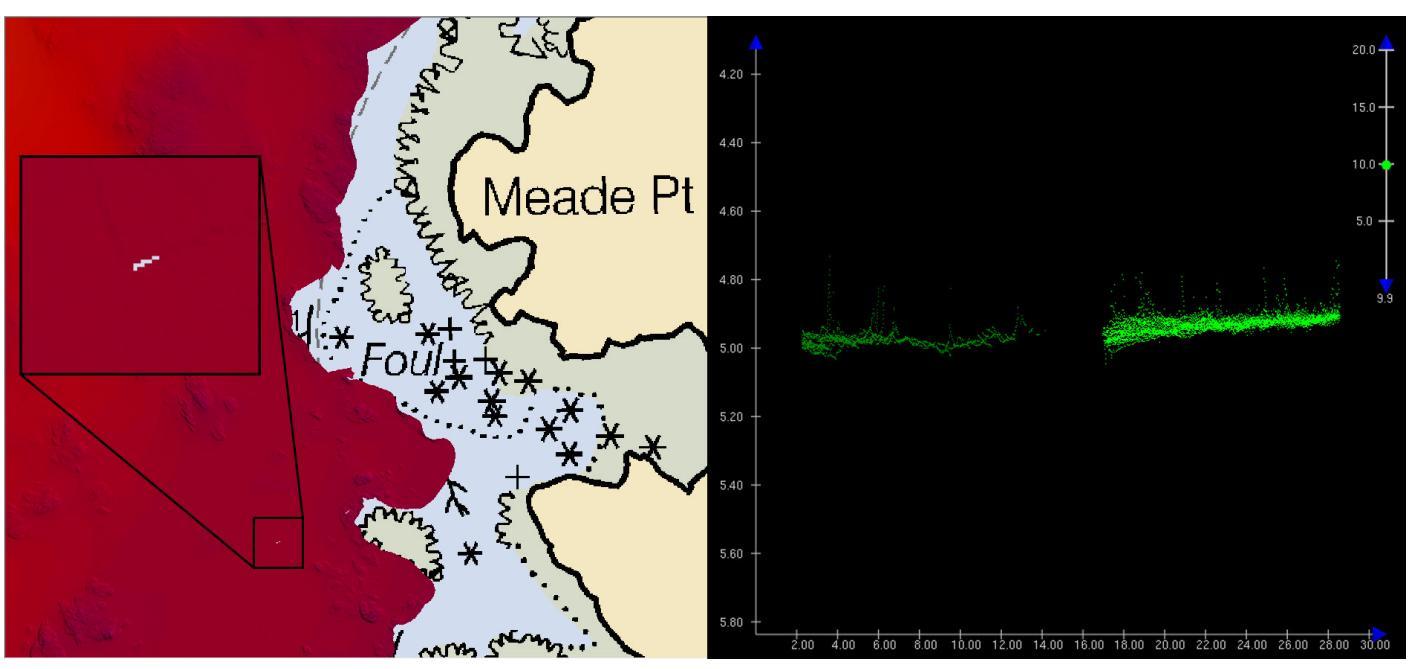
Figure **6***: Holiday in survey coverage measures approximately 3 x 8 meters.*

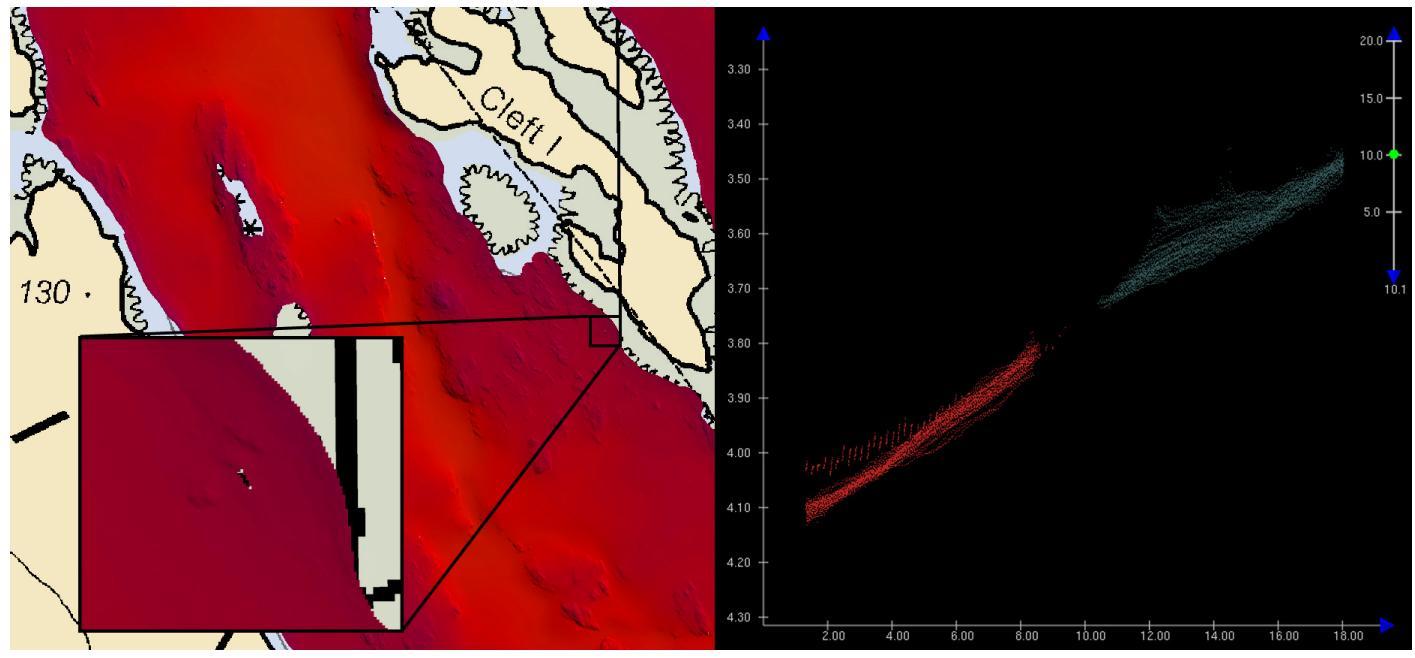
Figure 7: Holiday in survey coverage measures approximately 3 x 8 meters.

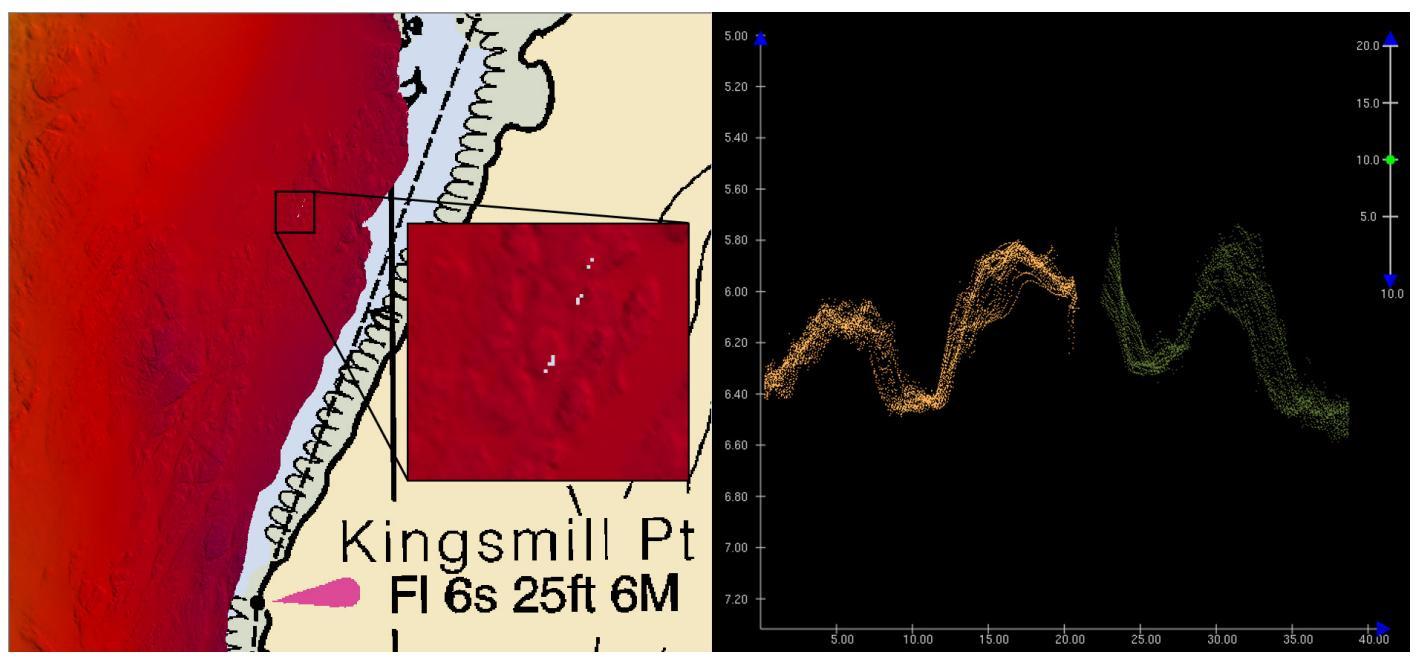
Figure **8***: Holiday in survey coverage measures approximately 3 x 3 meters.*

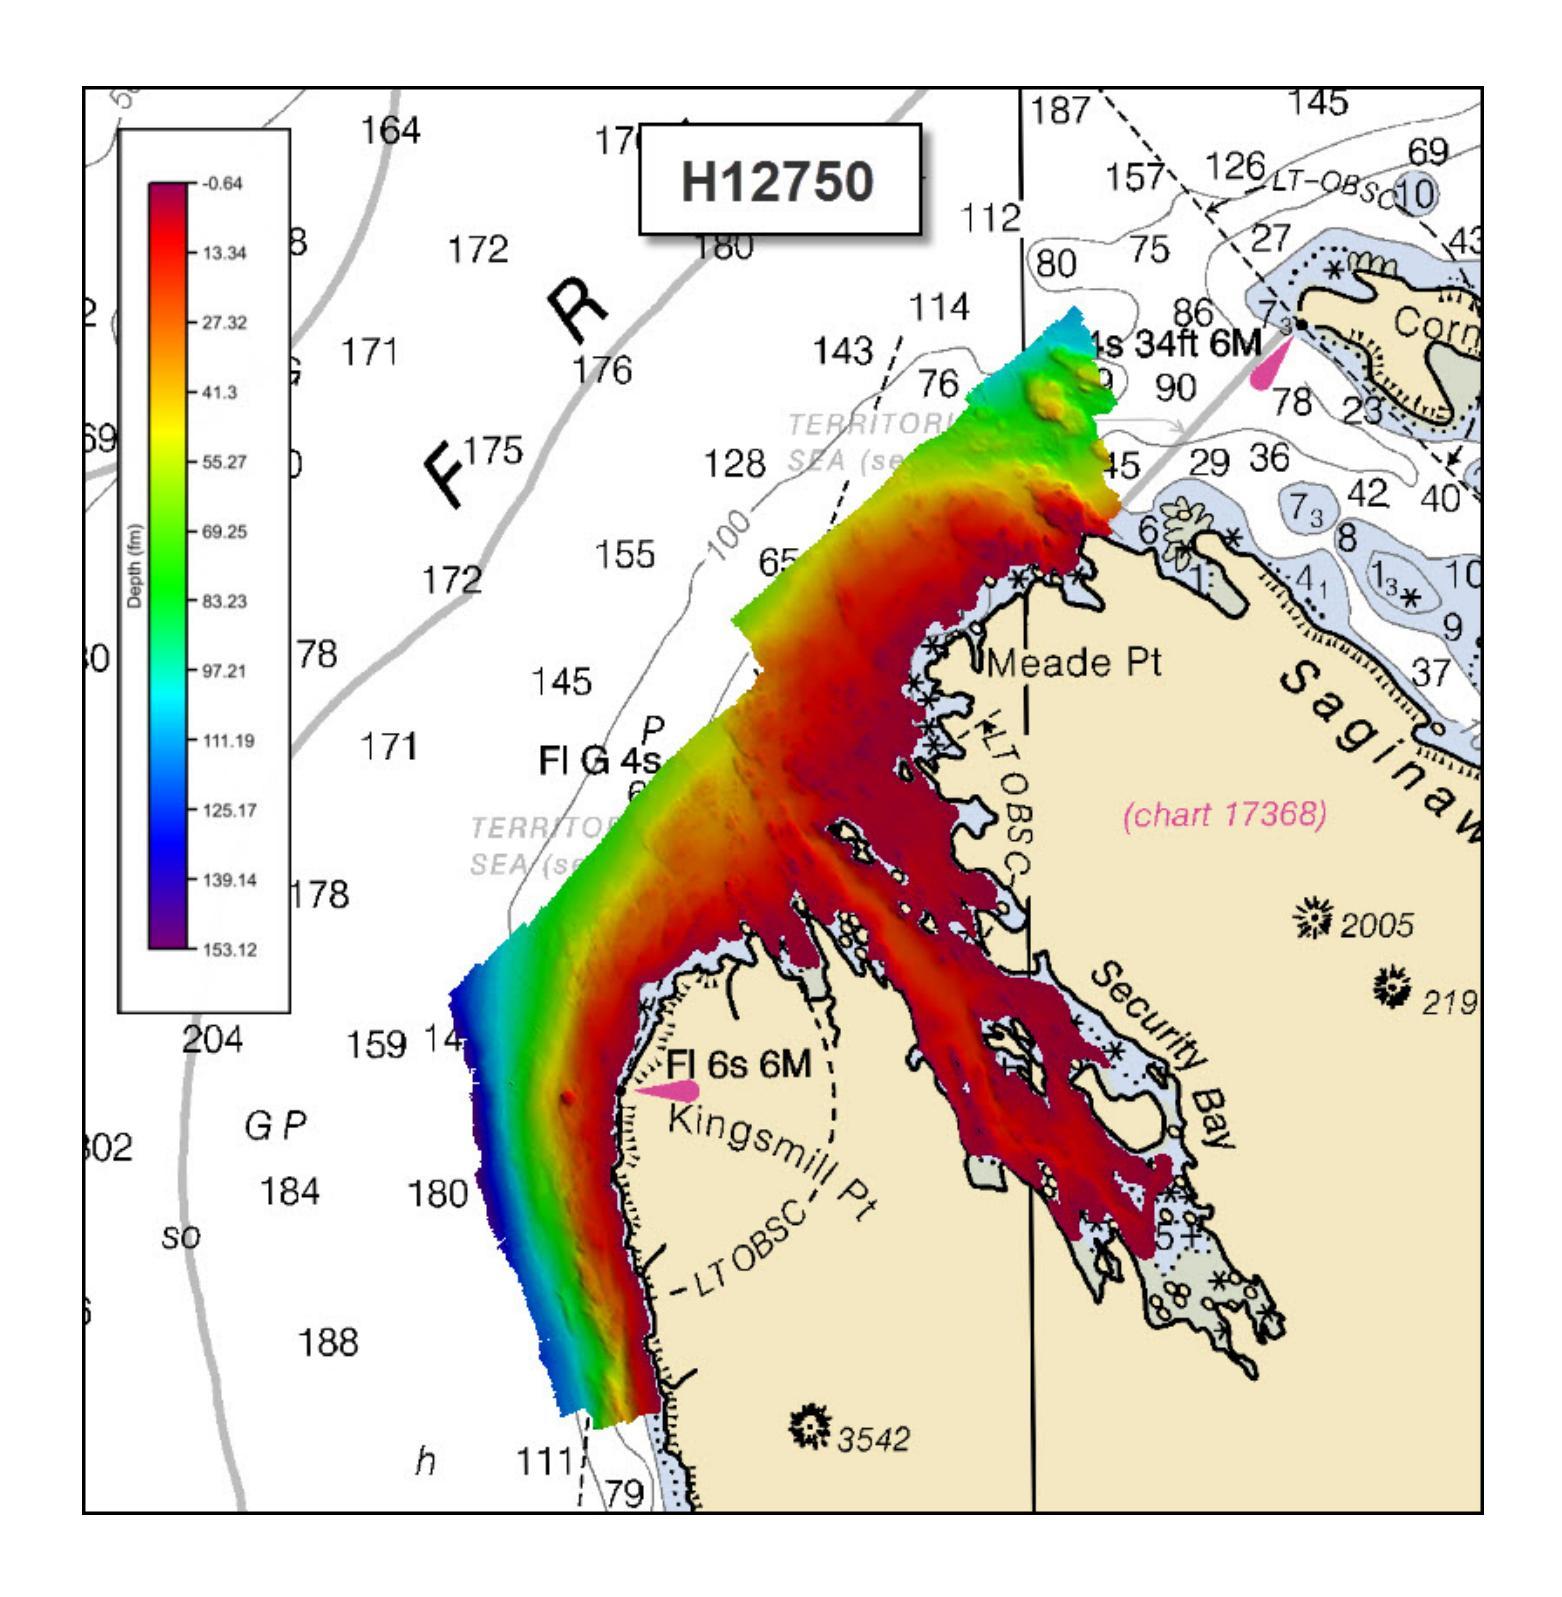
Figure 9: H12750 depth-colored MBES coverage overlay on Chart 17320

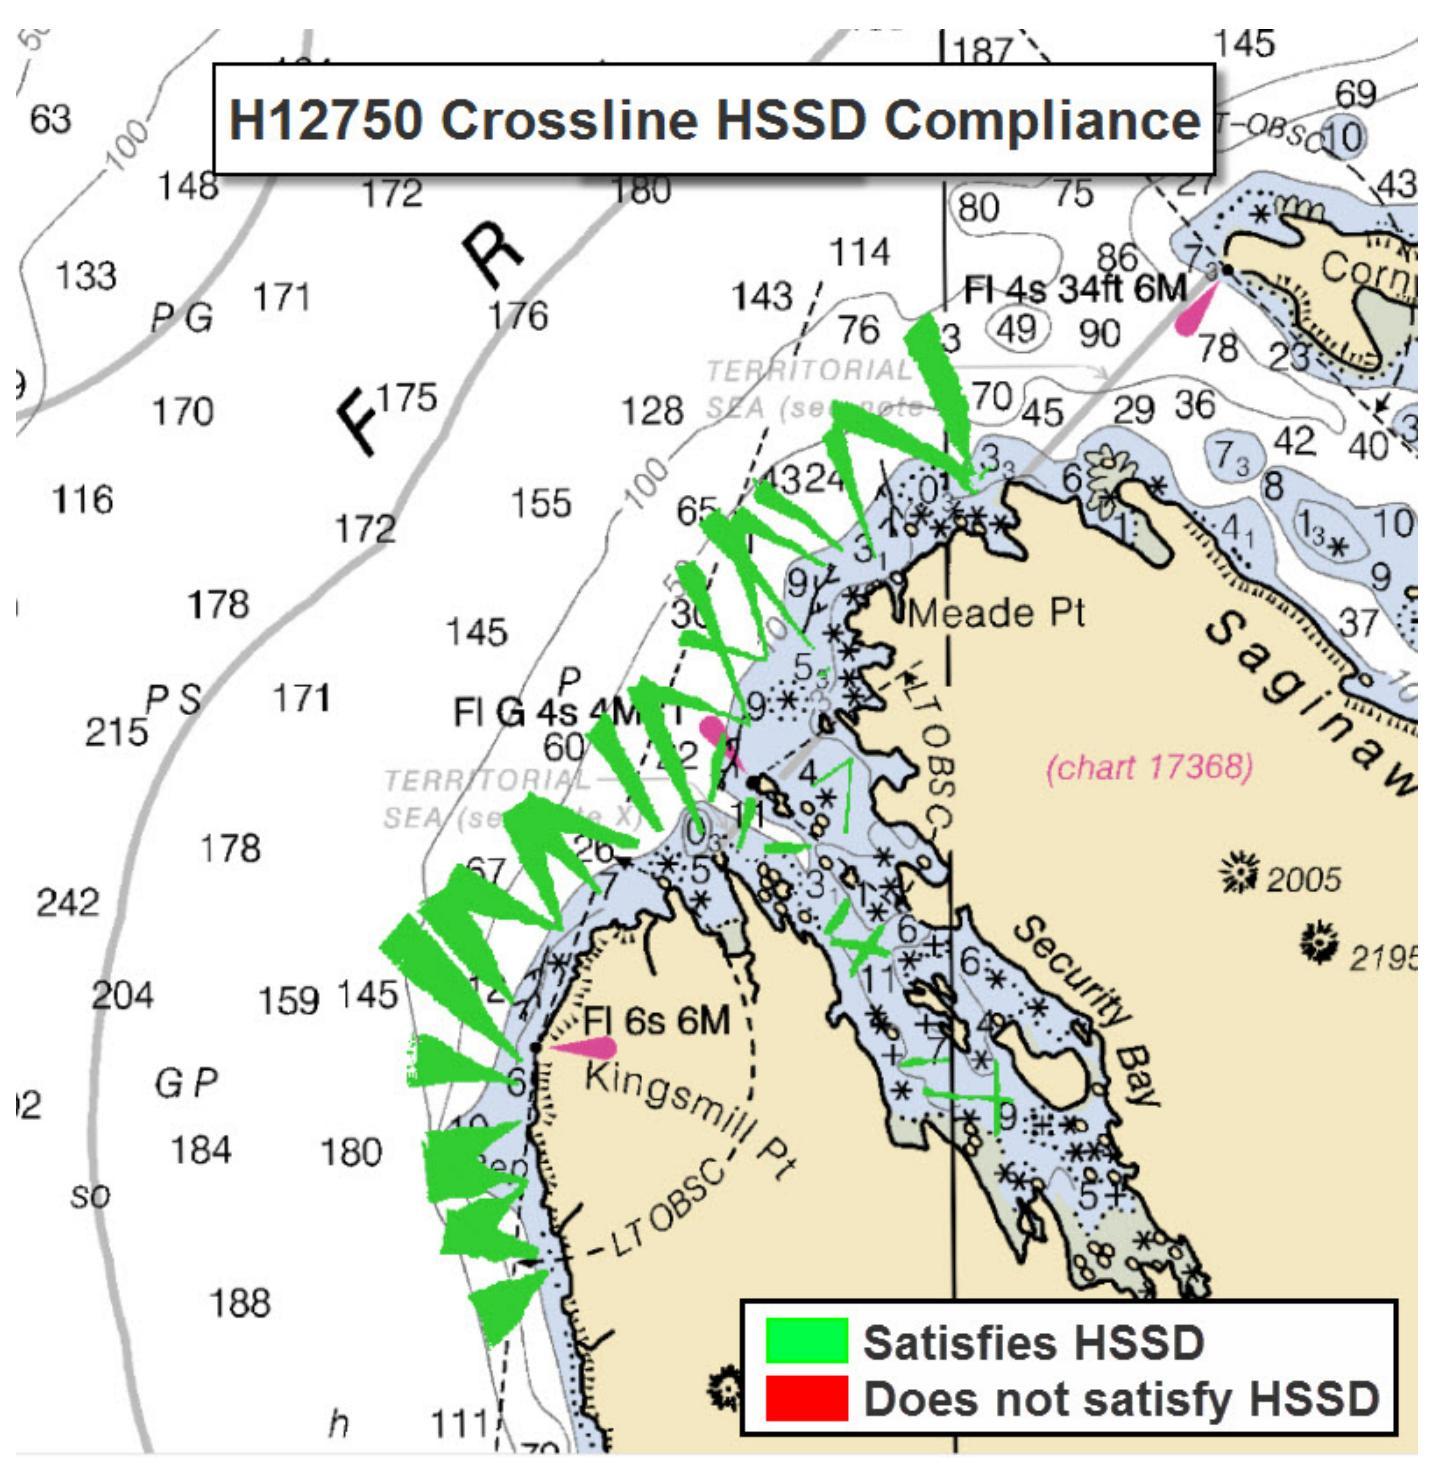
Figure 11: H12750 Crossline HSSD Compliance

Multibeam crosslines were acquired using the Reson 7125 sonars on Launches 2802 (RA-5) and 2804 (RA-6). A 4m CUBE surface was created using only mainscheme lines, a second 4m CUBE surface was created using only crosslines, and a difference surface was generated in Caris at a 4m resolution. This difference surface was compared to the allowable uncertainty values within the HSSD for the observed depths, and statistics were calculated in Excel. In total, 99.26% of the depth differences between H12750 mainscheme and crossline data are within the requirements of the HSSD.

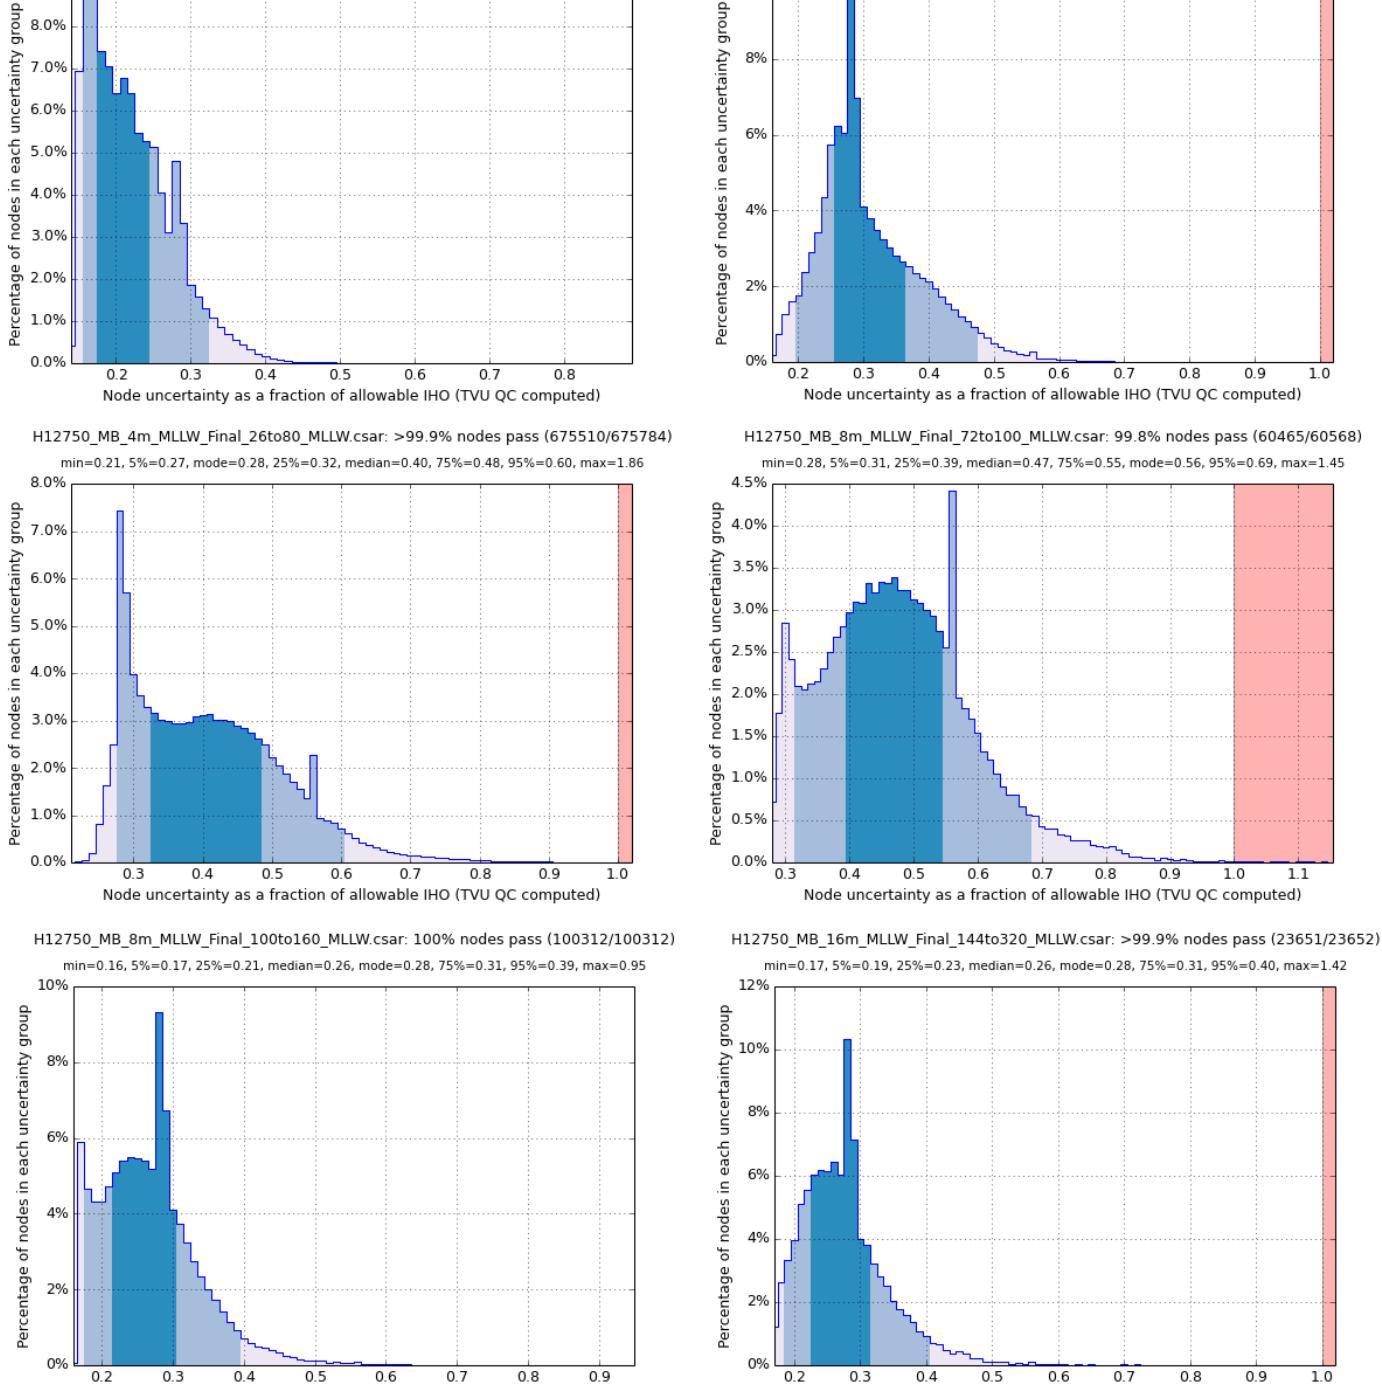
H12750_MB_1m_MLLW_Final_0to20_MLLW.csar: 100% nodes pass (14425975/14425975) min=0.14, 5%=0.15, mode=0.17, 25%=0.17, median=0.21, 75%=0.25, 95%=0.33, max=0.89

Figure 12: IHO compliance to uncertainty standards as calculated using Pydro Finalized CSAR Surface tool

H12750_MB_2m_MLLW_Final_12to40_MLLW.csar: >99.9% nodes pass (2824805/2824855)

min=0.16, 5%=0.20, 25%=0.25, mode=0.28, median=0.29, 75%=0.37, 95%=0.47, max=1.24

Uncertainty values of submitted finalized grids were calculated in Caris using the "Greater of the Two" of uncertainty and standard deviation (scaled to 95%). To visualize where uncertainty requirements were met, for each surface a custom "HSSD Compliance" layer was created, based on the difference between the calculated uncertainty of the nodes and the allowable uncertainty defined in the HSSD. To quantify the extent to which requirements were met, the HSSD Compliance layers were queried within Caris and examined in Excel. Overall, 99.99% of the nodes of survey H12750 met the uncertainty requirements specified in the HSSD. These HSSD Compliance layers were retained in the submitted surfaces. Additionally, the surfaces were analyzed using the Pydro Finalized CSAR Surface IHO Compliance tool, achieving similar results.

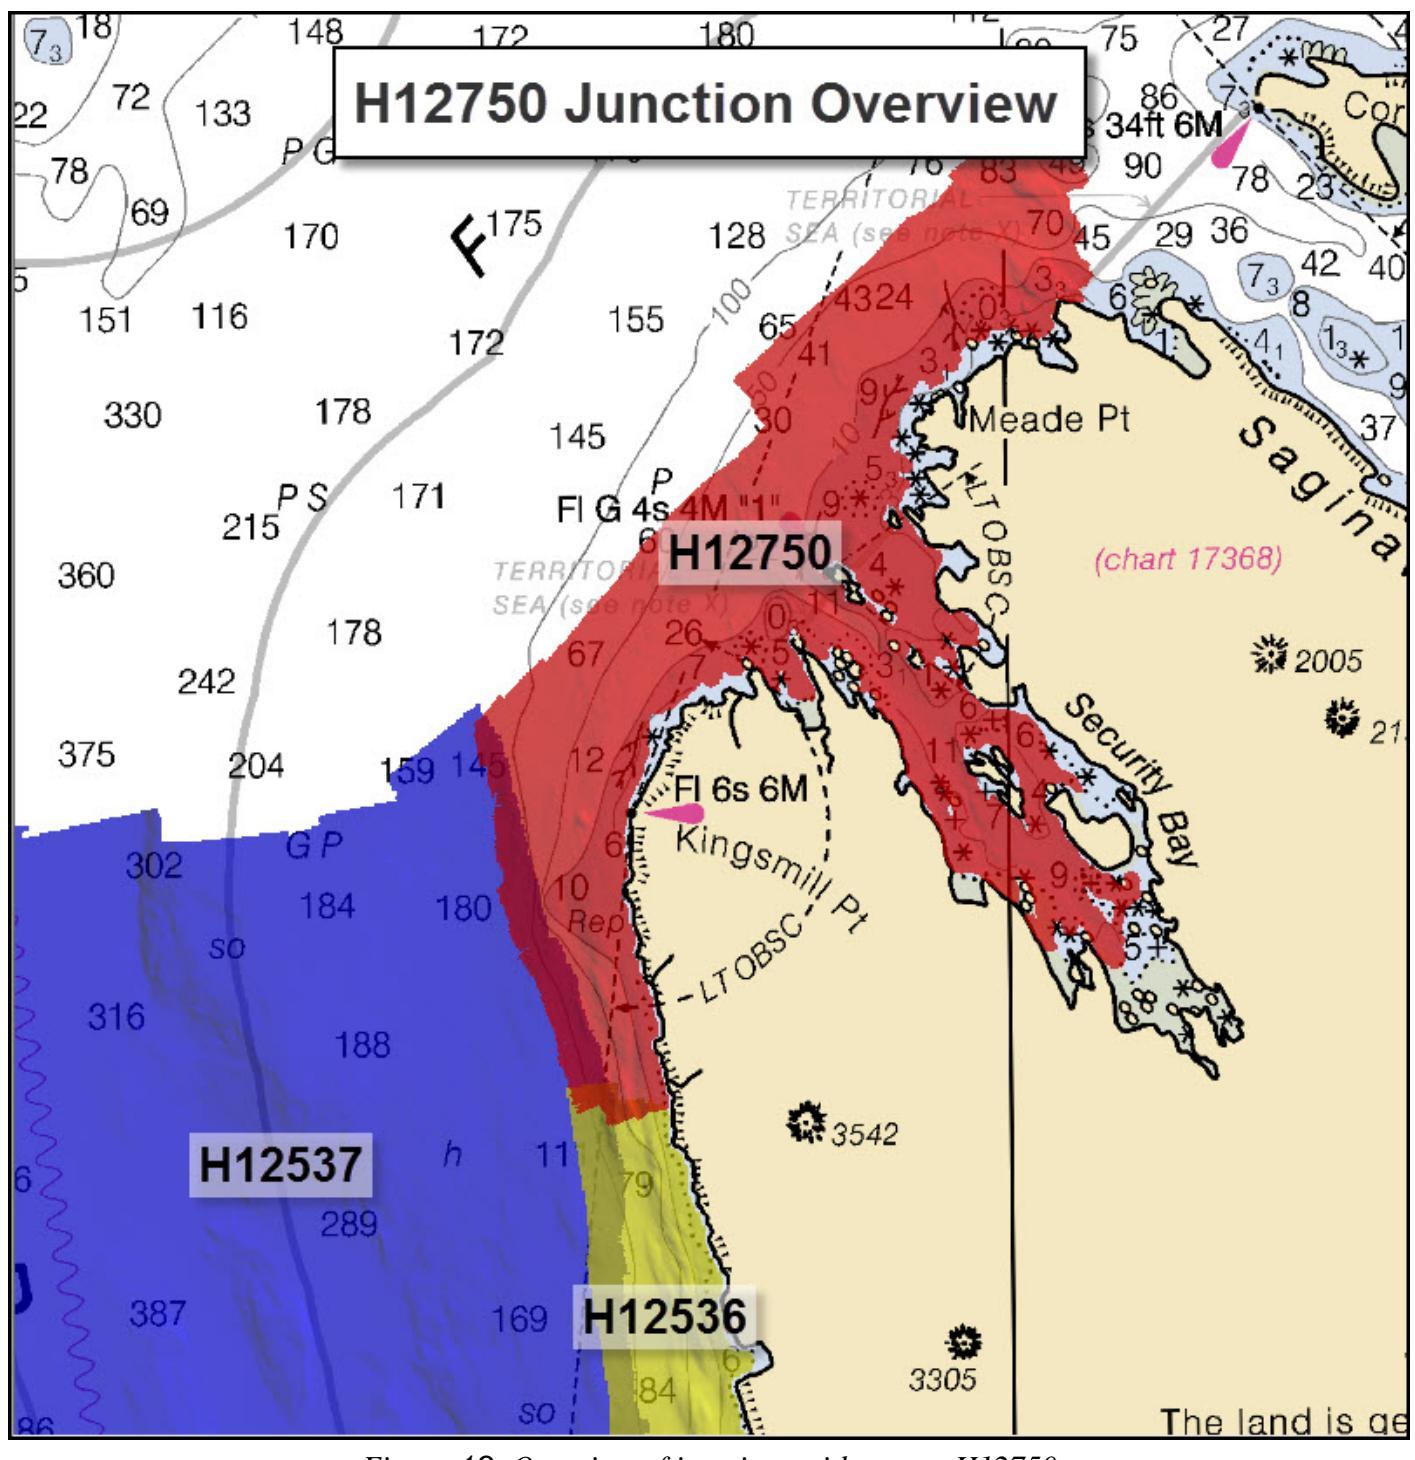
Figure 13: Overview of junctions with survey H12750

Two junction comparisons were completed for H12750 at MLLW (Figure 13). H12536 and H12537 were completed by NOAA Ship Rainier in 2013. Depth comparisons were performed by creating Caris difference surfaces. For the junction of H12750 and H12536, the 4m finalized surfaces for each survey were used for the comparison. For the junction of H12750 and H12537, the 16m finalized surfaces for each survey were used.

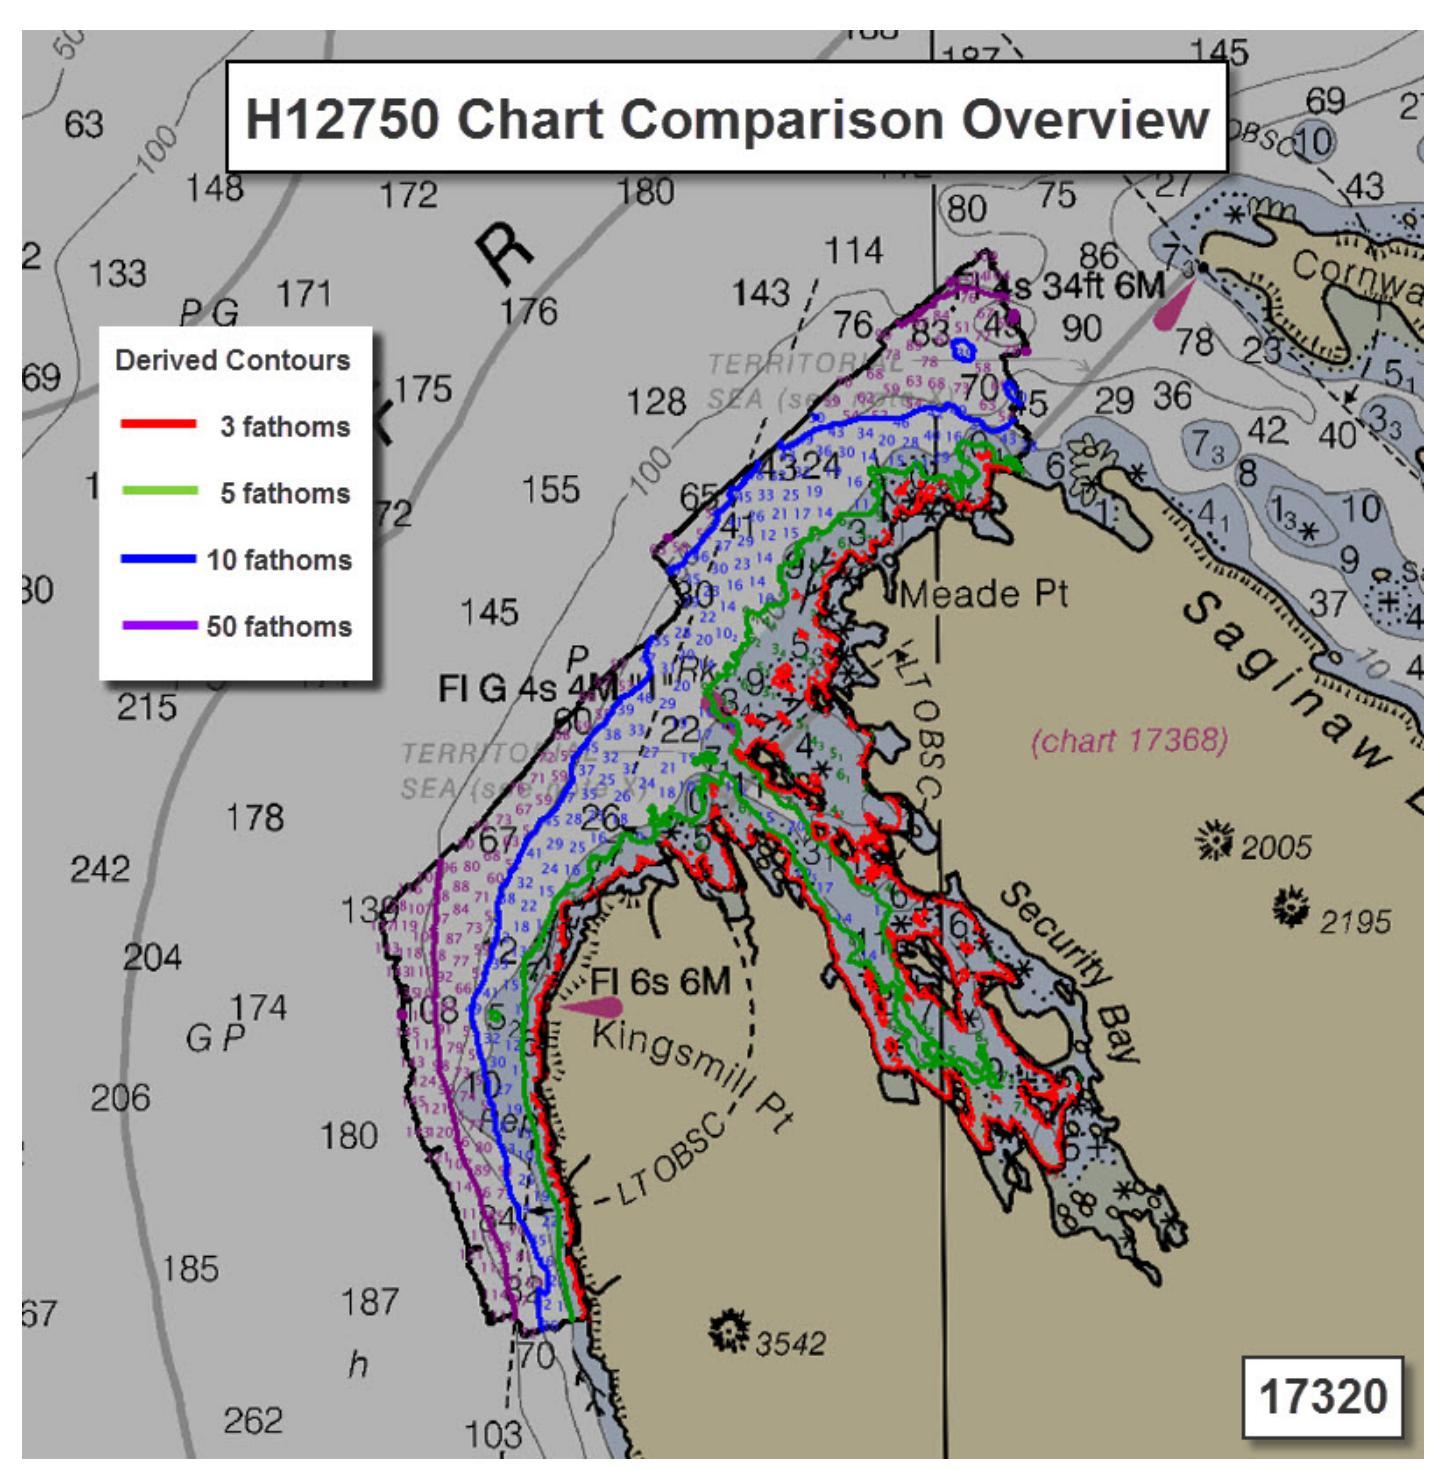
Figure 16: Overview of derived contours over Chart 17320. Note: The chart has been darkened to enhanced the visibility of soundings and contours. The contour legend in Figure 16 has incorrect depth labels. The correct depth labels for each color are shown below.

Chart comparisons were performed using a Caris sounding and contour layer based on the 16-meter combined CUBE surface. The contours and soundings were overlaid on the charts and compared for general agreement and to identify areas of significant change.

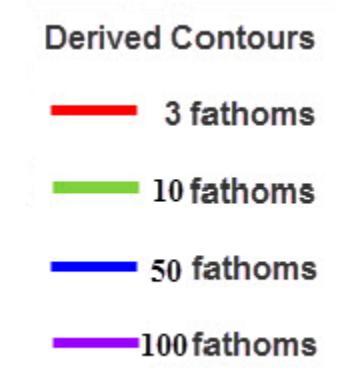
Corrected contour legend for Figure 16.
