Descriptive Report to Accompany Survey H12750

Project: OPR-O322-RA-15 Locality: Chatham Strait, AK Sublocality: Security Bay Scale: 1:20000 May 2015 - May 2015

NOAA Ship Rainier

Chief of Party: Edward J. Van Den Ameele, CDR/NOAA

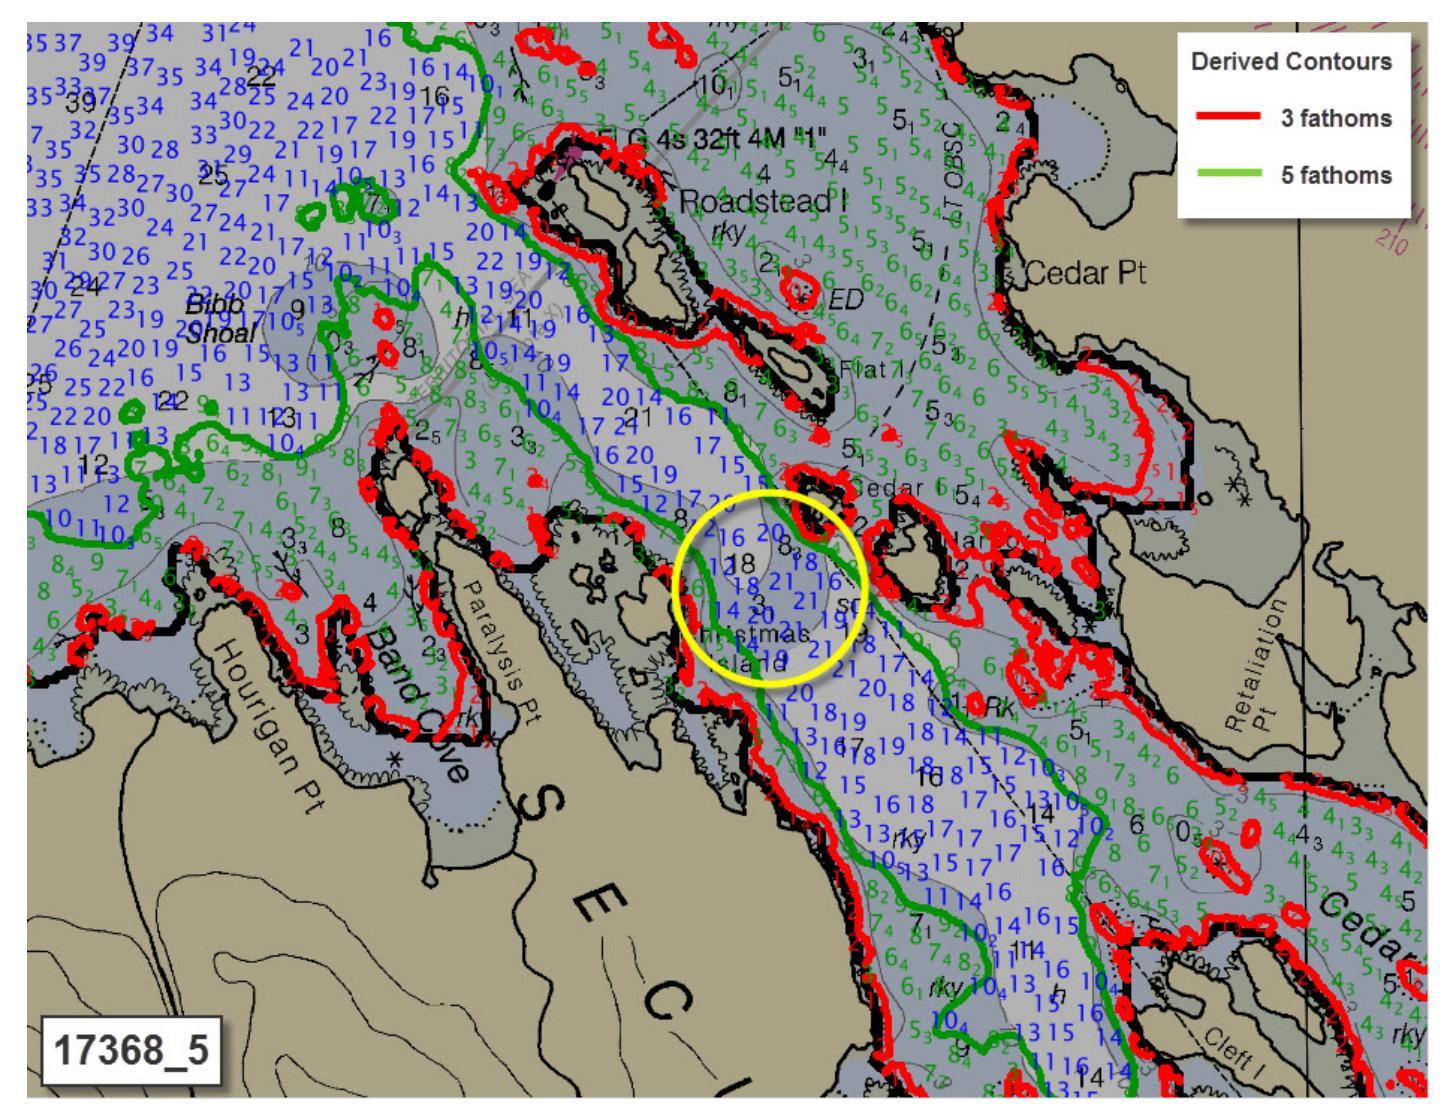
Figure 17: Soundings disprove charted 3 fathom contour crossing Security Bay on Chart 17368_5.

Multibeam data disproves the 3-fathom contour crossing Security Bay between Christmas Island and Cedar Island (Figure 17).

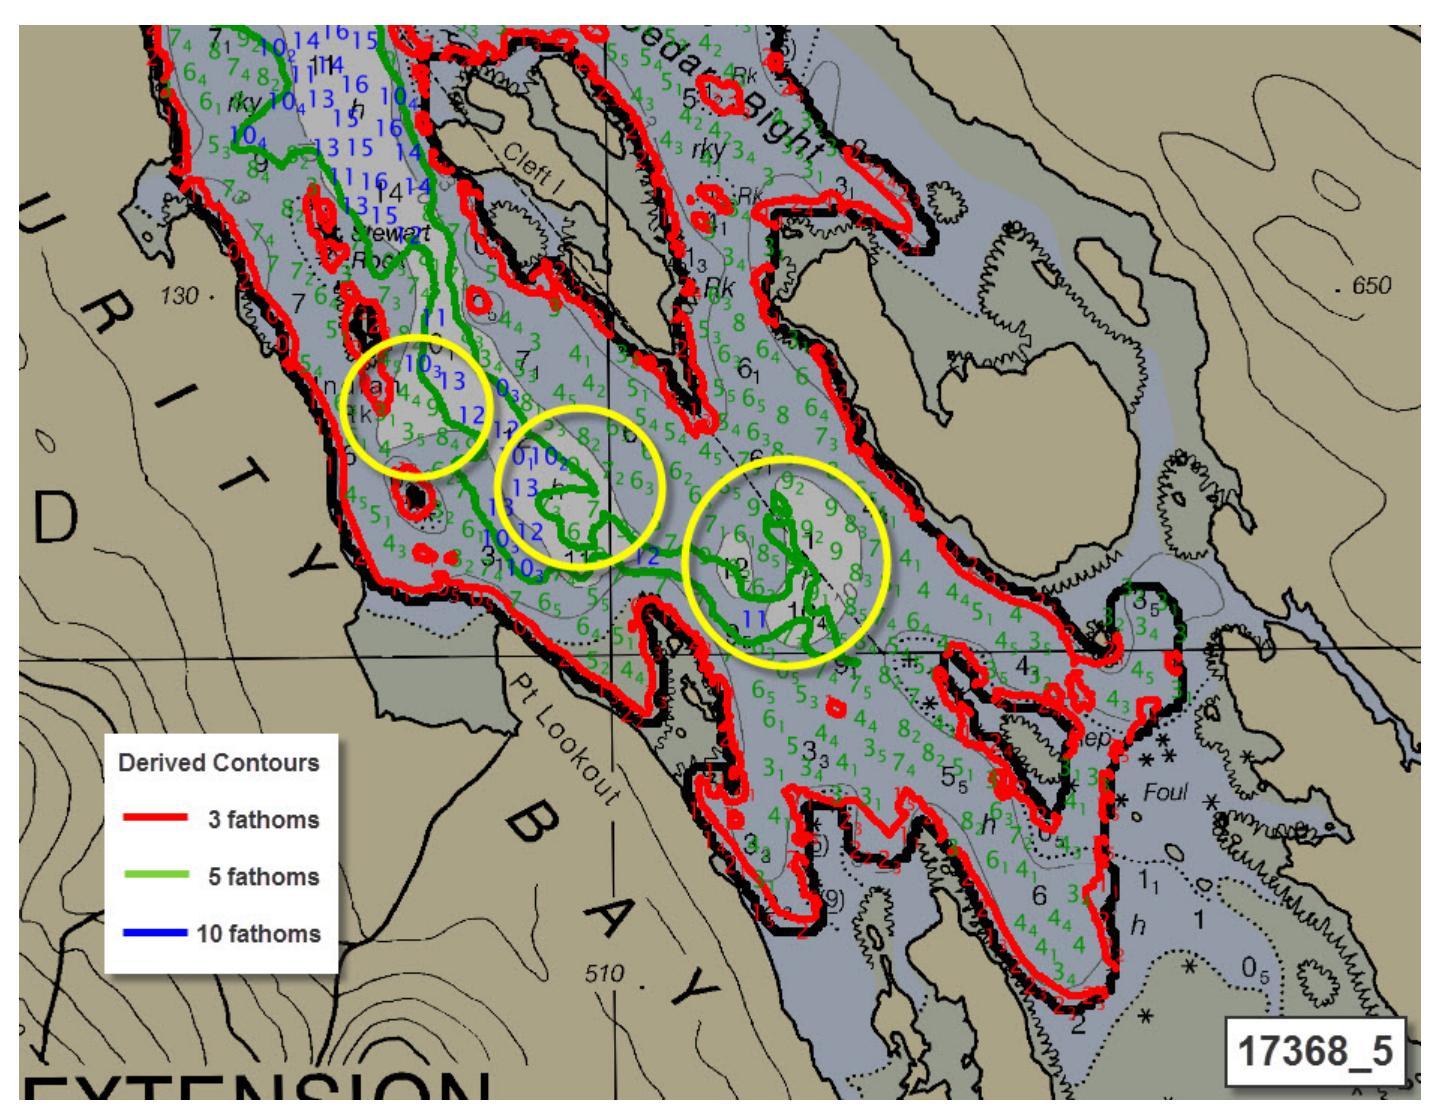
Figure **18***: Considerable differences between charted contours and derived contours highlighted on Chart* **17368_5***.*

Other areas of considerable disagreement are depicted below (Figure 18-20).

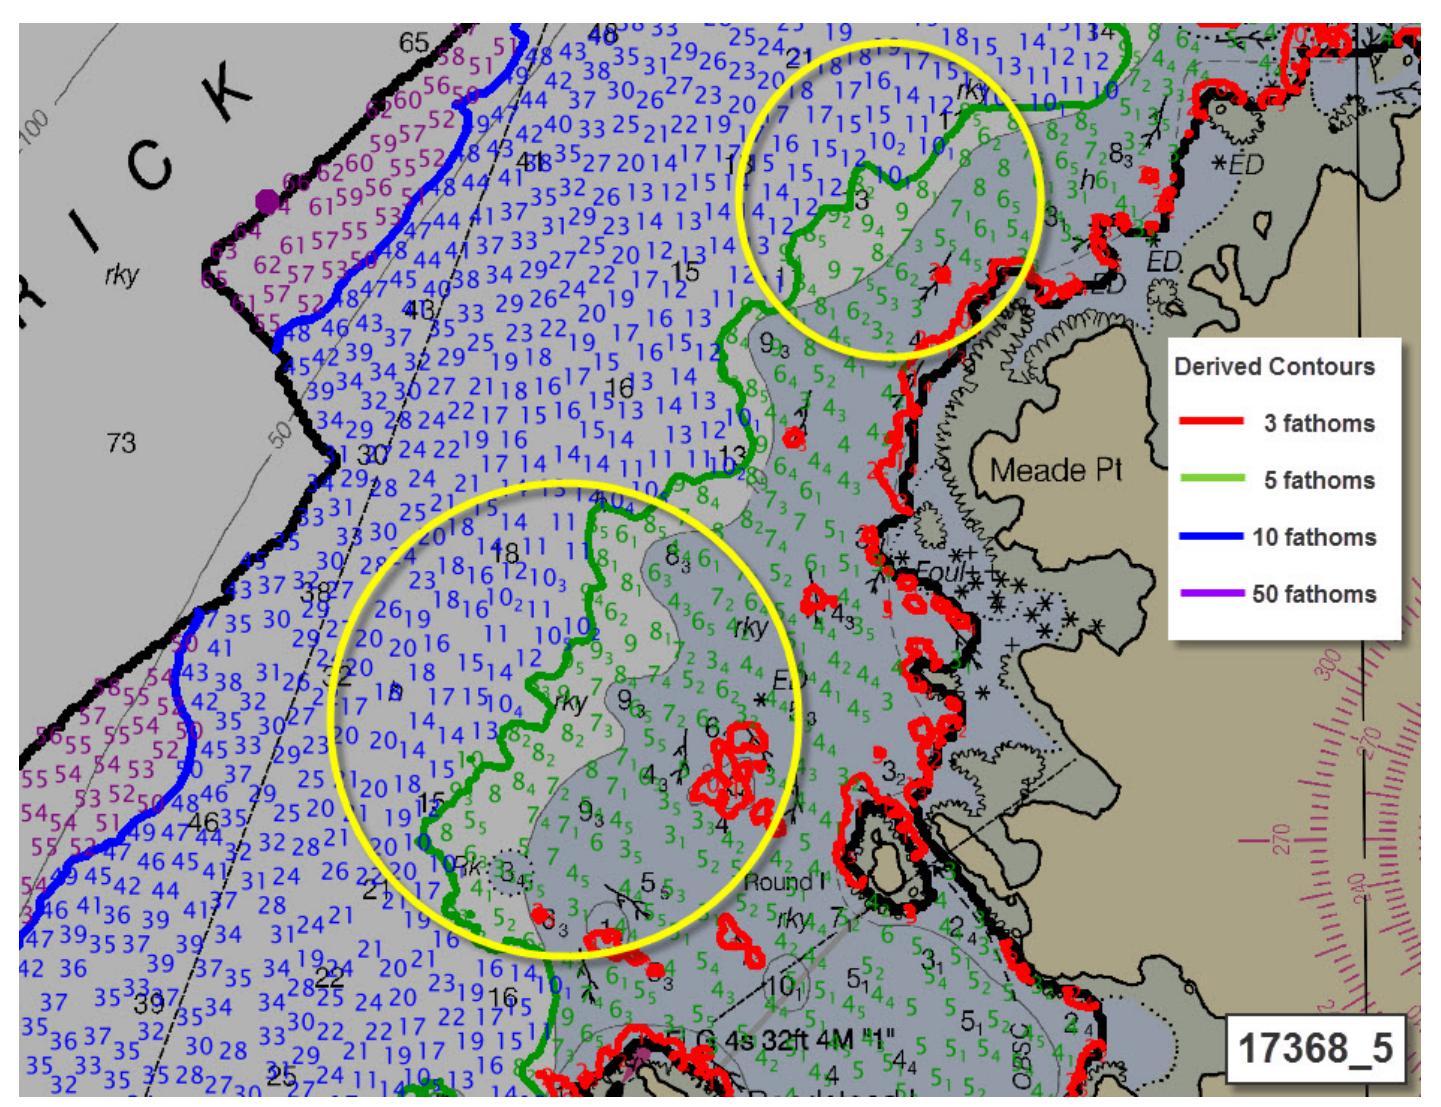
Figure **19***: Considerable differences between charted contours and derived contours highlighted on Chart* **17368_5***.*

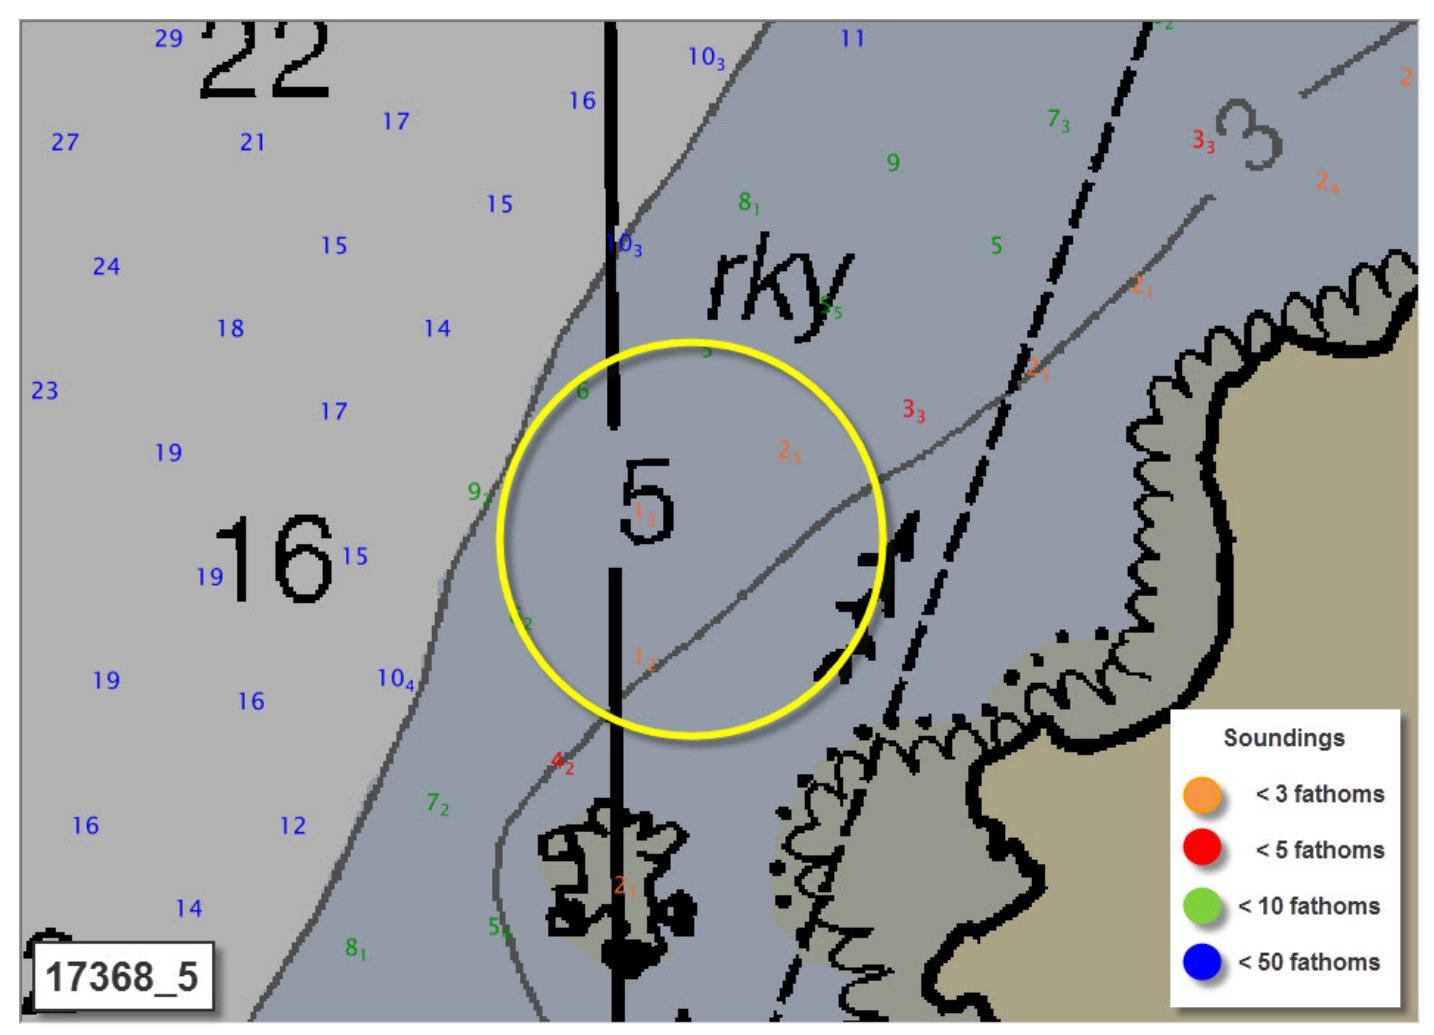
Figure 20: Soundings considerably shoaler than charted highlighted on Chart 17368_5. Figure 17: The charted contour crossing Security Bay between Christmas Island and Cedar Island is a 10 fm contour, not a 3 fm contour. Figure 17-19: Corrections to legend, green lines represent 10 fm contours and blue lines represent 50 fm contours.

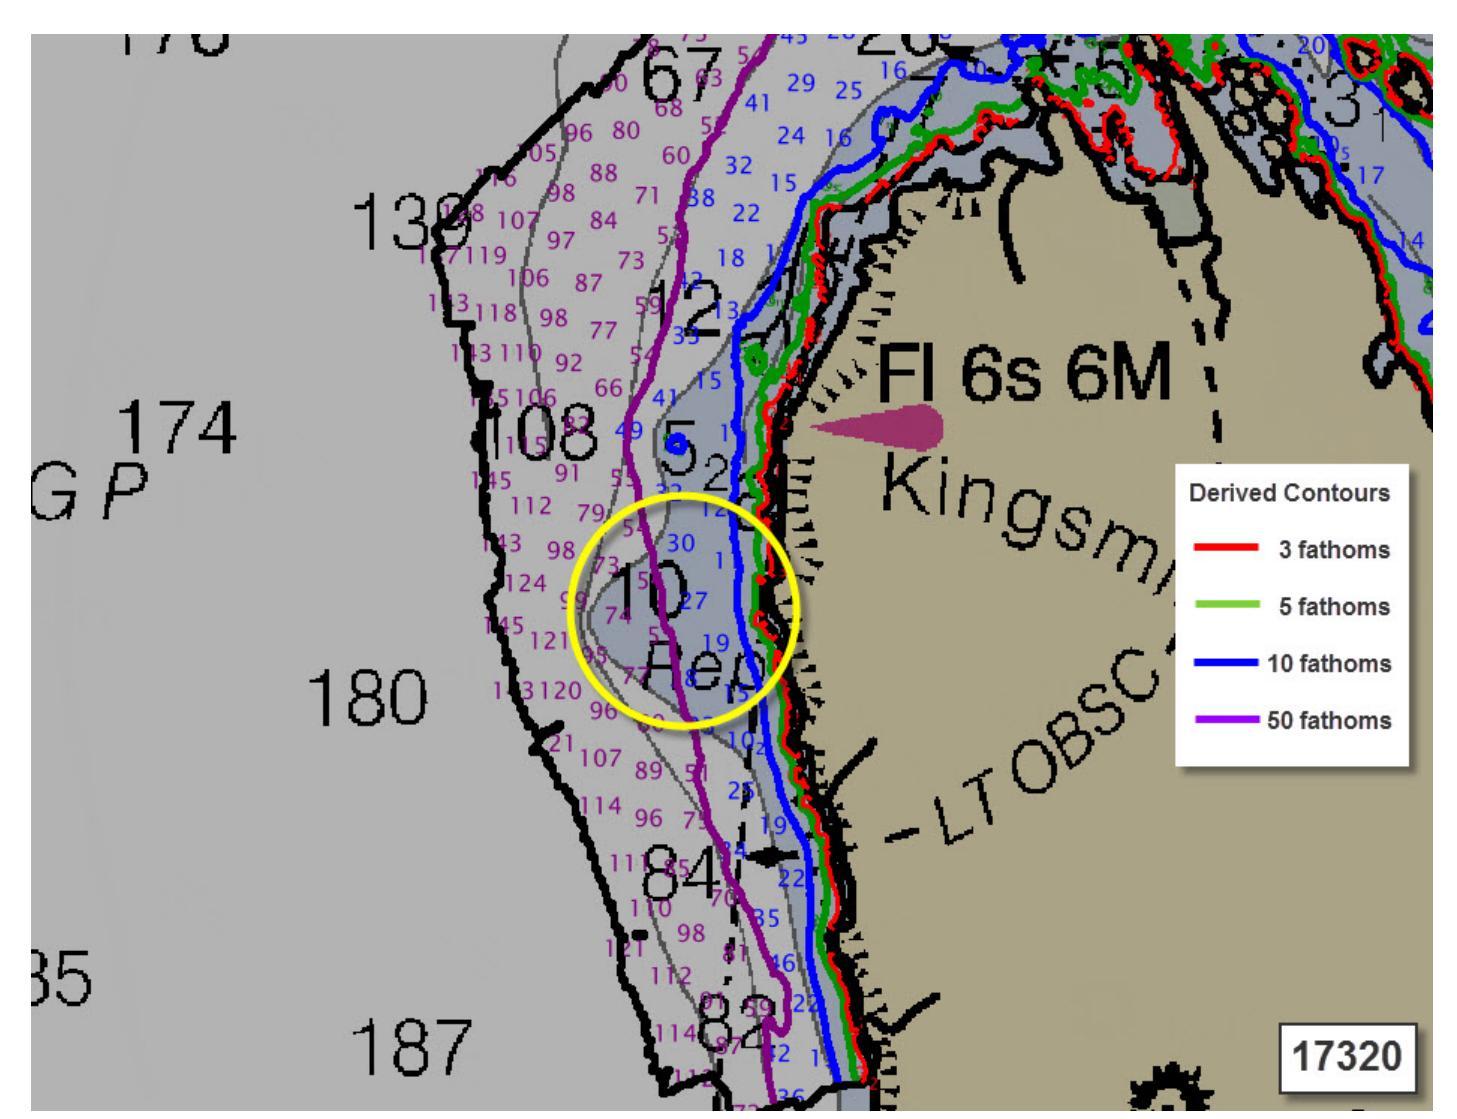
Figure 21: Soundings disprove reported shoaling on Chart 17320.

The reported 10-fathom shoaling near Kingsmill Point on Chart 17320 was investigated and disproved through inspection of multibeam data (Figure 21). The reported shoaling and obstructions near the junction of Frederick Sound and Saginaw Bay on Chart 17368_5 were investigated and confirmed through inspection of multibeam data (Figure 22).

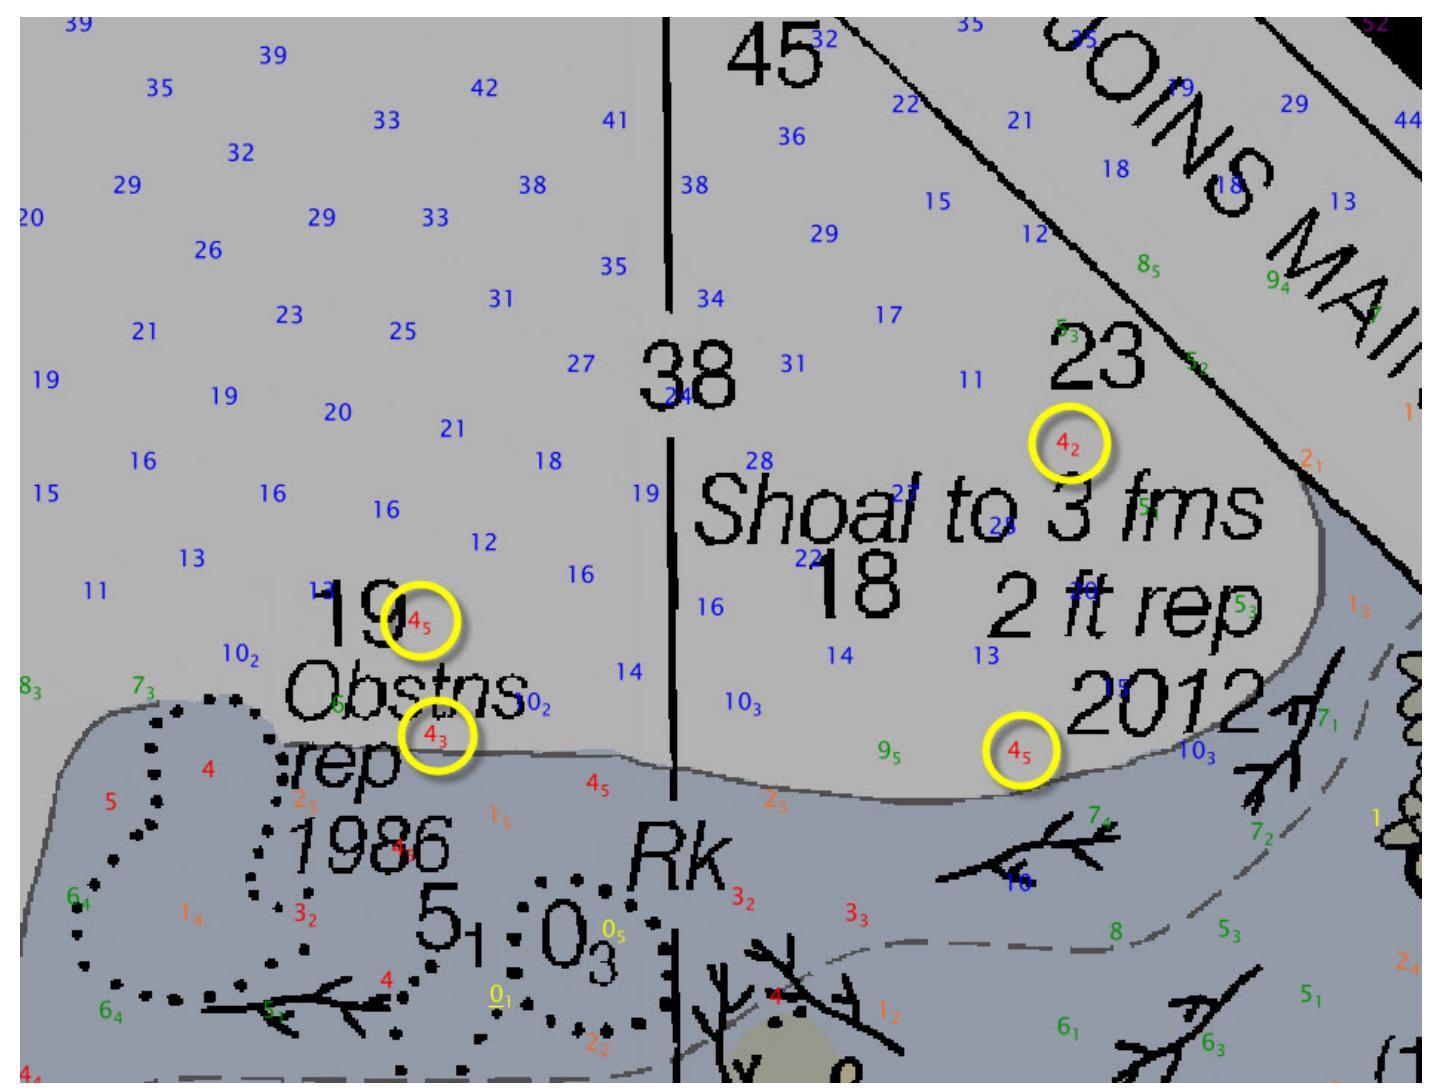
Figure 22: Soundings confirm reported shoaling and obstructions on Chart 17368_5.

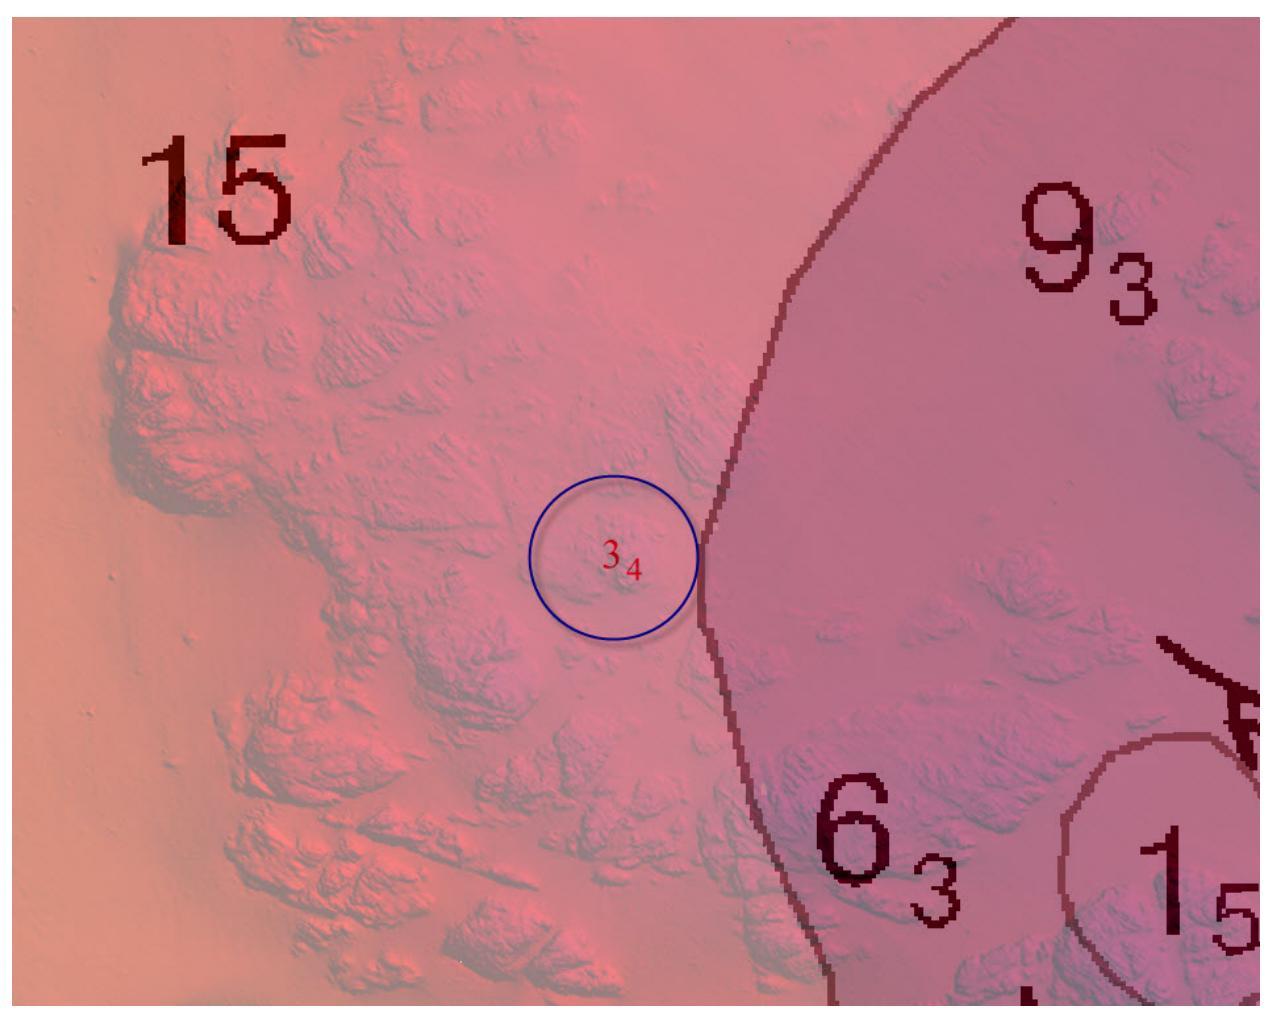
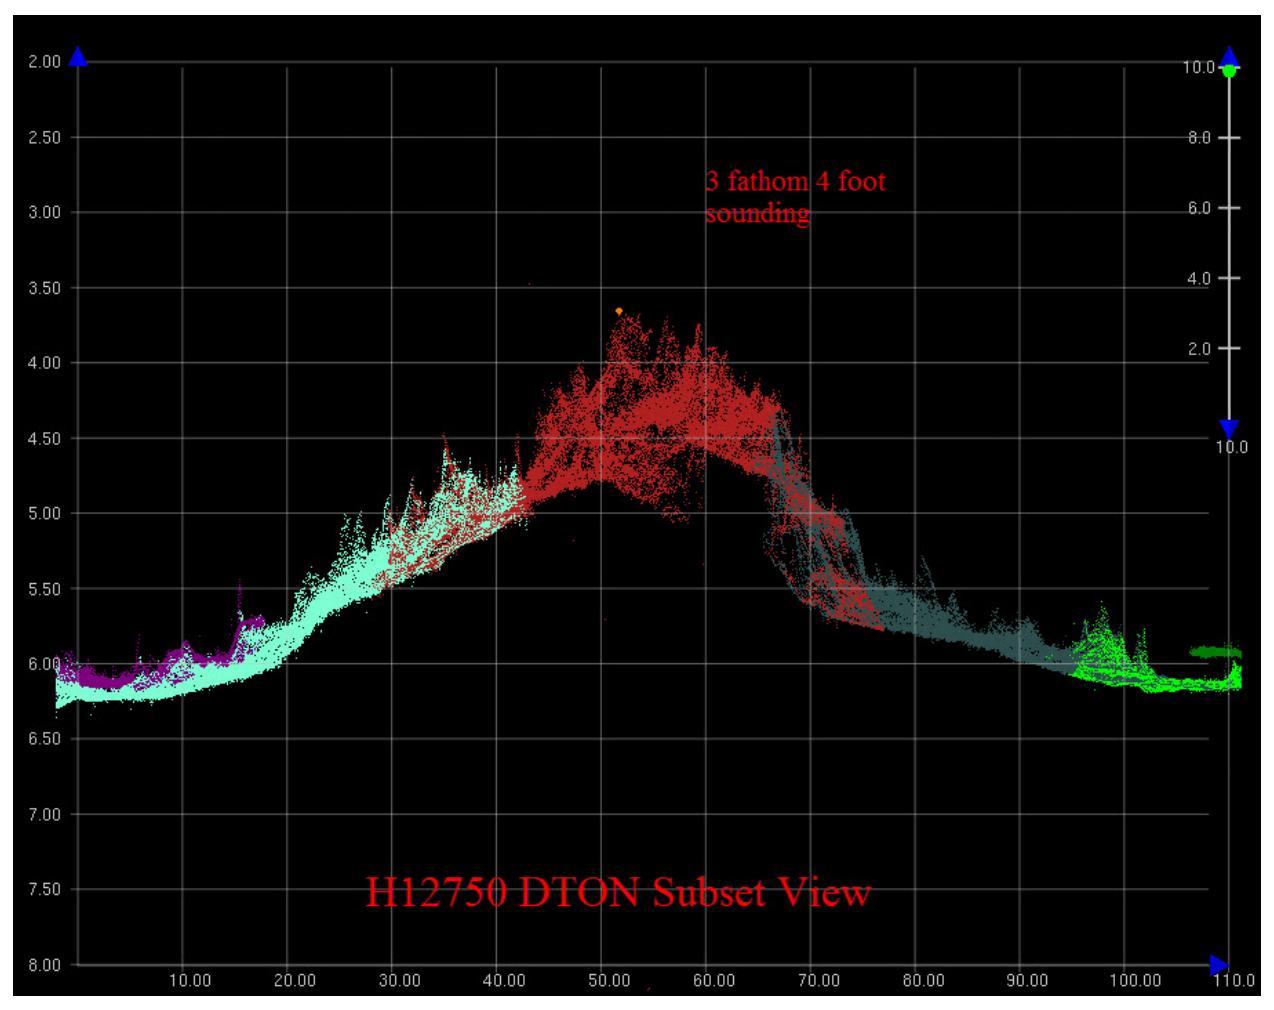
Figure 1.5.1

Geo object 1: Underwater rock / awash rock (UWTROC)

Attributes: VALSOU - 6.645 m

Office Notes: After office processing, a 3fm 1ft rock was included in the chart update product.
