U.S. Department of Commerce National Oceanic and Atmospheric Administration National Ocean Service		
]	DESCRIPTIVE REPORT	
Type of Survey:	Navigable Area	
Registry Number:	H13207	
	LOCALITY	
State(s):	Texas	
General Locality:	Galveston Bay	
Sub-locality:	Galveston Bay-Red Fish Shoal	
	2019	
	CHIEF OF PARTY Dan Jacobs	
	LIBRARY & ARCHIVES	
Date:

## **Descriptive Report to Accompany Survey H13207**

Project: S-K928-NRT4-19 Locality: Galveston Bay Sublocality: Galveston Bay-Red Fish Shoal Scale: 1:10000 October 2018 - December 2019 **NOAA Navigation Response Team - Galveston** Chief of Party: Dan Jacobs

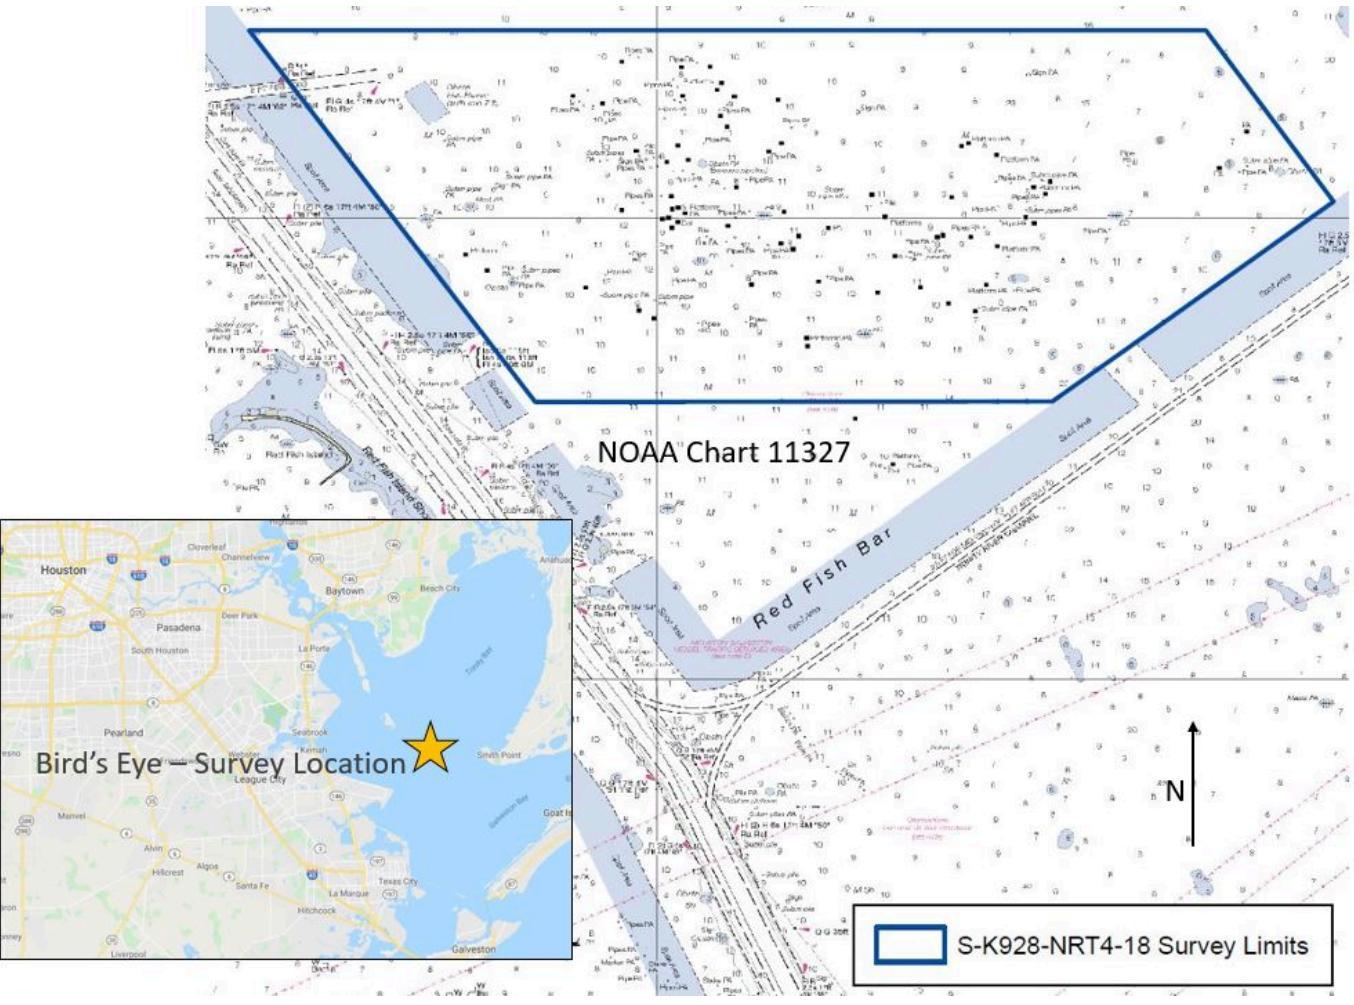
Figure 1: Assigned survey limits, H13207 (Chart 11327).

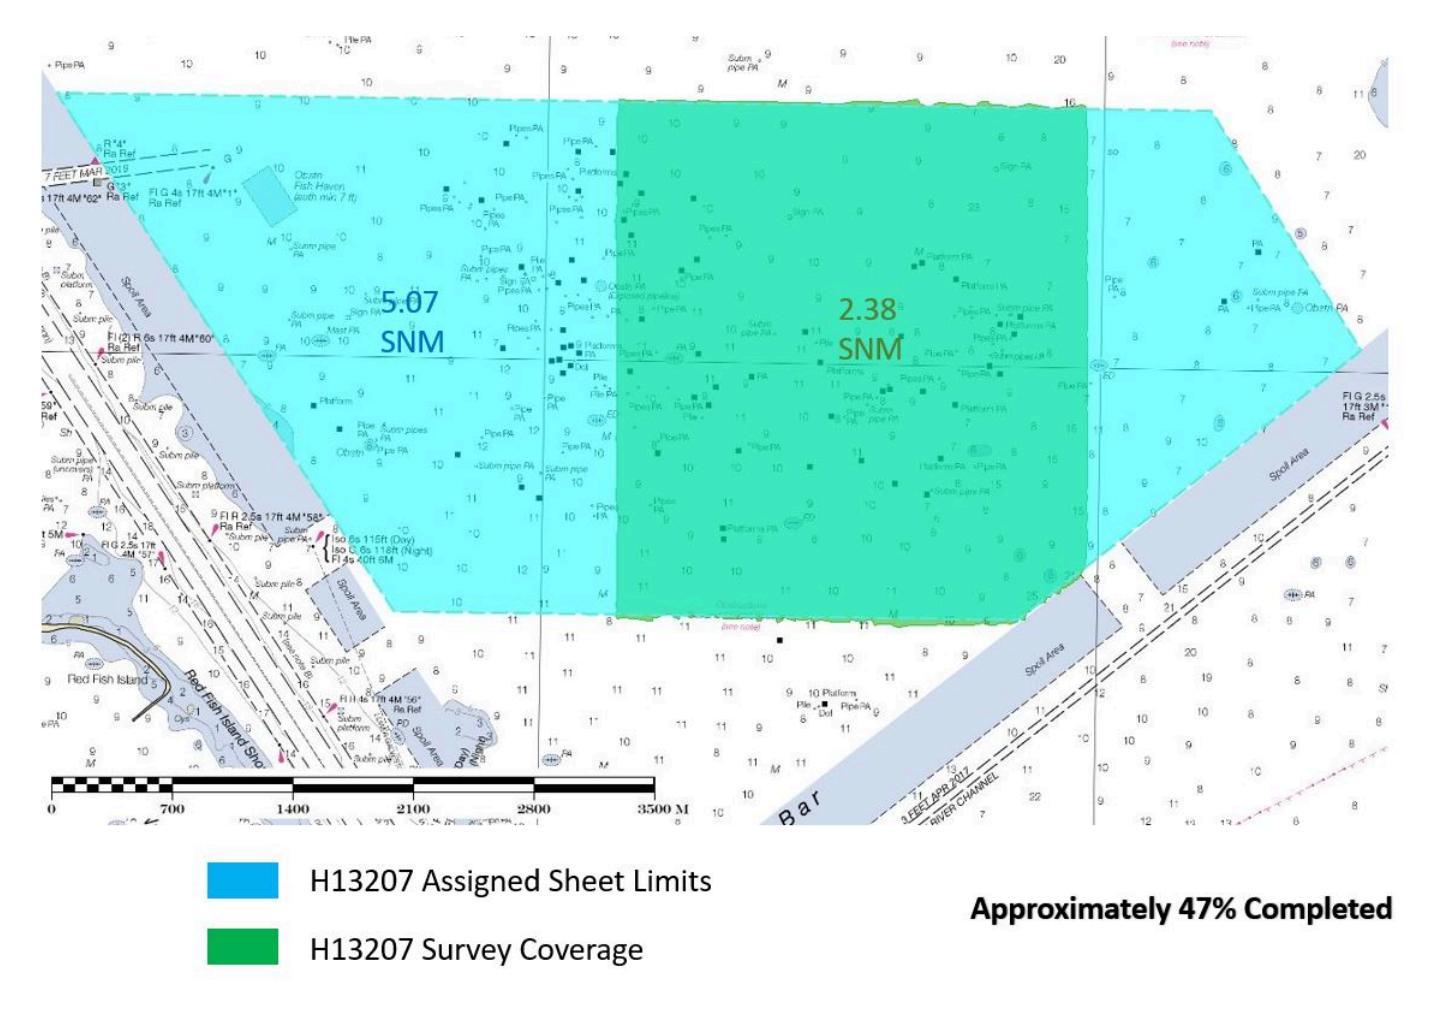
Approximately 47 percent of the assigned survey area was completed with Object Detection Multibeam concurrent with 200 Percent Side Scan coverage. Crew and equipment safety considerations for this industrialized area made H13207 particularly challenging. S3008 experienced two propeller strikes which in turn created maintenance delays. Additionally, the team's staffing was down 1 person thus no daily shore side processing or support occurred. By late summer, it became evident that the project area was replete with new features; some posing safety concerns for the crew and equipment. As such, it was determined by leadership that the project would be "squared off" as weather dictated and the team began work on a separate survey near the Galveston Bay Entrance. Please reference the project's Correspondence Folder for all emails pertaining.

Figure 2: Survey Limits, Approximately 47 percent of project was completed.

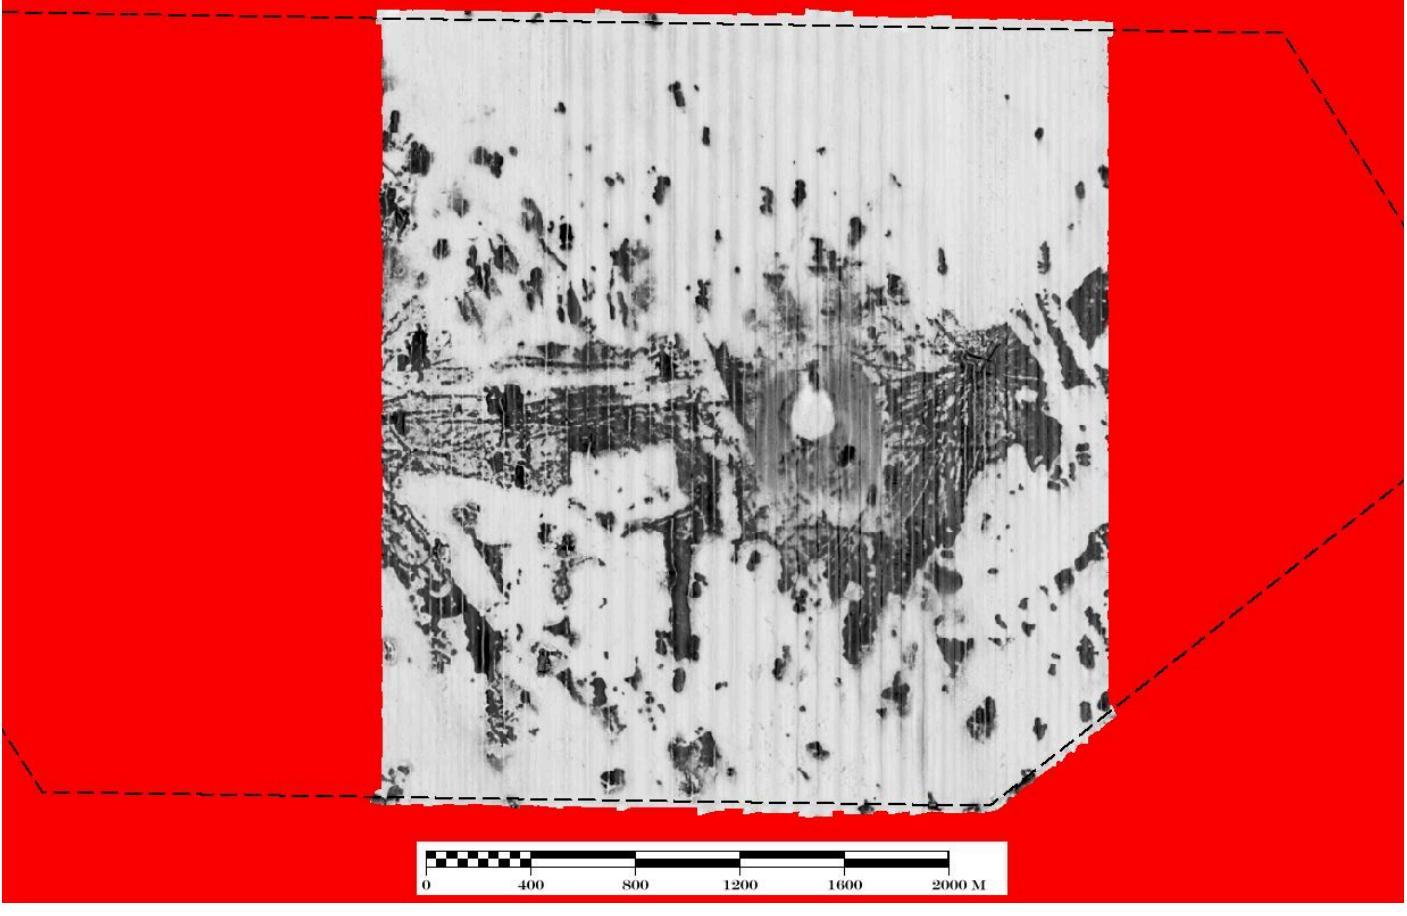
Figure 3: H13207 100 percent Side Scan Mosaic, 1m resolution.

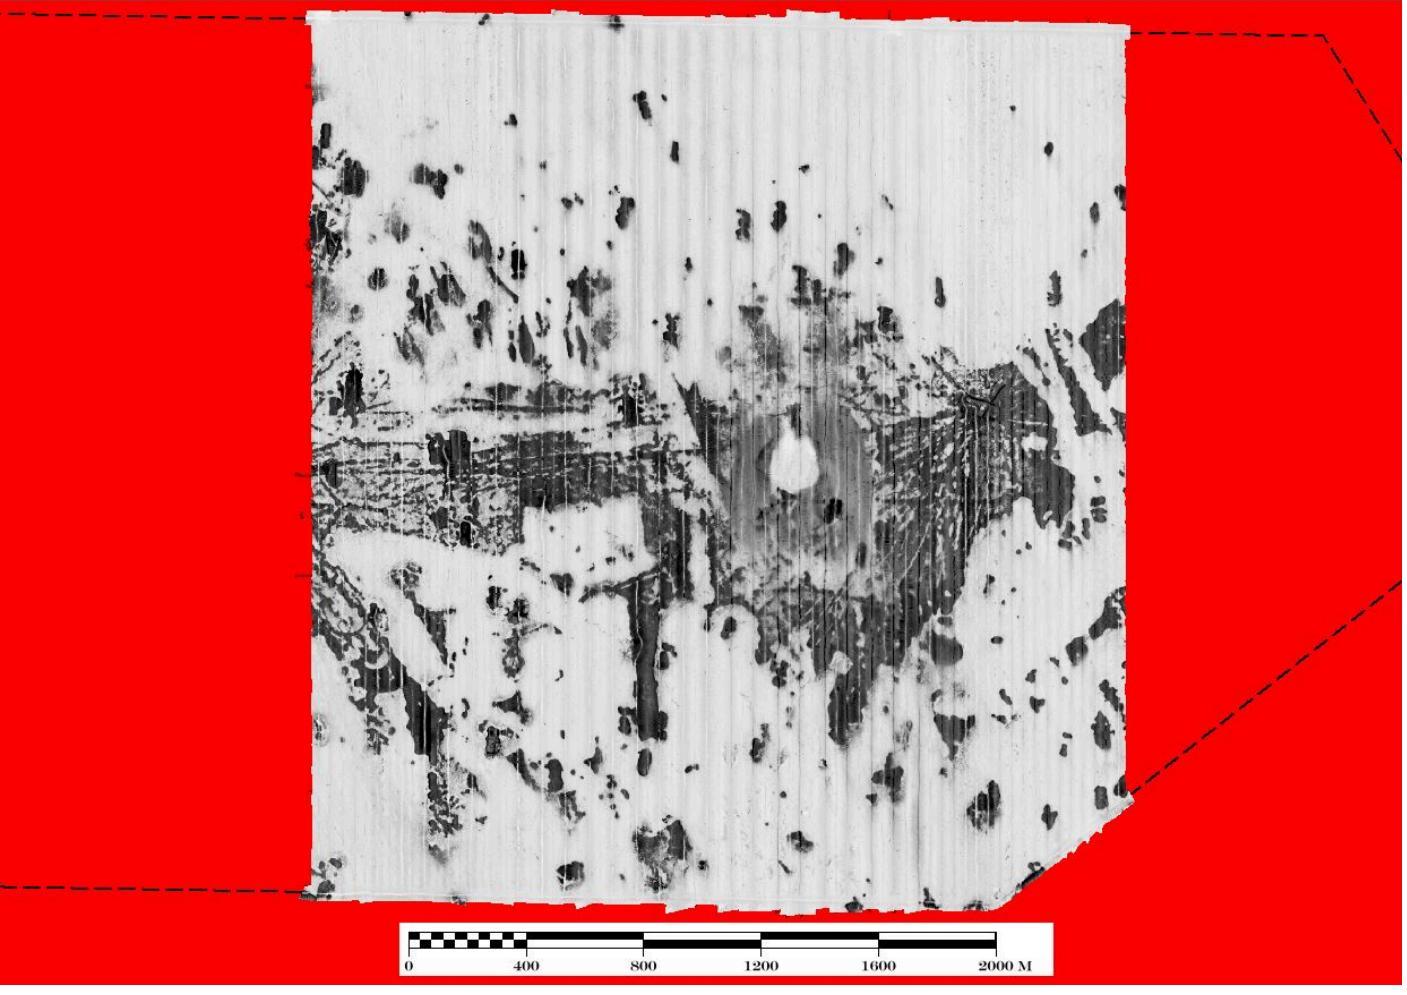
Figure 4: H13207 200 percent Side Scan Mosaic, 1m resolution.

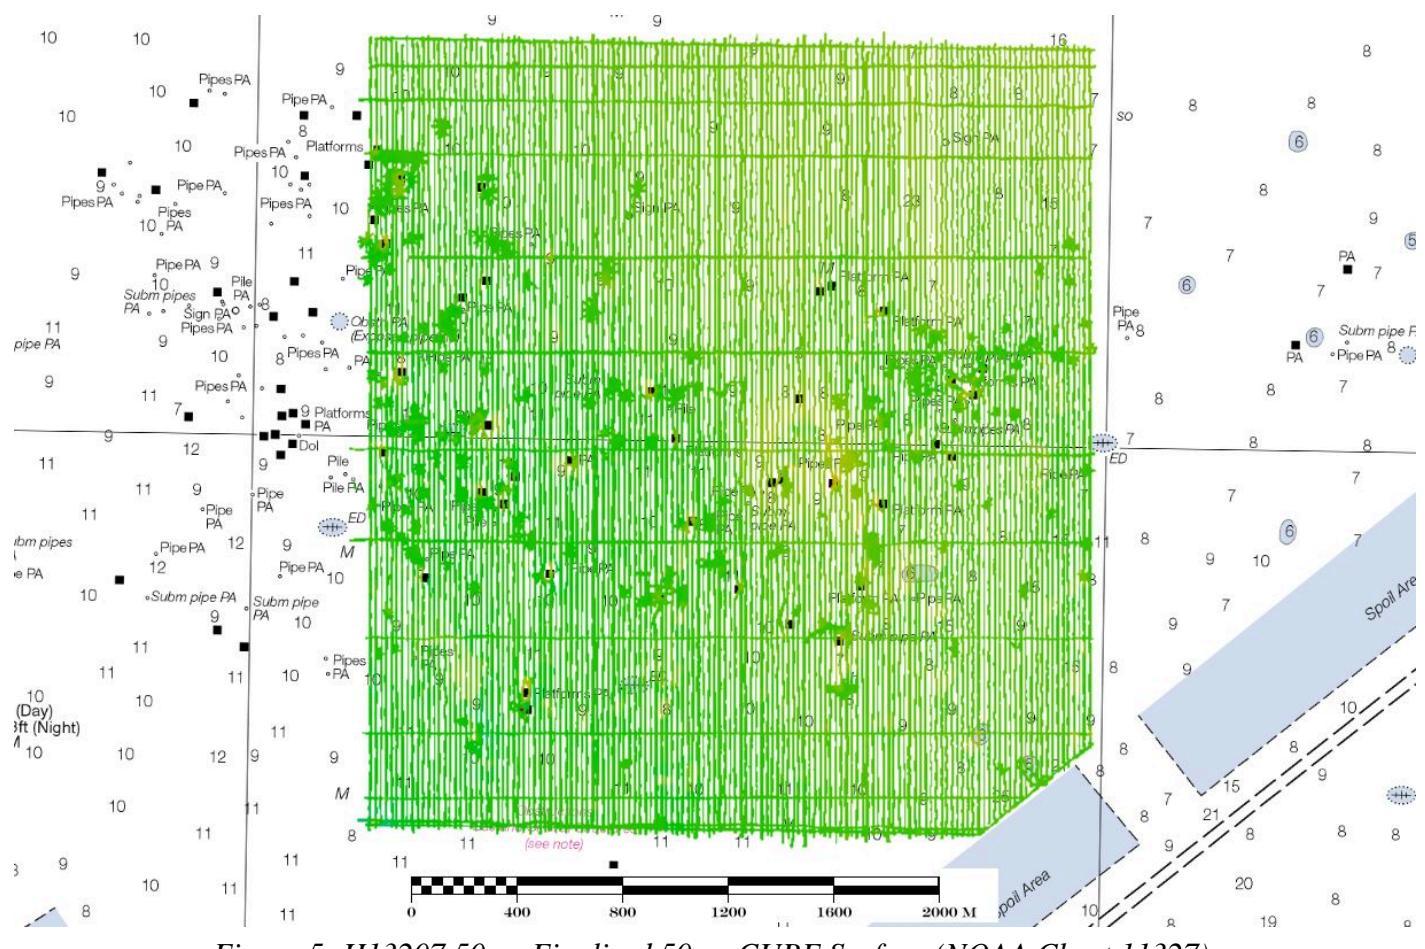
Figure 5: H13207 50cm Finalized 50cm CUBE Surface (NOAA Chart 11327).

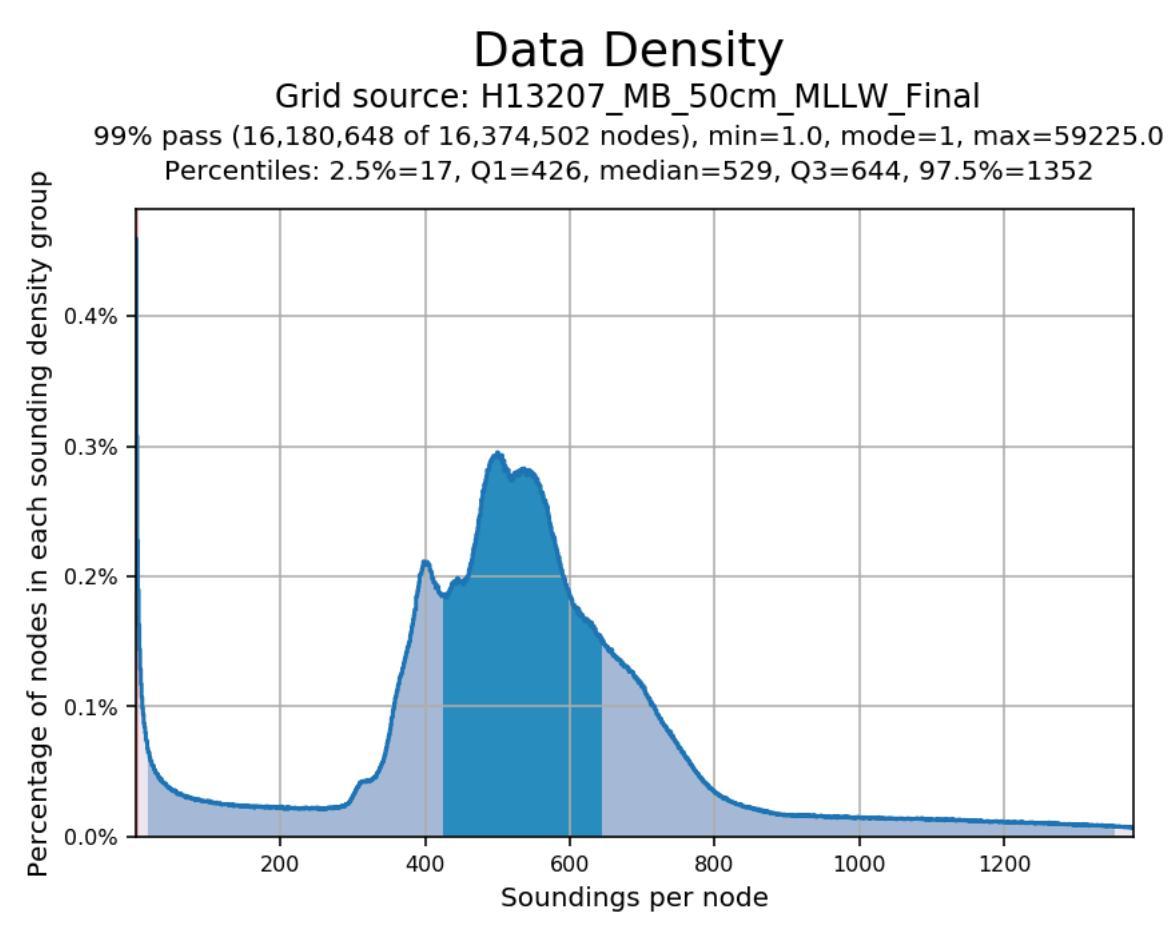
Approximately 47 percent of the assigned survey area was completed with Object Detection Multibeam coverage concurrent with 200 Percent Side Scan coverage in accordance with 2019 HSSD, paragraph 5.2.2. Object detection multibeam coverage was attained per 2019 HSSR guidelines "At least 95 percent of all nodes on the surface shall be populated with at least 5 soundings" in section 5.2.2. See each 100 percent mosaic Pydro derived Data Density Compliance histogram below.

Figure 6: Data Density Compliance, Finalized 50cm CUBE Surface.

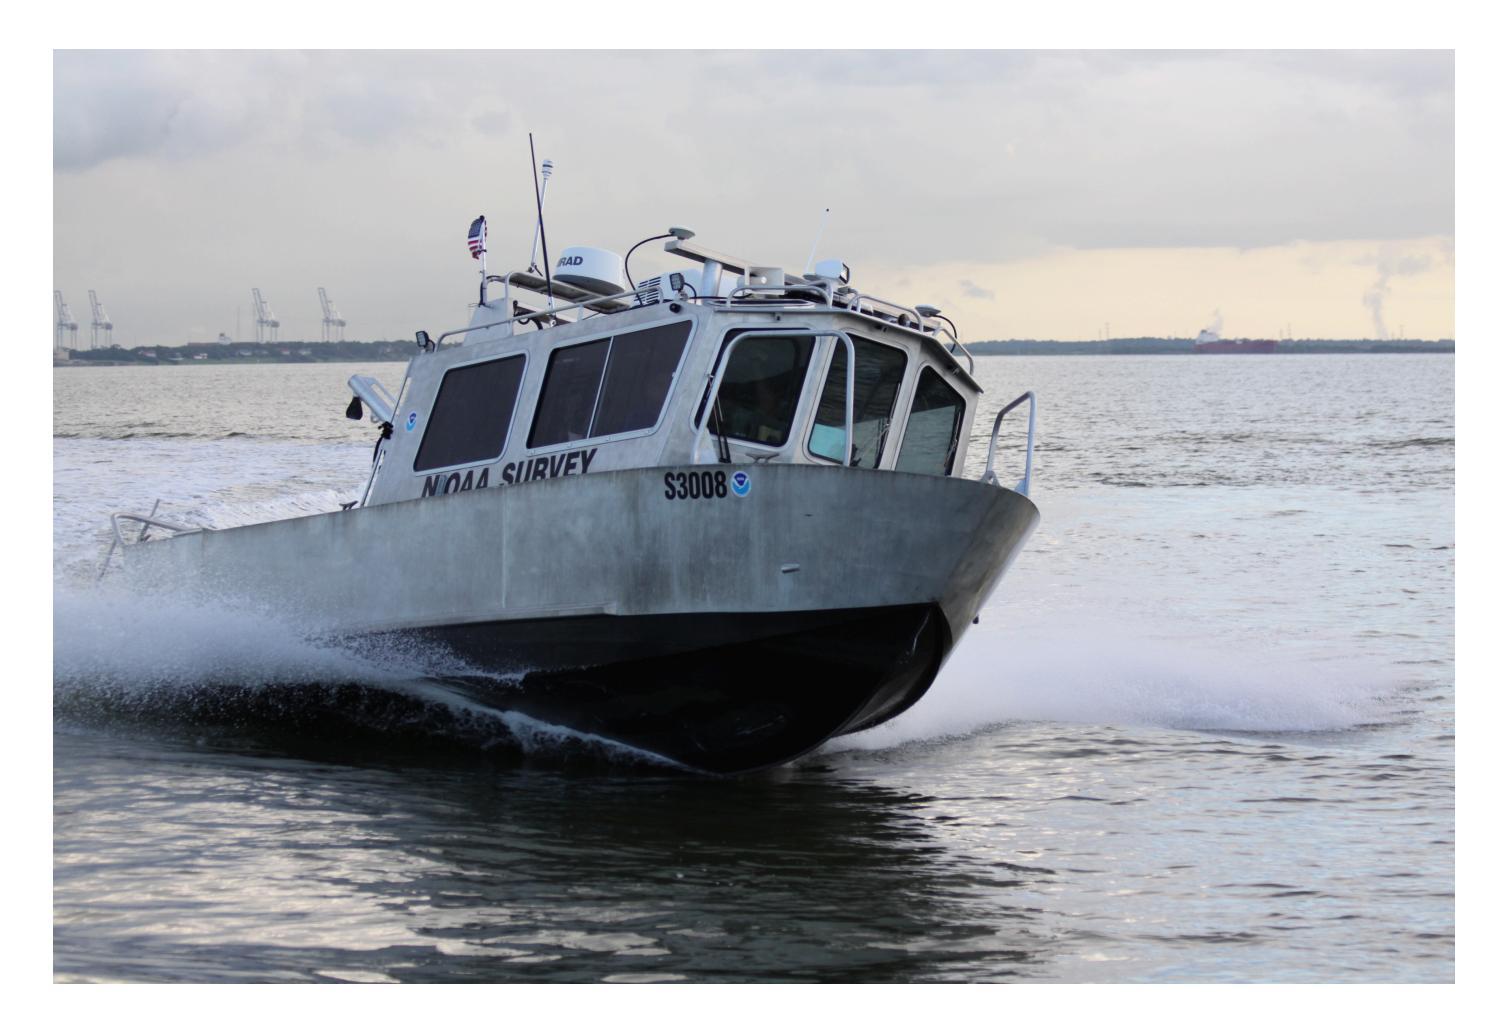
*Figure 7: S3008*

NOAA Survey Vessel S3008 is a 30 foot, aluminum hulled fire boat modified for NOAA hydrographic survey operations. S3008 is powered by dual 225 horsepower Honda outboard engines. A Kohler 7.5 EKD generator supplies AC power for two workstations, 5 monitors, one POS system, one multibeam echosounder system, and one side scan sonar system.

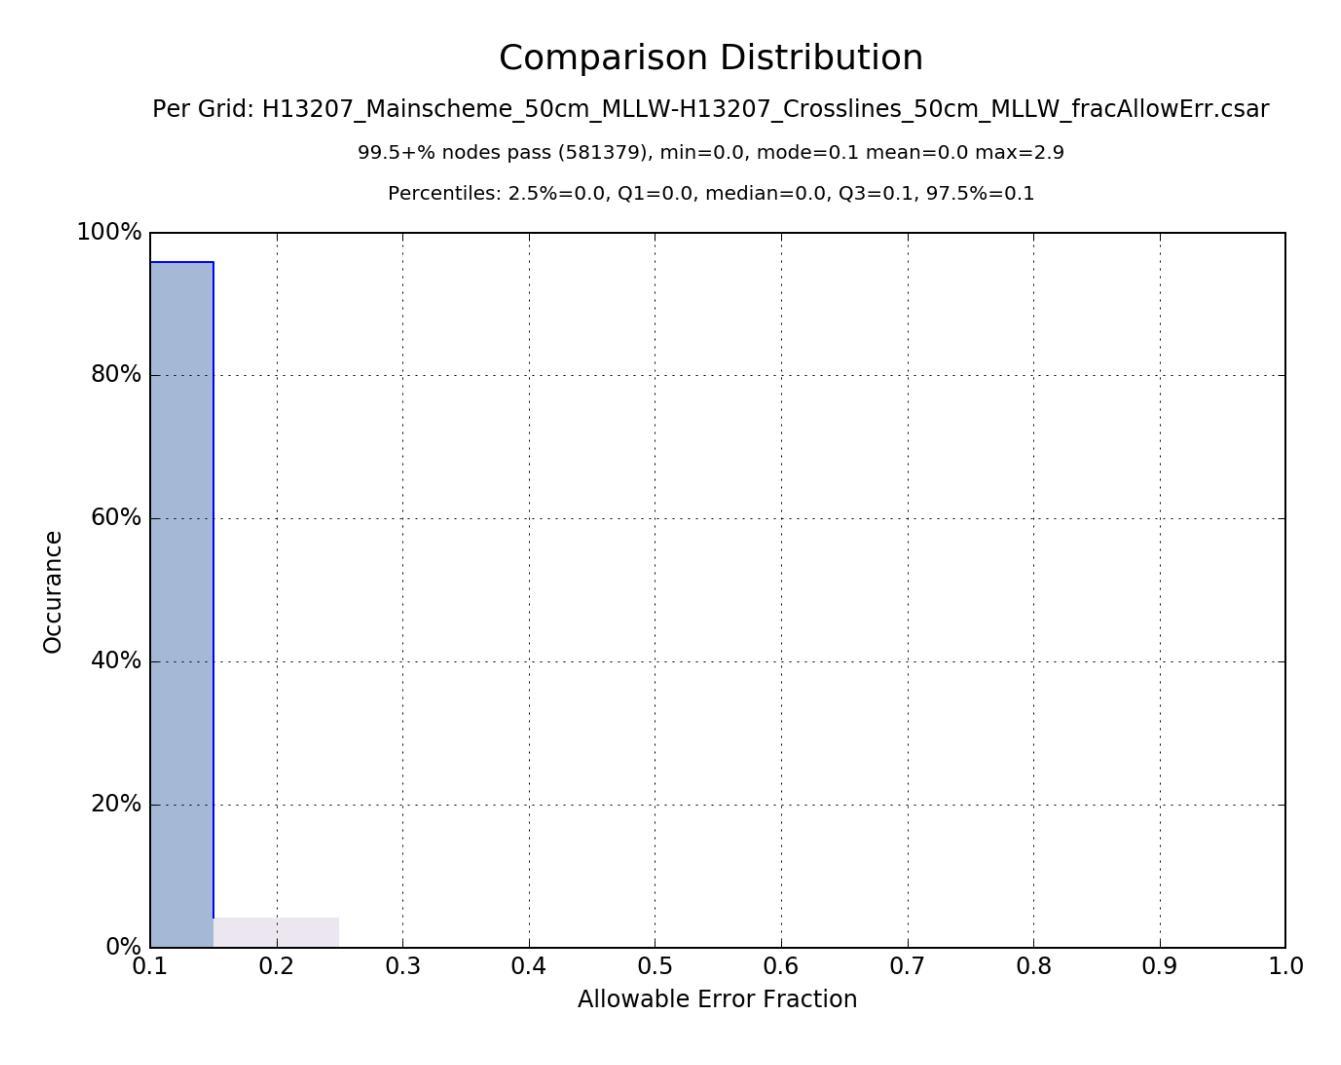
Multibeam crosslines acquired for H13207 totaled 35448.97 meters or 7.51 percent of mainscheme lines (472336.15 meters) thus exceeding the 2019 HSSD object detection requirement of 4 percent. A 50 cm crossline surface was compared to a 50 cm mainscheme surface invoking the Pydro Compare Surfaces script. The two surfaces were in excellent agreement with each other as 99 percent of the nodes passed the allowable IHO error fraction. The analysis was performed on MBES data reduced to MLLW using ellipsoidally referenced RTX SBET methods. Please reference the folder named Crossline\_Comparisons for all analysis outputs. Please reference crossline comparison graphic, below.

Figure 10: H13207 Crossline Comparison

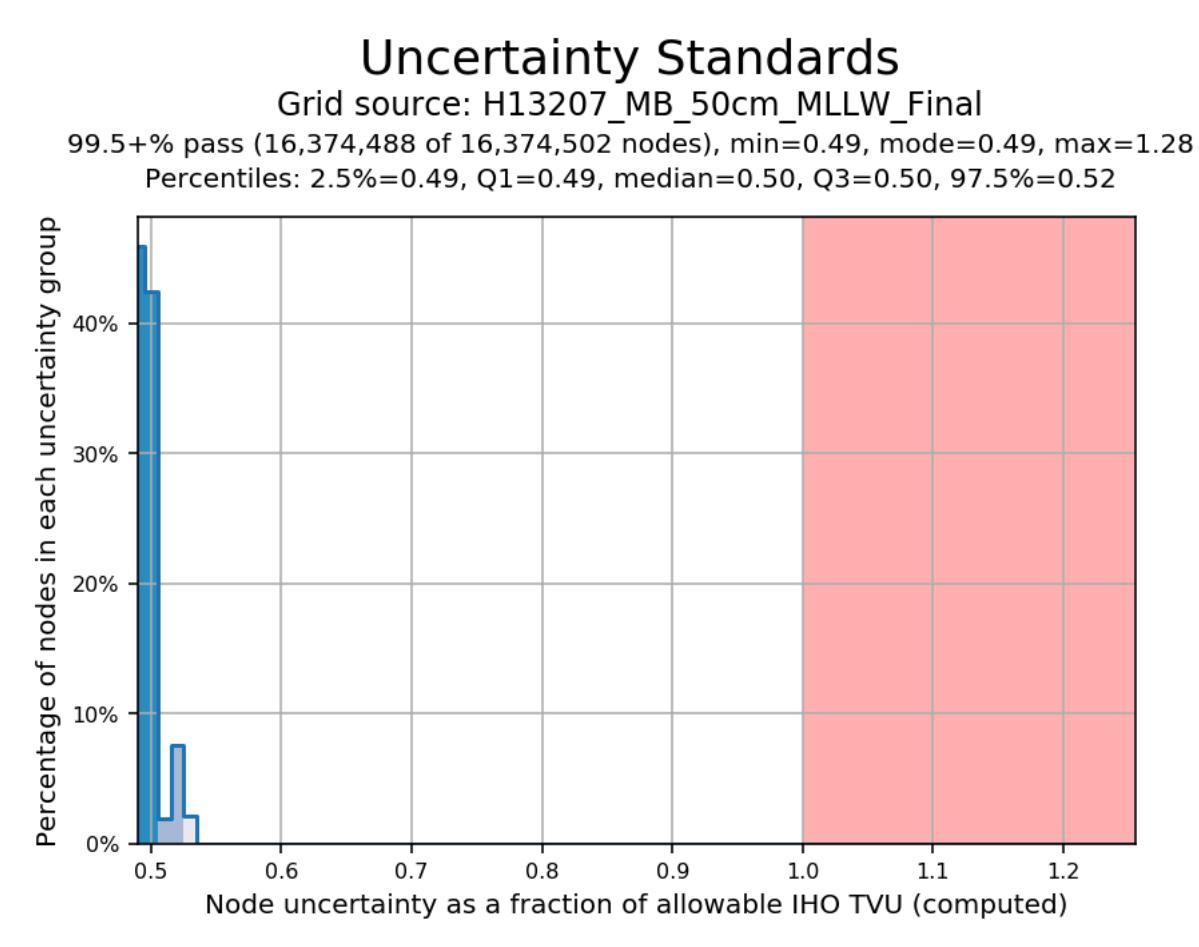
A priori and realtime uncertainty sources were incorporated into the depth estimates of this survey. The realtime uncertainties from the Kongsberg MBES sonar and POS MMS (delayed heave) were recorded and applied during post processing. Likewise, the post-processed uncertainties associated with vessel position were applied in CARIS HIPS 11.1 using SBET/RTX files (smrmsg file) generated by POSPac software. The finalized, 50cm grid's uncertainty was calculated using "greater of the two" of uncertainty and standard deviation. Over 99 percent of processed, finalized grid nodes passed object detection Total Vertical Uncertainty (TVU) criteria. See Pydro derived histogram plot below.

Figure 11: Finalized 50cm CUBE Surface, Passes Total Vertical Uncertainty (TVU) Object Detection Criteria.

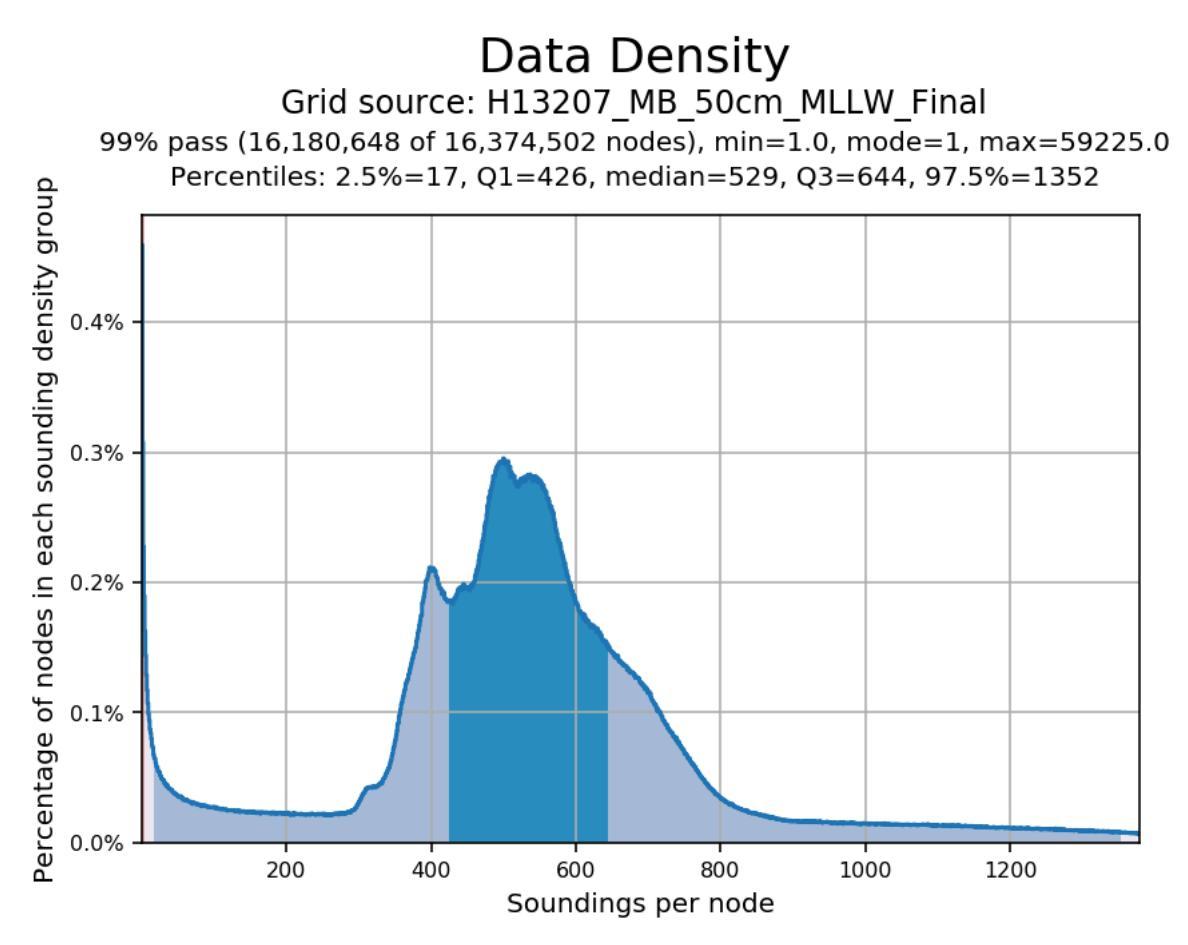
Object detection multibeam coverage was attained per 2019 HSSR guidelines "At least 95 percent of all nodes on the surface shall be populated with at least 5 soundings" in section 5.2.2. See Pydro derived Data Density Compliance histogram below.

Figure 12: Data Density Compliance, Finalized 50cm CUBE Surface.

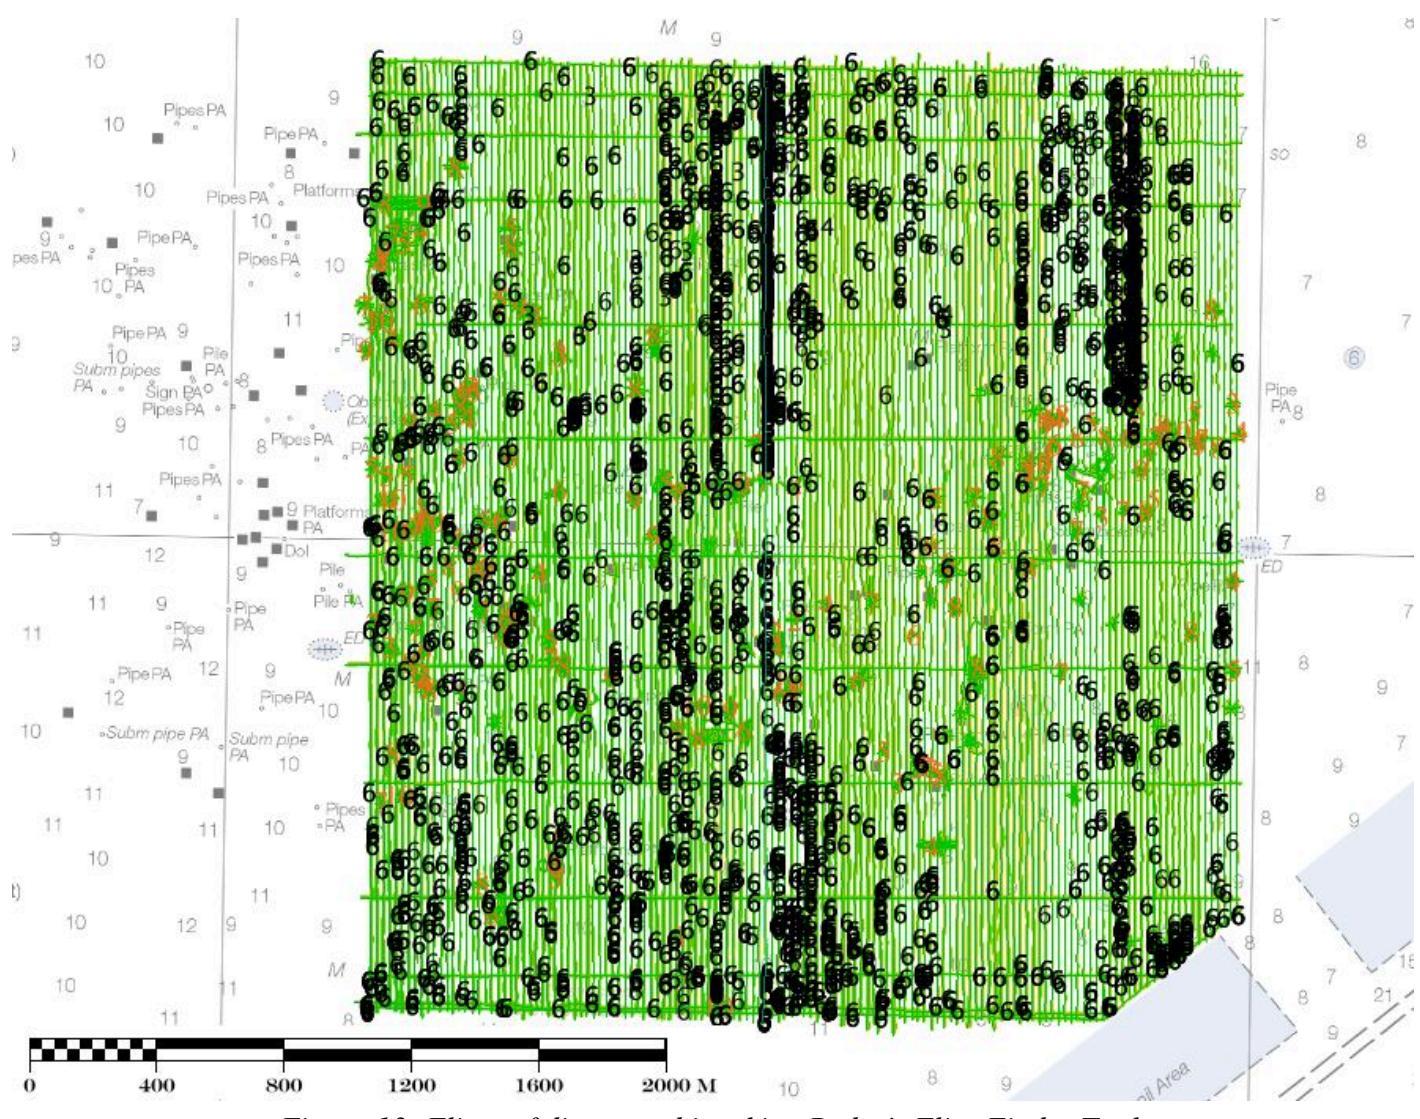
Multibeam data exhibited much noise, particularly in the outer quarters of the beam swath. Although Kongsberg swath width was reduced from 65 to 55 degrees in SIS (beginning on DN151\_2019), over 9000 fliers existed resulting in multiple iterations of cleaning. The majority of these fliers were of the category "6" classification - Edge Fliers. Noisy outer beams continue to plague the teams due to hull design and MBES placement.

*Figure 13: Fliers of discovered invoking Pydro's Flier Finder Tool. The 50 cm grid was manually cleaned in CARIS 11.2 Subset Editor.*

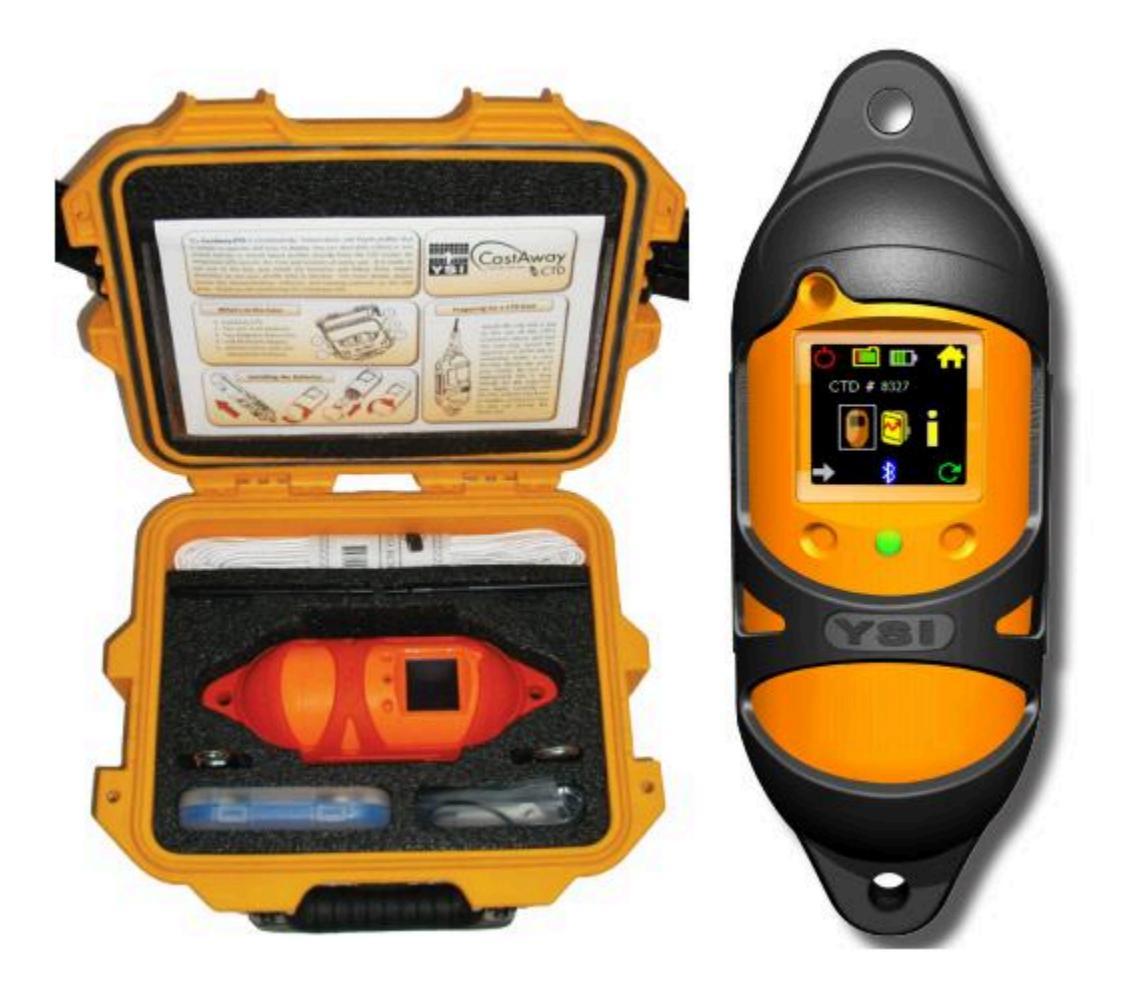
The CastAway-CTD is a small, rugged CTD designed for profiling to depths of up to 100m. The system achieves a 5 Hz response time, fine spatial resolution, and high accuracy, with sound speed measurements accurate within ±0.15 m/s. It uses a six electrode flow-through conductivity cell with zero external field coupled with a rapid response thermistor to attain high measurement accuracies. The instrument is simple to deploy, does not require a pump and is hydrodynamically designed to free fall rate of 1 m/s. Each CastAway-CTD cast is referenced with both time and location using its built-in GPS receiver. Latitude and longitude are acquired both before and after each profile. Plots of conductivity, temperature, salinity and sound speed versus depth can be viewed immediately on the

CastAway's integrated color LCD screen. Raw data is downloaded via Bluetooth to the launch acquisition computer for analysis and to export into SIS. The survey area was not zoned to account for sound speed variations as differing water masses did not exist in this area, out in the middle of Galveston Bay.

Figure 14: SonTek Castaway CTD.

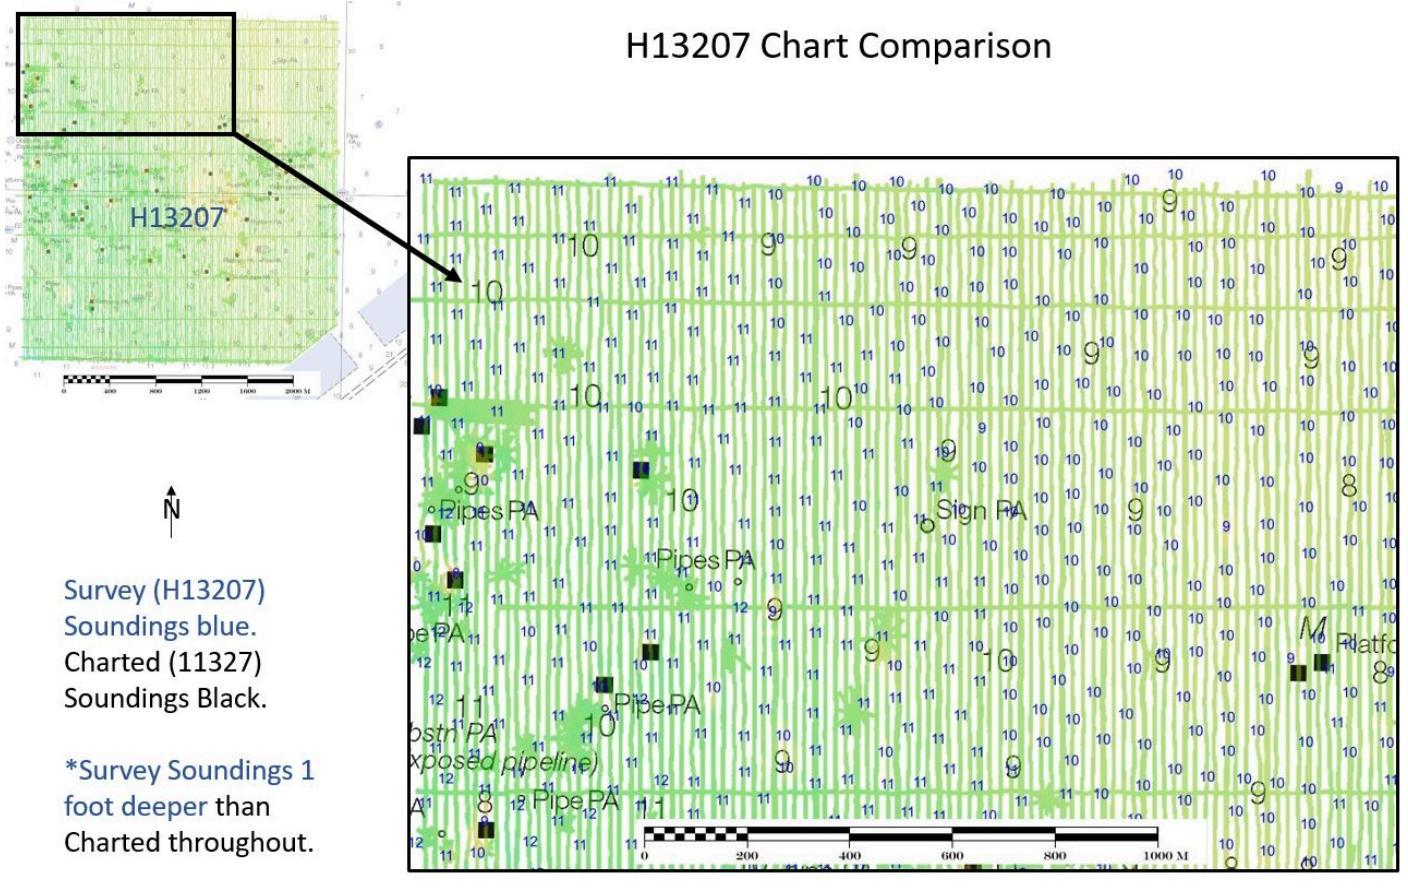
H13207 Survey Soundings were found to be consistently 1 foot deeper compared to Charted (11327) soundings throughout the project. Charted (11327) 6 foot contours no longer exist in the southeast corner of survey coverage. Charted (11327) "15" foot soundings do not exist in the southeast portion of the survey coverage.

Figure 16: H13207 Soundings 1 foot deeper than Charted (11327) Soundings.

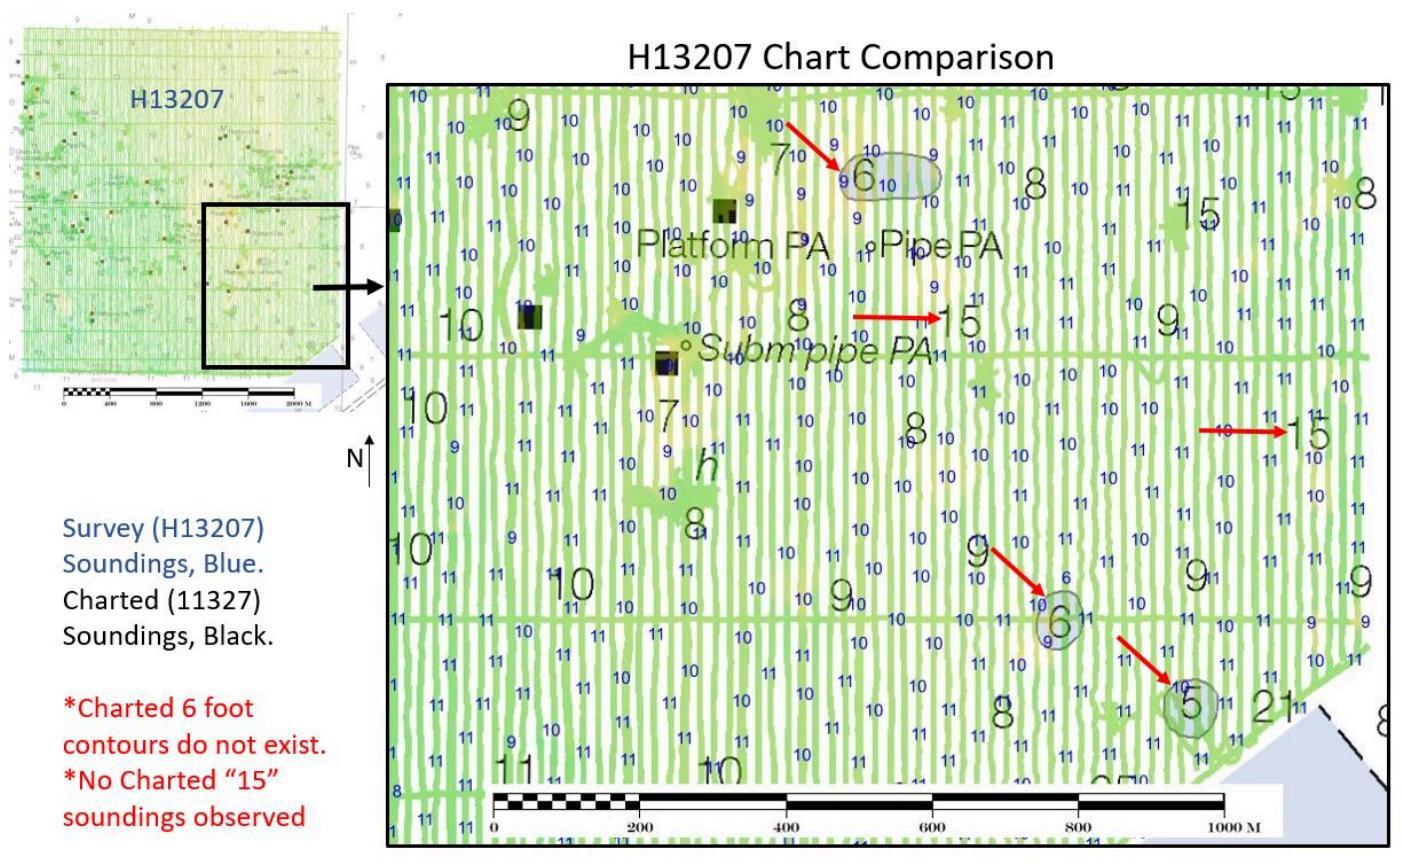
*Figure 17: Charted (11327) 6 foot contours no longer exist. Charted (11327) "15" foot soundings no longer exist.*

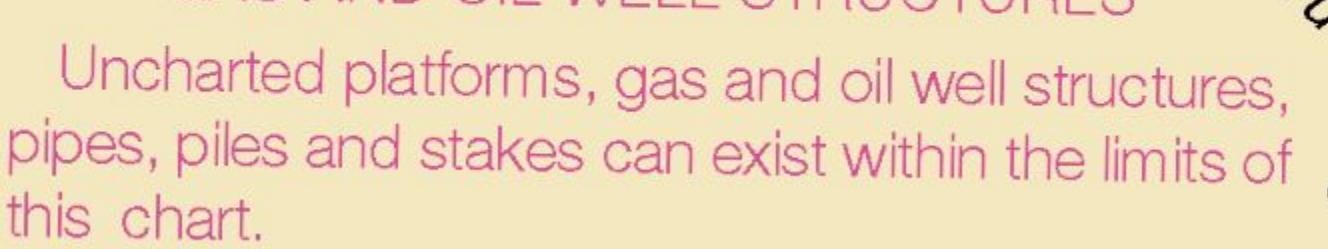
No DTONs were selected for this project despite abundance of NEW and "PA" protruding pipes, stakes, tubes, pilings and platforms. Two chart notes (11327) explicitly and adequately warn the prudent mariner of industrial obstructions throughout this oil field. Vessel traffic in the area was observed to be rare during survey dates specified. Maintenance activities to some platforms were observed occurring via shallow draft, oil tender boats - an estimated frequency of 1 vessel every 10 days.

Figure 18: Chart 11327 Obstruction Warning, south end of project area.

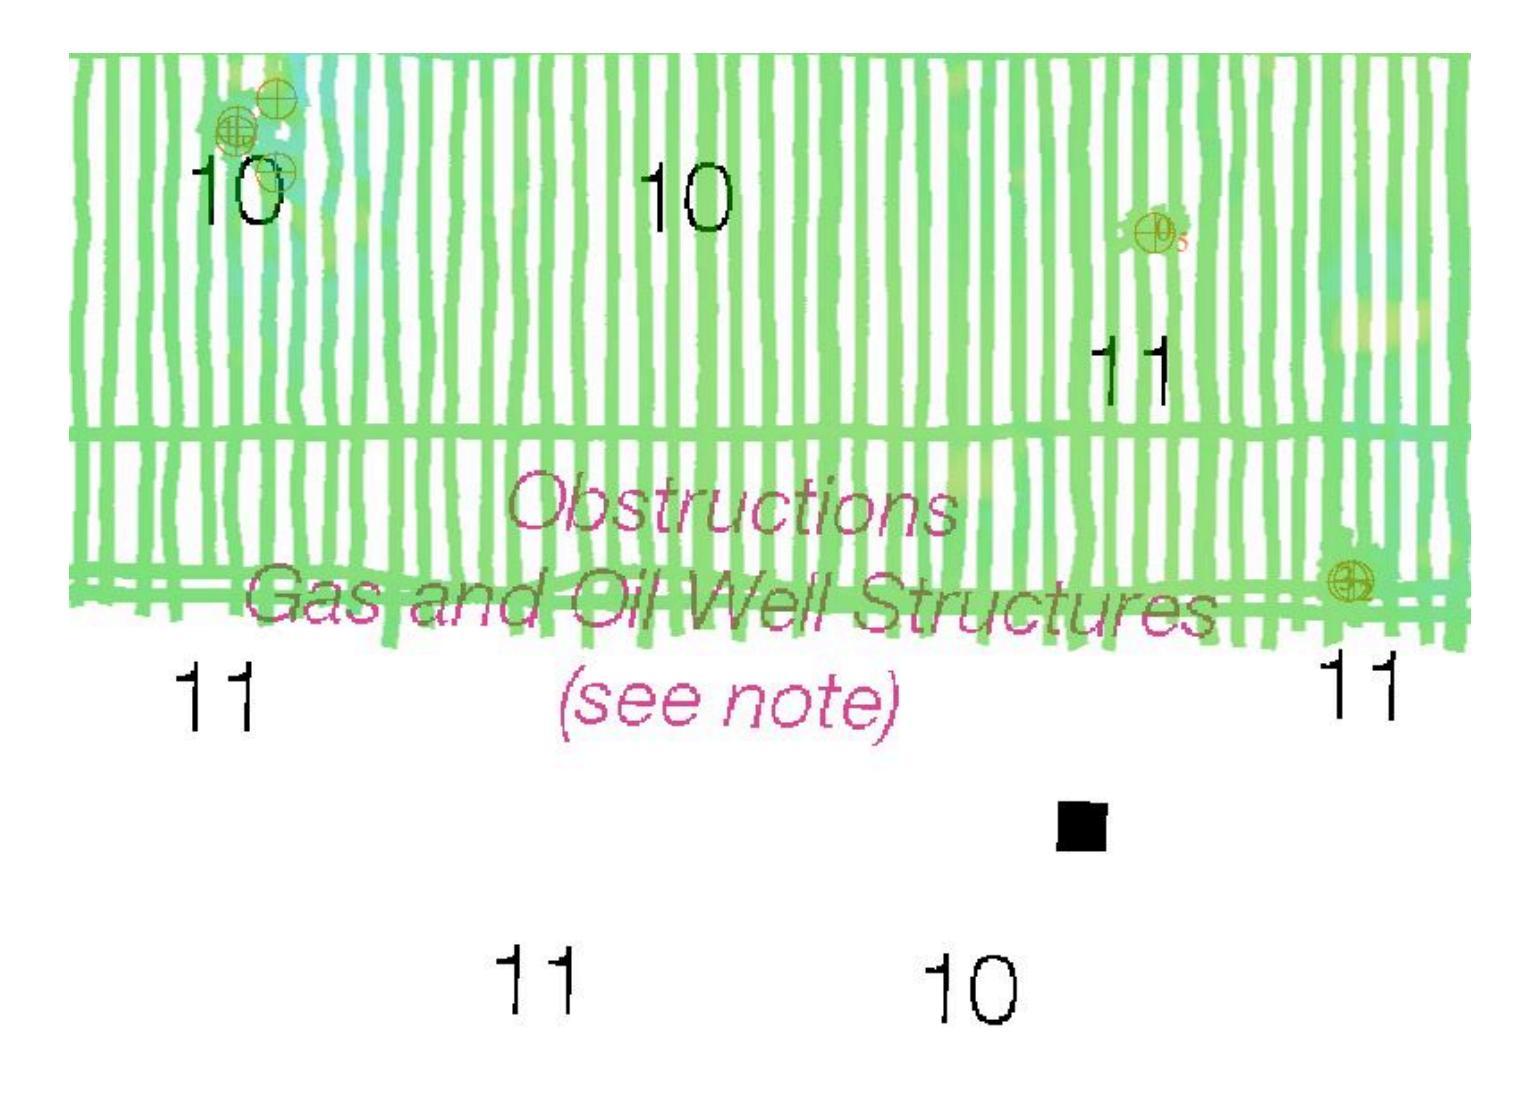
Figure 19: Chart 11327 Note - Obstructions Exist - Pipes, Piles, Stakes, Platforms.
