U.S. Department of Commerce National Oceanic and Atmospheric Administration National Ocean Service		
]	DESCRIPTIVE REPORT	
Type of Survey:	Navigable Area	
Registry Number:	H13207	
	LOCALITY	
State(s):	Texas	
General Locality:	Galveston Bay	
Sub-locality:	Galveston Bay-Red Fish Shoal	
	2019	
	CHIEF OF PARTY Dan Jacobs	
	LIBRARY & ARCHIVES	
Date:

## **Descriptive Report to Accompany Survey H13207**

Project: S-K928-NRT4-19 Locality: Galveston Bay Sublocality: Galveston Bay-Red Fish Shoal Scale: 1:10000 October 2018 - December 2019 **NOAA Navigation Response Team - Galveston** Chief of Party: Dan Jacobs

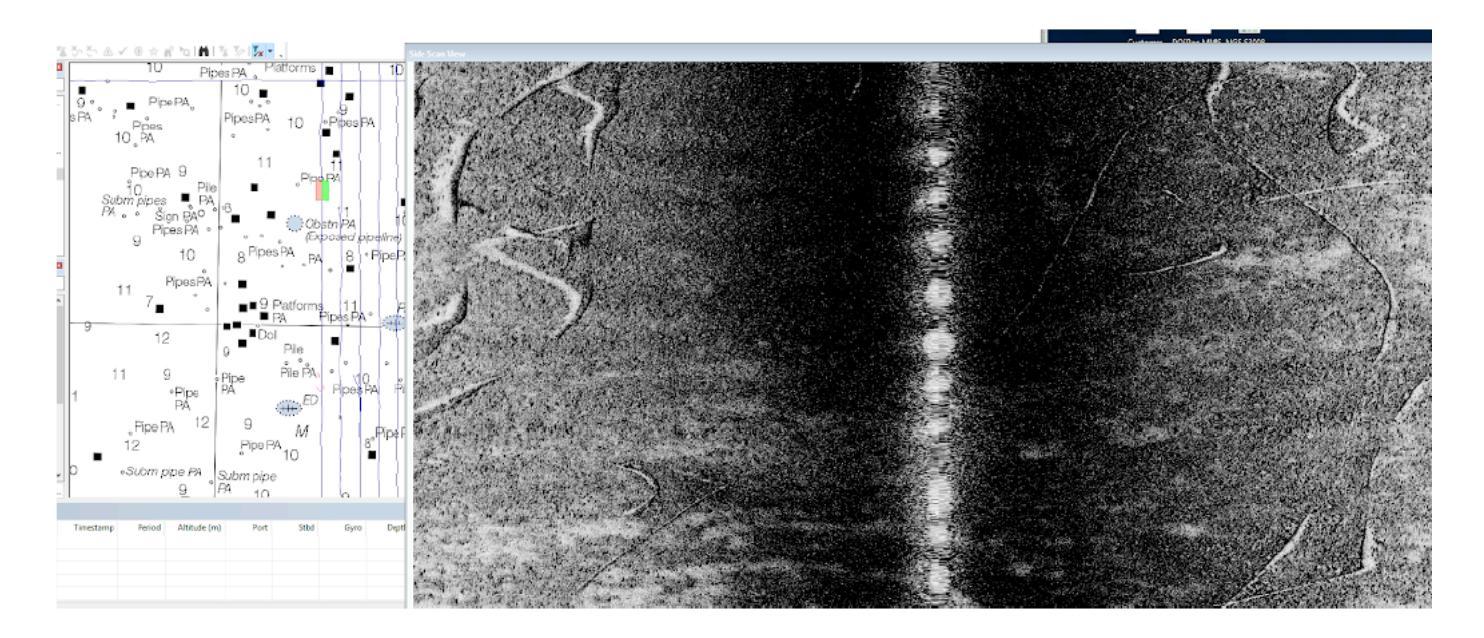
Uncharted pipelines or pipe segments occur in great numbers throughout the H13207 survey area. At the Hydrographer's discretion only pipelines which appeared to be main trunks and/or interconnecting pipes between platforms were digitized to delineate and generalize pipeline areas (vs discrete pipeline "Line" features). Both side scan line imagery and mosaics were consulted in the assessment. Individual pipelines segments "Pipsol" were not fully attributed in CARIS SIPS or BDB, nor was this a requirement. Please reference electronic communications between Chief, PHB and NRT4 regarding "PIPARE" digitizing in the project correspondence folder. The line features were exported as as "CSYM\_pisol" and archived in a folder entitled "SSS\_First\_Round" of the S57/Side Scan Sonar Contacts folder for the Reviewer's appraisal and readjustments to the derived pipeline area polygons.

Figure 20: Uncharted pipelines and pipe segments occurred in great numbers, H13207.

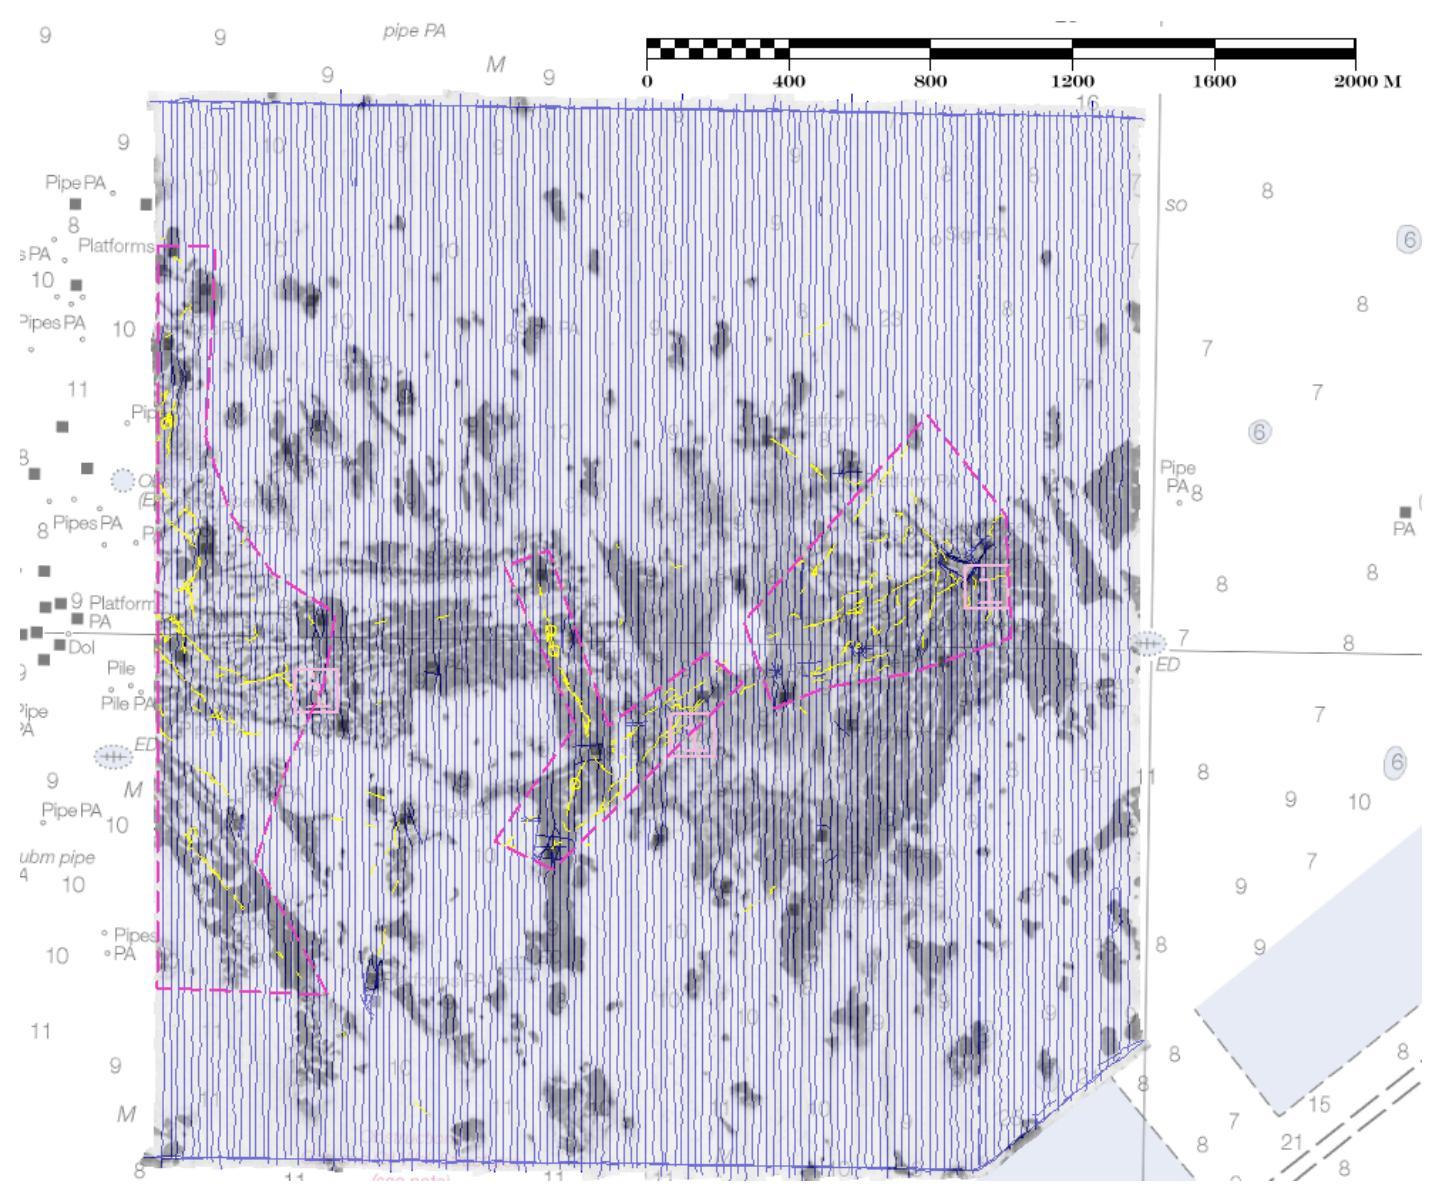
Figure 21: NEW Pipeline area polygons, pink, dashed lines. (yellow - previously digitized line segments)
