# DATA ACQUISITION AND PROCESSING REPORT

<i>Type of Survey</i>	<b>Hydrographic</b>
<i>Project</i>	<b>OPR-J348-KR-12</b>
<i>Contract No</i>	<b>DG133C-08-CQ-0006</b>
<i>Task Order No</i>	<b>T0007</b>
<i>Time Frame</i>	<b>May 2012</b>

<i>State</i>	<b>Mississippi</b>
<i>General Locality</i>	<b>Approaches to Mississippi Sound</b>

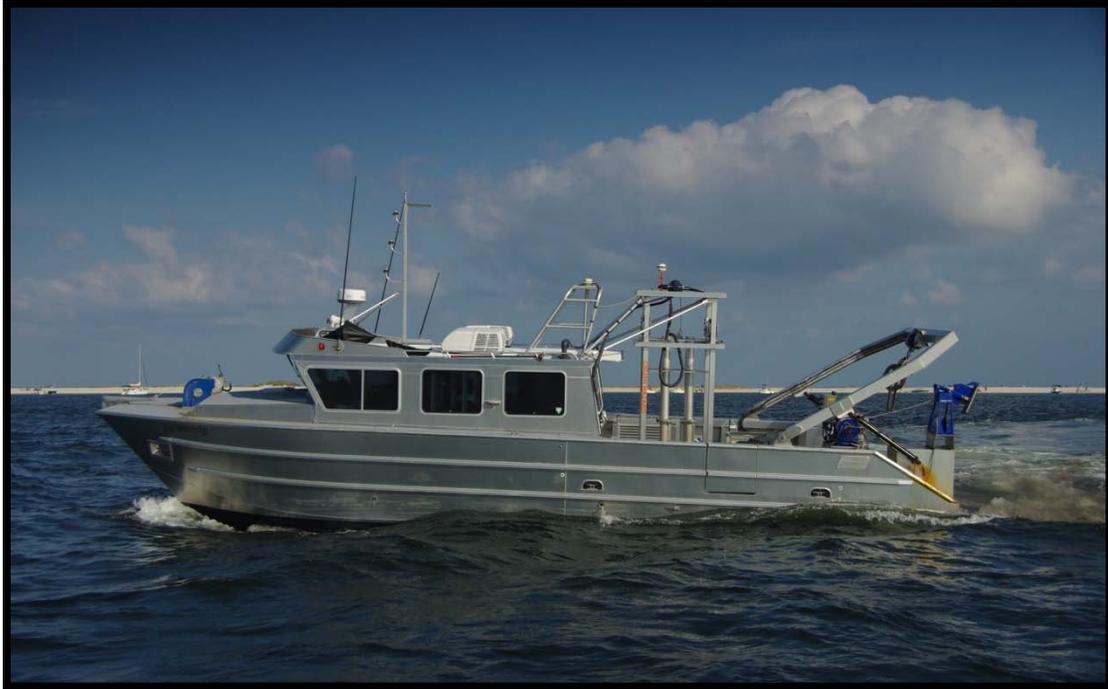
**Figure 1. R/V *Westerly***

The R/V *Westerly*, hull registration number 1231991 is a 38-foot, 13-gross ton, aluminum catamaran with 16.5-foot beam and a draft of 4.6 feet. The vessel is equipped with twin Hamilton jets, centerline moon pool hydraulic multibeam mount, stern mounted A-frame, air-cushioned server station, and acquisition station.

The R/V *Westerly*, which is owned and operated by Zephyr Marine (Figure 1), was the survey vessel for the project.

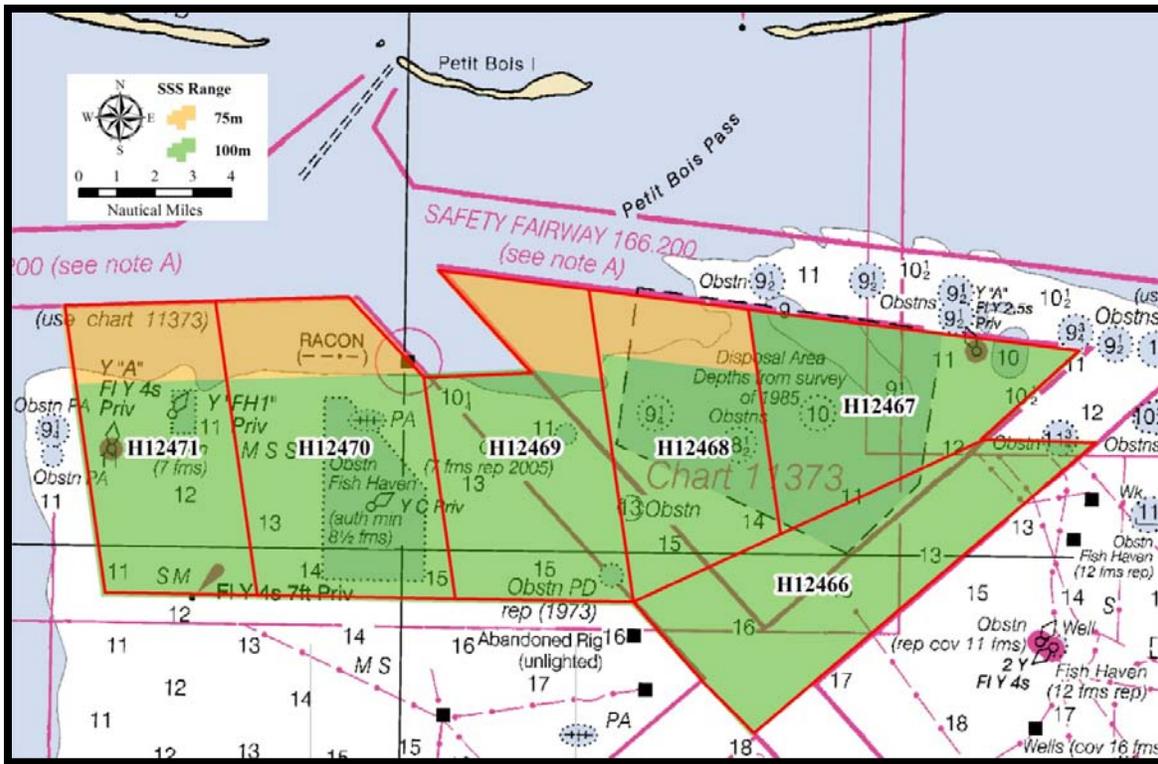
**Figure 2. Side Scan Sonar Range Scale Use by Survey**

The side scan sonar was operated at 300 kHz in the multi-pulse high-speed mode at a range of 100 meters for deep areas and a range of 75 meters for shallower areas. The planned operation mode for project OPR-J348-KR-12 is depicted in Figure 2. This project was still active at time of DAPR submission.

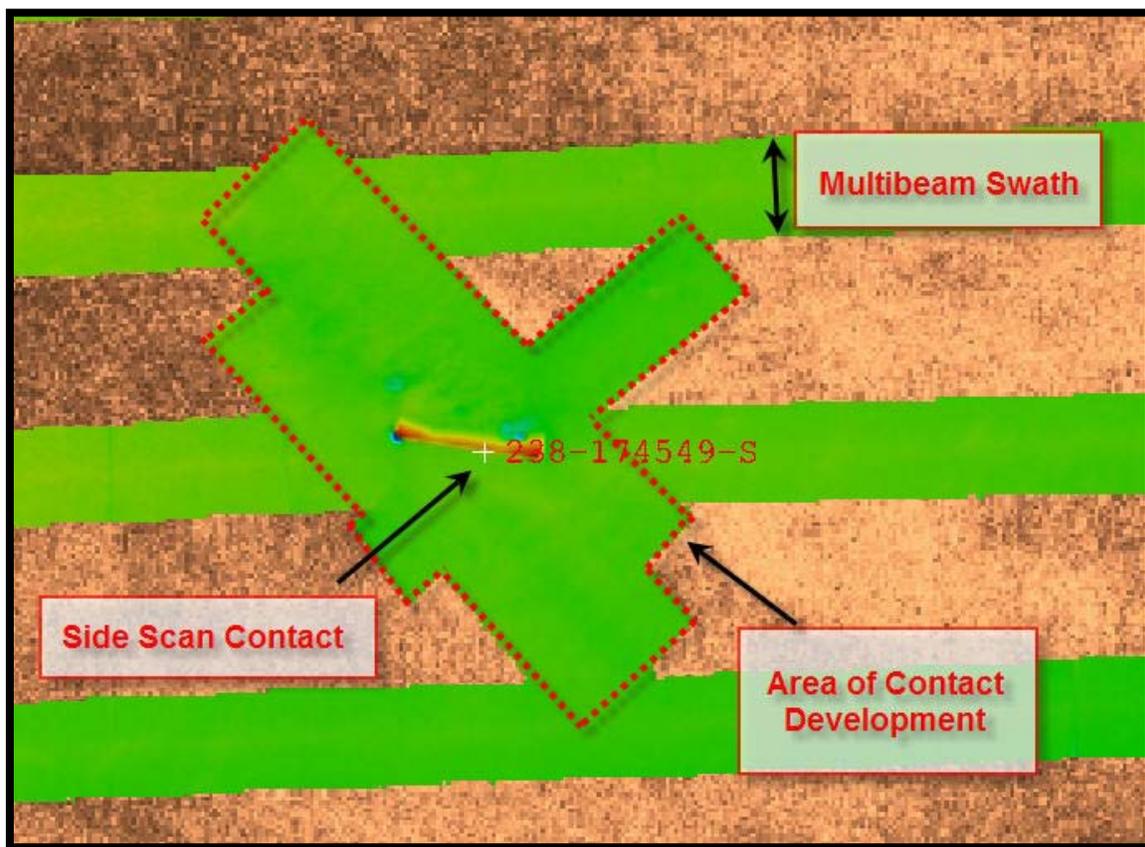
**Figure 3. Side Scan Sonar Mosaic Overlaid with Multibeam and Sonar Contacts**

All side scan contacts that were determined to be significant were investigated with multibeam according to object detection specifications. Investigations were conducted even if the object was covered in the initial set-line multibeam mainscheme. This technique is shown in Figure 3.

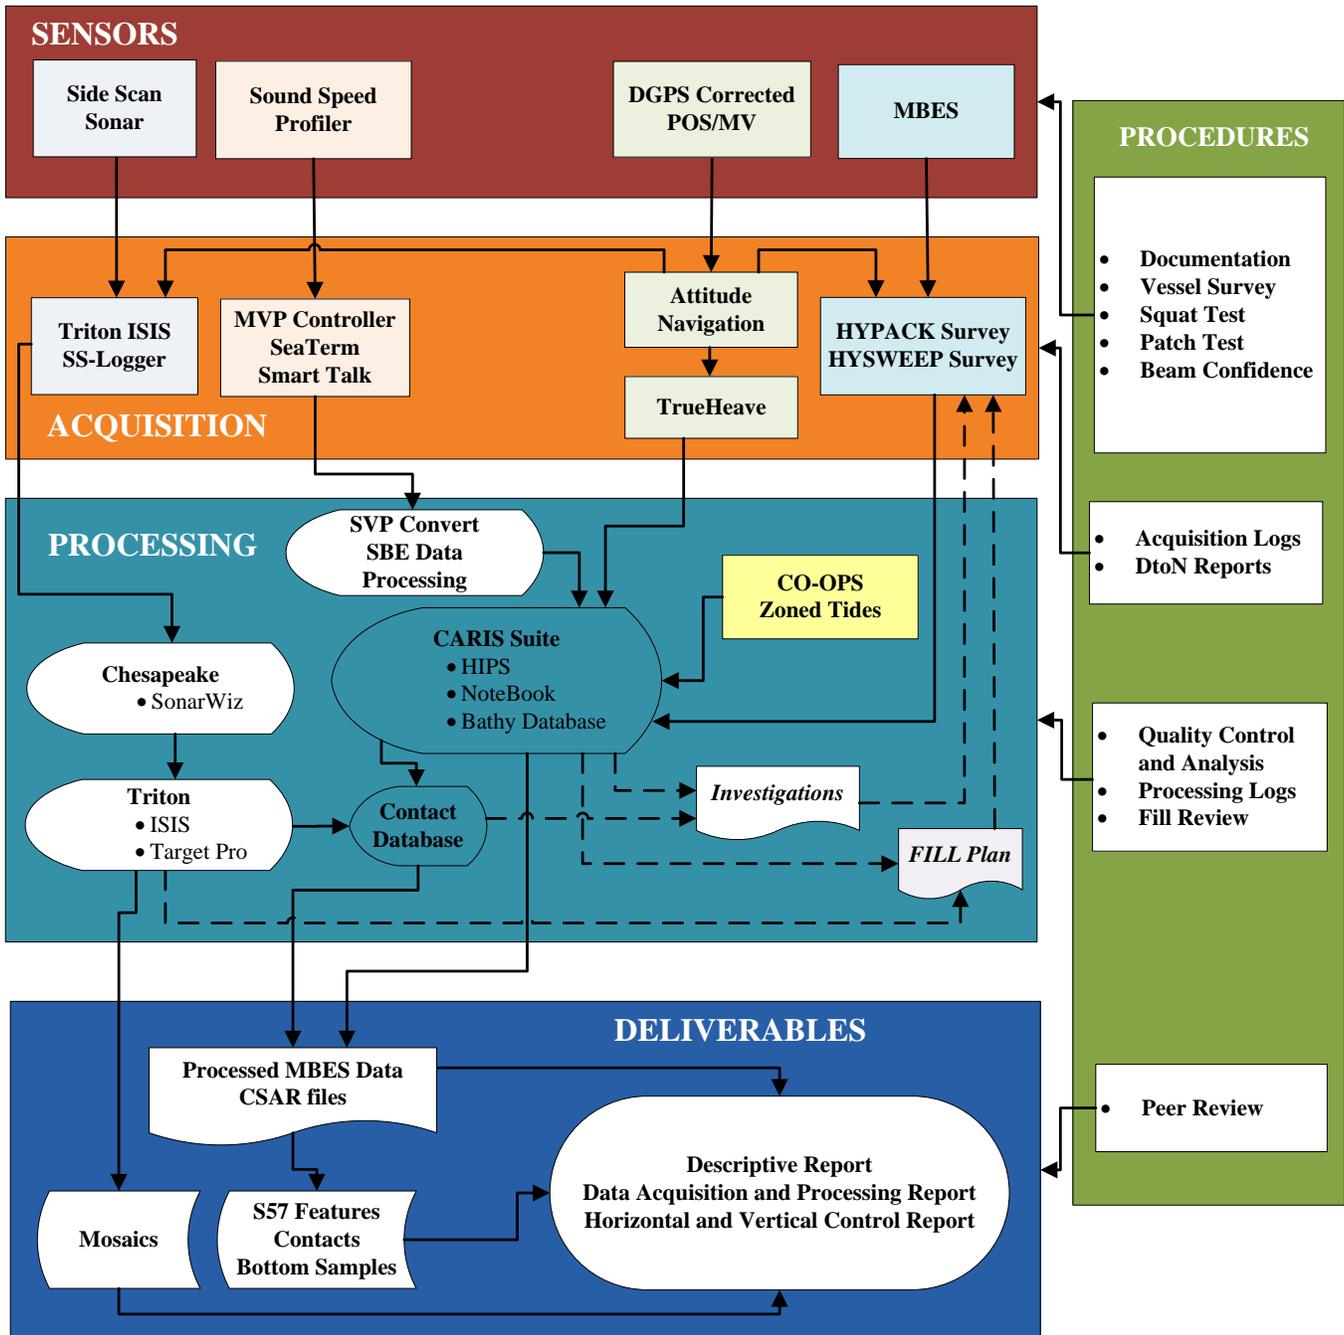
Figure 4. Flowchart of Data Acquisition and Processing Pipeline

A flow diagram of the data acquisition and processing pipeline is presented in Figure 4. This diagram graphically illustrates the data pipeline and processing workflow from acquisition to delivery.
