Data Acquisition & Processing Report

Type of Survey Multibeam and Side Scan Sonar

Project No. OPR-K371-TJ-10

General Locality Cameron, LA to Sabine, TX

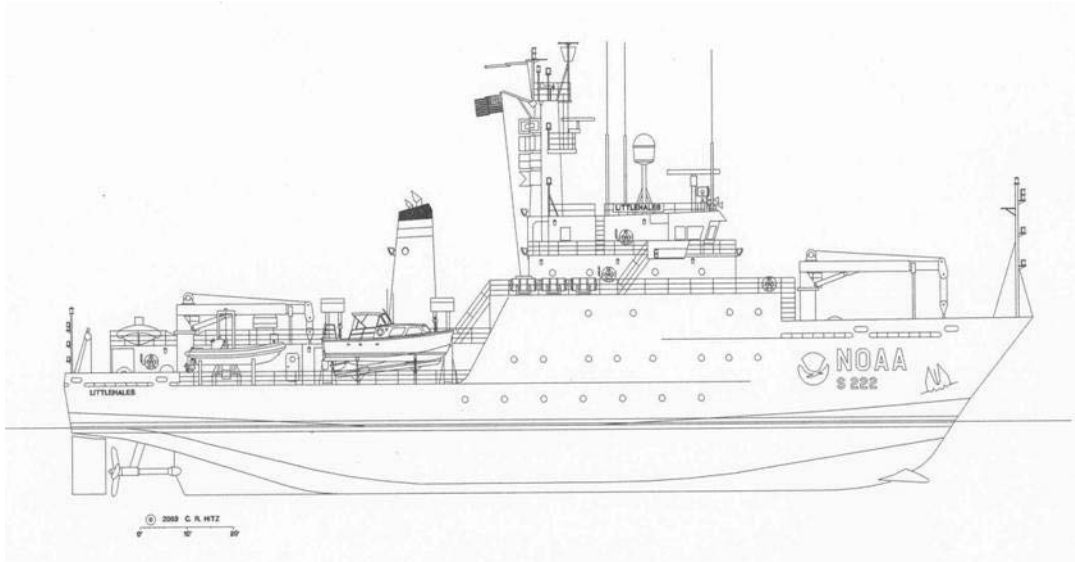
Figure A-1. The NOAA Ship *Thomas Jefferson*

The platforms used for data collection were the *NOAA Ship Thomas Jefferson*, (Figure A-1) and *Hydrographic Survey Launches 3101 and 3102* (Figure A-2). *THOMAS JEFFERSON* acquired multibeam echosounder (MBES) data, Side Scan Sonar (SSS) imagery and sound velocity profile (SVP) data. The vessel is equipped with a DT Marine Products tow winch (Model 307EHLWR) for side scan deployment, and a DT Marine Oceanographic winch with approximately 1500m of galvanized steel cable for CTD and bottom sample deployment, and a Brooke Ocean Technology MVP 100 Moving Vessel Profiler (MVP). Launches 3101 and 3102 acquired multibeam echosounder (MBES) data, vertical beam echosounder (VBES) data, Side Scan Sonar (SSS) imagery and sound velocity profile (SVP) data. Table A-1 presents the vessel characteristics for all platforms.

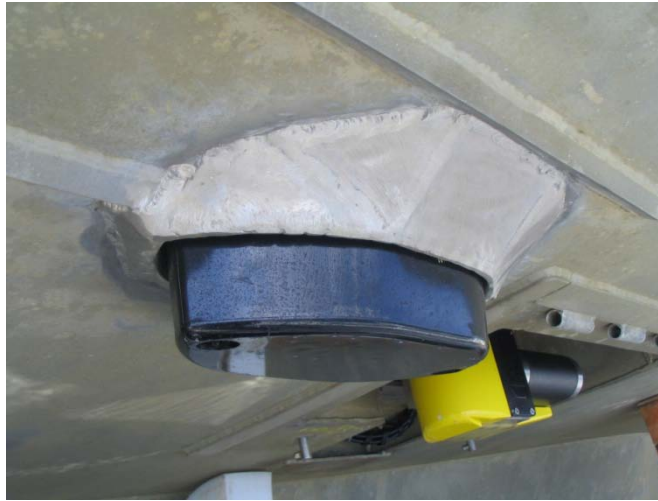
Figure A-3. Odom Vertical Beam on 3101 / 3102

On Launches 3101 and 3102, the transducer is mounted on the port side forward of the retractable arm that accommodates the RESON 7125-SV (Figure A-3). The installation of the Odom on Launch 3101, 3102 allows simultaneous acquisition of KLEIN 5000 side scan with general survey-grade bathymetry when the ODOM is operated in either low or high frequency mode.

When the transducer was lowered, as mentioned above, it was noticed that one of the tabs securing the Odom Echotrac transducer to the hull had a cracked weld. On DN 133, new tabs were welded into place on HSL 3101. On DN 134 new tabs were welded onto HSL 3102. The arrangements were engineered such that the transducer height would not be affected. Measurements verified that the height had not changed, therefore, no HVF entries were made for either vessel.

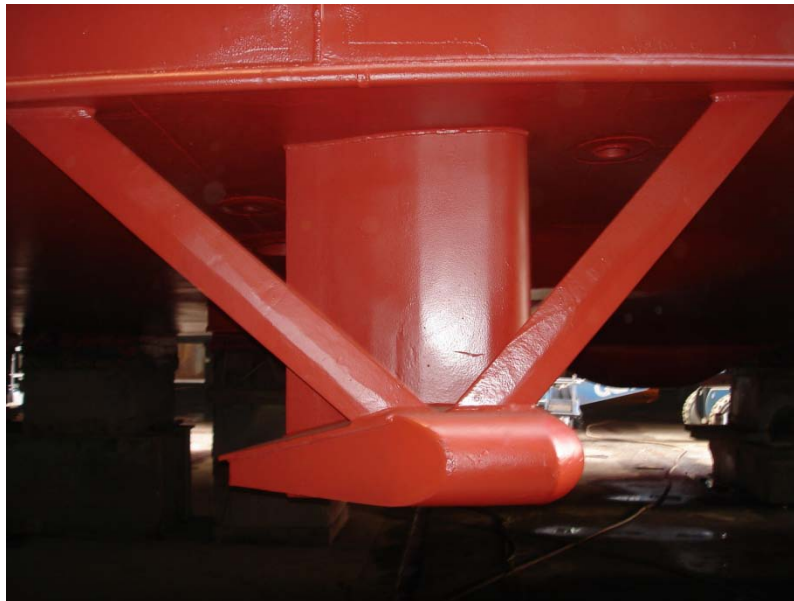
Figure A-4. 7125 Housing on *Thomas Jefferson*

The RESON SeaBat 7125 system is a single-frequency, digital recording multibeam echosounder with a central frequency of 400 kHz. The RESON 7125 system aboard *THOMAS JEFFERSON* is installed in a steel housing assembly with hydrodynamic shape mounted to a pylon extending from the starboard hull of the ship (Figure A-4).

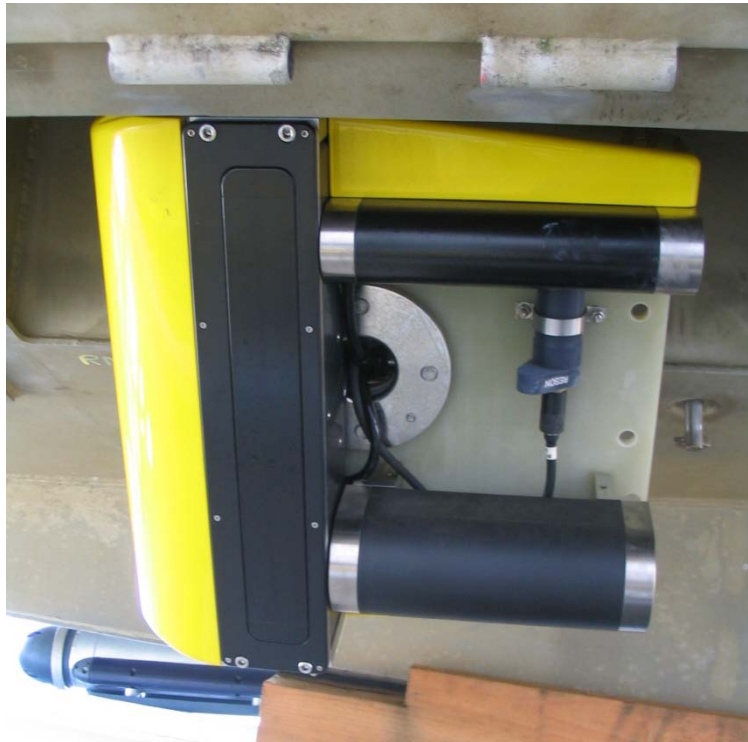
Figure A-5. 7125-SV Housing on Launch 3101/3102

The RESON 7125-SV system aboard Launches 3101, 3102 are installed on a RESON Seabat 7125 mounting bracket deployed on a retractable arm from the hull. (Figure A-5).

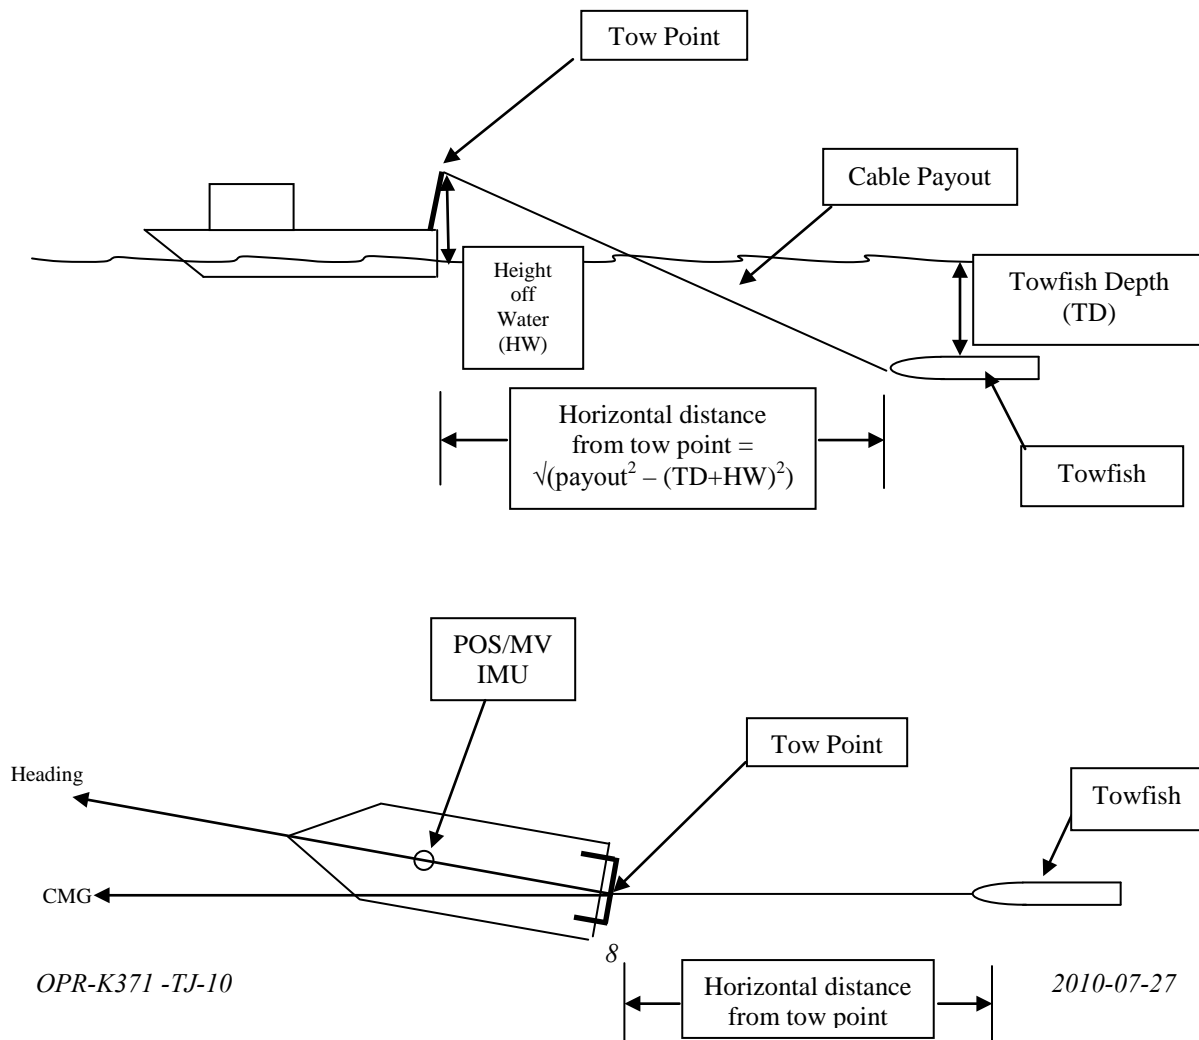
Figure A-6. Side Scan Towfish Position Calculations

Towfish positioning was provided by CARIS HIPS using cable out values recorded in the Sonar Pro SDF files. This program uses Payout and Towfish Depth, Figure A-6, to compute towfish positions. The Payout and Depth method computed the position of the tow point using the offsets of the tow point from the POS/MV IMU and the vessel heading. The tow fish position was calculated from the position of the tow point using the cable out value received by SonarPro from the cable payout meter, the towfish pressure depth (sent via a serial interface from the KLEIN 5000 computer to SonarPro), and the Course Made Good (CMG) of the vessel. This method assumes that the cable is in a straight line therefore no catenary algorithm is applied at the time of acquisition, but in processing, CARIS SIPS applies a 0.9 coefficient to account for the catenary.

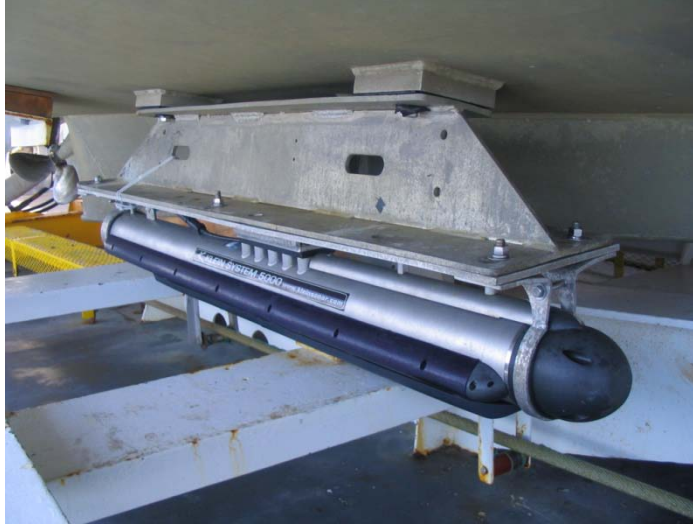
Figure A-7. Side Scan Hull Mounted on 3101 / 3102

Aboard both survey launches, the lightweight or heavyweight Klein 5500 towfish can be mounted to an aluminum sled using omega brackets.

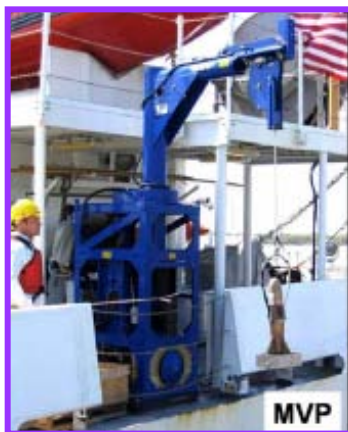
Figure A-8. MVP 100 on S-222

The Moving Vessel Profiler (MVP) (figure A-7) is a self-contained profiling system capable of sampling water column profiles to 100m depth. MVP-100 was mounted to the port stern quarter. Configuration parameters, offsets, and installation diagrams are included in Appendix A. The MVP consists of a computer-controlled high speed hydraulic winch, a cable metering, over-boarding and docking system, a conductor cable and a streamlined free fall fish (FFF) housing an Applied Microsystems “time of flight” SV&P Smart Sensor (see SV&P below) . The system as configured aboard the *THOMAS JEFFERSON* collects vertical profiles of sound velocity data while the ship is underway at survey speed. The unit is located on the fantail and controlled remotely from the ship’s acquisition room. The MVP is capable of importing its data directly into the Kongsberg SIMRAD EM 1002 multi-beam echosounder (MBES) at the time of acquisition. When using MVP casts in conjunction with the RESON 7125 MBES, sound velocity data is processed using Velocwin software, then applied in CARIS HIPS during post processing.

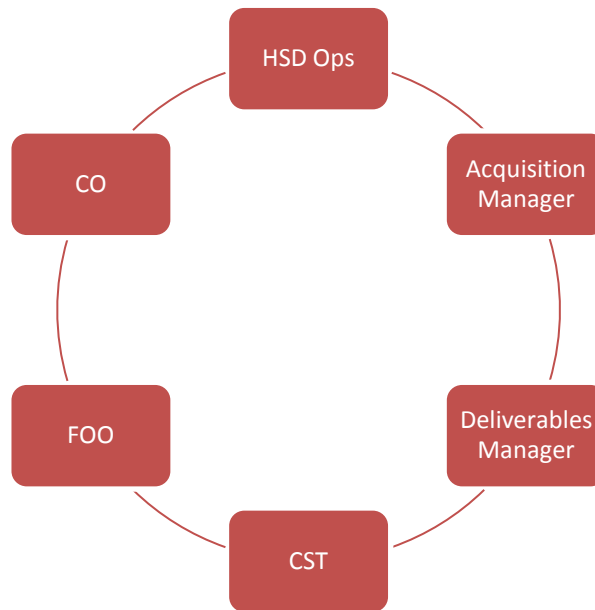
Figure B-1: Quality management loop

Clear and concise communication is critical at all stages of the survey, and is established between all relevant parties¹ at the earliest stage of the process. Figure 1 represents the parties involved at all stages of the Quality Management process.

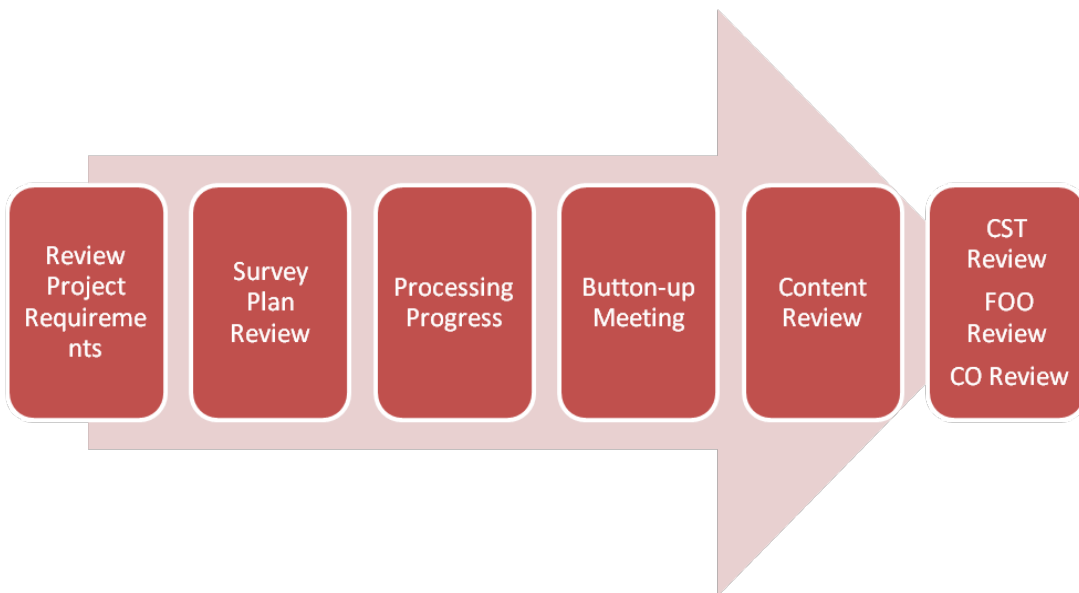
Figure B-2: Quality Review Stages

Below is a graphic showing the Quality review steps used aboard the *Thomas Jefferson*.

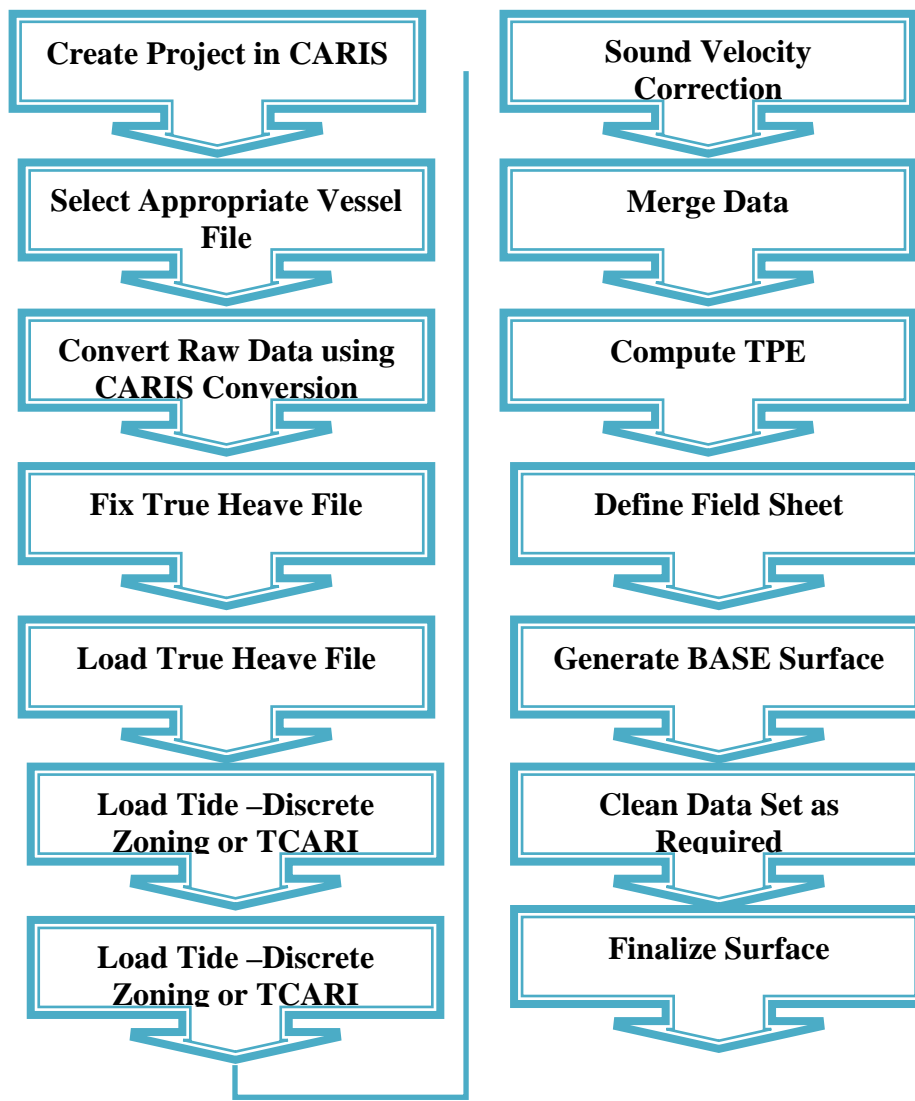
Figure B-3: MB Data processing flow

Figure B.3 shows the general processing flow for Multibeam data after collection.

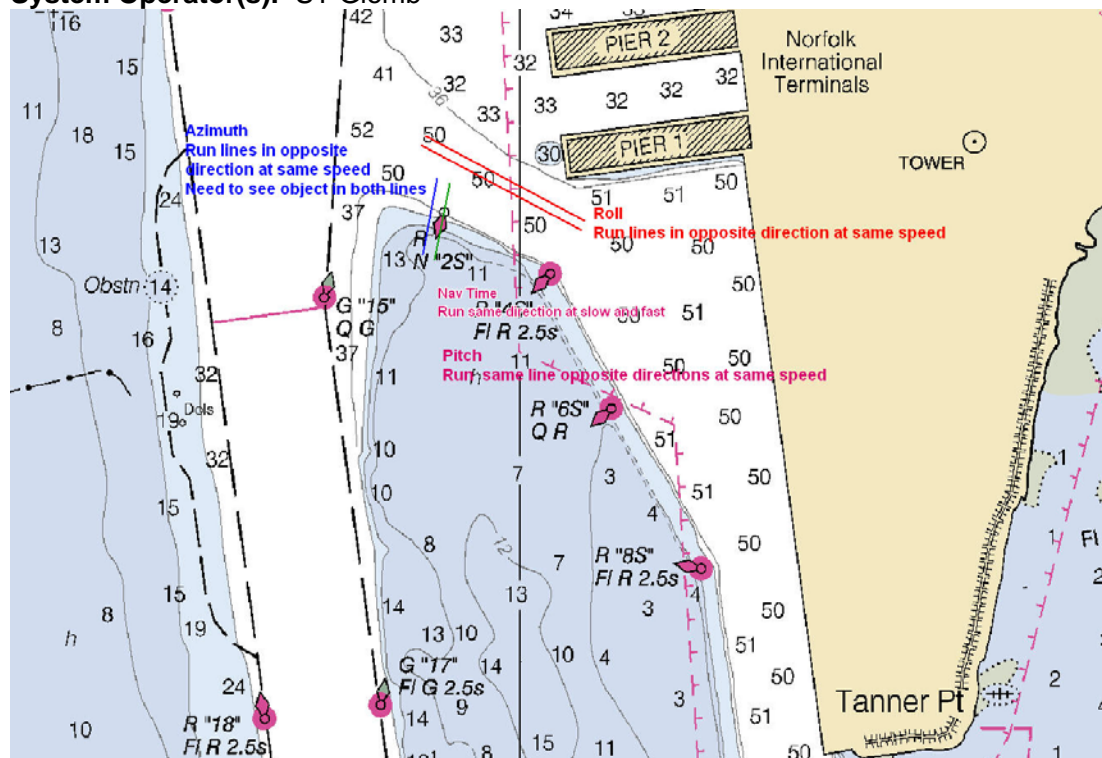
Figure 1 – Patch test area off Tanner Pt in the Elizabeth River, Norfolk, VA

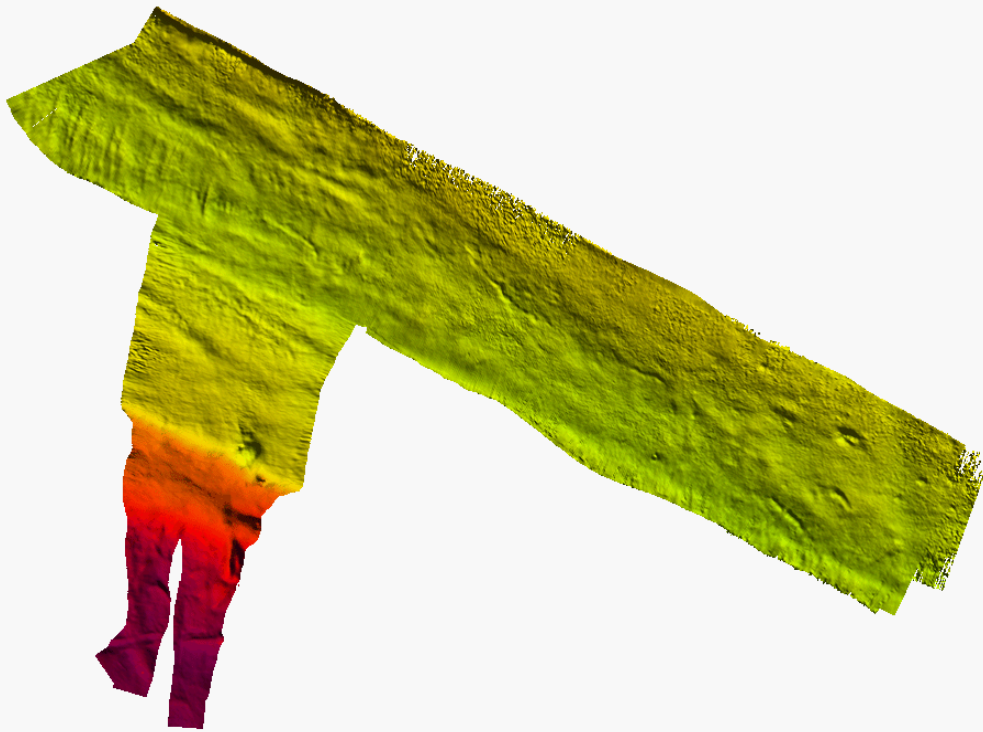
Figure 2 – 0.5m CUBE surface of patch test area

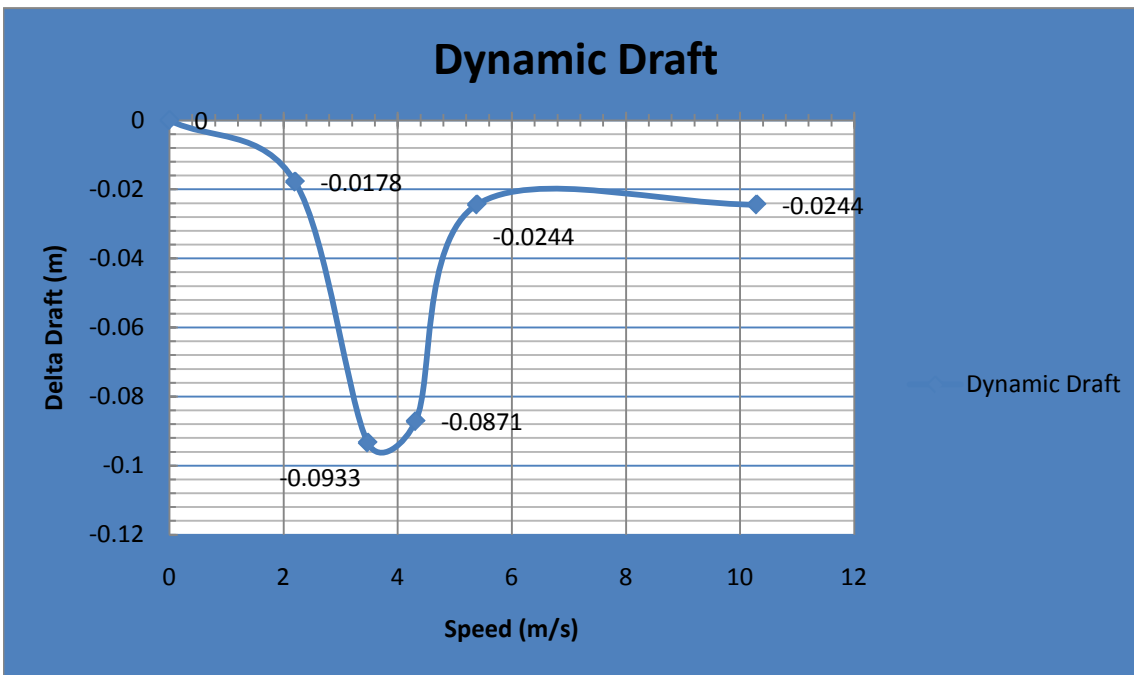
3101 Dynamic Draft Calculation Comparisons
Thomas Jefferson - 2010

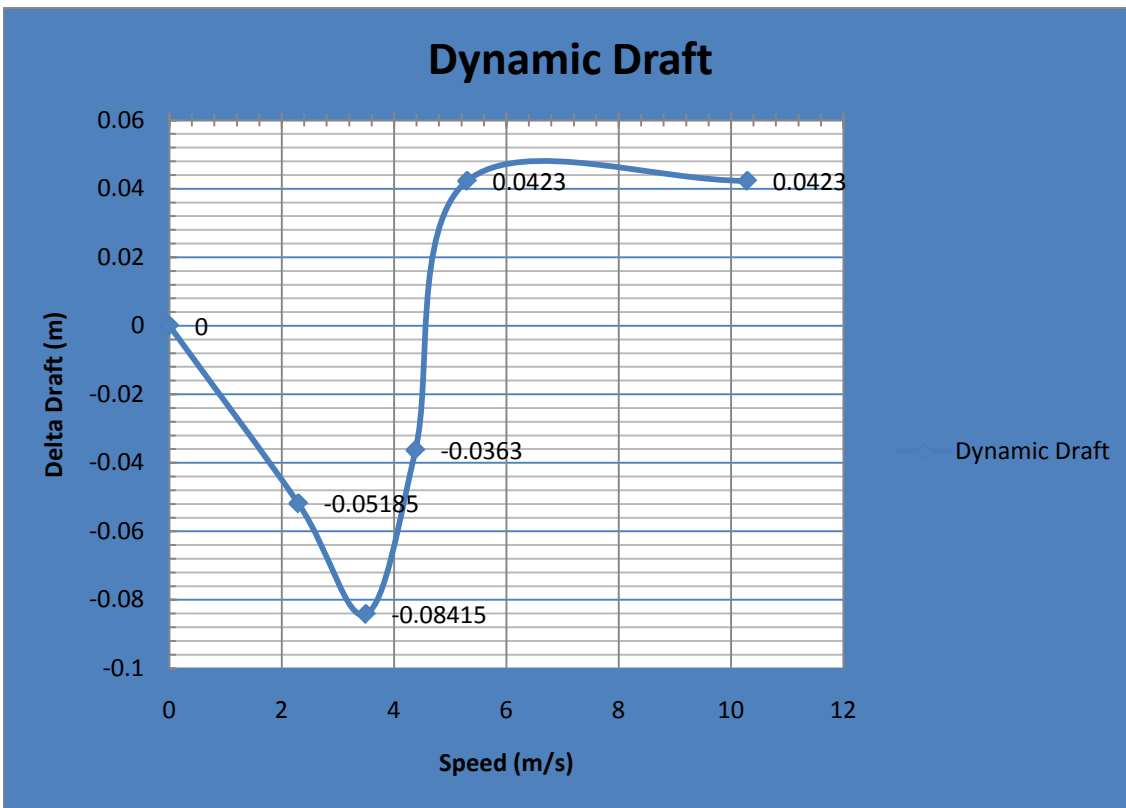
S222 Dynamic Draft Calculation Comparisons

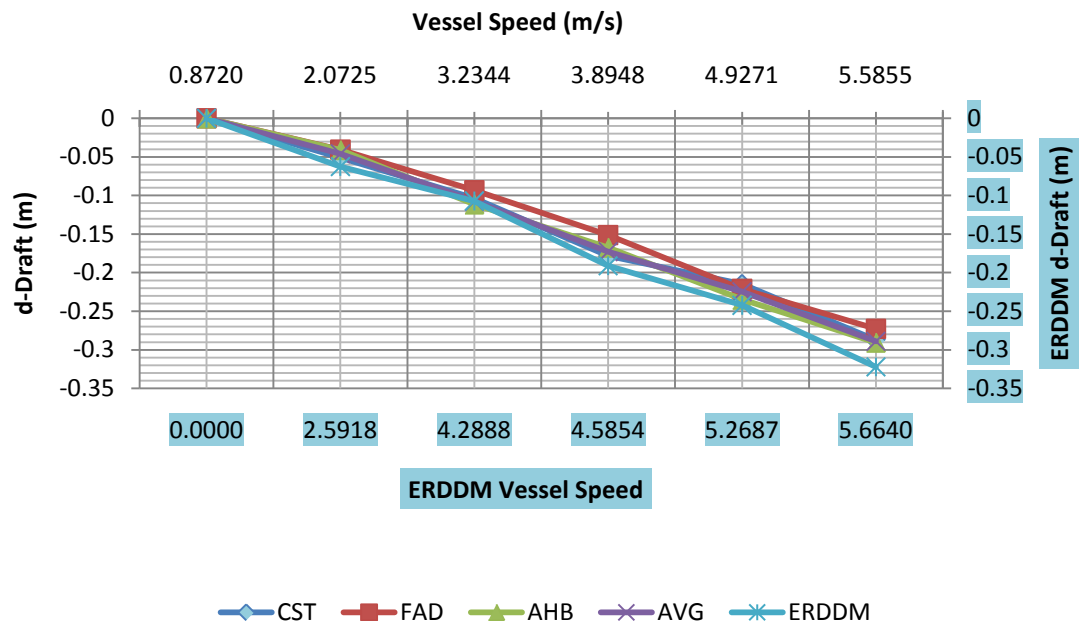
Comparison of Historic Values for Dynamic Draft

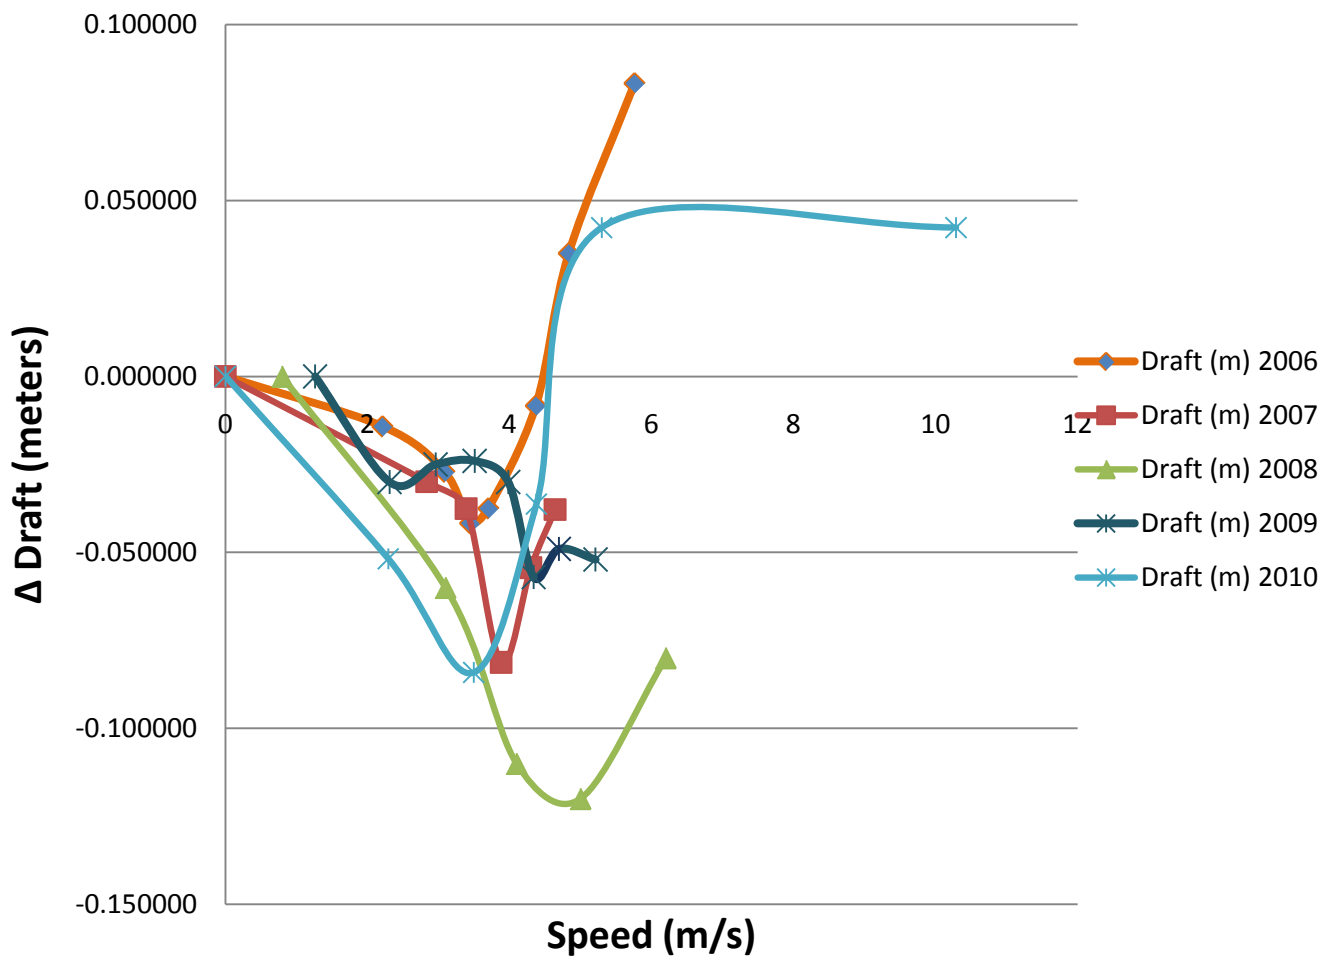
Launch 3102 Historical Dynamic Draft Residuals

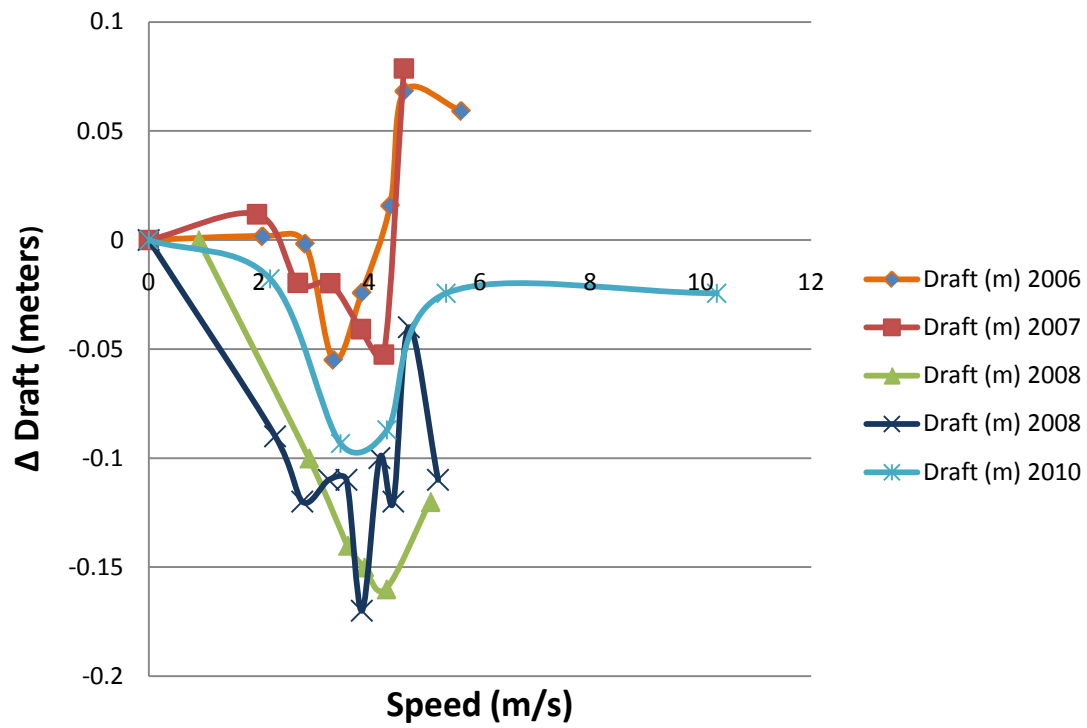
2010 HSRR Reference Surface Summary of Difference Surfaces
