Data Acquisition & Processing Report

Type of Survey: Navigable Area

Project Number: OPR-R340-KR-23

General Locality: Bristol Bay

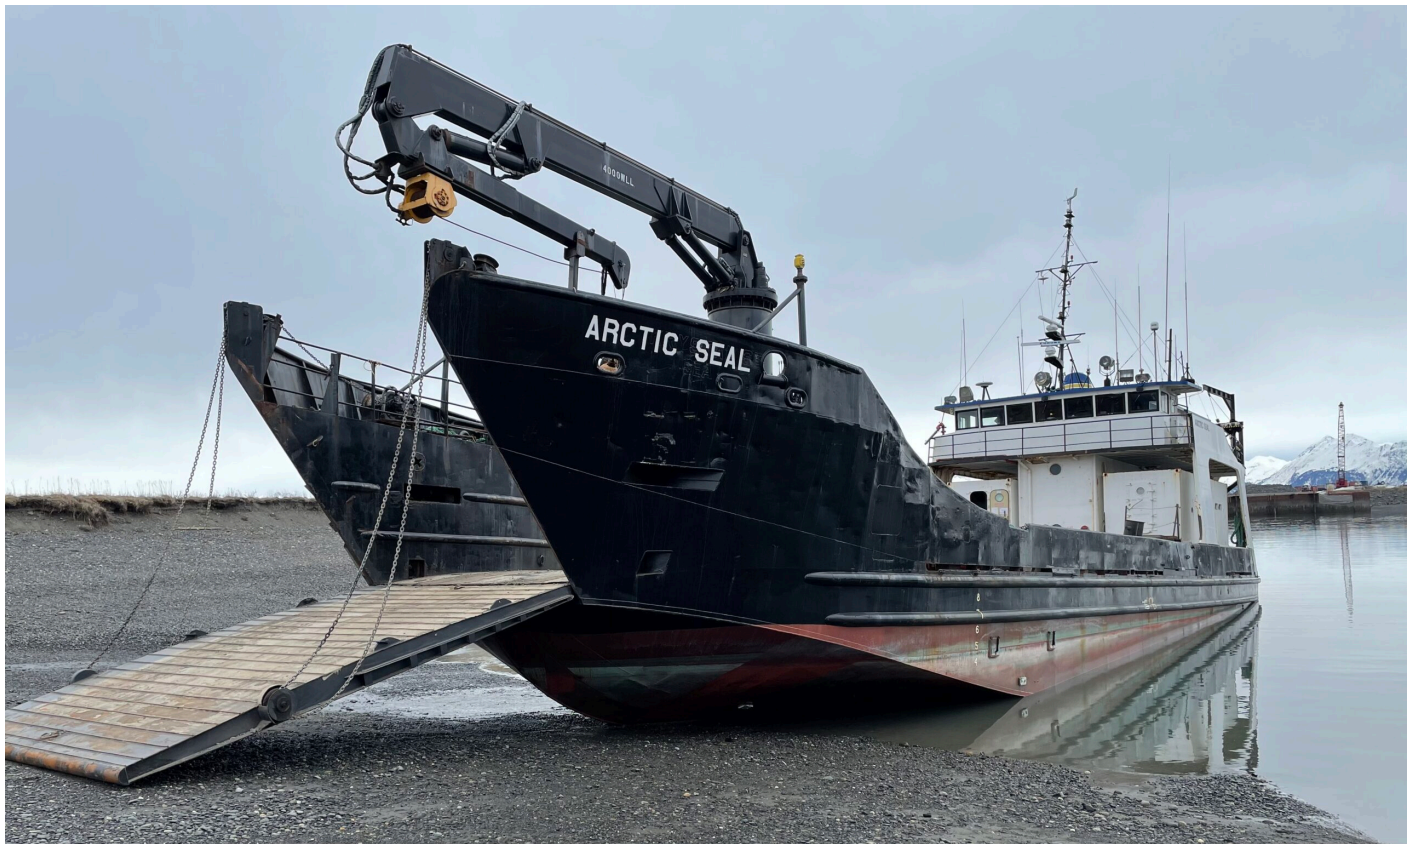
Figure 1: The Arctic Seal with bow ramp lowered.

<i>Vessel Name</i>	Arctic Seal	
<i>Hull Number</i>	594237	
<i>Description</i>	<p>The Arctic Seal is a 130' (39.6 m) steel vessel that is owned and operated by Support Vessels of Alaska (SVA). It is home-ported in Homer, Alaska. 2023 was the first year it was chartered by TerraSond to complete a NOAA task order.</p> <p>The Arctic Seal carries a USCG Oceanographic Research Vessel Designation and a USCG Certificate of inspection for Hauling Freight. The R/V Arctic Seal is configured as a landing craft. It is powered by two Cat C-18 diesel engines and has a 5500 nautical mile endurance. Features include a 8.5-ton deck crane, 4' moonpool, davit, survey skiff, and hydraulic over-the-side MBES arm.</p> <p>On this project the Arctic Seal surveyed as the primary survey platform, housing all staff and operating on a 24/7 schedule. It was used to collect MBES data, sound-speed profiles, collect bottom samples, deploy/operate the ASV-CW5 vessel, and transport/deploy the LC-25 skiff. Preliminary (field) data processing was also completed aboard the vessel.</p>

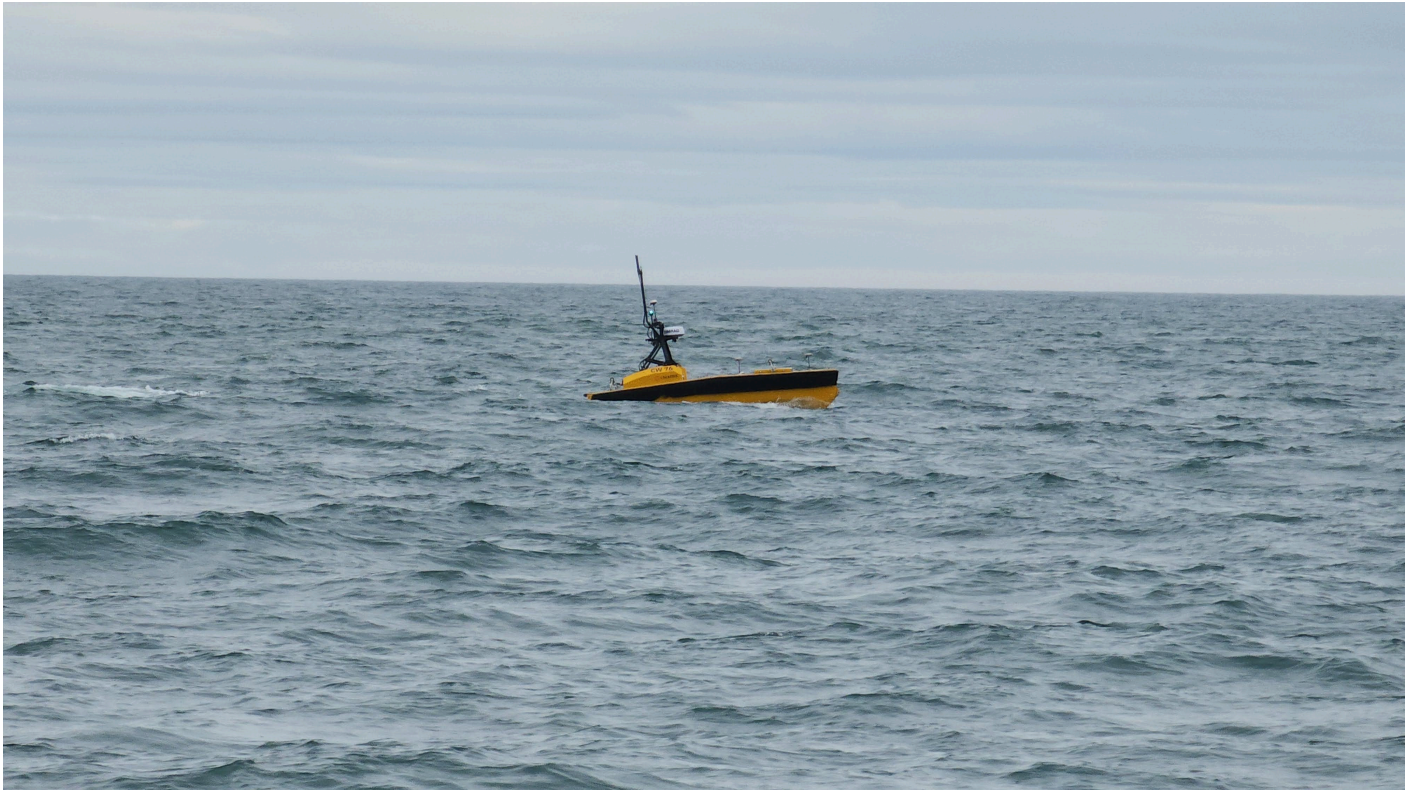
Figure 2: The ASV-CW5 working in the survey area.

<i>Vessel Name</i>	ASV-CW5	
<i>Hull Number</i>	CW76	
<i>Description</i>	<p>The 18' (5.5 m) aluminum-hulled vessel ASV-CW5 (C-Worker 5 model), owned and operated by L3Harris, was used to acquire MBES data on this project. The vessel has been used yearly by TerraSond on previous NOAA task orders in Alaska from 2016 through 2020, and 2022 through 2023.</p> <p>The unmanned vessel is propelled by a single 57 HP Yanmar diesel engine. Once deployed from the larger vessel it was operated in an "unmanned-but-monitored" mode, at ranges up to 3km from the larger vessel. It collected MBES data on lines parallel to the Arctic Seal and also surveyed the shallower portions of the survey areas. The vessel worked a 24/7 schedule with an endurance of approximately 4-5 days between refueling.</p>	
<i>Dimensions</i>	<i>LOA</i>	5.5
	<i>Beam</i>	1.7
	<i>Max Draft</i>	0.9

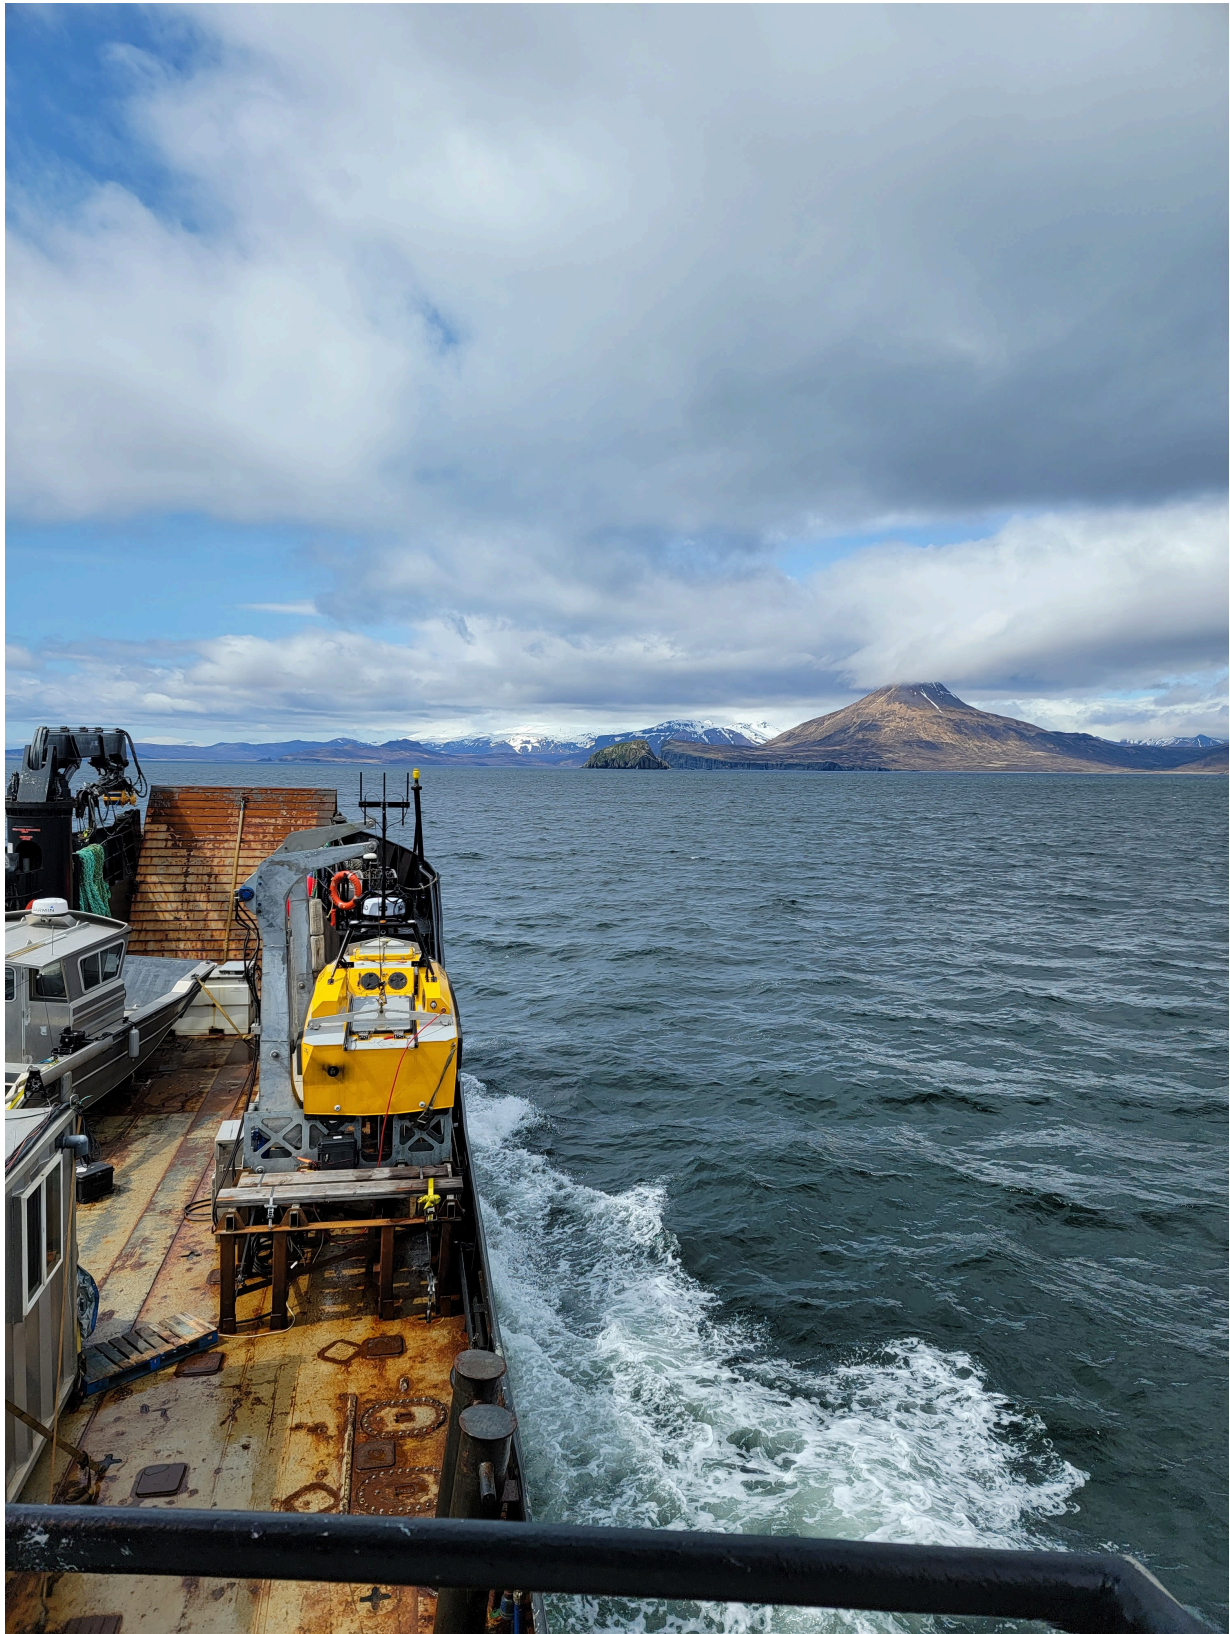
Figure 3: The ASV-CW5 in its launch system on the deck of the Arctic Seal

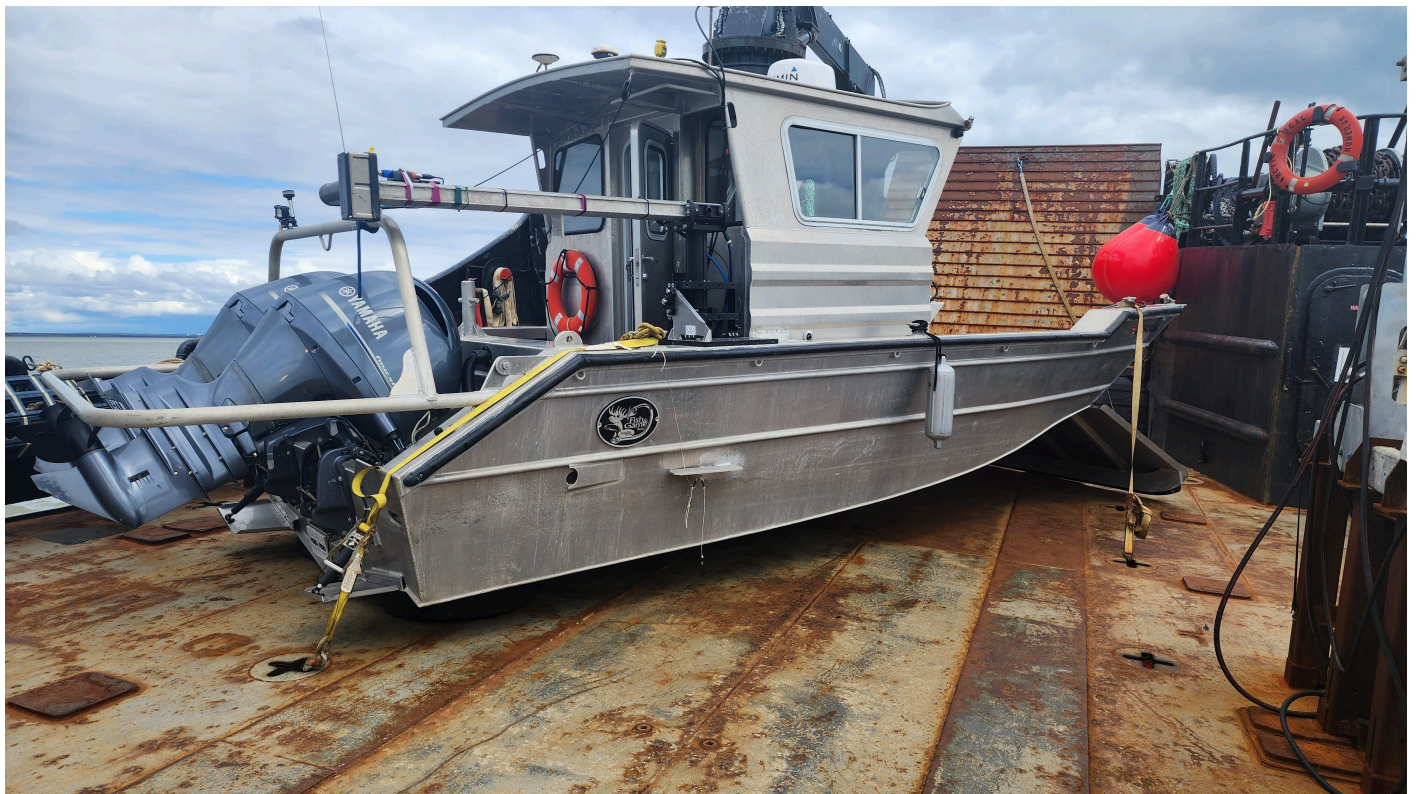
Figure 4: LC-25 on the deck of the Arctic Seal.

<i>Vessel Name</i>	LC-25	
<i>Hull Number</i>	FGA10005D020	
<i>Description</i>	<p>The 26' (7.9 m) aluminum-hulled vessel LC-25 (work skiff owned and operated by Support Vessels of Alaska), was used to acquire MBES data on this project, as well as to perform feature investigations. The vessel was utilized periodically as-needed, primarily to work areas that were inaccessible for the other vessels.</p> <p>The vessel is propelled by two gasoline Yamaha outboards with a combined output of 300 HP. After deployment from the Arctic Seal via crane, it was operated by a crew of one vessel operator and one surveyor. The skiff collected MBES data and sound velocity profiles (via hand deployment) in the shallow areas of H13714 and H13726, and performed MBP investigations in H13718.</p>	
<i>Dimensions</i>	<i>LOA</i>	7.9
	<i>Beam</i>	3
	<i>Max Draft</i>	1
<i>Most Recent Full Offset Verification</i>	<i>Date</i>	2023-06-07

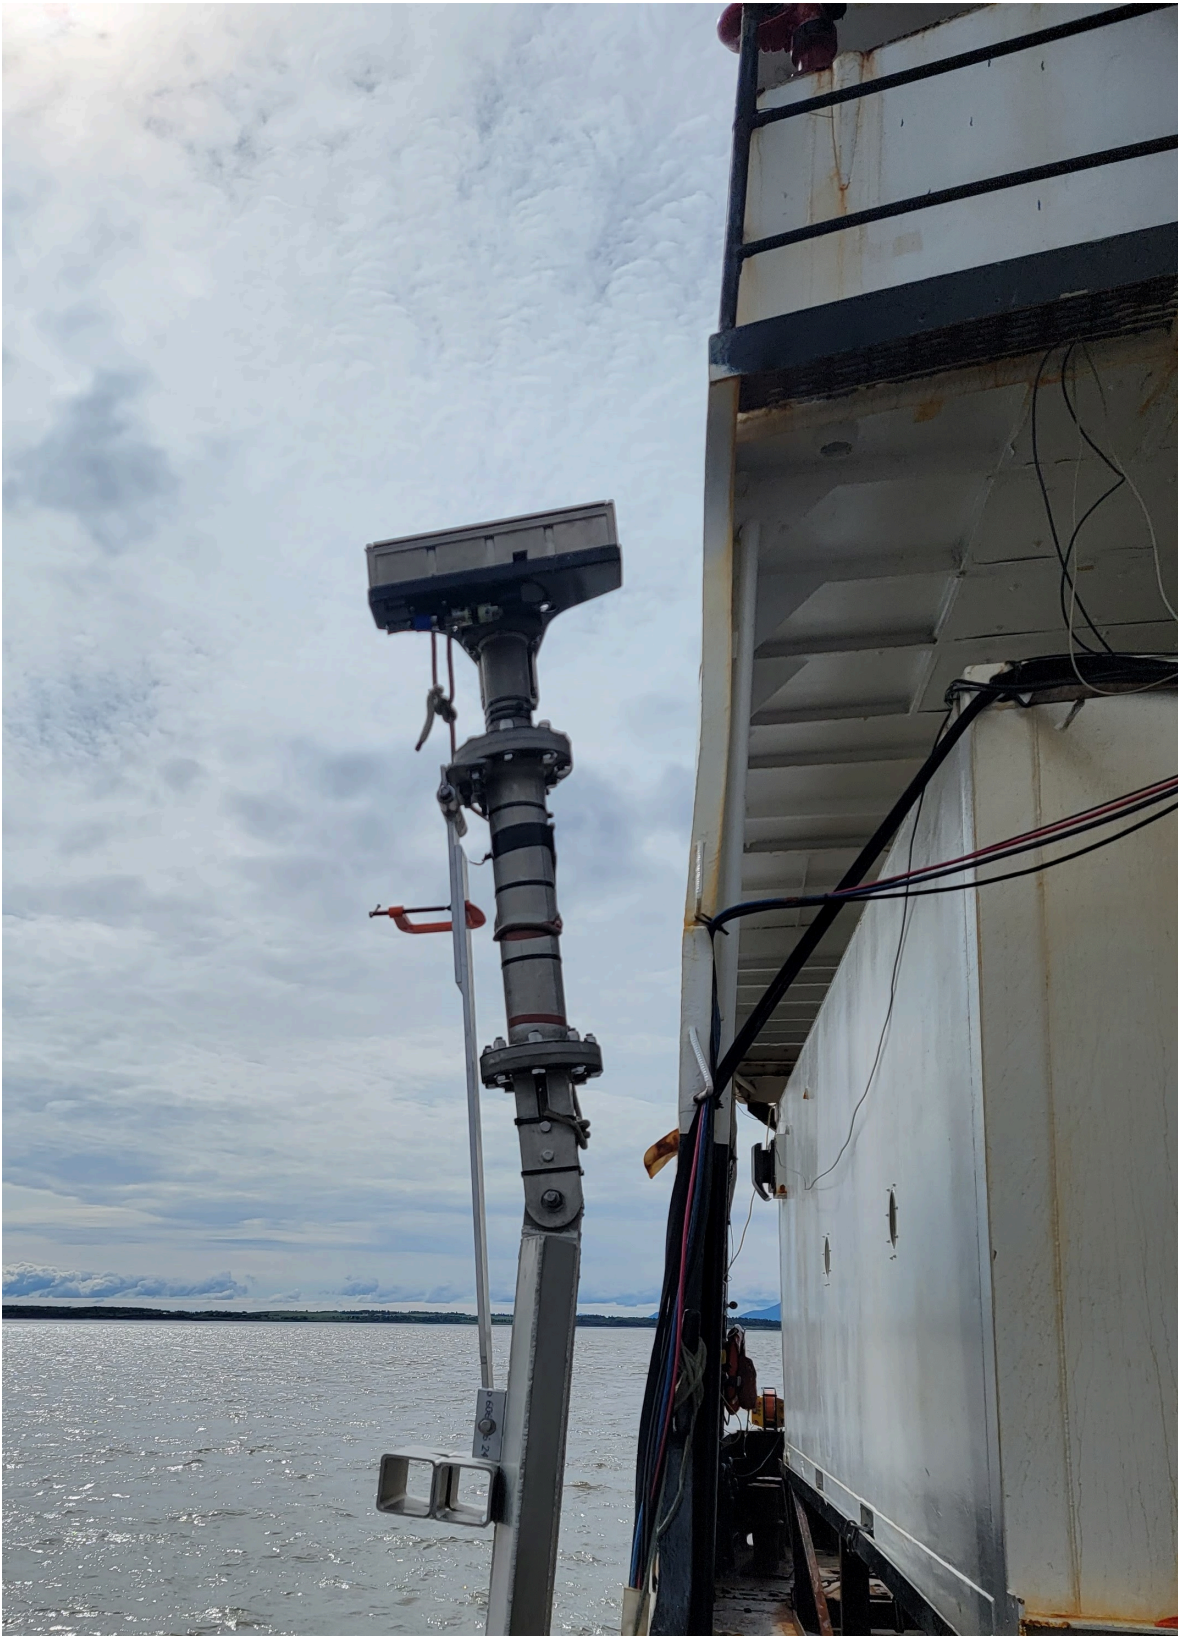
Figure 5: T50-R mounted on the Arctic Seal's Hydraulic Arm.

The Teledyne Reson SeaBat T50-R was used on both the Arctic Seal and ASV-CW5 for multibeam echosounder (MBES) data collection. The T50 platform offers a wide variety of configuration options. Two were utilized on this project: The first, mounted on the Arctic Seal, was the SeaBat T50-R integrated system. This system consisted of a transmit (Tx) array, a receiver (Rx) array, and one topside rackmount processor. On this vessel the wet end components were mounted on a hydraulic arm on the vessel's starboard side, approximately midship.

The MBES arm on the Arctic Seal was designed to be held firmly against the vessel hull by hydraulic pressure. However, it was found that pressure was intermittently being lost or reduced enough that the arm could move away from the hull in some conditions, especially in dynamic sea states with significant port-starboard roll. The hydraulic system was repaired and monitored, but issues remained with the system for the majority of the project.

In addition, a hinged joint on the MBES arm was found to have shifted position on JD178. The hinged joint was addressed on JD181 with installation of a brace on the MBES arm. The brace installation required tilting the Arctic Seal sonar and IMU slightly, calculated to be 8.15 degrees. Note that the 8.15 degree correction was applied to the Arctic Seal POSMV starting on JD188 at 21:55 to bring the POSMV and vessel reference frames into alignment, which also necessitated a 8.15 correction applied in the CARIS HIPS HVF at the same time, as a roll correction.

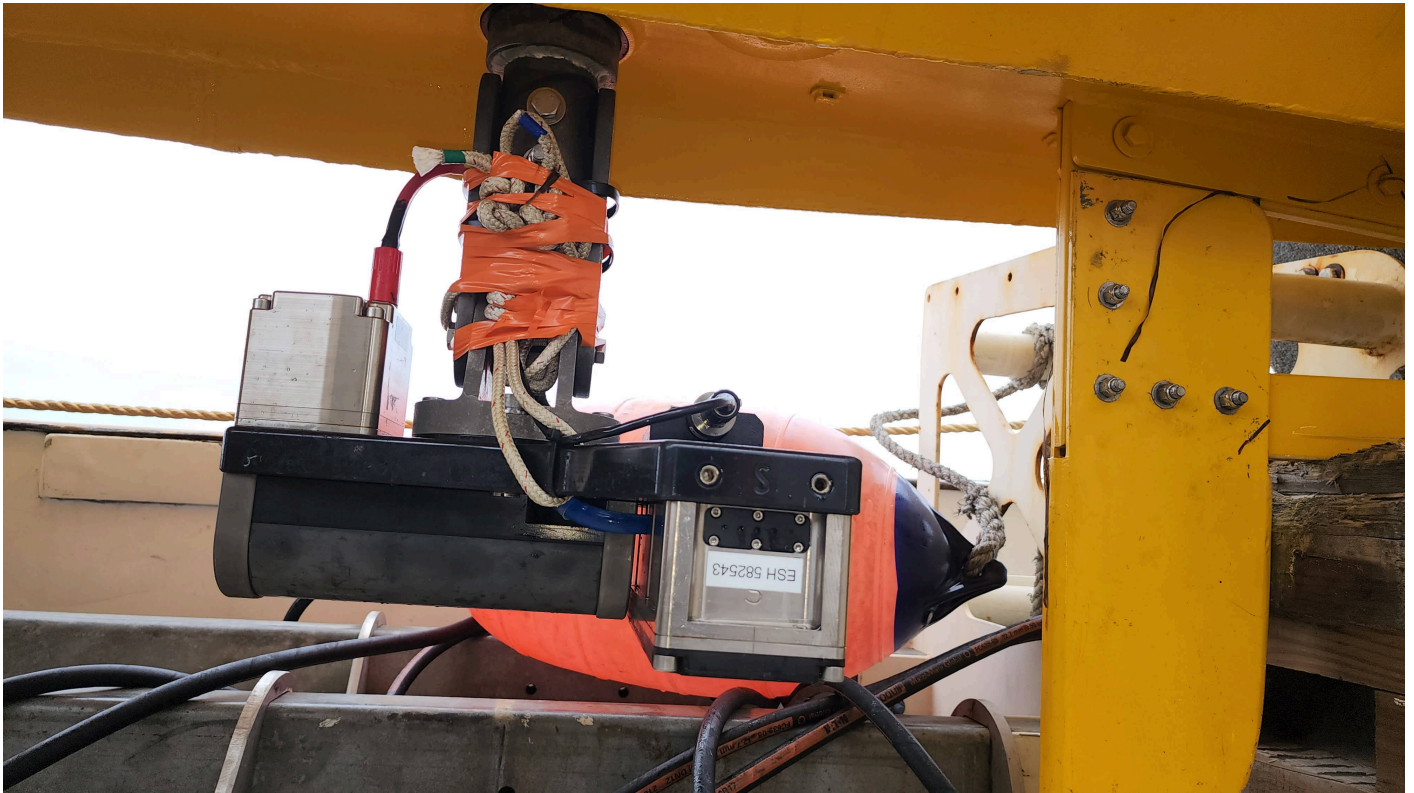
Figure 6: T50-R mounted on the ASV keel.

The second system, consisting of a transmit (Tx) array, receive (Rx) array, and a topside rackmount processor, was used on the ASV-CW5. On this vessel wet-end components were hull-mounted on the vessel's keel, approximately midship. Specifications of the T50-R MBES are as follows:

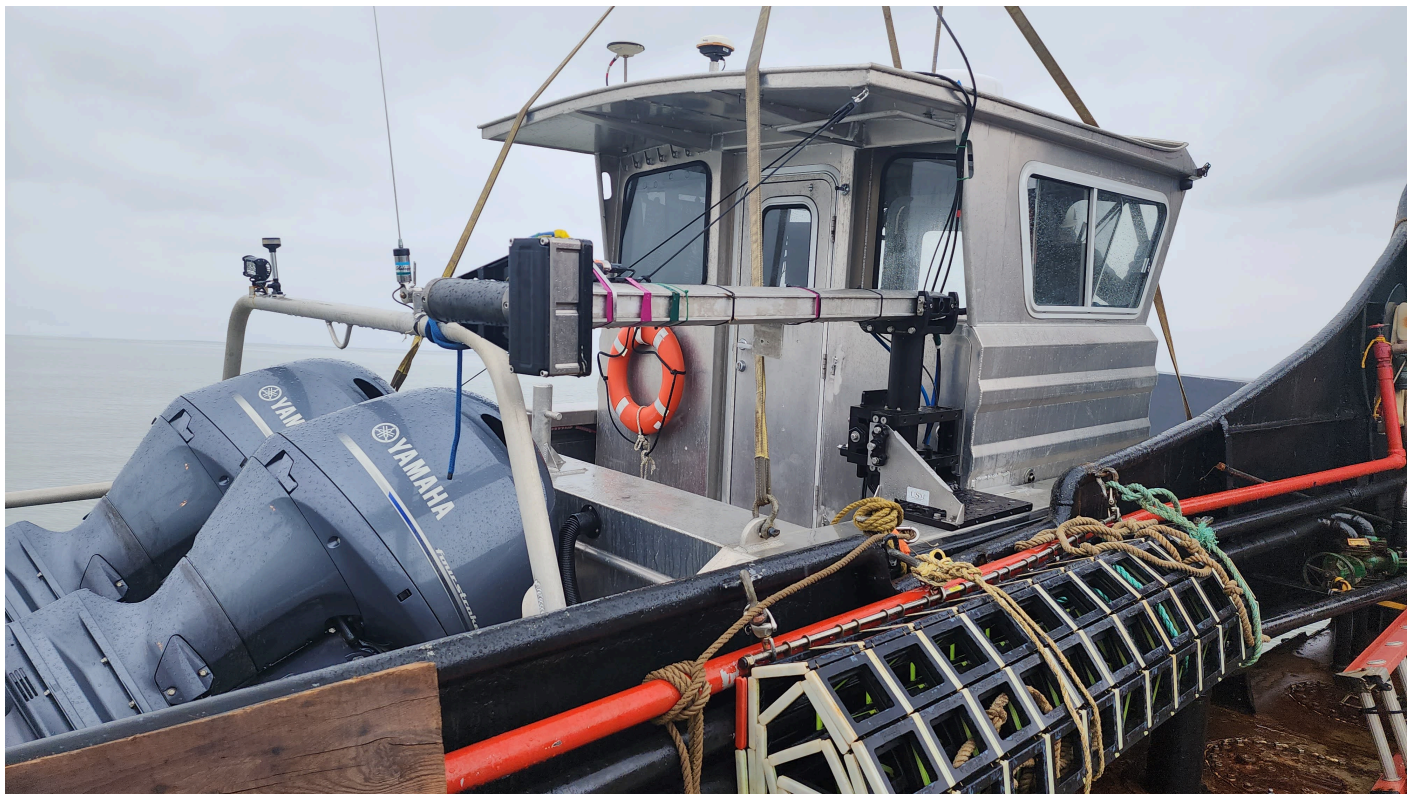
Figure 7: T20-P Mounted on LC-25 swivel pole.

The Teledyne Reson SeaBat T20-P was used on LC-25 for multibeam echosounder (MBES) data collection. The T20 platform offers a wide variety of configuration options. For this project a standalone T20-P system was utilized on the LC25, with a separate positioning system. This system consisted of a transmit (Tx) array, a receiver (Rx) array, and one portable topside processor. On this vessel the wet end components were mounted on a manually actuated arm on the vessel's starboard side, towards the aft quarter of the vessel.

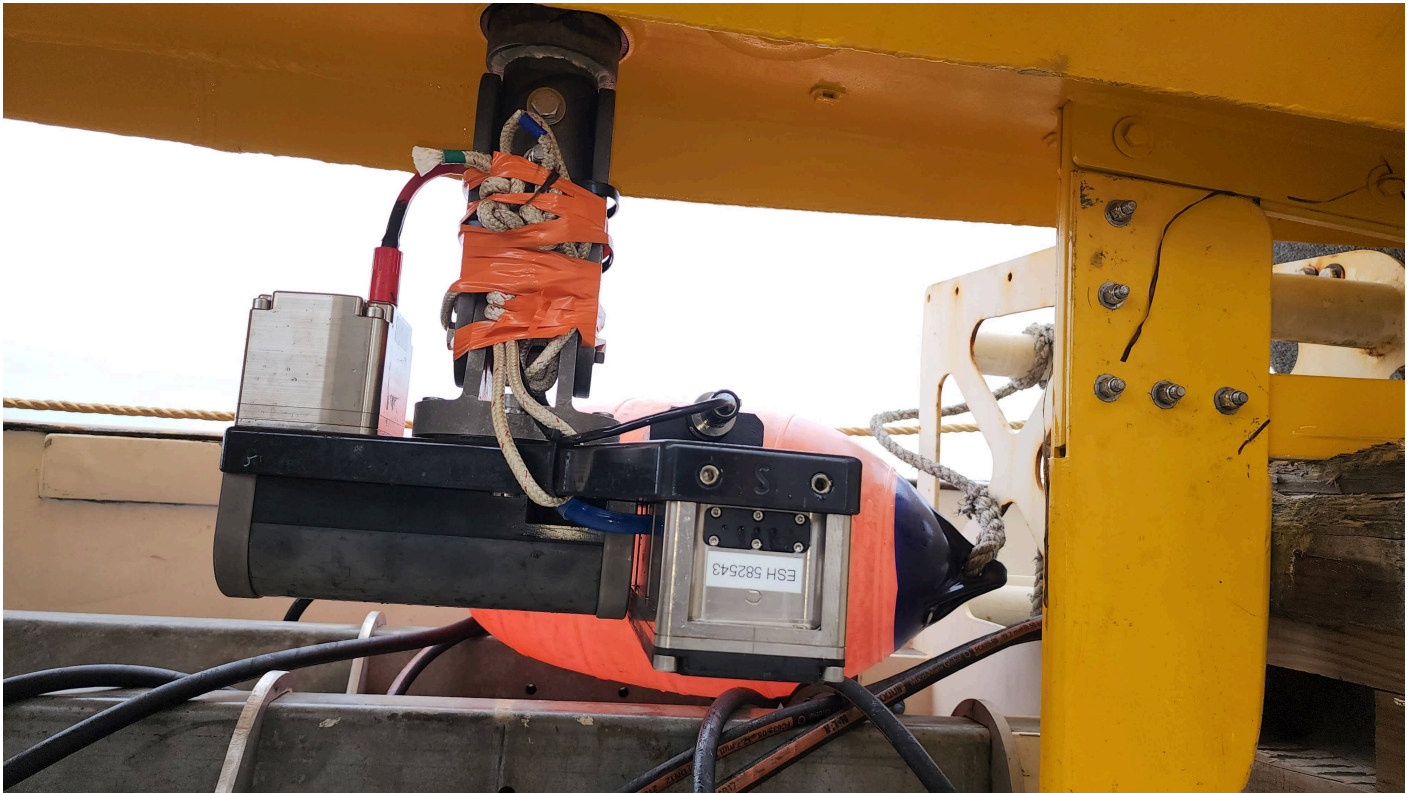
Figure 8: Applanix IMU-30 co-located on the ASV T-50 mounting bracket.

The issue was largely mitigated by the fact that the POSMV IMU was co-located with the sonar and moved to the same degree as the sonar, therefore measuring the motion. However, the motion still resulted in lever arm errors due to the IMU shifting position relative to the POSMV reference frame.

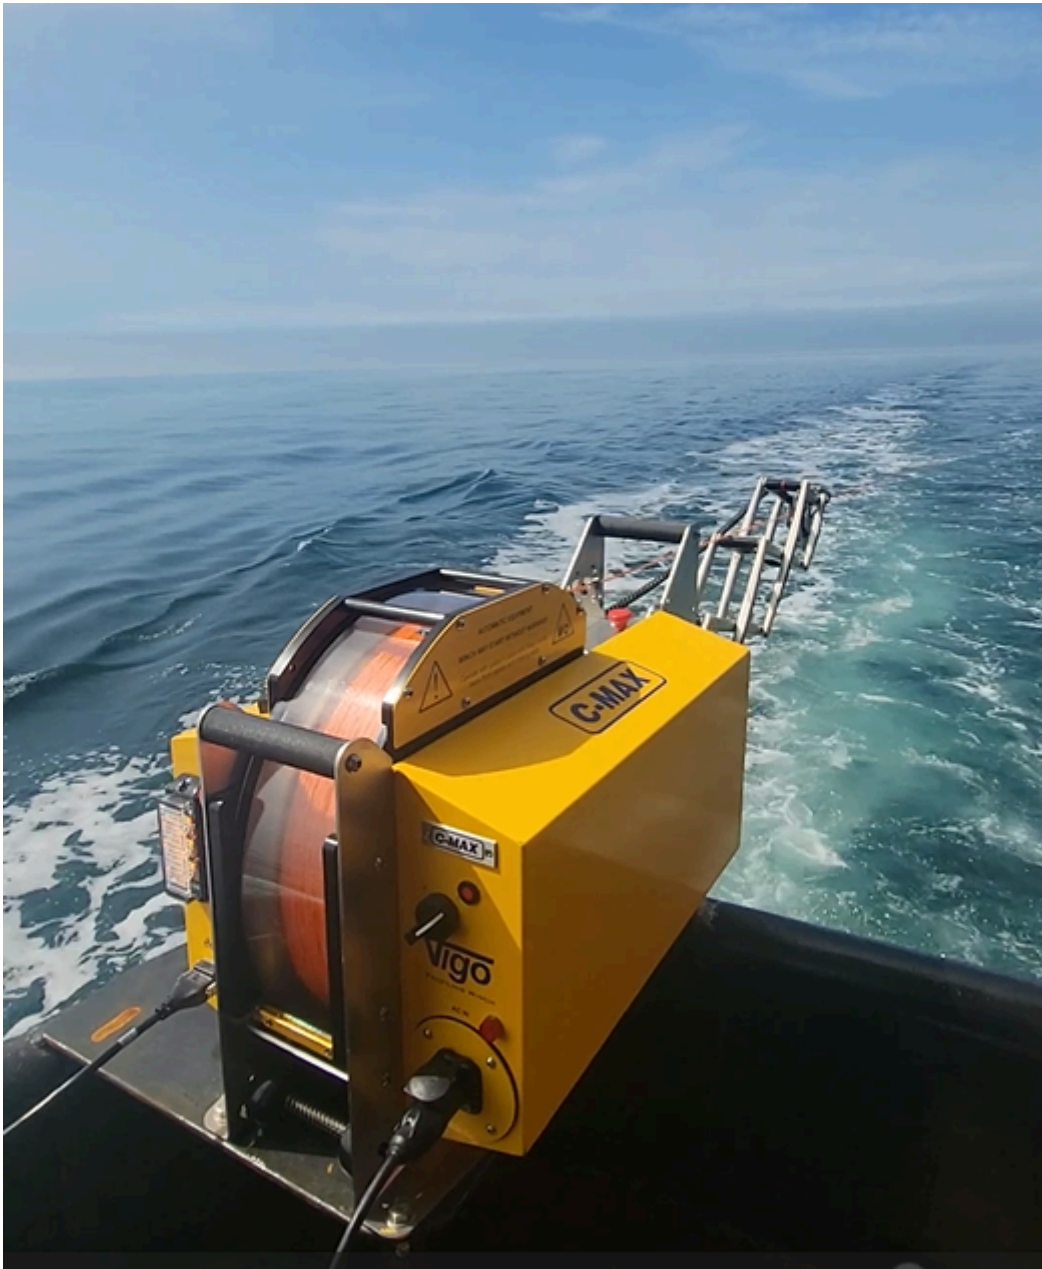
Figure 9: Vigo Winch mounted on the Arctic Seal starboard stern.

<i>Manufacturer</i>	C-MAX		
<i>Model</i>	Vigo Winch		
<i>Inventory</i>	594237	<i>Component</i>	Sound Speed Deployment Winch
		<i>Model Number</i>	Vigo
		<i>Serial Number</i>	0017
		<i>Calibration</i>	N/A

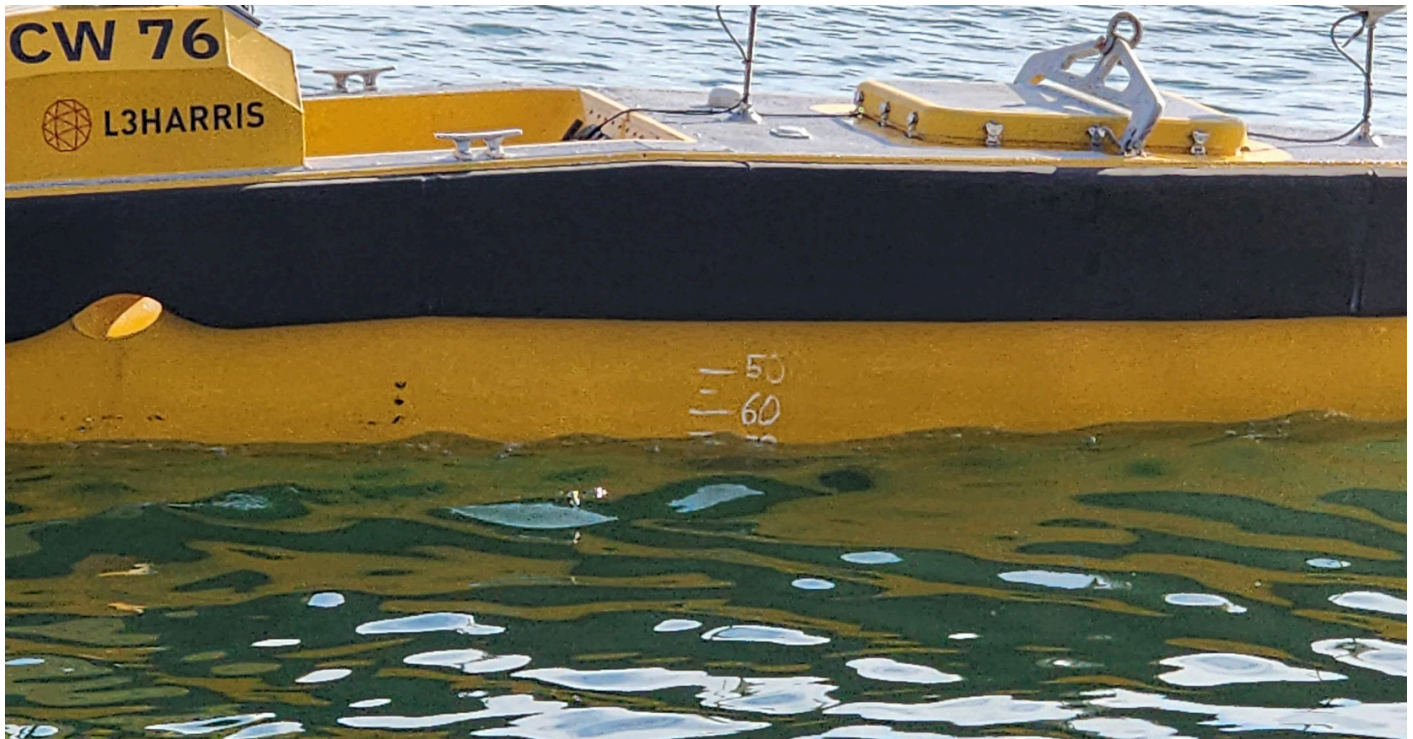
Figure 10: Static Draft marks on the ASV-CW5.

On the ASV-CW5, the static draft was recorded in the following manner: Draft markings on the vessel's starboard side were visually examined when the vessel was alongside the Arctic Seal, and the value at their intersection with the water was noted. The draft marks represented the vertical distance from the MD point, which was the vessel's deck directly above the CRP.

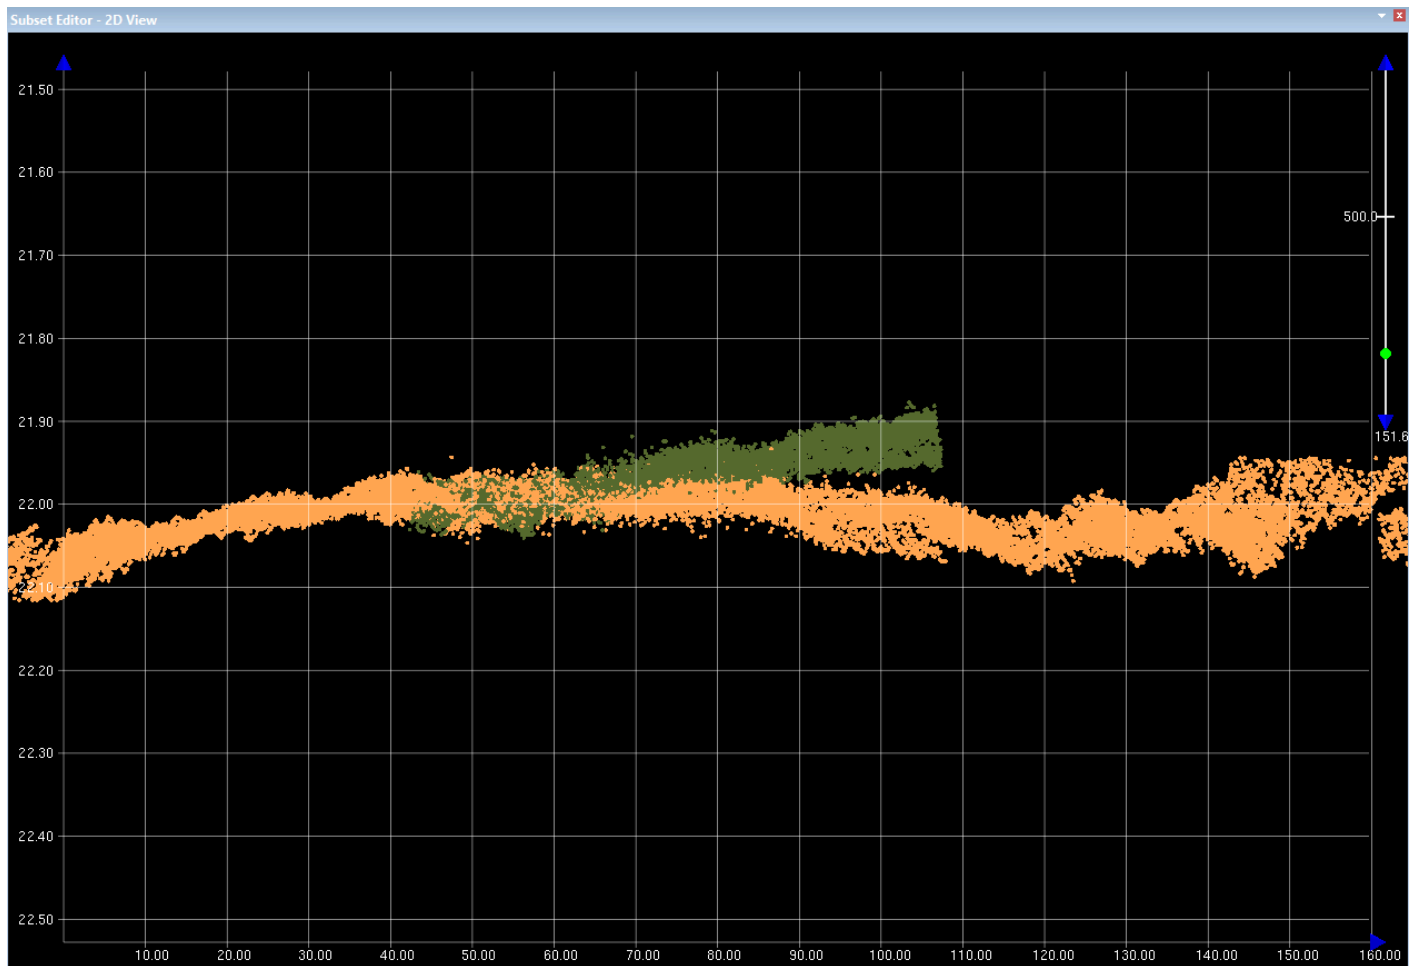
Figure 11: Residual roll bias error in final data following corrections for movement in the Arctic Seal MBES arm; the dark green line shows a slight roll bias from intersecting crossline data.

Still, a roll bias was intermittently induced in collected data. This is visible as a roll offset or angular tilt at some crossline intersections, as shown in the image below. To mitigate the issue roll corrections were determined by a day-by-day analysis of Arctic Seal mainscheme at crossline intersections, and systematically applied in the HVF as a roll correction to Transducer 1 in the range of 0 to 0.30 degrees. The fix significantly reduced the effect of the shifts in the MBES arm. In addition, all Arctic Seal MBES data was filtered at 55 degrees, which removed outer beams most subject to the error. Where the issue is present, these measures reduced the impact on final surfaces to 0.20 m or better.

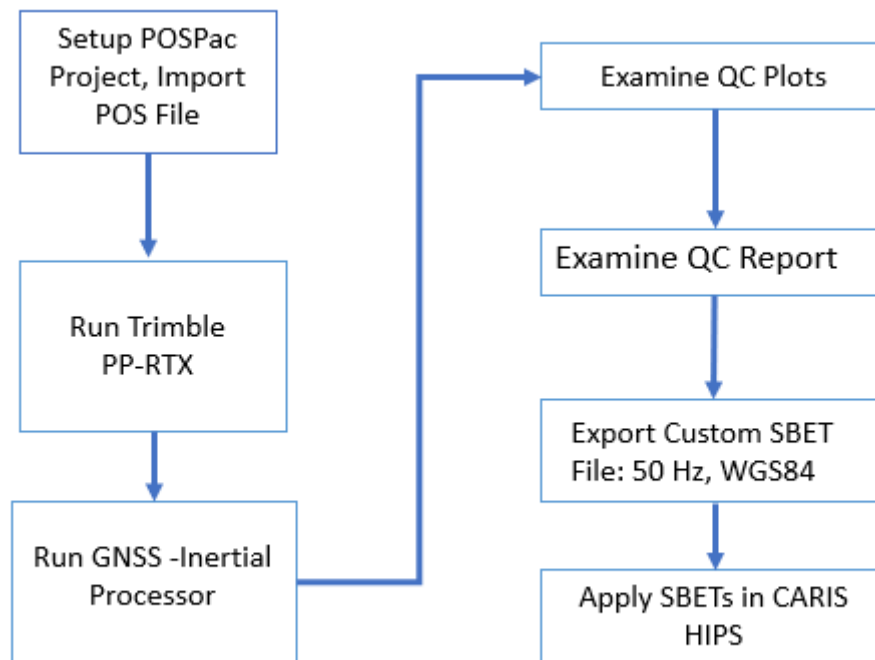
Figure 13: Generalized POSPac processing procedure.
