DESCRIPTIVE REPORT

Type of Survey Hydrographic Survey

Registry No. D00146

General Locality West of Prince Wales Island

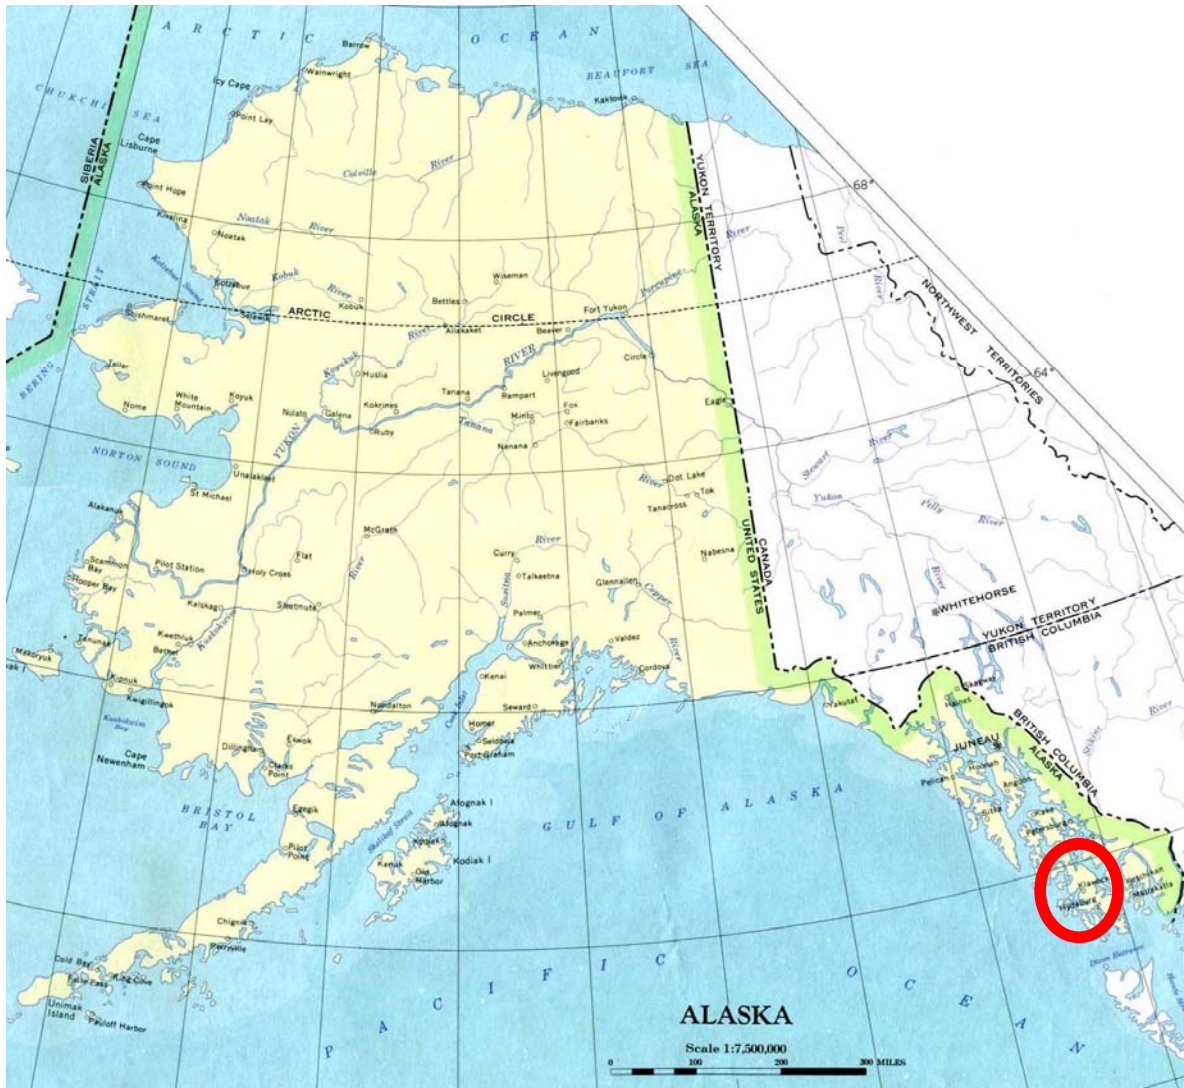
Figure 1 – General Locality of OPR-O190-KRL-08

Survey operations covered seven registered sheets over the OPR-O190-KRL-08 project area, West of Prince of Wales Island, AK (see Figure 1 and Figure 2).
