DESCRIPTIVE REPORT.

HYDROGRAPHY

SAN JUAN CHANNEL,

SOUTHERN ENTRANCE,

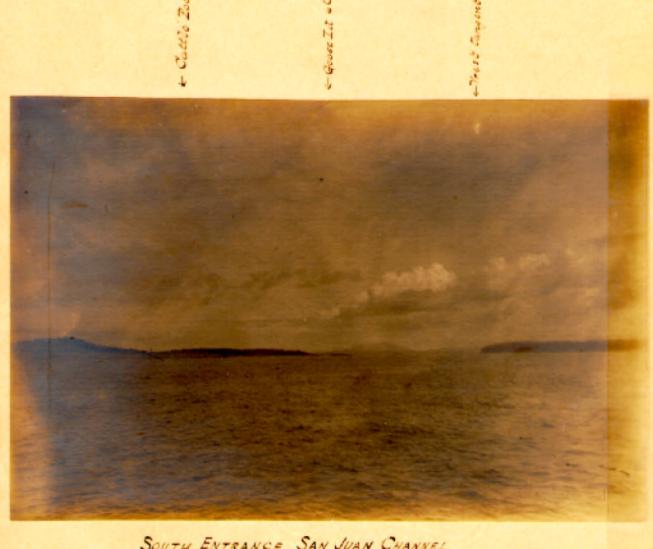
SOUTH ENTRANCE, SAN JUAN CHANNEL, looking North through "Pass"

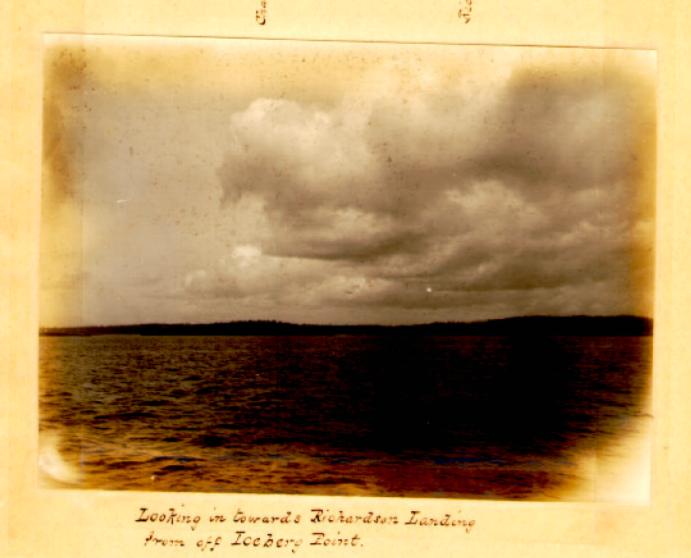
SOUTH ENTRANCE, SAN JUAN CHANNEL, looking South through the Zass

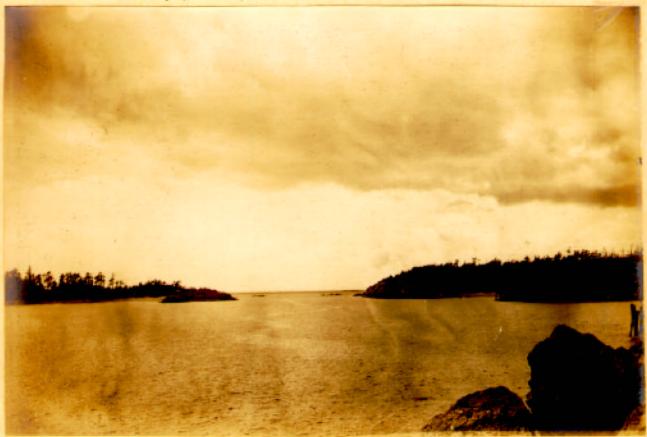
Looking West through Pearson Channel from off Bichardson Landing
