DESCRIPTIVE REPORT

LOSTMANS RIVER AND VICINITY

HYDROGRAPHIC TITLE SHEET

HYDROGRAPHIC SHEET #~~F4453~~ 5066
(LOSTMANS RIVER)

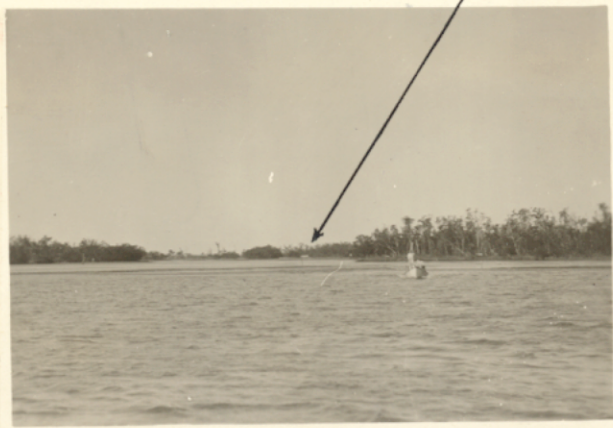
CHANNEL MARKER

hydrographic boat sheets furnished the party were found to be slightly out of position in Lostmans first bay. This is corrected on the smooth sheet. Channel markers placed by local guides mark the passage through the bars and the location of these mark the edge of the reefs. These markers are not permanent.

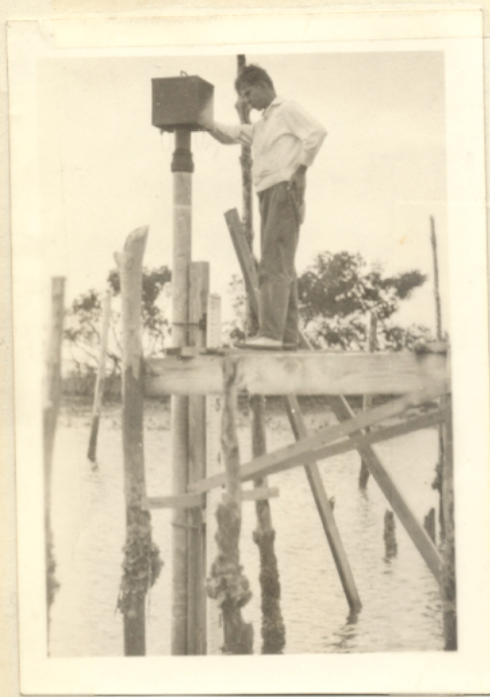
TIDE GAUGE LOSTMAN RIVER

A portable automatic tide gauge was maintained at Lostmans River entrance, Lat. 25 33.06 Long. 81 12.82 and another at Onion Key Lat. 25 36.7 Long. 81 08.02. At Lostmans entrance three bench marks were established and levels run at the beginning and end of the observations. At Onion Key the station mark and reference marks were used for bench marks. Comparisons were made with the standard gauge at Everglades.

The Lostmans River entrance gauge was installed on February 5 and taken up on February 25. The observations were not continuous as considerable difficulty was experienced with the tension spring in the gauge. One stretch of 230 hours is continuous. At Onion Key 243 continuous hours were recorded. The range here was about one foot. M.L.W. on the staff was 2.95.

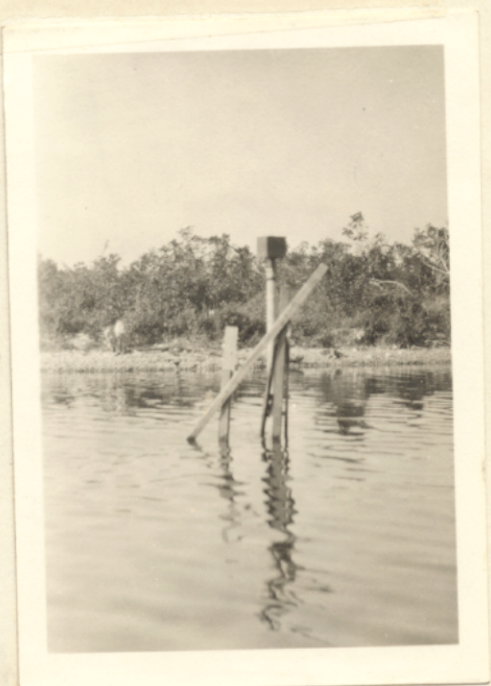
TIDE GAUGE ONION KEY
