DESCRIPTIVE REPORT

Registry No. H10960

General Locality San Francisco Bay

**Descriptive Report to Accompany Hydrographic Surveys¹
H10960, H10961 and H10962**

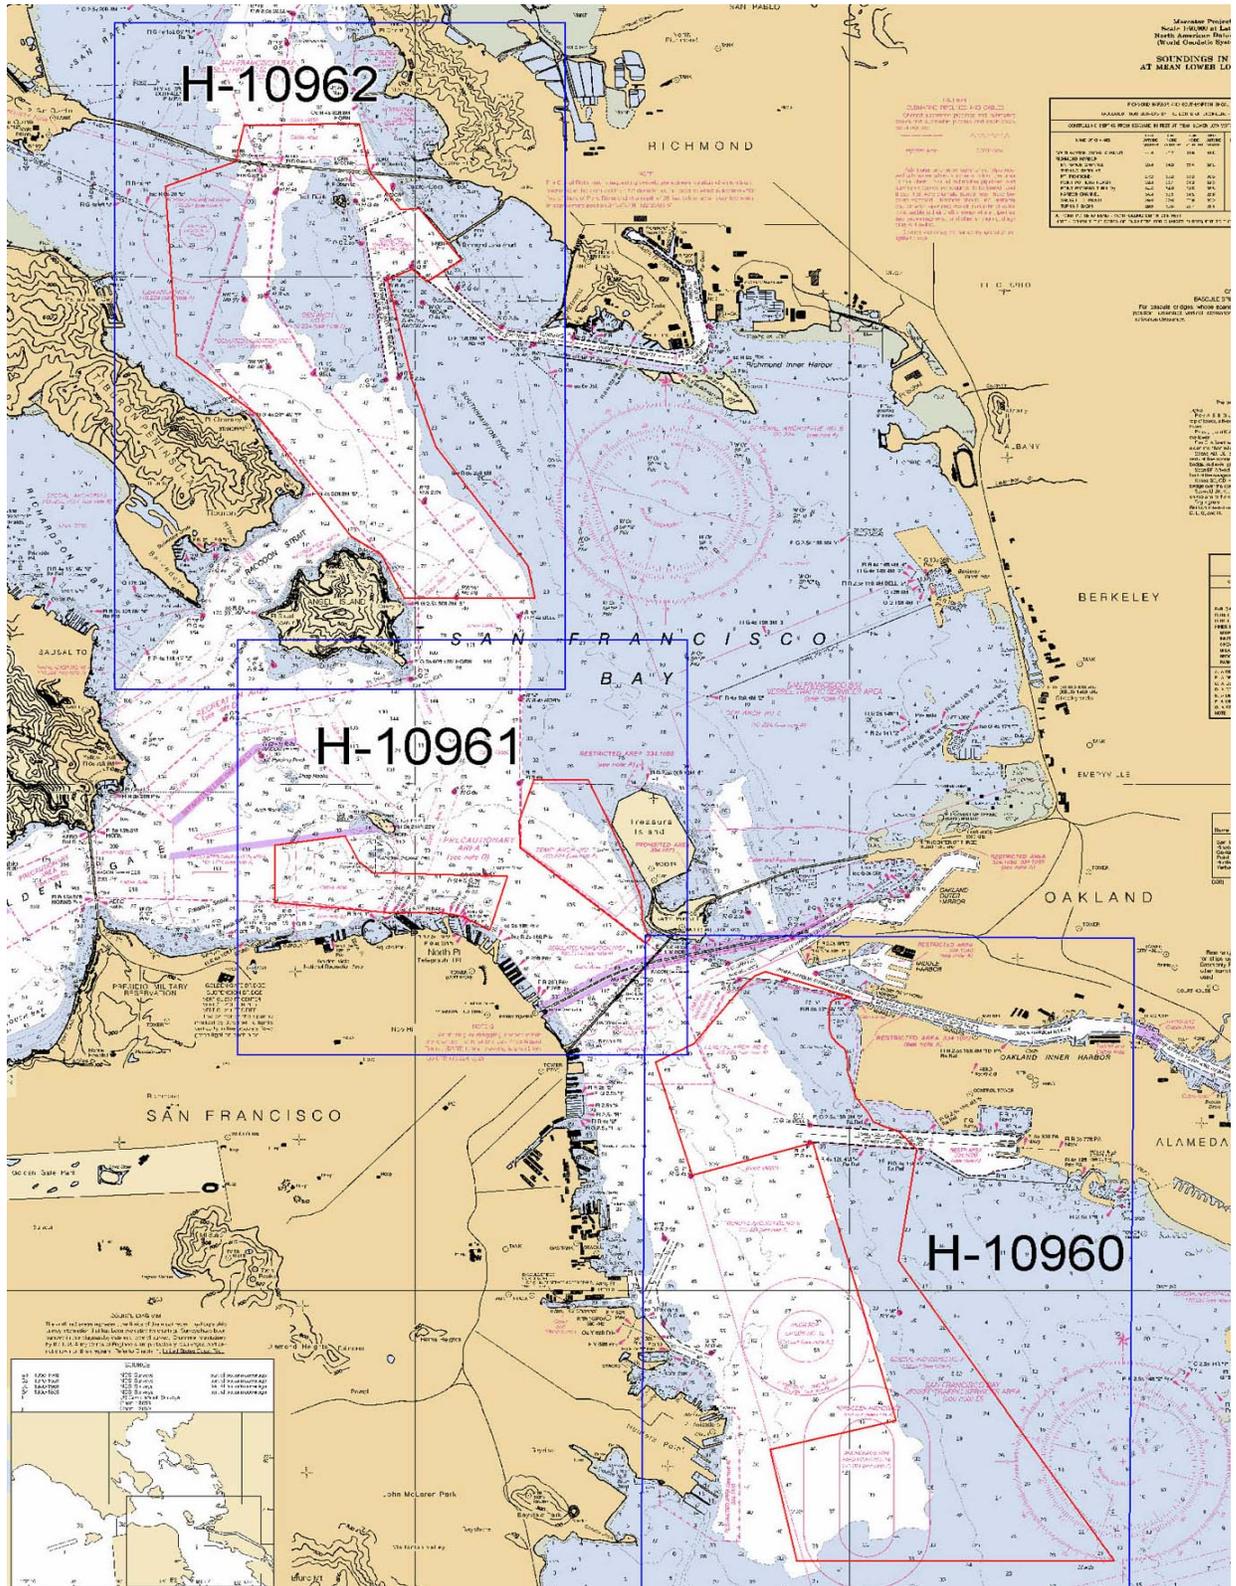
STUDY AREA FOR SHEETS H10960, H10961, AND H10962, SAN FRANCISCO BAY, CALIFORNIA (NOAA CHART NO. 18649)

The chartlet on the following page shows the survey limits and sheet layout.

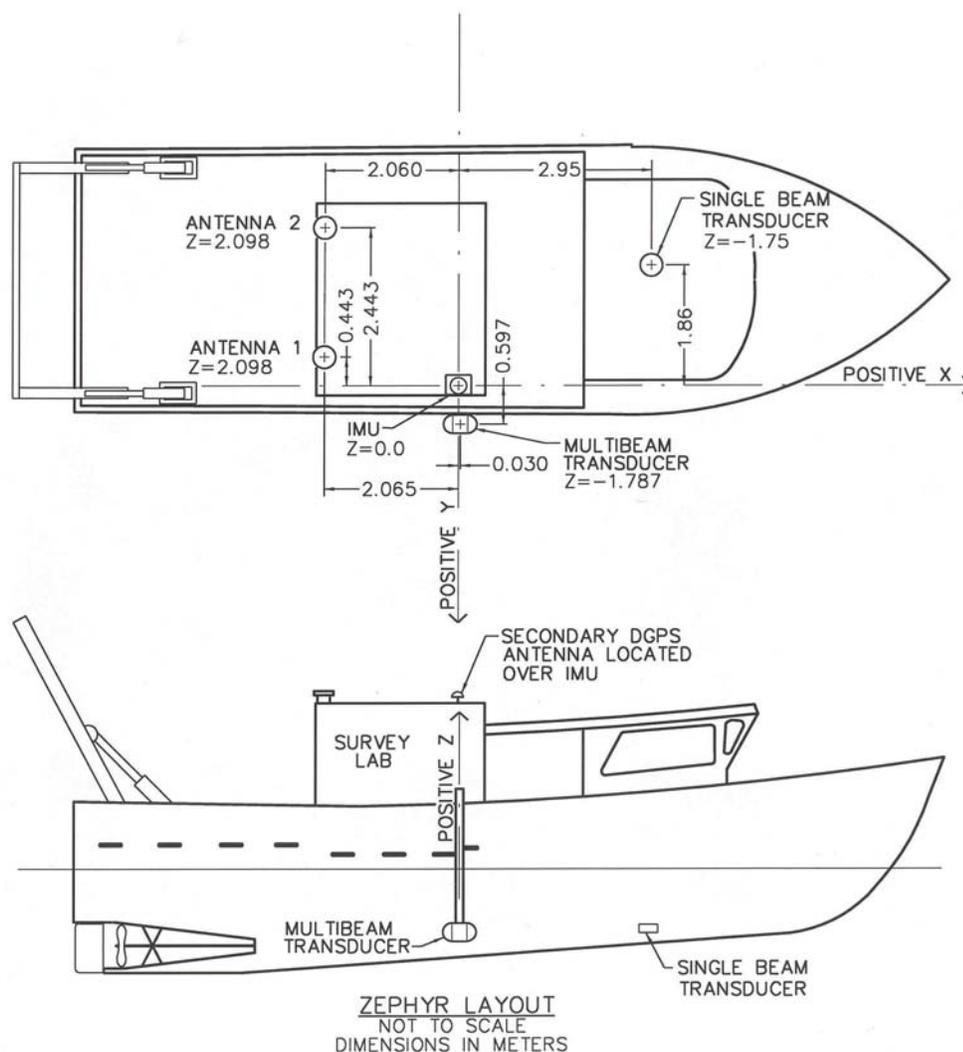
SENSOR LAYOUT ON THE R/V ZEPHYR

All sensor offsets were measured from the inertial motion unit (IMU) located inside the acquisition lab on the starboard side, close to the multibeam sensor. Offsets were applied to the data during acquisition, and no changes occurred throughout the survey period. A schematic of the vessel and sensor set-up is shown on the following page.

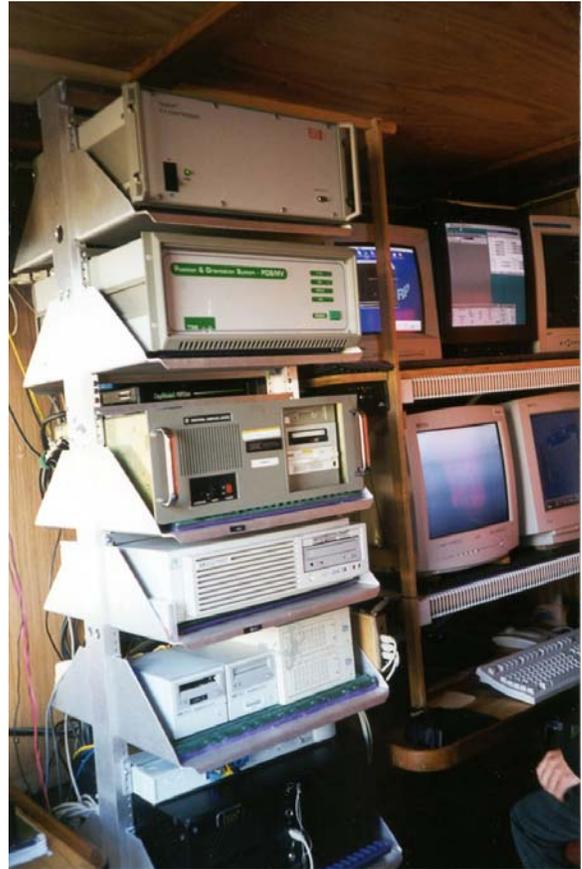
DATA ACQUISITION LAB ABOARD THE ZEPHYR

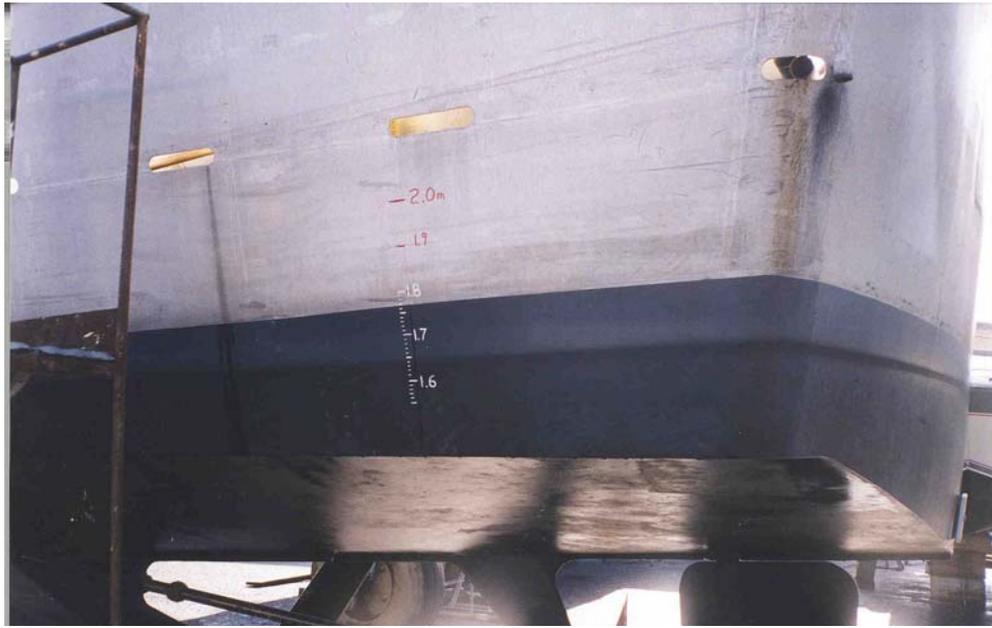
R/V ZEPHYR DRAFT MARKS

With the vessel out of the water, markings were placed on the aft quarters and the forward section of the hull, providing a means to monitor vessel draft. Static draft readings were recorded at the start of each survey day. Changes to vessel loads were kept at a minimum during the survey, resulting in small changes to both the vessel and transducer drafts. The multibeam mount was marked to provide a visual reading of the static draft of the transducer below the water line. Using the TSS POS/MV to monitor vessel roll, draft readings were observed only when roll was less than 0.2 degrees. The draft of the Reson multibeam sonar ranged from 0.96 to 0.98 meters throughout the survey. Markings along the port side of the vessel, in line with the Odom transducer, indicated the draft of the single beam sensor. With the vessel alongside the pier and a roll angle of less than 0.2 degrees, the draft of the transducer was recorded. The draft of the Odom single beam transducer ranged from 0.64 to 0.66 meters throughout the survey.

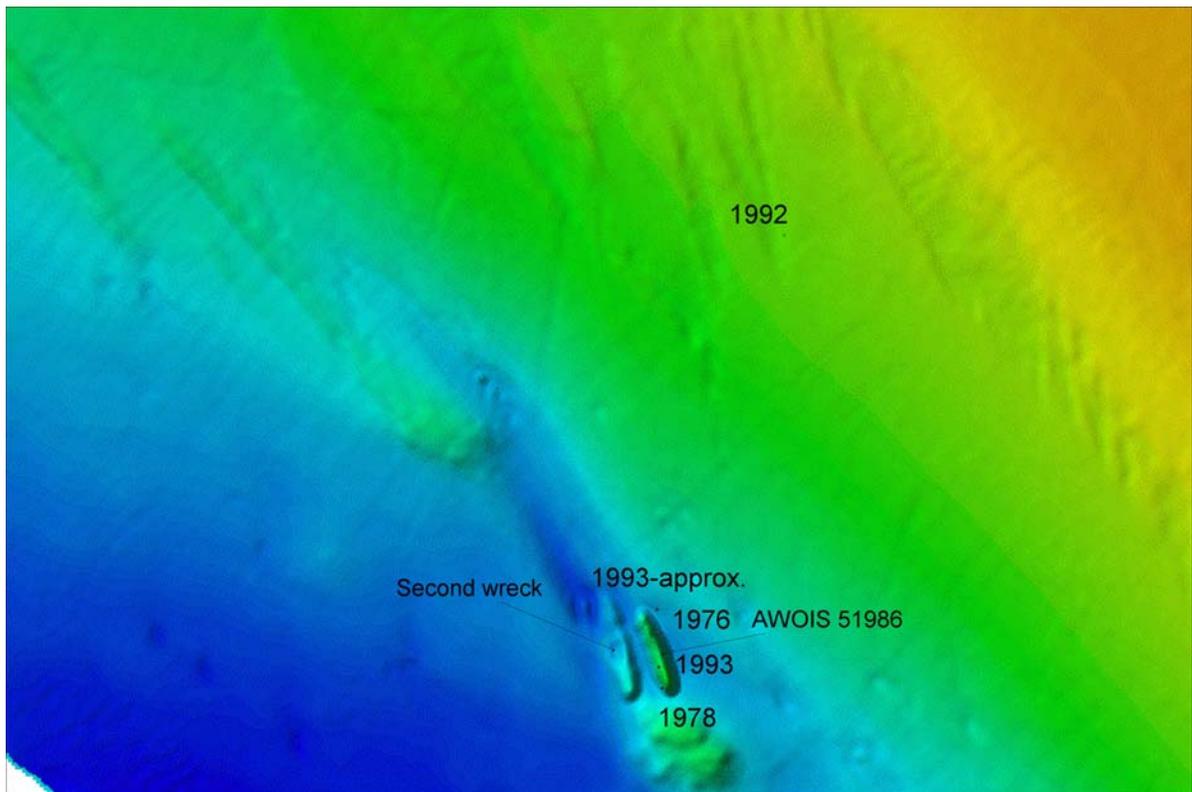
HISTORY OF AWOIS ITEM #51986

AWOIS 51986 was located during survey operations, in the vicinity of the charted Wreck 800 meters west of Treasure Island. This wreck was found at position 37 48 57.663 N, 122 22 56.707 W with a least depth of 69.4 feet. This position is 15 meters southeast of the reported location in the AWOIS database. The depth in the database was reported as 69.2 feet in 1976 and 75 feet in 1993. It is recommended that the depth of the wreck be revised to 69 feet. A second wreck, which was originally discovered in 1993, was located approximately 10 meters west of the AWOIS item. The wreck was found at position 37 48 57.543 N, 122 22 57.743 W with a least depth of 81.5 feet. It is recommended that the second wreck be added to the AWOIS database.

Following is a hill shaded model of multibeam data from this survey, illustrating the orientation of the wrecks, and the history of AWOIS positions for AWOIS 51986.

Two wrecks were observed in the vicinity of the charted wreck on the southwestern section of the survey area. The area containing these wrecks corresponds to AWOIS item 51986 and is included in Section M. A least depth of 69 feet was found on this item.

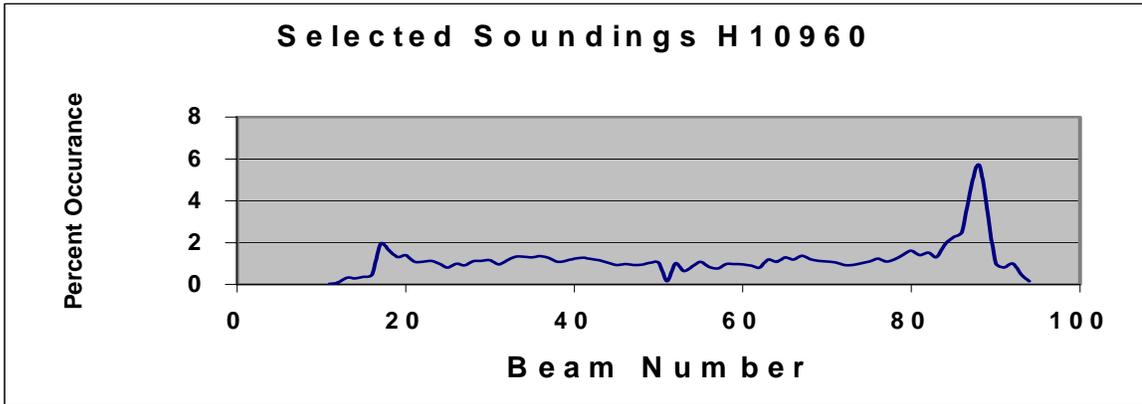
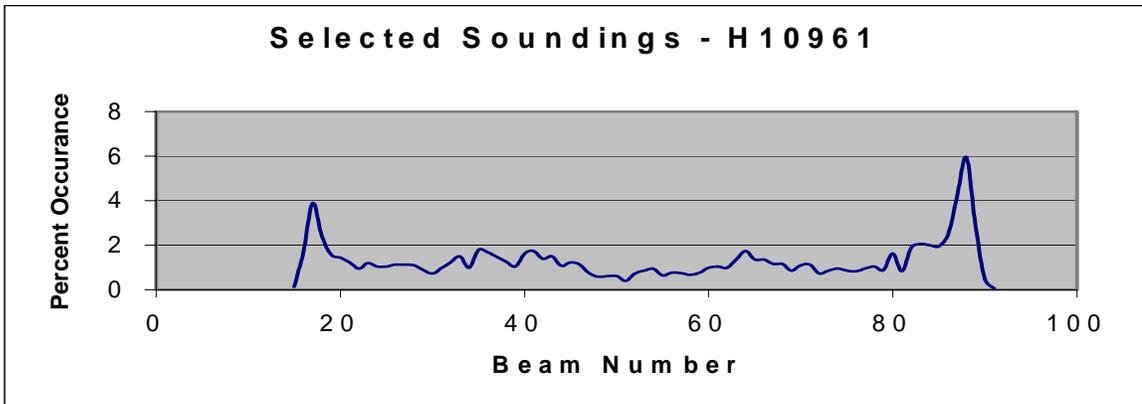
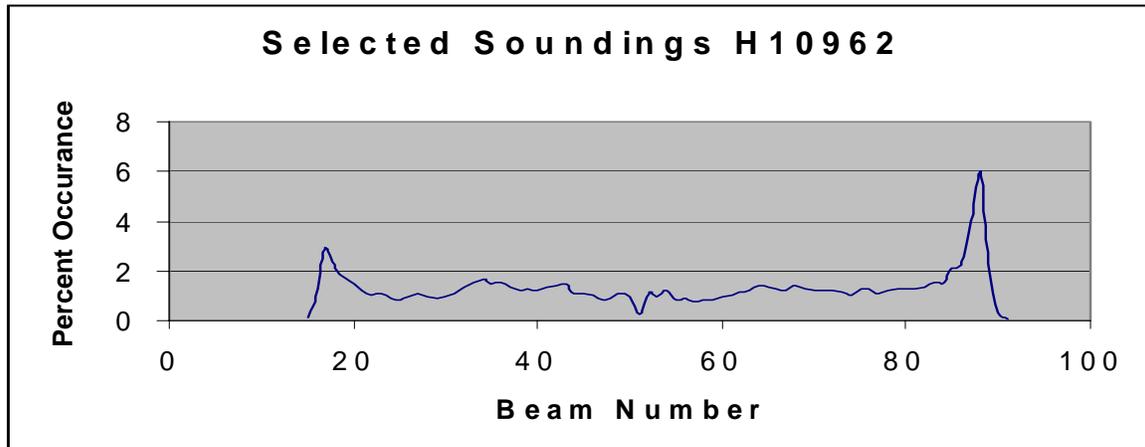
A histogram of all selected soundings was made and is plotted below. The graph represents the number of times each beam is used as a selected sounding. The selected sounding process was a shoal-biased selection, based on a 10-meter bin selection and exported through a Caris overplot

A high incidence of outer beams was selected in the sounding routine and investigated to determine if a systematic bias was introduced into the data. No single source was found. The selected data can be attributed to a number of factors; the primary reason is due to the nature of a multibeam system with outer beams having a lower incident angle. This may result in shoaler depths when comparing outer beams to near nadir beams.
