DESCRIPTIVE REPORT

Type of Survey Hydrographic

Registry No. H10962

State CaliforniaGeneral Locality San Francisco BaySublocality Angel Island to RichmondScale 1:10,000Date of Survey 03/10/2000-08/13/2000Instructions Date 10/1/1998 *Project No. OPR-L304-KR-00

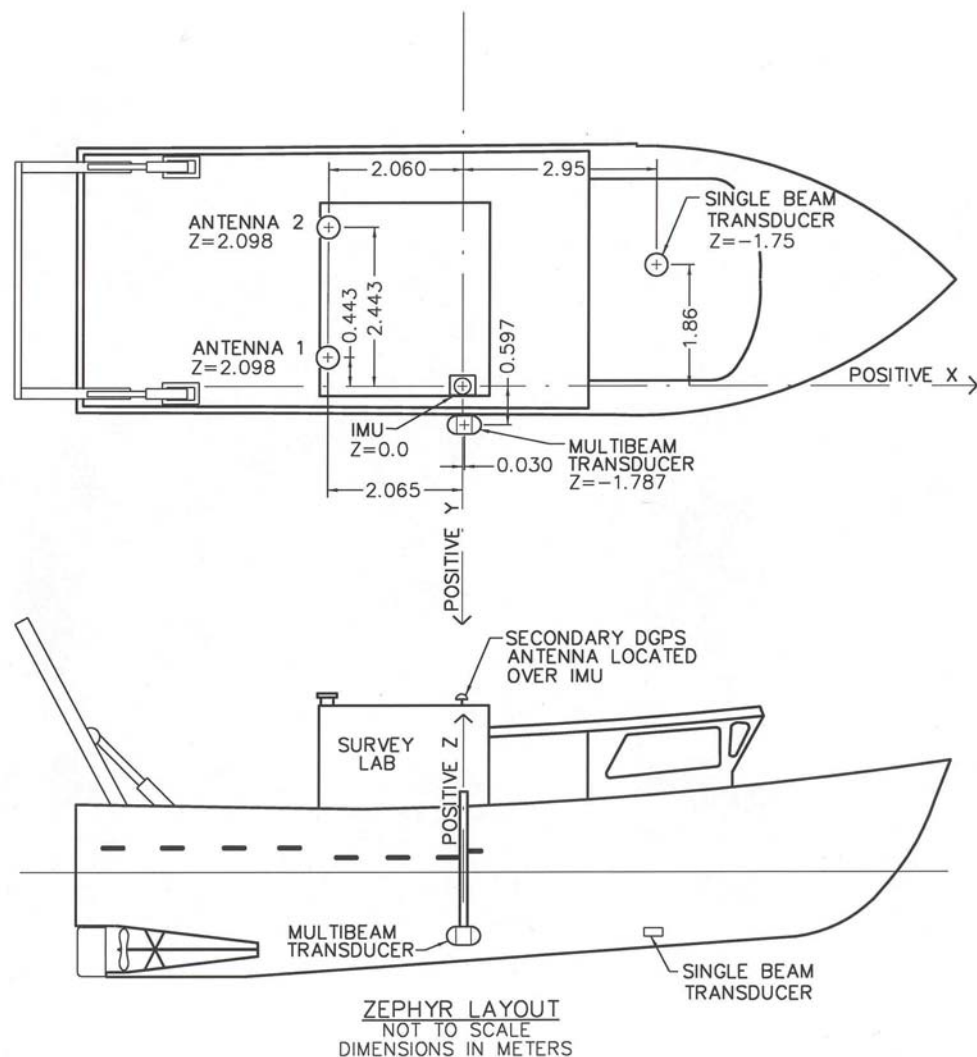
All sensor offsets were measured from the inertial motion unit (IMU) located inside the acquisition lab on the starboard side, close to the multibeam sensor. Offsets were applied to the data during acquisition, and no changes occurred throughout the survey period. A schematic of the vessel and sensor set-up is shown on the following page.

SENSOR LAYOUT ON THE R/V ZEPHYR

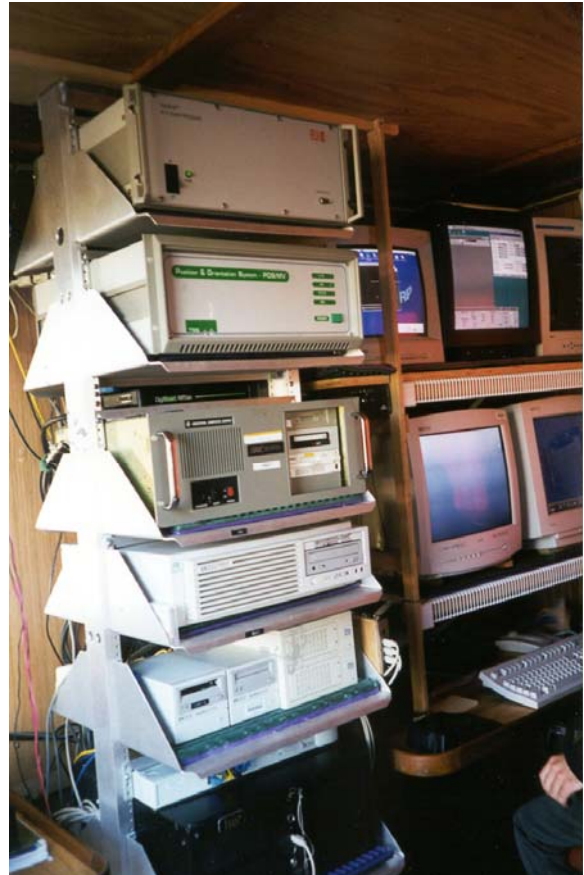
**DATA ACQUISITION LAB ABOARD THE
ZEPHYR**

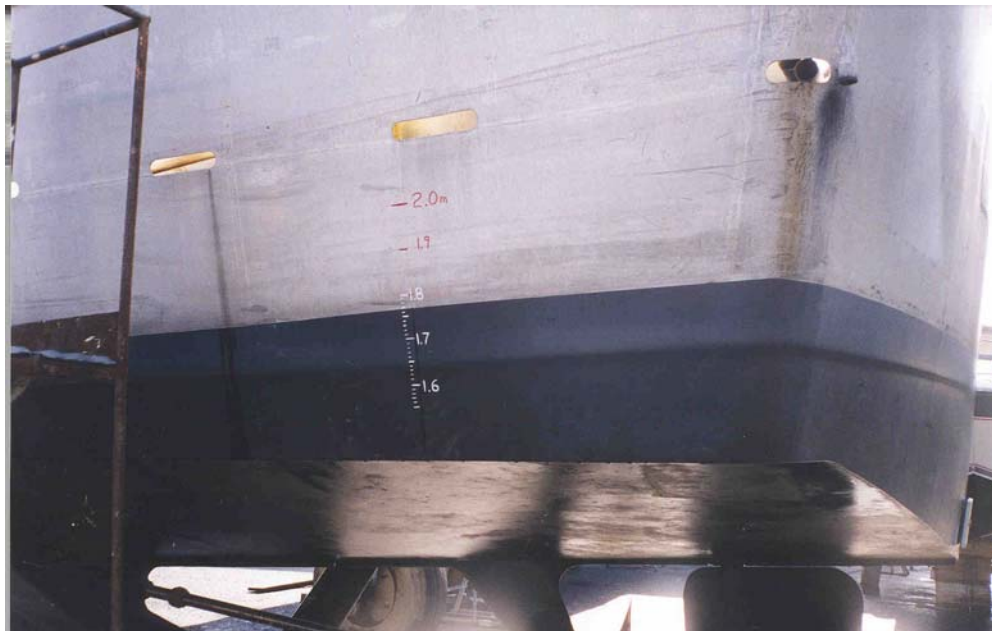
With the vessel out of the water, markings were placed on the aft quarters and the forward section of the hull, providing a means to monitor vessel draft. Static draft readings were recorded at the start of each survey day. Changes to vessel loads were kept at a minimum during the survey, resulting in small changes to both the vessel and transducer drafts. The multibeam mount was marked to provide a visual reading of the static draft of the transducer below the water line. Using the TSS POS/MV to monitor vessel roll, draft readings were observed only when roll was less than 0.2 degrees. The draft of the Reson multibeam sonar ranged from 0.96 to 0.98 meters throughout the survey. Markings along the port side of the vessel, in line with the Odom transducer, indicated the draft of the single beam sensor. With the vessel alongside the pier and a roll angle of less than 0.2 degrees, the draft of the transducer was recorded. The draft of the Odom single beam transducer ranged from 0.64 to 0.66 meters throughout the survey.

R/V ZEPHYR DRAFT MARKS

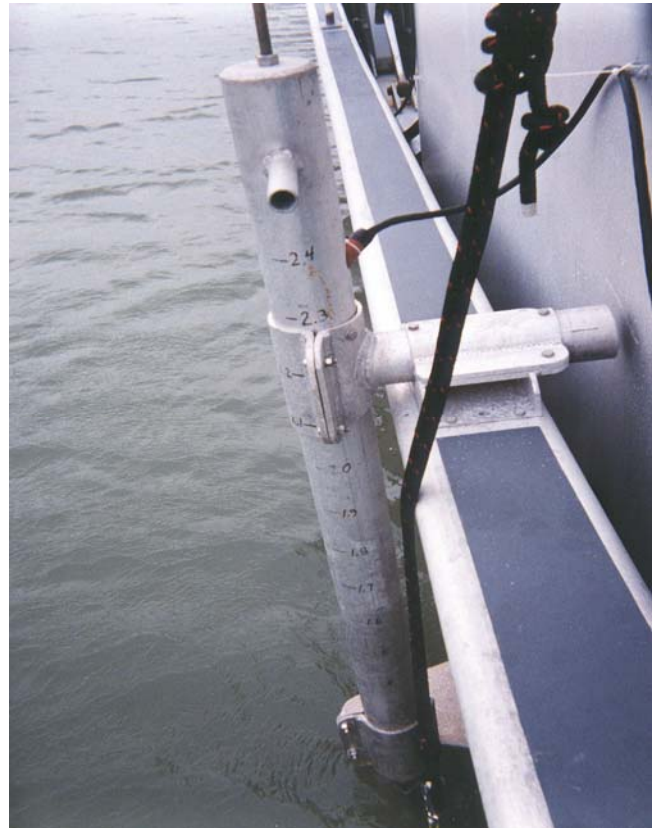
MULTIBEAM MOUNT WITH DRAFT MARKS

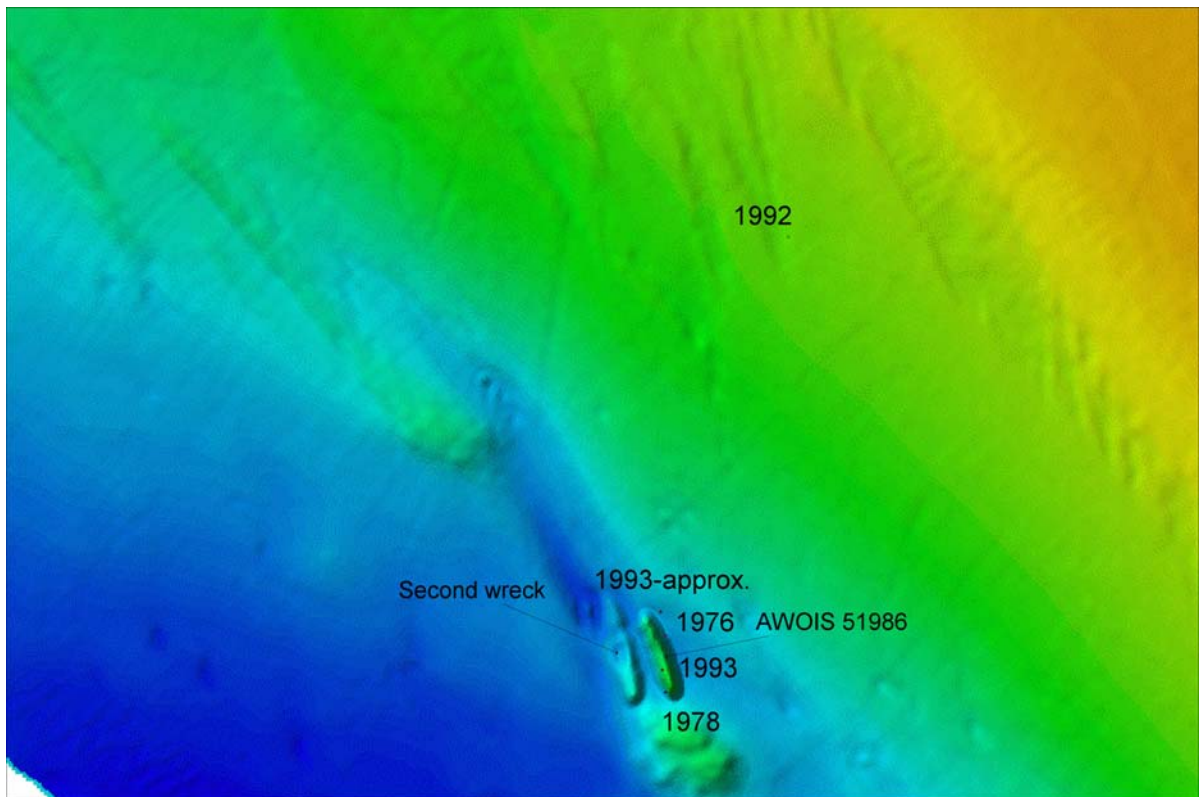
AWOIS 51986 was located during survey operations, in the vicinity of the charted Wreck 800 meters west of Treasure Island. This wreck was found at position 37 48 57.663 N, 122 22 56.707 W with a least depth of 69.4 feet. This position is 15 meters southeast of the reported location in the AWOIS database. The depth in the database was reported as 69.2 feet in 1976 and 75 feet in 1993. It is recommended that the depth of the wreck be revised to 69 feet. A second wreck, which was originally discovered in 1993, was located approximately 10 meters west of the AWOIS item. The wreck was found at position 37 48 57.543 N, 122 22 57.743 W with a least depth of 81.5 feet. It is recommended that the second wreck be added to the AWOIS database.

Following is a hill shaded model of multibeam data from this survey, illustrating the orientation of the wrecks, and the history of AWOIS positions for AWOIS 51986.

HISTORY OF AWOIS ITEM #51986

Two wrecks were observed in the vicinity of the charted wreck on the southwestern section of the survey area. The area containing these wrecks corresponds to AWOIS item 51986 and is included in Section M. A least depth of 69 feet was found on this item.

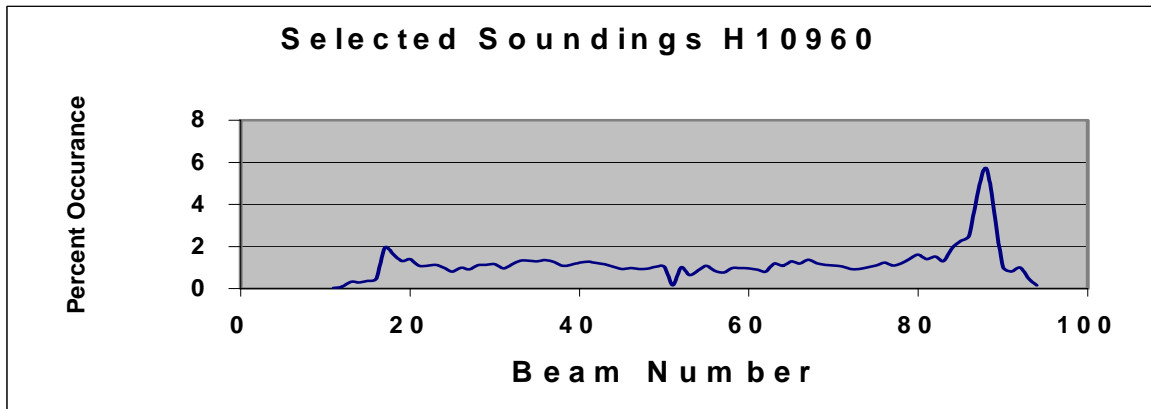
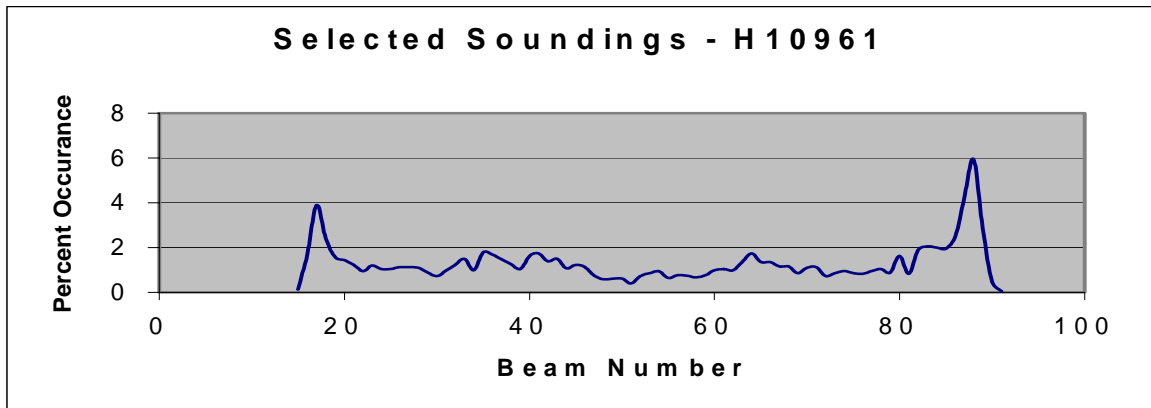
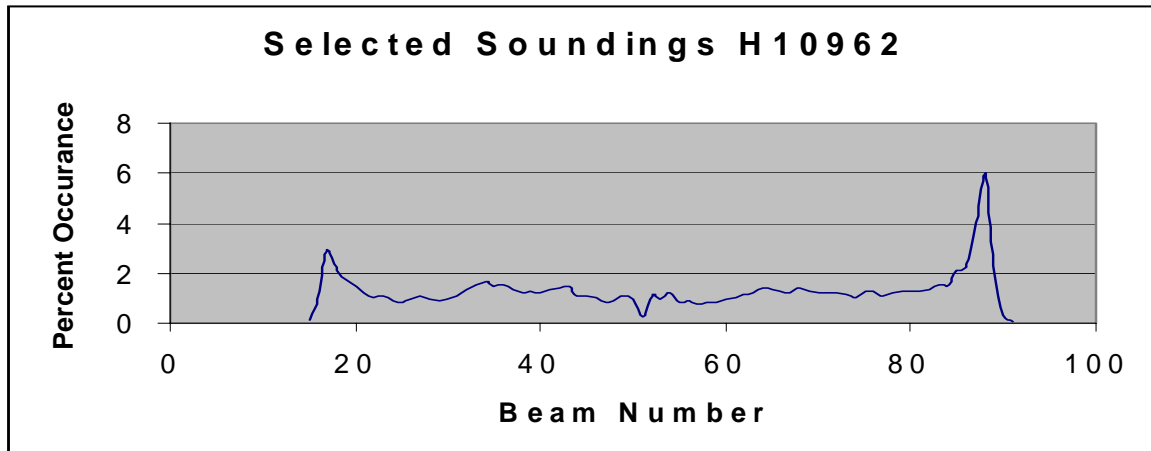
A histogram of all selected soundings was made and is plotted below. The graph represents the number of times each beam is used as a selected sounding. The selected sounding process was a shoal-biased selection, based on a 10-meter bin selection and exported through a Caris overplot

A high incidence of outer beams was selected in the sounding routine and investigated to determine if a systematic bias was introduced into the data. No single source was found. The selected data can be attributed to a number of factors; the primary reason is due to the nature of a multibeam system with outer beams having a lower incident angle. This may result in shoaler depths when comparing outer beams to near nadir beams.
