DESCRIPTIVE REPORT

Type of Survey Hydrographic\ Multibeam

General Locality Casco Bay

Locality 4 Miles East of Cape Elizabeth

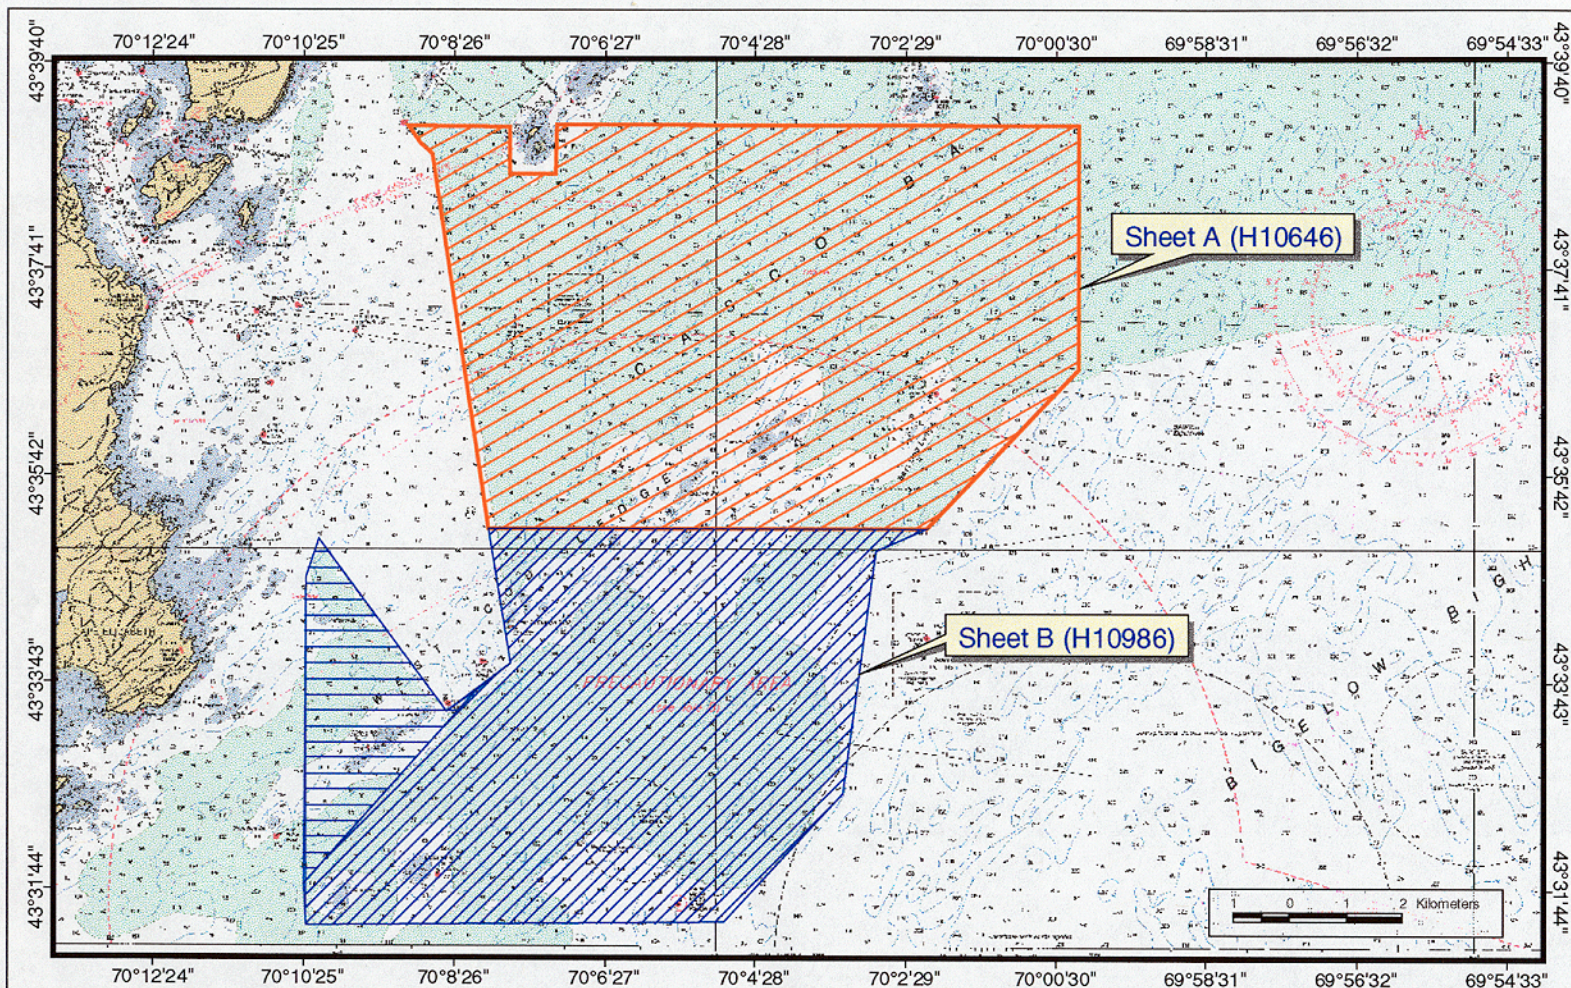
PROGRESS SKETCH
 PROJECT OPR-A318-KR
 H10646, H10986 CASCO BAY, ME
 MULTIBEAM SONAR

The Progress Sketch on the following page indicates:

1. Survey Outlines
2. Field Survey Letters and Survey Registry Numbers
3. Work Accomplished by Month

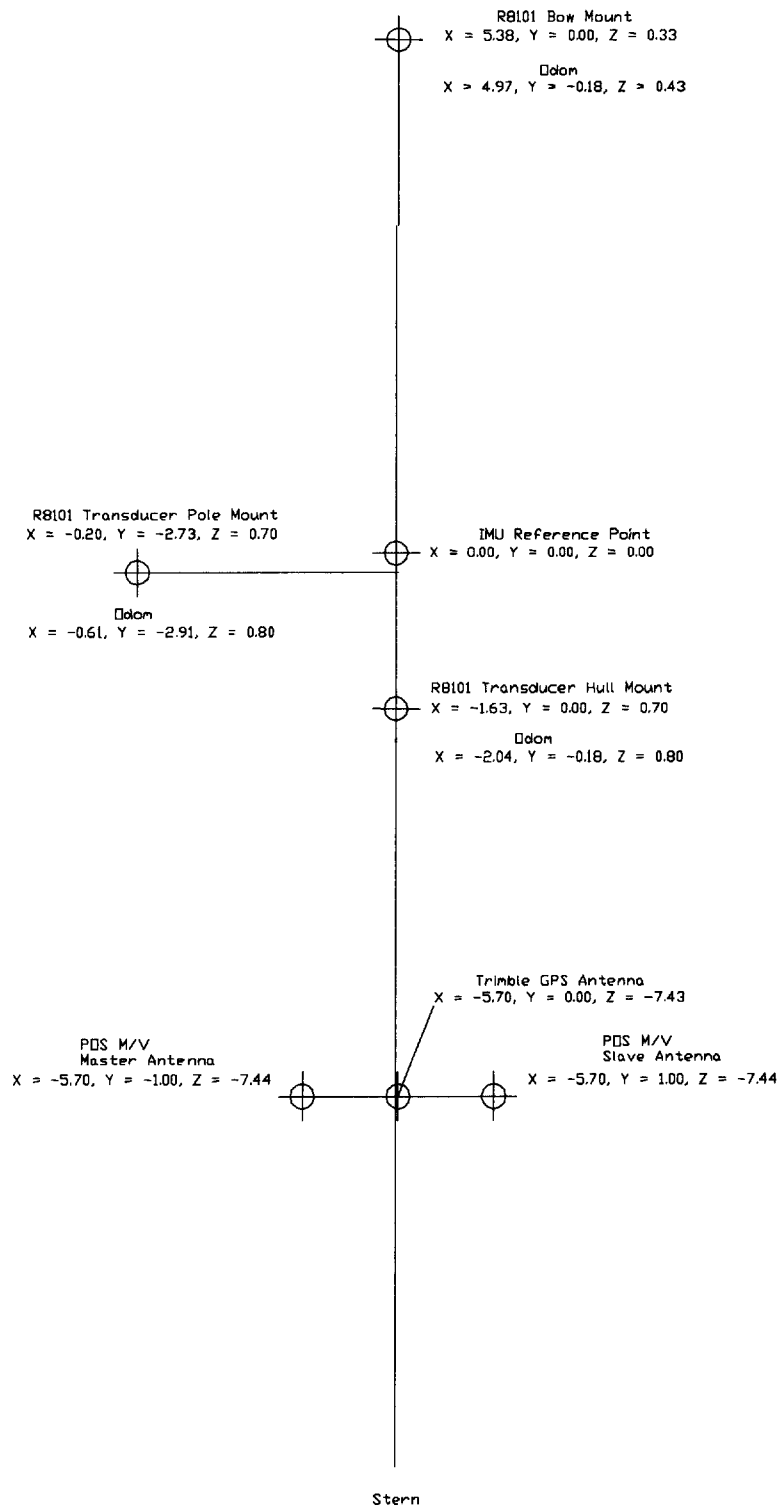
Figure C-1. Configuration of R/V OceanExplorer during Survey Operations, measurements in meters

The R/V OceanExplorer sensor configuration is depicted in Figure C-1 and the vessel offsets are shown in Table C-2. For these surveys, the R8101 transducer was installed on the hull mount. Figure C-2 shows the draft calculations for the R/V OceanExplorer. All measurements are in meters. The Reference Point for the entire multibeam system is located at the top centerline of the POS/MV IMU. The transducer depth was recorded as 3.07 meters below the boat's main deck. The distance below the boat deck to the water surface was measured and subtracted from the transducer hull depth to determine the draft of the electronic center of the transducer. Measurements were made on each side of the vessel before departure from port and upon return to port in order to prorate the daily draft for fuel and water consumption.

Sensor	Offset in ISS2000		POS/MV IMU	
Multibeam Reson 8101 Transducer Hull Mount			X	-1.63
			Y	0.00
			Z	0.70
ODOM Singlebeam Transducer	X	-2.04		
	Y	-.018		
	Z	0.80		
Trimble 7400 Antenna	X	-5.70		
	Y	0.00		
	Z	-7.43		
POS/MV GPS Master Antenna			X	-5.70
			Y	-1.00
			Z	-7.44
