DESCRIPTIVE REPORT

Type of Survey HYDROGRAPHIC/LIDAR
Field No. OPR-P182-KR-04
Registry No. H11265

State ALASKA
General Locality Southwest Alaska Peninsula
Sublocality Western Portion of Mitrofanina Island

DESCRIPTIVE REPORT TO ACCOMPANY**HYDROGRAPHIC SURVEY H11265****SCALE 1:10,000, SURVEYED IN 2004****TENIX LADS AIRCRAFT, VH-LCL****TENIX LADS, INC. (TLI)****MARK SINCLAIR, HYDROGRAPHER****PROJECT****Project Number:** OPR-P182-KRL-04**Original:** DG 133C-03-CQ-0011**Date of Instructions:** August 15, 2003**Task Order:** T0005**Date of Supplemental Instructions:** May 7, 2003 email regarding meeting with PHB, NOAA and November 24, 2004 e-mail regarding SOW revision.**Sheet Number:** AW**Registry Number:** H11265**PURPOSE¹**

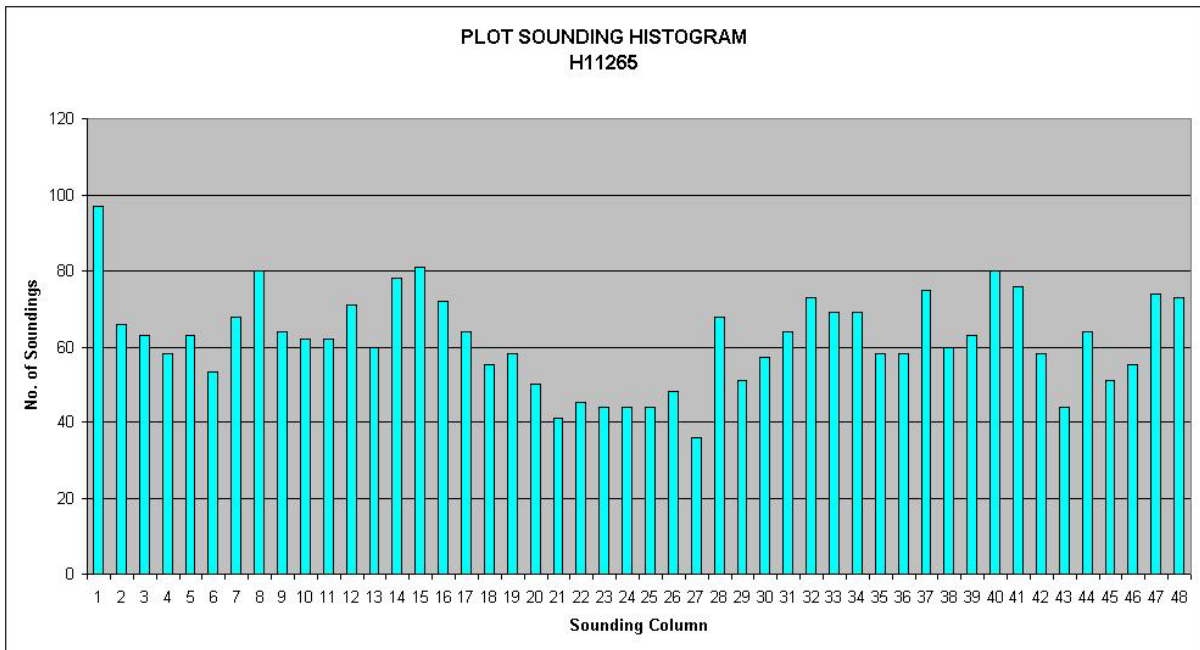
Graph 1 – Sounding Histogram of Smooth Sheet H11265

A sounding histogram has been produced of the column and occurrence of each sounding shown on the smooth sheet. The graph shows that there is no evident scan angle bias in the data.
