DESCRIPTIVE REPORT

Type of Survey: **Navigable Area**

Registry Number: **H11360**

Sub-locality: Jacob's Point to Albany Rock

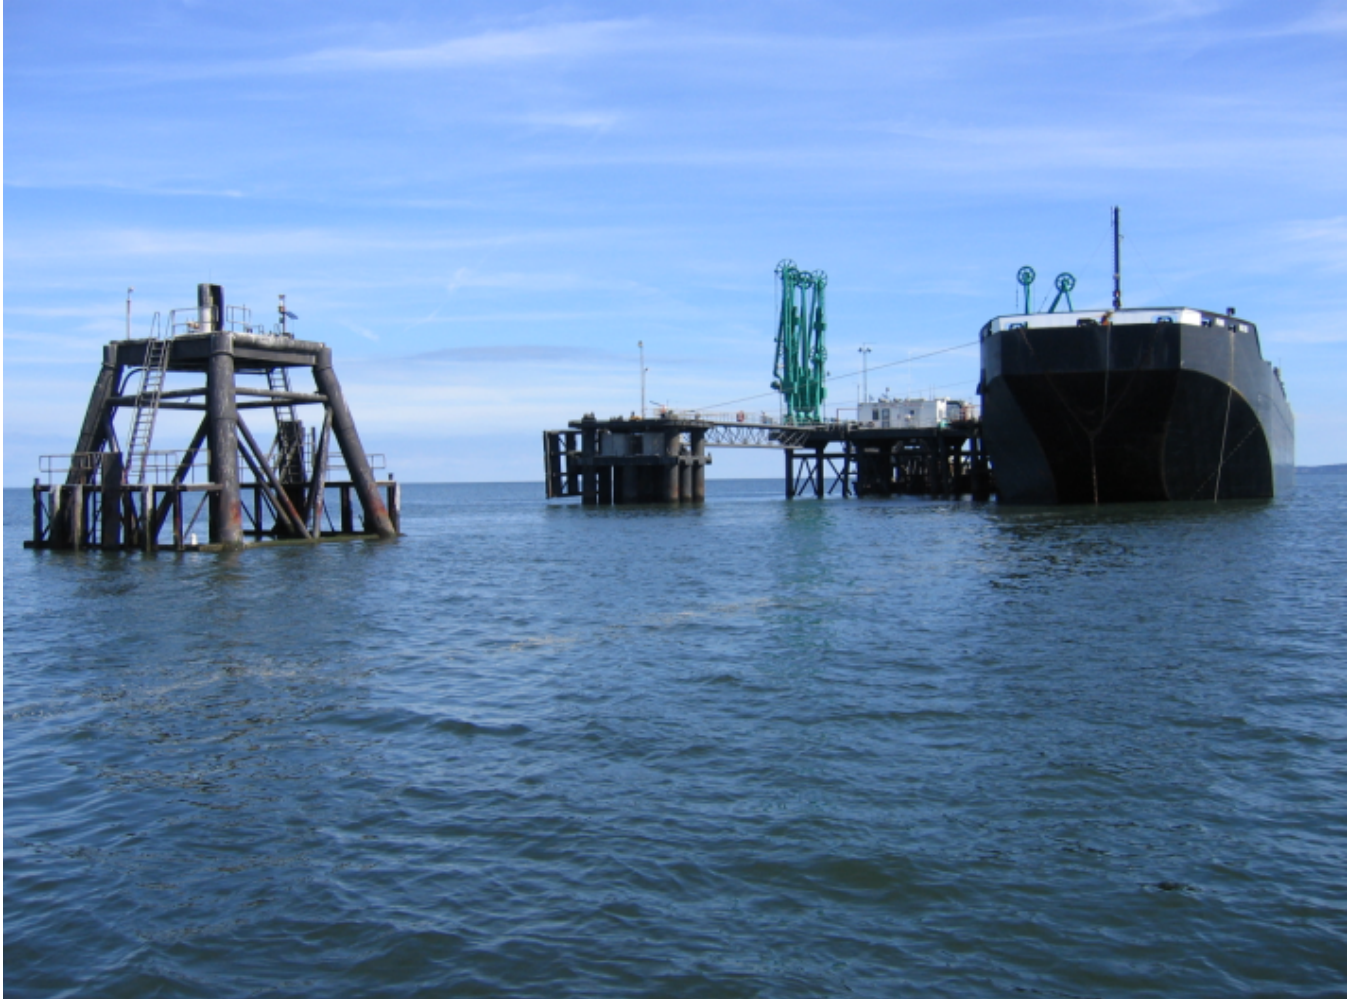
TECSOU - ~~2: found by side scan sonar; 3: found by multi-beam~~

VALSOU - m

WATLEV - ~~1: partly submerged at high water~~ **2: always dry**

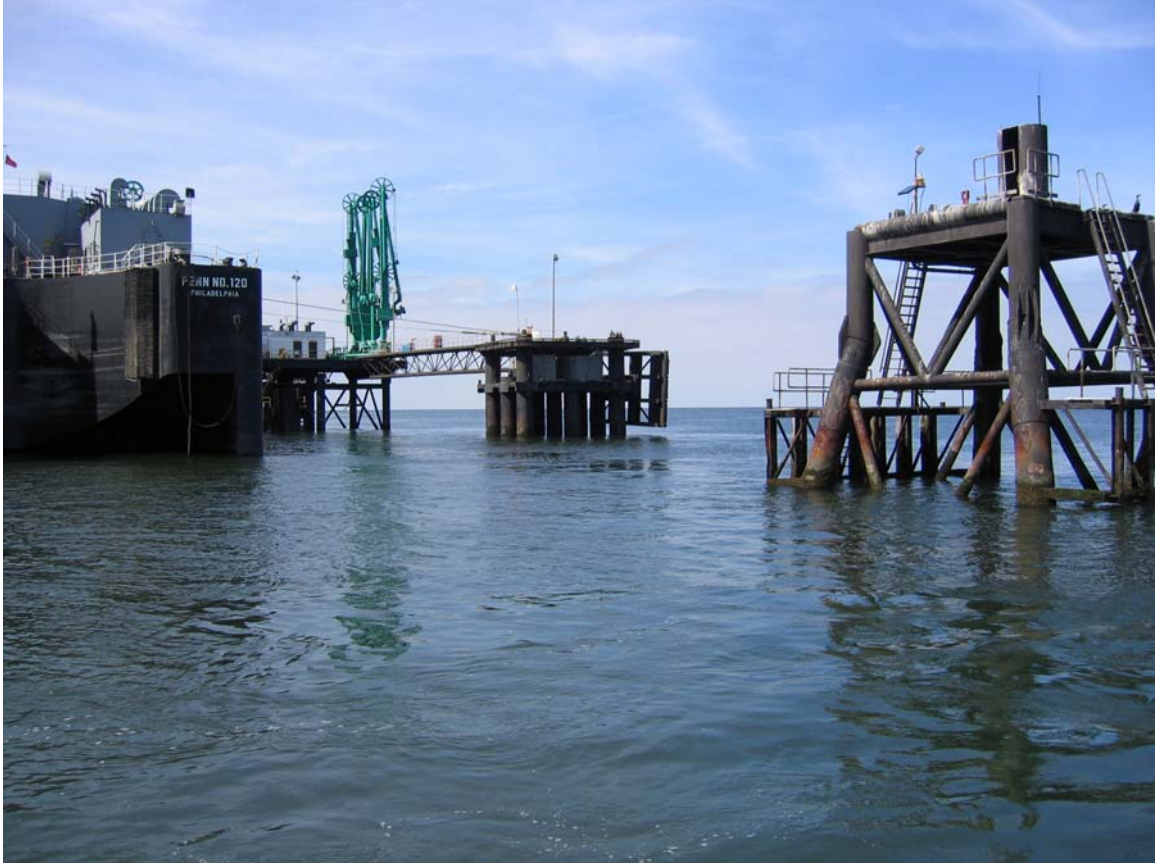
TECSOU - ~~2:found by side scan sonar; 3:found by multi-beam~~

VALSOU - m

WATLEV - ~~1:partly submerged at high water~~ **2: *always dry***

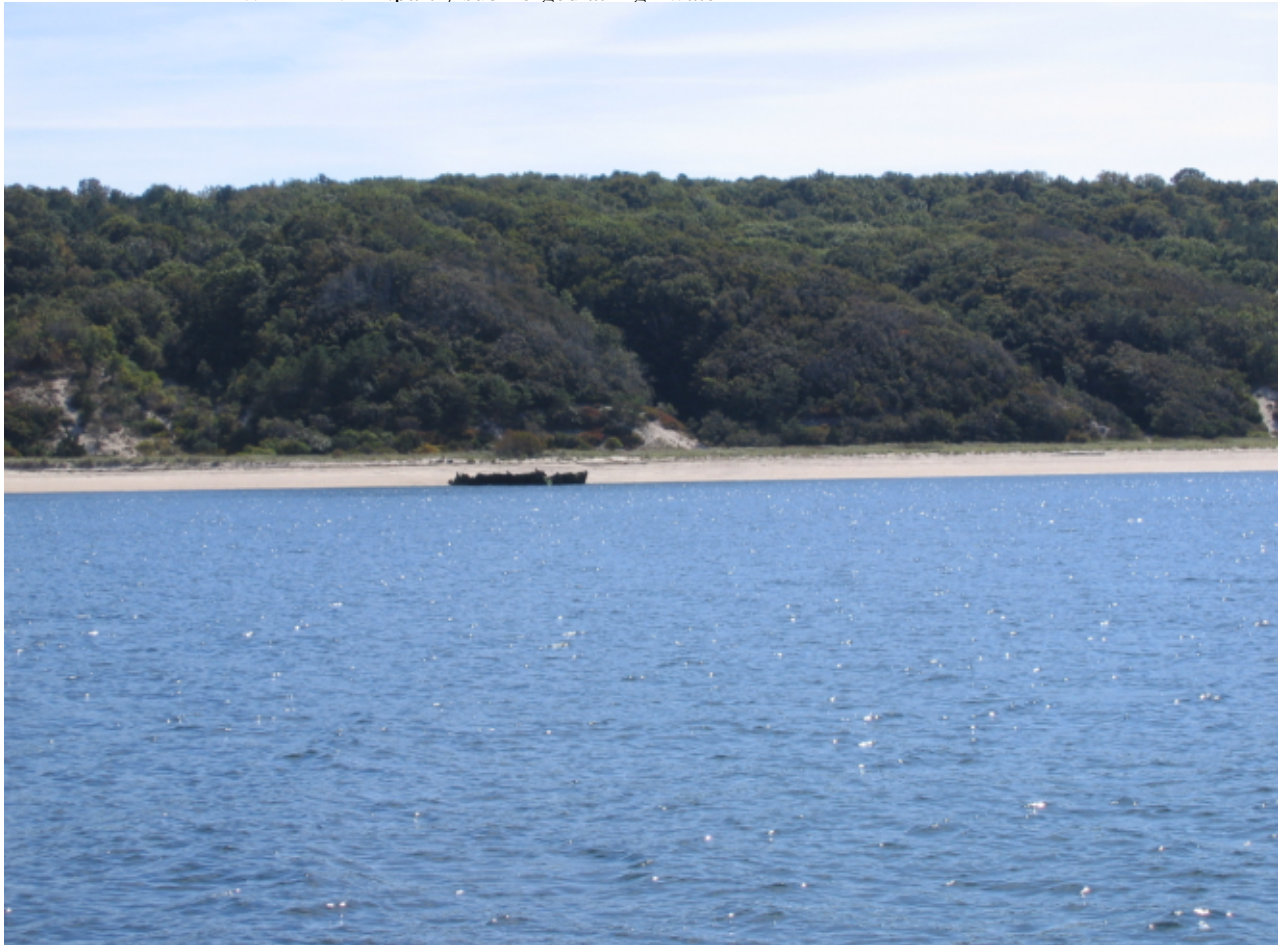
VALSOU - m

WATLEV - 1:partly submerged at high water

Further investigation and shoreline verification is recommended to verify the precise position of the wreck. Until such a time, the hydrographer recommends retaining the AWOIS item as charted. **Concur.**

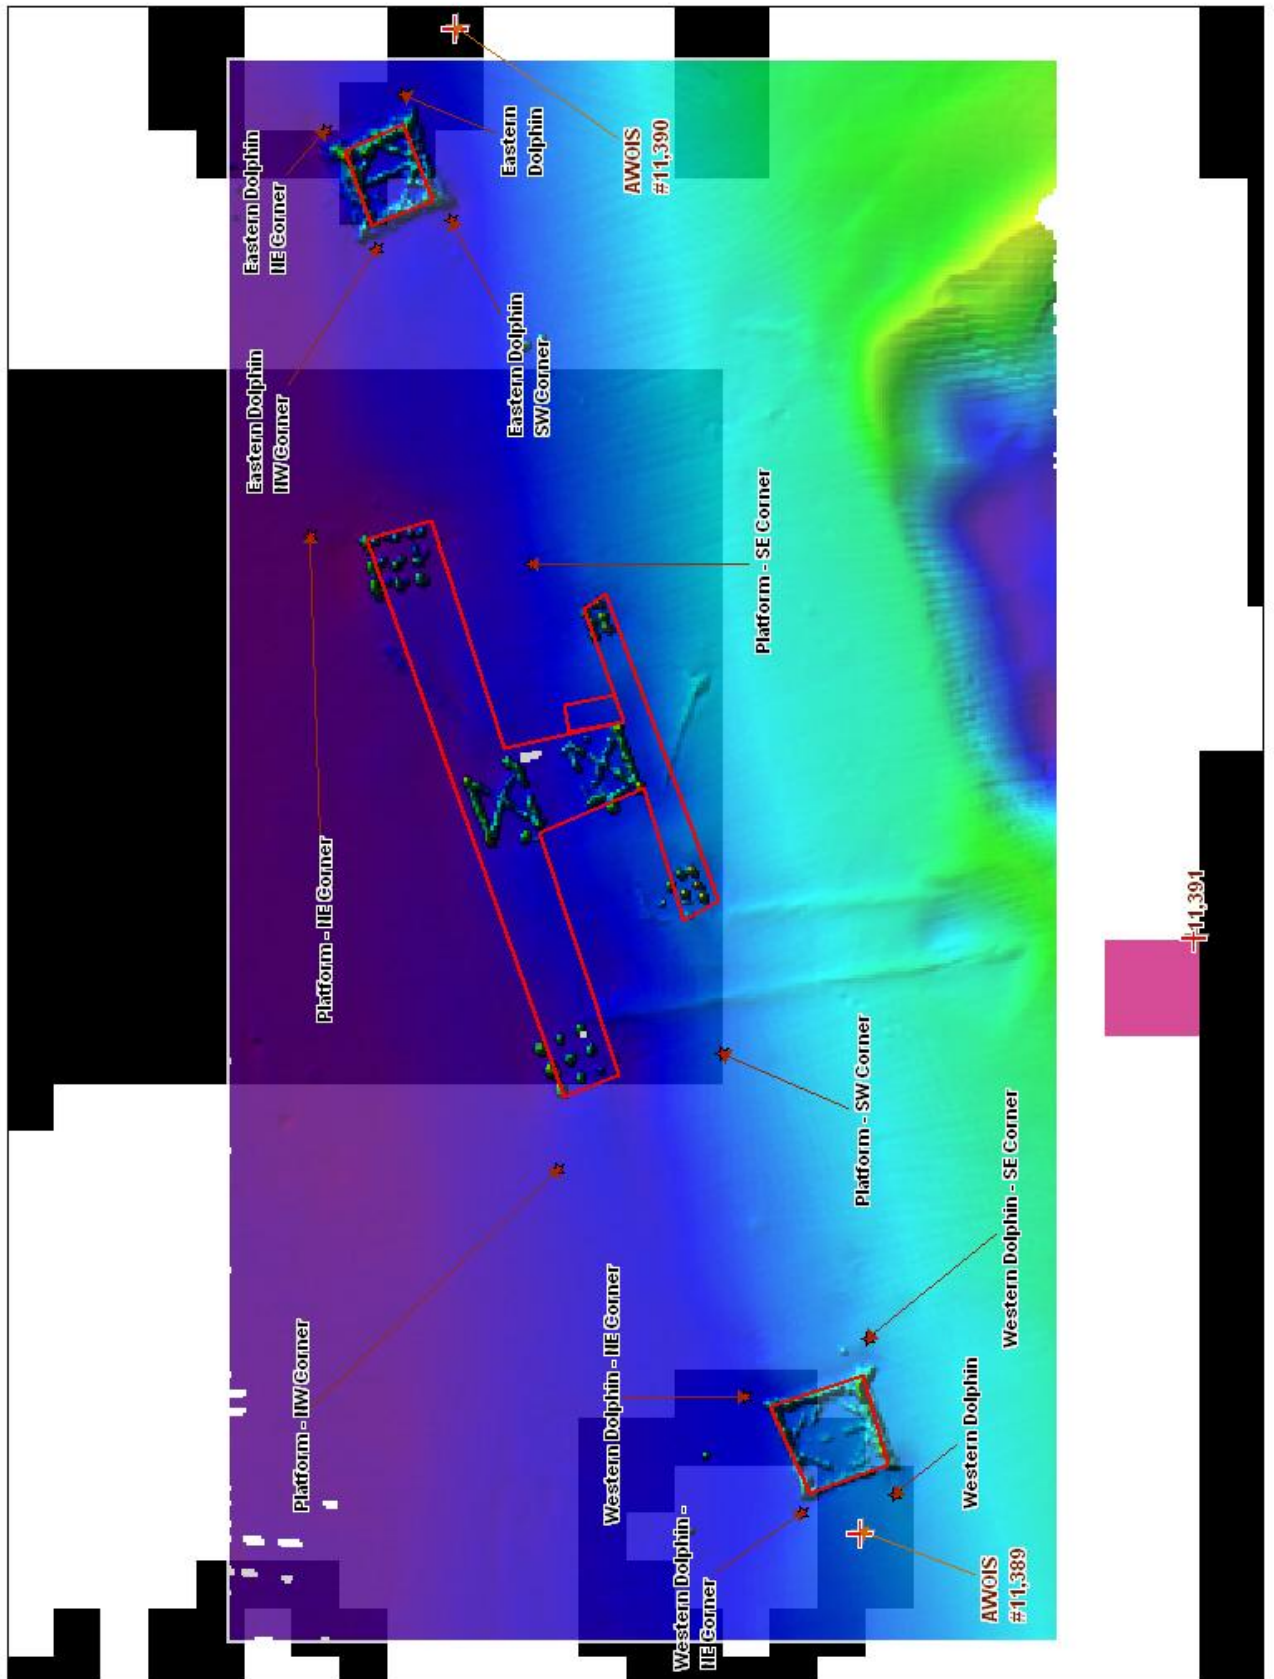
Chartlet Tosco Corporation Riverhead Platform

Positioning of the Tosco Corporation Riverhead Terminal and its shoreside pier was accomplished using HYPACK detached positions from Launch 1014. Due to project time constraints, a target’s range and bearing to the actual feature was not measured. Launch 1014 was maneuvered as close to the feature as sea conditions would allow. The ranges from the targets to the features were in most cases approximately 3 – 7 meters, with the greatest range estimated at no more than 10 meters from the reference point of the vessel. The digital data, namely SSS imagery, may provide more precise positioning of the terminal to meet charting needs. **Do not concur. See pages 43, 44, and 48 of the Features Reports in data attached to this report.**

The position of the Tosco Corporation Riverhead Terminal was found to be in close agreement with its charted position. *Concur.*
