**DESCRIPTIVE REPORT**

Registry Number: H11668

General Locality: Southeast Coast of Kodiak Island

Sub-locality: Twoheaded Island

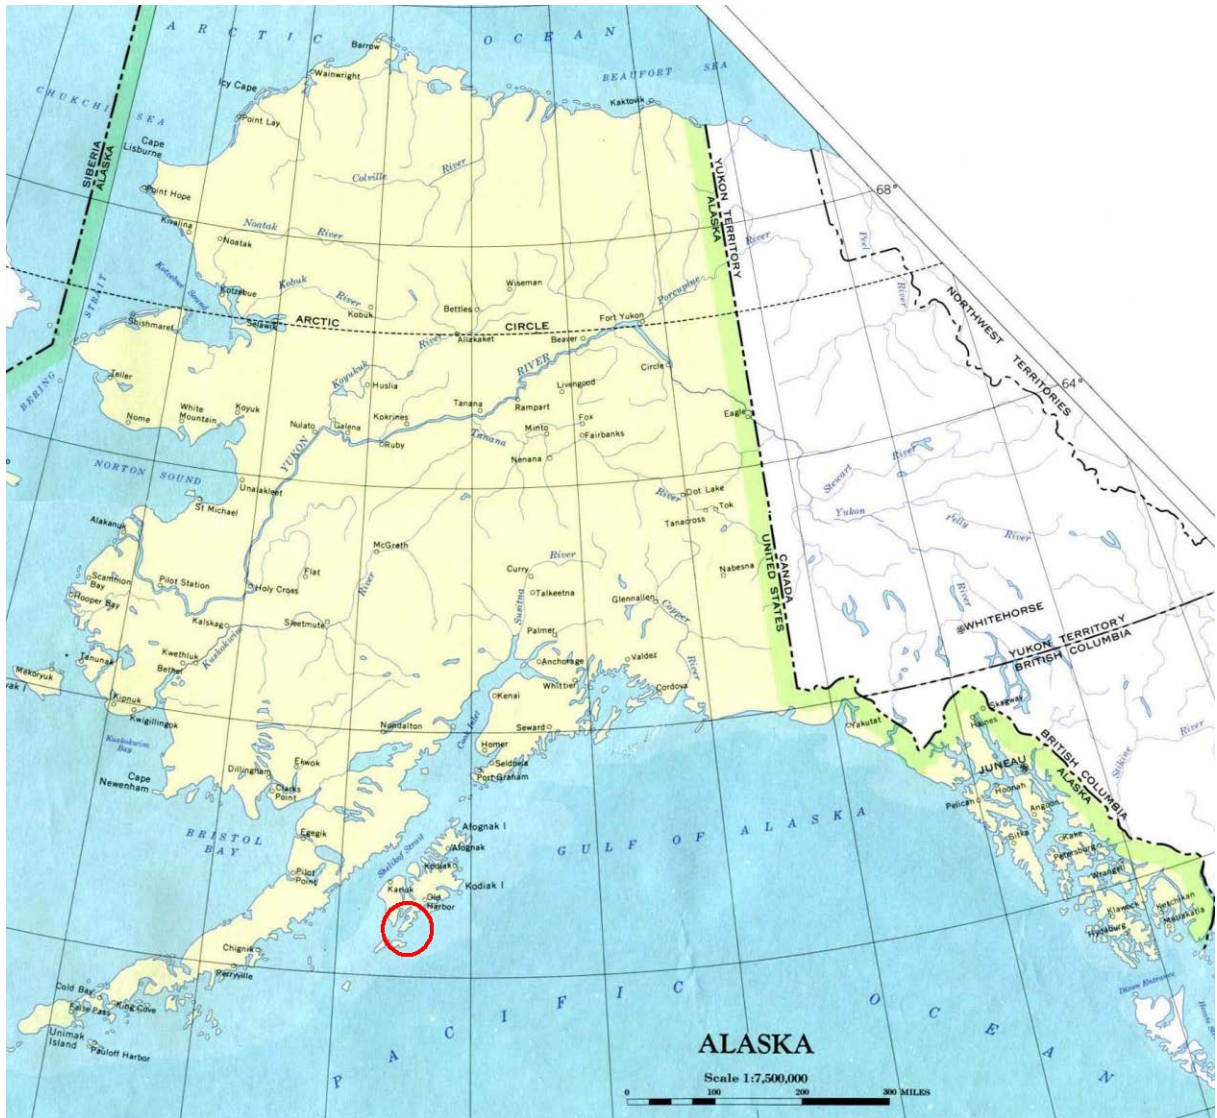
Figure 1 – General Locality of OPR-P135-KRL-07

Survey operations covered five registered sheets over the OPR-P135-KRL-07 project area, Southeast Coast of Kodiak Island, AK (see Figure 1 and Figure 2).

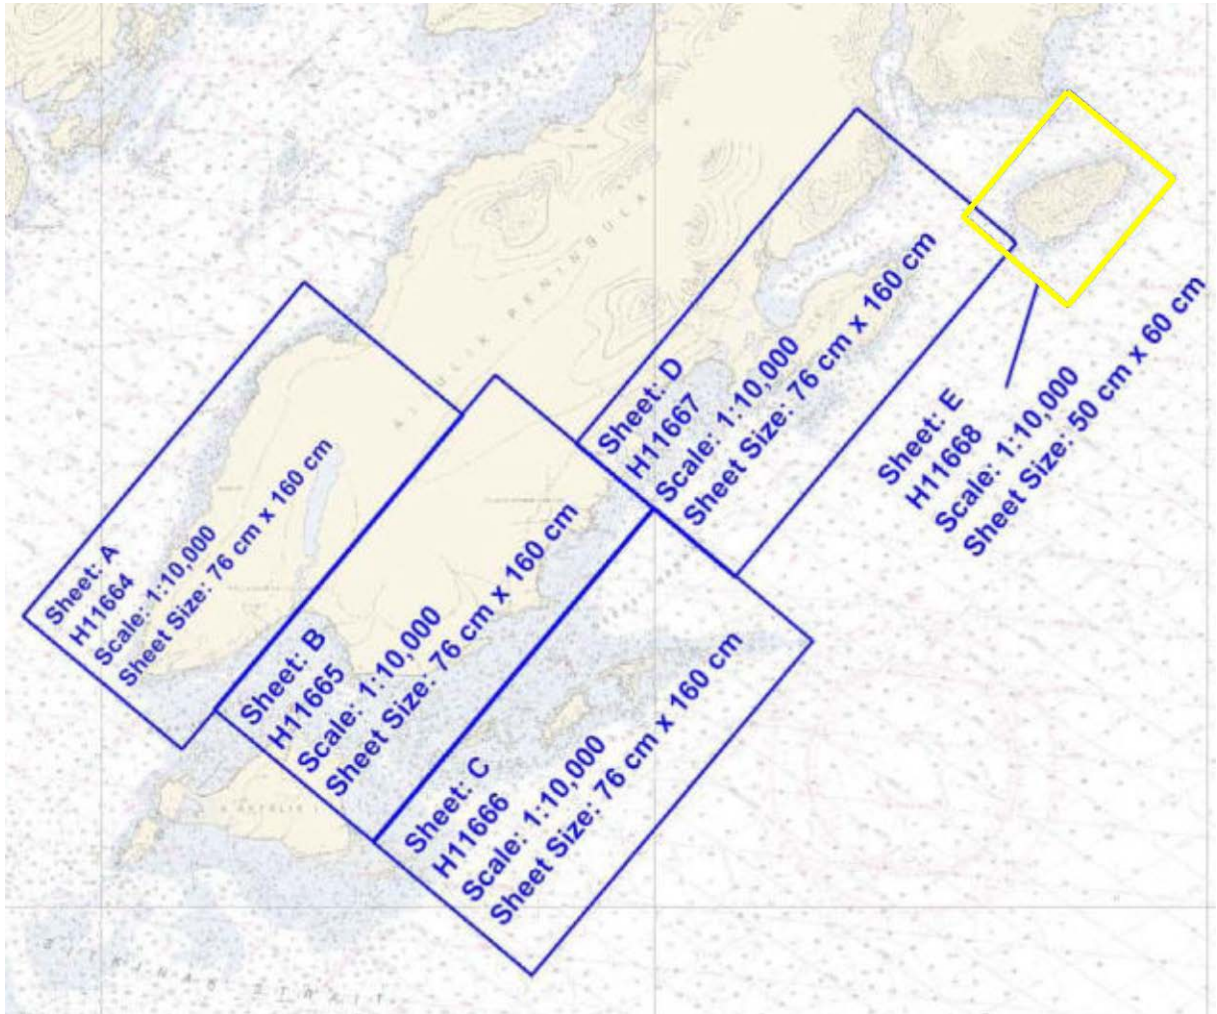
Figure 2 – Sub-Localty of H11668

This Descriptive Report describes Sheet E, which covers Twoheaded Island (see Figure 2).

The sheet limits are as follows for Sheet E:

<b>H11668 (E)</b>	<b>Latitude (N)</b>	<b>Longitude (W)</b>
<b>SE corner</b>	56° 53' 46.32"	153° 38' 43.47"
<b>NE corner</b>	56° 56' 13.89"	153° 34' 53.16"
<b>NW corner</b>	56° 54' 28.77"	153° 31' 08.42"
<b>SW corner</b>	56° 52' 01.31"	153° 34' 58.86"
