**DESCRIPTIVE REPORT**

*Type of Survey* **Hydrographic Lidar**  
*Project No.* **OPR-H328-KRL-09**  
*Registry No.* **H12118**

*State* **Florida**  
*General Locality* **Broward County**  
*Sub-locality* **Dania Beach to Golden Beach**

**DESCRIPTIVE REPORT TO ACCOMPANY****HYDROGRAPHIC SURVEY H12118****SCALE 1:10,000, SURVEYED IN 2008****FUGRO LADS AIRCRAFT, VH-LCL****FUGRO LADS, INC. (FLI)****MARK SINCLAIR, HYDROGRAPHER****PROJECT****Project Number:** OPR-H328-KRL-09**Original:** DG 133C-06-CQ-0066**Date of Instructions:** June 17, 2009**Task Order:** T0007**Registry Number:** H12118**Sheet:** C**A. AREA SURVEYED**

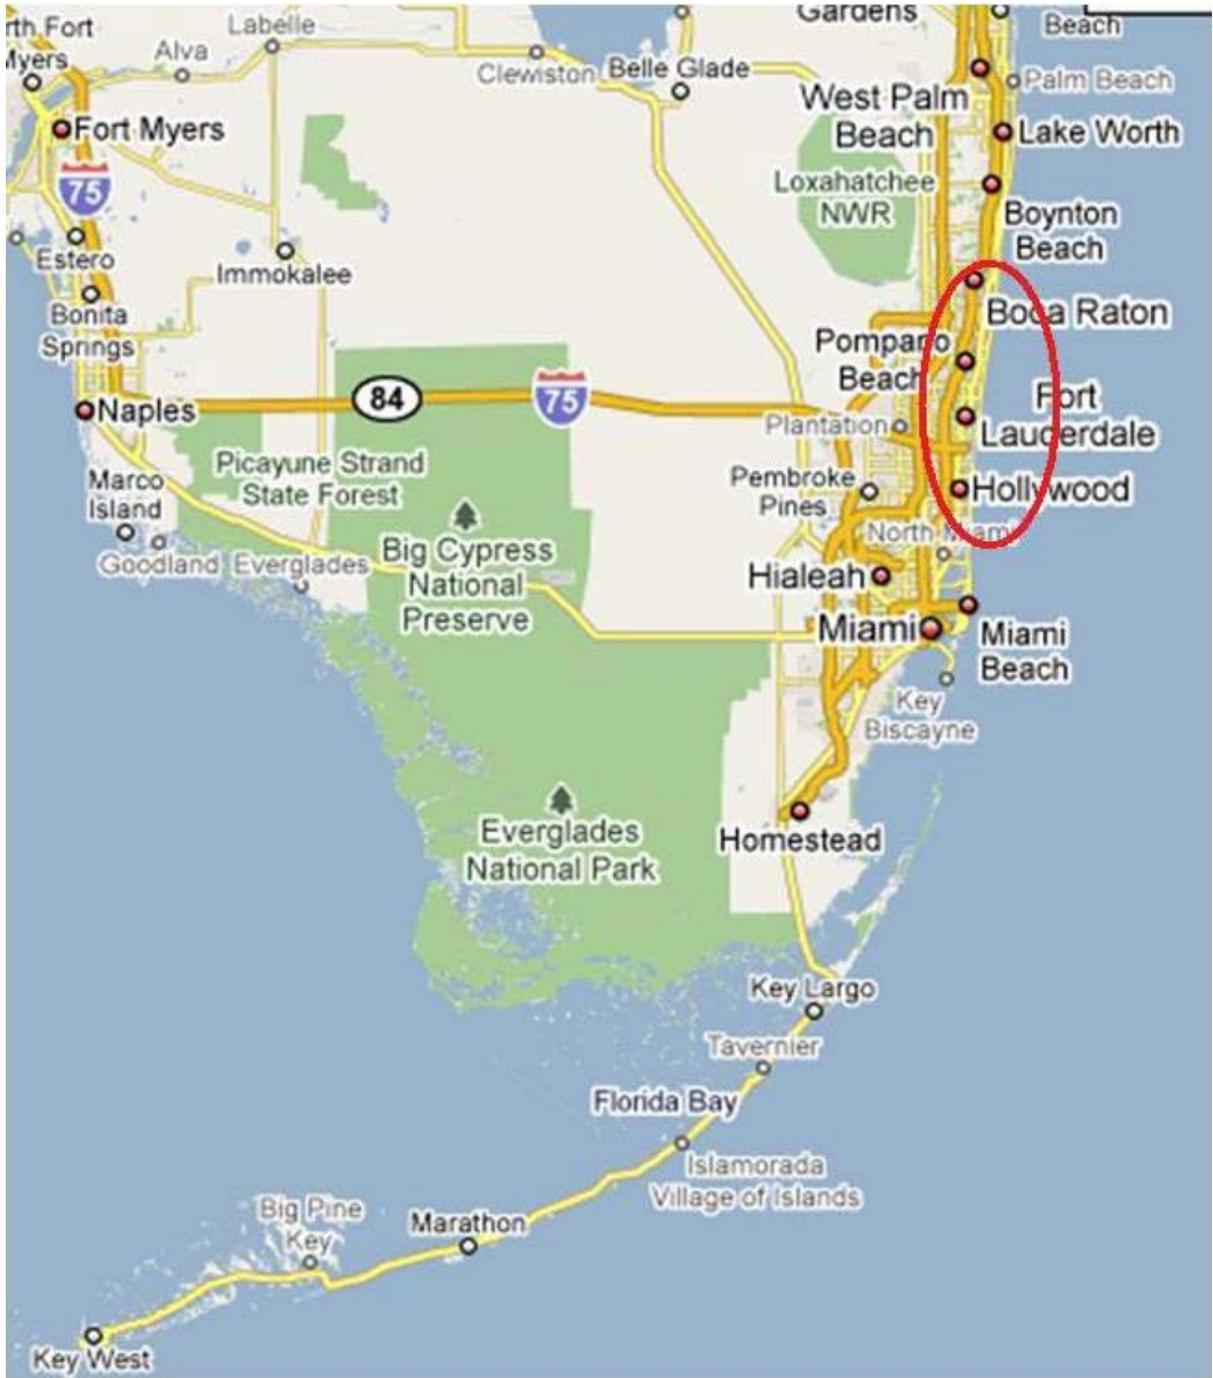
Figure 1 – General Locality of Broward County

Survey operations covered the entire coast of Broward County, FL, between Golden Beach and north of Boca Raton Inlet, from above the high waterline to beyond 35m water depth (see Figure 1). *Concur.*

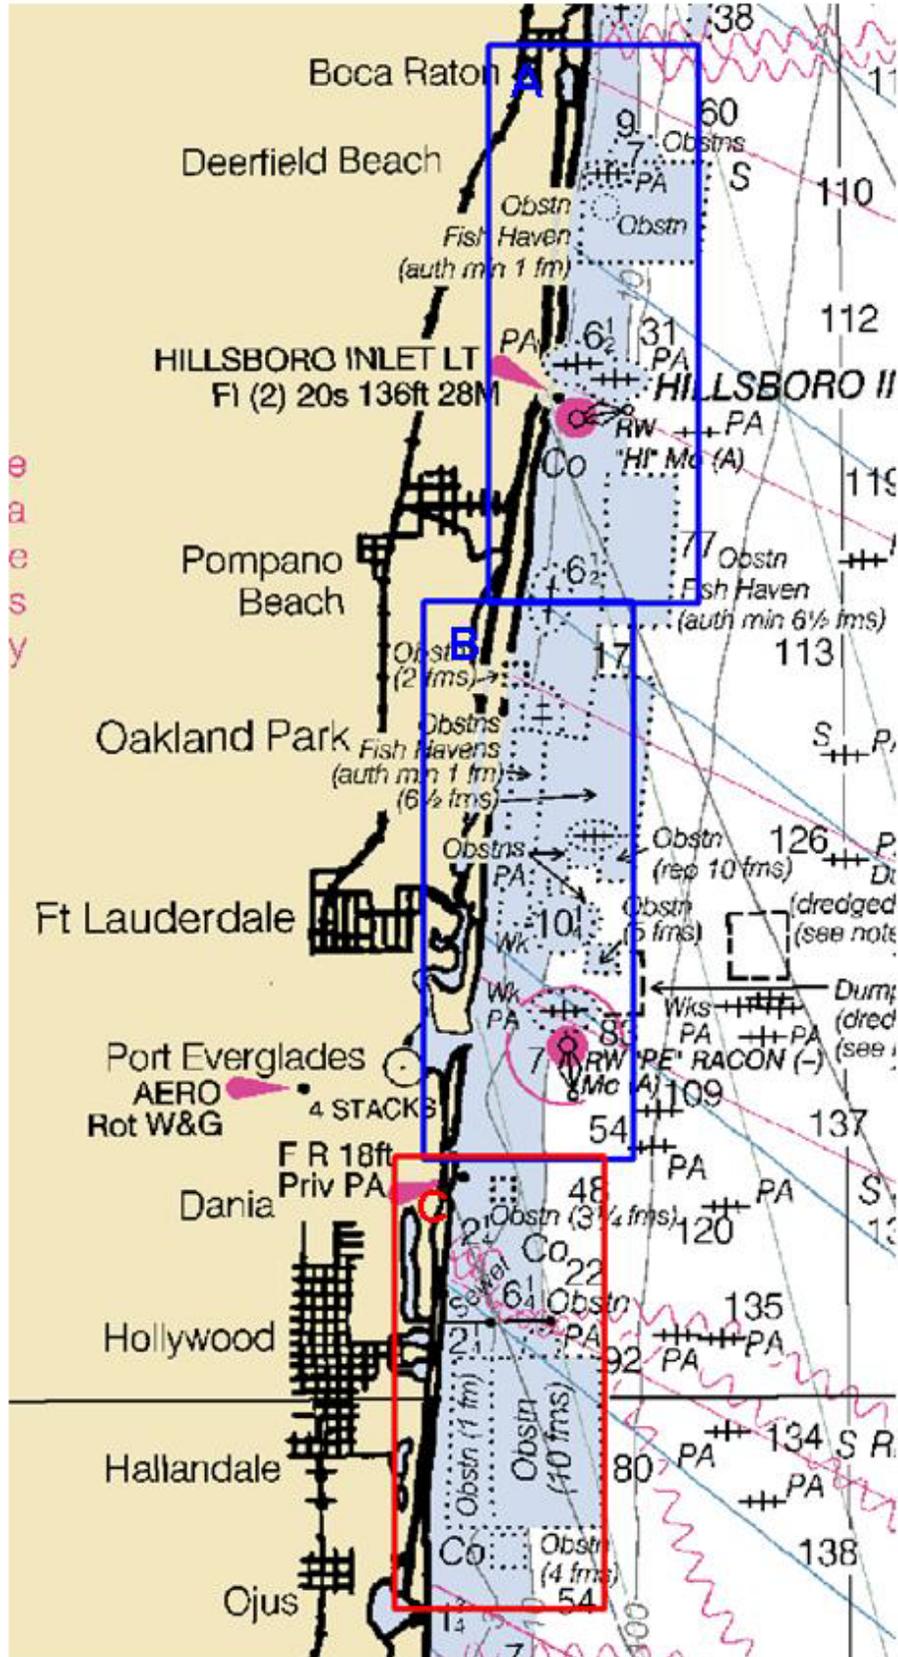
Figure 2 – Sub-Localty of H12118 (Sheet C)

This Descriptive Report describes Sheet C, which covers Dania Beach to Golden Beach (see Figure 2). *Concur.*

The sheet limits are as follows for Sheet C (coordinates are NAD83): *Concur.*

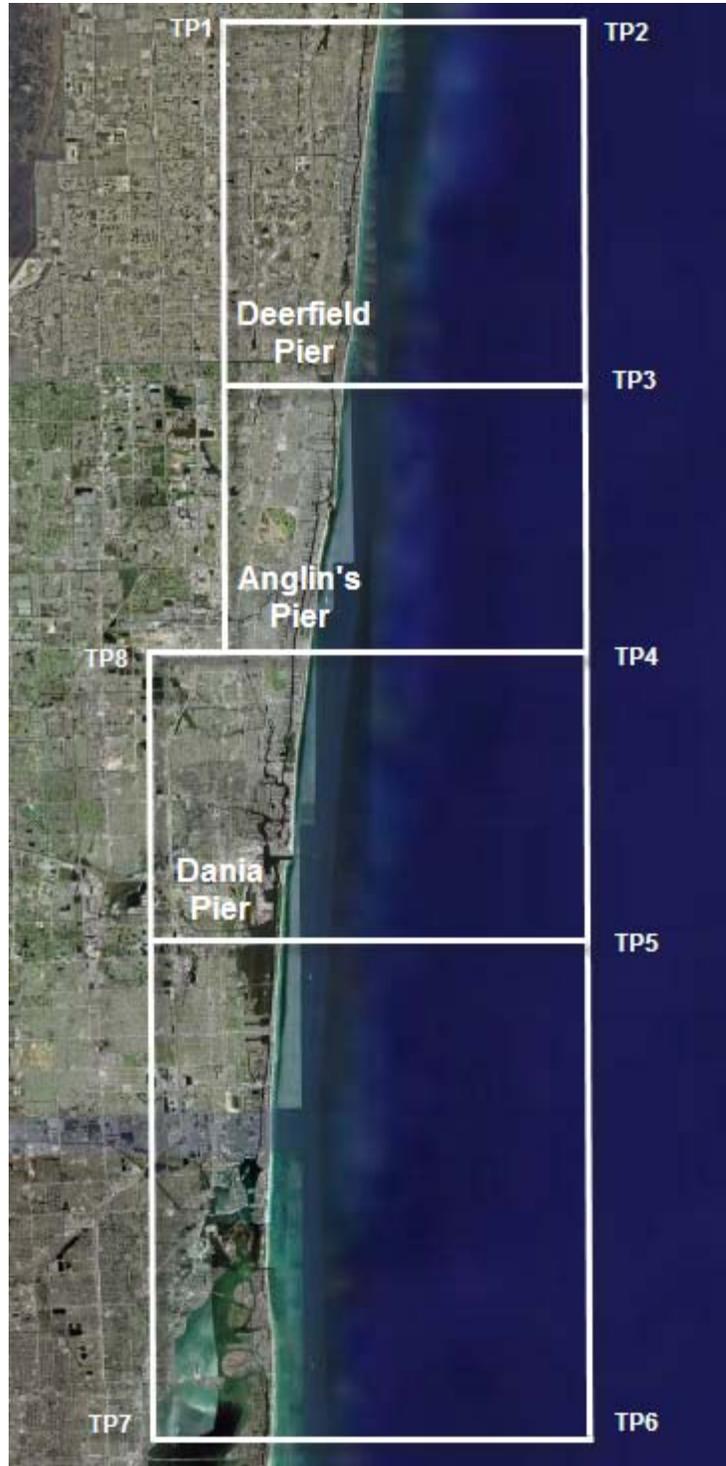
**Figure 3 – Final Tide Zones in the LADS GS**

The final tide zones were designed to incorporate at least one observed tide station (established by BOV). In some of the zones two observed tide stations were used to provide a co-tidal model. An analysis of depth benchmark and crossline comparisons, and overlaps of the mainlines of sounding concluded that final tide zoning was adequate. The final tide zones superseded the preliminary tide zone. *Concur.*

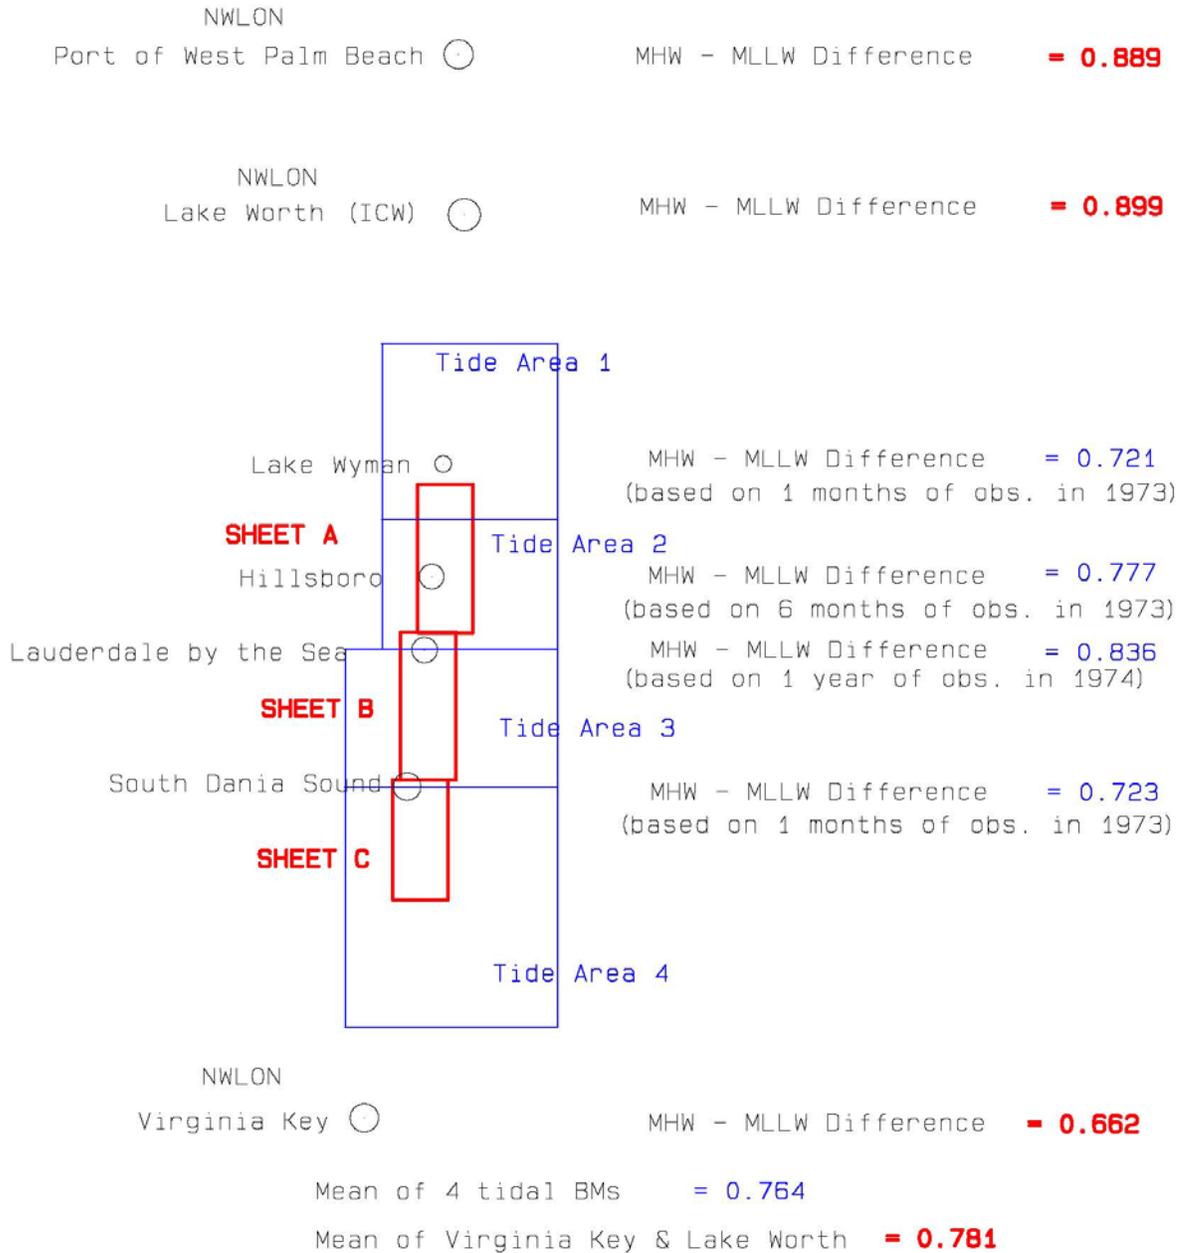
**Figure 4 – Vertical Difference between MLLW and MHW for Tidal Benchmarks and NWLON Gauges**

The values for the differences between MLLW and MHW for adjacent tidal benchmarks and NWLON gauges are shown in the diagram below:

The mean value of MLLW – MHW differences for tidal benchmarks is 0.764m. The mean value of MLLW – MHW differences for adjacent NWLON gauges is 0.781m. Therefore, for all registered sheets under OPR-H328-KRL-09, including H12118, a MHW value of 0.77m has been used.

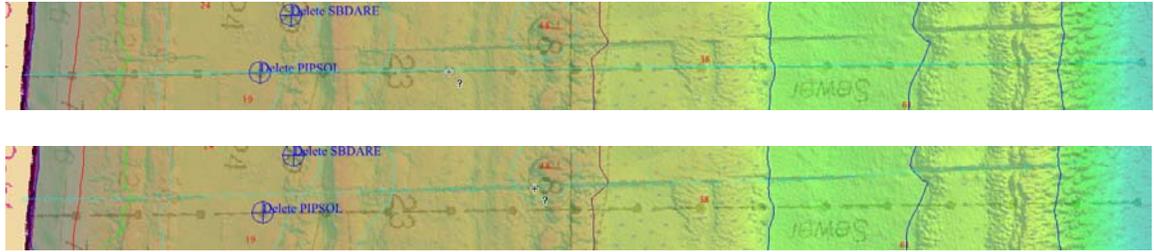
1. The pipeline (submarine/on land) charted in the vicinity of Latitude 26-01-05.323N, Longitude 80-06-11.534W was investigated by the present survey and repositioned. The grid shows the pier to be north of its charted position in the vicinity of Latitude 26-01-07.262N, Longitude 80-06-10.293W. It is recommended that the charted pipeline is deleted. It is further recommended that a pipeline is charted based on the present survey findings in the present survey position.

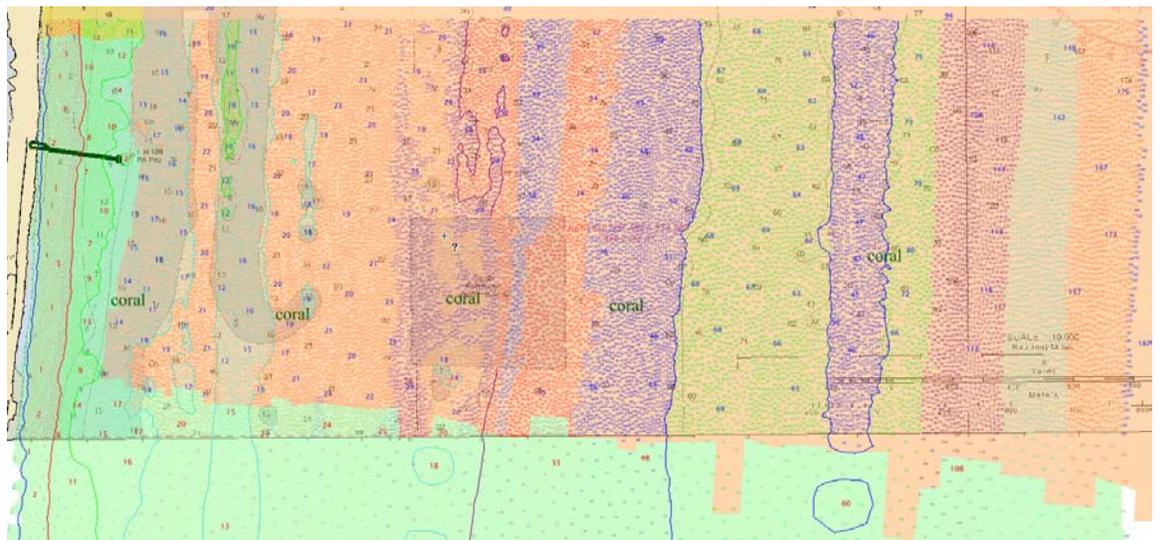
The southern portion of survey H11896 (2009) junctions to the northern portion of present survey H12118. There is excellent sounding agreement throughout the junctional area. Survey H11896 is a single and Multibeam echo sounder and side scan sonar survey, its data is considered more accurate than H12118's Lidar data. It is therefore recommended that H11896 supersede H12118 in the junctional area, except in regards to the coral seabed area features on the present survey. (H12118 is in green, H11896 is in orange and H12117 is gold.)

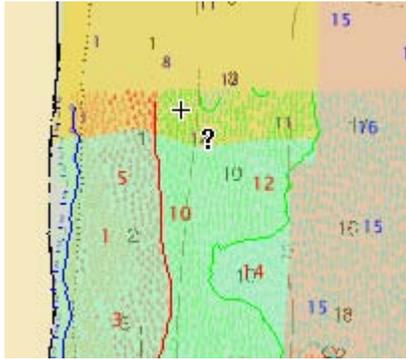
The southwestern edge of survey H12117 (2008) junctions to the northwestern edge of present survey H12118. Both surveys are Lidar surveys and depth comparison is excellent, all depths

agree within 0 and 1 foot. (H12118 is in green, H12117 is in gold, H10896 is orange.)
