DESCRIPTIVE REPORT

Registry No. H12124

General Locality Pacific Ocean - Northern Oregon

Project M-N928-KR-09
Oregon Coastal Mapping Project
Cape Falcon
Scale 1:20,000
August 2009 - October 2009
July 2010 - September 2010
David Evans and Associates, Inc.
Lead Hydrographer: Jonathan L. Dasler

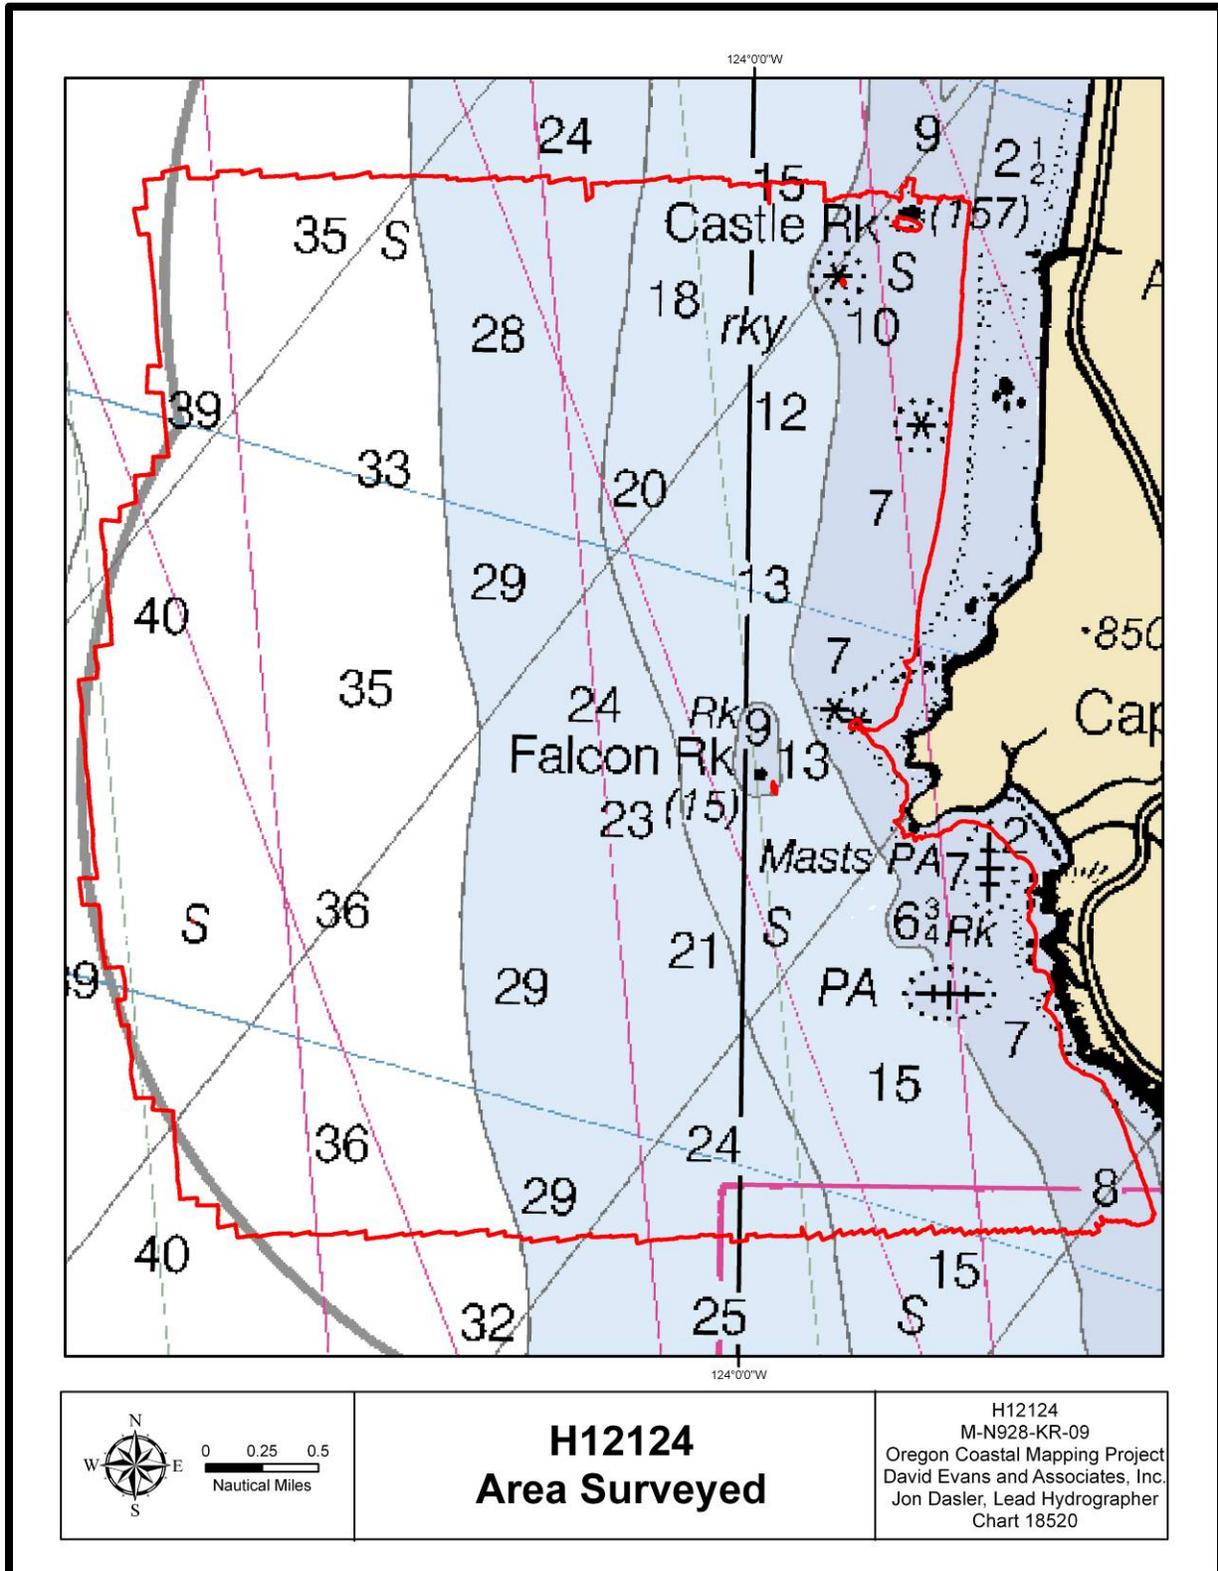
Figure 1. H12124 Area Surveyed

David Evans and Associates, Inc. (DEA) conducted hydrographic survey operations in the Pacific Ocean along the Northern Oregon Coast. The survey area (Figure 1) is located between Arch Cape and Manzanita, Oregon and seaward to the charted three nautical mile line. This project is in support of the Oregon Coastal Mapping Project established under the West Coast Governor's Agreement.

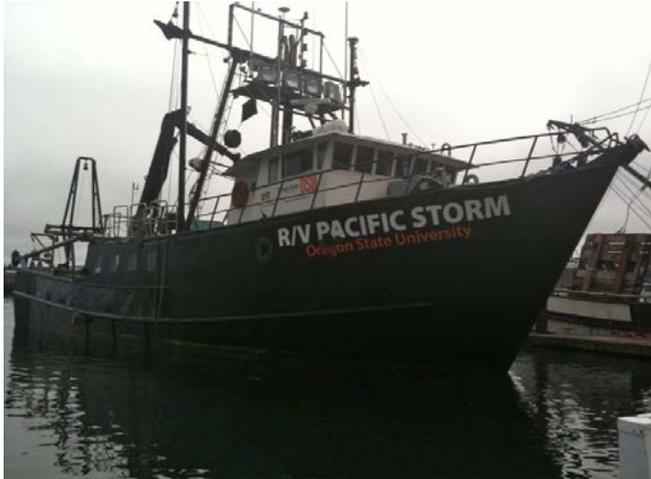
Table 3. R/V Pacific Storm Equipment and Vessel Specifications

Official Number (O/N)	604146
Builder	Spence Bros Boat Works
Design	Steel Displacement Hull
Year Built	1979
Length Overall	84'
Beam	24'
Cruising Speed	8.5 knots
Max Survey Speed	8.2 knots
Primary Echosounder	RESON 8101-ER
Sound Velocity Equipment	<ul style="list-style-type: none"> • Brooke Ocean MVP-30 with AML Micro SV&P and Dissolved Oxygen Sensor • Sea-Bird SEACAT SBE 19 CTD Profiler
Positioning & Attitude	<ul style="list-style-type: none"> • Navcom StarFire GPS • Applanix POS/MV 320 v4

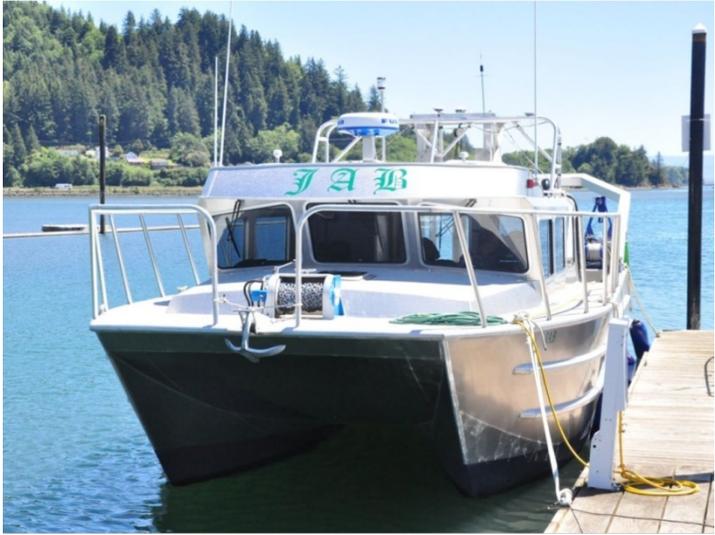
R/V JAB

Table 4. R/V J.A.B. Equipment and Vessel Specifications

Hull Registration Number	IAR38CATK910
Official Number (O/N)	1229272
Builder	Armstrong Marine
Design	Catamaran
Year Built	2010
Length Overall	42'
Beam	15'
Cruising Speed	30 knots
Max Survey Speed	8 knots
Primary Echosounder	RESON 7101-ER
Sound Velocity Equipment	<ul style="list-style-type: none"> • Brooke Ocean MVP-30 with AML Micro SV&P • Sea-Bird SEACAT SBE 19 CTD Profiler • RESON SVP71
Positioning & Attitude	<ul style="list-style-type: none"> • Navcom StarFire GPS • Applanix POS/MV 320 v4

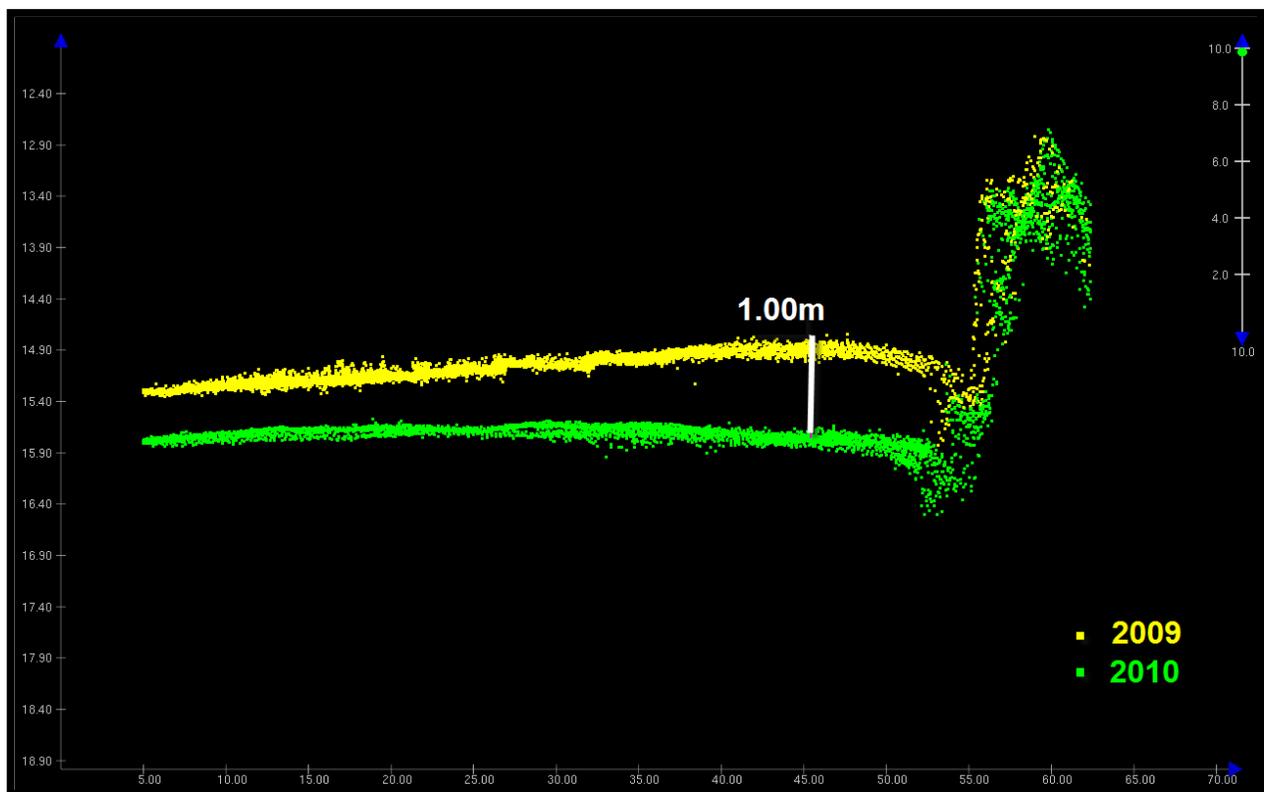
Figure 2. Difference between 2009 and 2010 seafloor

The 2009 and 2010 datasets exhibit differences of over 1 meter at their junction due to physical changes in the seafloor that occurred over the time frame between the two datasets. The datasets show good agreement over rocky areas, which is evidence of no systematic errors between the surveys, but do not agree in the sandy areas surrounding the rocks, as shown in Figures 2 and 3 below. These differences over the sandy bottom are attributable to sediment transport between the 2009 and 2010 collection efforts, and are representative of a true physical difference in the seafloor. As a result, nodes which fail due to high standard deviation at the junction between the datasets are considered within specification. To alleviate the effect of the year-to-year depth difference on the resulting CUBE surface, mainscheme data from each collection effort were trimmed along the primary junction to limit overlapping data in sandy areas.⁷ This provided a clear demarcation in the resulting CUBE surface between the 2009 and 2010 datasets.

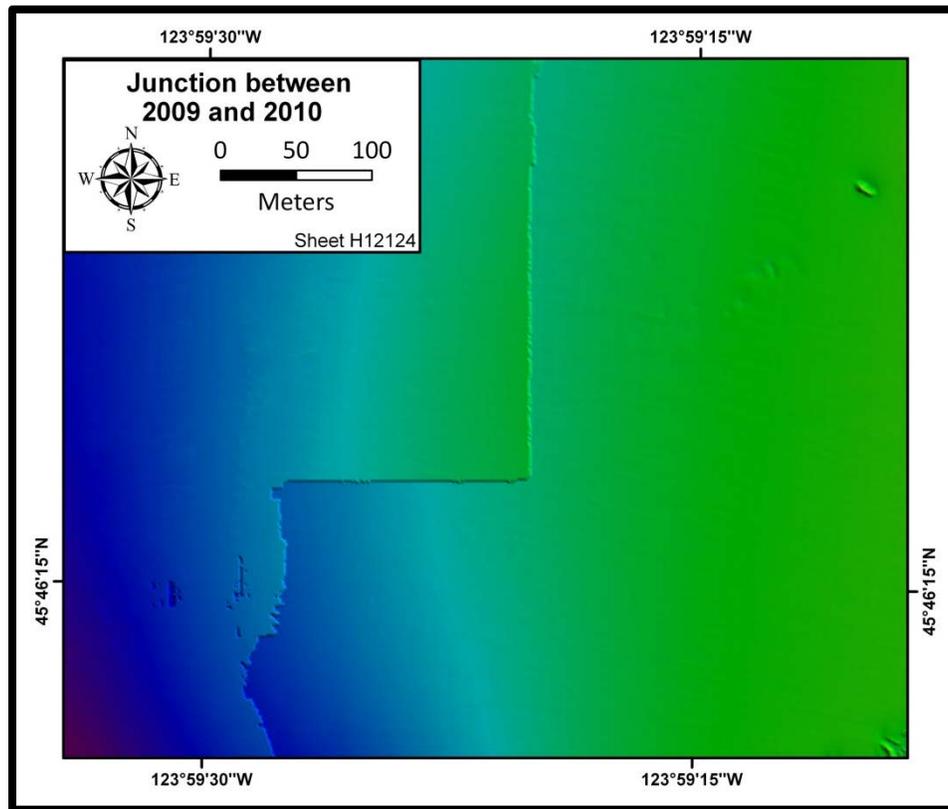
Figure 3. Plan view of the 2009 and 2010 survey junction

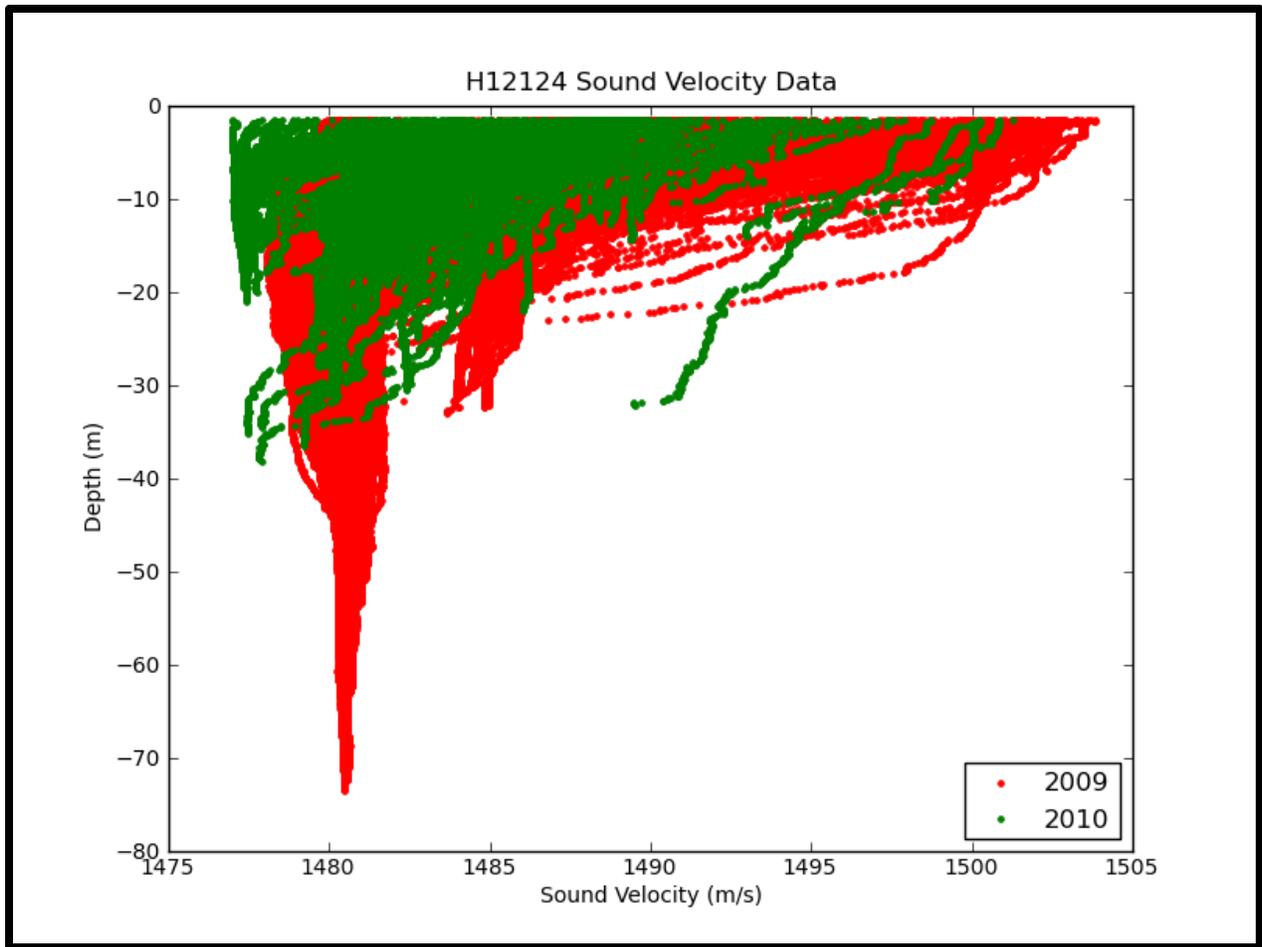
Figure 4. H12124 Sound Velocity Profile

Survey data were adversely affected by very steep sound velocity gradients and high variability in the sound velocity profile. Although an MVP30 moving vessel profiler was used to measure sound velocity profiles every 10 to 15 minutes, the variability in between casts resulted in errors of 20 to 30 centimeters in outer beam soundings, with some instances in deeper water reaching 50 centimeters. Figure 4 depicts all 824 sound velocity profiles collected during survey operations.¹²

While sound speed at depth is relatively constant over the course of the survey, the sound speed near the surface varies by nearly 20 meters per second. In addition, the depth of the sound speed gradient maximum varies by over 30 meters. Significant spatial variability in sound speed was also observed, with changes in sound speed of up to 18 meters per second occurring over spatial scales of as little as several hundred meters. Some of this spatial variability is depicted in Figure 5 on the following page, which shows the interpolated sound velocity at five meters water depth for specific survey days. As a result of this high degree of variability in sound velocity, refraction artifacts are still present within the dataset, despite frequent sound velocity casts from the MVP in accordance with procedures described in the DAPR.¹³ As described in the DAPR, a weekly comparison of sound velocity casts was made between the MVP30 and a Seabird SBE-19 CTD to verify the performance of the sound velocity and depth sensor in the MVP30 towfish. Results from these comparisons are included in Separate II *Sound Speed Data* along with a copy of the annual calibration reports for all sound speed sensors.

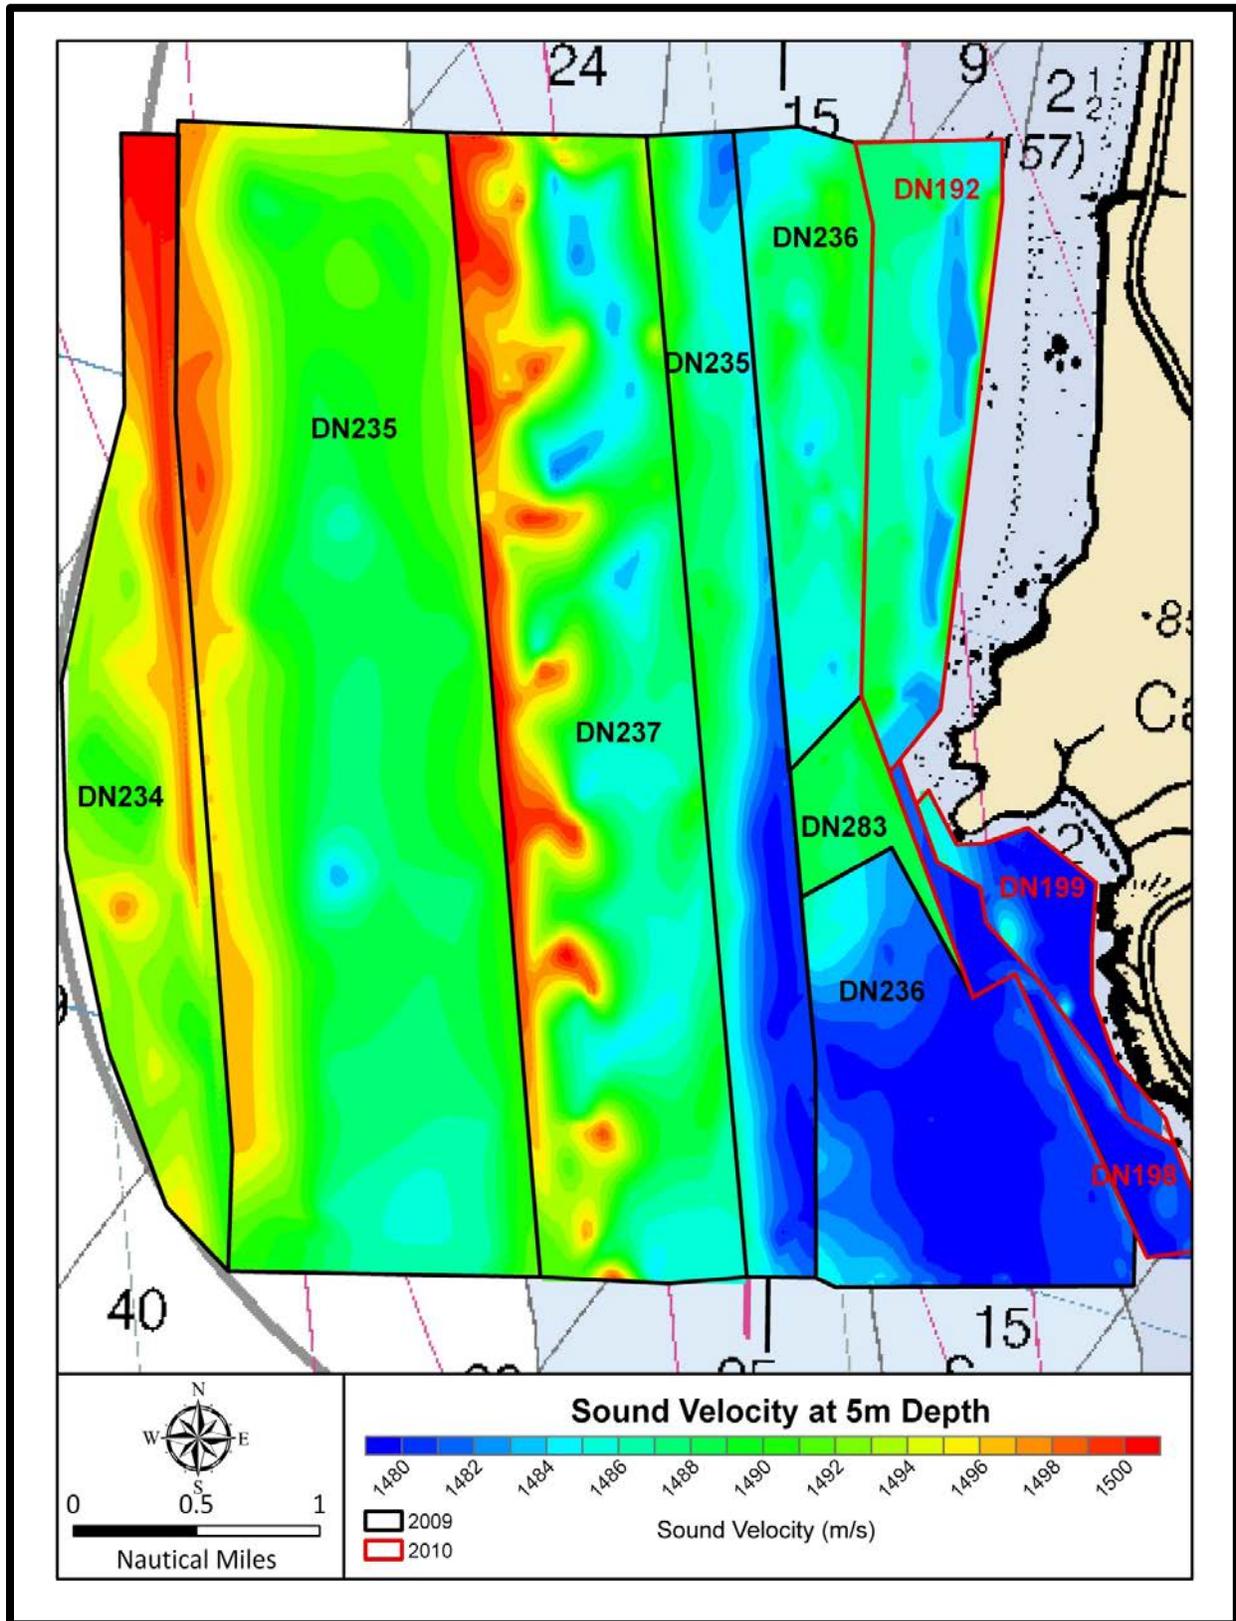
Figure 5. Sound Velocity at 5-meter Depth by Survey Day

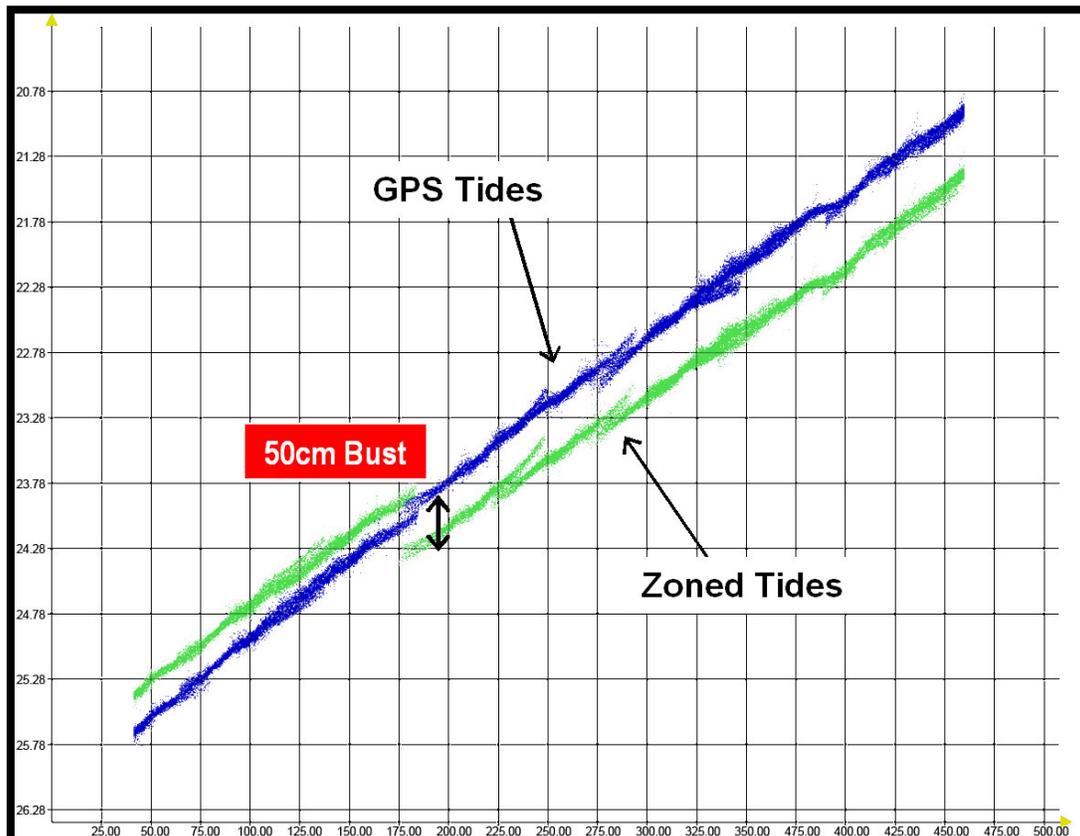
Figure 6. Depth discrepancies between tides derived from GPS and tidal zoning

The decision to use GPS Tides in lieu of discrete zoning was made for the entire project rather than on a sheet by sheet basis. As shown in the example for H12124 (Figure 6), the use of GPS Tides considerably improved swath to swath agreement of adjacent survey lines. In many cases, the use of GPS tides removed 50- to 60-centimeter offsets between adjacent survey lines reduced with discrete zoning.

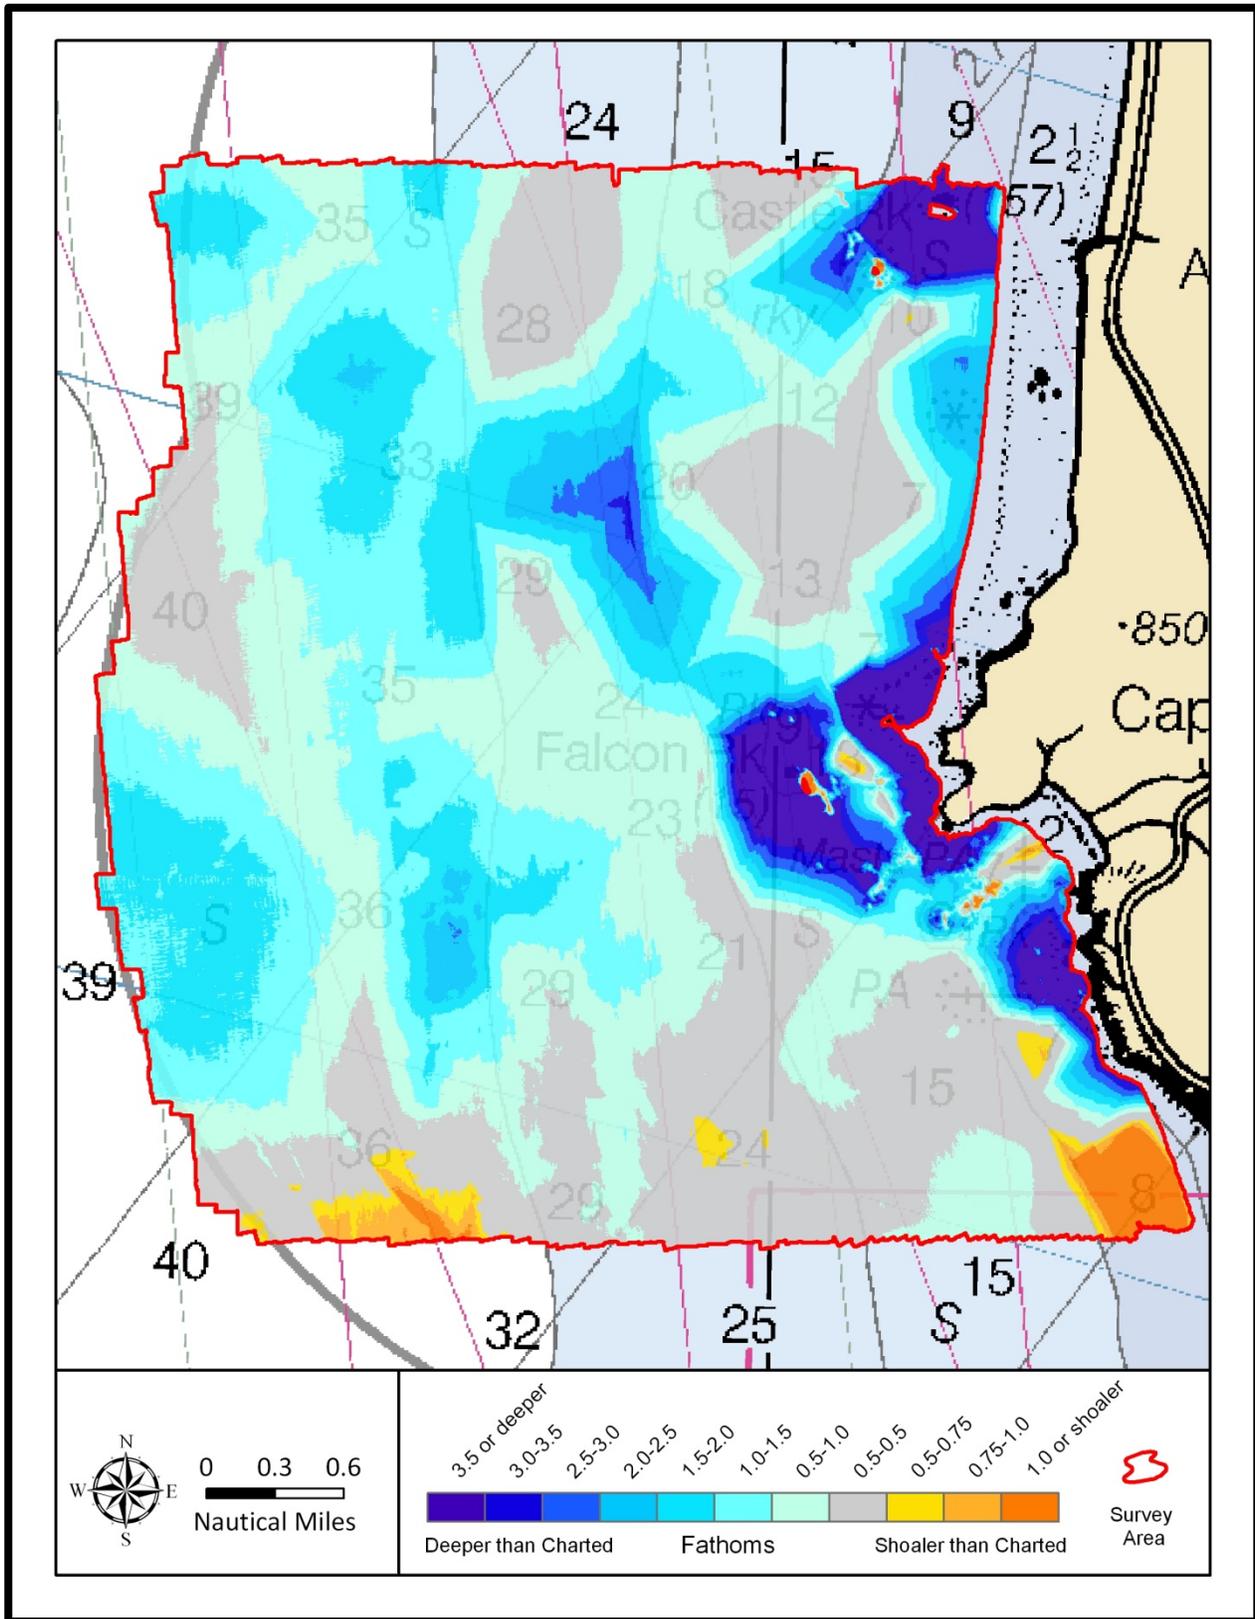
Figure 7. Depth discrepancies between H12124 and US3OR01M; Chart 18520 displayed

In general, survey H12124 depths are 1 to 2 fathoms deeper than those from the chart (Figure 7). The difference surface also shows areas of significant difference, from as much as 4 fathoms deeper to 3 fathoms shoaler. These more significant differences are mostly a byproduct of comparing a dense dataset to a surface produced from a triangulated irregular network (TIN) of a small scale ENC composed of sparse soundings and contours. Most of the significant variations occur in the vicinity of charted rocks where the surveyed seafloor is being compared to the interpolated surface. Given the scale of the underlying chart, most of these discrepancies are not considered navigationally significant.²⁰

1. There is shoaling of over three fathoms centered on the charted eight fathom sounding in the southeast corner of the survey area.²¹

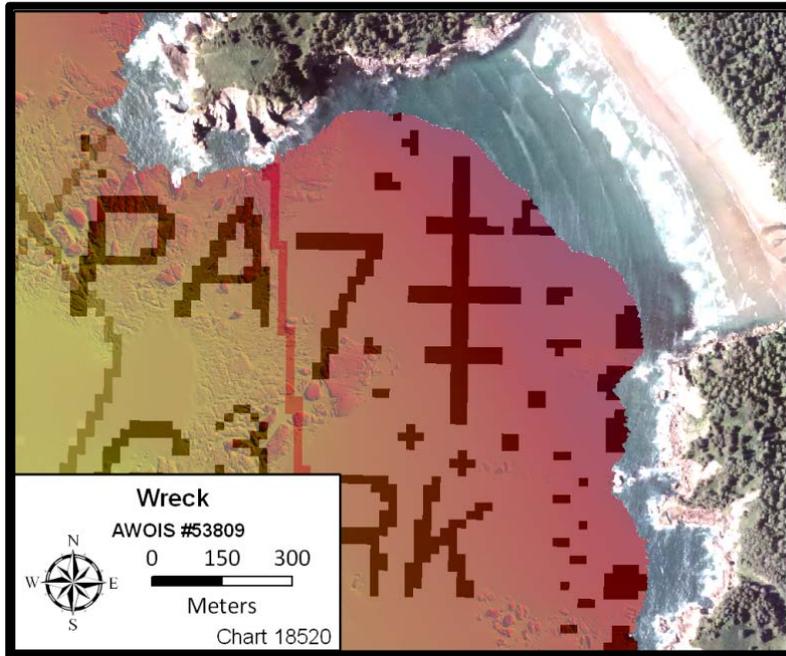
Figure 8. Comparison of data to AWOIS #53809

The search radius for AWOIS #53809 extends onto land (Figure 8). The survey vessel proceeded as far shoreward of the 4-meter contour as was safely possible and found no indication of the presence of a wreck. No exposed masts were visible to the survey vessel. AWOIS #53809 is considered disproved within the surveyed area.²³

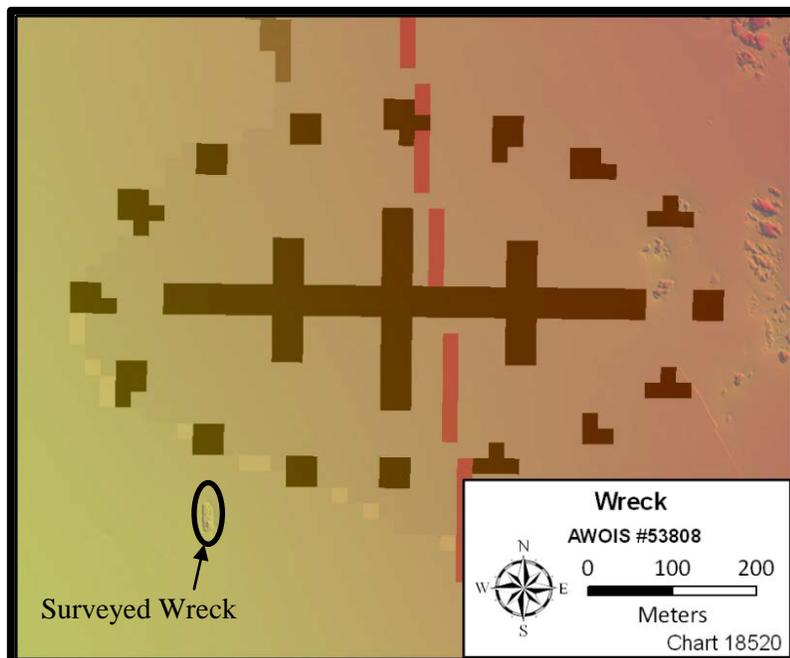
Figure 9. Comparison of data to AWOIS #5808

The wreck PA (AWOIS ID#53808) was not found at its charted location and has been disproved (Figure 9). A wreck was discovered inside the AWOIS search radius 340 meters, or 1.8 millimeters at chart scale, to the south-west of the charted position of the wreck PA. This wreck is included in the S-57 feature file.²⁴

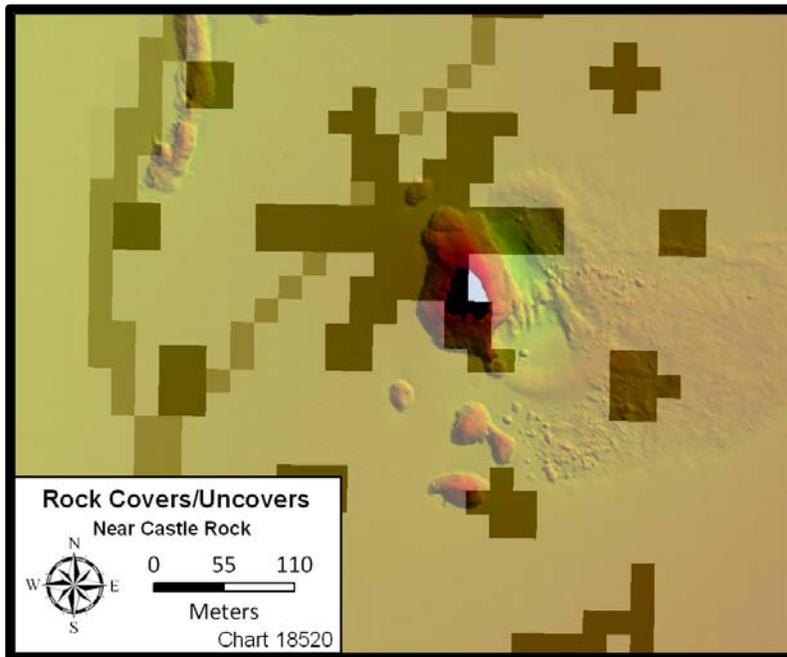
Figure 10. Comparison of data to charted rock

The charted and surveyed positions of the rock which covers and uncovers to the south-west of Castle Rock agree well (Figure 10). The center of the surveyed area lies 65 meters, or 0.4 millimeters at chart scale, to the south-east of the charted position. Due to the shift in the position of the rock, the ENC feature was disproved. The feature file includes an underwater rock feature which identifies the most shoal depth obtained around the base of this rock. The hydrographer recommends charting this rock as covers and uncovers and using the one meter BAG to estimate the geographic position of the rock.²⁵

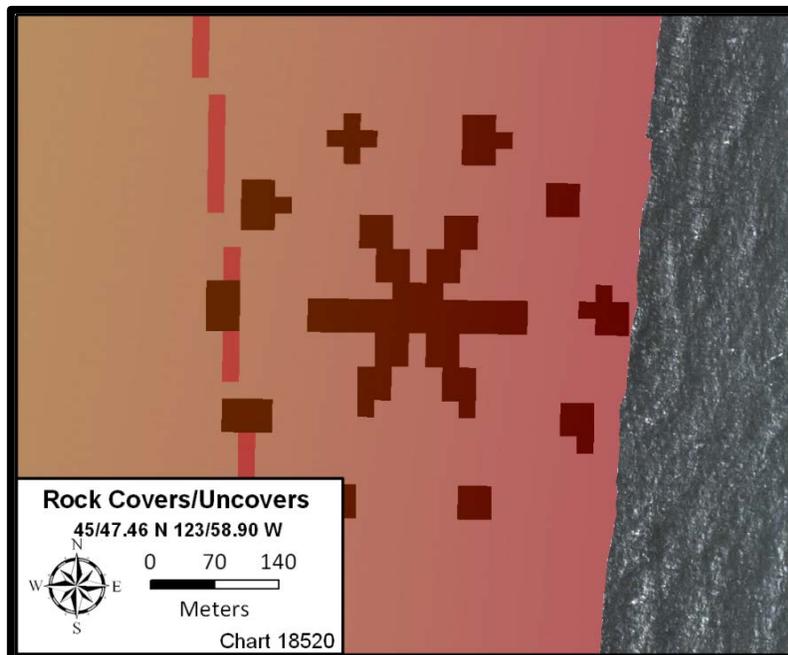
Figure 11. Comparison of data to charted rock

The charted rock which covers and uncovers approximately 1 nautical mile due south of Castle Rock, does not correlate to any rock within the surveyed dataset, or any rock observed by the field crew (Figure 11). The ENC feature is disproved within the surveyed area.²⁶

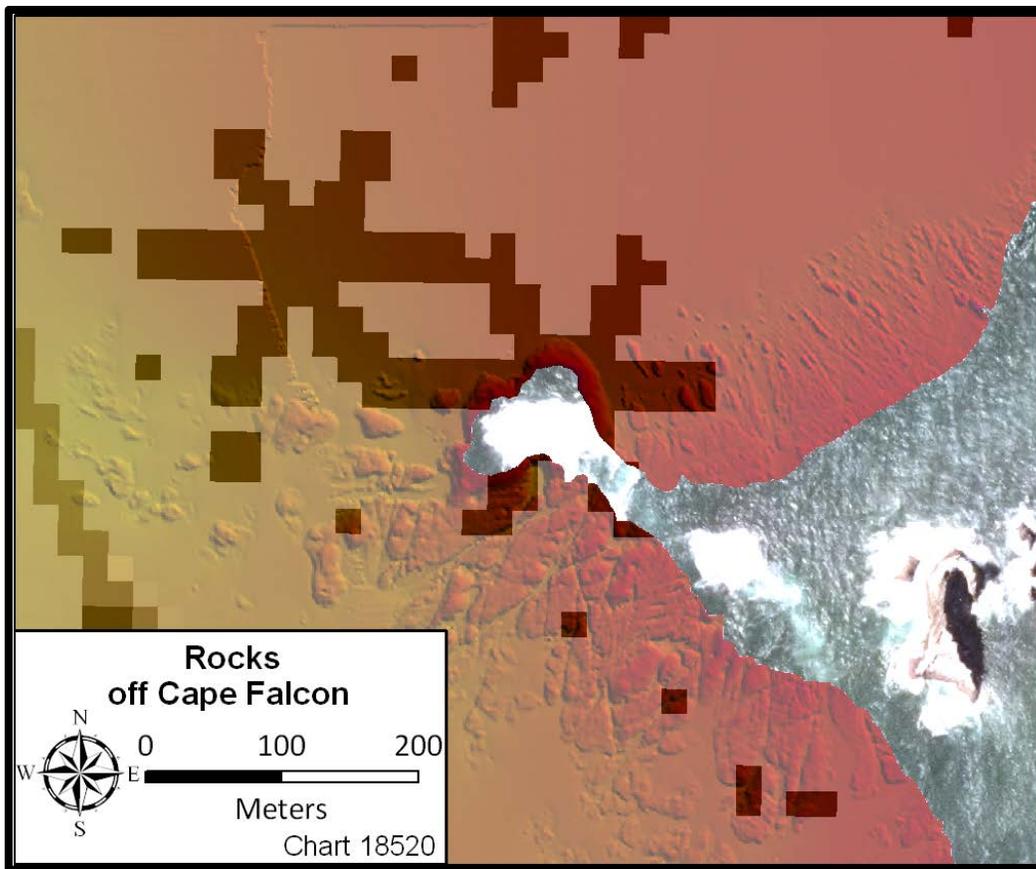
Figure 12. Comparison of data to charted rocks

The charted position of the north-west rock of the pair of rocks off Cape Falcon did not correlate to any observed feature within the dataset and was disproved by the survey (Figure 12).²⁷ The charted position of the rock to the south-east agreed well with the survey. The center of the surveyed area lies approximately 35 meters, or 0.2 millimeters at chart scale, to the south-west of the charted position. Due to the slight change in position, the ENC feature was considered disproved.²⁸ The feature file includes an underwater rock that marks the most shoal depth attained on this feature. Field personnel visually noted an exposed rock shoreward of this location. Field personnel also noted an additional rock approximately 150 meters to the south-east. The hydrographer recommends charting two rocks that cover and uncover in this area. The position of the rock to the north-west may be estimated using the one meter BAG. The position of the rock to the south-east may be estimated from overhead imagery from the National Agriculture Imagery Program (NAIP).²⁹

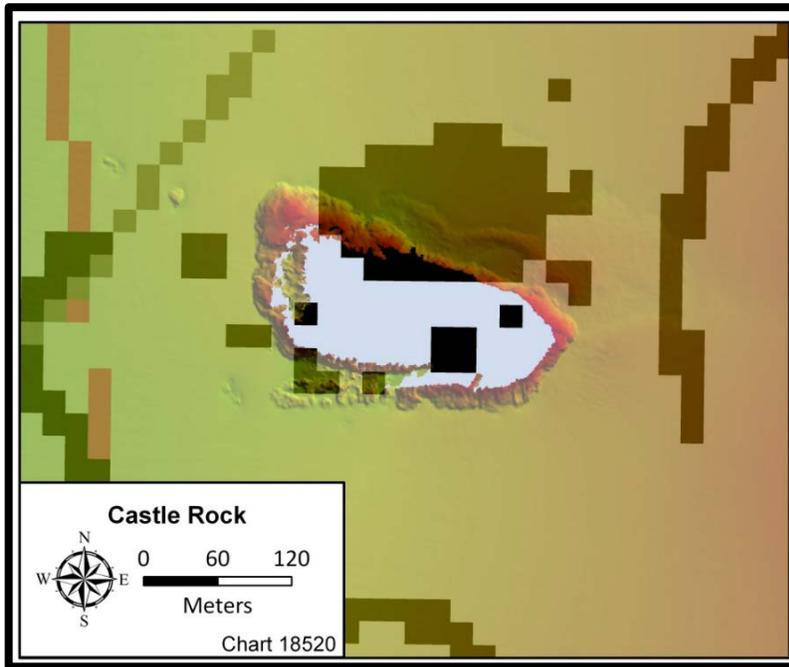
Figure 13. Comparison of data to Castle Rock

The charted and surveyed positions of Castle Rock agree well at chart scale (Figure 13). The surveyed position lies approximately 90 meters, or 0.5 millimeters at chart scale, to the south-south-east of the charted position. The hydrographer recommends adjusting the position of the land area to coincide with the survey data.³⁰

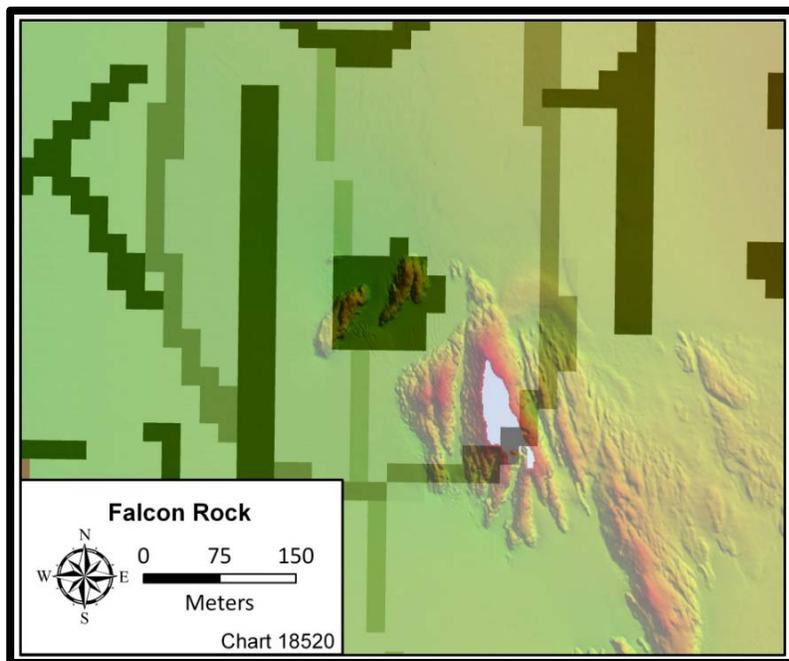
Figure 14. Comparison of data to Falcon Rock

The charted and surveyed positions of Falcon Rock agree well at chart scale (Figure 14). The surveyed position lies approximately 170 meters, or 0.9 millimeters at chart scale, to the south-east of the charted position. The hydrographer recommends adjusting the position of the land area to coincide with the survey data.³¹

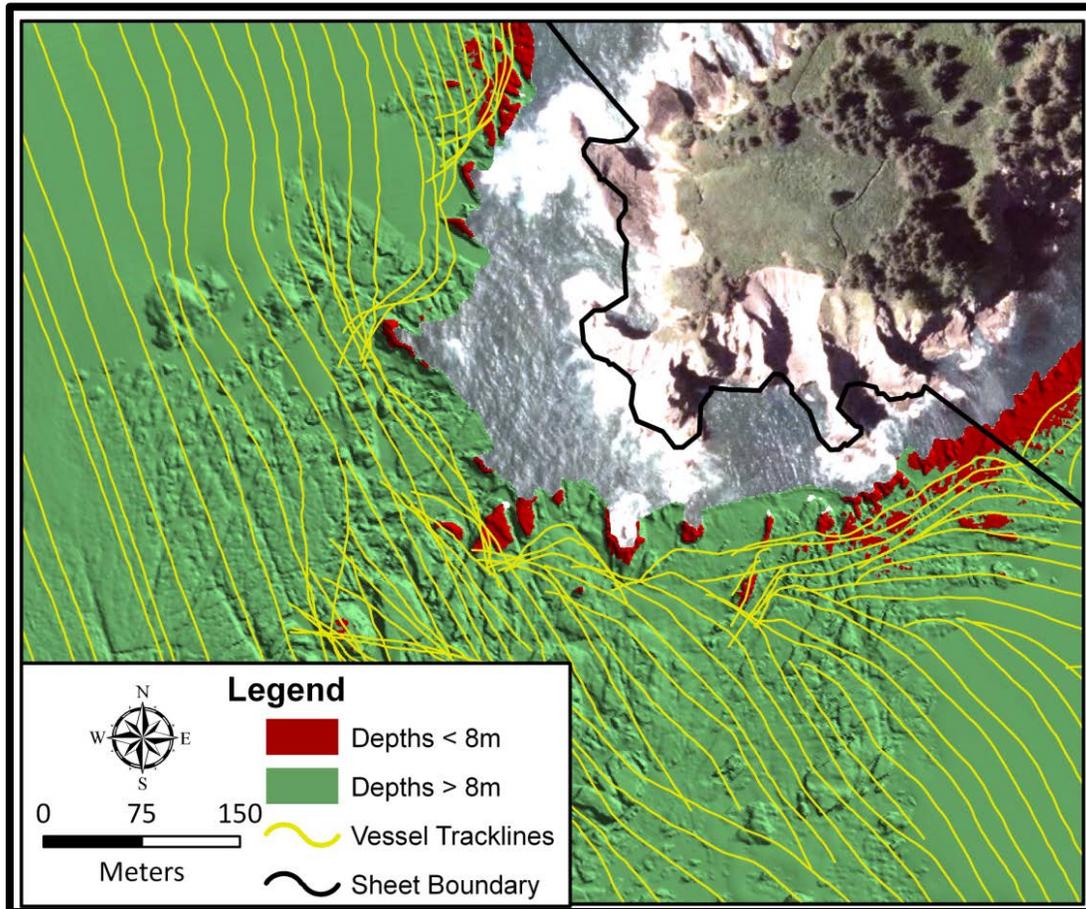
Figure 15. Data gaps near hazardous areas

The coastline in vicinity of the survey area offers no protection from incoming swell and sea. As a result, ocean swell was a continuous presence and presented a hazard when working near to shore and adjacent to awash rocks. This prevented the survey vessel from collecting data as close to shore and awash rocks as would otherwise be possible. Additionally, this resulted in areas where the survey data did not extend to either the sheet boundary or continuously map the 8-meter contour. The most significant departure from the 8-meter contour is shown in Figure 15, where depths shallower than 8 meters are depicted in red, survey vessel track lines in yellow, and the survey boundary provided with the *Project Instructions* in black. Despite revisiting this area during relatively calm conditions, safety of navigation precluded surveying further than depicted due to the effect of swell on the vessel.

Every effort was made to survey as close as possible to awash or baring features. Working close to dangerous features in the presence of ocean swell required the close and constant coordination of both members of the survey crew and the vessel captain. This close coordination and the use of a purpose built vessel enabled data to be collected much closer to shore and to dangerous rocks than would normally be possible. At times awash rocks and baring rocks were visible close aboard the survey vessel. However, the environmental conditions did not allow time for the survey crew to safely estimate the height and position of these features. Annotations were entered into the log once the risk to the vessel had passed.

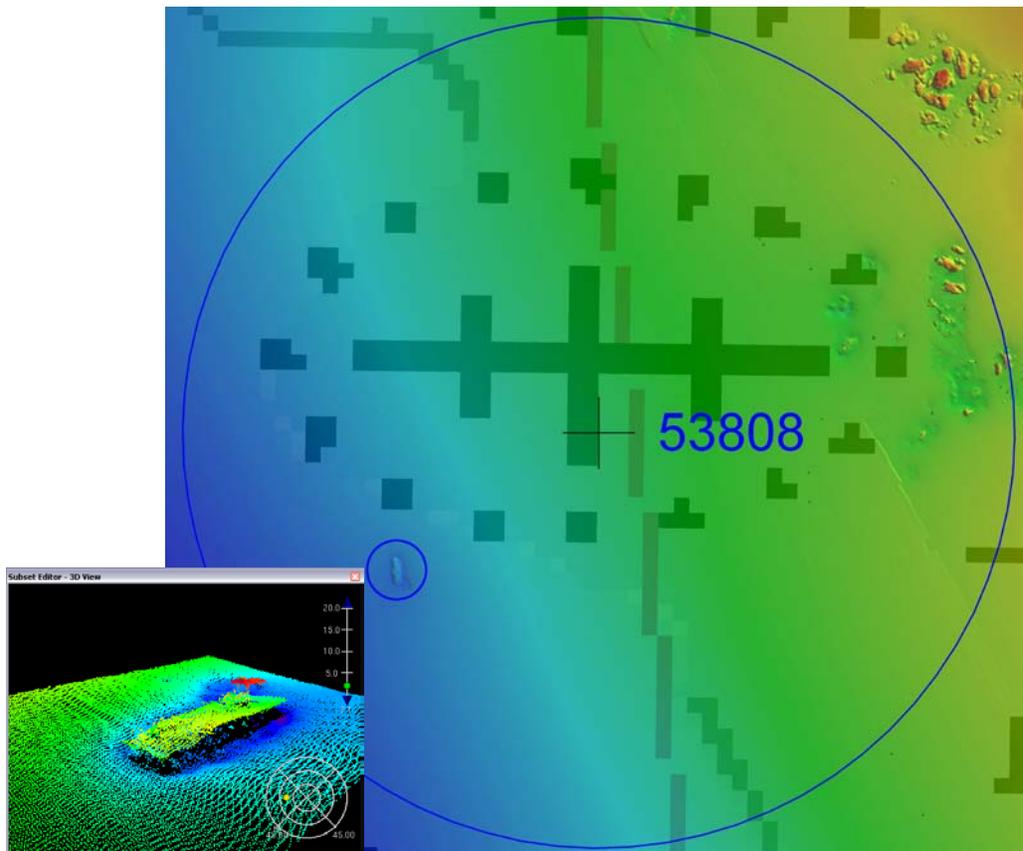
**Figure 1. AWOIS 53808 Radius.
Complete multibeam coverage and 3D view. Chart 18520.**

Remove the charted wreck *PA* symbol and add a non-dangerous wreck to the charts at the surveyed position.

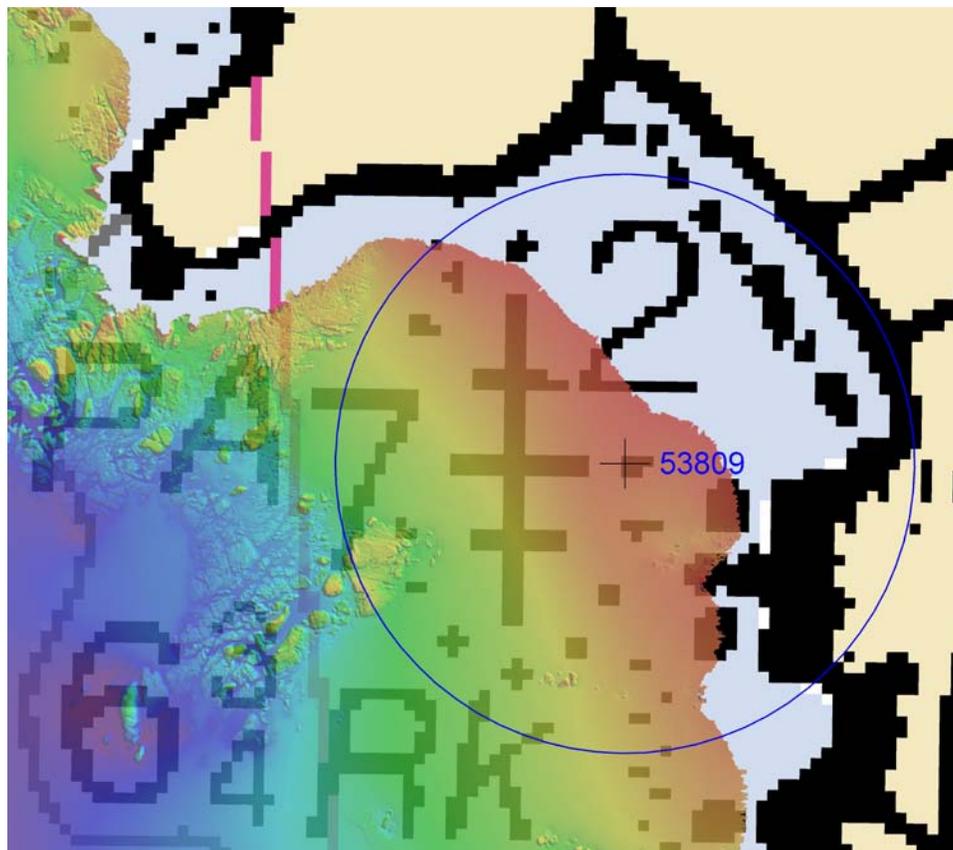
Figure 2. AWOIS 53809 Radius.
100% multibeam coverage to a depth of 4m. Chart 18520.
Page 3 of 3

The charted *Masts PA* submerged wreck, AWOIS 53809, was not found with 100% multibeam coverage to a depth of at least 4m or as close to shore as rocks and safe navigation permitted. Field personnel did a visual sweep to shore of the bay and found no masts or other sign of wreckage. Full coverage of the AWOIS radius was not possible due its positioning over land.

Remove the wreck from its charted location. Either chart the wreck shoreward of the survey coverage or remove from the charts altogether.
