H12170

DESCRIPTIVE REPORT

Type of Survey Hydrographic Survey

General Locality Kuskokwim River

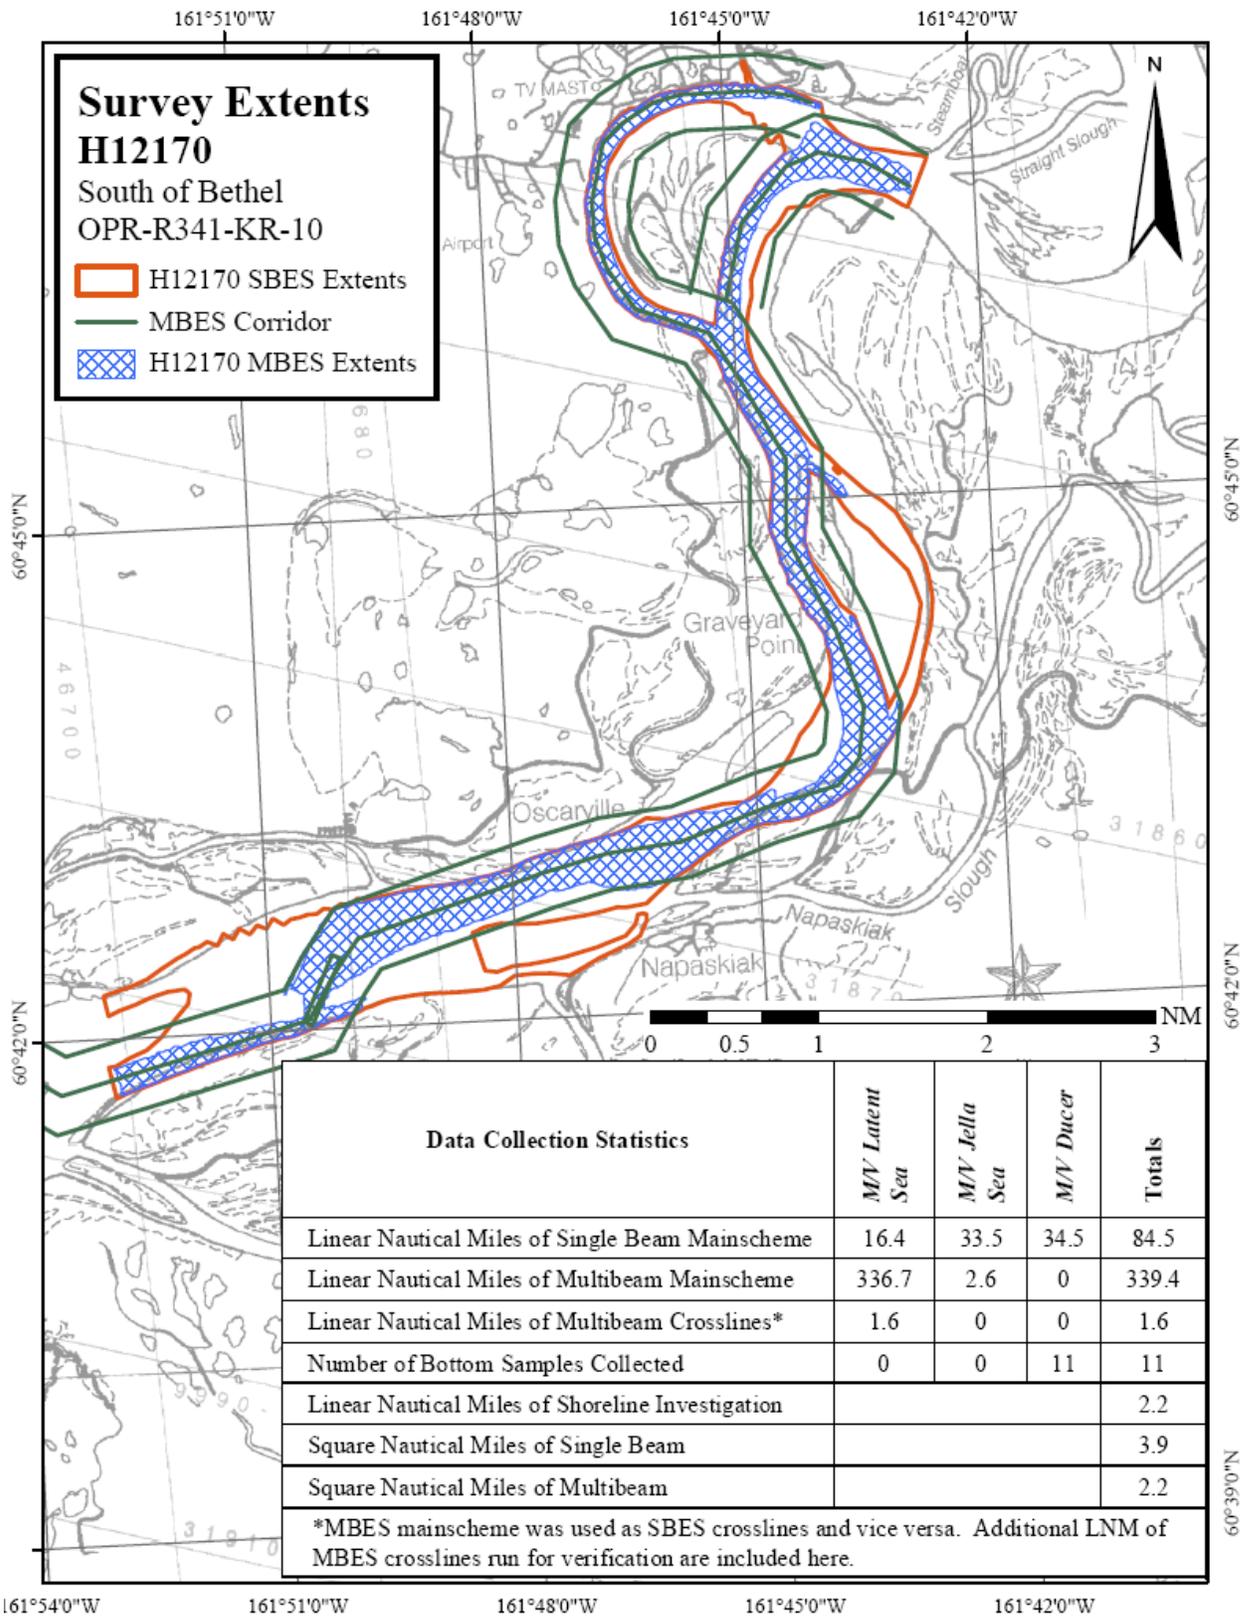
Figure 1 – H12170 Survey Extents and Statistics

For complete survey limits, refer to Figure 1 above and *Appendix III: Final Progress Sketch and Survey Outline* of this report.

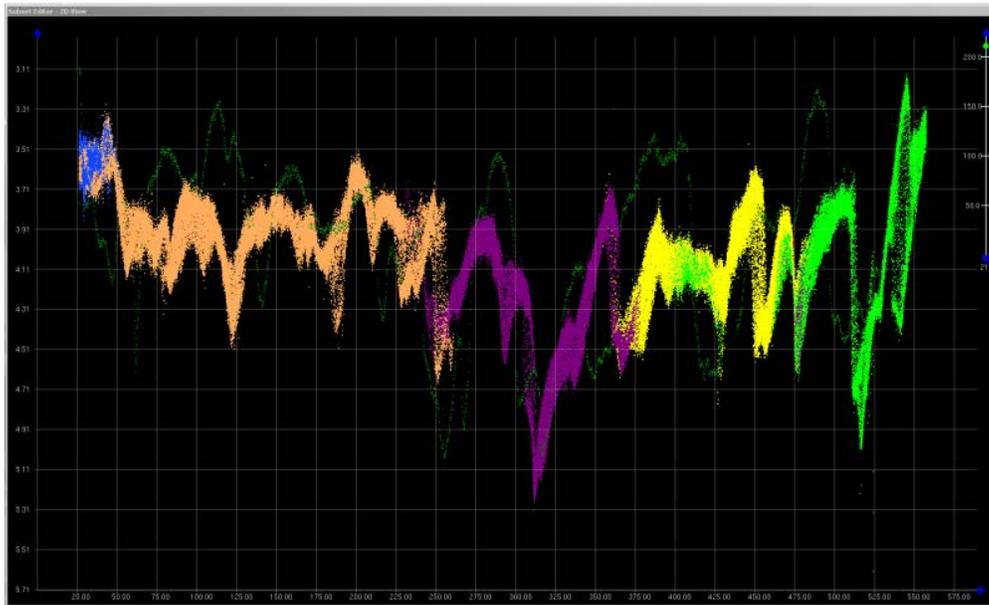
Figure 2 – Example from CARIS subset of QC failure due to bottom change. Single beam crossline (IG-18-SB01330a shown in dark green) run on JD173 transects multibeam data ran between JD220 and 233. Example from 60-42-19.7 N, 161-50-25.6 W. Vertical scale is 0.20m.

An example of a crossline that fails QC is shown below.

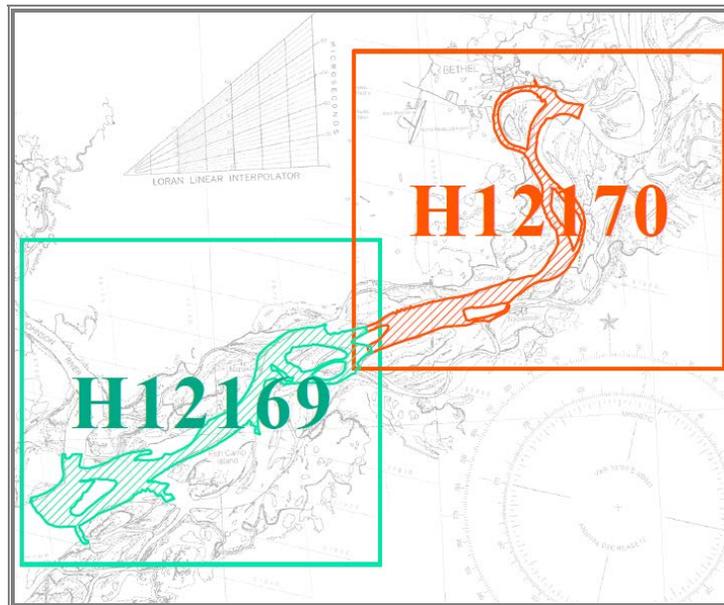
Figure 3 – Junction of H12170 (orange) with H12169 (turquoise) from this project (OPR-R341-KR-10) on chart 16304 (2nd edition, January 2005).

For the junction with H12169, the soundings are also in good general agreement between the surveys, with the majority agreeing to better than 0.10 m¹². Larger offset is observed (up to 1.00 m) between Julian days 221 and 244, attributed to bottom change.

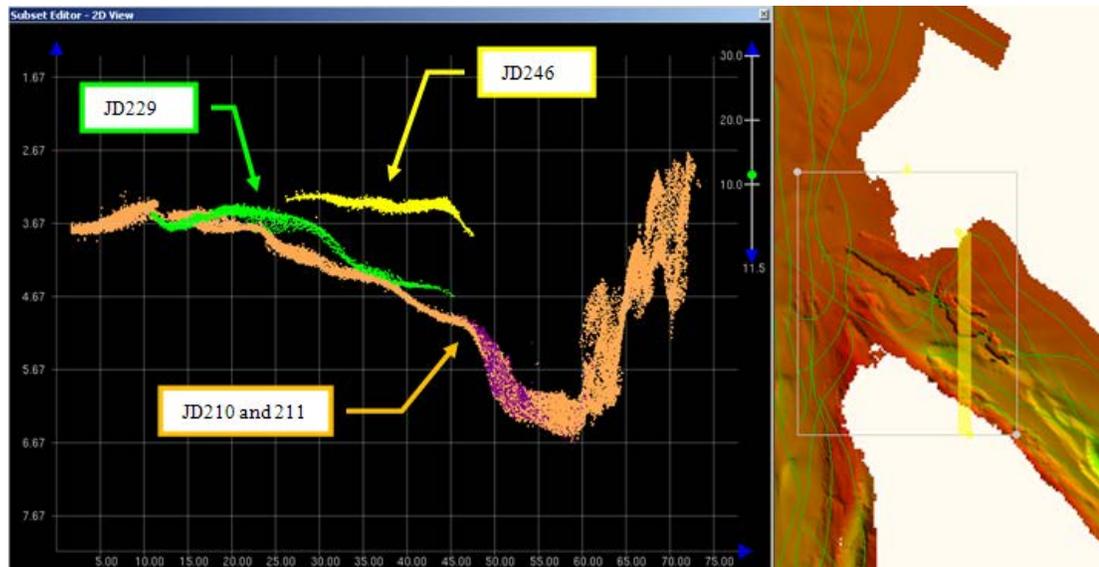
Figure 4 – Example from CARIS subset at 60-45-11.4 N, 161-44-08.8 W of lines in H12170 showing up to 1.5 m of bottom change over a 36 day period. Lines are colored by day – yellow line is a final infill collected for the area. Area is in a side-slough that appears to be progressively shoaling over time at its entrance. Vertical scale is 1 m.

- Bottom changes due to sediment transport were identified as the primary cause of busts between adjacent data sets. Significant changes are apparent whenever large periods of time (days to weeks) separate times of data collection. The issue is more common when comparing single-beam data to multibeam data, and multibeam mainscheme with multibeam in-fills, due to the differences in times of acquisition¹⁵. An example of significant bottom change in this survey is shown below.

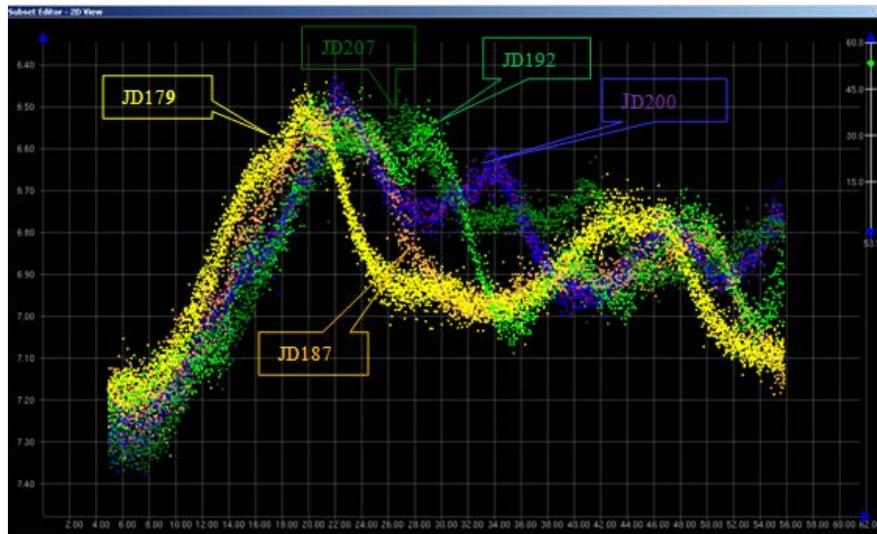
Figure 5 – Example from CARIS subset of JD179 to JD207 echosounder comparisons. Lines are colored by day. Matchup is poor – sand waves shift up to 4 meters, causing up to 0.50 meters of vertical shift. Vertical grid spacing is 0.10 m.

Note that in one portion of the survey, the weekly echosounder comparison was done on the same line consecutively five times, from Julian days 179 to 207. All show excellent agreement between vessels and echosounders, but when all five days are plotted together, significant bottom change is apparent. During this time sand waves shift up to 4 meters horizontally and appear and disappear altogether¹⁶. An example from the echosounder comparisons is shown below.

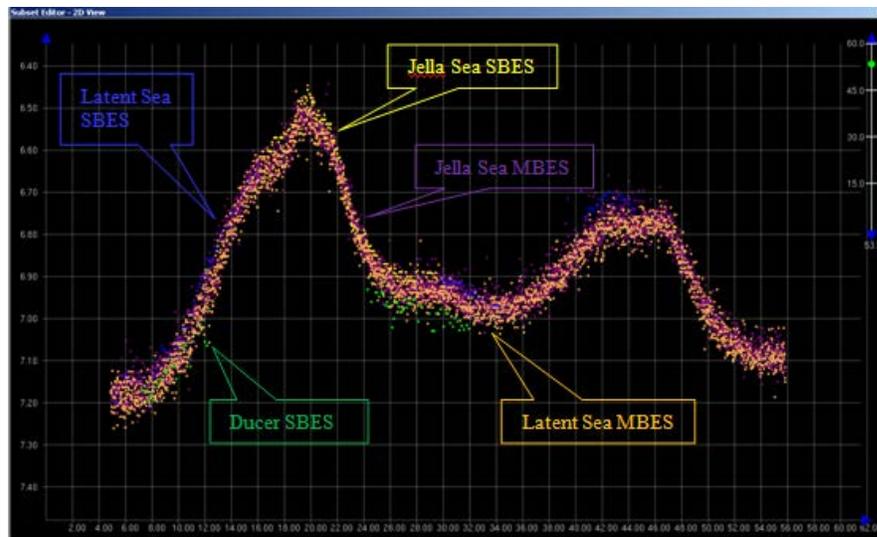
Figure 6 – Example from CARIS subset of JD179 echosounder comparison data only, same area as above figure. Lines are colored by vessel, and consist of the three single-beam echosounders and two multibeam sonars, showing good agreement. Vertical grid spacing is 0.10 m.

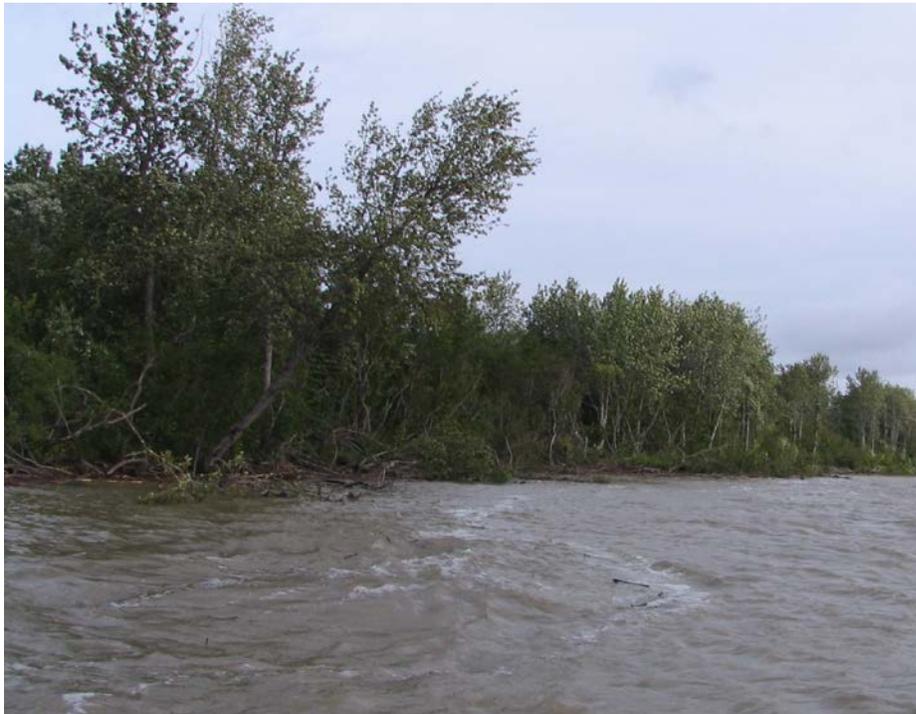
Figure 7 – Example from the M/V Ducer of eroding river bank with overhanging bushes swept by current in H12170. It was not possible to achieve the 1 meter contour with single beam in some of these areas, even at high tide. Photo taken near 60-46-04 N, 161-45-49 W.

- Multibeam coverage was achieved for the most part along the Bethel waterfront. However due to the vertical nature of the wharf and the presence of vessels tied up alongside it, achieving 4 m wasn't always possible²¹. One example is at 60-46-44.36 N, 161-46-41.23 W, where multibeam achieved about 5.4 meters due to the continuous presence of barges unloading at the ramp in this location.
- The 1-meter contour may not be achieved with single beam in areas of steep, undercut banks – frequently with overhanging brush and trees from erosion and swept by current. In these cases the survey vessel would push as close as safely possible to the bank and often still not achieve minimum depth specification. In some of these cases multibeam was able to achieve shoaler depths the singlebeam although not always to 1-meter²². An example from this survey is shown below.

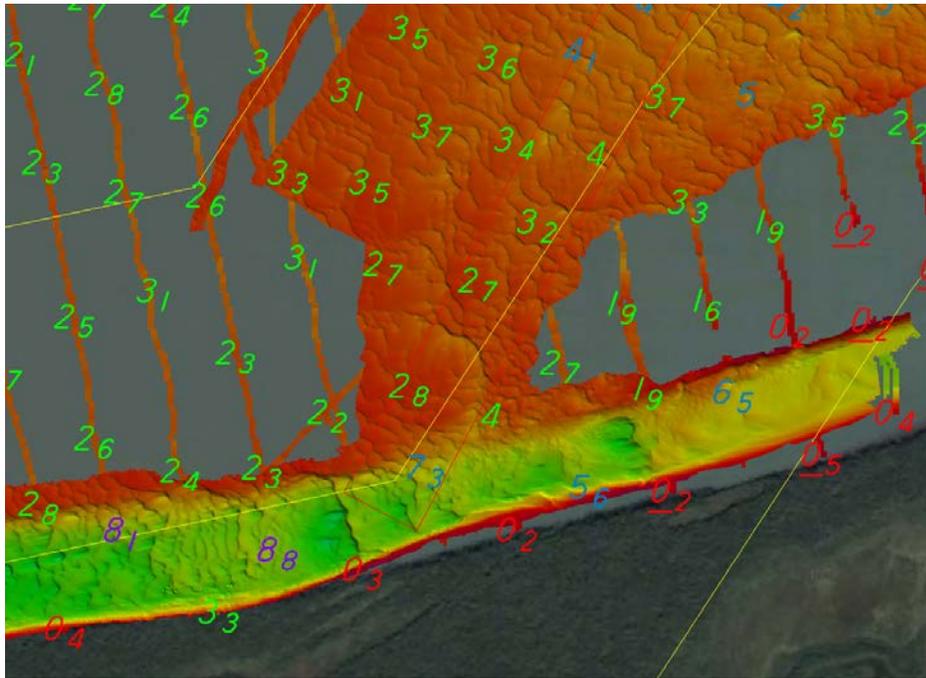
Figure 8 – Plot of data collected in natural constriction in river. Additional single beam lines were collected at 100 meter line spacing, and additional multibeam acquired in depths less than 4 meters to ensure continuous coverage. Shoal-biased single beam soundings are shown in meters on top of available multibeam coverage. Overlaid on Google Earth imagery.

- A natural constriction in the river exists in the vicinity of 60-42-08 N, 161-50-29 W. Additional single beam lines were run in the area (100 m line spacing) to provide denser single beam data per verbal request of the NOAA COTR. Additional multibeam lines were also run in the area despite depths of less than 4 meters per agreement with the NOAA COTR, to ensure continuous multibeam coverage. *Appendix V* includes correspondence relating to this area²³. All data is included with the survey deliverables. A plot of the area is shown below.

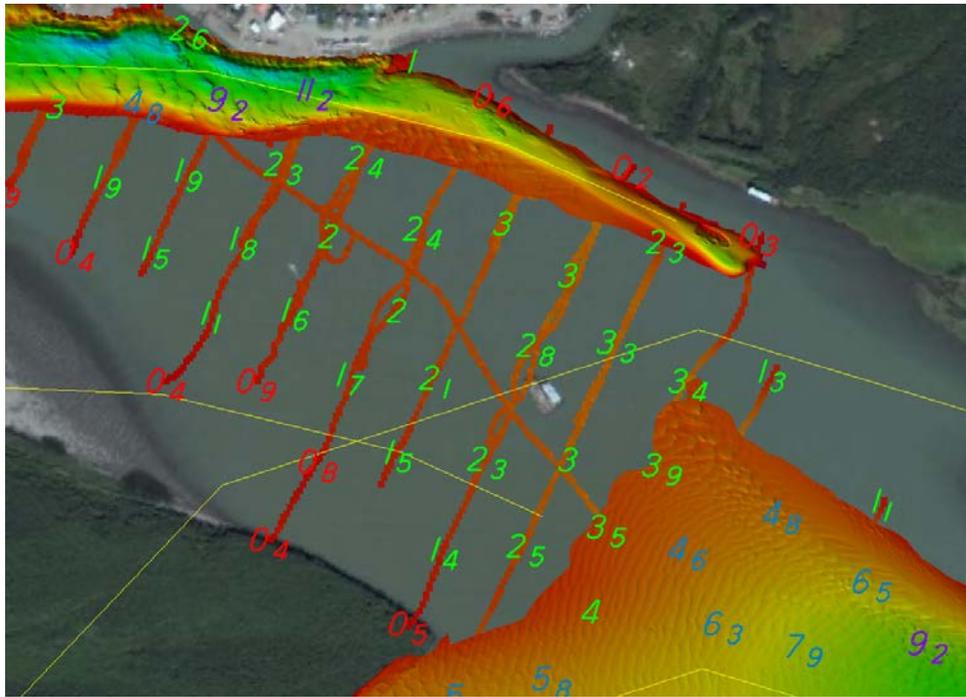
Figure 9 – Plot of additional single beam data collected near Bethel. Additional single beam lines were collected at 100 meter line spacing to provide denser data since the area is utilized as shortcut by vessel traffic continuing up river from Bethel. Shoal-biased single beam soundings are shown in meters on top of available multibeam coverage. Overlaid on Google Earth imagery.

- Additional singlebeam lines at 100 meter line spacing were collected near Bethel in the vicinity of 60-47-15 N, 161-44-10 W. These were collected per verbal request of the NOAA COTR to provide denser data in the area since it is utilized heavily by vessel traffic from Bethel continuing upstream. The area did not receive multibeam coverage because it was shoaler then 4 meters. All data is included with the survey deliverables. A plot of the area is shown below.

It is recommended that single beam data collected in the vicinity of 60-47-15 N, 161-44-10 W be applied to the chart. The area did not receive multibeam coverage because it was shoaler than 4 meters, but the area is utilized heavily by vessels as a shortcut from Bethel to continue upstream. The area is also described in section B.2.7 of this report where a plot is also included⁴⁴.

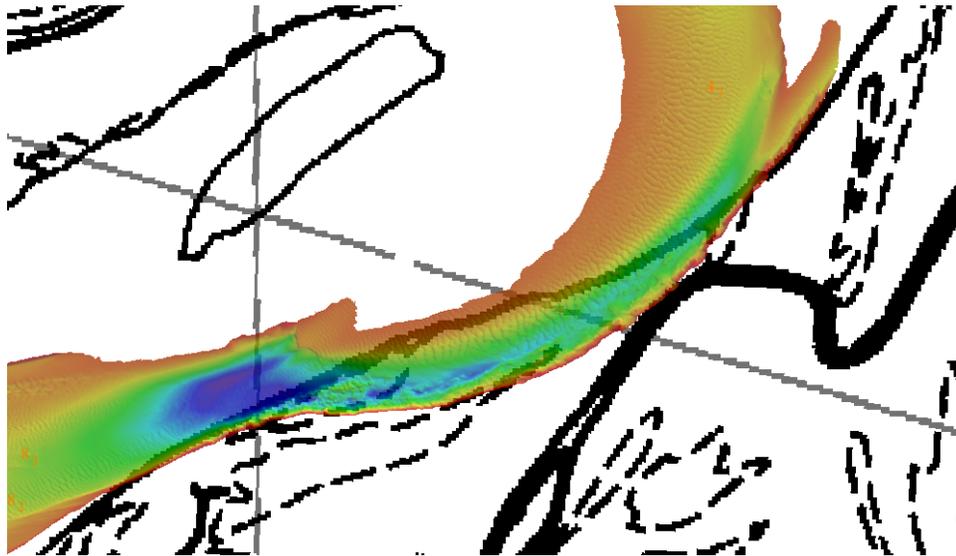
Figure 10 – Example of shoreline discrepancy on chart 16304. Multibeam coverage plotted on top of charted MHW.

- Survey data shows up to 250 meters of discrepancy with shoreline as portrayed on chart 16304 in the vicinity of 60-43-15 N, 161-44-29 W, due to significant erosion of the river bank. This survey was not tasked with shoreline verification (except along the Bethel waterfront); recommend updating shoreline detail³¹. See figure below.

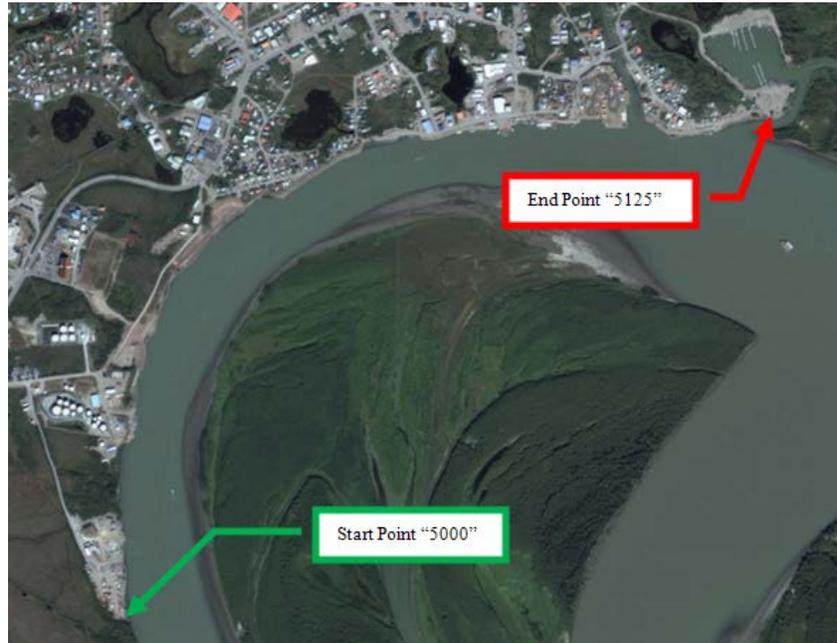
Figure 11 – Extents of Bethel waterfront shoreline verification. Data collected between the points shown. Shown on Google Earth imagery.

Shoreline verification was tasked for the Bethel waterfront in this sheet per verbal agreement with NOAA. The waterfront area extended from the southern-most developed area of town to the entrance of the small boat harbor, shown in the figure below.

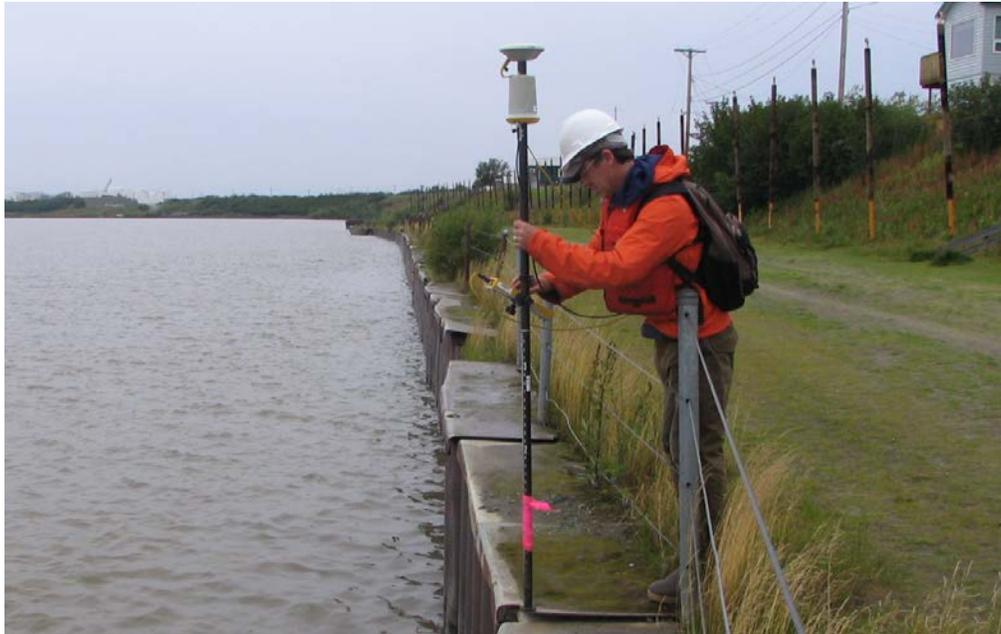
Figure 12 – RTK survey of Bethel waterfront

The equipment used was setup in an RTK-backpack design. A Trimble 5700 receiver was interfaced with a Trimble Zephyr Geodetic GPS antenna and Trimble RTK antenna, which were mounted on a survey rod. A Trimble Survey Controller (TSCe) was used to monitor the positioning quality and to log positions. Altitudes were corrected for height of instrument within the TSCe. The receiver was configured to accept NAD83 RTK corrections broadcast from TerraSond's RTK01 base station.

With this configuration the survey crew walked the approximately 2.2 mile Bethel waterfront and took positions at any significant change in shoreline vector or shoreline type. In areas of sloping shoreline the position was taken on the estimated mean high water line, while along the city wharf or wall the position was taken on the edge as shown in the photo below³⁴. Field notes were kept and digital photos taken to document the data and to facilitate S-57 attribution. These are included in *Separate I*.

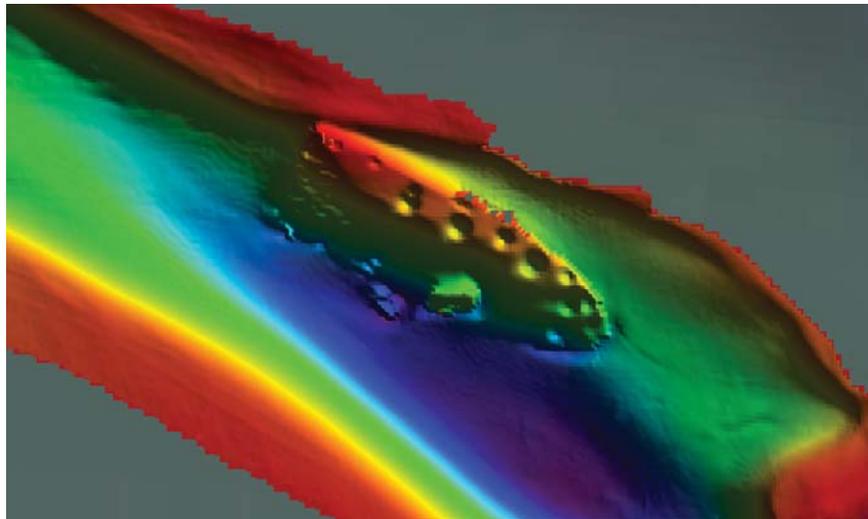
Obvious wreck in H12170. BASE surface shown at 0.5 m resolution.

An uncharted wreck was found in the survey area at 60-47-20.32 N, 161-43-52.85 W (geographical position of center). The wreck is apparent in the multibeam BASE surface.

Exact dimensions are difficult to determine due to scour and sedimentation, but the wreck is approximately 42 meters in length and 8 meters in width. It has a least depth of 1.195 meters. It is portrayed in the accompanying S-57 feature file at the least depth position.
