**DESCRIPTIVE REPORT**

Type of Survey: Basic Hydrographic Survey

Registry Number: H12954

General Locality: Southeastern Vicinity of the  
Chandeleur Islands

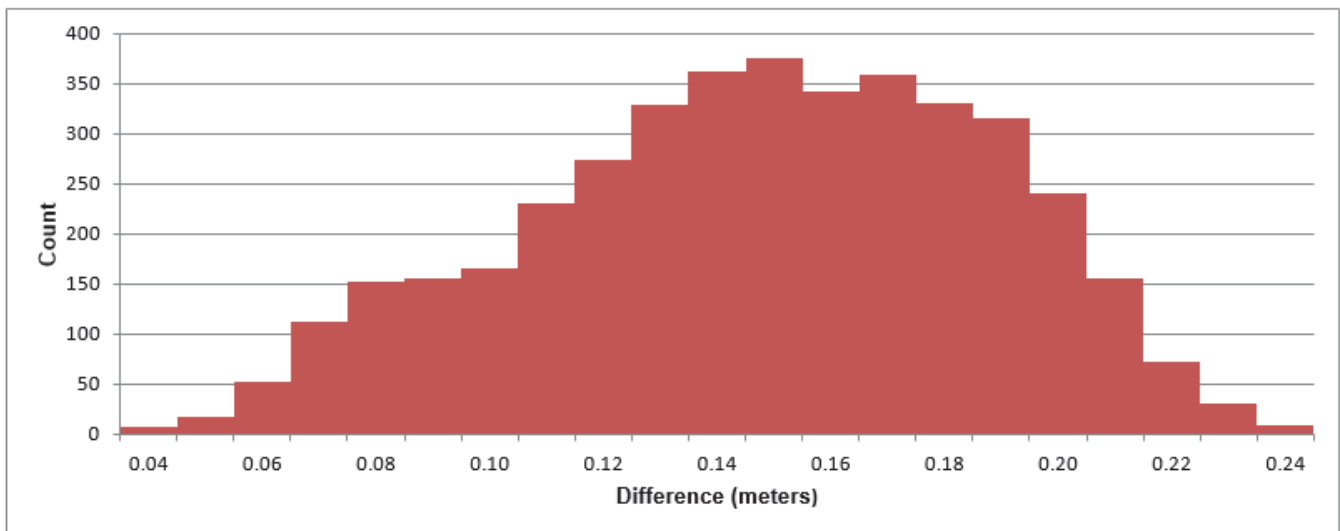
*Figure 5: Junction results between H12954 1-meter and H12528 4-meter bathy grids*

Mean:	0.149 m	Standard Deviation:	0.040 m
Minimum:	0.039 m	Bin size:	0.01 m
Maximum:	0.242 m	Number of Nodes:	4,091

Descriptive statistics from the junction comparison with H12528 are presented in Figure 5. The minimum and maximum differences are associated with sound speed and tide zoning artifacts. It appears that the depth bias between the two surveys also result from the use of disparate tide zoning schemes and refraction. Prior survey H12528 used zoning correctors from the NWLON gauge Pascagoula NOAA Lab, MS (8741533) while survey H12954 was controlled from the NWLON gauge Dauphin Island (8735180). The bias resulting from the use of different zoning schemes is intensified in the area of the survey junction do to refraction experienced during the H12954 survey.

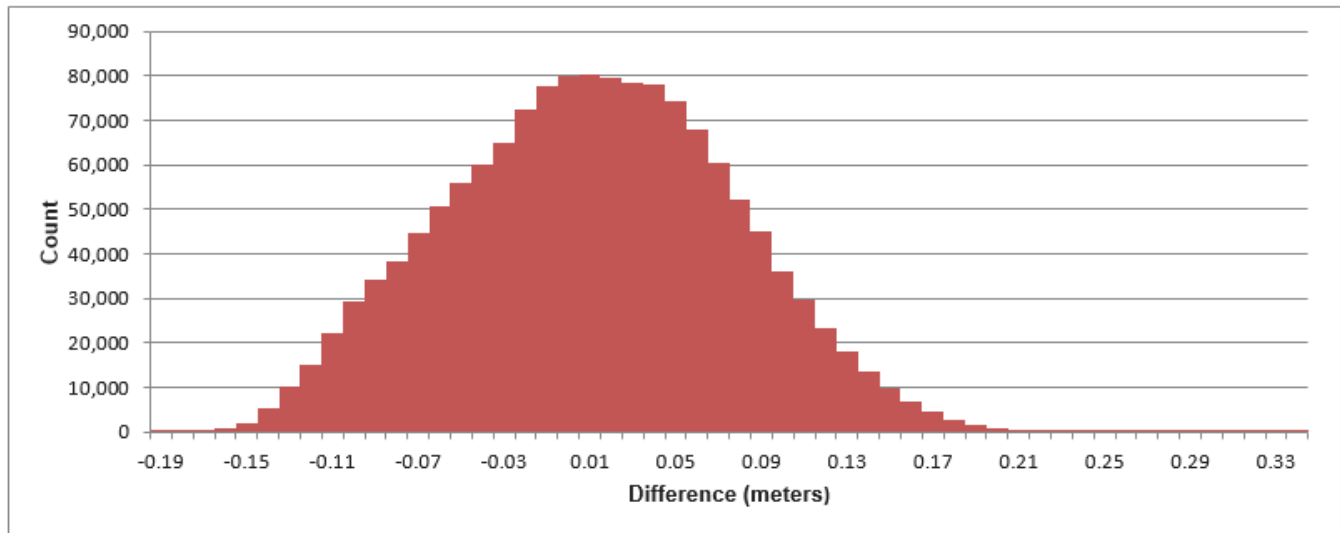
*Figure 6: Junction results between H12954 1-meter and H12529 4-meter bathy grids*

Mean:	0.015 m	Standard Deviation:	0.066 m
Minimum:	-0.187 m	Bin size:	0.01 m
Maximum:	0.346 m	Number of Nodes:	1,430,682

Descriptive statistics from the junction comparison with H12929 are presented in Figure 6. The surveys agree well, with minimum and maximum differences representative of surveys impacted by refraction and inaccuracies in discrete zoning methods

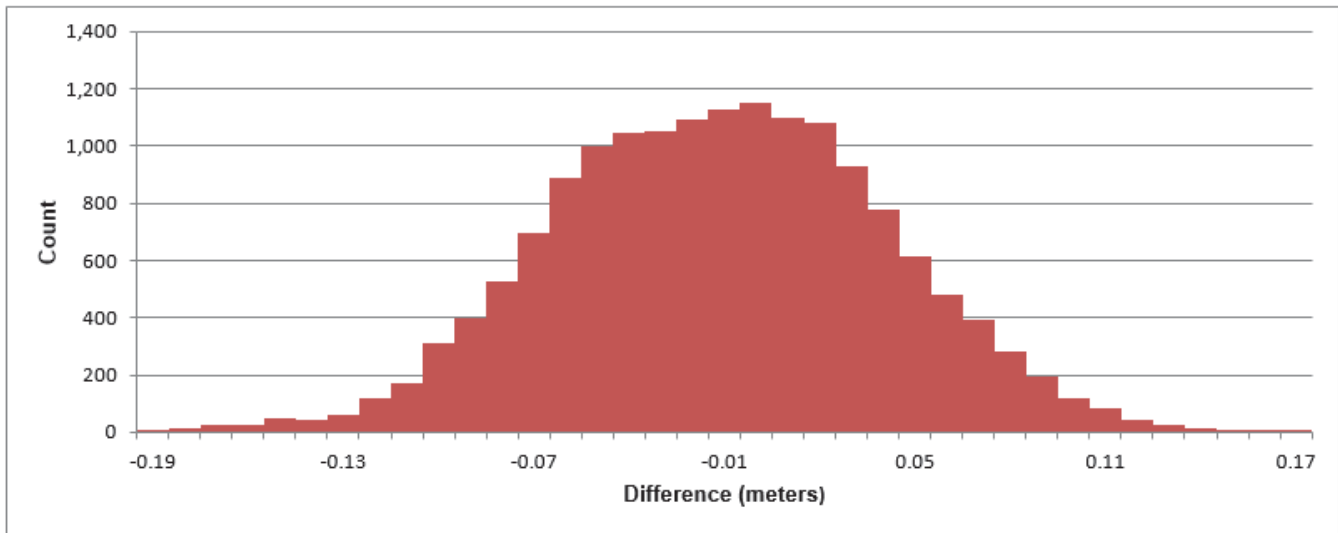
*Figure 8: Junction results between H12954 1-meter and H12953 1-meter bathy grids*

Mean:	-0.014 m	Standard Deviation:	0.052 m
Minimum:	-0.197 m	Bin size:	0.01 m
Maximum:	0.173 m	Number of Nodes:	15,942

Descriptive statistics from the junction comparison with H12953, which was also part of the OPR-J311-KR-16 survey project, are presented in Figure 8. The surveys agree well, with minimum and maximum differences representative of surveys impacted by refraction and inaccuracies in discrete zoning methods.
