DESCRIPTIVE REPORT

Type of Survey: Navigable Area

Registry Number: H13014

Sub-locality: Eggemoggin Reach

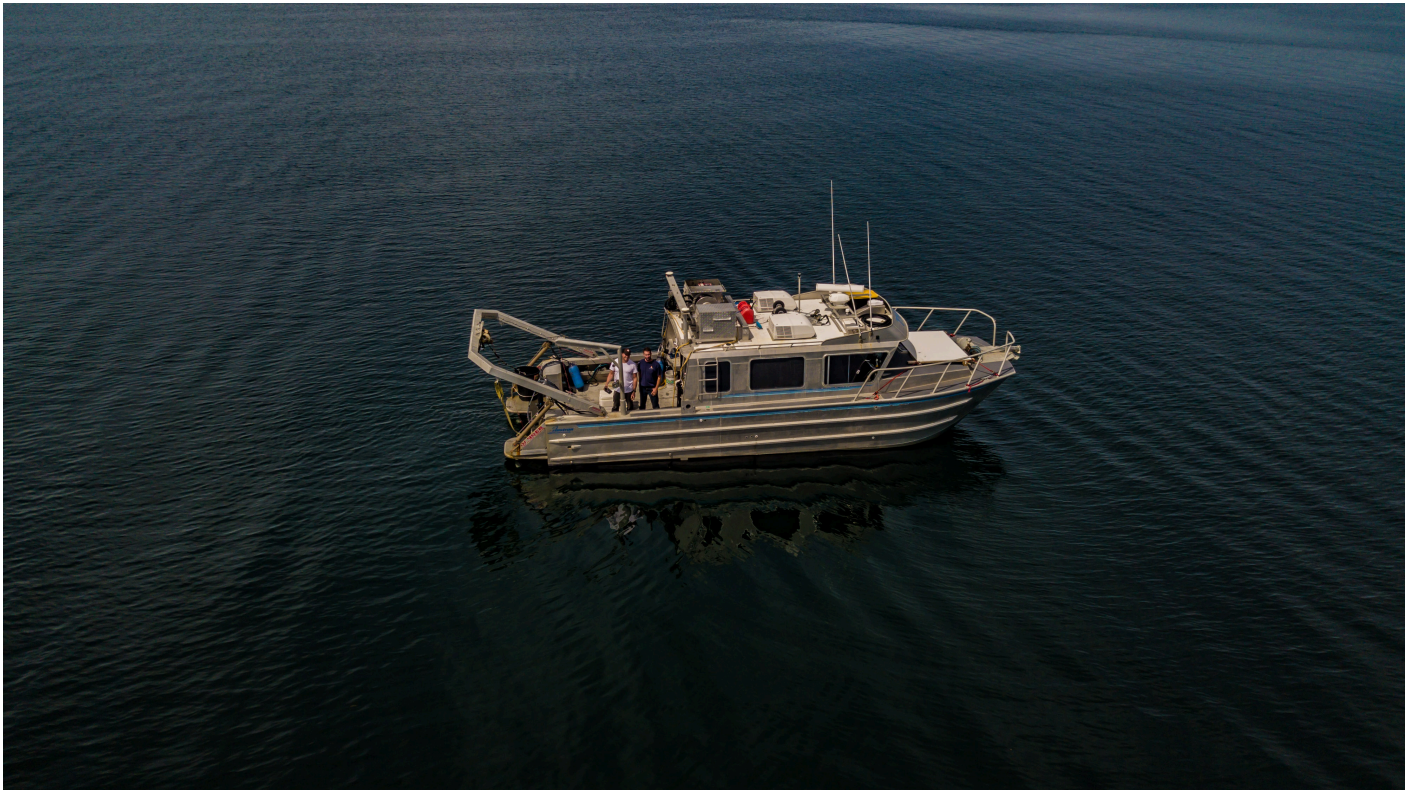
Figure 5: RV Theory

Fugro Pelagos, Inc. (Fugro) mobilized two catamaran-style jet drive survey boats (Theory and Westerly), which were equipped with an over-the-stern pole that housed an underwater IMU and dual-head Reson 7125 multibeam sonars (dual meaning two independent systems). The Reson systems and IMU were installed on a special mount, where each Reson 7125 was rotated approximately 15 degrees and the IMU was centered above the 7125s. These vessels were used to survey in water depths greater than 8 meters, and to augment the LiDAR collection effort in the 3-meter to 8-meter water depth range. In addition to the two vessels, a small aircraft was fitted with a SHOALS-1000T Airborne LiDAR Bathymetry (ALB) system to map data inshore of the 8-meter contour. An Allied Prosilica GX3300 down-look camera and VQ-820-G (RIEGL) LiDAR sensor were also installed. These extra systems were not part of the project instructions or a requirement, but were installed to aid with feature verification and detection.

Sound Speed Cast Frequency: Sound velocity casts were normally performed every two to three hours on the R/V Theory and R/V Westerly. For each cast, the probes were held at the surface for one to two minutes to achieve temperature equilibrium. The probes were then lowered and raised at a rate of 1 m/s. Between casts, the sound velocity sensors were stored inside the lab or in fresh water to minimize salt-water corrosion and to hold them at ambient water temperature.

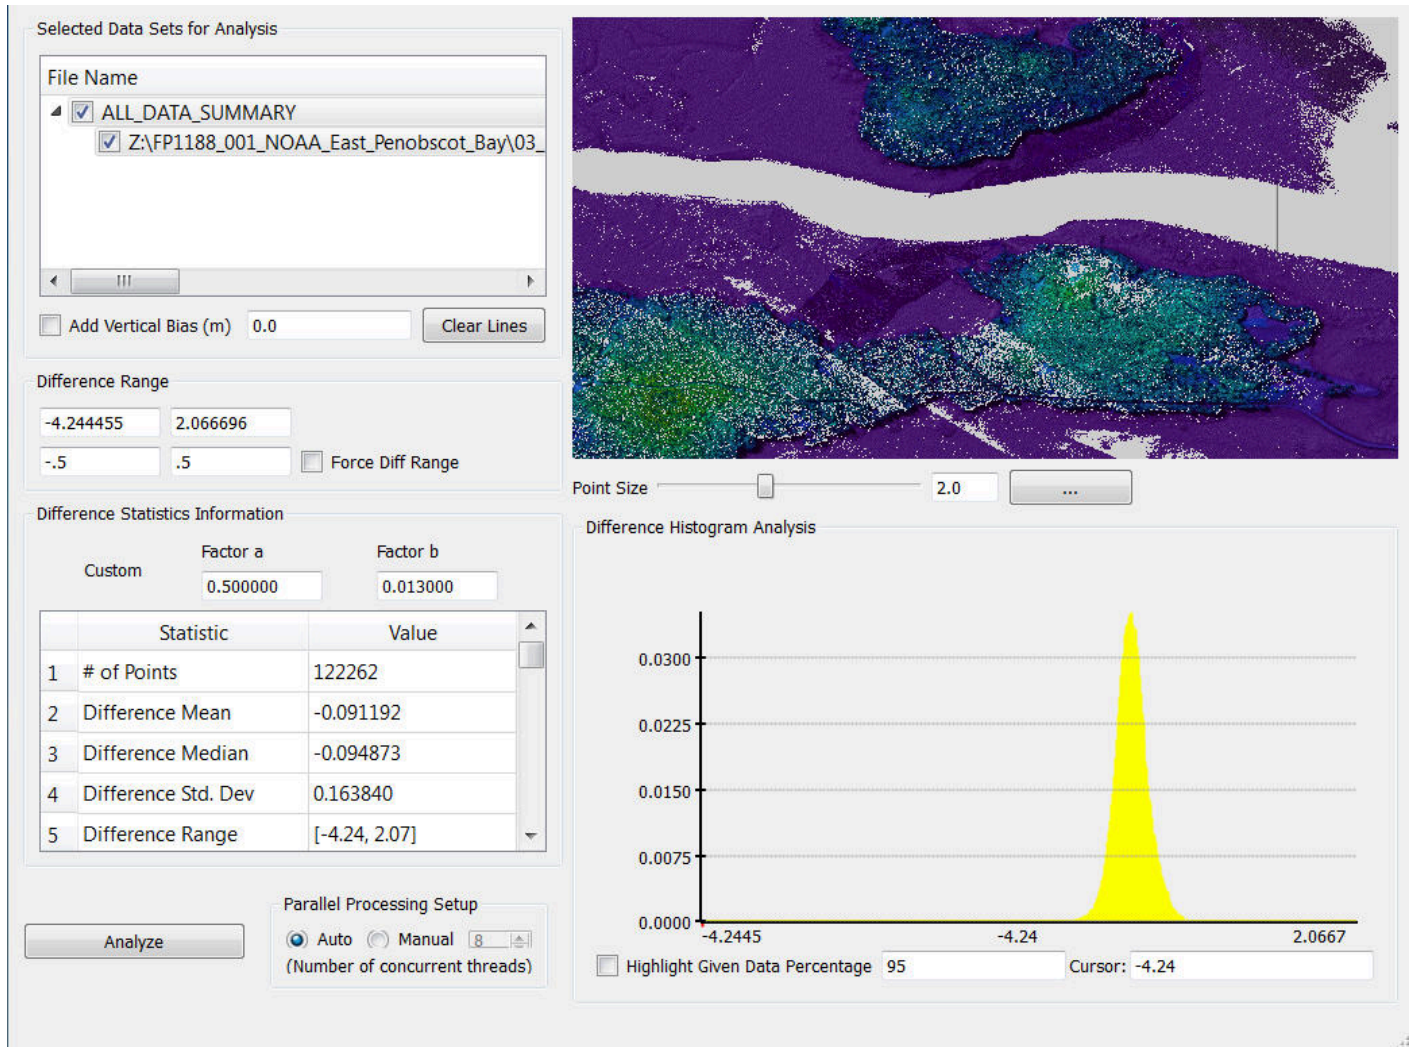
Figure 13: Flight Line 170628_1509_A_02091 QC

Statistic	Value
1	# of Points	122262
2	Difference Mean	-0.091192
3	Difference Median	-0.094873
4	Difference Std. Dev	0.163840
5	Difference Range	[-4.24, 2.07]

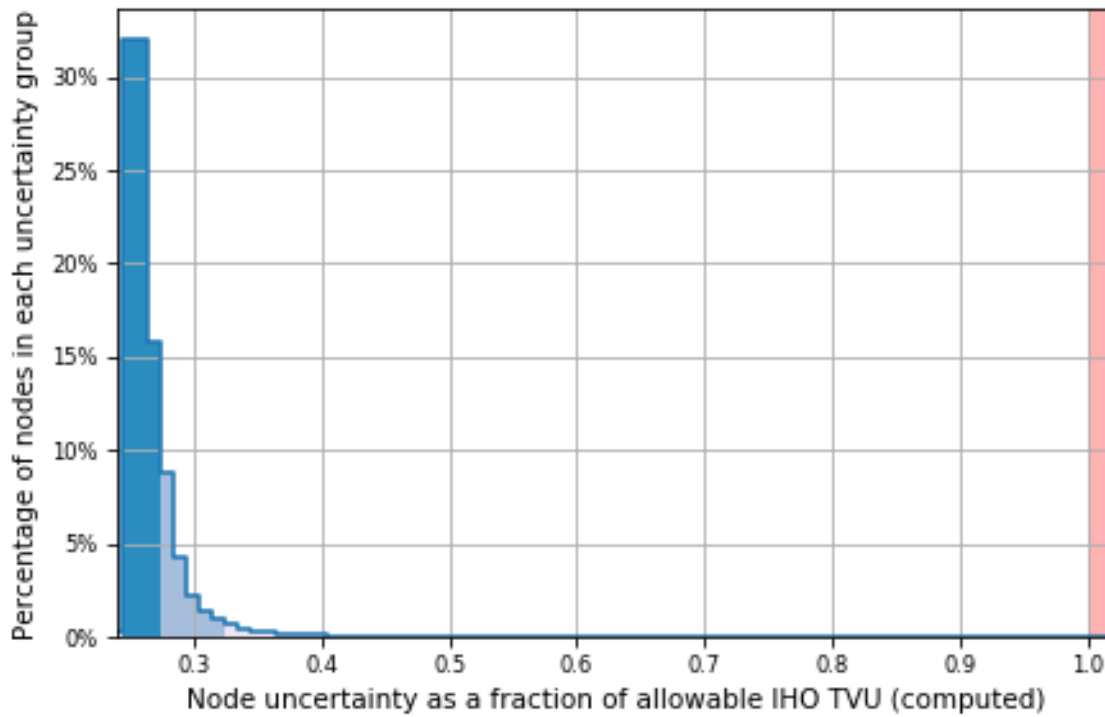
Figure 16: Hydroffice Surface Report H13014 (Priority 4) 1m

99.5+% pass (53,351,270 of all nodes), min=0.24, mode=0.25, max=1.31

Percentiles: 2.5%=0.25, Q1=0.25, median=0.26, Q3=0.27, 97.5%=0.32

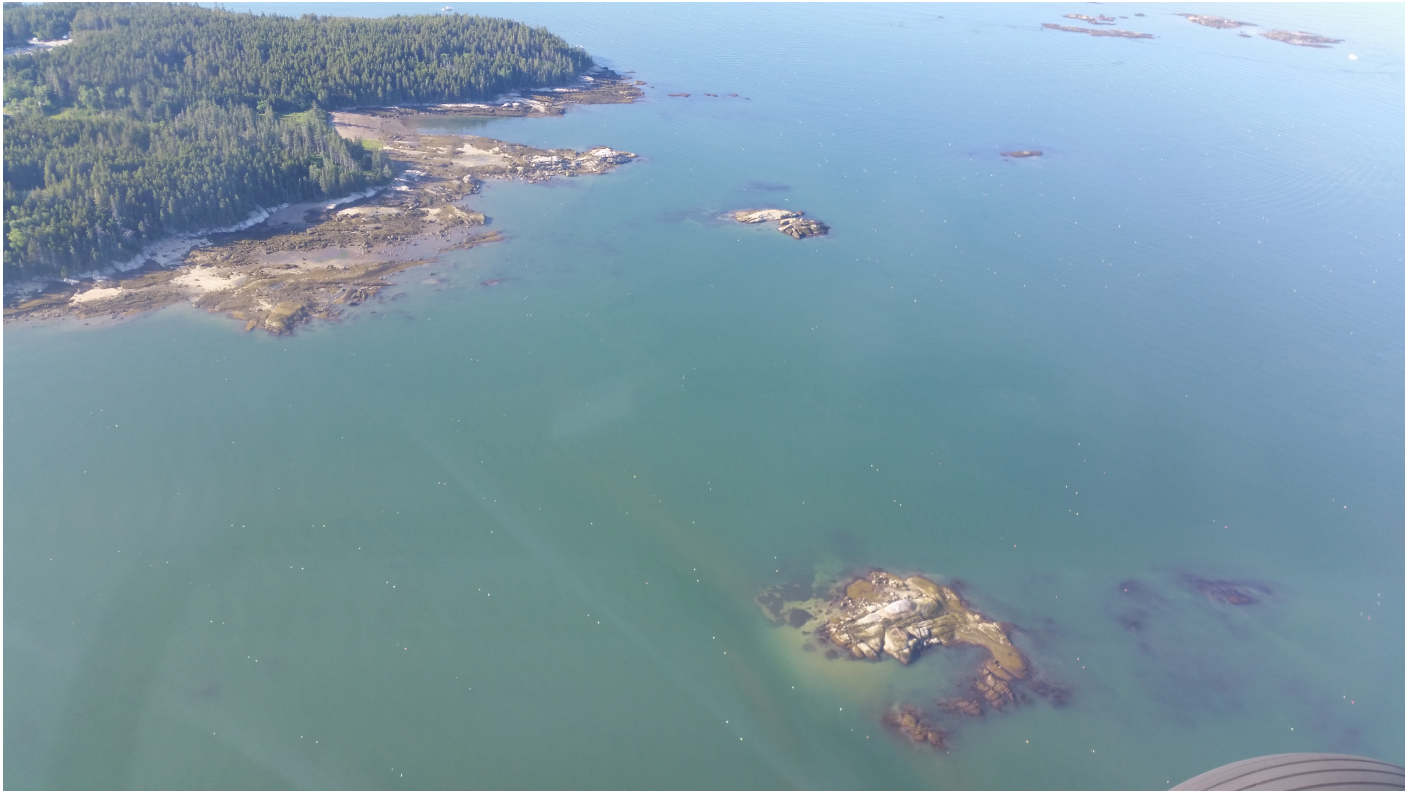
Figure 27: Water Clarity

From the start of the mission flights on 26 June 2017, Fugro staff undertook water quality assessments along the survey sub-areas. Conditions were documented in many photos and water clarity was, on the whole, found to be relatively poor. Water was seen to be clear in the very shallow depths (likely under four meters) and murky in deeper waters; plumes of sediment swirling around shallow areas near the shoreline and islands were also identified and determined to be in detriment for LiDAR performance.

In general, water clarity in the East Penobscot Bay survey area was less than ideal for ALB acquisition. Clear water was more common in shallow areas, but water in the full eight meter range of interest was typically murky.

Conditions were similar in the survey area around Eggemoggin Reach, with shallow depths being clearer than the full depth range of interest.

In addition to being an issue in equipment effectiveness, water clarity was a factor affecting soundings. Refer to section B.2.5 for the explanation on water clarity.

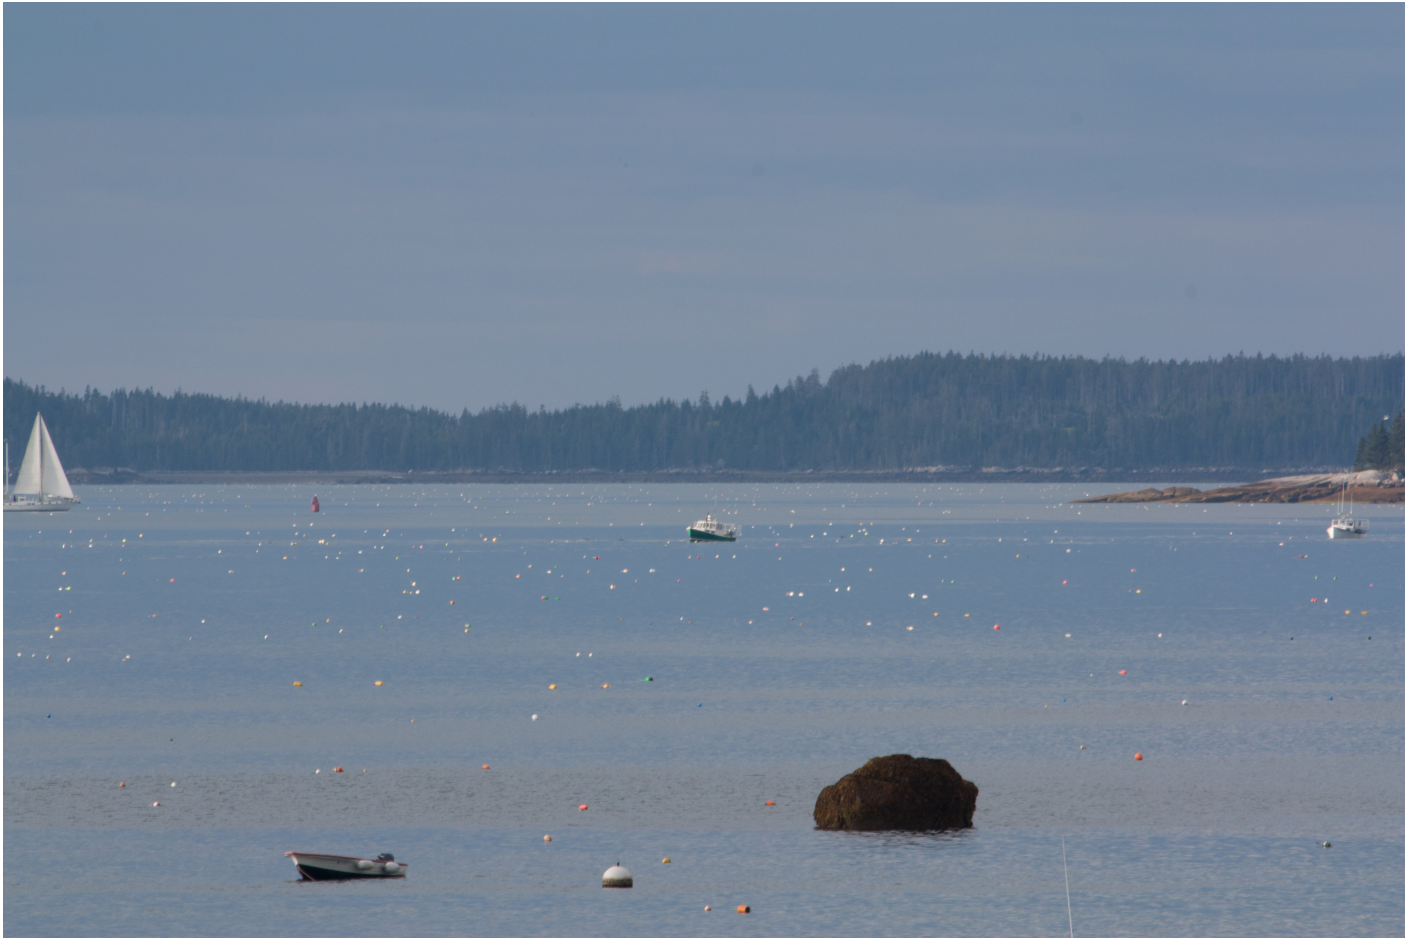
Figure 31: Fishing Gear

The survey was awarded and conducted during the peak of lobster season, resulting in an extremely high presence of fishing gear (and fishing vessels) in the survey area. This resulted in having to maneuver in and around the surface buoys and fishing vessels causing not only numerous in-fills and re-runs, but increased time spent on manually rejecting erroneous data (fishing gear in the water column) in CARIS HIPS.

Because of the density of fishing gear in the area, vessel speed was at times reduced to near idle. Entanglements between the survey vessel's deployed sonar equipment and fishing gear happened quite often, resulting in a loss of survey time. The risk of entanglement also increased before and after the high tide peaks due to submerged buoys in some areas.

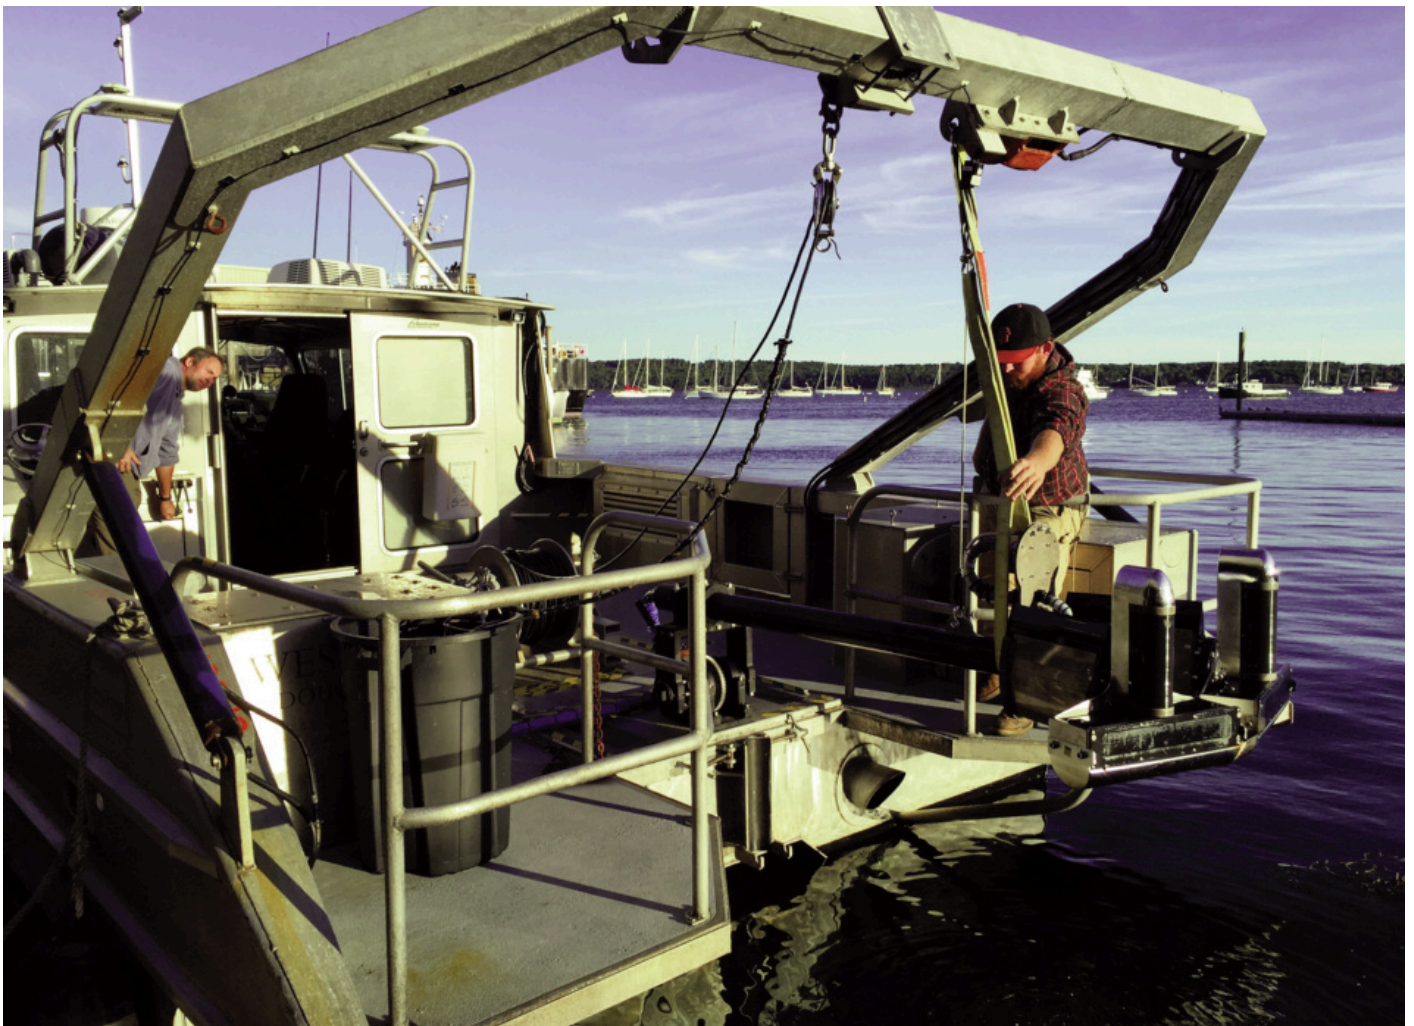
Figure 35: AML SVP

Each vessel was equipped with two AML SV&Ps. The instruments were mounted within a weighted cage and deployed using a hydraulic winch that contained 350 meters of shielded Kevlar reinforced cable via a stern mounted A-Frame.

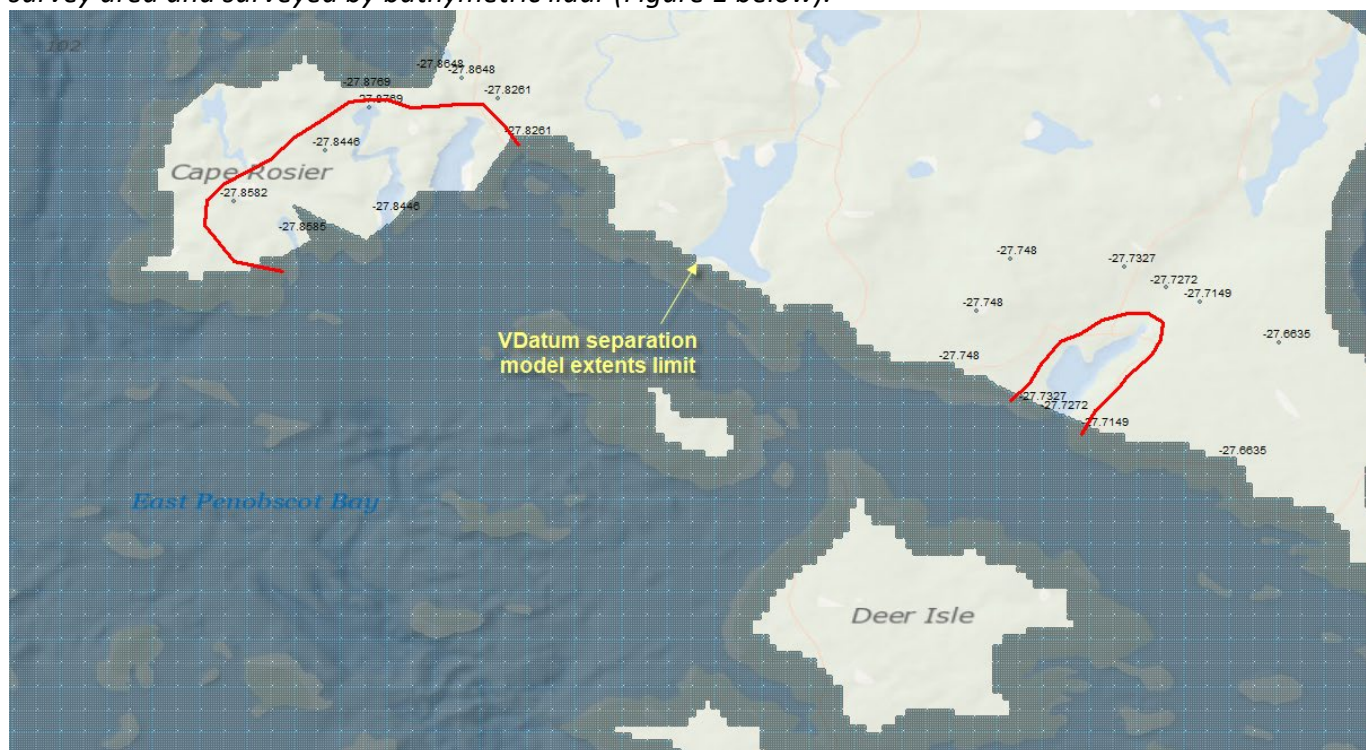
Figure 1. VDatum separation model extents and the areas surveyed by bathymetric lidar not covered by it (in red).

"The separation model was generated with VDatum for a region that included all the survey area boundary extents. However, VDatum conversion from NAD83 2011 ellipsoidal heights to MLLW is geographically limited to include only land areas up to 700 m inland from a coarse depiction of the coastline; inlets and small bays may not be covered by this limit, as it was the case for small sections in the survey area and surveyed by bathymetric lidar (Figure 1 below).

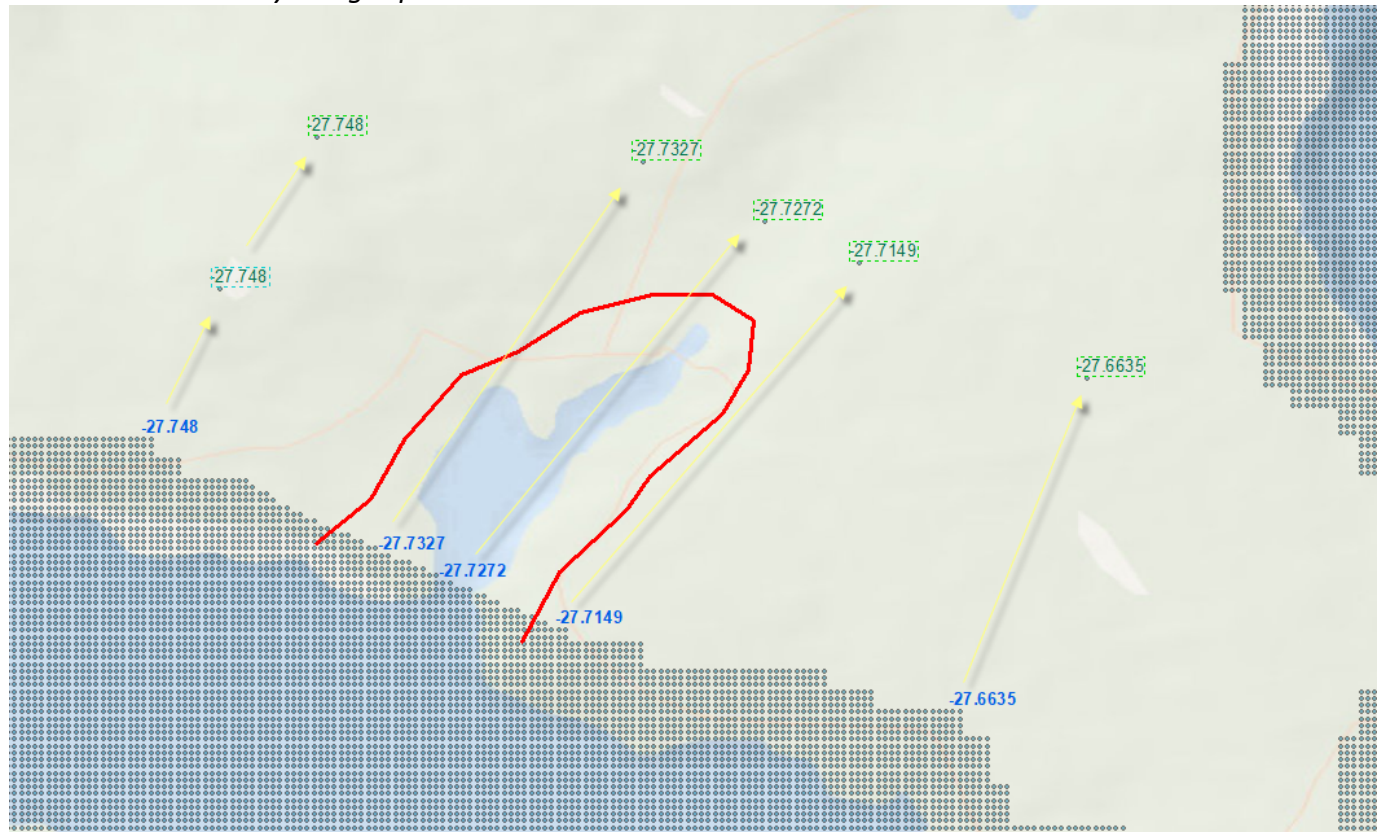
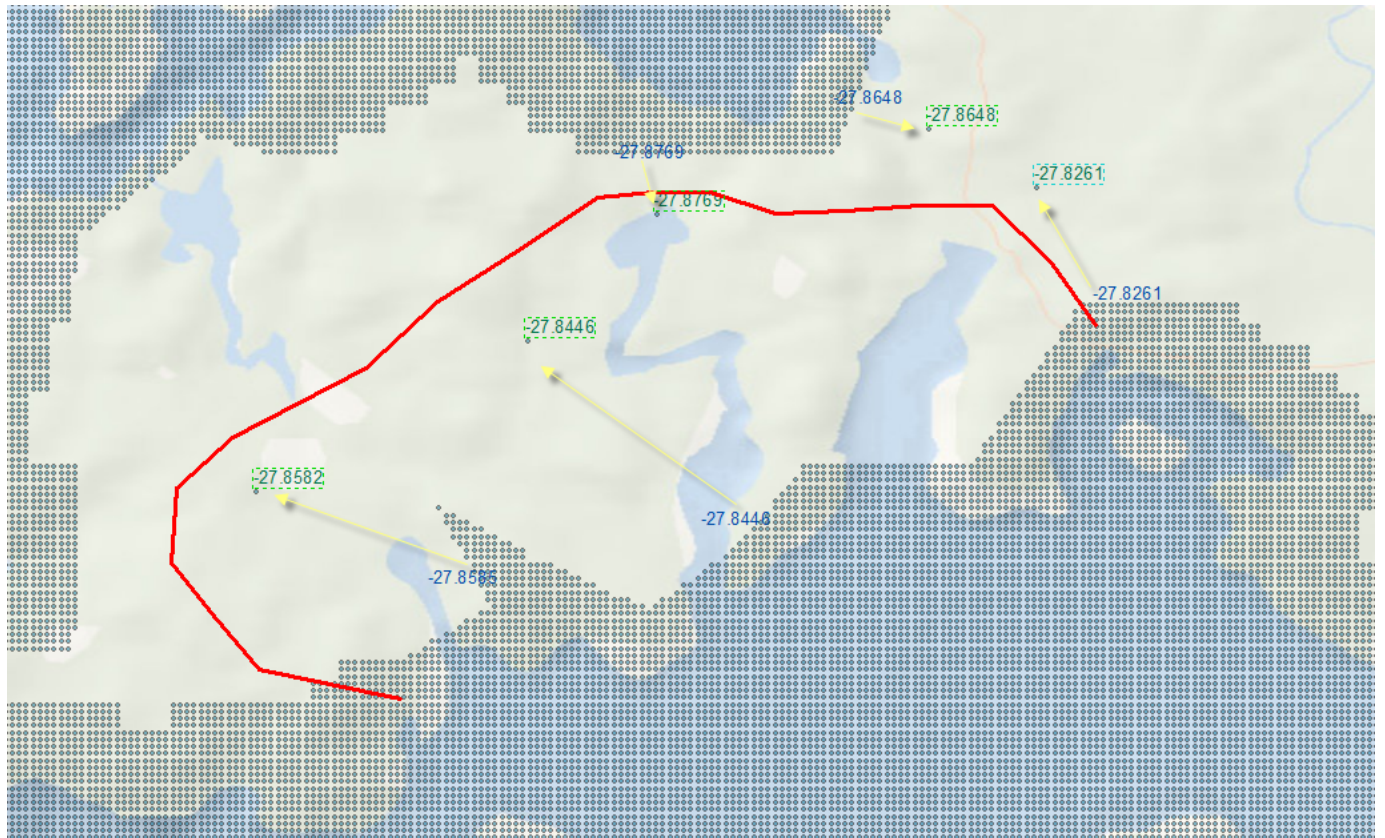
Figure 2. Extrapolation of separation model value at edge limit to include survey area (in red)

In order to reduce lidar ellipsoidal elevations to MLLW datum on these sections, it was decided to extrapolate a number of points at the edge of the model further inland. This was done at the discretion of the hydrographer with the only consideration given to point values that were closest to the selected extrapolated location, as seen in the two graphics in Figure 2. The separation variations in these small areas are at centimeter-level (4-8 cm), thus potential uncertainty introduced on the bathymetric lidar data could be in same magnitude; it was not evaluated but considered to be within the overall MLLW depth reduction uncertainty using separation model.

The modified separation model was then imported into Caris HIPS and SIPS v9.x where the datum conversion tools reads the point data file and perform interpolation across existing model points."

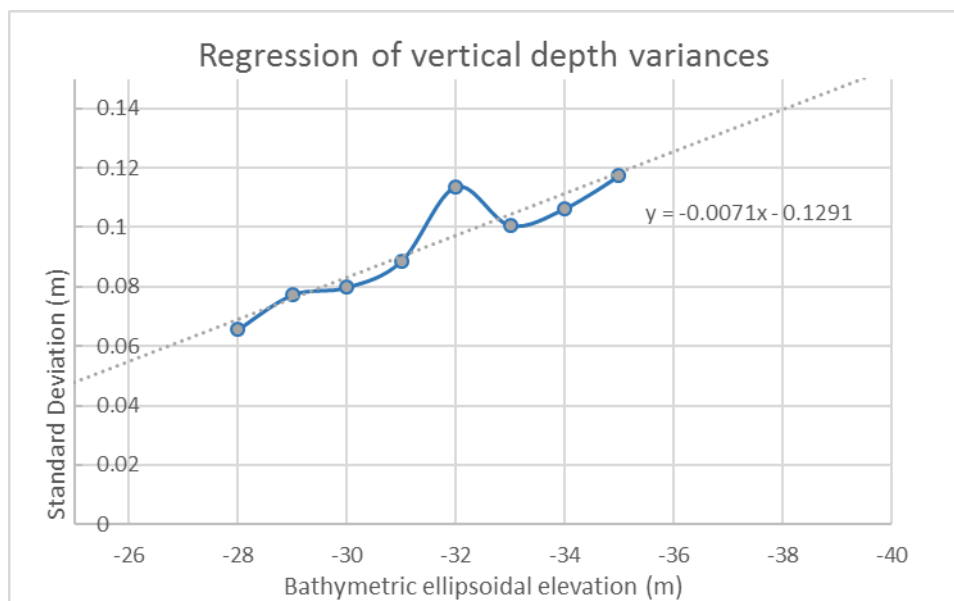
Figure 4. Total Bottom Uncertainty for SHOALS data sample.

The results of the analysis were tabulated and plotted to derive a depth-dependent model of Total Bottom Uncertainty (TBU) (Figure 4). The linear regression represents an uncertainty model from the analyzed data that also aids to calculate *TBU* for depths where sampling data was insufficient (gaps in coverage).

TBU contains variance introduced by the SHOALS sensor measurements and the natural seafloor bottom (slope and roughness). In order to isolate the SHOALS LIDAR Sensor uncertainty (LSU) from seafloor Bottom Variability (BV), modeling was conducted on synthetic seafloor depths to replicate the potential components of slope and roughness. Modeled *BV* over relative featureless synthetic bottom has been found to be 0.015 m (1 σ) (Lockhart et al, *op cit.*); then *BV* is subtracted from the *TBU* to obtain *LSU* in the form:

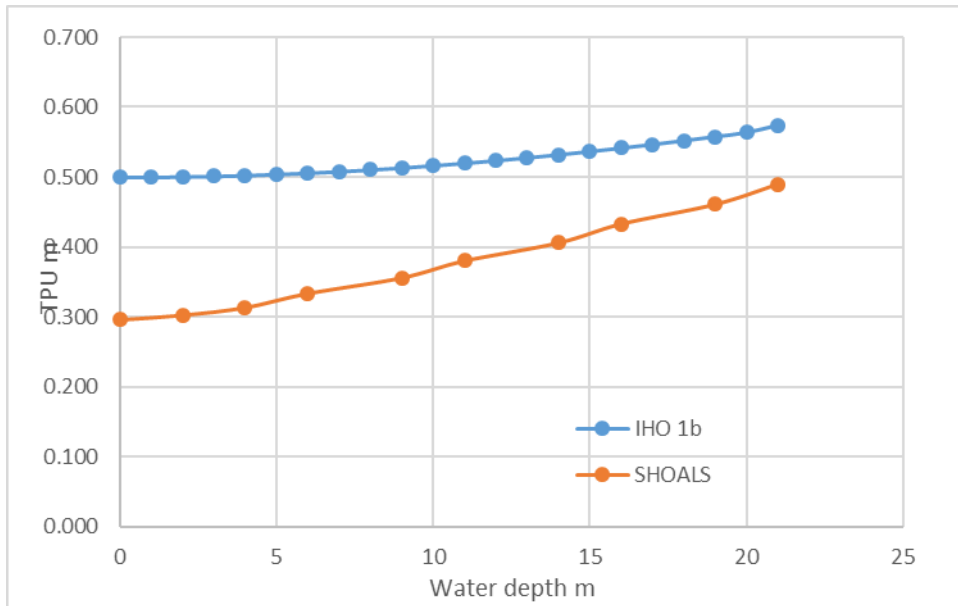
Figure 5. vTPU for SHOALS system with VDatum depth reduction

Depth	LiDAR Unc. (LSU)	<i>VDatum</i> Unc.	<i>vTPU</i> 1 σ	<i>vTPU</i> 2 σ (95%)	IHO Order 1
-200	0.045	0.134	0.141	0.277	na
-2.0	0.055	0.134	0.145	0.284	0.500
-1.0	0.062	0.134	0.148	0.290	0.500
0.0	0.069	0.134	0.151	0.296	0.500
2.0	0.076	0.134	0.154	0.302	0.501
4.0	0.087	0.134	0.160	0.313	0.503
6.0	0.105	0.134	0.170	0.333	0.506
9.0	0.122	0.134	0.181	0.356	0.514
11.0	0.140	0.134	0.194	0.380	0.520
14.0	0.158	0.134	0.207	0.406	0.532
16.0	0.175	0.134	0.221	0.433	0.542
19.0	0.193	0.134	0.235	0.461	0.558
21.0	0.211	0.134	0.250	0.489	0.574
