DESCRIPTIVE REPORT

Type of Survey: Navigable Area

Registry Number: H13282

Sub-locality: 17 Miles South of West Pass

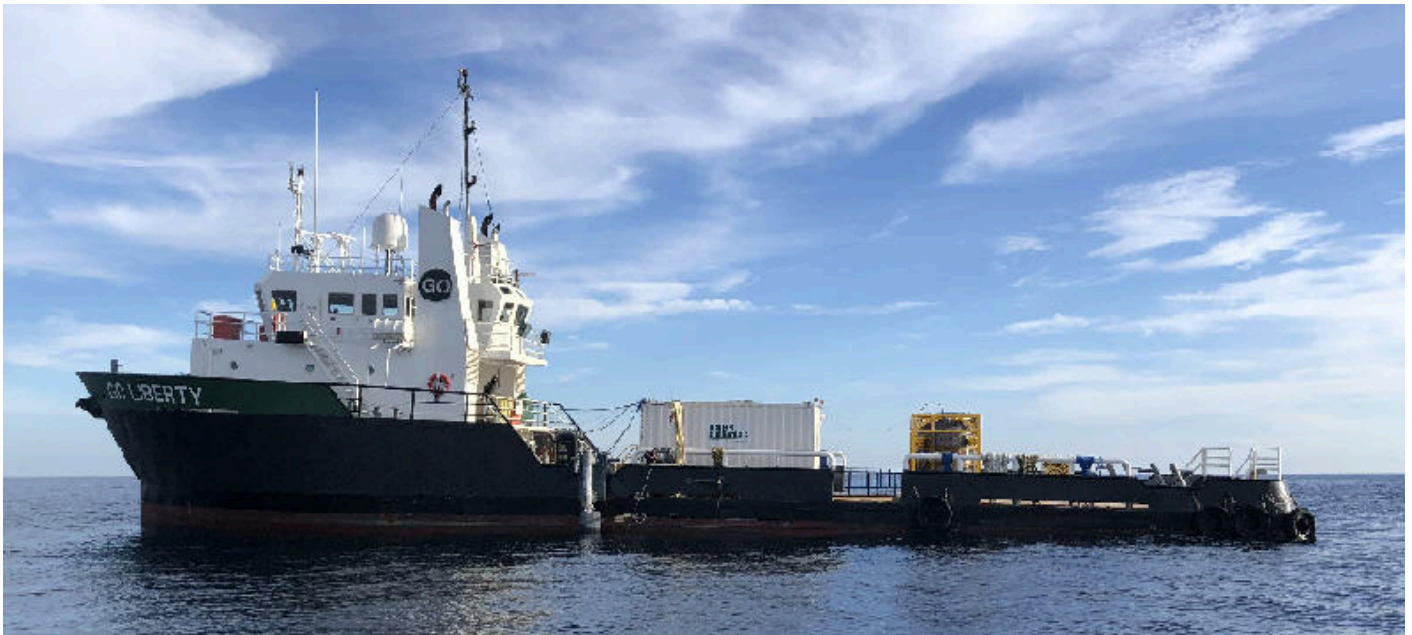
Figure 5: M/V Go Liberty

M/V Go Liberty (Table 5 and Figure 5) acquired MBES, MBAB, surface sound velocity, sound velocity profiles, attitude and positioning data within the survey limits of H13282 (Table 6). For a detailed listing of equipment used to acquire survey data, refer to the DAPR submitted with this report under Project Reports.

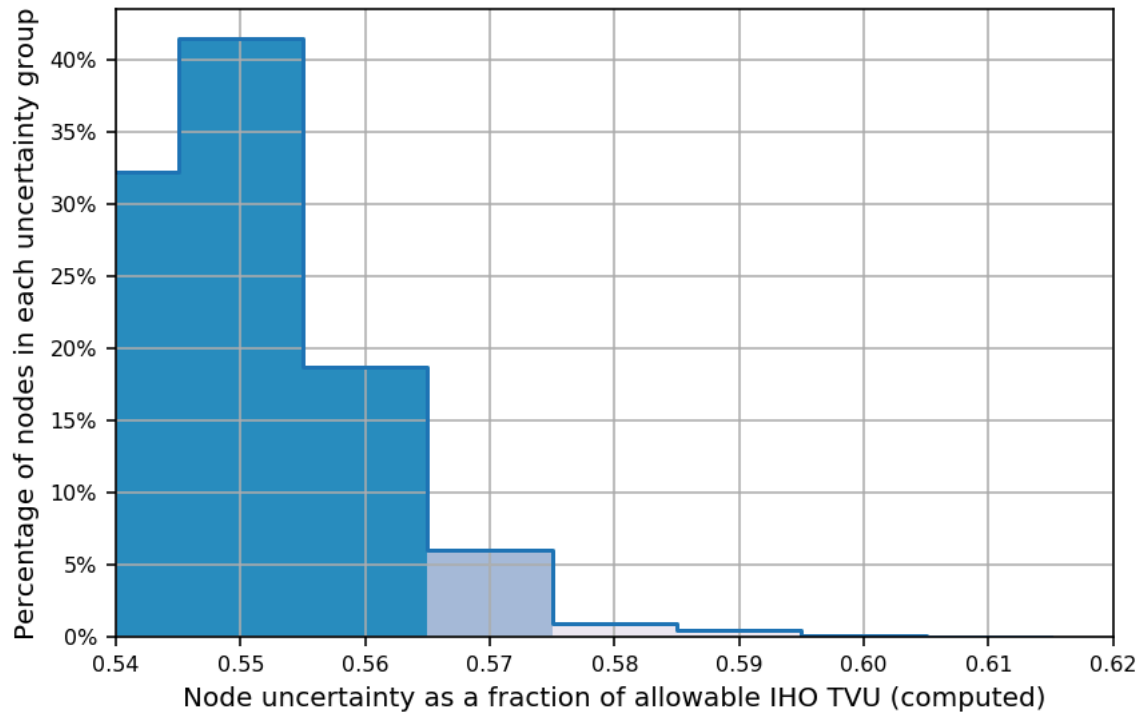
Figure 8: H13282 1m finalized grid TPU QC

Survey H13282 uncertainty values (Tables 7 and 8) were evaluated both in CARIS HIPS 9.1 and via Pydro QC Tools v3.0.19. The finalized 1m (Figure 8) and 2m (Figure 9) bathymetric grids meet uncertainty standards with 100% of nodes passing.

100% pass (272,292 of 272,292 nodes), min=0.54, mode=0.55, max=0.62

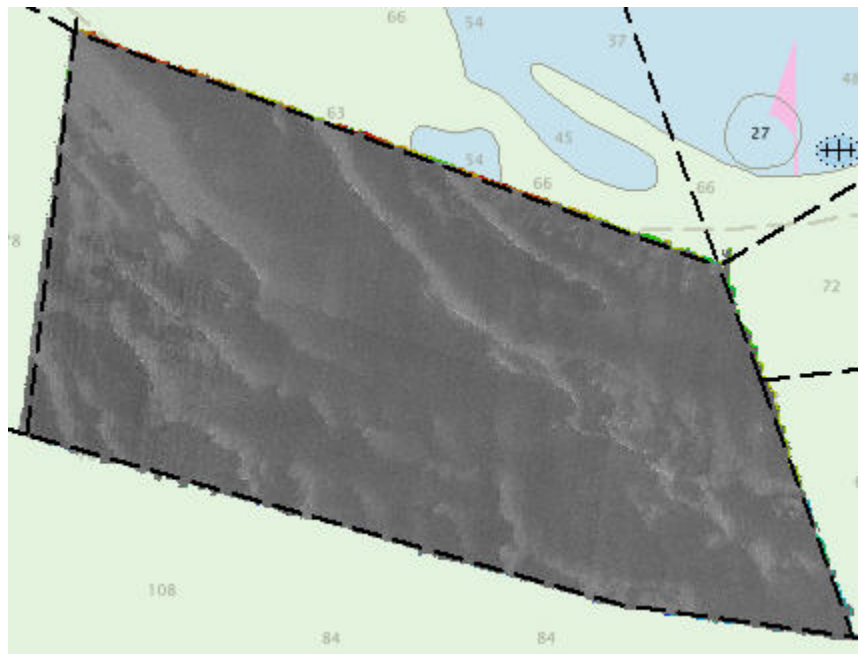
Figure 15: Survey H13282 backscatter coverage

All equipment and survey methods utilized in the acquisition and processing of Survey H13282 backscatter (Figure 15) are detailed in the DAPR.
