DESCRIPTIVE REPORT

Type of Survey: Navigable Area

Registry Number: H13677

General Locality: Approaches to Calcasieu

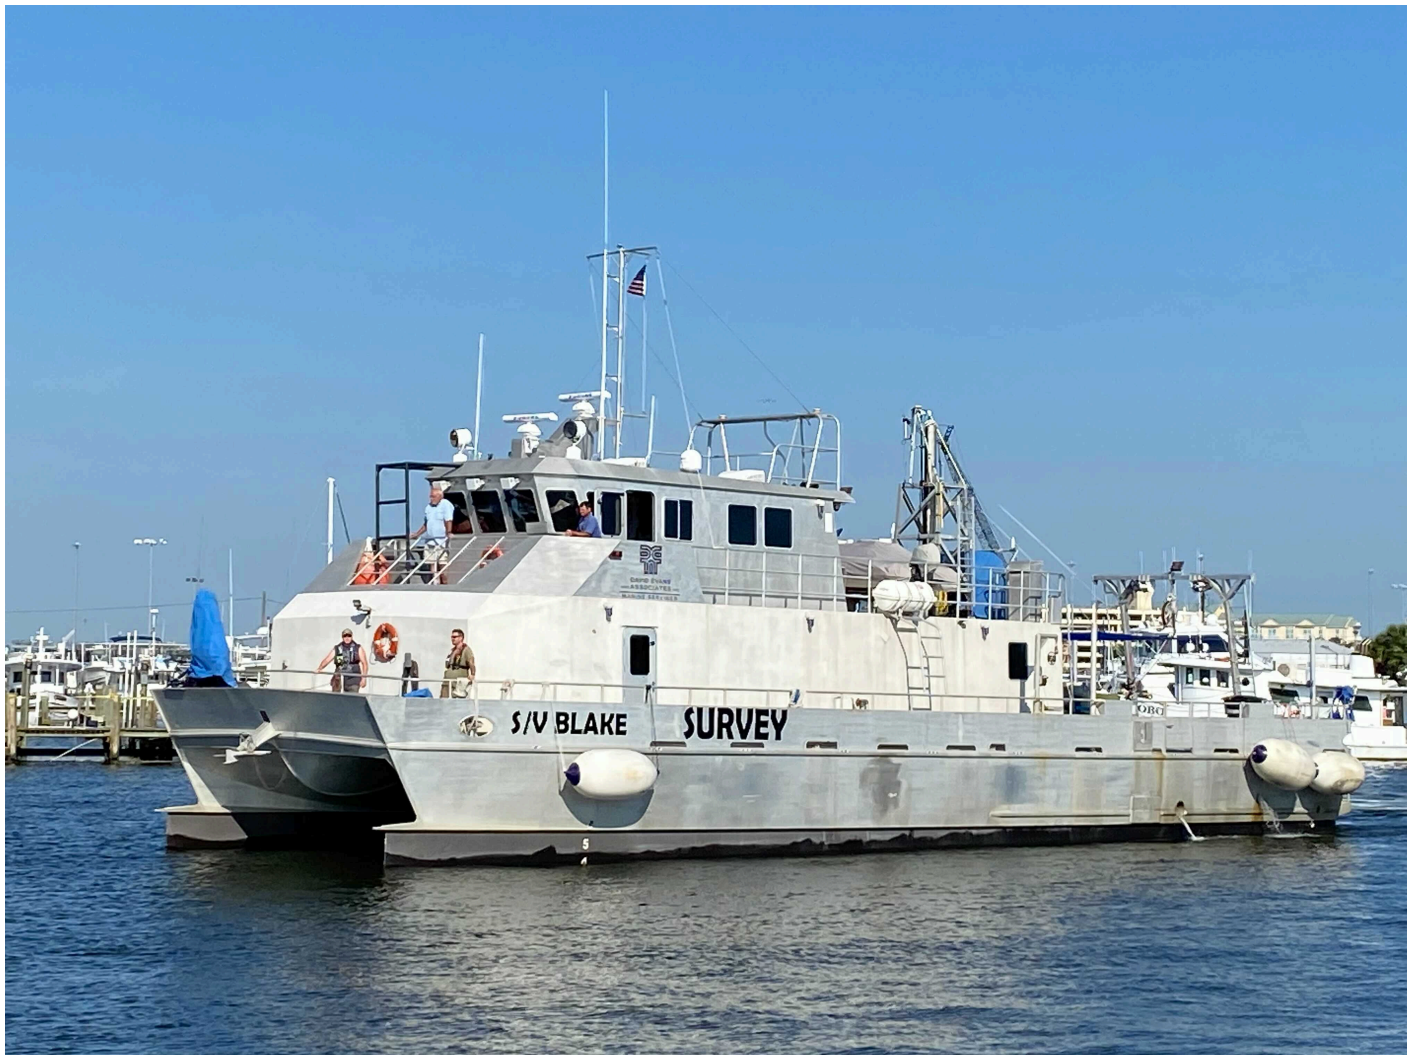
Figure 3: S/V Blake

The S/V Blake is an 82-foot aluminum catamaran with a 27-foot beam and a draft of 4.5 feet (Figure 3).
