DESCRIPTIVE REPORT

Type of Survey: Navigable Area

Registry Number: H13715

Sub-locality: East Nushagak Bay

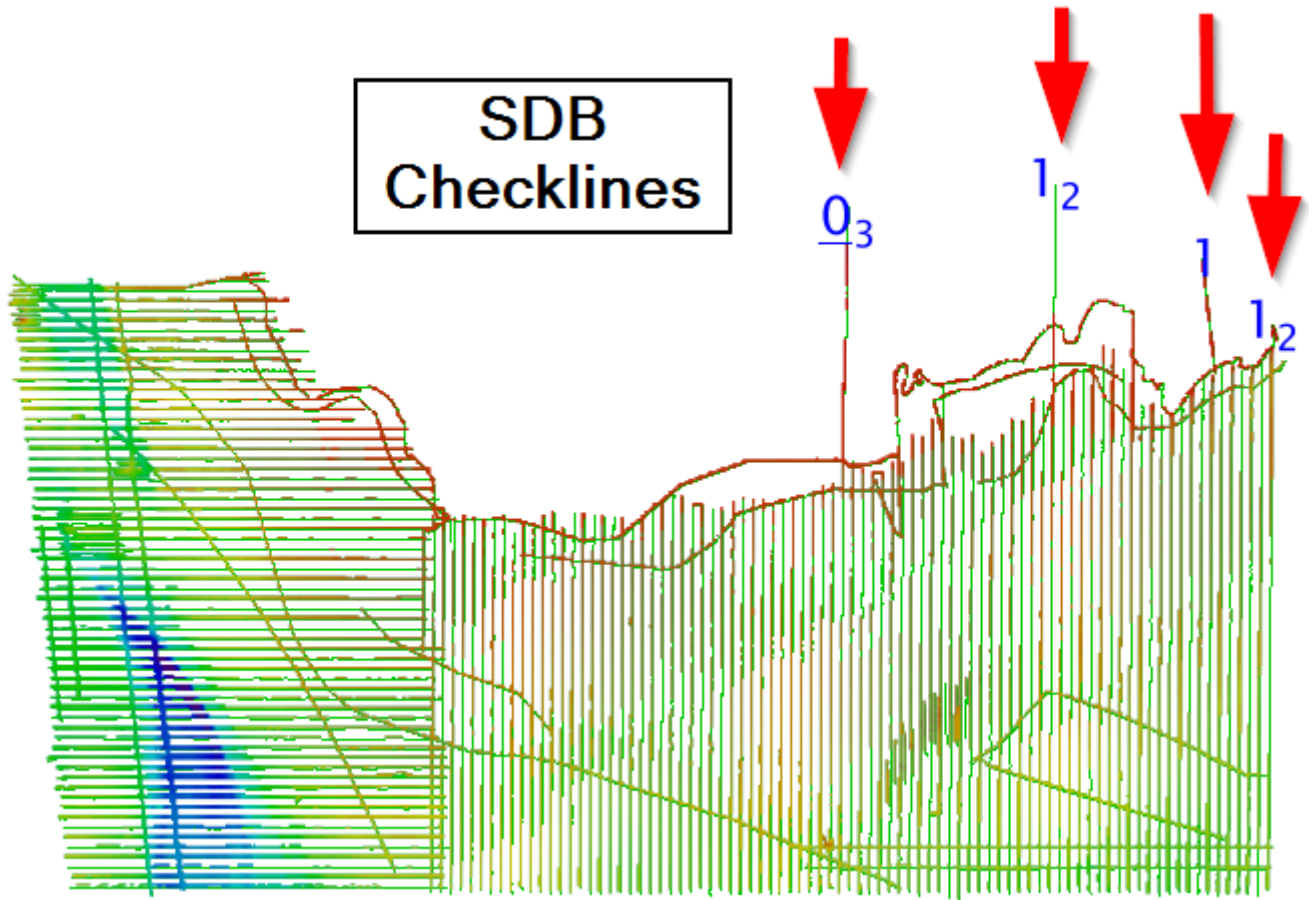
*Figure 2: Image showing the relative location of SDB checklines.
The least depth achieved on each checkline is shown in meters.*

SDB Checklines: SDB (Satellite Derived Bathymetry) checklines, to be used for SDB calibrations, were acquired at geographically dispersed locations chosen by the field crew. These were also run co-incident with NASA ICESat-2 data provided by NOAA when practical per NOAA's request for overlap (see included correspondence), but personnel and vessel safety took precedence in location decisions. For the checklines, the ASV-CW5 vessel collected data as shallow as possible, until it was deemed unsafe to continue closer to shore. These checklines were normally acquired at mid- to high- tide in order to achieve as shoal of a tide-corrected depth as possible. All checkline data is incorporated in the final surface submitted with the survey deliverables.

Four checklines were acquired for this sheet. They are grouped in the east part of the survey due to adverse conditions on the west part of the survey when on site for collection there. Their location relative to the survey area and the least depth achieved on each line is shown in the image below. Note that one checkline achieved a negative depth; however due to HSSD requirements for final grids, depths shoaler than 0 are not in the finalized version of the submitted surface. The negative depth is still available in the non-finalized version.

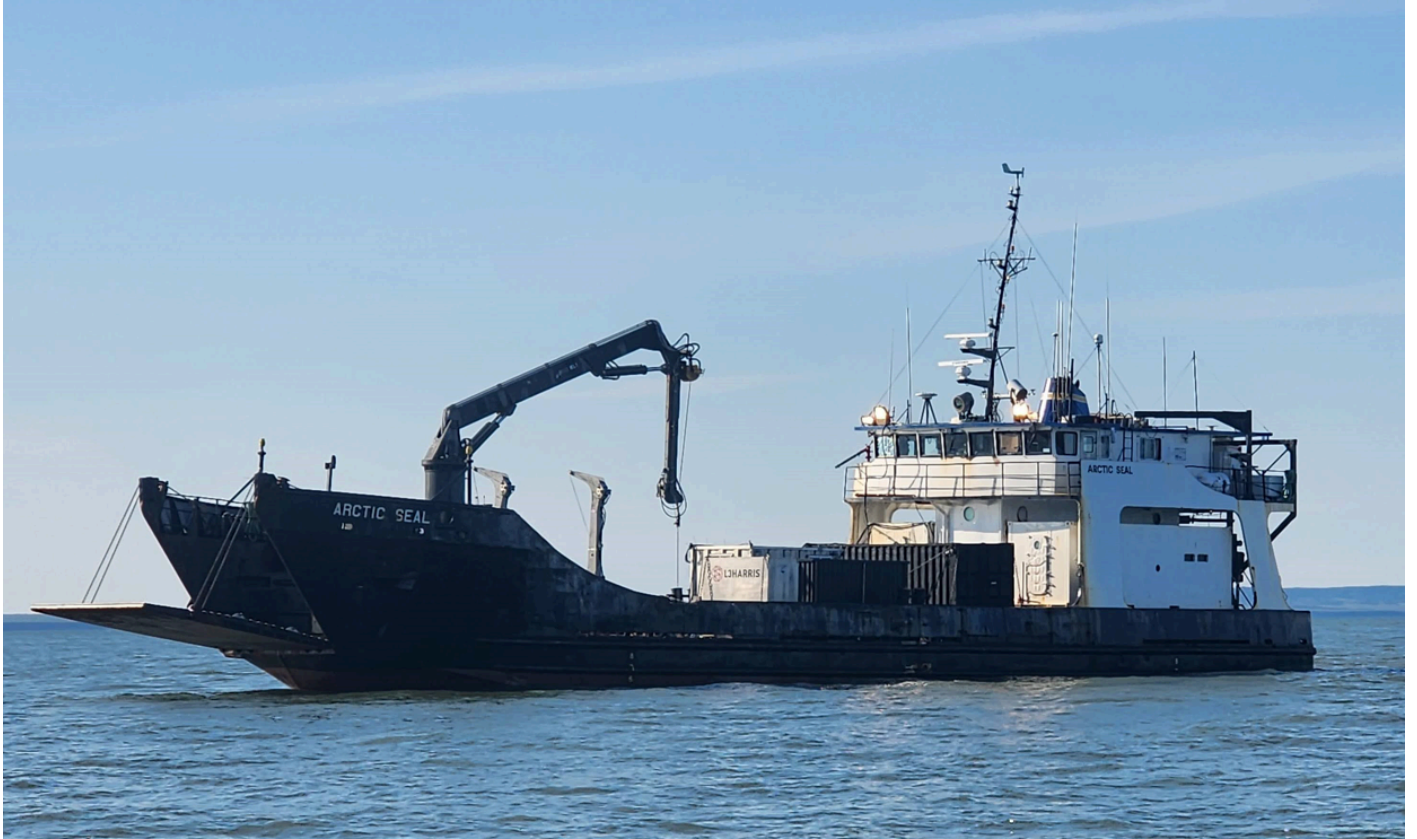
Figure 4: The Arctic Seal in the Bristol Bay survey area.

The Arctic Seal is a 40 m steel-hull, landing craft style vessel owned and operated by Support Vessels of Alaska. The Arctic Seal acquired multibeam data and provided housing and facilities for on-site data processing. The vessel was also used to collect bottom samples, conduct sound speed casts, and deploy/recover the ASV-CW5 (uncrewed) launch and LC-25 (crewed) launch.

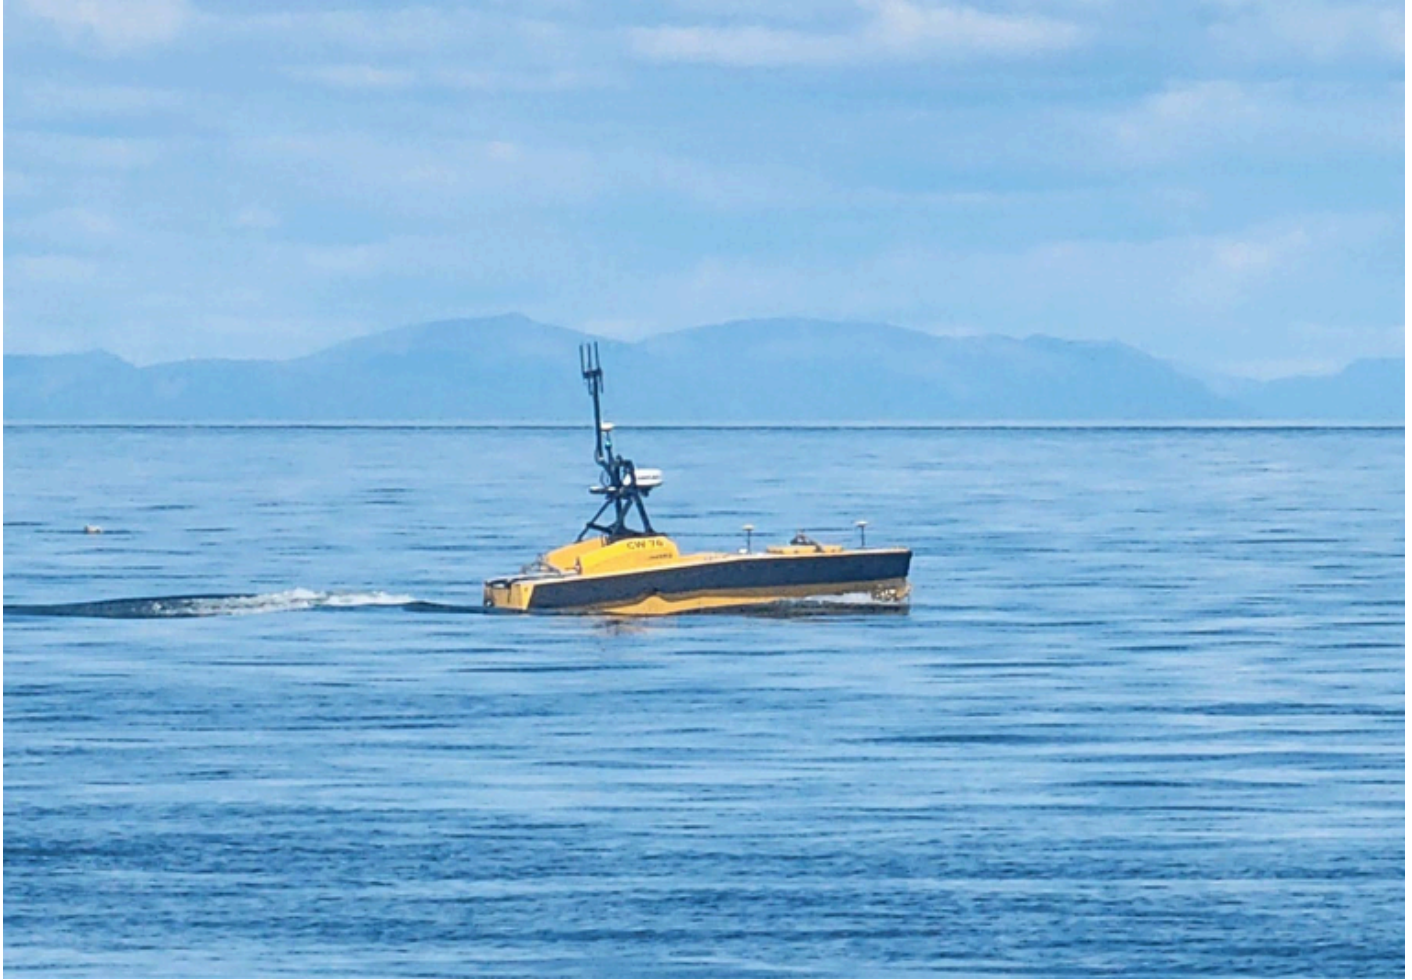
Figure 5: The ASV-CW5 in the Bristol Bay survey area.

The ASV-CW5 (ASV) is a 5.5 m aluminum-hull Autonomous Surface Vessel (ASV), C-Worker 5 model, owned and operated by L3-Harris ASV. The ASV was operated in an uncrewed but monitored mode, collecting multibeam data in close proximity to the Arctic Seal, as well as in areas too shallow for the larger vessel.

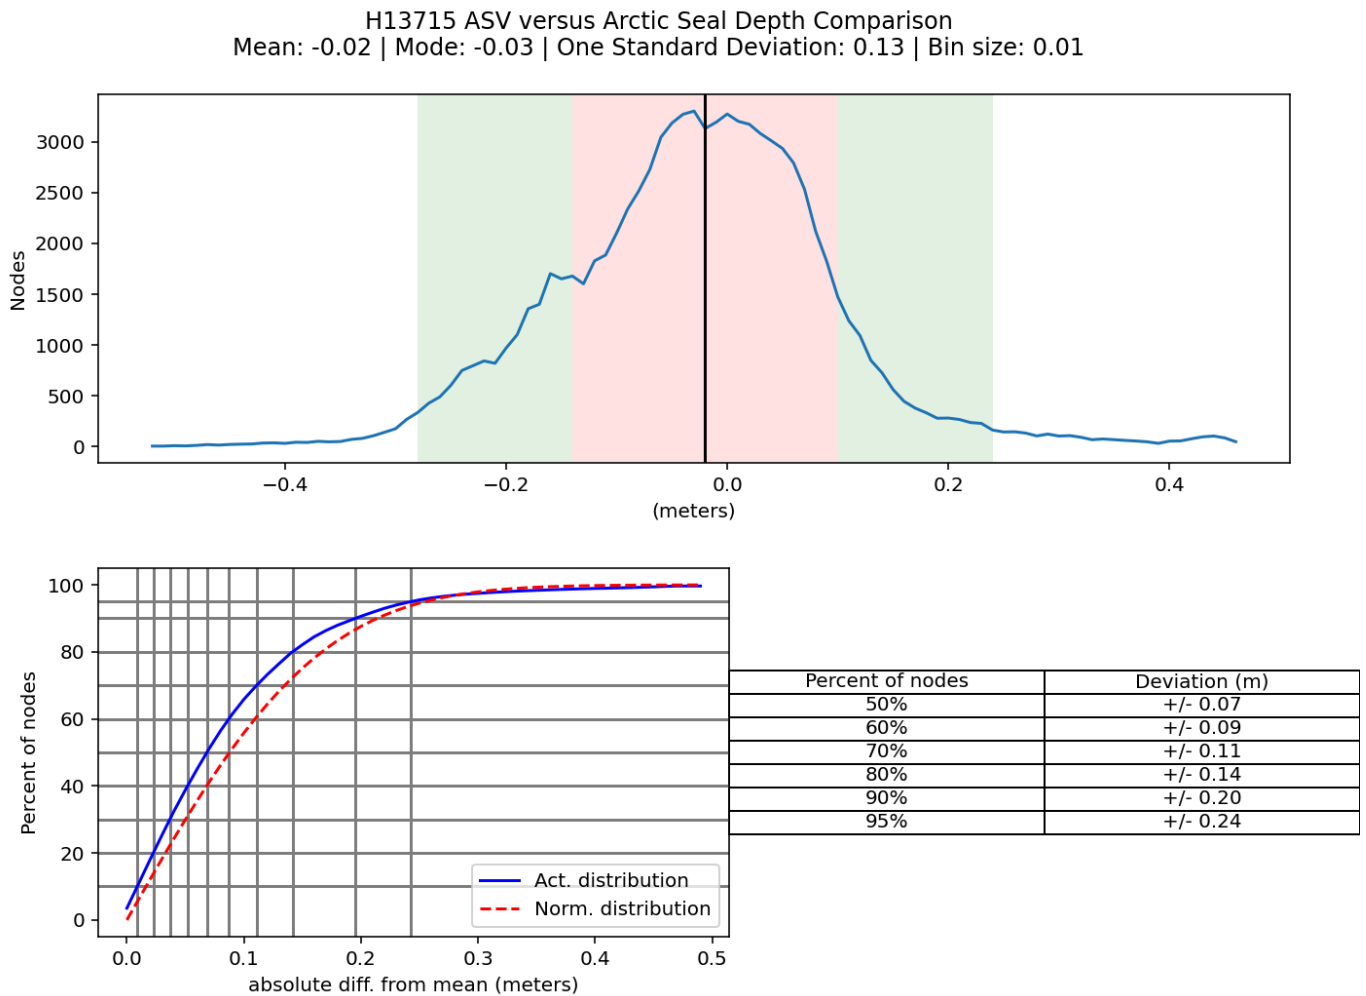
Figure 7: The results of the difference between ASV and Arctic Seal depth data for this survey.

In addition to the crossline checks which included inter-vessel comparisons, as an additional area-specific QC check, the depth data acquired by each vessel was gridded separately at 4 m resolution and differenced from each other. The results are excellent, with the two vessels comparing within 0.02 m on average, with a standard deviation of 0.13 m. Greater than 99.5% of the grid cells agree within the allowable TVU by depth. The results are shown below.

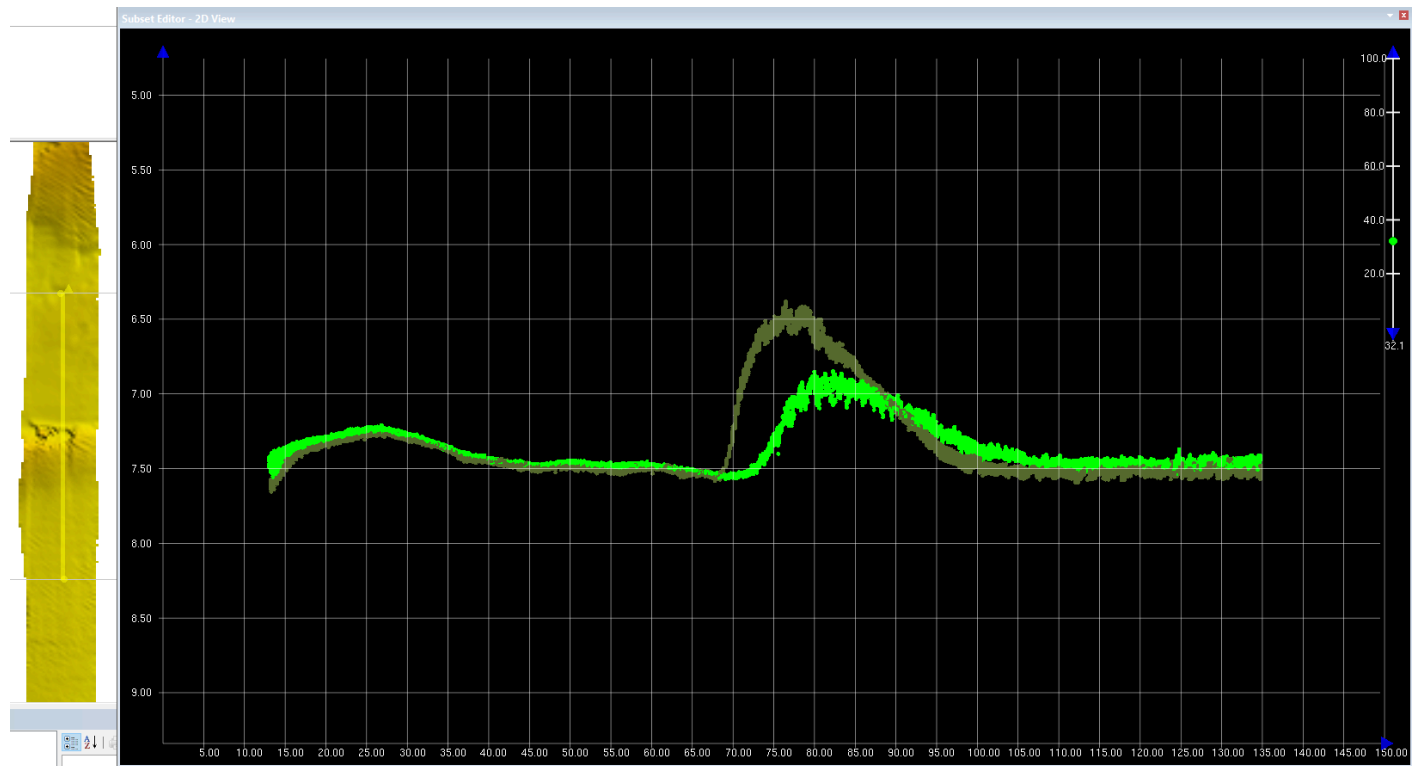
Figure 8: Example of bottom change on this survey viewed in CARIS HIPS subset. Dark green line (ASV, line 1756) was run on JD224, 59 days after the green line (Arctic Seal, 0293) run on JD165. This results in about 0.75 m of vertical change.

The seafloor in the area is dynamic due to the large amount of sediment deposition from the many rivers draining into the area. The sediment is then readily transported by the strong tidal currents that flood the area daily. Sandwaves are present in the survey area, and data acquired distant in time, for example crosslines late in the job that cross mainscheme acquired earlier in the project, frequently show evidence of bottom change. Note that in most cases of bottom change data was not edited to "choose" a bottom.

Up to 0.75 m of vertical change was observed over the course of this survey due to bottom change in some areas. An example is shown below.

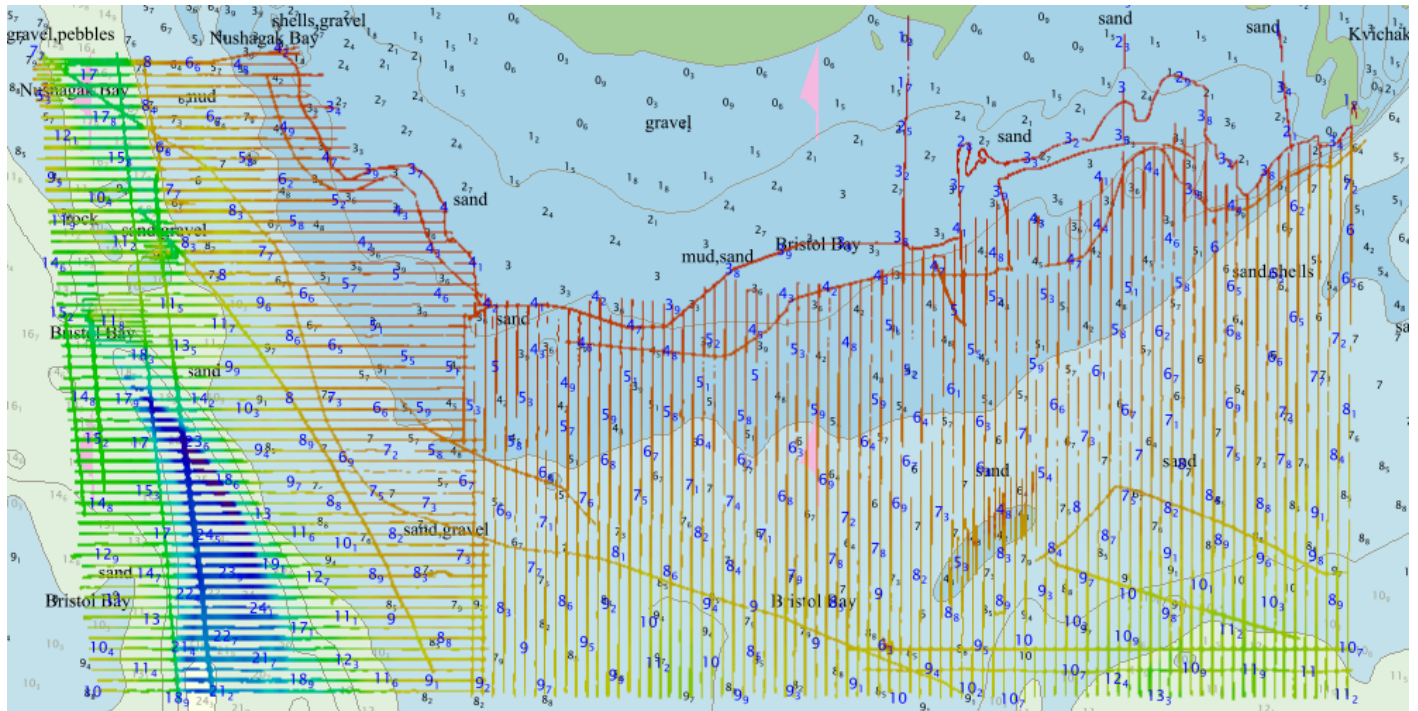
Figure 9: This survey overlaid on affected ENCs. Soundings from this survey are blue. All soundings in meters.

An overview of this survey overlaid on affected charts is shown below.
