DESCRIPTIVE REPORT

Type of Survey HYDROGRAPHIC

Registry No. W00054-W00055

General Locality Tinian Island

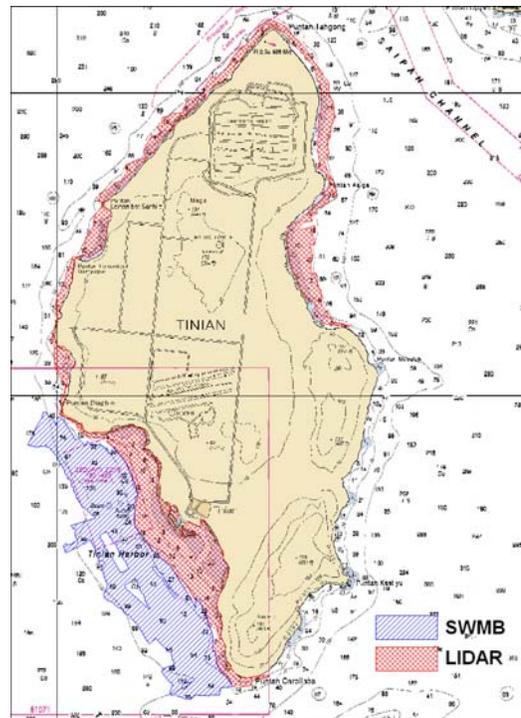
Figure 1: Coverage for W00054 and W00055

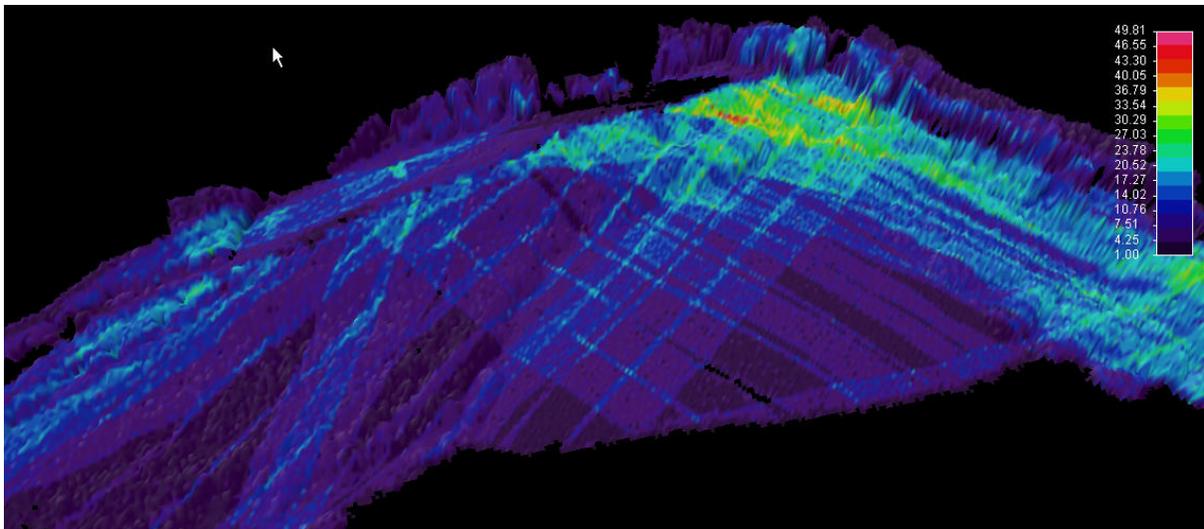
The triangular area in the lower right hand corner is an example of an area with only 100% LIDAR coverage

NAVO personnel assessed that the survey area was covered at 4x4 meter spot density (110-meter swath) and with greater than 200% coverage to ensure a very high confidence of target detection. See the *WESTPAC LIDAR ROS* for additional information.¹² The Evaluator examined LIDAR coverage using the Pure File Magic (PFM) dataset in Fledermaus. While in general 200% or greater coverage was obtained, there were some cases where only 100% coverage was obtained. These areas were most notably in the northern portion of the survey area. See section **D.2** of this report for further analysis of LIDAR data quality.

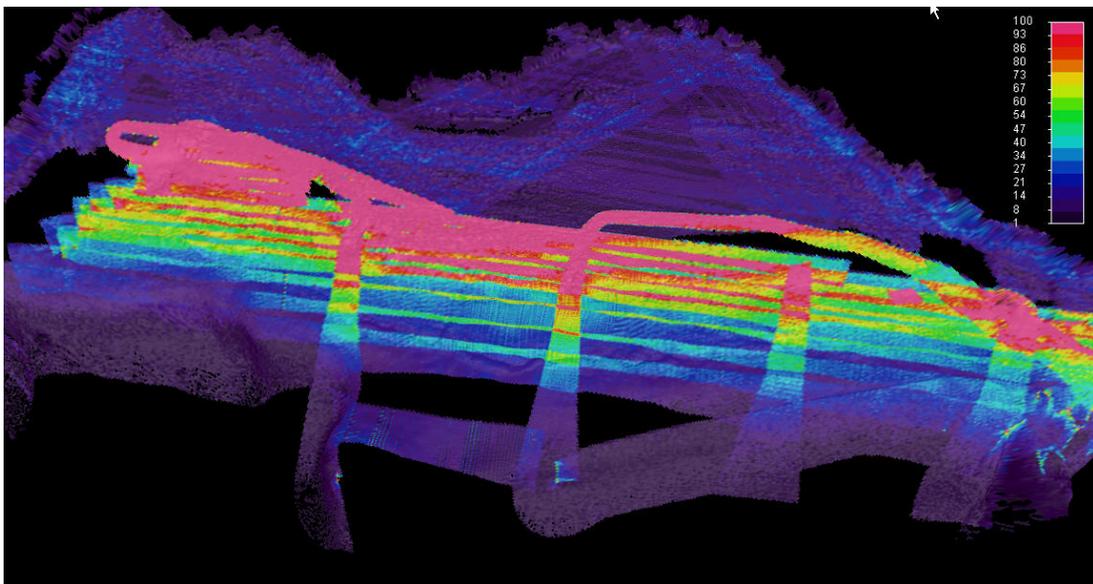
Cross line coverage by the USNS Sumner

NAVO assessment of the SWMB data found that the maximum sounding error was not expected to exceed 1.5 meters. The Evaluator observed that four cross lines were run over the SWMB portion of the survey area. While the percentage of cross lines does not meet the NOAA specified 5% of main scheme lines, the lines cover a representative portion of the survey area. Visual comparisons in Fledermaus of the full density soundings from cross lines and those from main scheme lines showed a good general comparison of 0.2-0.3 meters, with occasional differences of up to 0.5 meters.

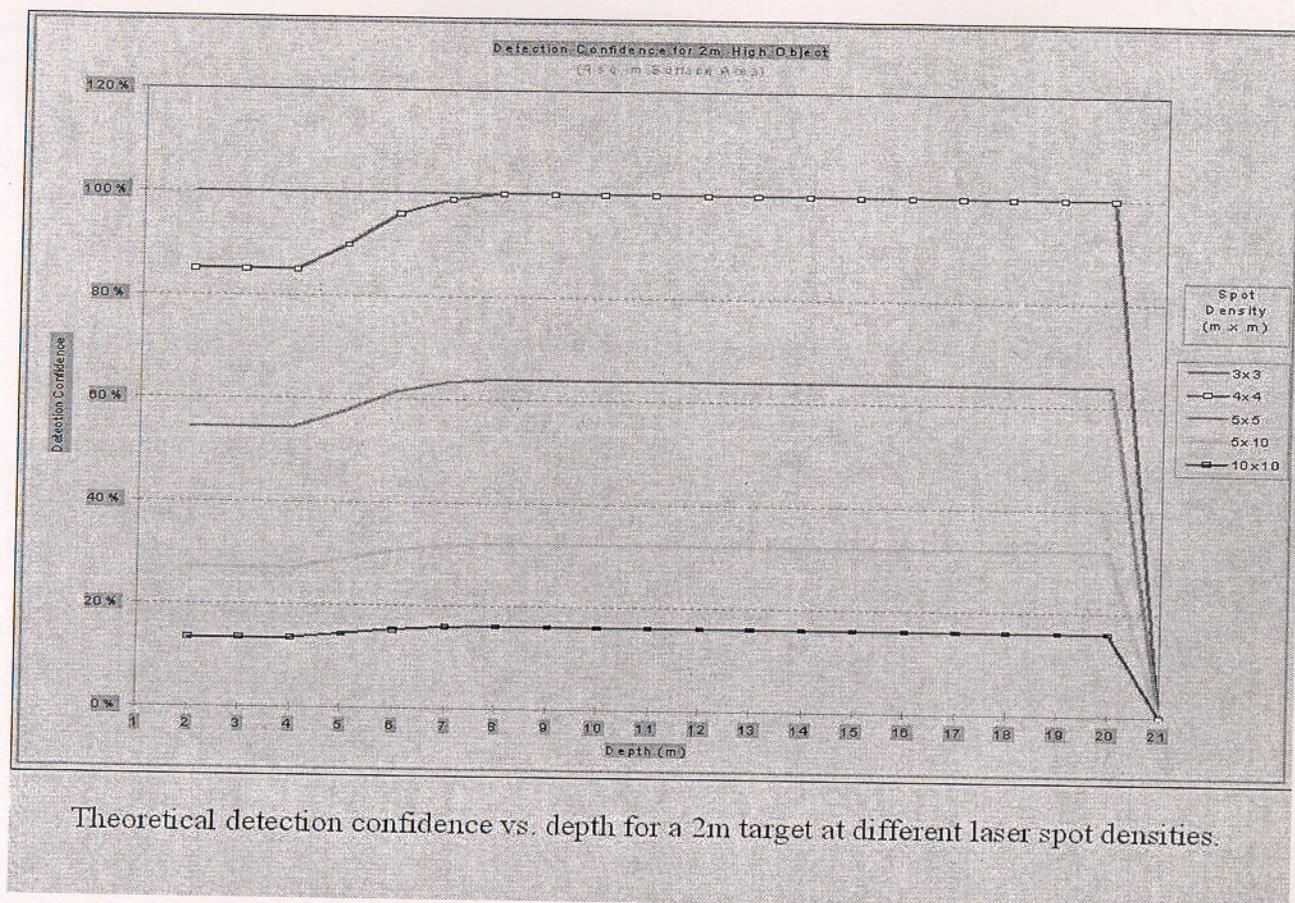
Figure 1. Target detection confidence

1.4.7 Subsequent testing of the follow-on CHARTS system, utilizing the same operating principles and algorithms and a lower power laser at 4x4 spot spacing, targets of 2 meters were detected 100% of the time in depths of 5 to 30 meters. Based on these actual tests the LIDAR system meets IHO Order 1 target detection requirements. Multiple coverage provides a degree of redundancy for this capability.

1.4.8 All Navy WESTPAC areas covered by LIDAR, were surveyed at 4x4 meter spot density and with greater than 200% coverage to ensure a very high confidence of target detection.

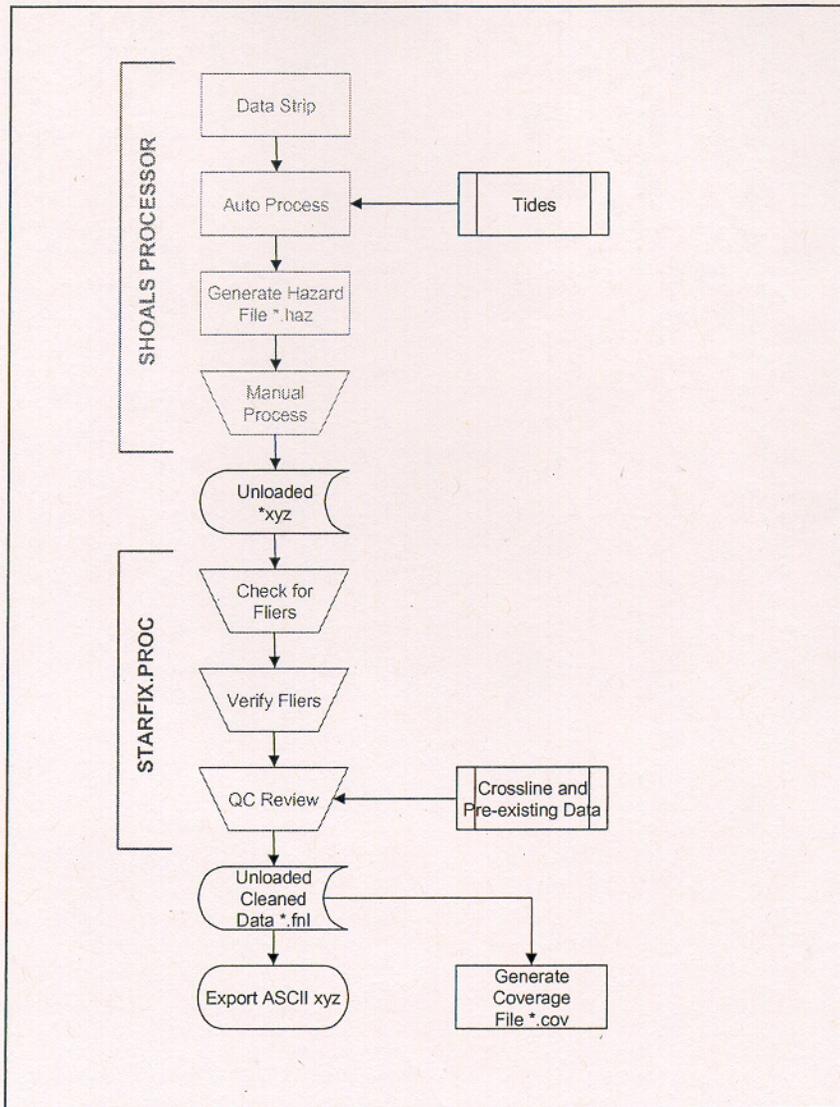
Figure 6: Data Processing Flow

The processed data is then output as an ASCII (*.xyz) file which can either be input directly into Hypack, or converted to Fugro Binary Format (*.fbf) for input into Starfix.Proc for review, QC and ultimately subsequent mapping and product generation. This process is outlined in Figure 6.

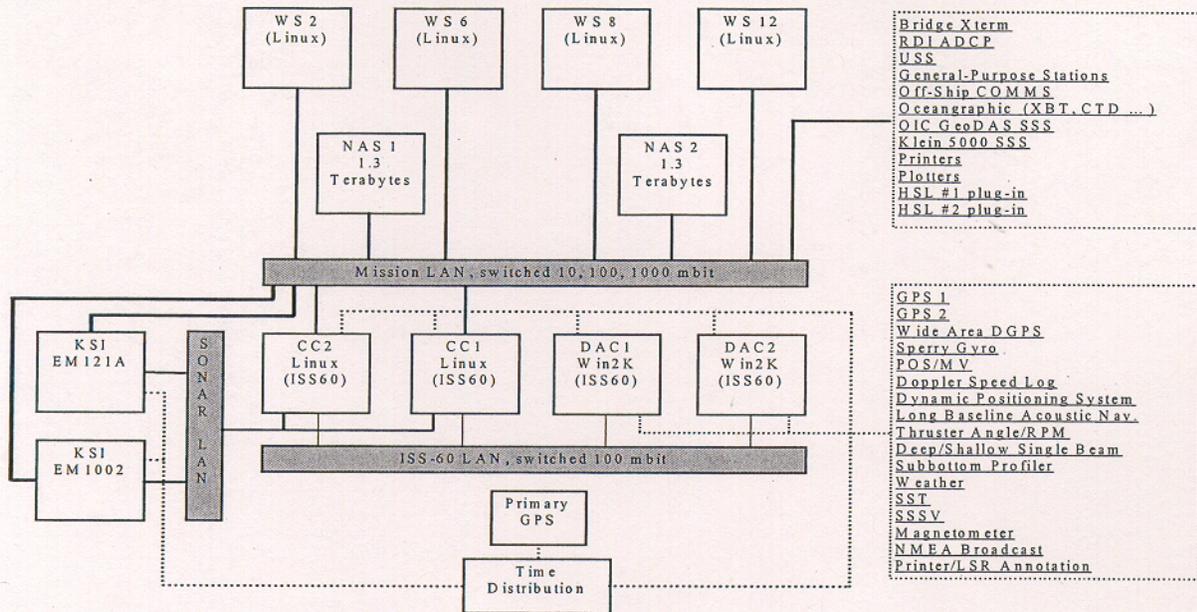
USNS SUMNER data acquisition system is shown in block diagram below.

The SIMRAD EM1002 is a 150 beam, 150 degree multibeam sonar system. Several operating modes are available; 150 degree swath, 120 degree swath, equal-angle (EA) and equal-distant (ED). In EA mode the beams are formed such that the beams are an equal and constant angle apart across the swath. This results in the bottom footprints getting progressively further apart toward the outer swath. In ED mode the beams are formed such that the beam footprints are an equal distance apart on the bottom. ED mode provides consistent coverage across the swath.

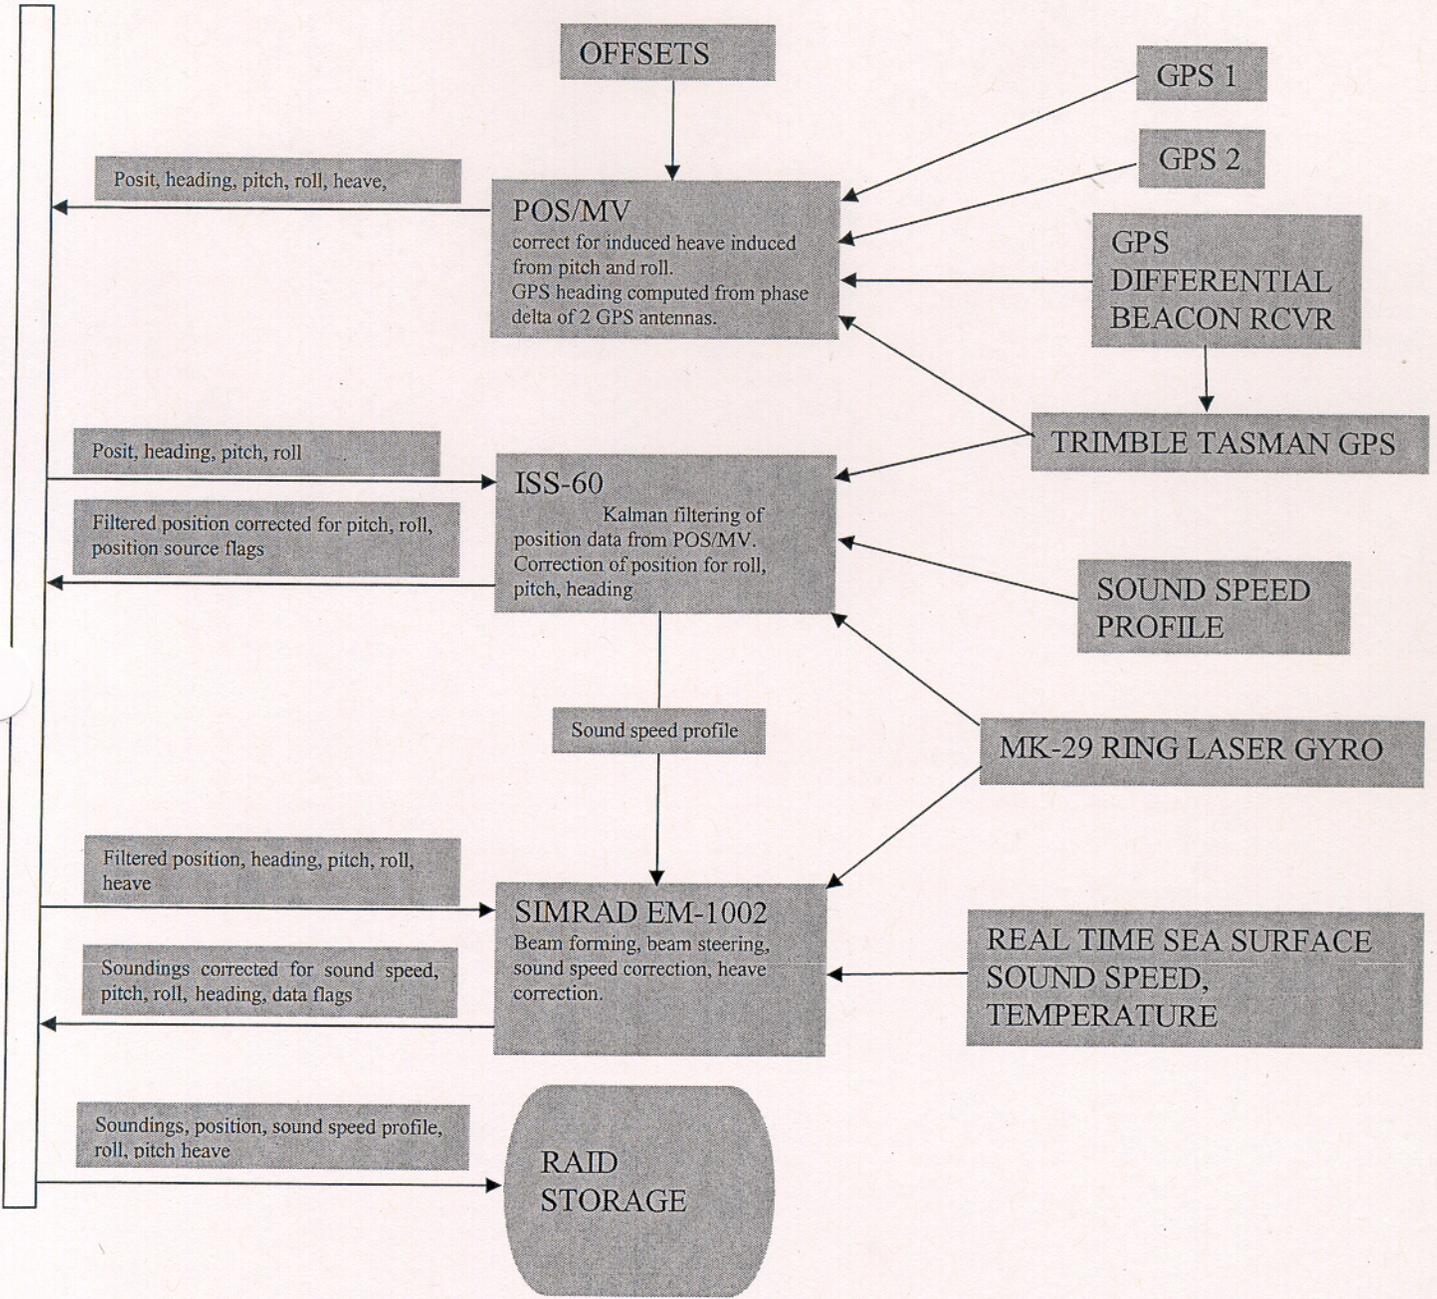
USNS SUMNER DATA FLOW

USNS SUMNER data flow is described in block diagram below

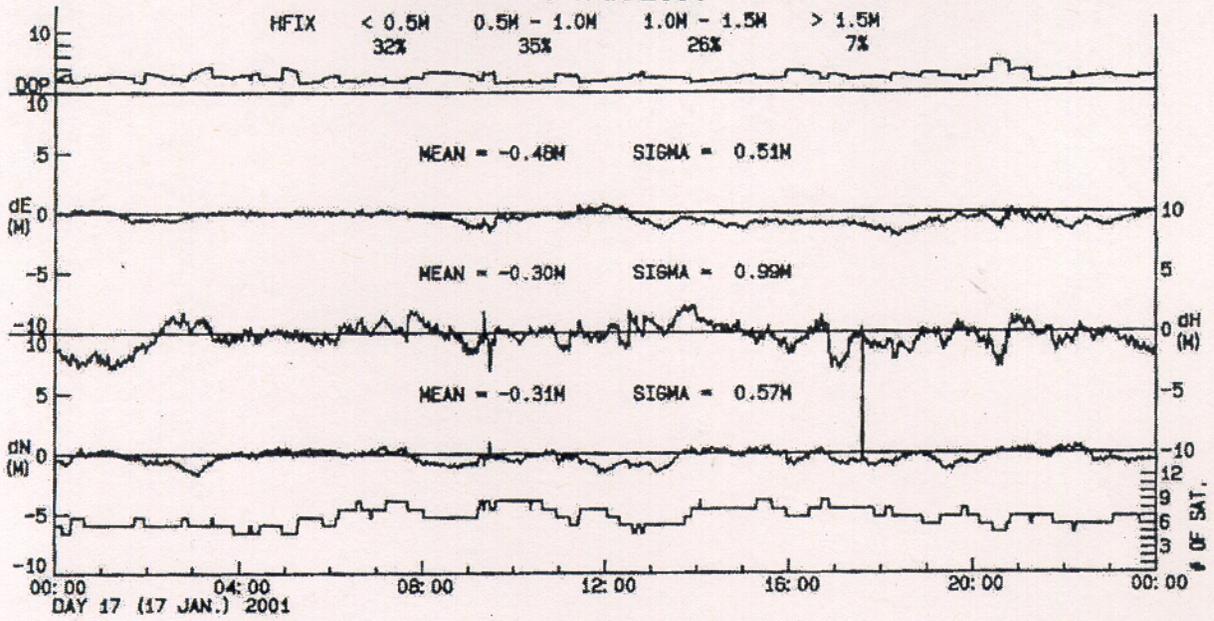
FUGRO OMNISTAR DGPS ERRORS
 GUAM, SAIPAN, TINIAN, FDM
 17 JAN 2001

8.2.1 Positional Accuracy. USNS SUMNER utilized the Fugro/Chance Omnistar DGPS system. Error predictions for the WESTPAC survey errors are shown below.

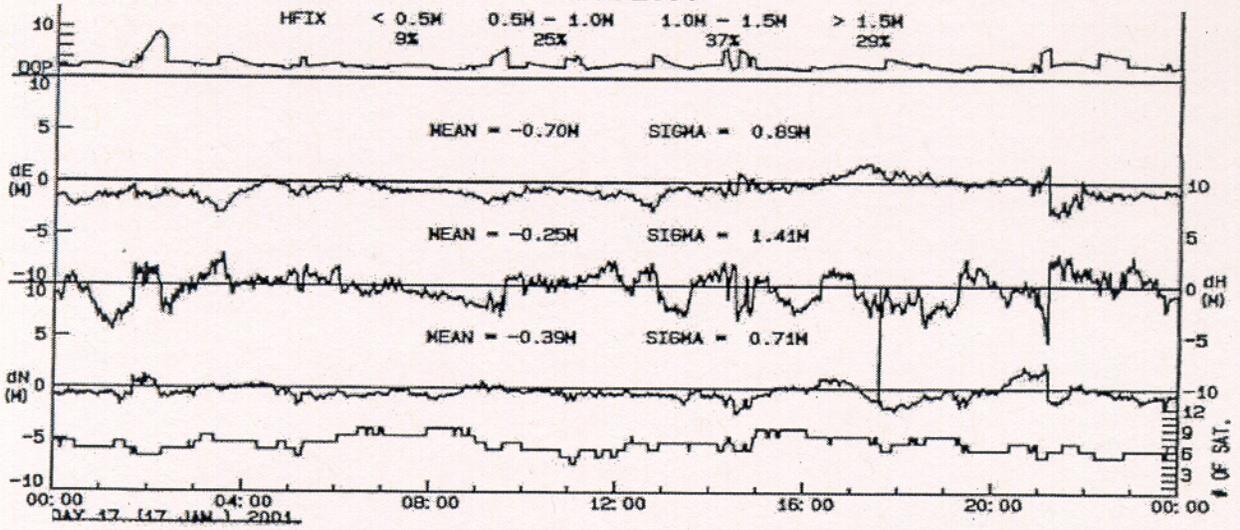
FUGRO OMNISTAR DGPS ERRORS
 GUAM, SAIPAN, TINIAN, FDM
 17 JAN 2001

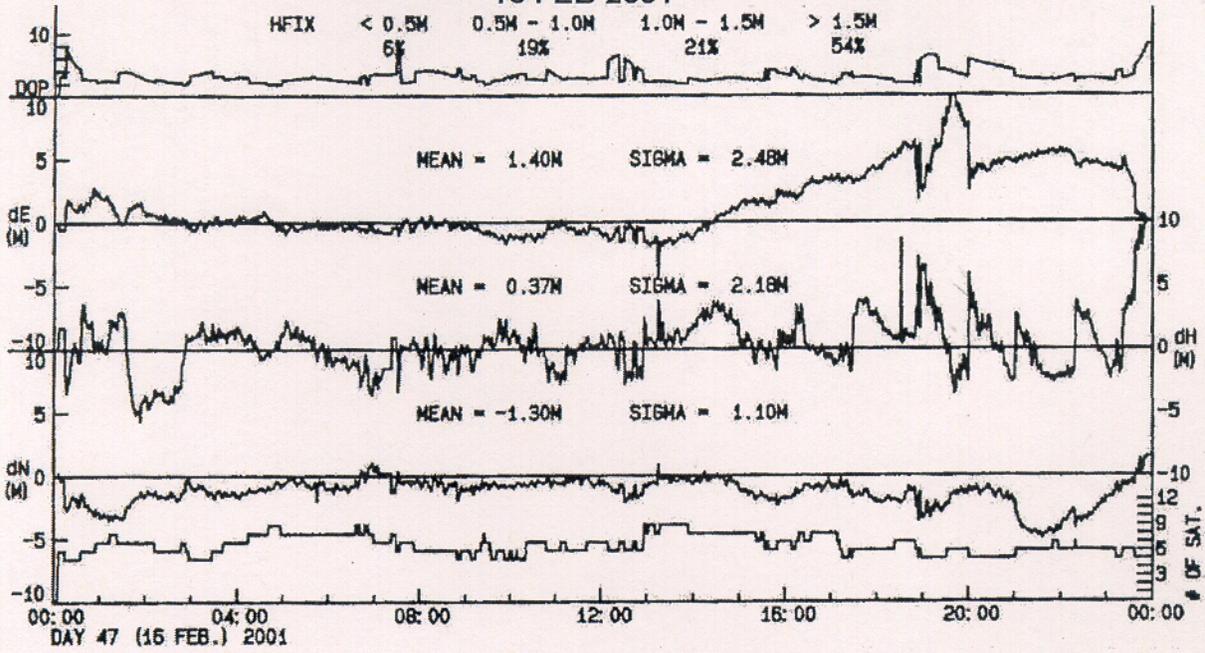
FUGRO OMNISTAR DGPS ERRORS
 GUAM, SAIPAN, TINIAN, FDM
 16 FEB 2001

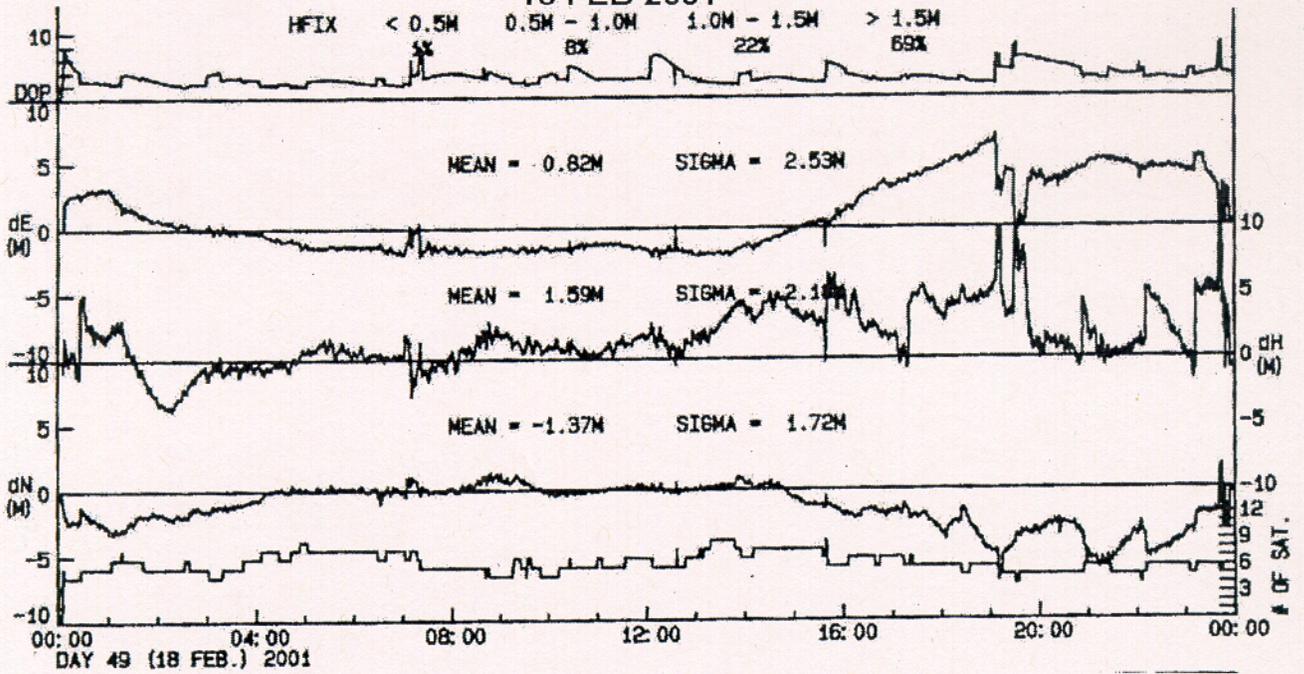
FUGRO OMNISTAR DGPS ERRORS
 GUAM, SAIPAN, TINIAN, FDM
 18 FEB 2001

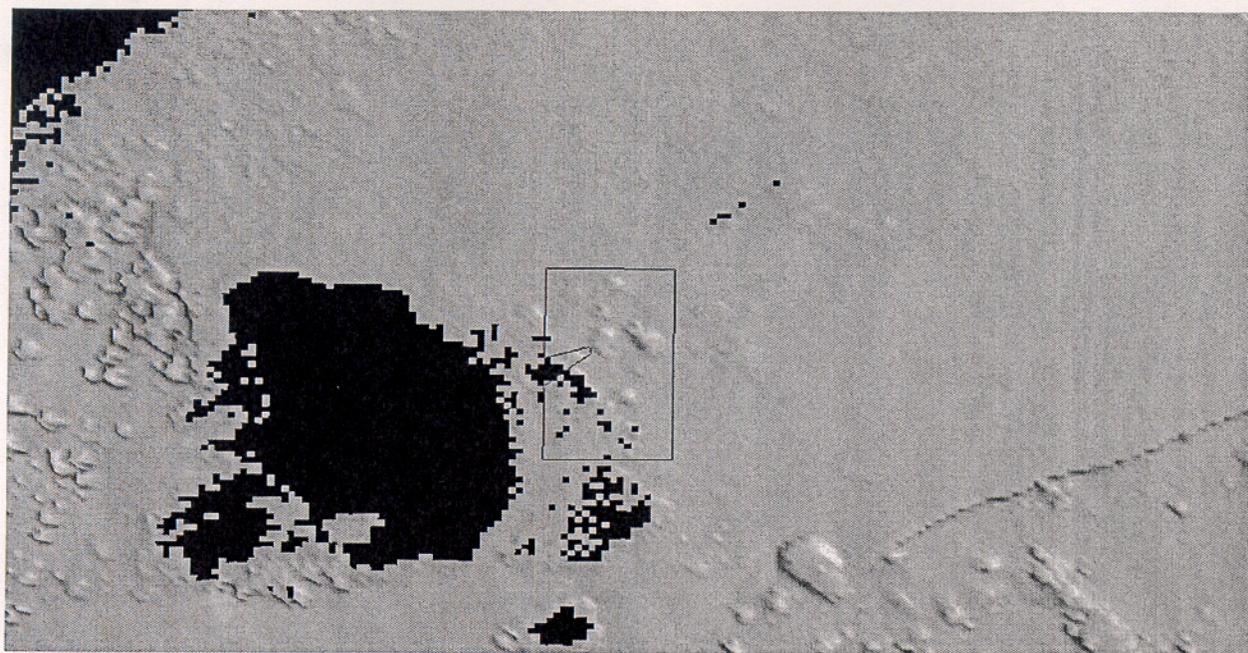
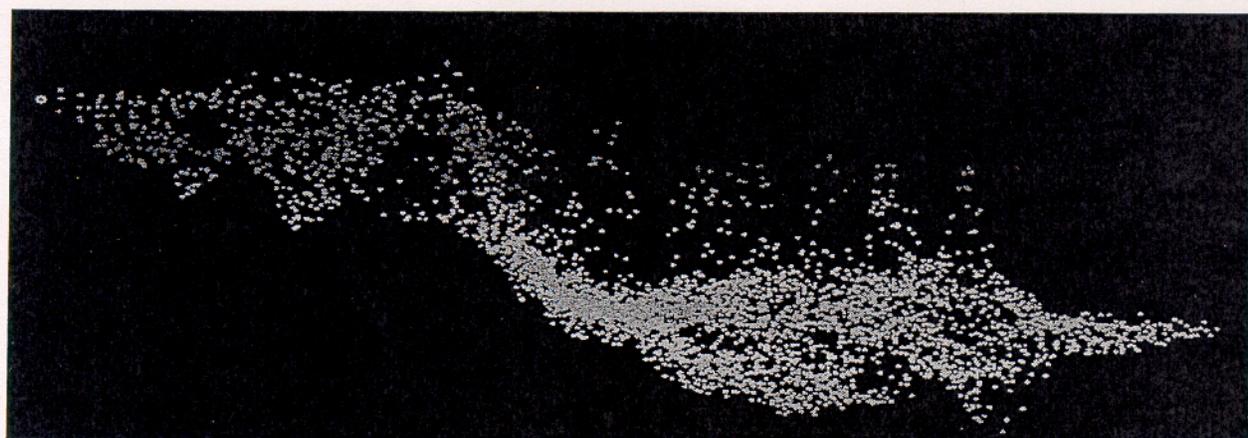
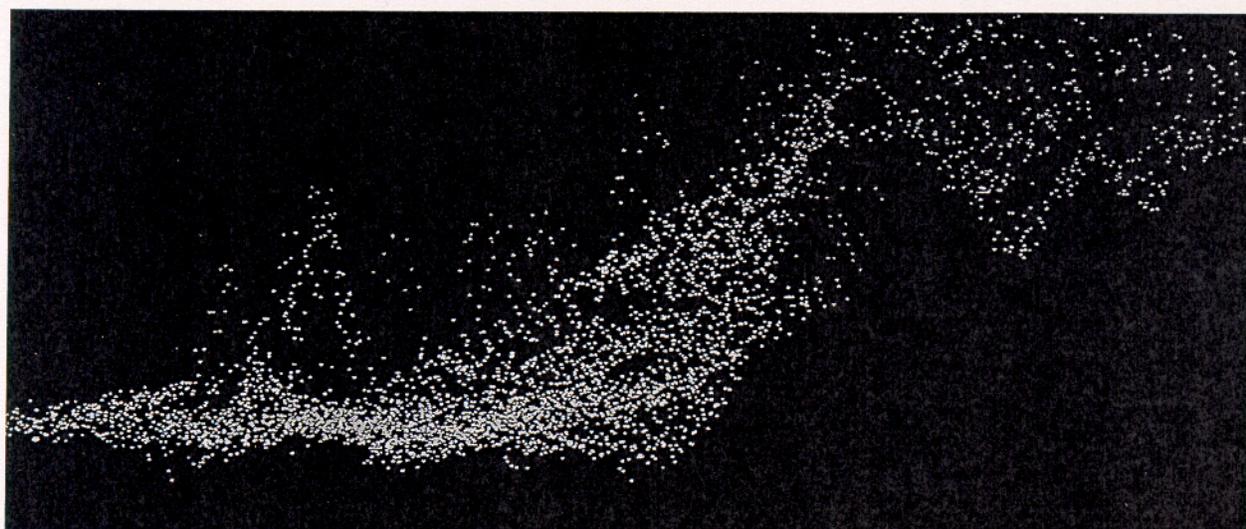
12.2.1 Two wrecks are charted just to the east of Isleta Managaha at approximately N 15 14.52' E 145 42.9'. Lidar data tends to support coral heads in this area. If the two wrecks are present, they are not evident in the data.

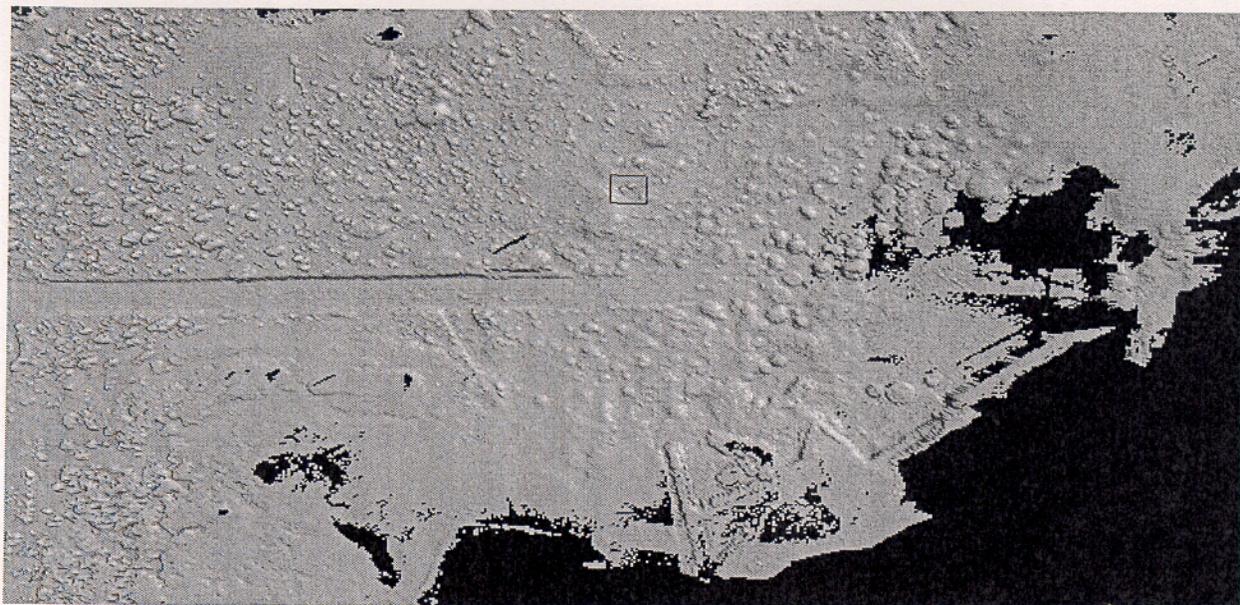
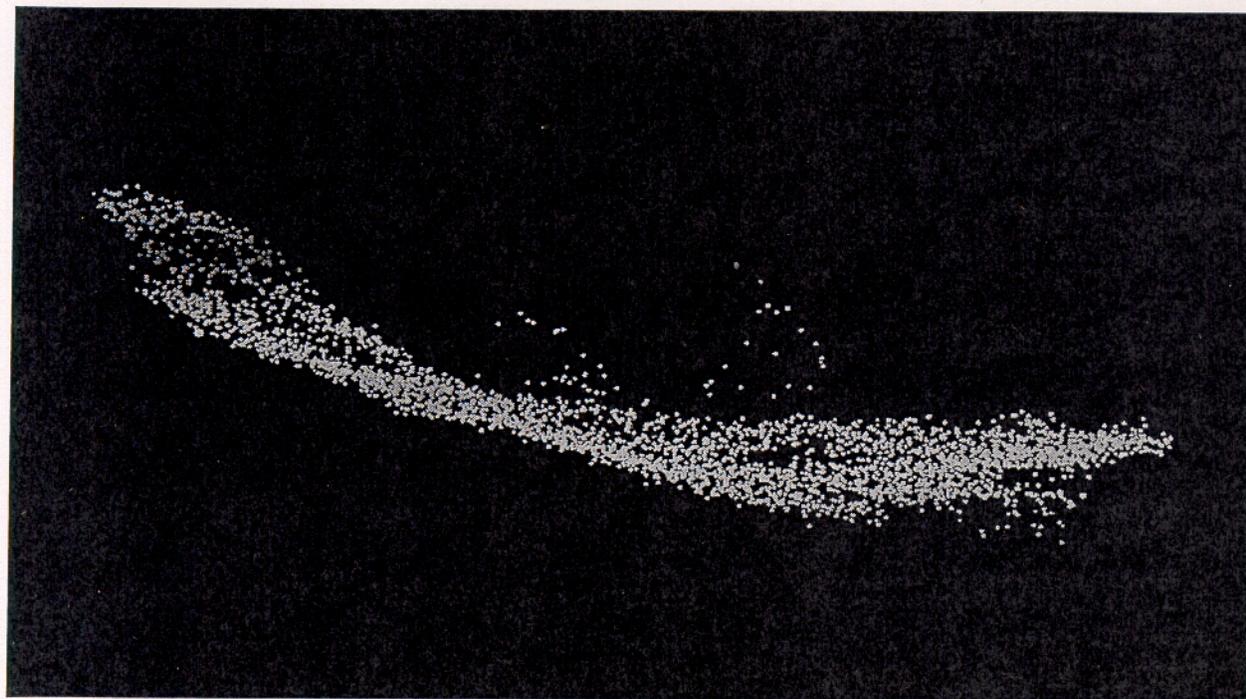
12.2.2 A charted wreck just to the north of Garapan Harbor Channel at approximately N 15 13.9653 E 145 43.3175, appears to be evident in the data with a minimum corrected Lidar depth of 5.88 meters.

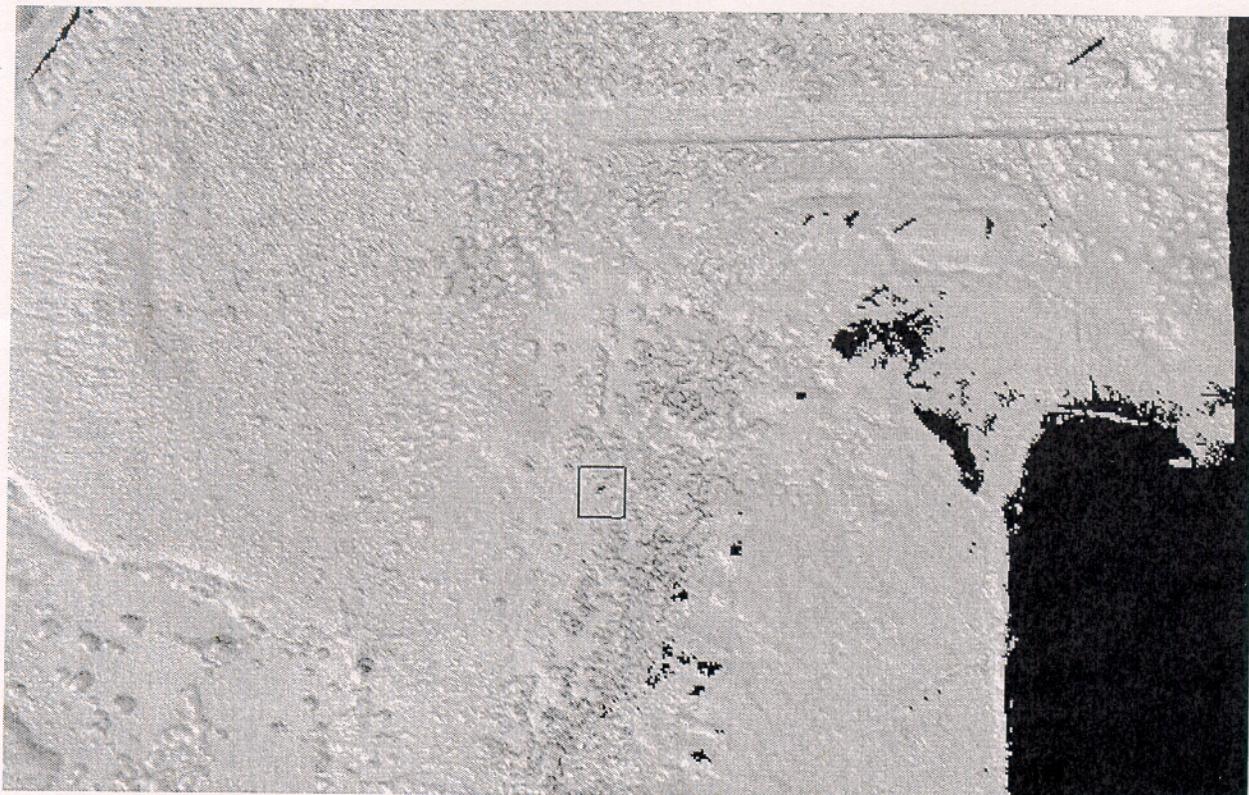
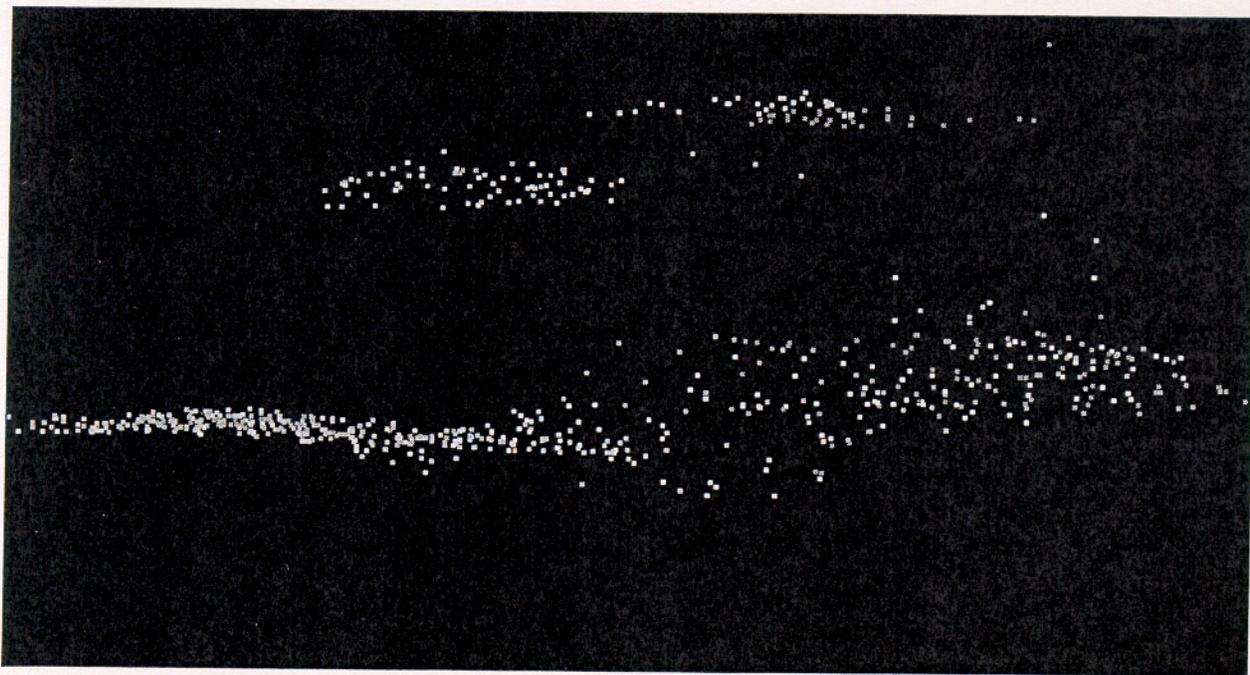
12.2.5 Charted wreck located at N 15 13' 02.44" E 145 42' 14.65" is visible. This wreck is

approximately 100 meters long, orientated NE-SW. Much of the deck is awash and visible with breaking waves often evident. The maximum Lidar detected height of 2.4 meters above the tidal datum of MLLW is located at N 15 13' 02.8" E 145 42' 14.74".

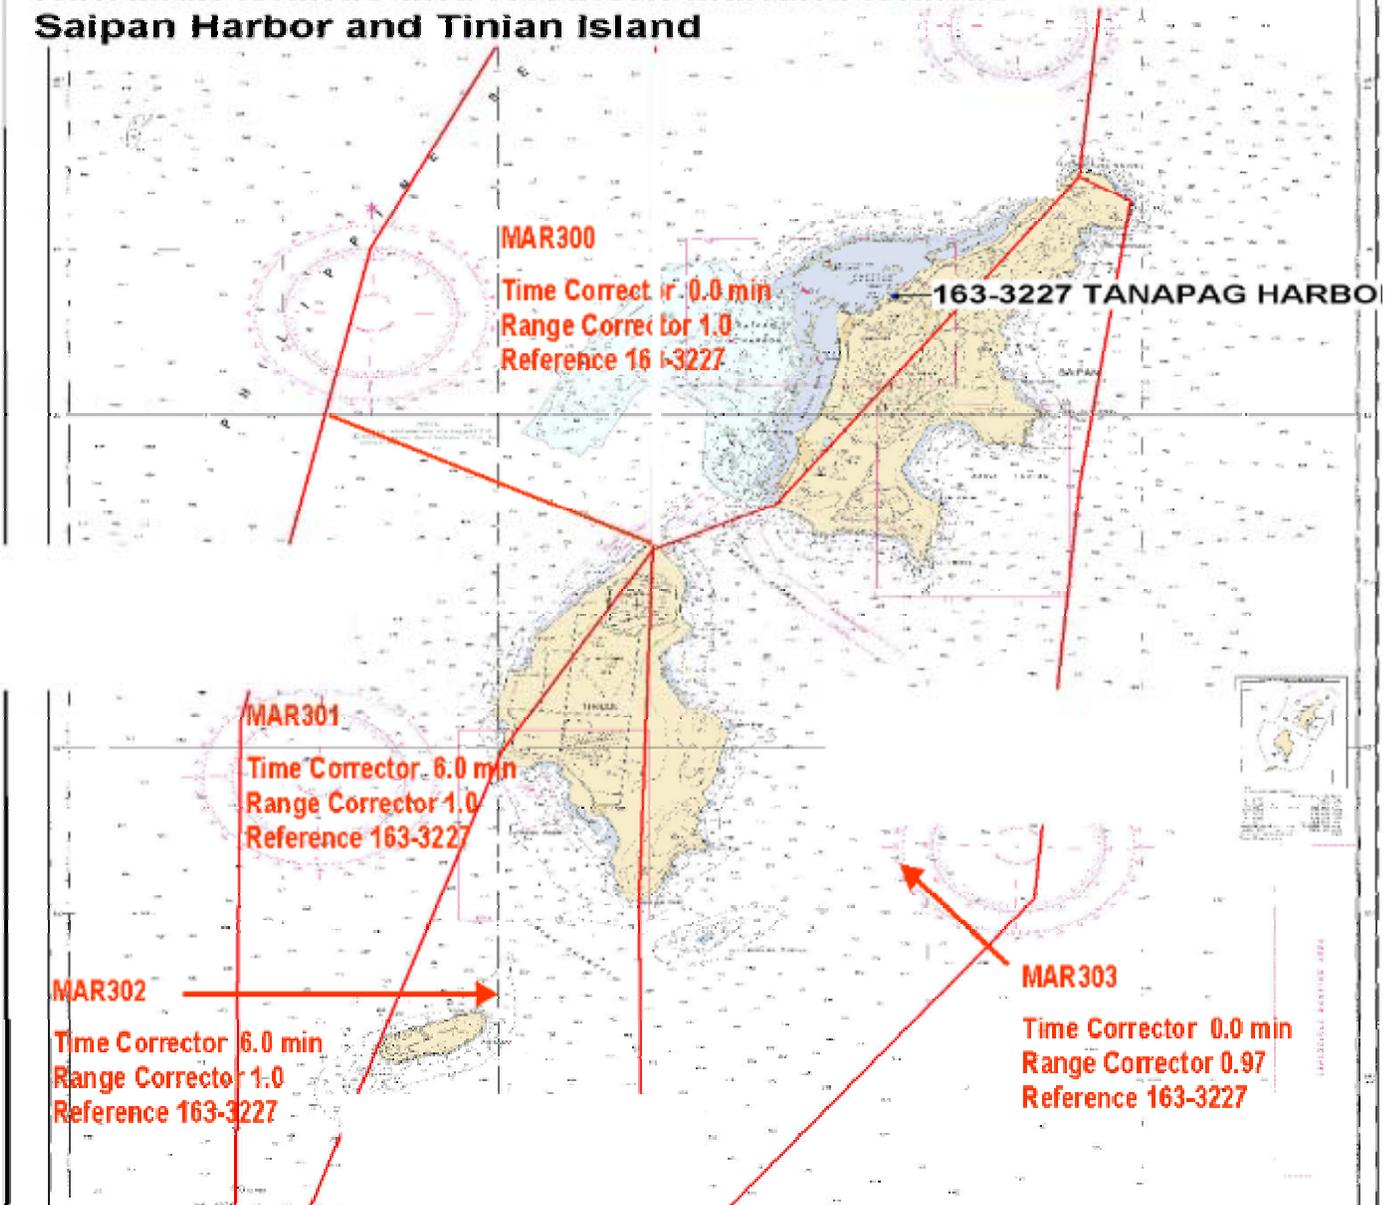
The tide zone around Saipan and Tinian were modified as shown here. It was felt that using the Saipan tide gauge (163-3227) would better represent the local tide regime than a reference gauge at Apra Harbor Guam (163-0000). Details can be found in the ROS text, section 6.4, Final Tide Zoning.

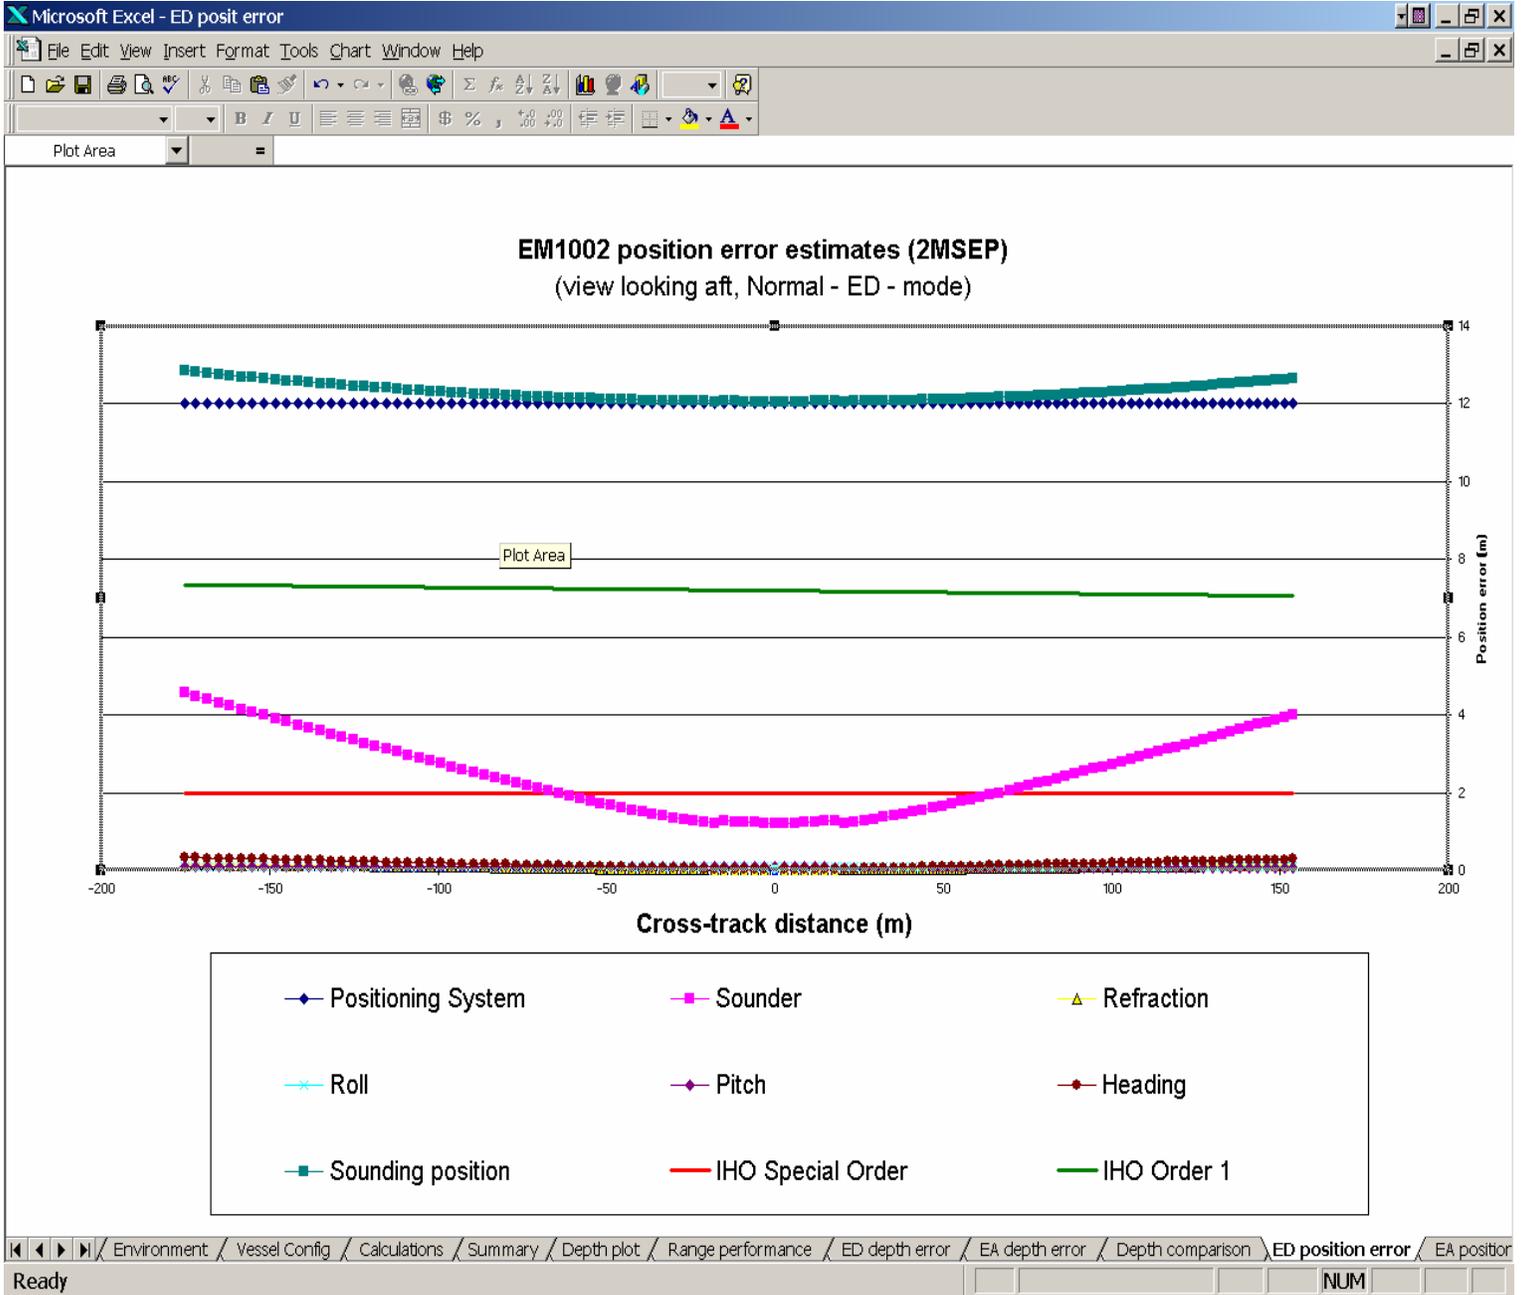
USNS SUMNER utilized the Fugro StarFix Wide Area Differential GPS (WADGPS). Position accuracy modelling by Fugro for the CNMI area indicated positioning errors of up to 12 meters. All data collected around Guam, Saipan, Tinian and FDM is down graded to IHO order 2 for positioning accuracy.

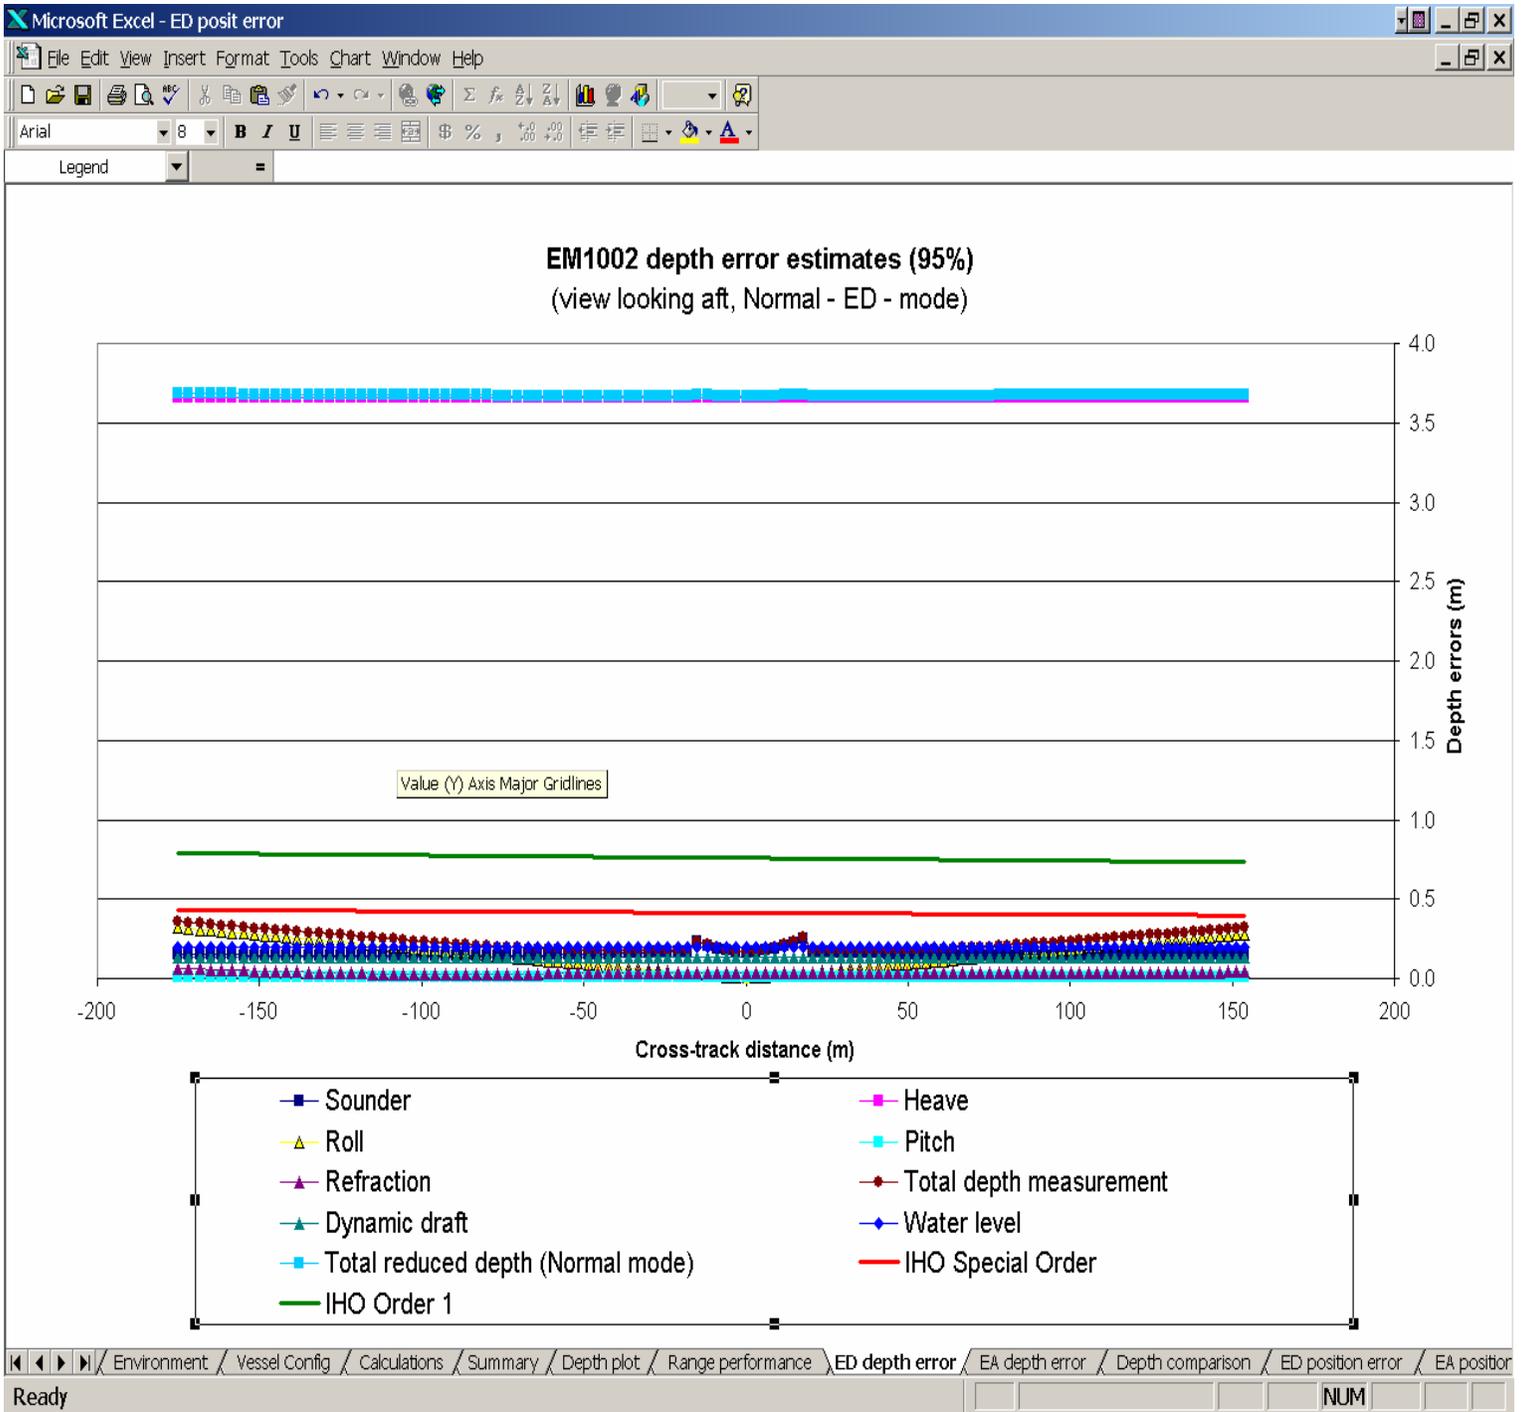
USNS SUMNER heave corrections were applied twice; once in the POS/MV and again in the SIMRAD EM-1002 multi beam sonar system. The first application of the heave correction removed the heave artifact from the data. The second application of the heave correction, effectively, put the heave back in the data. Therefore, the data collected around FDM is uncorrected for the 4 meter swell experienced by the vessel. USNS SUMNER hull response to this sea state is believed to be approximately 66% of the swell height. This results in a total reduced depth (corrected depth) with an error of 3.7 meters. Depth accuracy is downgraded to order 2 for the area around FDM.
