DESCRIPTIVE REPORT

Type of Survey HYDROGRAPHIC

Registry No. W00054-W00055

General Locality Tinian Island

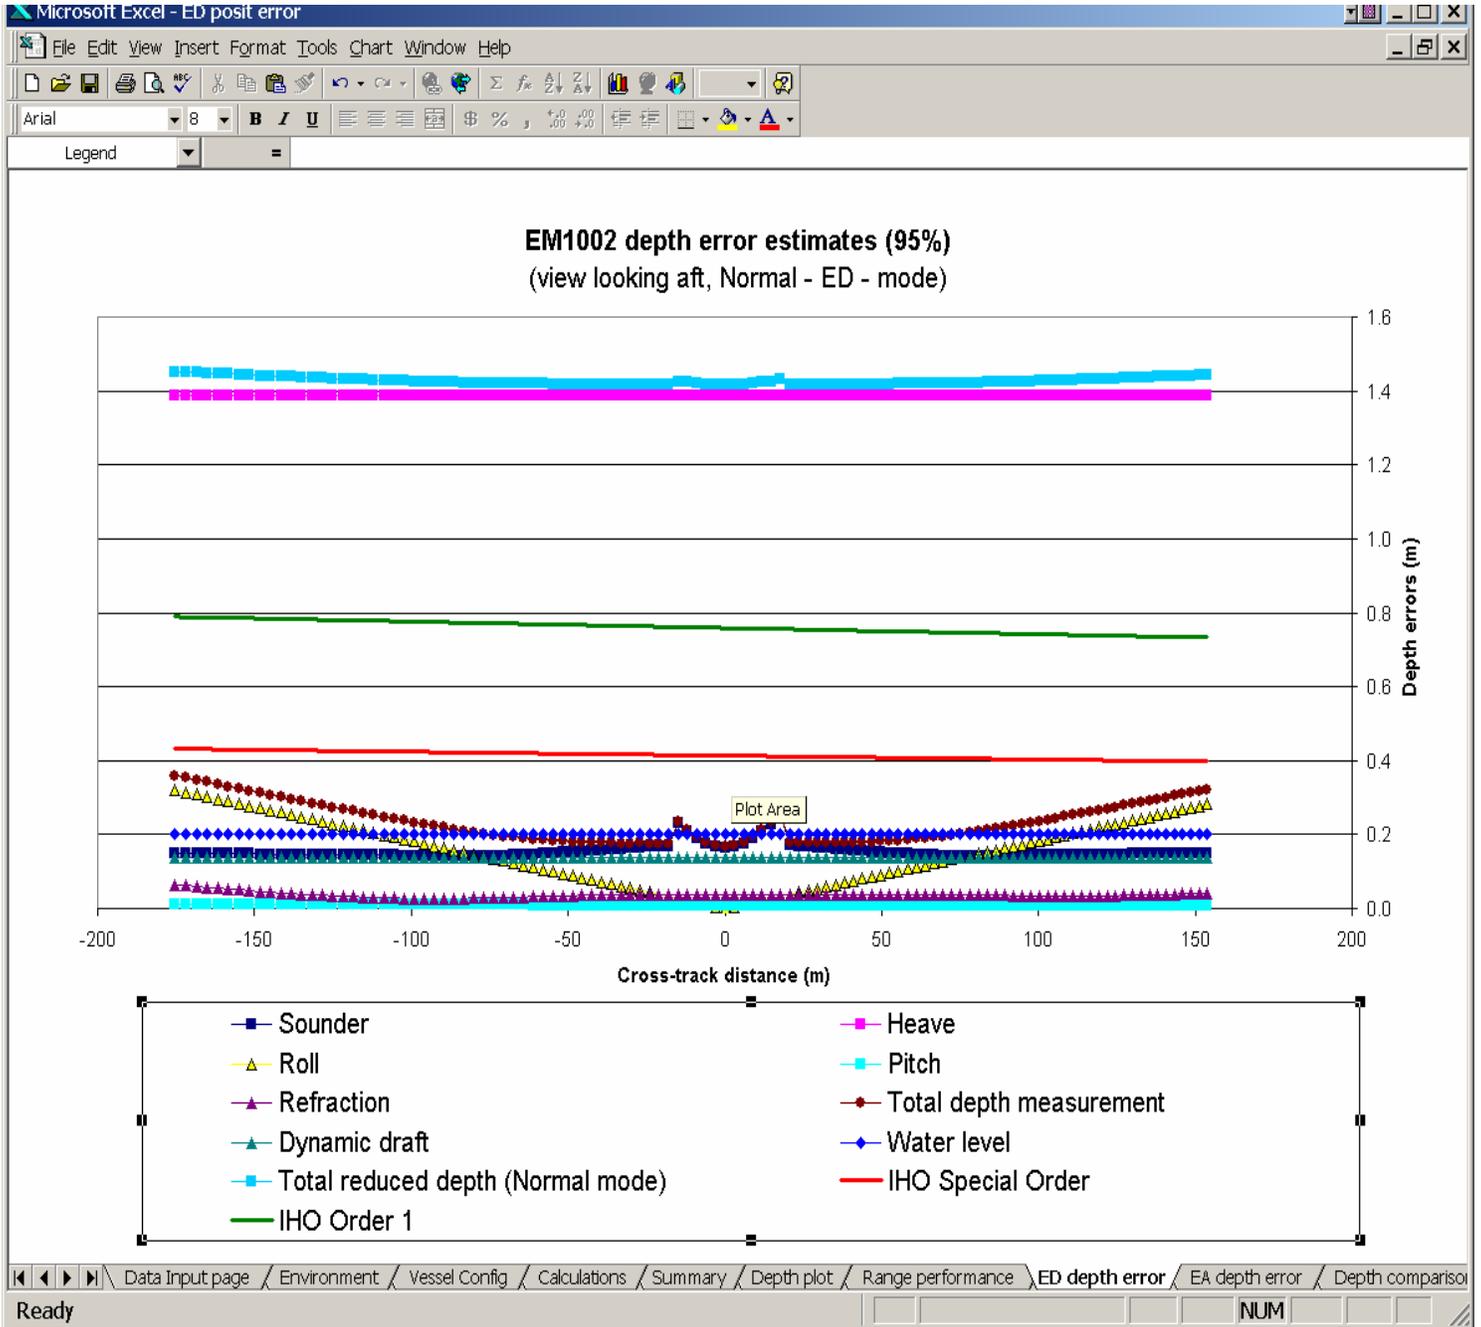
USNS SUMNER heave corrections were applied twice, once in the POS/MV and again in the SIMRAD EM-1002 multi beam sonar system. The first application of the heave correction removed the heave artifact from the data. The second application of the heave correction, effectively, put the heave back in the data. Therefore, the data collected around Saipan and Tinian is uncorrected for the approximate 2 meter swell experienced by the vessel. USNS SUMNER hull response to this sea state is believed to be approximately 50% of the swell height. This results in a total reduced depth (corrected depth) with an error of 1.4 meters. Depth accuracy is downgraded to order 2 for the areas around Saipan and Tinian.

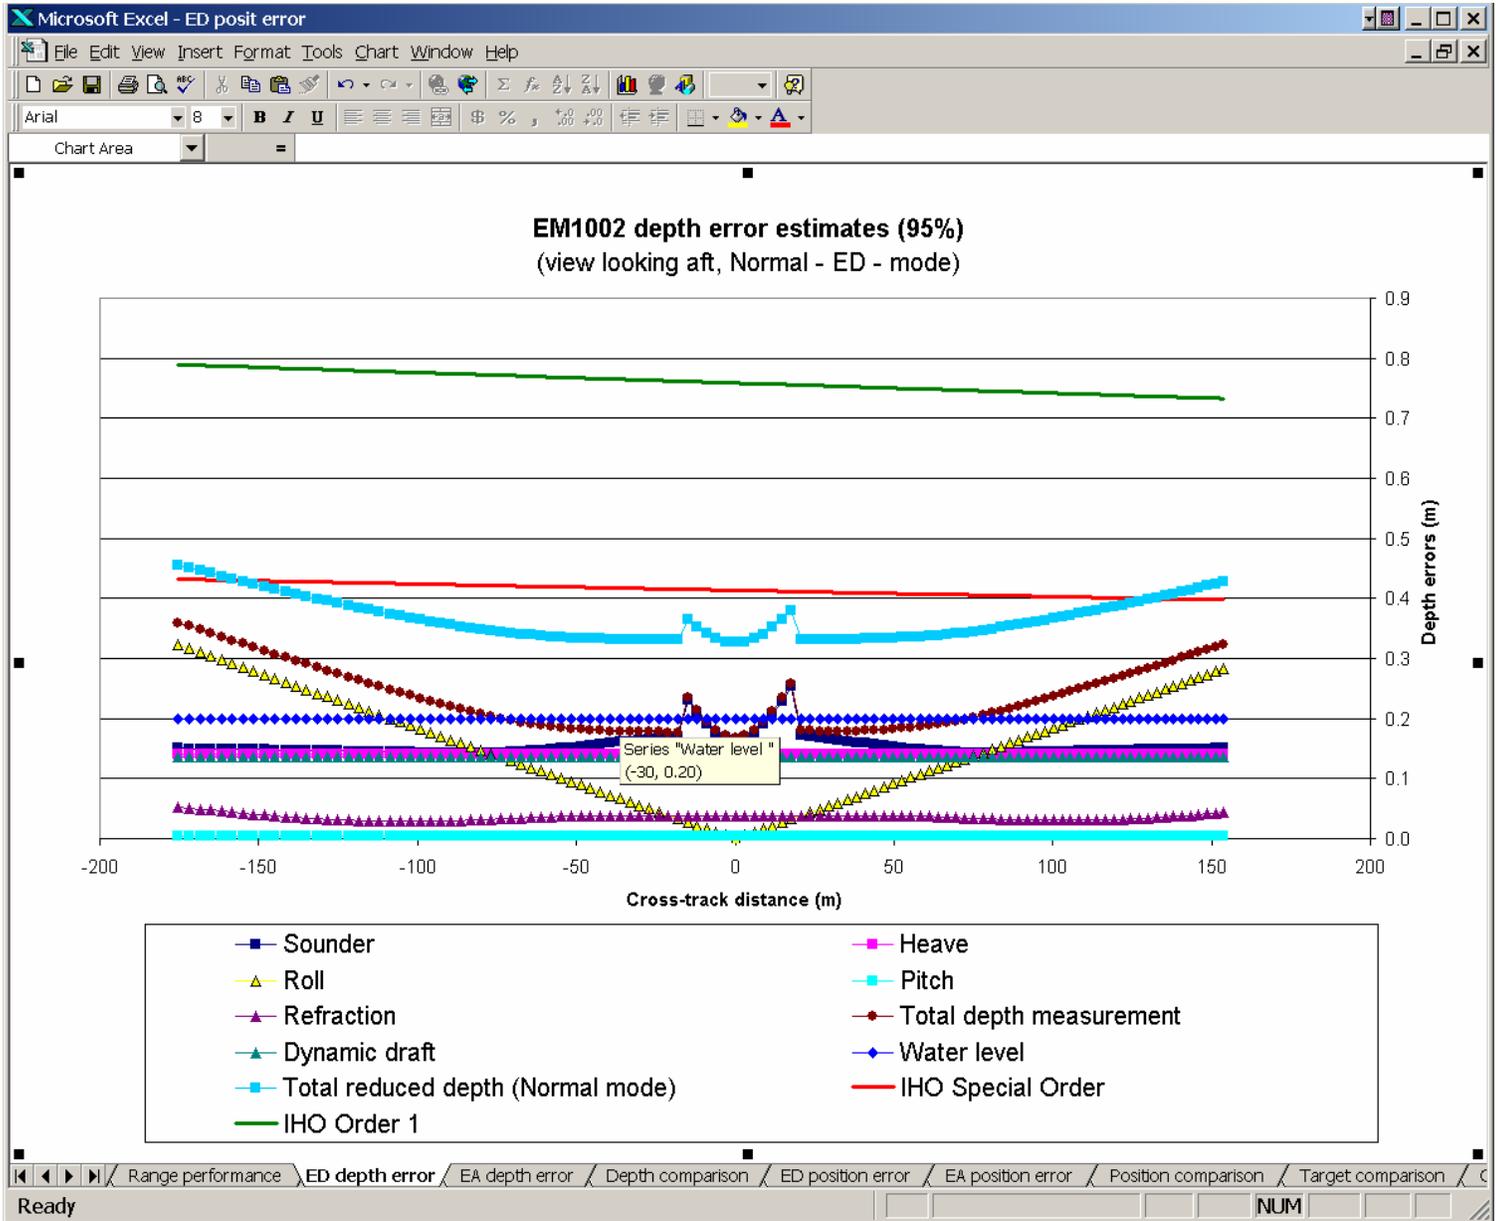
USNS SUMNER heave corrections were applied twice, once in the POS/MV and again in the SIMRAD EM-1002 multi beam sonar system. The first application of the heave correction removed the heave artifact from the data. The second application of the heave correction, effectively, put the heave back in the data. Therefore, the data collected around Guam is uncorrected for the approximate 1 meter swell experienced by the vessel. USNS SUMNER hull response to this sea state is believed to be approximately 5% of the swell height. This results in a total reduced depth (corrected depth) with an error of 0.33 to 0.43 meters across the swath. Depth accuracy meets order 1 for the area off of Apra Harbor Guam.

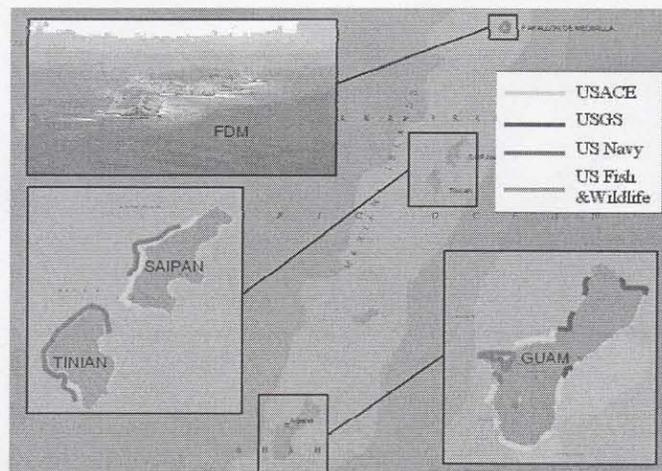
Fig. 1. Survey Areas and Requirements.

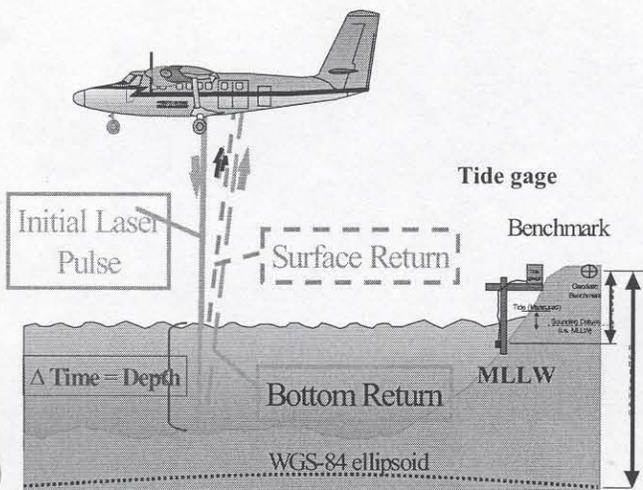
Fig. 2. Chart Depth determined by time between water surface and bottom return, minus the tide correction.

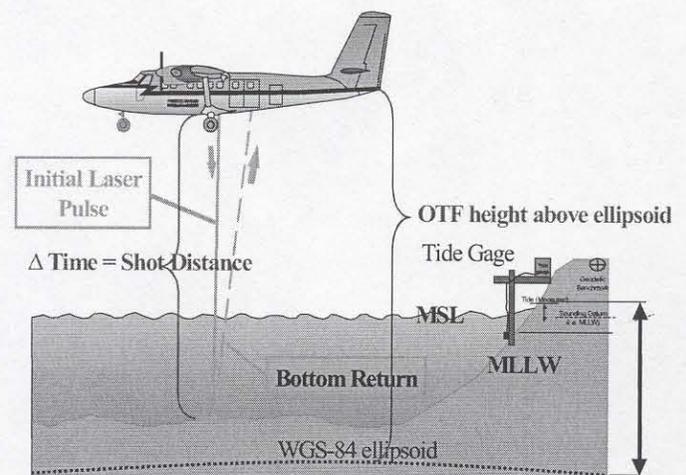
Fig. 3. Chart Depth = Laser Shot Distance - OTF aircraft height above ellipsoid + Offset ellipsoid to MSL - Offset MSL to MLLW.

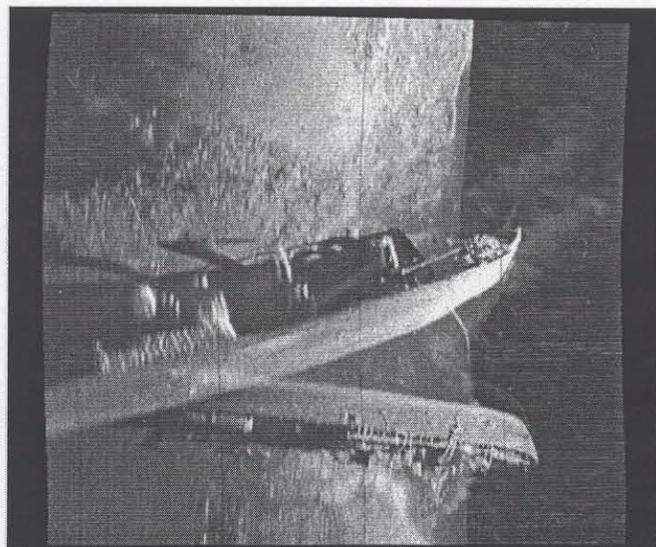
Fig. 4. One of many wrecks found by the FST side scan.

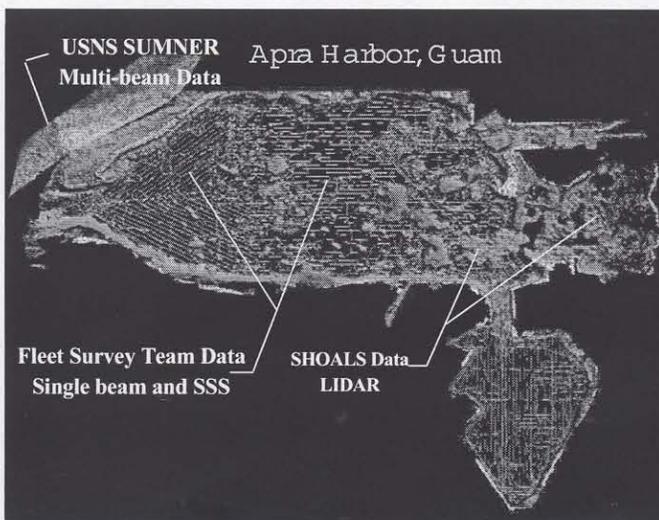
Fig. 5 SHOALS, FST, and SUMNER data fusion for Guam.

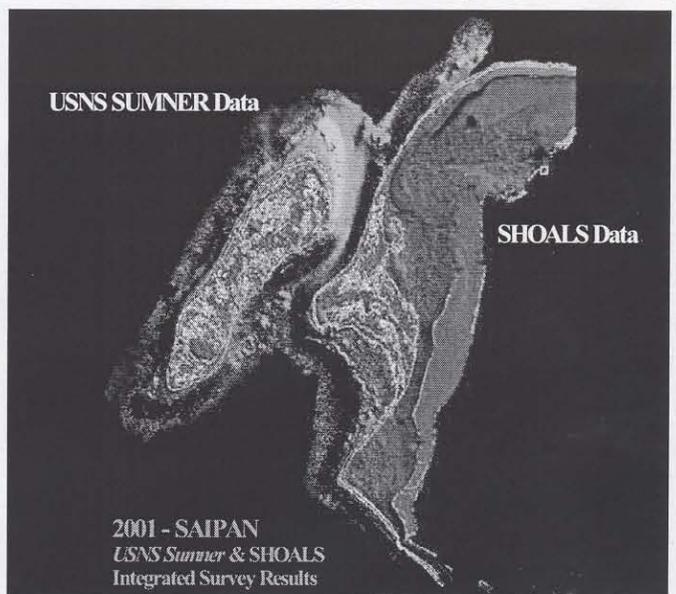
Fig. 6 SHOALS and SUMNER data fusion for Saipan

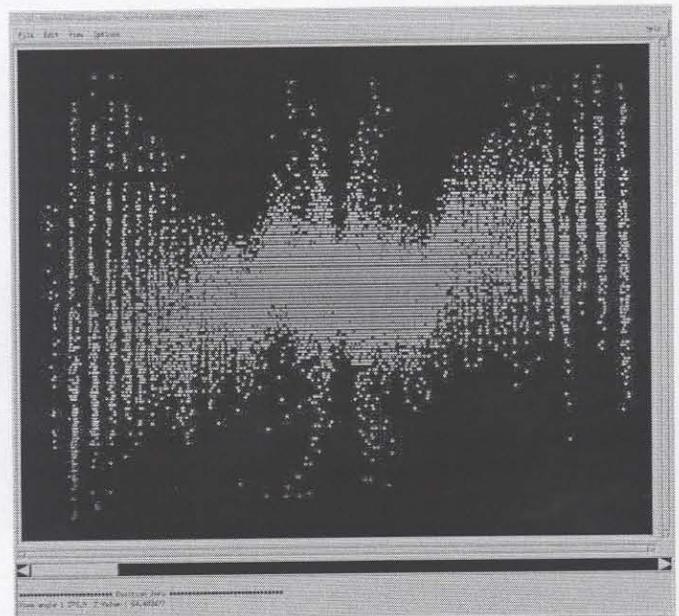
Fig. 7. EM1002 Swath Profile (gsgf_geoswath) showing ridge-like effects.

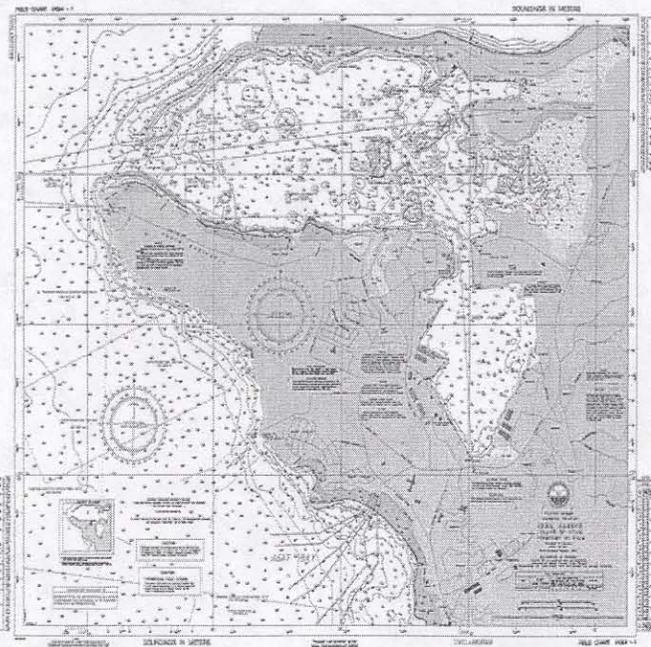
Fig. 8. Field Chart of Apra Harbor, Guam.

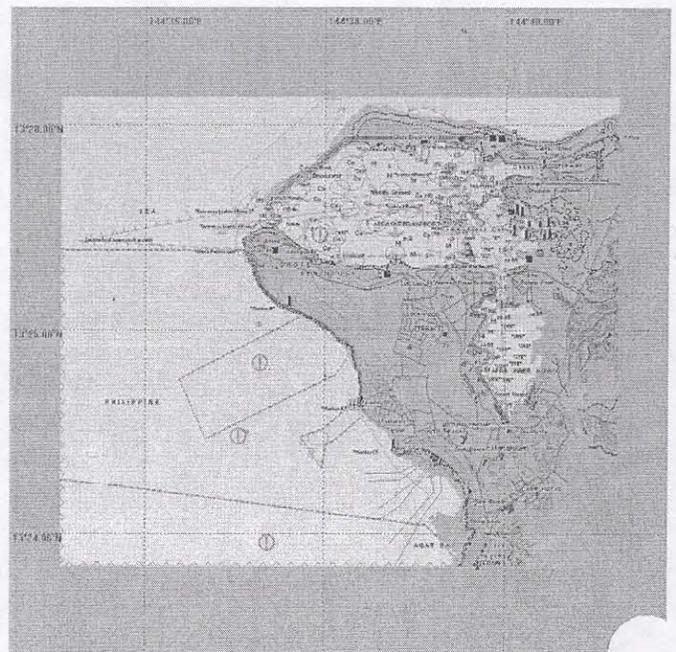
Fig. 9. Updated DNC library for Apra Harbor, Guam.

Major changes were made to the Hydrography, Aids to Navigation, and Obstructions layers of the Apra Harbor DNC®. Changes included the addition of 46 bottom characteristics, the repositioning or addition of 53 aids to navigation, and the addition of 48 new obstructions
