DESCRIPTIVE REPORT

Type of Survey HYDROGRAPHIC

General Locality Northwest Coast of Oahu

Sublocality Kaena Point to Kahuku Point

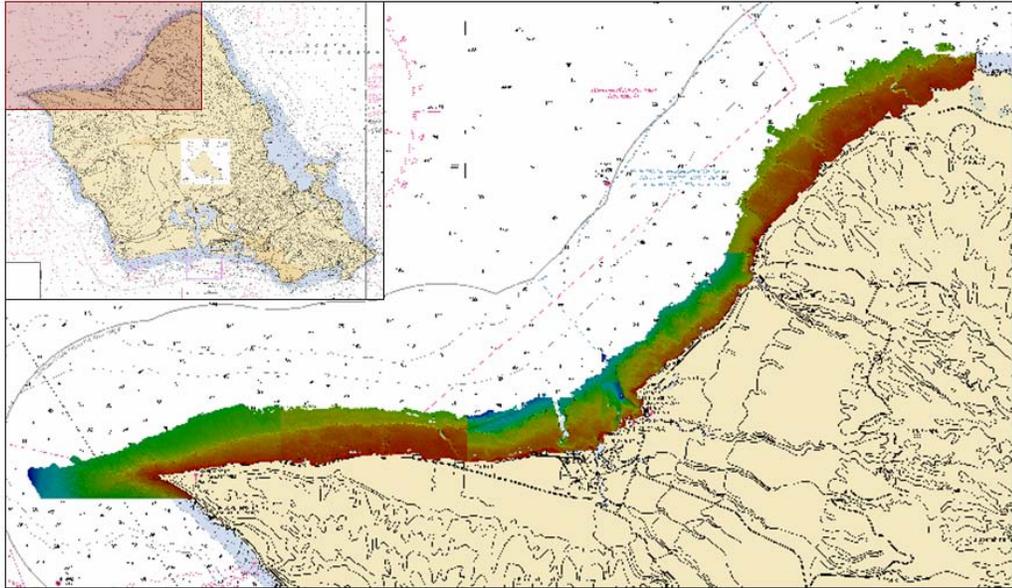
Figure 1. An overview of the area covered by NAVOCEANO surveys W00085 through W00090 and W00092. The surveys cover the Northwest coast of Oahu, HI, spanning from Kaena Point to Kahuku Point. Digital terrain models (DTMs) from each survey area are overlain on NOAA chart 19357.

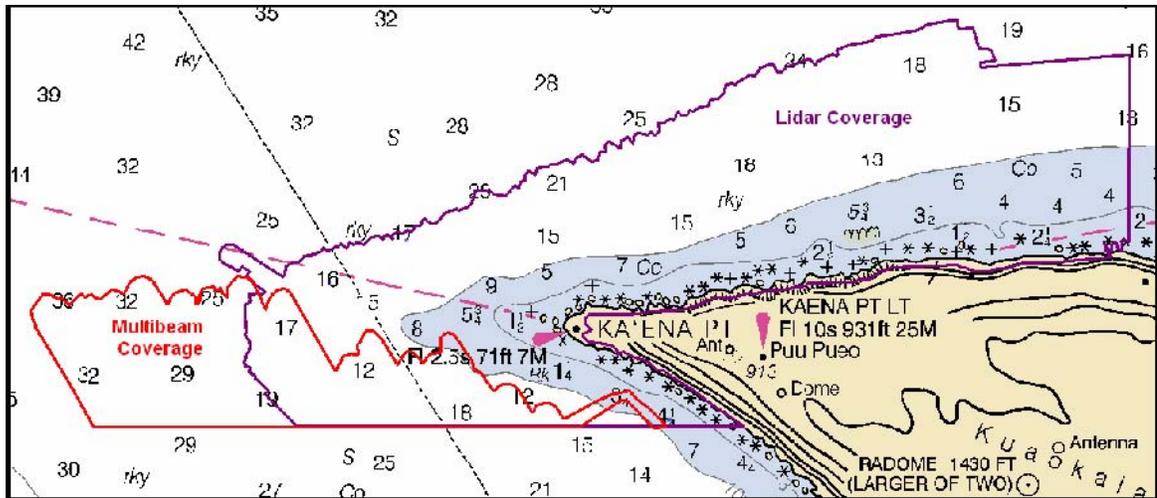
Figure 2. Areas of overlapping Lidar and multi-beam coverage for survey W00085.

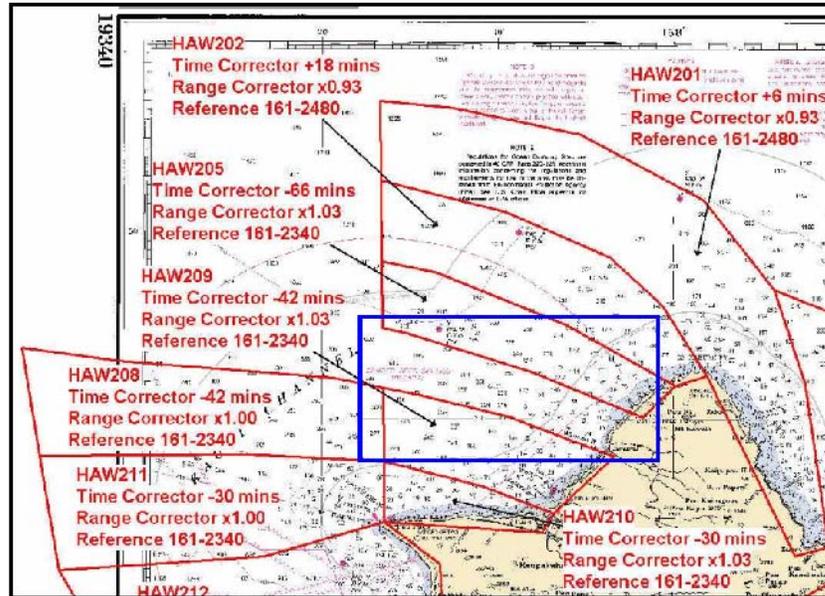
Figure 3. The blue rectangle highlights a gap in preliminary tide zone coverage for the island of Oahu. Preliminary tide zoning for NAVOCEANO was provided by CO-OPS. The gap in tide zone coverage spans along the coastline northeast from Waimea Bay to approximately 21°40'29.74" N, 158°02'25.48" W. ¹

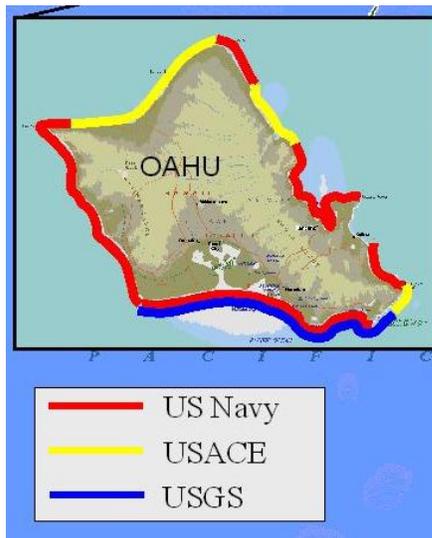
Figure 4. Image depicting Lidar coverage for Oahu. Areas surveyed by the US Navy and USGS were surveyed with 4x4 meter spot density and 200 % coverage. Areas surveyed by the USACE were surveyed with 8x8 meter spot density and 100 % coverage. The image was submitted in Appendix A of the Hawaii Lidar ROS. ²

A stretch of coast spanning from just east of Kaena Point to Kahuku Point does not meet HSSDM standards for data redundancy and object detection. The region was surveyed per request of the US Army Corps of Engineers using 8x8 meter spot density and 100% coverage and was not required to meet charting standards. The lack of redundant data increases uncertainty regarding the accuracy of least depth soundings over charted or new shoals and obstructions. There were also a number of gaps in data coverage due to lack of data overlap between lines. The surveys affected by this coverage deficiency include all surveys except W00085. ²

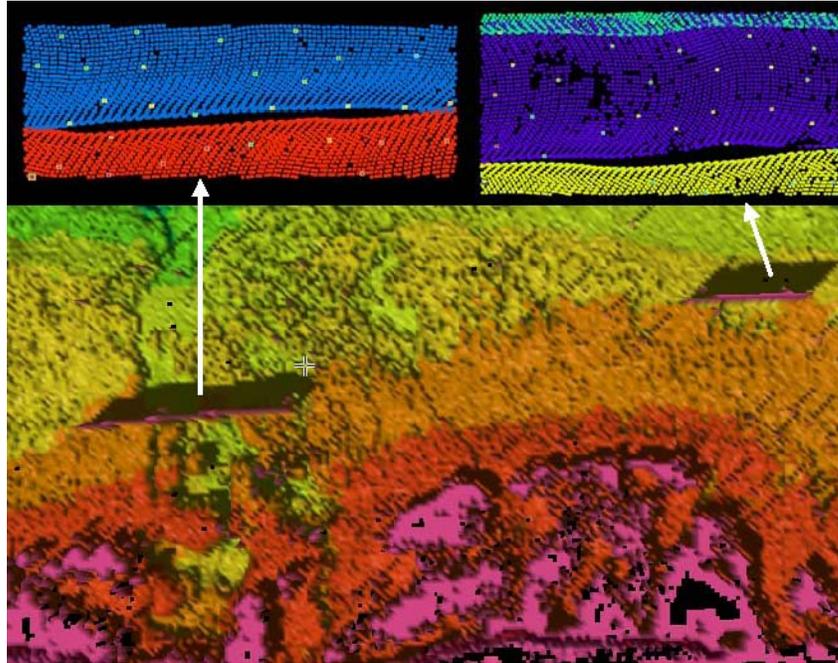
Figure 5. Gaps in coverage from survey W00087 displayed in Fledermaus (bottom) and Fledermaus 3D Editor (top). The bottom image is colored by depth with the pink regions representing gaps in coverage. The top images are colored by line and display holidays that occurred due to lack of data redundancy.³

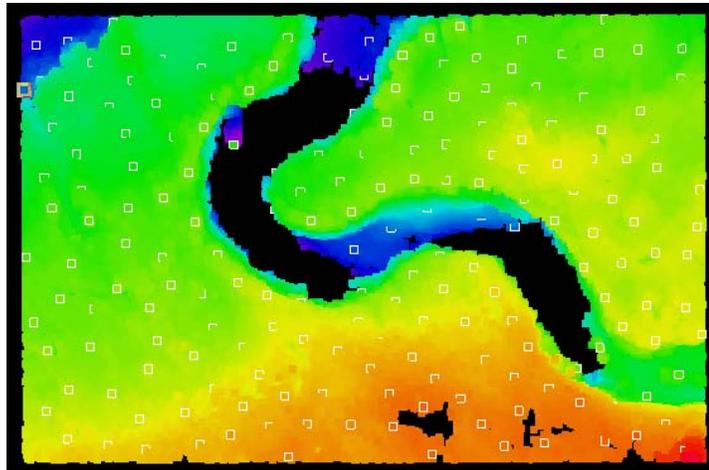
Figure 6. Gaps in Lidar coverage in a channel located in survey W00090. Lidar displayed difficulty acquiring data in deep portions of channels.⁴ The image is displayed in Fledermaus 3D Editor and colored by depth.

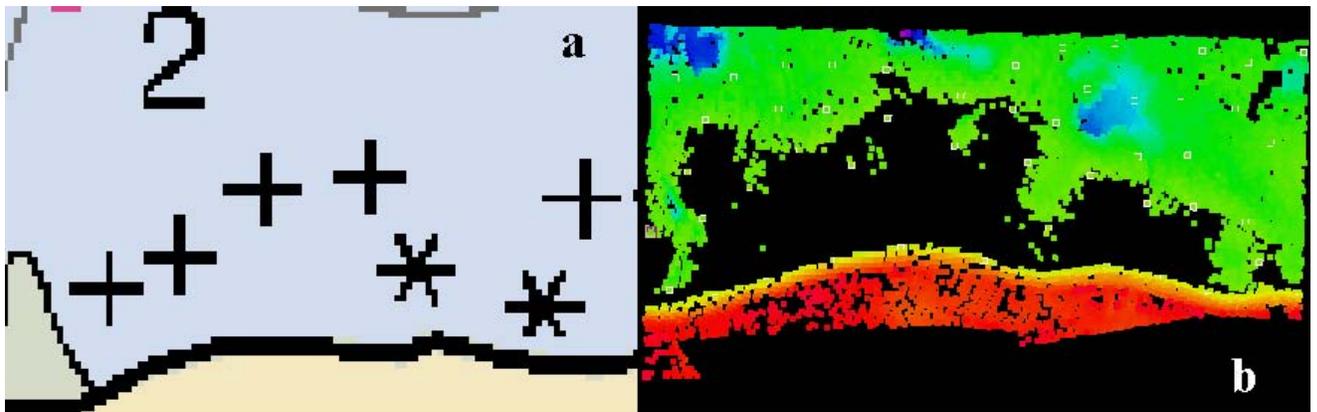
Figure 7. A near shore gap in Lidar data coverage over a charted area foul with rocks within survey W00087 is displayed above. The same area is displayed on chart 19357 (a) and in Fledermaus 3D Editor with soundings colored by depth (b).⁵

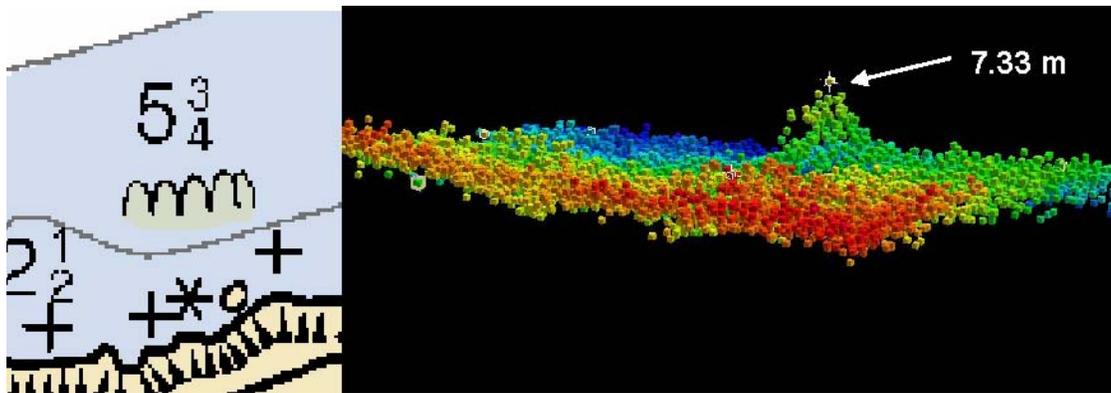
A charted reef¹⁰ located Northwest of Kaena Point at 21°34'53.75" N, 158°15'20.62" W was not visible in the NAVOCEANO smooth sheet or in the high-density Fledermaus data set. A submerged pinnacle was located in the vicinity of the charted reef with a least depth of 7.33 meters (4 fathoms) (Figure 8). It is recommended that the reef be retained as charted and added to the AWOIS database for future investigation or disproval.¹¹

Figure 8. A charted (19357) reef located Northwest of Ka'ena Point was surveyed as a submerged pinnacle with a least depth of 7.33 meters. The surveyed soundings are shown above in Fledermaus 3D-Editor and are colored by depth.

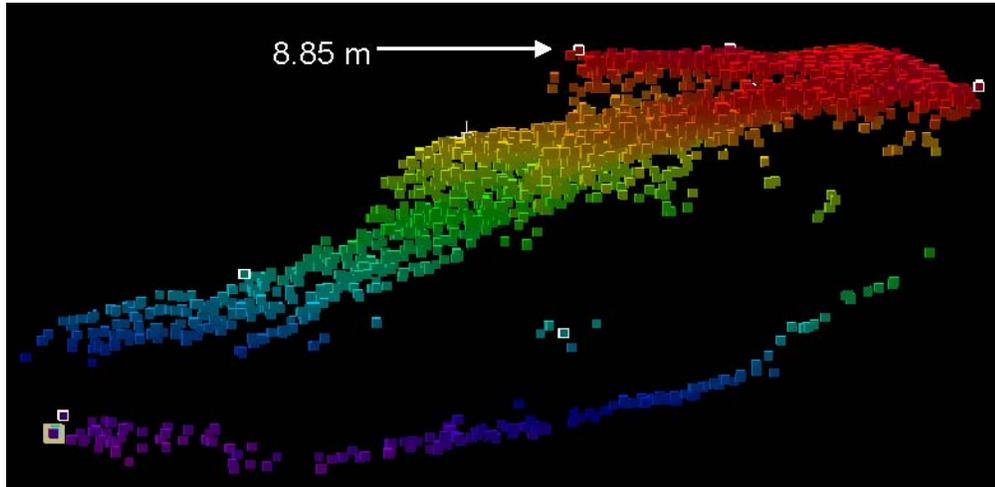
A new shoal was surveyed in Waialua Bay with a least depth of 8.85 m (4.84 fms) located at 21°35'57.49" N, 158°06'46.64" W (Figure 9). The shoal is located in the vicinity of a charted 7-fm sounding. It is recommended that the surveyed shoal supersede charted depths.¹³

Figure 9. Image of a new shoal from survey W00086 with soundings colored by depth and displayed in Fledermaus 3D Editor.

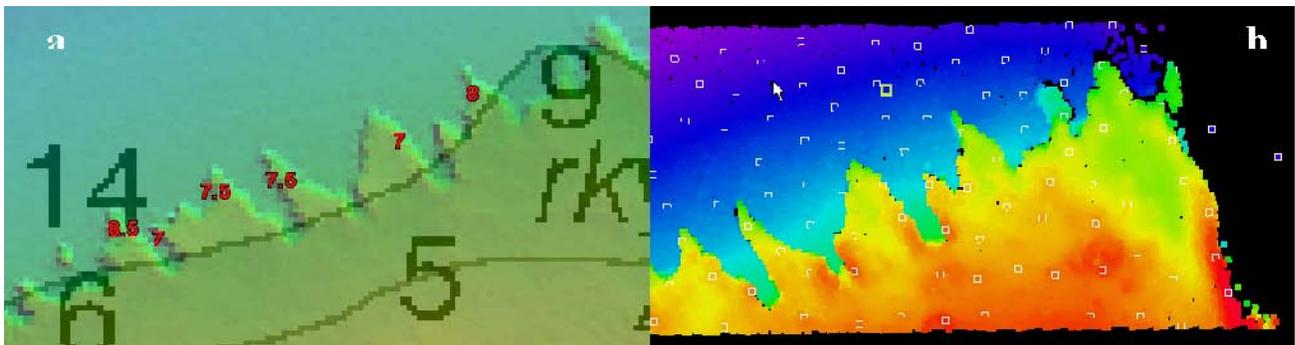
The seaward edge of the reef¹⁴ has advanced beyond the charted 10-fm contour near the entrance of the charted channel leading into Kaiaka Bay (21°35'49.19" N, 158°08'02.8" W). Lidar depths to the west of the channel entrance were 2 to 3 fathoms shoaler than the charted contour (Figure 10) and were 2 to 5 fathoms shoaler than charted on the east side of the entrance (Figure 11). It is recommended that the charted contours be updated using the surveyed depths.¹⁵

Figure 10. (a) An image displaying the extension of the reef surveyed beyond the charted (19357) 10-fm contour to the west of the entrance to Kaiaka Bay. (b) The same section of the reef in image “a” displayed in Fledermaus 3D Editor with soundings colored by depth.

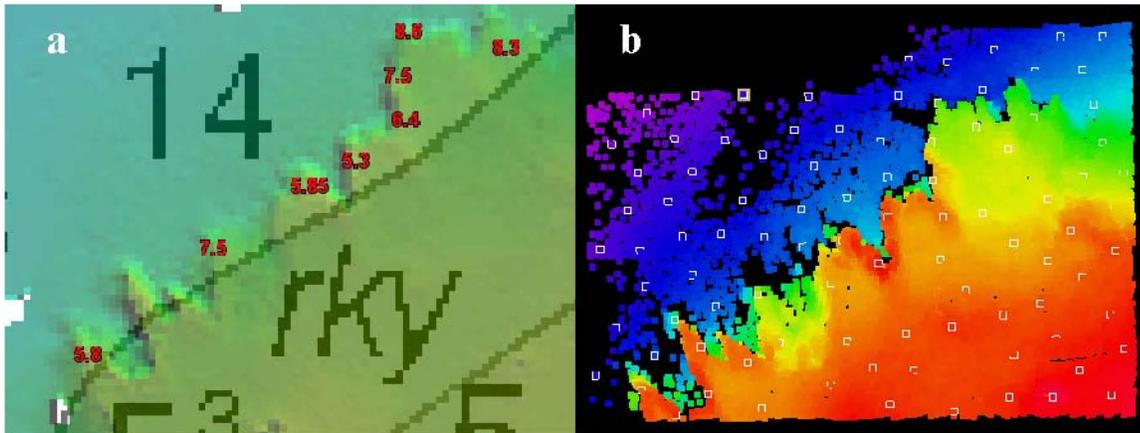
Figure 11. (a) An image displaying the extension of the reef surveyed beyond the charted (19357) 10-fm contour to the east of the entrance to Kaiaka Bay. (b) The same section of the reef in image “a” displayed in Fledermaus 3D Editor with soundings colored by depth.

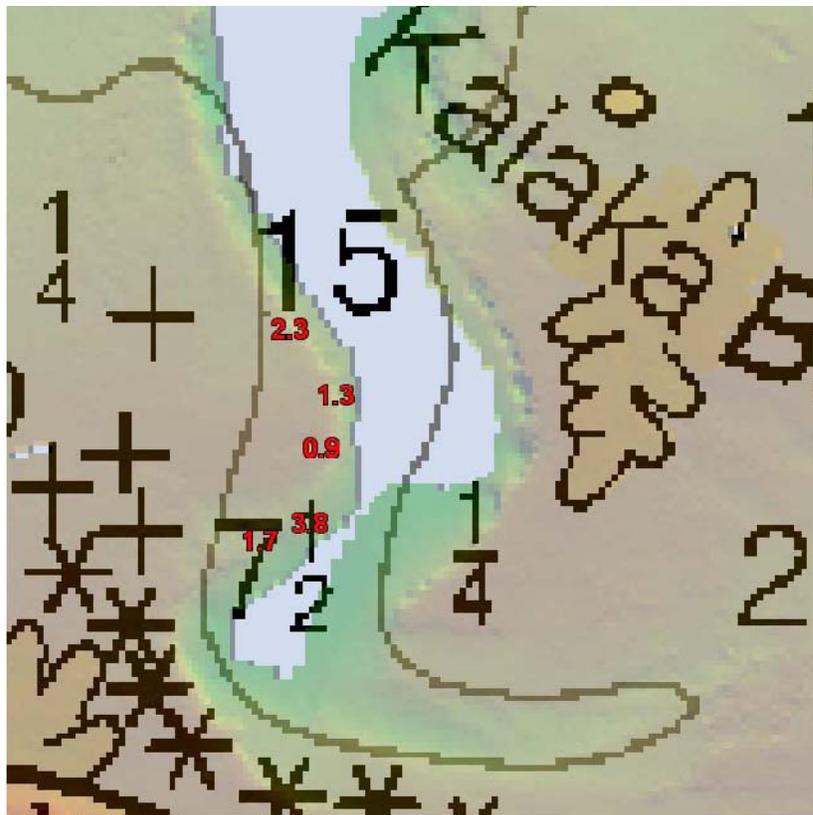
The high density Lidar sounding set for survey W00088 was reviewed in Fledermaus and the surveyed depths over the reef appear valid. The Coast Pilot advocates a depth of 3 feet in Kaiaka Bay, which is less than the least depth found in the channel; therefore, the discrepancy was not reported as a Danger to Navigation. It is recommended that the charted 3-fm contour be updated with surveyed depths to better define the channel limits. ¹⁹

Figure 12. An image highlighting the shift in the Kaiaka Bay channel boundaries. Lidar smooth sheet depths are displayed in red in Fathoms with a Digital Terrain Model (DTM) of survey W00088 overlaid on Chart 19357 as the background.

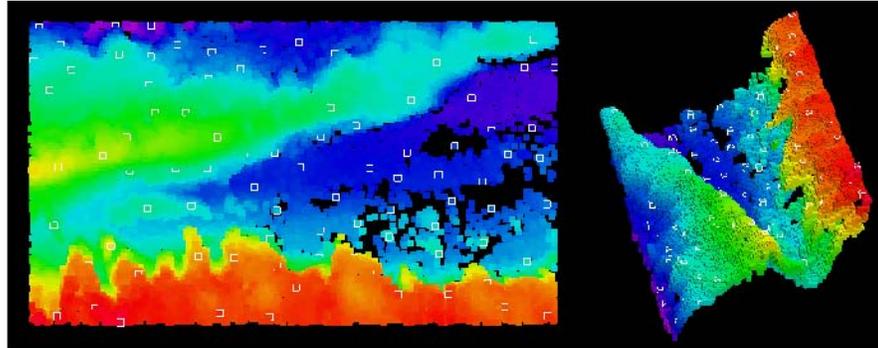
There is a new submerged ridge in the northwest corner of Survey W00088 (Figure 13). The ridge is located in over 20 meters of water, and does not pose a danger to navigation, however, surveyed depths are at times 7 fathoms shoaler than charted. The ridge ranges from an 8-fm charted depth located in the vicinity of 21°35'26.87" N, 158°09'57.53" W to a 17-fm charted depth located in the vicinity of 21°35'42.71" N, 158°09'15.21" W. It is recommended that surveyed depths supersede charted soundings. ²⁰

Figure 13. Lidar soundings of a new submerged ridge from survey W00088 displayed in Fledermaus 3D editor and colored by depth.

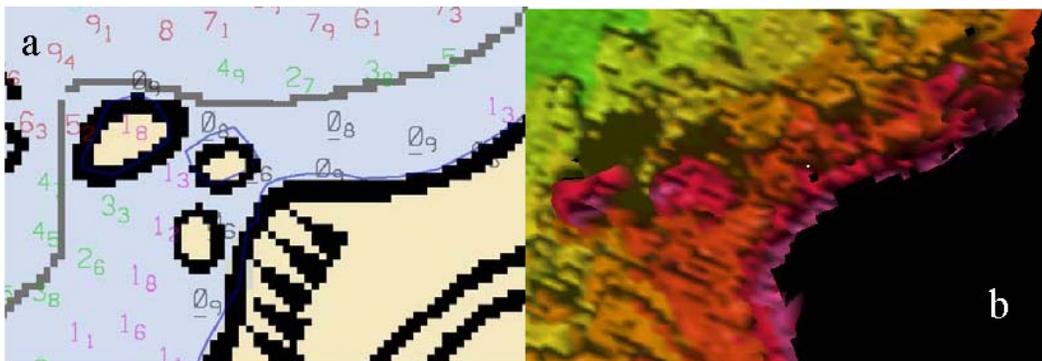
A new ledge was surveyed to the east of Wananapaoa Island, located at 21°38'19.6" N, 158°04'11.29" W. High points of the ledge are visible in the Lidar smooth sheet (Figure 14), with drying depths at Mean Low Water. It is recommended that the surveyed depths be used to add a new ledge to the chart. ²²

Figure 14. (a) Lidar smooth sheet depths from survey W00089 overlaid on chart 19357. The depths in black represent high points of the new ledge. (b) A DTM of the new ledge and islands shown in Fledermaus and colored by depth.

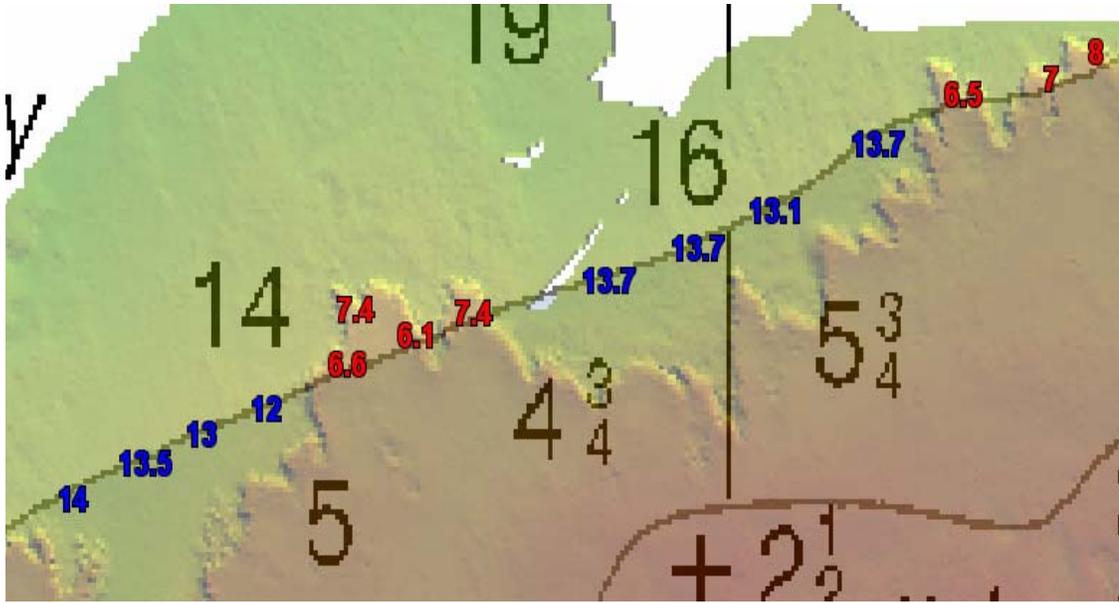
Shoaling and deepening trends were observed along the charted 10-fm contour throughout surveys W00090 and W00092 due to advancing and receding of the reef. Differences between surveyed and charted depths ranged between 0 to 4 fathoms (Figure 15). It is recommended that the charted contour be updated with the surveyed depths. ²⁴

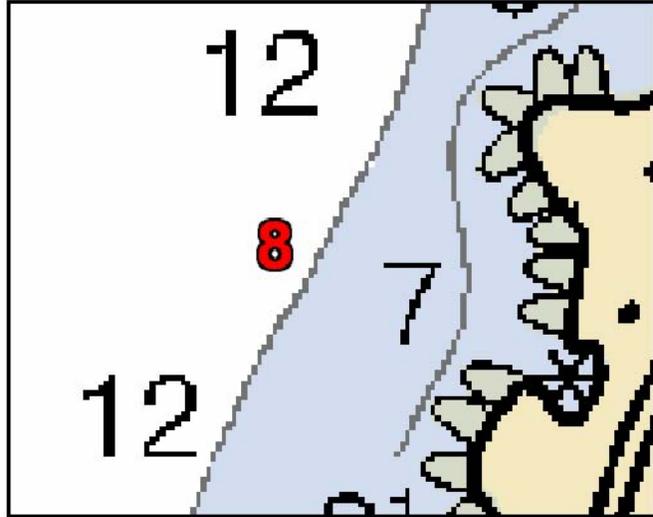
A new shoal was located at 21°39'11.53" N, 158°04'01.55" W within the limits of survey W00092, just seaward of the 10-fm contour (Figure 16). The shoal had a least depth of 15.09 m (8.25 fms) and had depth returns from multiple survey lines. The feature appears to be detached from the bottom with a well-defined sounding shadow below (Figure 17). It could be that the feature is an uncharted fish pen; however, the permanence of this feature is uncertain. It is recommended that the feature be added to the AWOIS database for further investigation. ²⁵

Figure 16. Image displaying location of the least depth of the new shoal located in survey W00092. The lidar sounding depth is displayed in red in fathoms with chart 19357 in the background.

²⁵ Concur with clarification, it is recommended that this feature, an 8 fathom depth, be charted as a 8 fathom obstruction until further investigation can be done to either verify or disprove the feature.

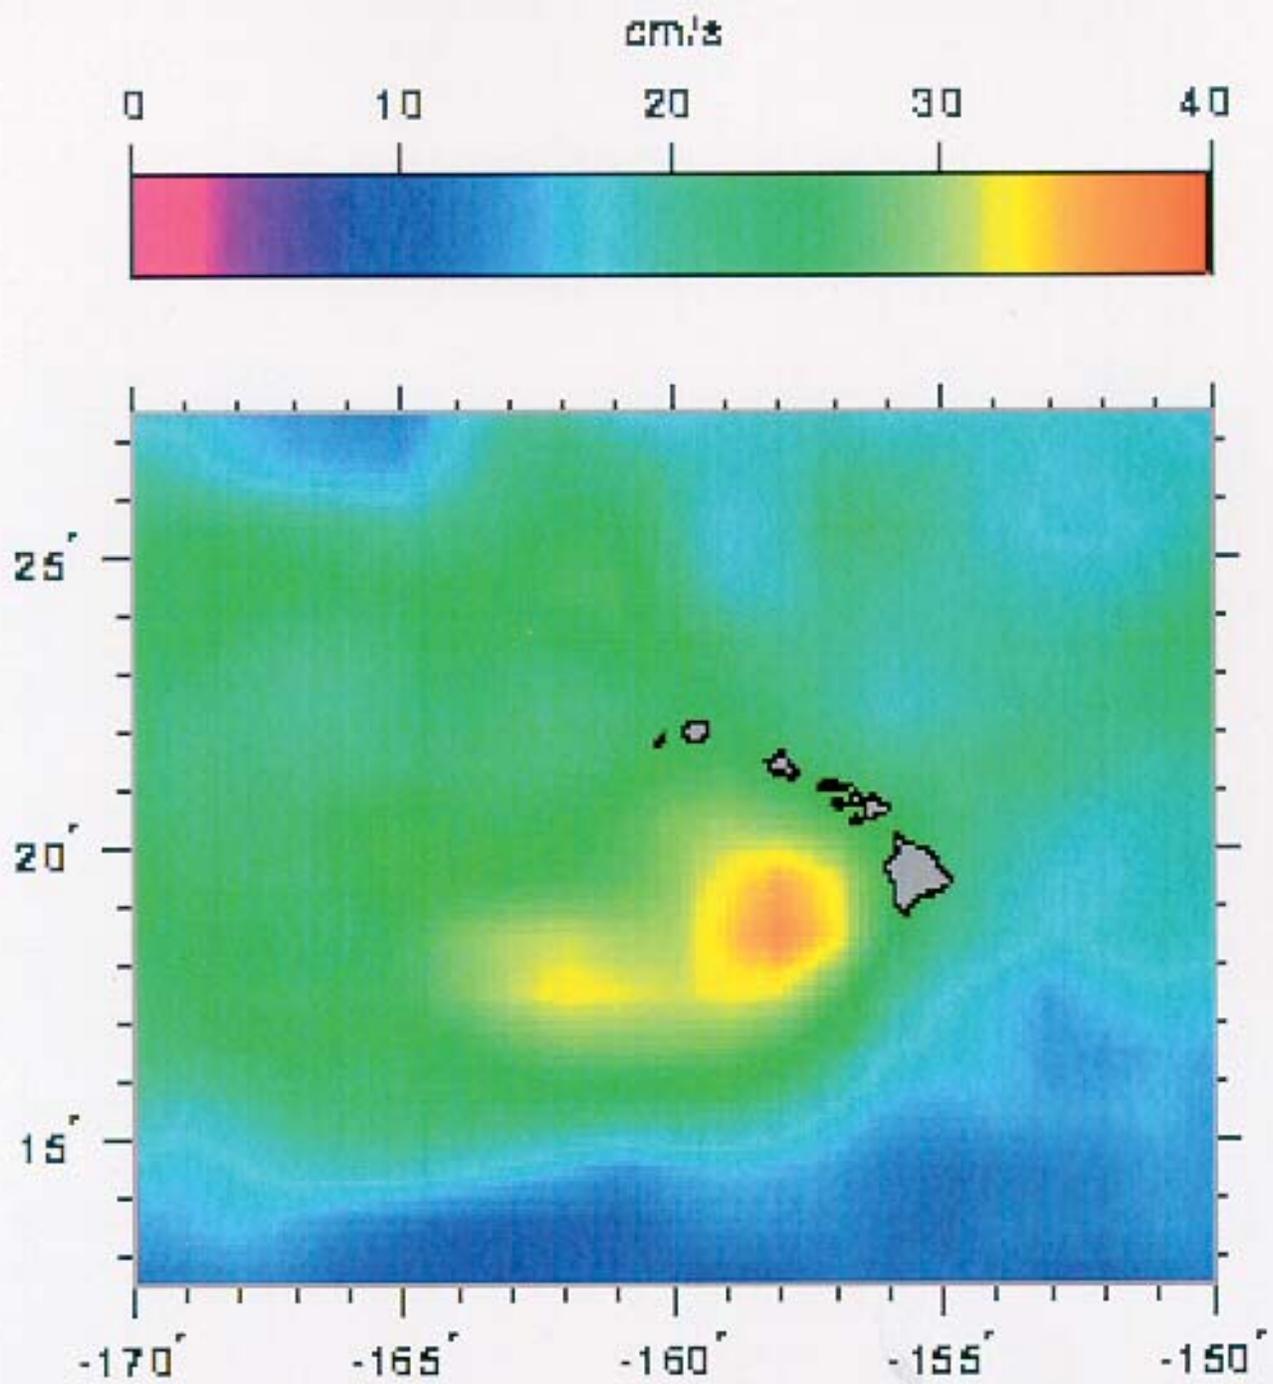
Figure 3. Large-scale ocean circulation variability around Hawaii indicates numerous eddies and swirls which obliterate slower average circulation.

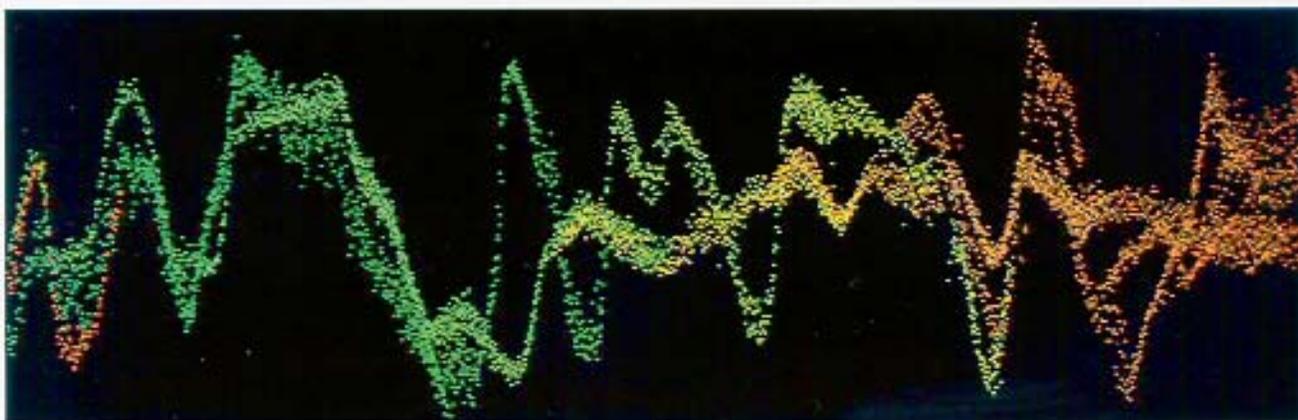
Figure 8. Series of near shore seabed to beach profiles from the area of Barking Sands, Kauai depicted in Figure 7. Insets a-d are west to east cross sections. Inset e is from the north east to southwest along the full length of the near shore.
