## DESCRIPTIVE REPORT

*Registry No.* ..... W00100 - W00101 .....

*General Locality* ..... South Coast of Oahu .....

*Sublocality* ..... Honolulu Harbor .....

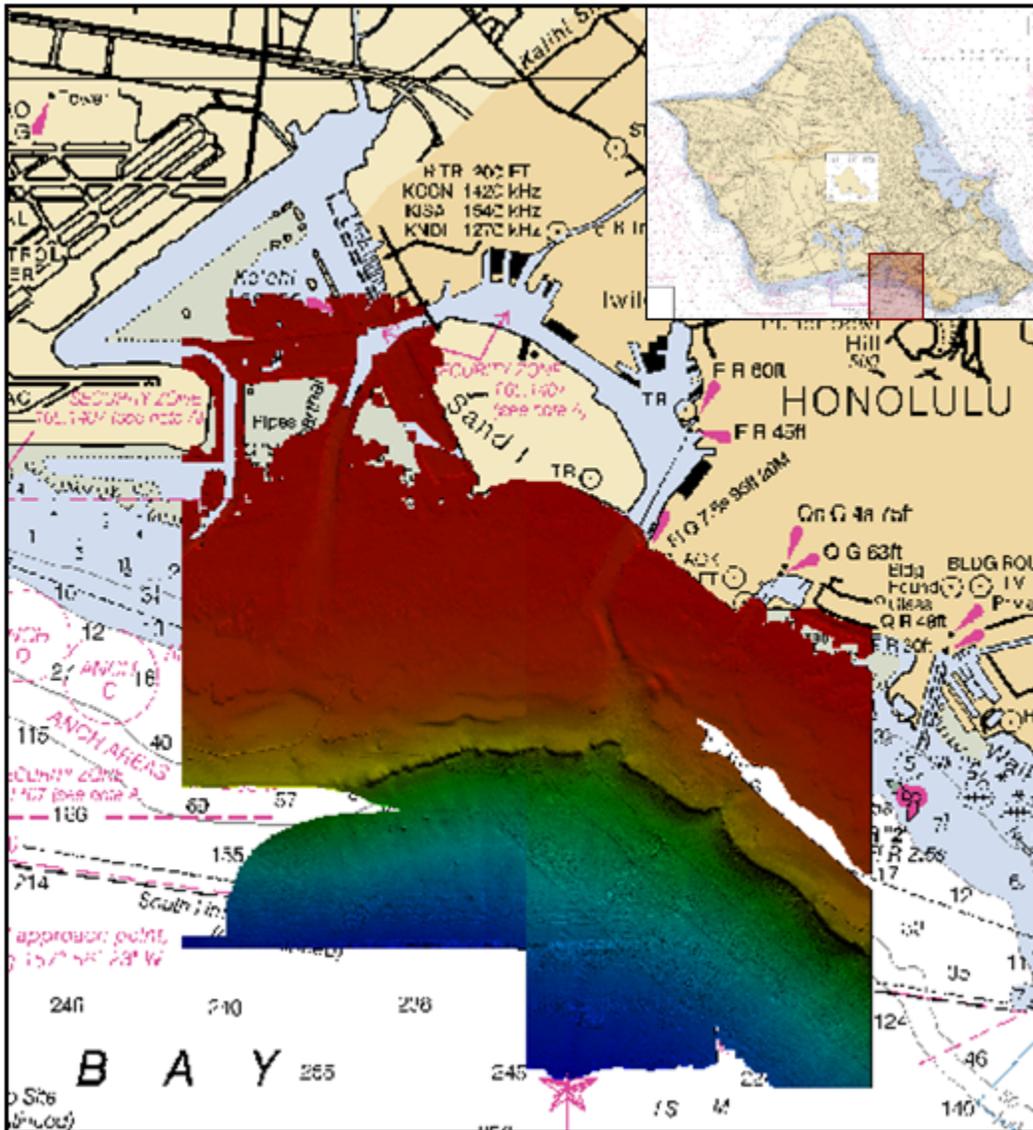
Figure 1. An overview of the area covered by NAVOCEANO surveys W00100 and W00101. The surveys cover the approaches to Honolulu Harbor located on the southern coast of Oahu Island, HI. Digital terrain models (DTMs) from each survey area were overlain on NOAA chart 19357.

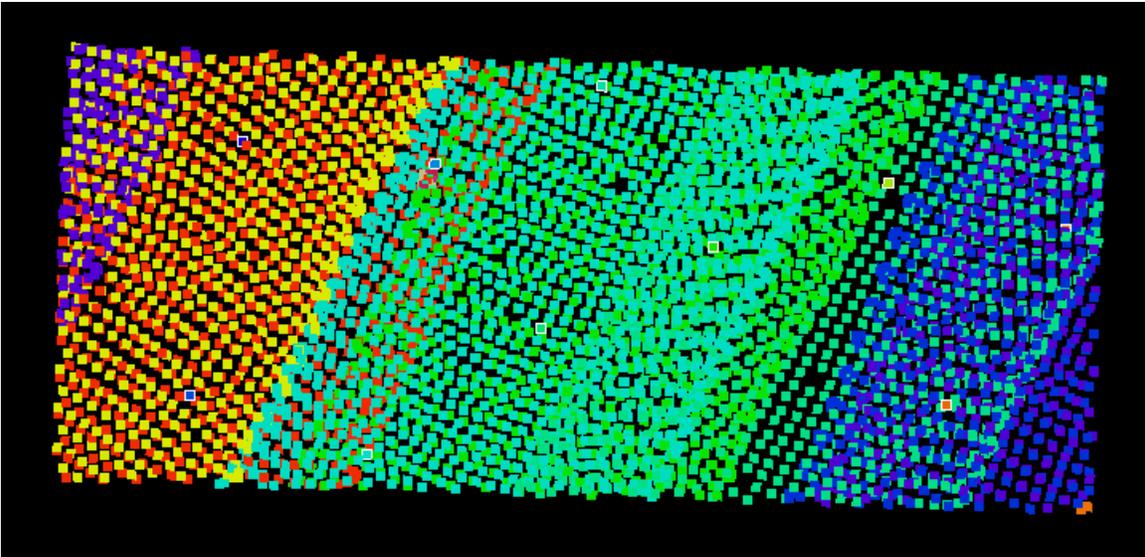
**Figure 2.** An image captured from Fledermaus' 3D Editor displaying the data redundancy from survey W00100. It appears that 200 percent coverage was achieved for the majority of the Lidar survey area, which greatly improves object detection capability of the SHOALS system. Soundings are colored by survey line.

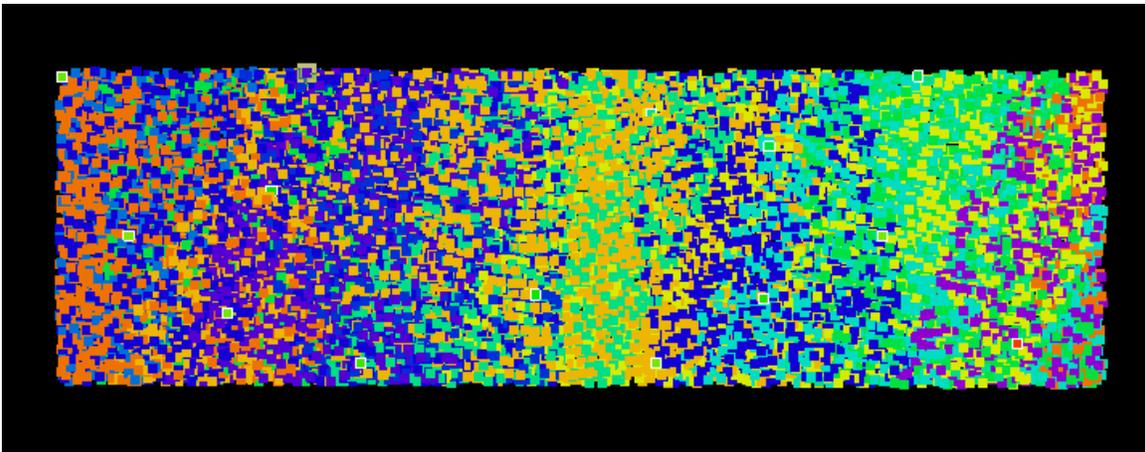
**Figure 3.** An image captured from Fledermaus' 3D Editor displaying the data redundancy from survey W00101. Lidar data coverage far exceeded 200 percent coverage. Soundings are colored by survey line.

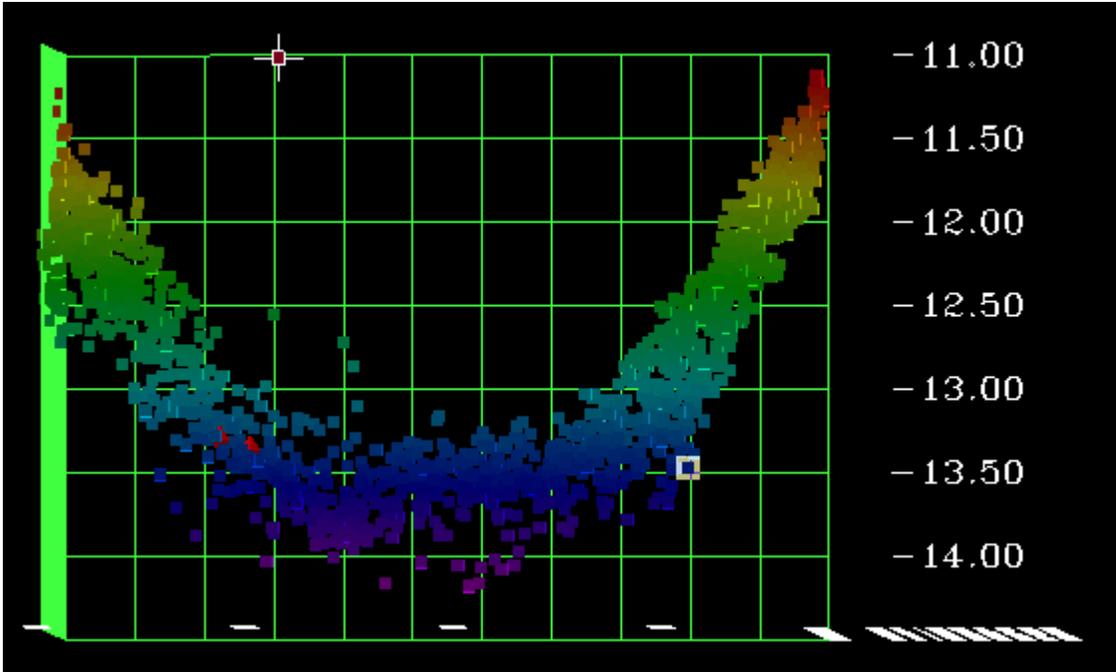
**Figure 4.** A flier from Kalihi channel (Survey W00101) is shown in Fledermaus 3D Editor with soundings colored by depth in meters. The flier was selected as a smooth sheet sounding by NAVOCEANO. The true depth of the channel is approximately 13 meters (42.7 feet). <sup>1</sup>

A flier was found in Kalihi Channel during review of survey W00101. The sounding was positioned at 21°18'8" N, 157°53'47" W and was plotted on the NAVOCEANO smooth sheet with a depth of 11 meters (36 feet). When reviewed in Fledermaus 3D Editor, the selected smooth sheet sounding appeared to be a flier (See Figure 4). The true depth of the channel at the location is approximately 13 meters (42.7 feet). It is recommended that the submitted smooth sheet sounding of 11 meters be rejected and charted as 13 meters. <sup>16</sup>

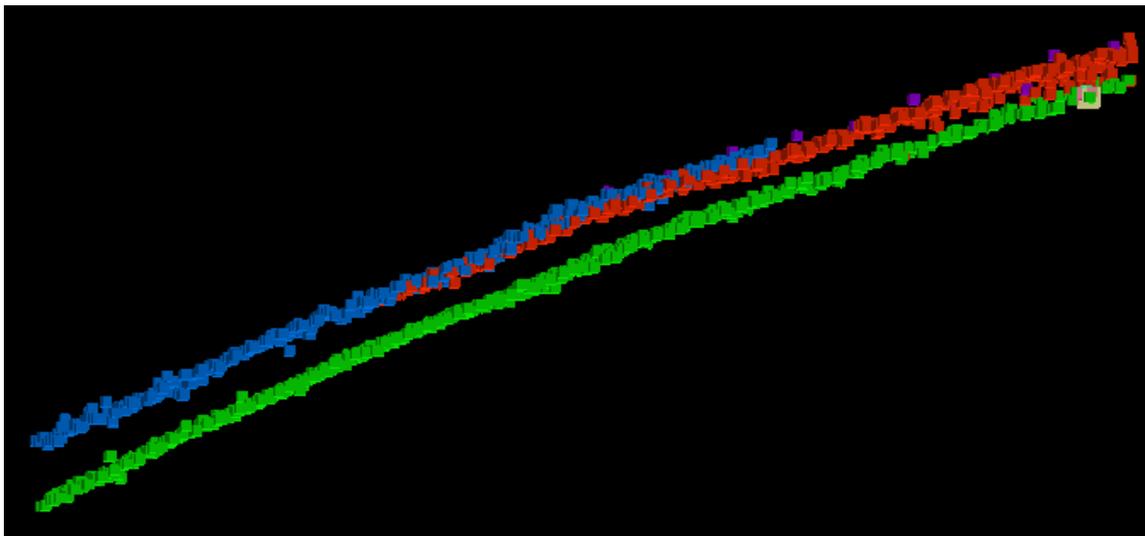
**Figure 5.** A vertical offset of up to 1 meter was observed between soundings surveyed with the EM3000 sonar system and those surveyed with the EM1002 sonar and SHOALS 400 Lidar system. An example of the offset can be seen in the above image taken in Fledermaus 3D Editor and colored by survey line. The soundings shown in green are from the EM3000 system, soundings in red and blue are from the EM1002 system and those in purple are from the SHOALS 400 system.

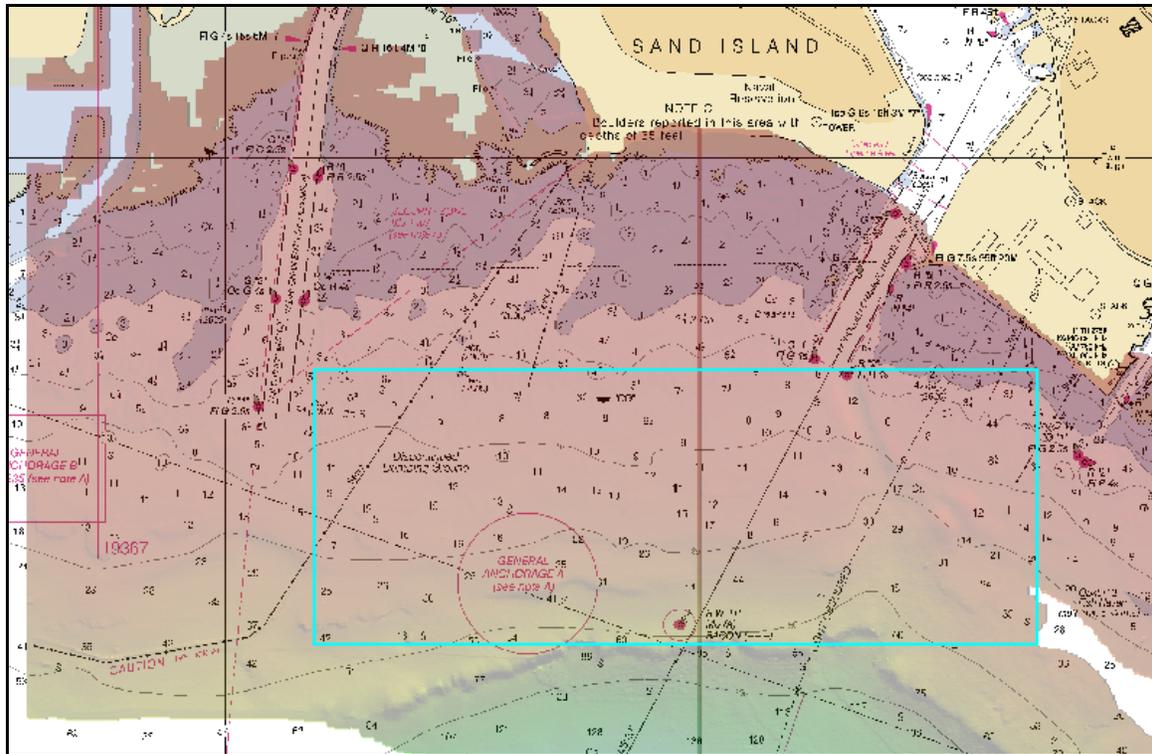
**Figure 6.** DTMs for survey W00100 and W00101 are overlain on chart 19369 with the blue squared-off region approximating the area where data was acquired with the EM3000 sonar system. EM3000 sounding data was consistently deeper than data acquired with the EM1002 and SHOALS Lidar system where the data overlapped.

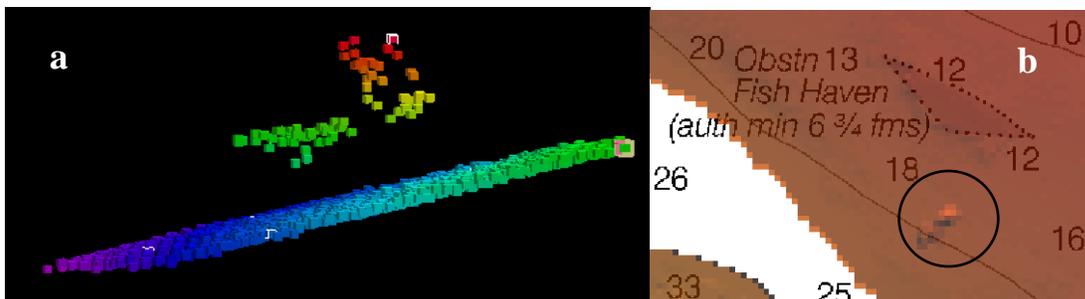
**Figure 7.** (a) A new obstruction displayed in Fledermaus 3D Editor with soundings colored by depth. (b) The obstruction is also visible in a DTM of survey W00100, located approximately 100 meters south of a charted fish haven. The DTM is overlain on chart 19369.

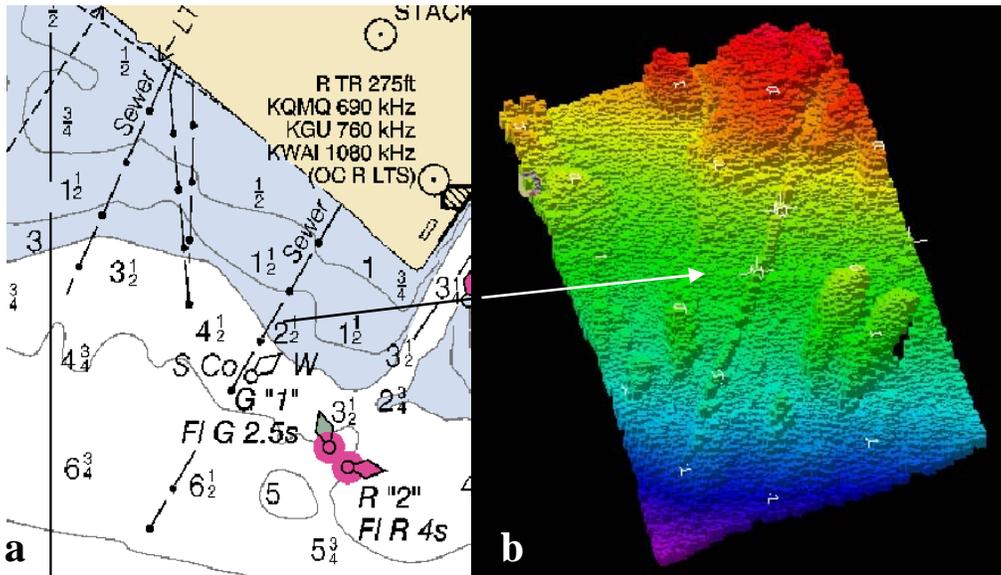
pipeline located between Honolulu Channel and Kewalo Harbor (Figure 8). The pipeline was visible in the Fledermaus DTM and sounding data submitted by NAVOCEANO (Figure 8).<sup>5</sup>

**Figure 8.** (a) The position of a charted (19369) sewer pipeline was corroborated by NAVOCEANO data. (b) The pipeline is visible in the sounding set when displayed in Fledermaus 3D Editor. The pipeline depths are slightly shoaler than the surrounding seafloor and follow a linear path from the northeast corner to the southwest.

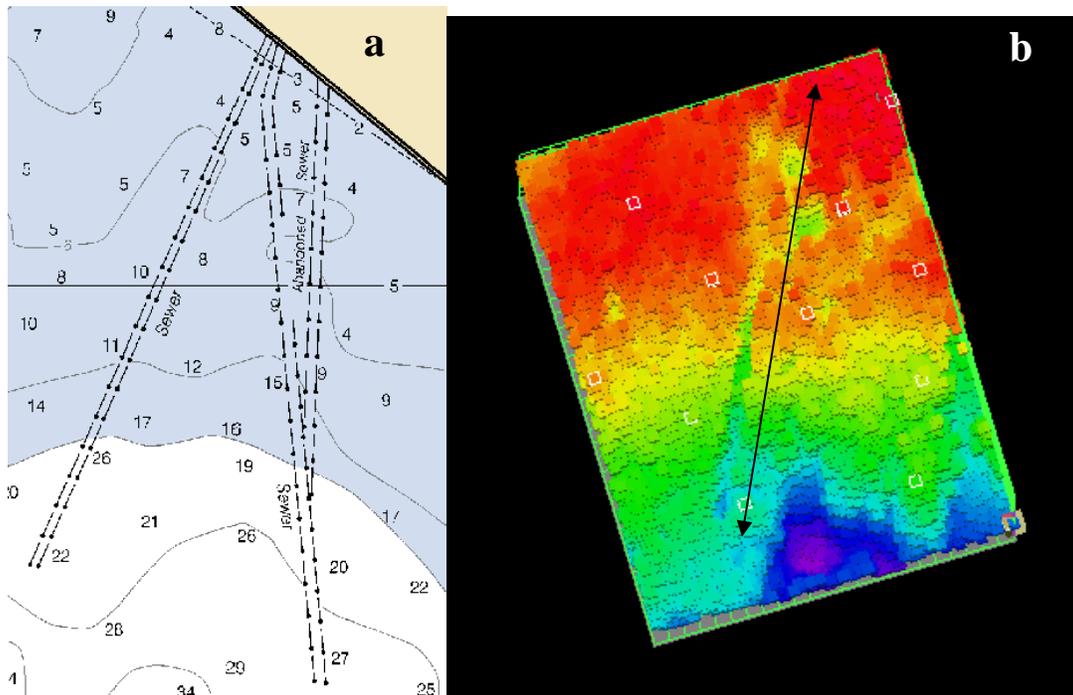
was noted in Fledermaus 3D Editor that closely approximates the position of the western most sewer pipeline in the cluster of three (Figure 9). It is recommended that the sewer pipelines remain as charted. <sup>7</sup>

**Figure 9.** (a) Three charted (19367) sewer pipelines were disputed by NAVOCEANO in the Lidar ROS. (b) Upon review of the sounding data in Fledermaus 3DEditor, a linear path was visible carved into the seafloor that closely approximated the position of the western most charted pipeline.

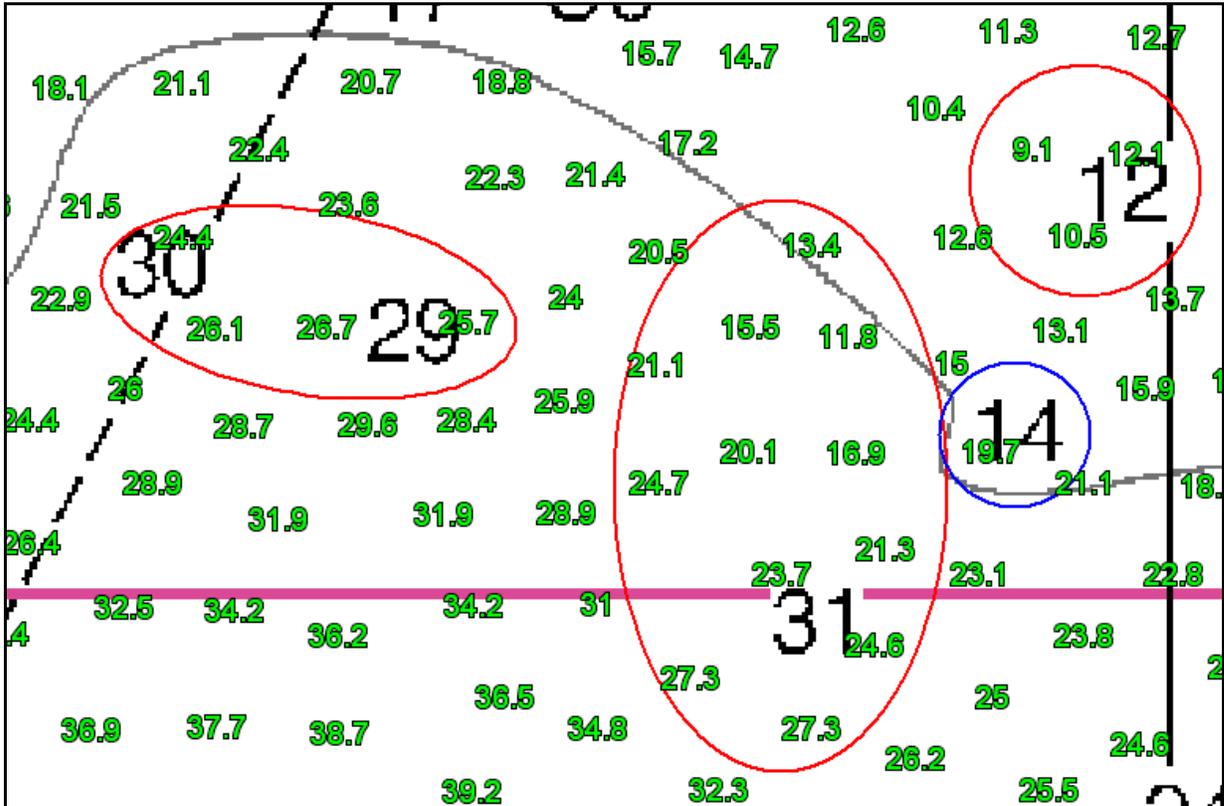
In the midst of the shoaling noted above, there is one instance of the surveyed depths proving deeper than charted depths. A depth of 19.7 fathoms was surveyed over a charted 14-fm depth (21°17'03.39"N, 157°52'02.77" W) located just north of a 20-fm contour line (Figure 10). It is

**Figure 10.** The image above is from a chart comparison completed between soundings acquired during survey W00100 and chart 19369. Surveyed depths are displayed in green and are overlain on chart 19369 with all depths shown in fathoms. The red circles highlight areas of significant shoaling and the blue circle indicates significant deepening.

recommended that the 14-fathom depth be superseded by surveyed depths and the 20-fathom contour updated to better approximate the new shoal.<sup>10</sup>

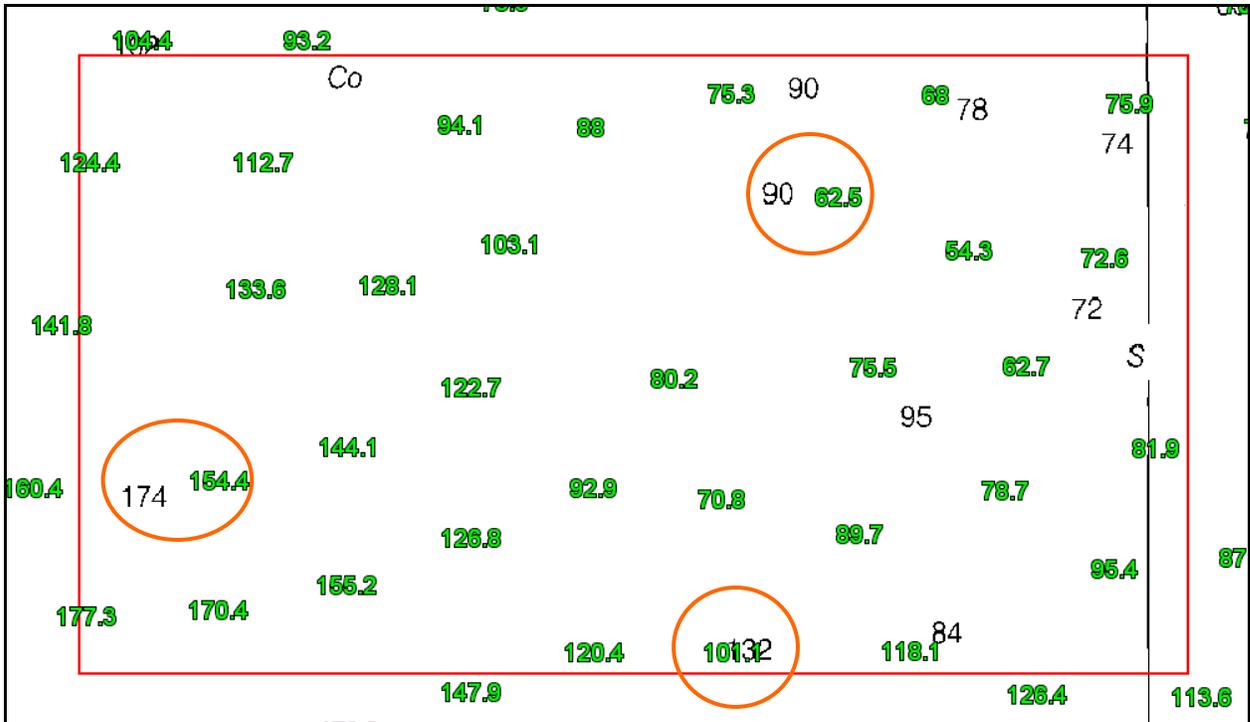
Significant shoaling was noted to the west of the 157°52' parallel on the southern portion of chart 19367. Surveyed depths are up to 31 feet shallower than charted soundings with a 101-foot sounding surveyed in the vicinity of a charted 132-foot depth (21°17'3.14" N, 157°52'05.4" W) and a 62.5-foot sounding surveyed in the vicinity of a charted 90-foot depth (21°17'08.99" N, 157°52'05.03" W) (Figure 11). The shoal extends to the southwest from the charted 90-foot depth where a 154-foot sounding is surveyed in the vicinity of a charted 174-foot depth (21°17'06.78" N, 157°52'06.99" W). It is recommended that the surveyed depths supersede charted soundings.<sup>11</sup>

**Figure 11.** A new shoaling trend was noted in the Southeast section of chart 19367 just west of the 157°52' parallel. Surveyed depths are shown in green, overlain on chart 19367. All surveyed depths are in feet. The orange circles highlight the pronounced depth discrepancies between charted and surveyed soundings described in the section above.

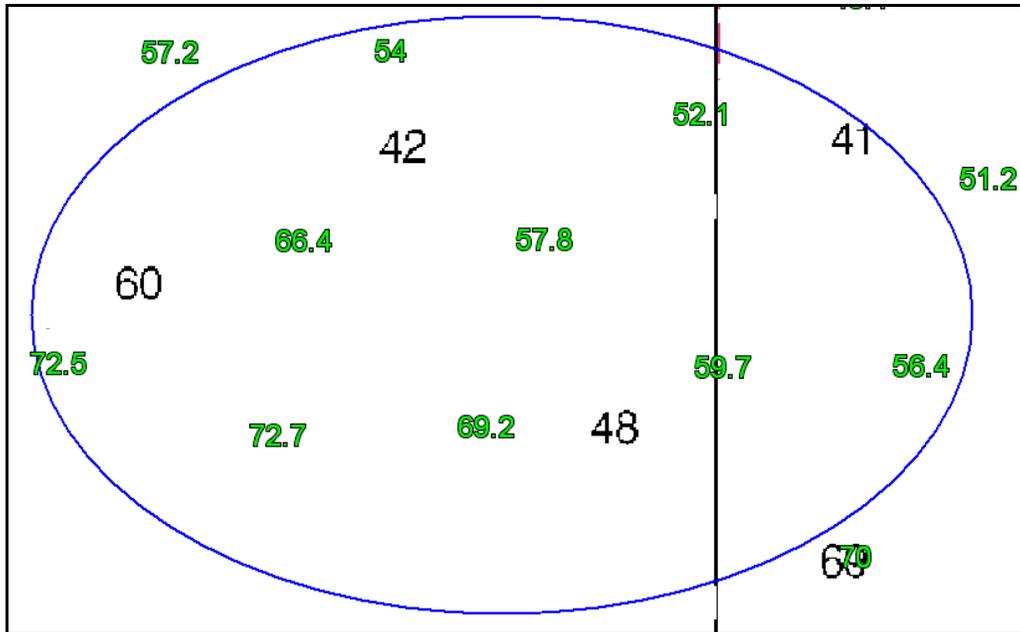
**Figure 12.** A deepening trend was noted in the vicinity of the 157°52' parallel, with surveyed depths approximately 10-15 feet deeper than charted depths. Smooth sheet soundings are displayed in green in feet and are overlaid on chart 19367 (feet).

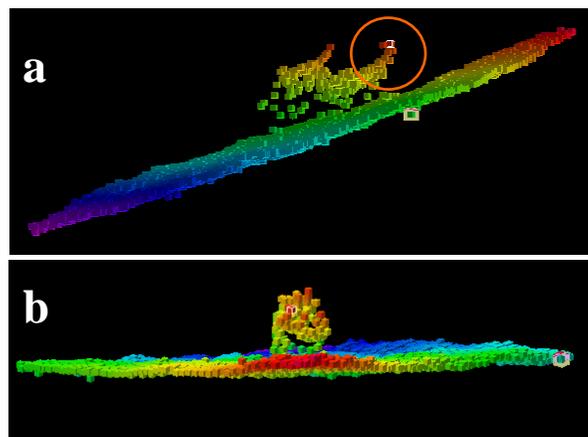
A new obstruction was located during the review of survey W00100. The obstruction appears to be a potential wreck with a least depth of 49.84 meters (163.5 ft, 27.3 fm) located at 21°16'59.30" N, 157°52'8.646" W (Figure 13). It is recommended that the wreck be added to charts 19369 and 19367; however it does not pose a danger to navigation.<sup>15</sup>

**Figure 13.** (a) The new obstruction viewed from the east displayed in Fledermaus 3D Editor with soundings colored by depth. The least depth is circled in orange. (b) The obstruction viewed from the north.

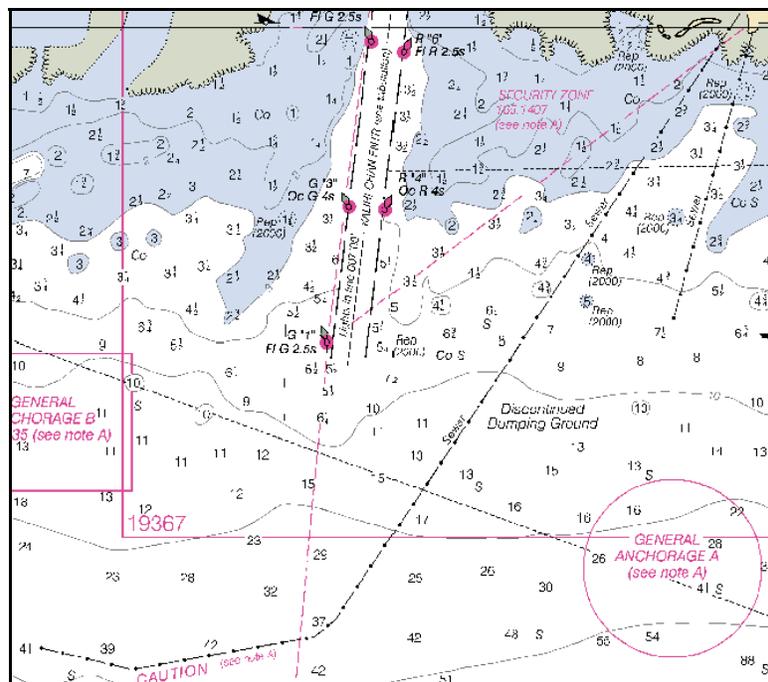
The position of two charted (19369, 19367) sewer pipelines were confirmed by survey W00101 (Figure 14). The longer, western-most sewer was prominently displayed in the DTM submitted for survey W00101 since the pipeline was approximately 2-3 meters shallower than the surrounding seafloor (Figure 15a). The shorter, eastern-most sewer was not readily visible in the DTM of the surveyed depths, however, when soundings was viewed in Fledermaus 3D editor, there was an apparent linear indentation that followed with the charted position of the pipeline (Figure 15b). It is recommended that the sewers remain as charted. <sup>17</sup>

Figure 14. The charted sewer pipelines are displayed above as shown on chart 19367 (—•—•—).

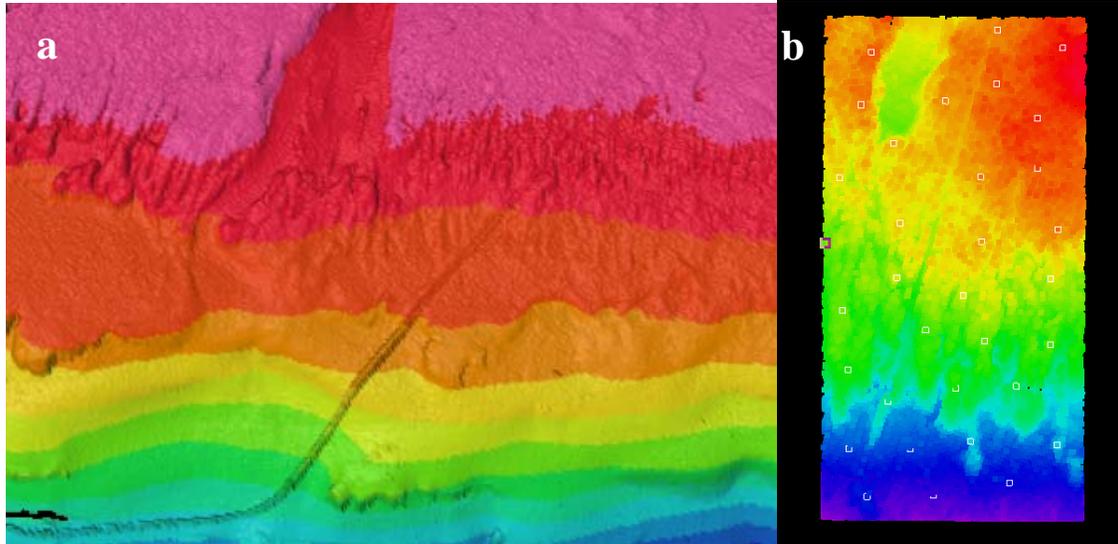
**Figure 15. (a)** A charted sewer from survey W00101 is prominently displayed in a DTM of the surveyed depths shown in Fledermaus. The pipeline was approximately 2-3 meters shallower than the surrounding seafloor. **(b)** The linear depression visible in the DTM from survey W00101 that traverses the image from northeast to southwest shows the track of the eastern-most charted sewer within the survey limits. The DTM is colored by depth.

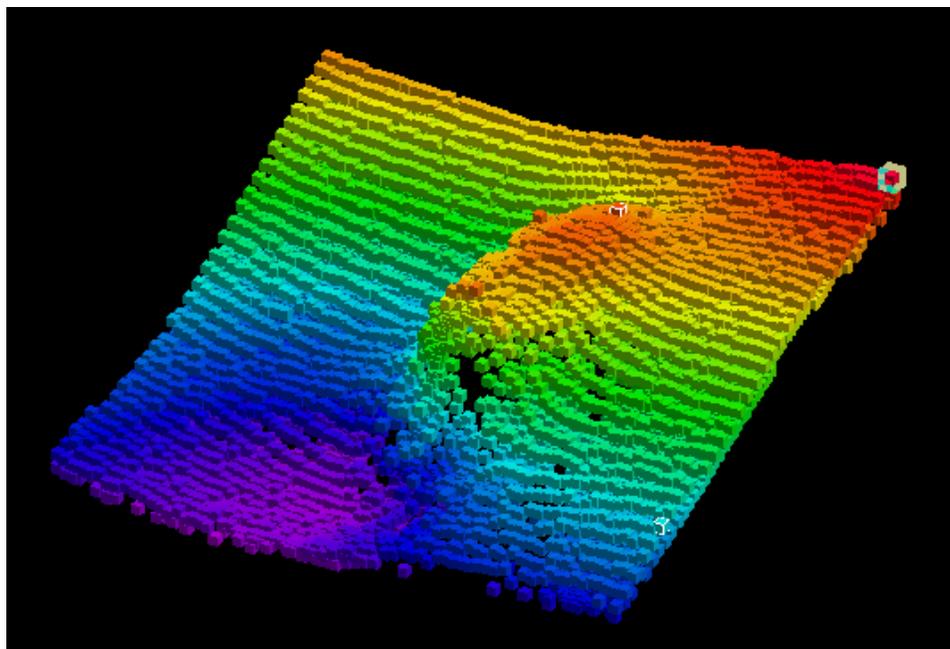
A 40-fathom sounding was surveyed in the vicinity of a charted 48-fm sounding located at 21°16'48.8" N, 157°53'31.7" W. The smooth sheet sounding of 73 meters represents the least depth of a new shoal (Figure 16). <sup>22</sup>

**Figure 16.** A new shoal located at 21°16'48.8" N, 157°53'31.7" W is displayed in Fledermaus 3D Editor with soundings colored by depth.

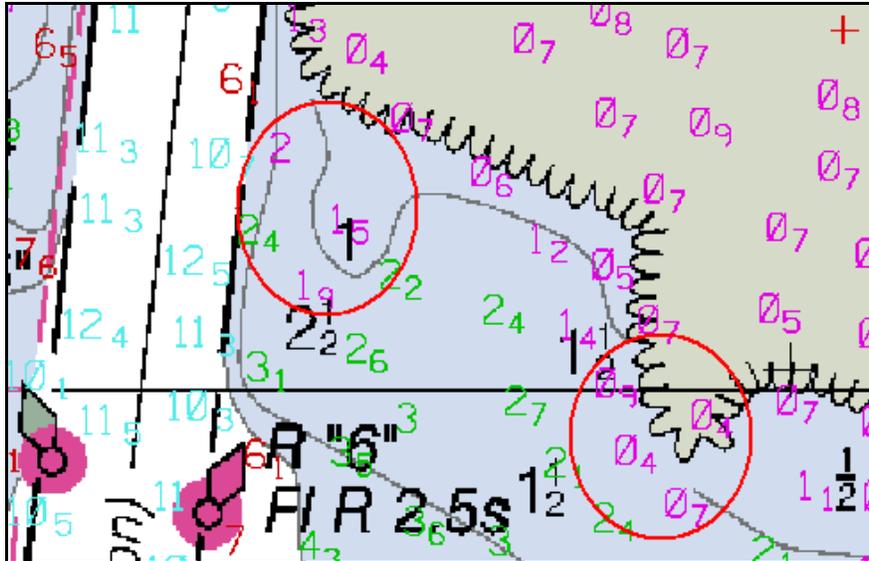
Some shoaling was also noted at the eastern entrance of Kalihi Channel where the reef has expanded seaward. In particular, the reef shoaling was most significant in the vicinity of 21°18'03.27" N, 157°53'42.38" W where 1-fm (2-m) soundings were surveyed seaward of the 1-fm contour and near 21°17'57.07" N, 157°53'33.16" W where a 0.2-fm (0.4-m) sounding was surveyed in the vicinity of a charted 1.5-fm depth (Figure 17). <sup>23</sup>

Figure 17. This image shows the W00101 smooth sheet overlain on chart 19369. Smooth sheet soundings are shown in blue, green, pink and red and are in meters, while charted depths are in fathoms. The red circles highlight areas where the reef has expanded seaward resulting in significant shoaling.

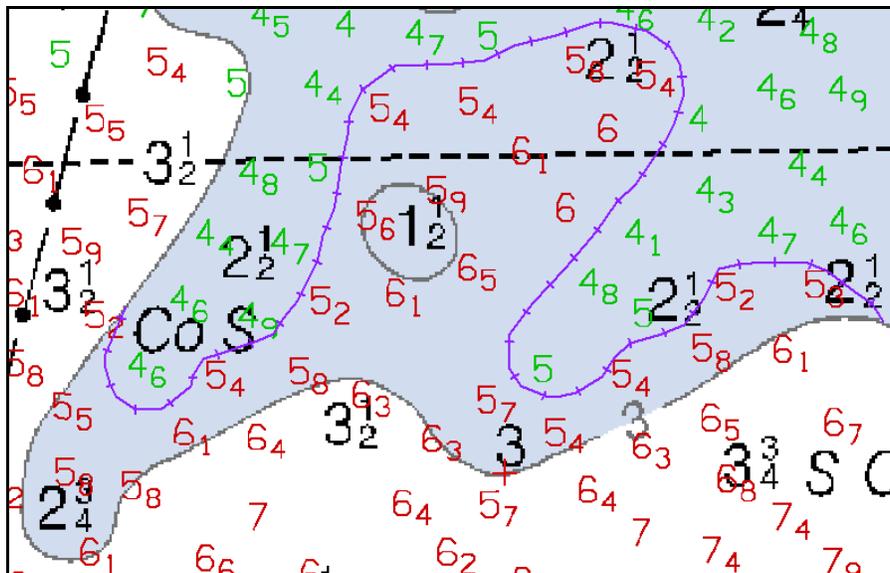
Figure 18. The purple line above is an approximation of the true 3-fm (5.5-m) depth contour. The chart in the background is 19369, with the smooth sheet from survey W00101 overlaid on top with depths in meters.

A significant deepening trend was noted to the east of the sewer pipelines along the 3-fm contour. It is recommended that the charted (19369) 3-fm contour be adjusted inland to better define the depth trends in the vicinity of 21°17'41.42" N, 157°52'55.84" W. An approximation of the true 3-fathom contour line based on the smooth sheet depths is shown in Figure 18.<sup>24</sup>

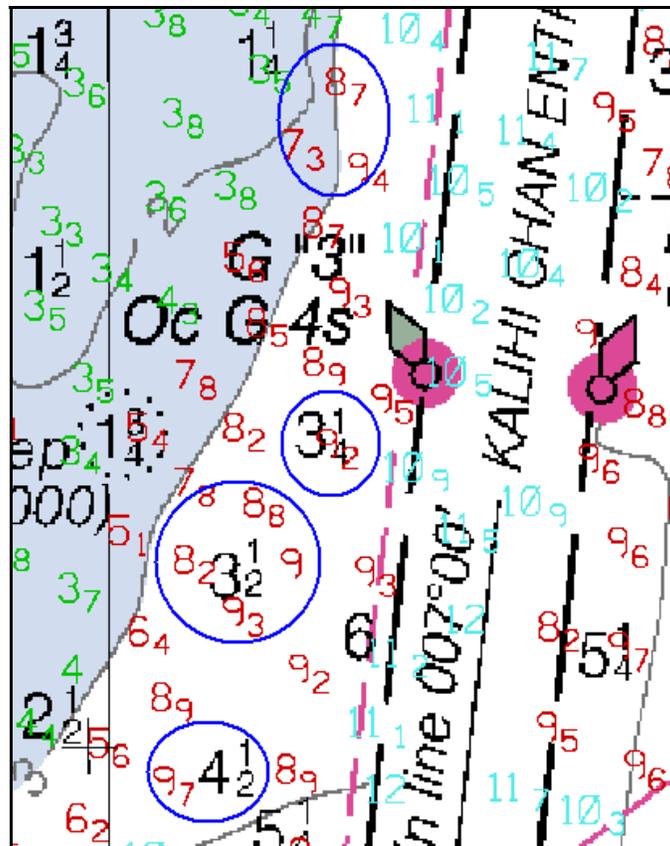
On the west side of the Kalihi Channel, a deepening trend was noted between the charted (19369) 3 and 5 fathom contours. Surveyed depths were 0.5 – 1.75 fathoms (1.5 – 3 m) deeper than charted. The deepening trend ranged approximately from 21°17'46.03" N, 157°53'53.7" W to 21°17'28.73" N, 157°53'57.2" W (Figure 19).<sup>25</sup>

**Figure 19.** The blue circles highlight areas where surveyed depths were significantly deeper than charted depths (0.5 to 1.75 fm deeper than charted). The smooth sheet soundings from survey W00101 are shown in meters in green, red and blue and are overlaid on chart 19369, with depths in fathoms.

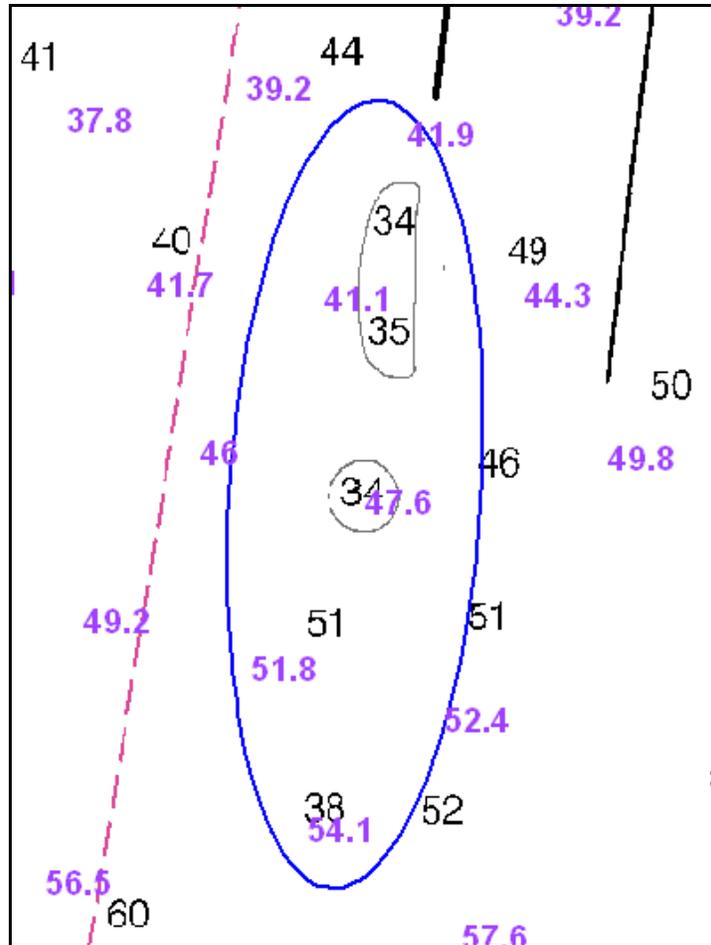
It was reported by NAVOCEANO that four charted shoal depths of 34, 35, 34 and 38 feet south of Kalihi channel buoy G “1” in the vicinity of 21°17'15" N, 157°53'55" W were not supported by surveyed data. A chart comparison and a review of the high density data set in Fledermaus confirmed this claim. Surveyed depths were between 6 and 16 feet deeper than the charted depths (Figure 20). It is recommended that the surveyed depths supersede the charted soundings.<sup>26</sup>

**Figure 20.** The blue circle highlights the four depths (34, 35, 34 and 38) that were surveyed significantly deeper than charted. Chart 19367 is shown in the background with smooth sheet depths from survey W00101 displayed in purple. Charted and surveyed depths are in feet.

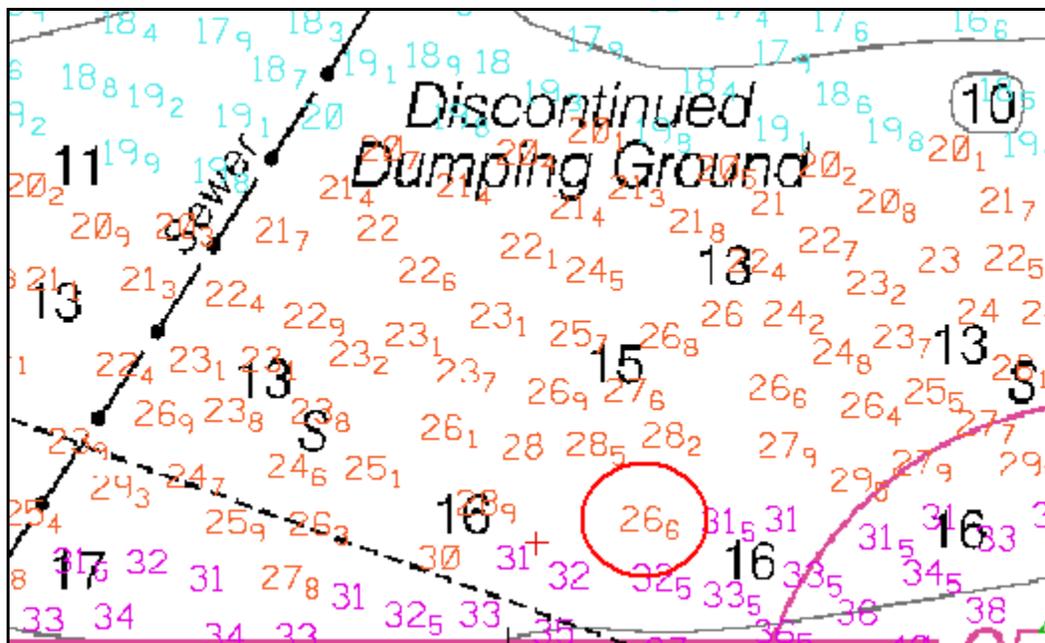
A small pinnacle was surveyed at 21°17'3.6" N, 157°53'25.8" W with a least depth of 14.5 fm (26.6 meters). This depth is represented on the NAVOCEANO smooth sheet for survey W00101, positioned between two charted (19369) depths of 16 fathoms (Figure 21). This pinnacle is of an unknown origin and does not pose a danger to navigation. When the pinnacle was reviewed in Fledermaus 3D Editor, it was discovered that there were only hits from one Lidar survey line, despite 4 survey lines being run over the feature (Figure 22).<sup>30</sup>

**Figure 21.** The red circle highlights the location of the pinnacle in comparison to chart 19369. The pinnacle had a least depth of 26.6 meters (14.5 fathoms). Smooth sheet soundings from survey W00101 are colored in blue, orange and pink and are shown in meters. Depths from chart 19369 are in fathoms.

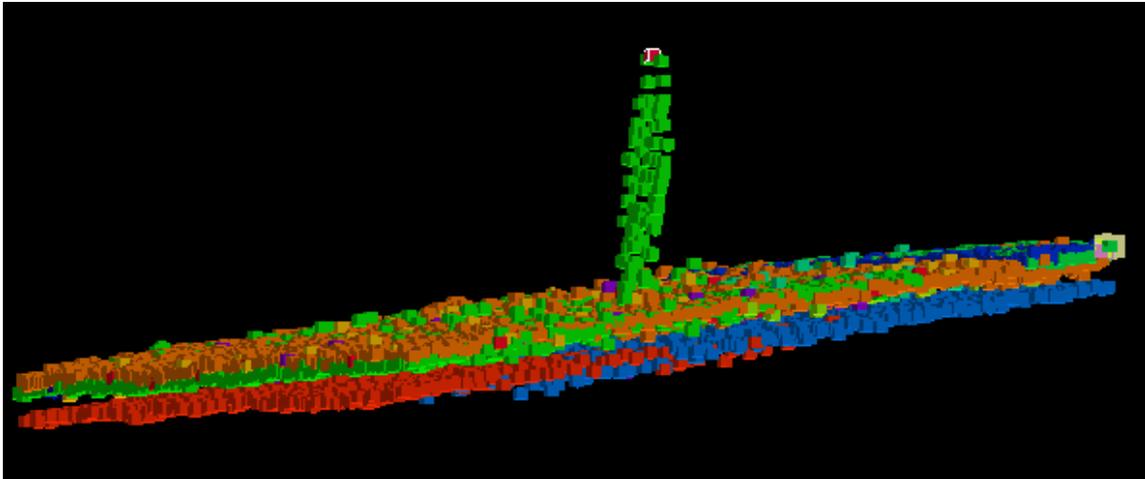
**Figure 22.** The new pinnacle shown in Fledermaus 3D Editor with soundings colored by survey line.

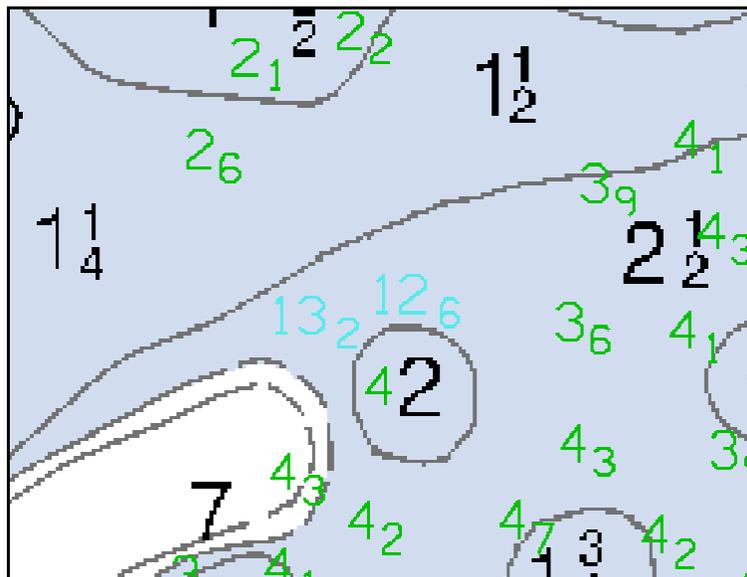
A small portion of a channel was surveyed in the northwest corner of survey W00101. Surveyed soundings of 13.2 and 12.6 meters (7.2 and 6.8 fathoms) were located in the vicinity of a charted 2-fathom sounding located at 21°17'44.97" N, 157°54'28.35" W (Figure 23). A review of the soundings in Fledermaus 3D Editor revealed a sudden drop in depth indicative of a channel (Figure 24). The westward extent of the channel is most likely defined by data from NAVOCEANO survey W00103.<sup>31</sup>

**Figure 23.** Smooth sheet soundings from survey W00101 are overlaid on chart 19369. The blue soundings represent the location of the surveyed channel. It is most likely an extension of the charted channel located slightly to the southwest. Smooth sheet soundings are in meters and charted depths are in fathoms.

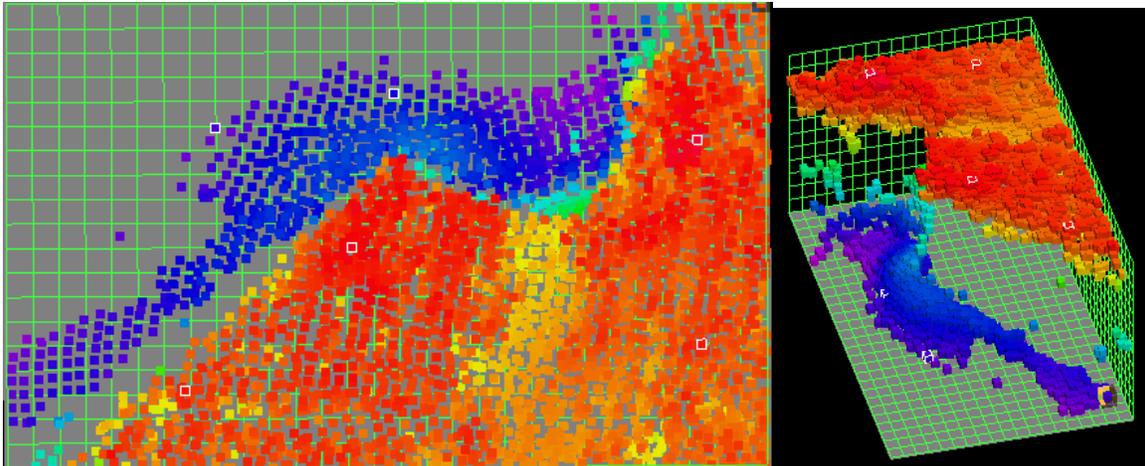
**Figure 24.** The channel boundary was clearly defined by surveyed data as viewed in Fledermaus 3D Editor from directly overhead and at a tilted angle. Soundings were colored by depth.

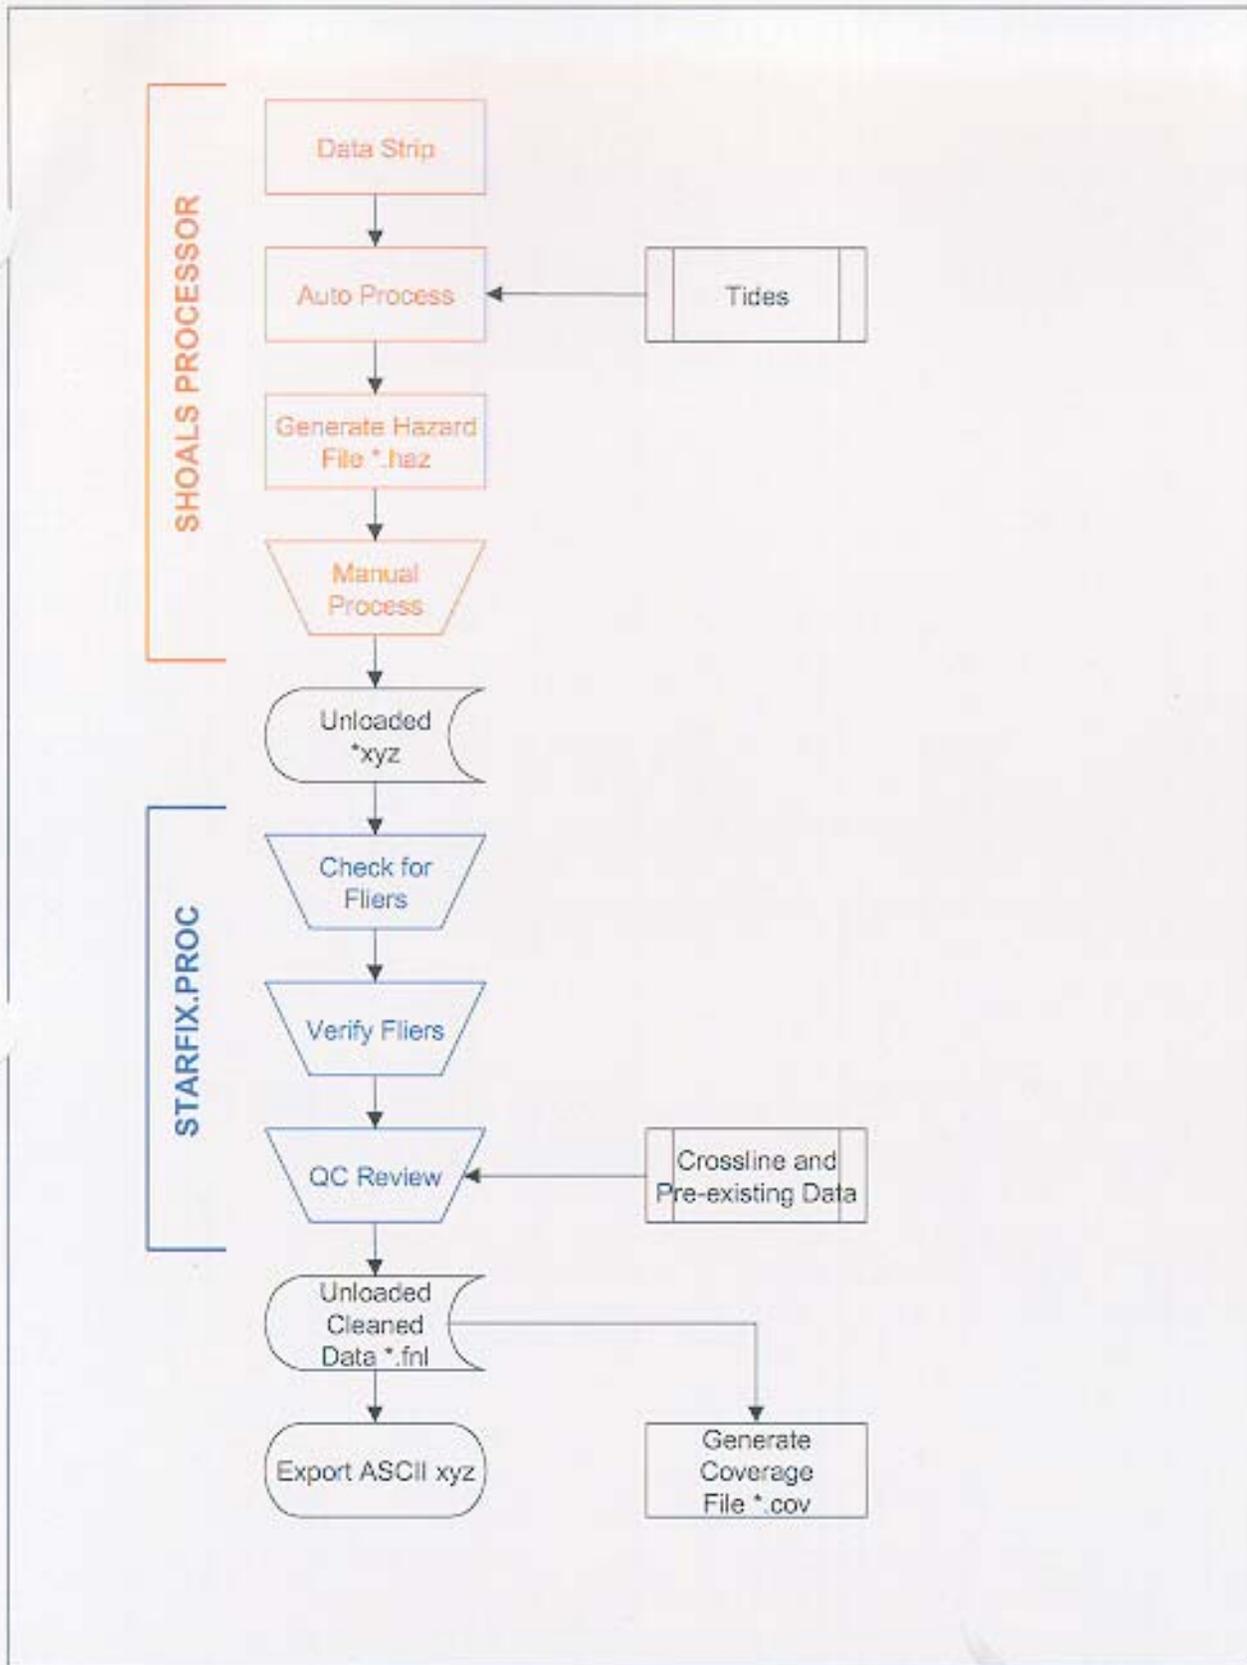
Figure 6: Data Processing Flow

3.5.5 All data is then manually edited for obvious anomalies. Where such anomalies are clearly due to fish, or similar causes, they will be flagged as invalid returns; any other anomalies resembling bottom hazards will require investigation of the waveform in order to determine whether the feature is real and should be retained in the data set. In cases of doubt, such features will be marked for further investigation through re-flight of the area in question. The processed data is then output as an ASCII (\*.xyz) file which can either be input directly into Hypack, or converted to Fugro Binary Format (\*.fbf) for input into Starfix.Proc for review, QC and ultimately subsequent mapping and product generation. This process is outlined in Figure 6.
