DESCRIPTIVE REPORT

Type of Survey HYDROGRAPHIC

Sublocality Entrance to Pearl Harbor and Vicinity

HYDROGRAPHIC TITLE SHEET

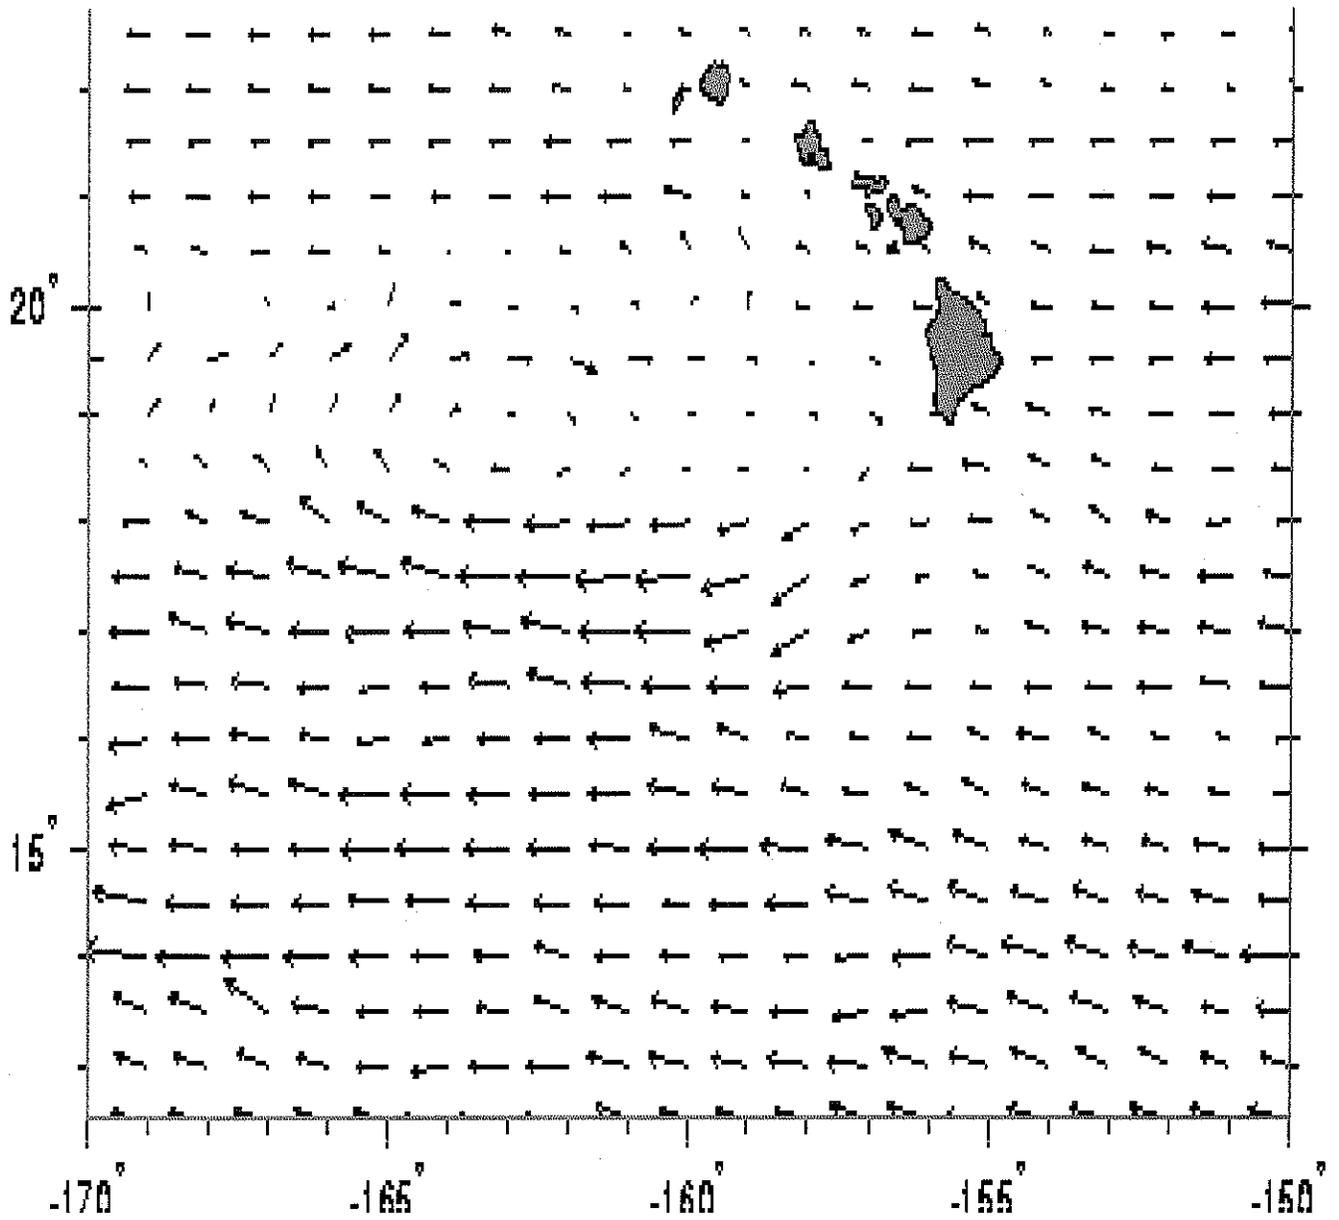
Figure 2. Large-scale ocean circulation around the Hawaiian Islands.

South of Hawaii, the surface North Equatorial Current (NEC) reaches an average westward speed 0.35 knot at 13 N, and gradually decreases towards the islands. Between 18 N and 22 N, the currents are strongly influenced by the islands. The NEC forks at Hawaii; the northern branch becomes the North Hawaiian Ridge Current (NHRC), and intensifies near the islands with a typical speed of 0.5 knots. West of the islands, two elongated circulations appear. A clockwise circulation is centered at 19 N, merging to the south with the southern branch of the NEC. A counter-clockwise circulation is centered at 20-30 N. Between them is the narrow Hawaiian Lee Counter

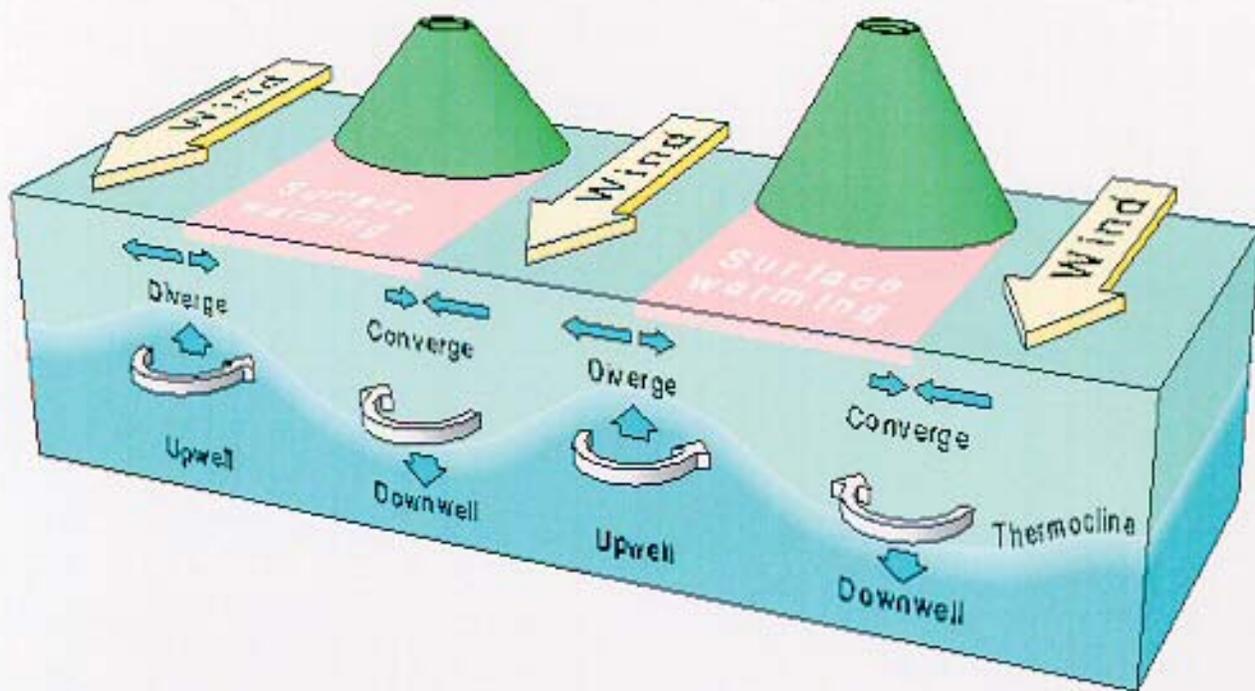
Figure 4. Regional current formation due to the modifying effect of land masses on large-scale circulation.

The island chain affects the ocean by two important mechanisms:

interactions of the islands with the large scale ocean currents, and wind speed variations in the lee of the islands.

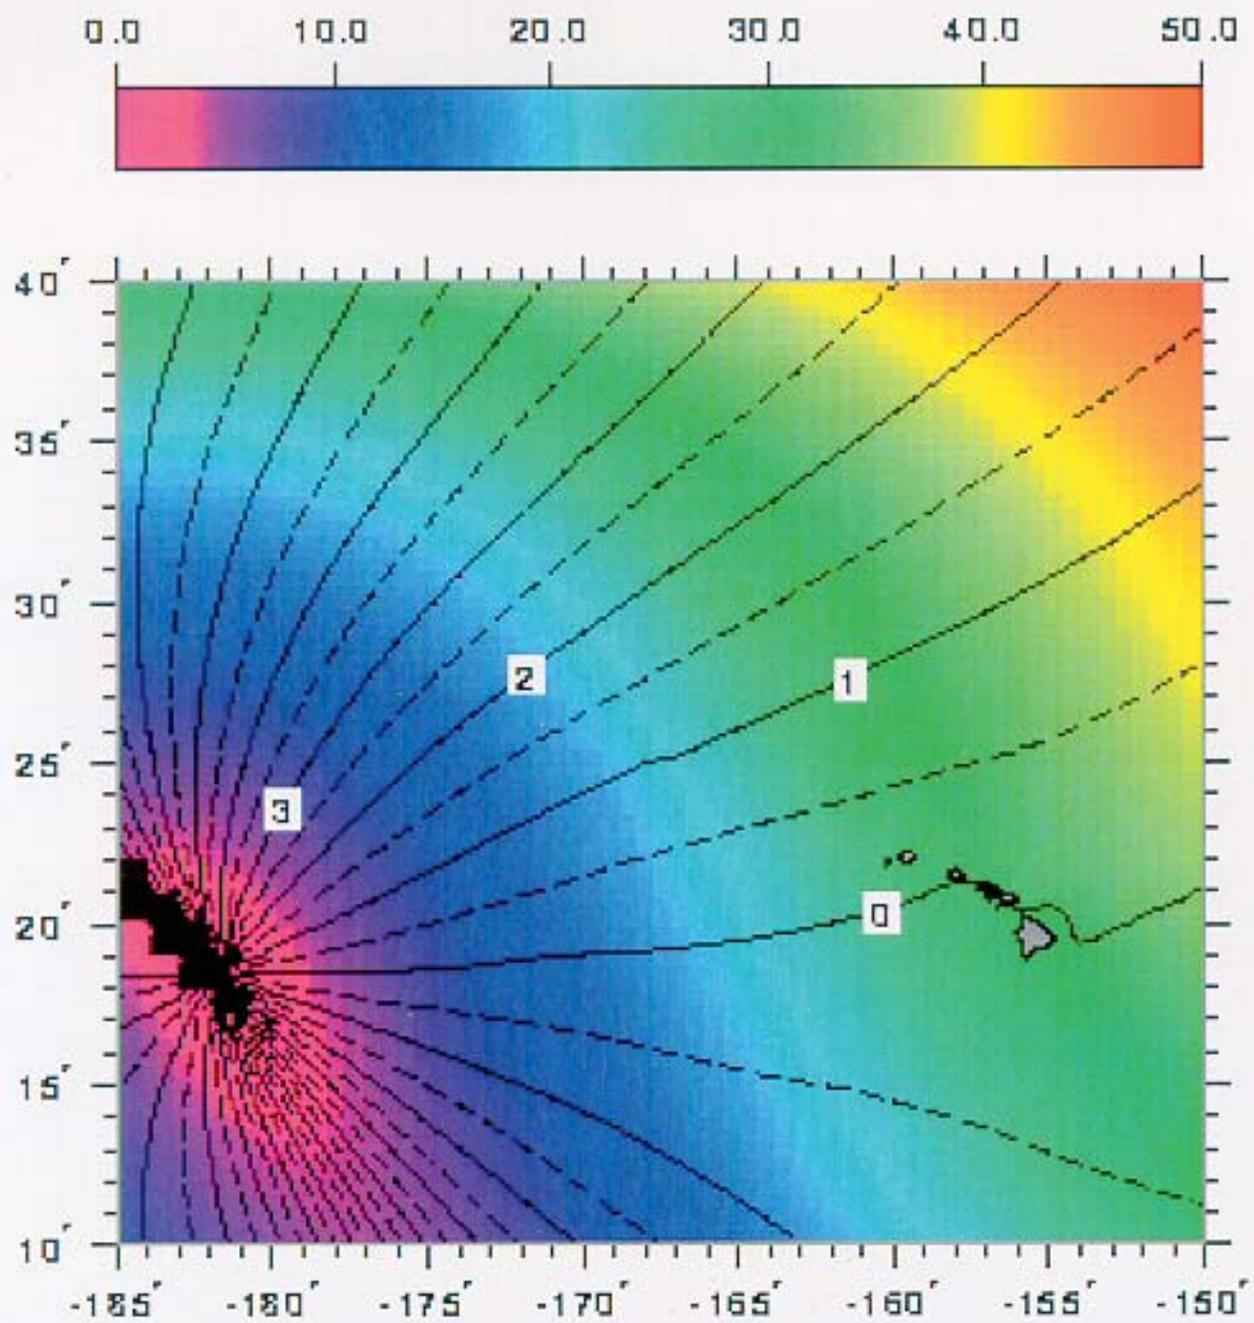
Figure 5. Response of the North Pacific to the longest duration tidal component (23h 56m) and the effect of the Hawaiian land mass.

Local bathymetry affects the ranges and phases of the tides along the shore, as the tidal waves wrap around the islands. For example, high tide at Haleiwa on the north shore of Oahu occurs over an hour before high tide at Honolulu Harbor.

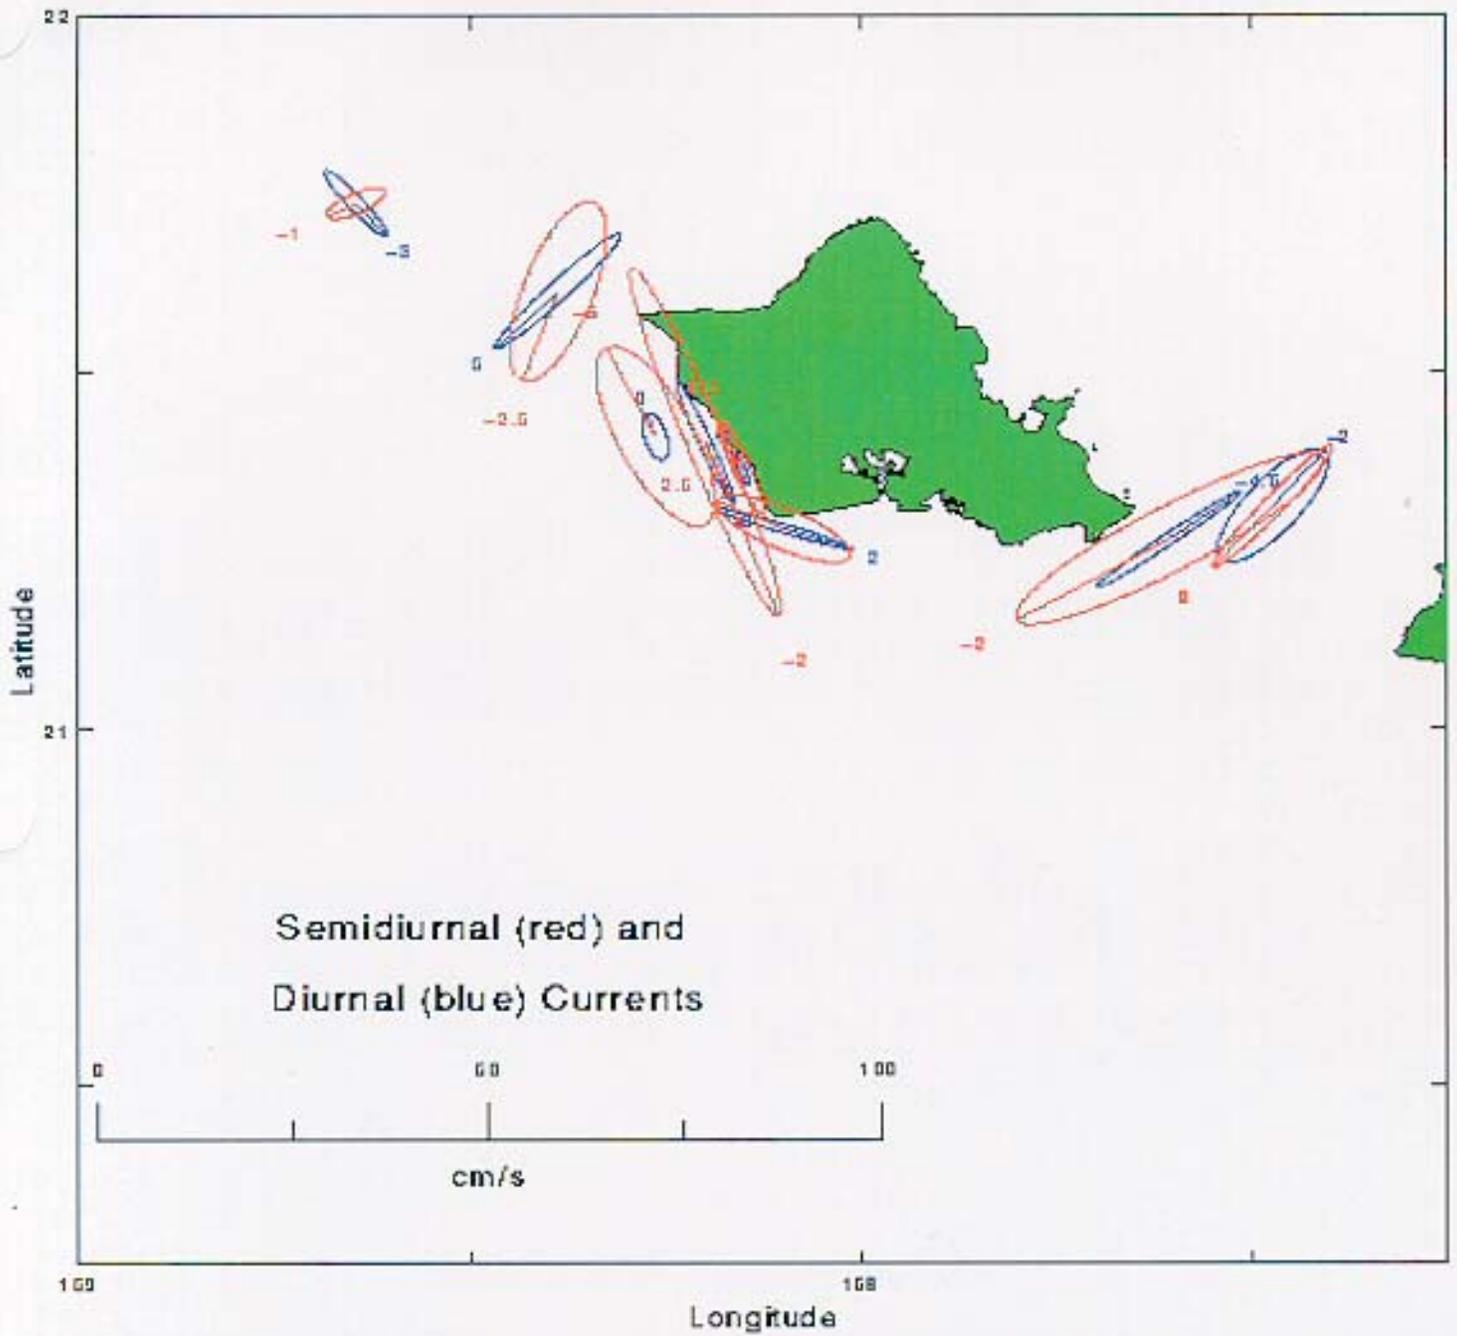
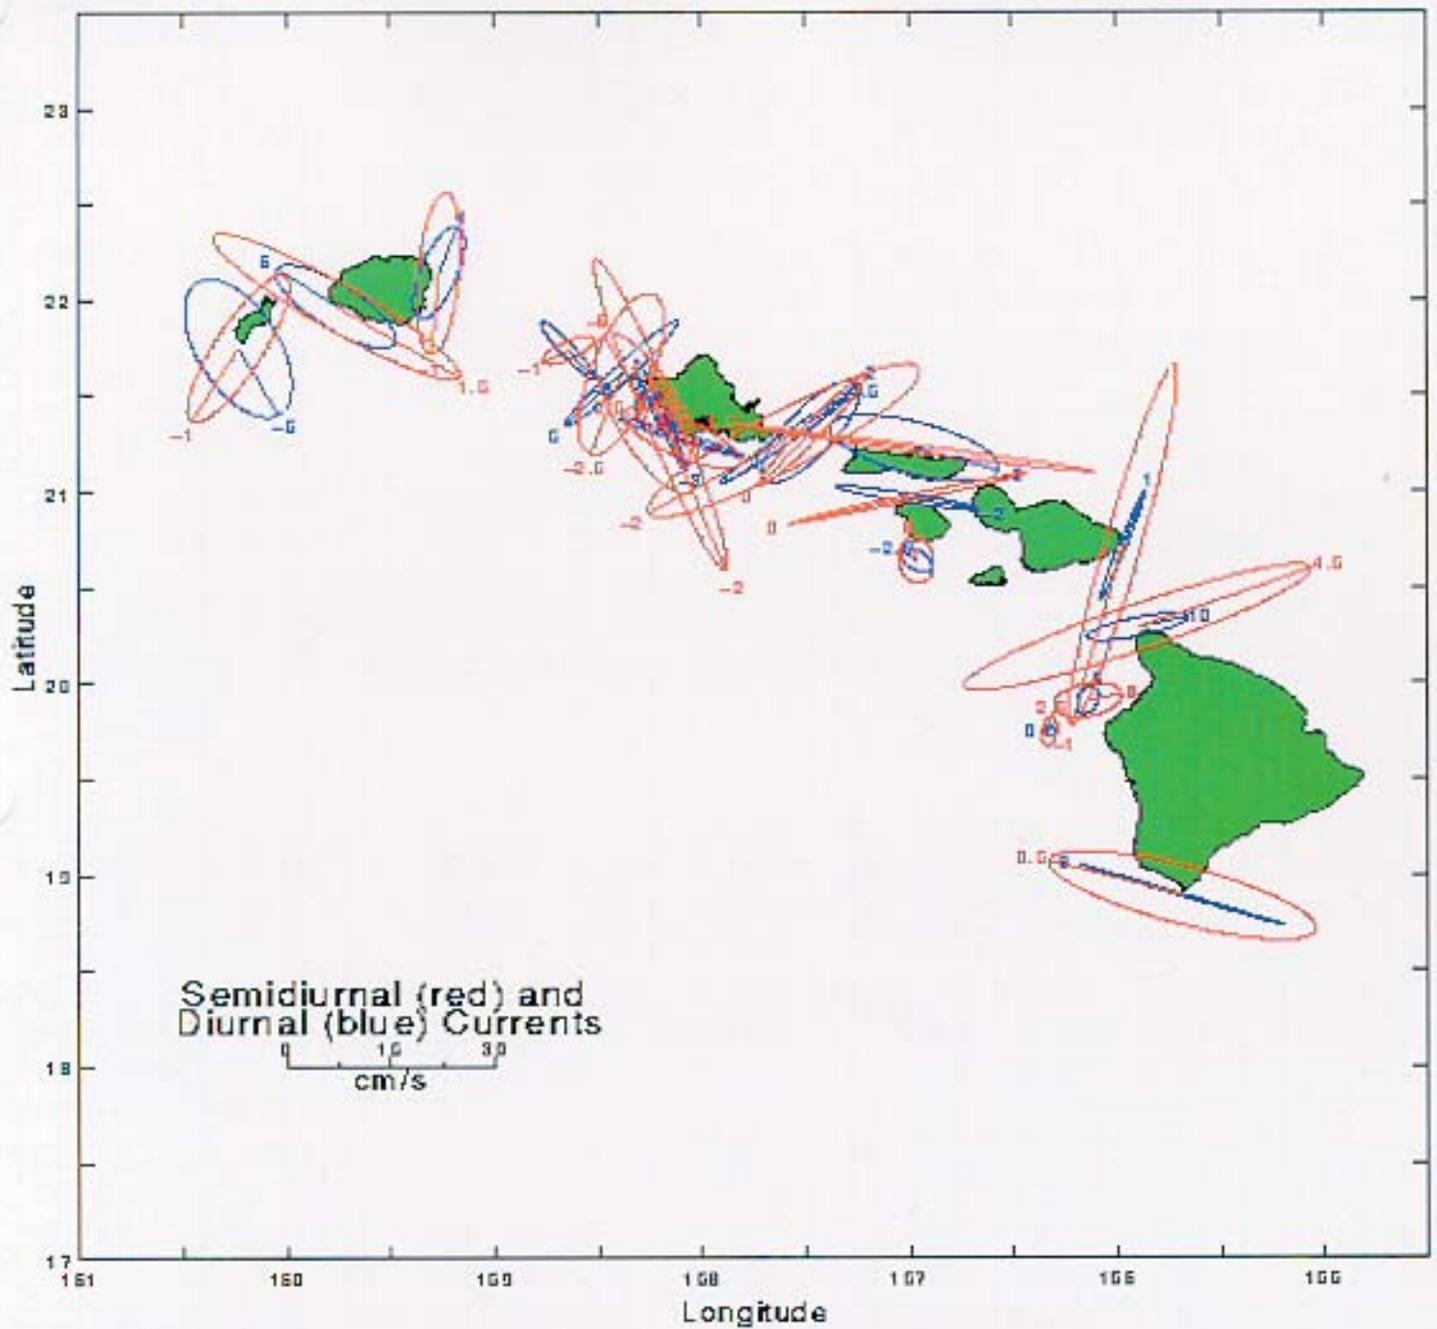
Figure 6a. Representative tidal current flow around the Hawaiian Islands. Diurnal and semi-diurnal tidal flows tend to be aligned with the shoreline. Strong eddies are often found around points and headlands.

Figure 6b. Representative tidal current flow around the Hawaiian Islands. Diurnal and semi-diurnal tidal flows tend to be aligned with the shoreline. Strong eddies are often found around points and headlands.

Due to high variability of tidal currents around the islands, however, this statistical representation may not correspond to the flow at a particular time -- tidal currents cannot be predicted as precisely as sea level. Strong swirls often result from tidal currents flowing around points and headlands, and present hazards to divers.
