## DESCRIPTIVE REPORT

*Type of Survey* ..... HYDROGRAPHIC .....

*Registry No.* ..... W00105 - W00112 .....

*Sublocality* ..... South Coast of Oahu .....

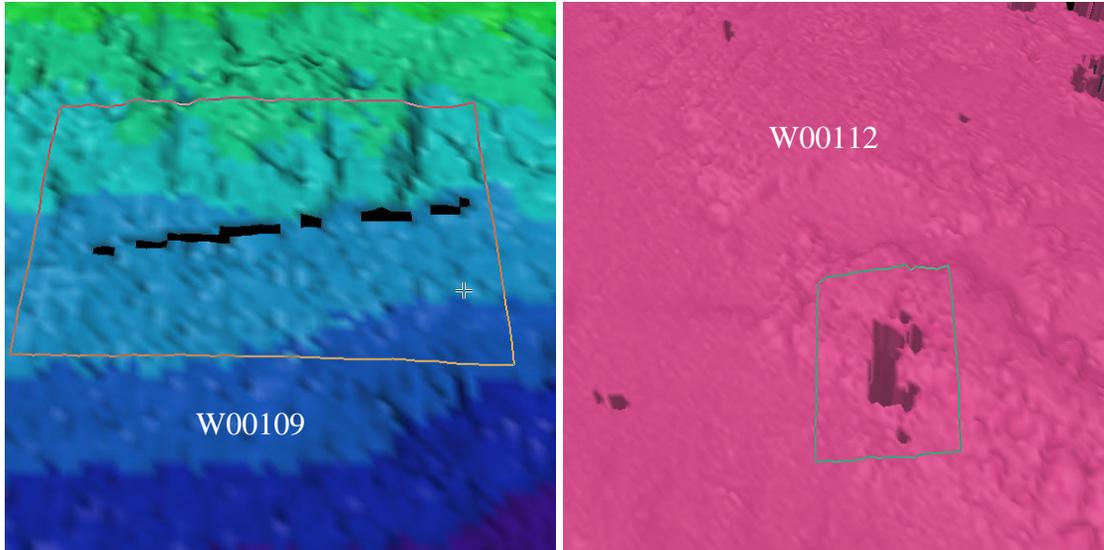
**Figure 1.** Small coverage holidays in the DTMs from survey W00109 and W00112 displayed in Fledermaus; soundings are colored by depth.

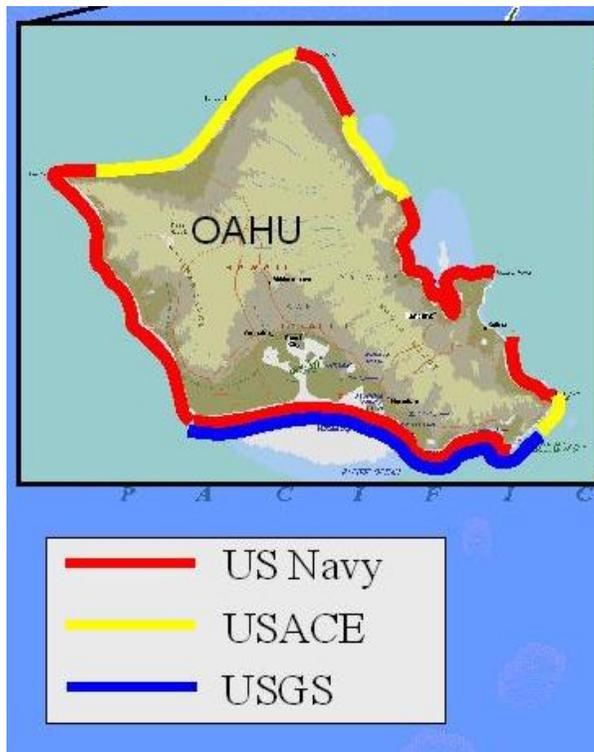
**Figure 2.** Image depicting LIDAR coverage for Oahu. Areas surveyed by the US Navy and USGS were surveyed with 4x4 m spot density and 200% coverage. Areas surveyed by the USACE were surveyed with 8x8 m spot density and 100% coverage. Image was submitted in Appendix A of Hawaii\_Final.doc.

8x8 meter spot density and 100% coverage and was not required to meet charting standards. The lack of redundant data increases uncertainty regarding the accuracy of least depth soundings over charted or new shoals and obstructions. The surveys affected by this coverage deficiency include W00107 and W00108.

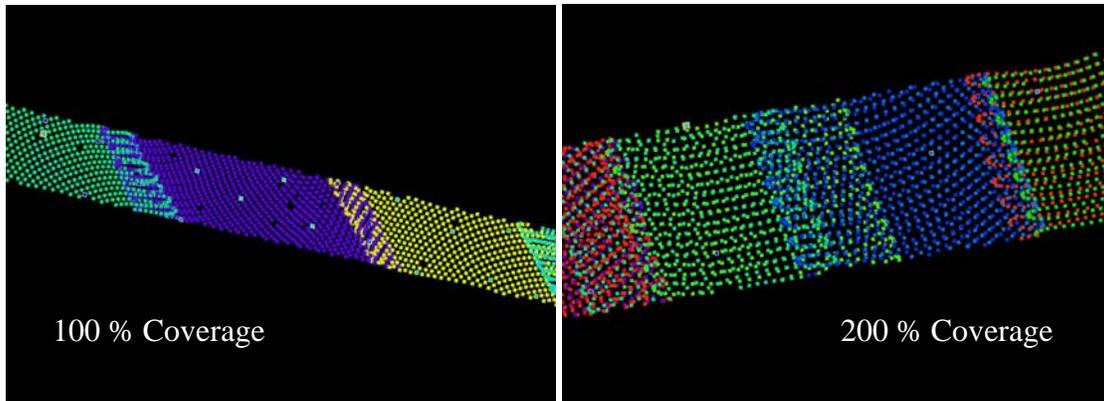
**Figure 3.** Images from Fledermaus 3DEditor displaying the difference in sounding coverage between LIDAR surveys run with 100% coverage versus 200% coverage. Soundings are colored by survey line.

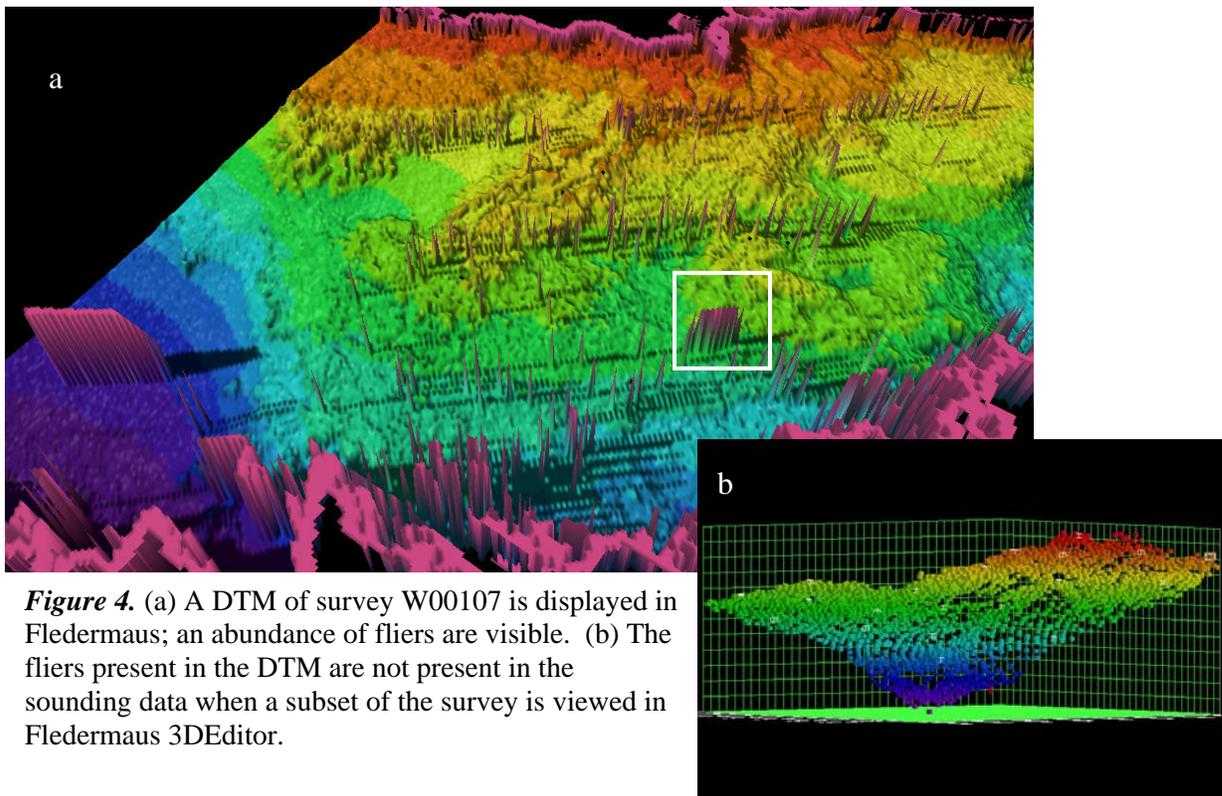
**Figure 4.** (a) A DTM of survey W00107 is displayed in Fledermaus; an abundance of fliers are visible. (b) The fliers present in the DTM are not present in the sounding data when a subset of the survey is viewed in Fledermaus 3DEditor.

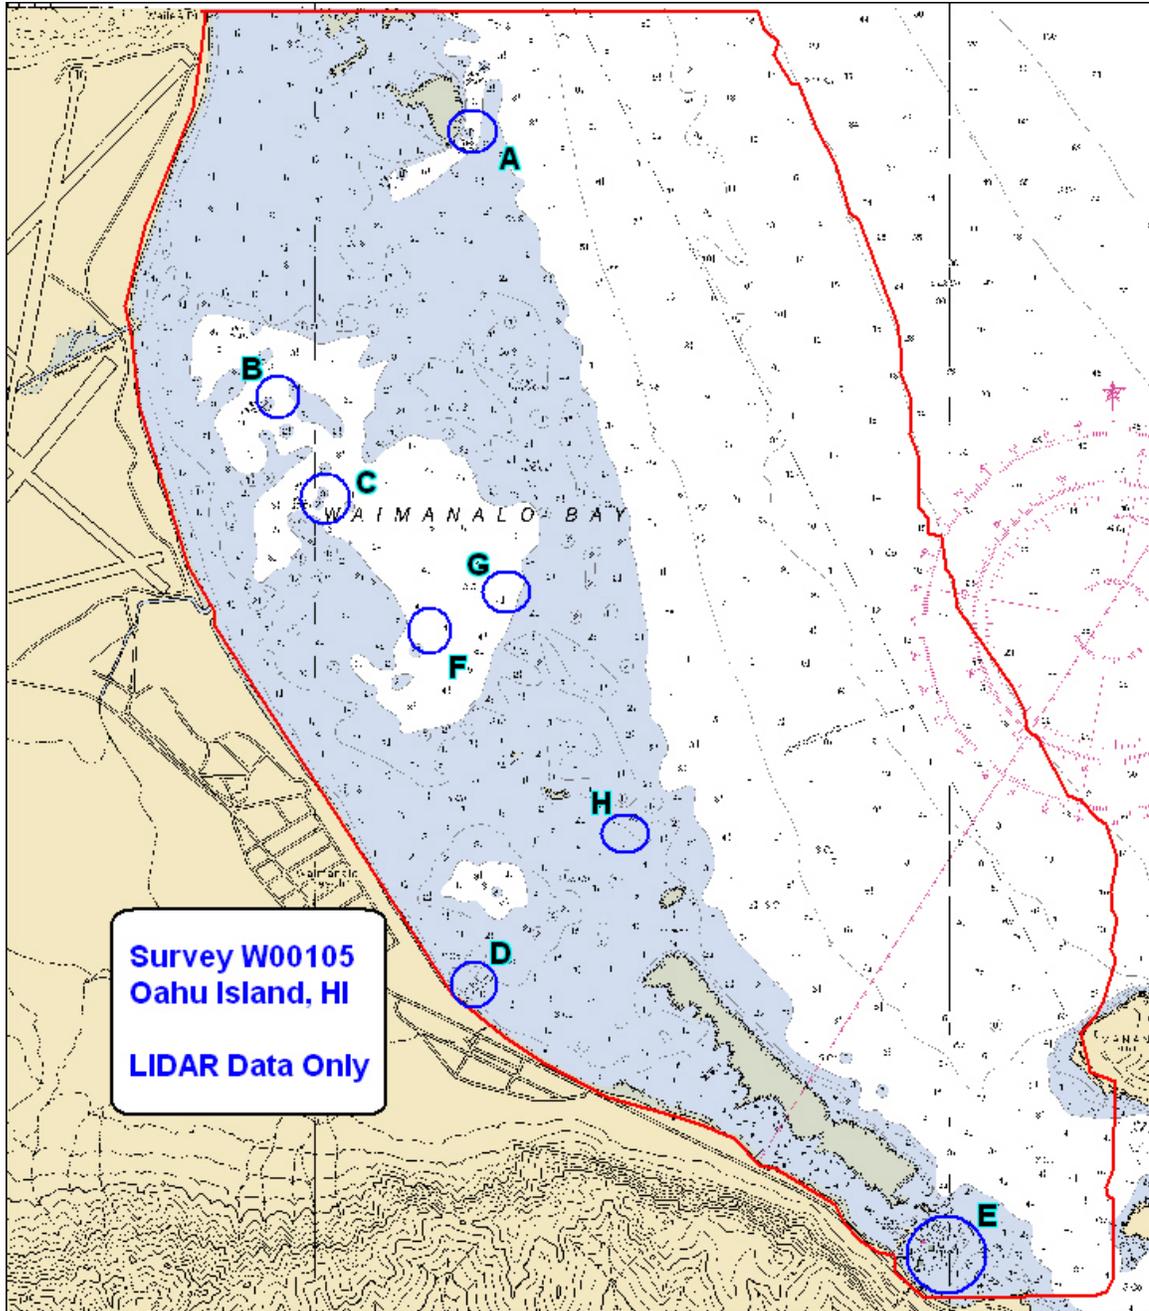
- A. Two soundings of 2.4 and 2.1 fathoms were found in the vicinity of a charted 2.25-fathom sounding reported in 2000. The charted sounding is located at 21°22'28.16" N, 157°41'28.96" W. It is recommended by the reviewer that the charted sounding be retained and the comment "Rep (2000)" be removed from the chart.<sup>5</sup>
- B. Two soundings of 2.7 and 2.2 fathoms were found in the vicinity of a 2.75-fathom charted sounding reported in 2000. The charted sounding is located at 21°21'41.64" N, 157°42'07.21" W. It is recommended by the reviewer that the charted sounding be retained and the comment "Rep (2000)" be removed from the chart.<sup>6</sup>

- C. A 1.8-fathom sounding was found in the vicinity of a charted 2-fathom sounding reported in 2000. The charted sounding is located at 21°21'21.83" N, 157°41'58.08" W. It is recommended by the reviewer that the charted sounding be retained and the comment "Rep (2000)" be removed from the chart. <sup>7</sup>

- D. It was reported by NAVOCEANO that the ruins approximately positioned at 21°19'55" N, 157°41'30" W were not visible in the data. It is recommended that the ruins be retained as charted and added to the AWOIS database for future investigation. <sup>8</sup>

- E. NAVOCEANO reported a limiting depth of 5.0 meters (2.734 fathoms) for the channel leading to the Oceanic Institute Pier. However, the reviewer found the channel to have a limiting depth of 1.2 fathoms located at 21°19'7.79" N, 157°40'0.06" W, significantly shoaler than the charted depth of 16 feet reported in 1984. It is recommended that the channel depth be updated to reflect the changes in depth evident in the survey soundings. <sup>9</sup>

- F. A 2.2-fm sounding located at 21°20'58.25" N, 157°41'38.27" W was reviewed in Fledermaus and it appears to be an uncharted submerged pinnacle with an approximate height of 3 meters. The reviewer recommends charting the feature at its surveyed least depth. <sup>10</sup>

- G. Smooth sheet soundings of 2.2 and 2.9 fms located in the vicinity of 21°21'5.08" N, 157°41'23.9" W were examined in Fledermaus. The soundings appear to represent an uncharted shoal falling between charted soundings of 4.25 and 5.25 fms. It is recommended that the charted soundings be superseded. <sup>11</sup>

- H. A 0.5-fm smooth sheet sounding located at 21°20'22.35" N, 157°41'1.03" W was examined in Fledermaus. The sounding was found in the vicinity of a 1.75-fm sounding and appears to be the new least depth of the charted shoal. It is recommended that the charted soundings be superseded. <sup>12</sup>

**Figure 5.** Image depicting data coverage and location of noted features for survey W00105; Chart 19358 is displayed in the background.

- <sup>8</sup> Concur
- <sup>9</sup> Do not concur, due to the uncertainty of the object detection capabilities of LIDAR systems, a controlling depth for the channel could not be determined. Until a controlling depth can be determined, the charted note, *16 ft rep 1984*, should be removed and replaced with a note, *12 ft rep 2000*.

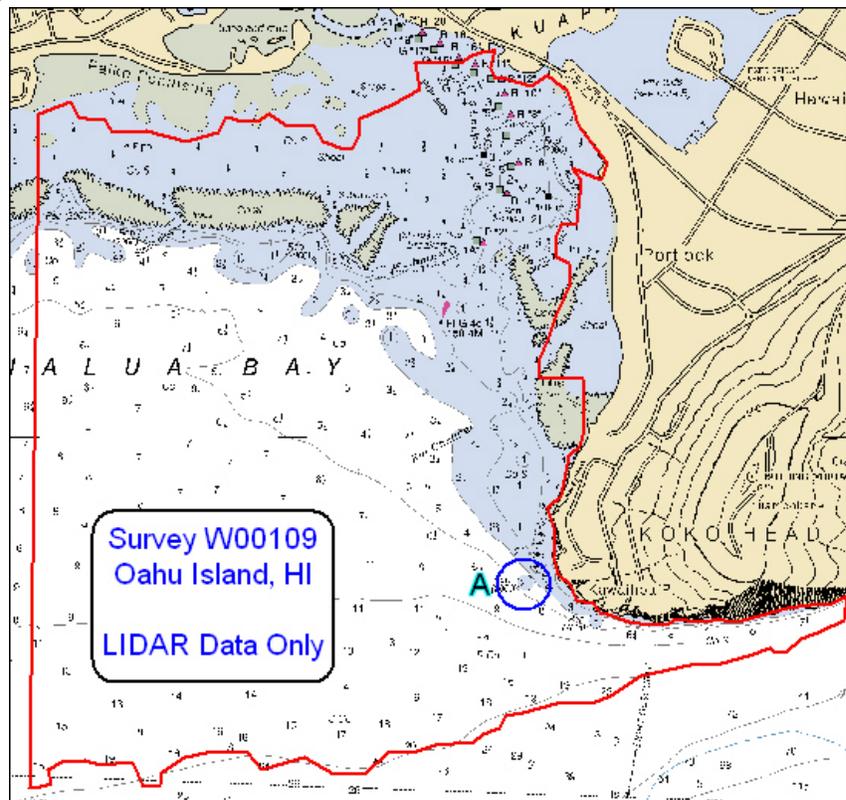
- A. A 2.5 fathom smooth sheet sounding was found in the vicinity of a charted 2.5-fathom sounding reported in 2000. The charted sounding is located at 21°15'42.22" N, 157°42'46.8" W. It is recommended by the reviewer that the charted sounding be retained and the comment "Rep (2000)" be removed from the chart. <sup>13</sup>

**Figure 6.** Image depicting data coverage and location of the noted feature for survey W00109; Chart 19358 is displayed in the background.

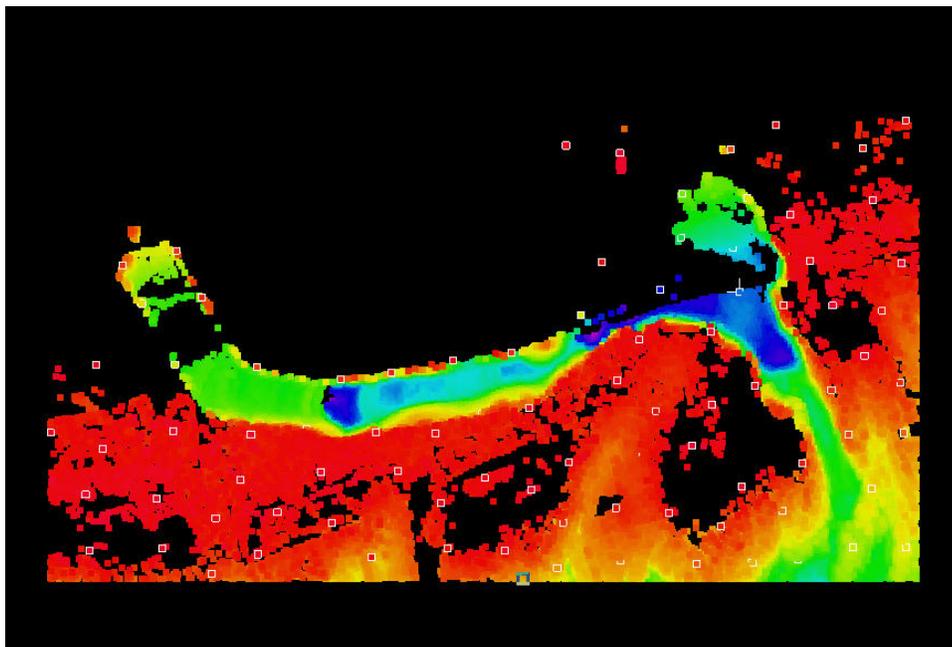
- C. A channel surrounding Wailupe charted (19358) as dredged to 12-feet was reported as partially filled in by NAVOCEANO. A limiting depth of 3.75 meters in the N-S Channel through the reef was reported. Limiting depths surrounding Wailupe were reported as 5.5 meters at the SE corner, approximately 4.0 meters on the south and 3.0 to 4.0 meters on the west side. The depth of the channel is not reflected on the NAVO smooth sheets, but is apparent in the full resolution data set viewed in Fledermaus 3DEditor (Figures 7a, 7b).

**Figure 7a.** A DTM of soundings from Wailupe channel displayed from above in Fledermaus 3DEditor. The soundings were colored by depth and the white boxes represent soundings selected for smooth sheet plotting.

It is recommended by the reviewer that the reported depth of the sounding remain as charted to 12 feet due to the uncertainty surrounding the object detection capabilities of LIDAR systems. <sup>16</sup>

- <sup>16</sup> Do not concur, a ten foot sounding was found within the charted boat harbor. The evaluator recommends revising the charted note *Reported dredged to 12 feet* with a *10 ft rep 2000* note unless MCD has additional information on the depths within this boat harbor.

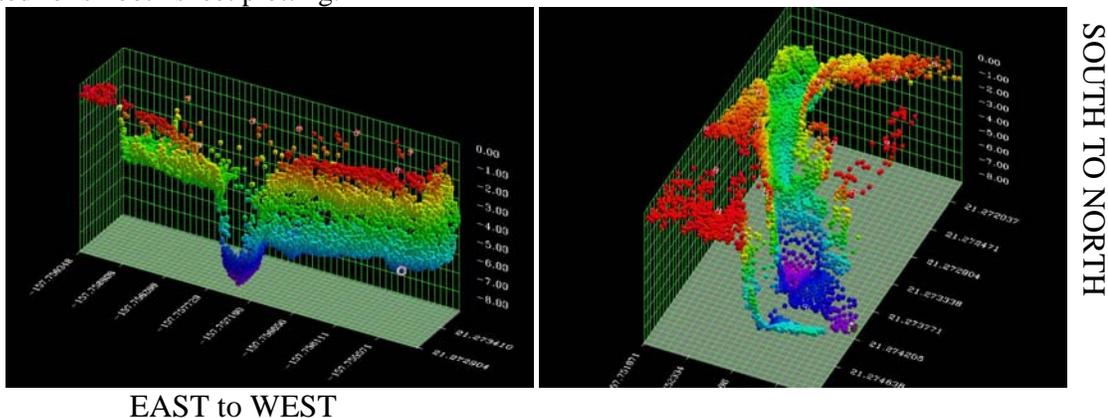
**Figure 7b.** The East to West and North to South topography of Wailupe channel as displayed in Fledermaus 3DEditor. Soundings are colored by depth.

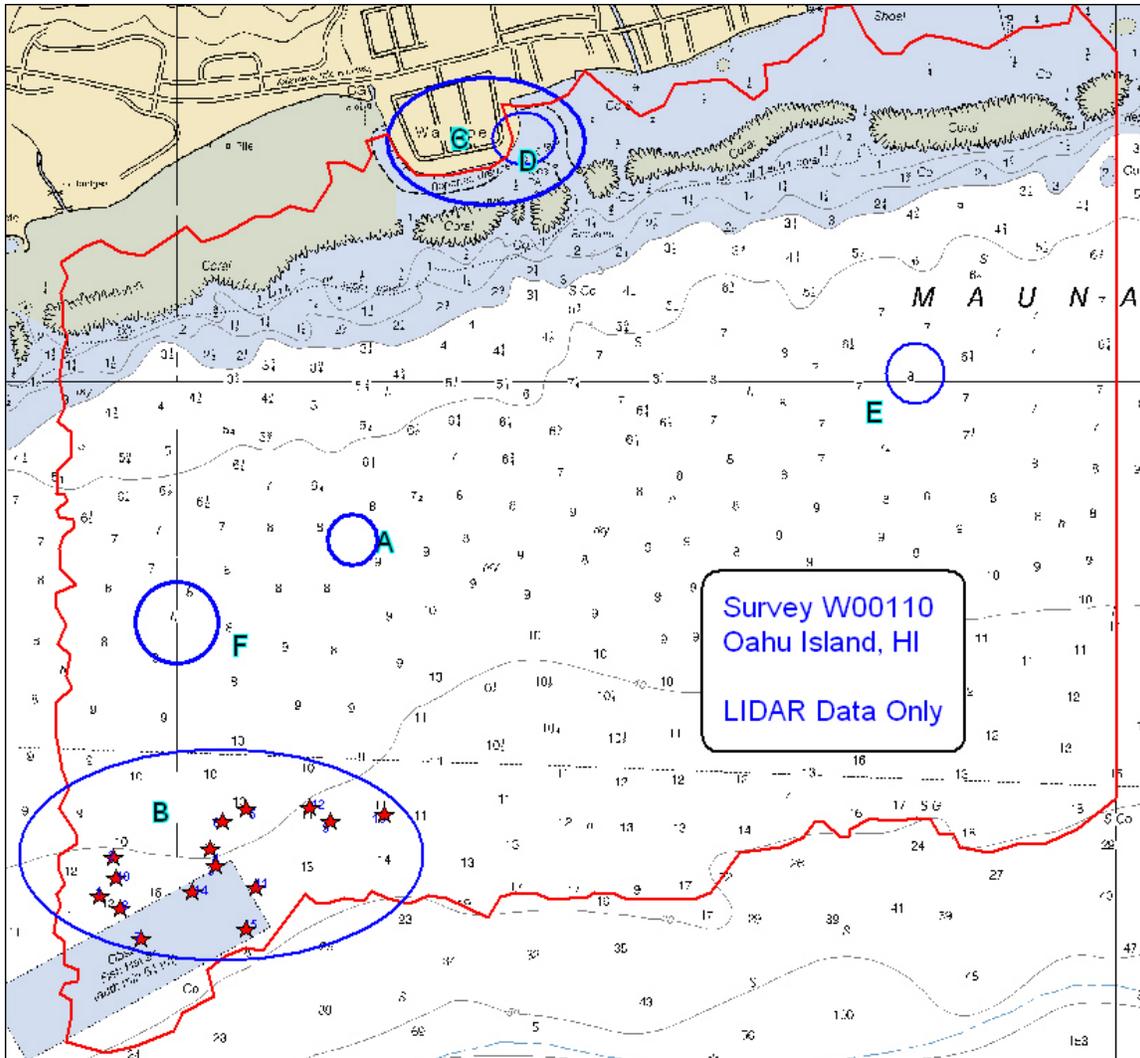
- A. A submerged pinnacle with a least depth of 13.89 meters (7.595 fathoms) was reported by NAVO at the following position: 21° 15' 41.12" N, 157° 45' 37.63" W. A visual review of the data in Fledermaus and 3DEditor confirmed the presence of the pinnacle and revealed a shallower least depth than was reported, 13.71 meters. The shallower depth of 13.7 is represented in the NAVO smooth sheet. It is recommended that the shallower sounding supersede the charted soundings. <sup>14</sup>
- B. NAVOCEANO reported 15 Fish Haven obstructions in the vicinity of the charted "Obstrn Fish Haven" with an approximate location of 21°14'50.31" N, 157°46'06.15" W. All of the obstructions were deeper than the minimum allowable depth of 6.75 fms listed on the chart. The positions and smooth sheet depths of the reported Fish Havens are listed in the table below. <sup>15</sup>

- D. It was not possible to verify a charted (19358) Pipes PA with an approximate position of 21°16'28.96" N, 157°45'20.5" W due to sparse data coverage in the area. It is recommended that the pipes be added to the AWOIS database for future investigation. <sup>17</sup>

- E. A smooth sheet sounding of 6.5 fms located in the vicinity of 21°15'58.12" N, 157°44'25.1" W was examined in Fledermaus. The sounding appears to represent the new least depth of a charted shoal. It is recommended that the charted soundings be superseded. <sup>18</sup>
- F. A 7-fm smooth sheet sounding located in the vicinity of 21°15'28.2" N, 157°45'59.9" W was located between charted soundings of 8 and 9 fathoms. The sounding was examined in Fledermaus and it appears to be the least depth value of a new shoal. It is recommended that it supersede the charted soundings. <sup>19</sup>

**Figure 8.** Image depicting data coverage and locations of noted features for survey W00110; Chart 19358 is displayed in the background.

- <sup>15</sup> Revise fish haven note and it is recommended that the charted fish haven limits be expanded to include the fifteen obstructions listed in this report

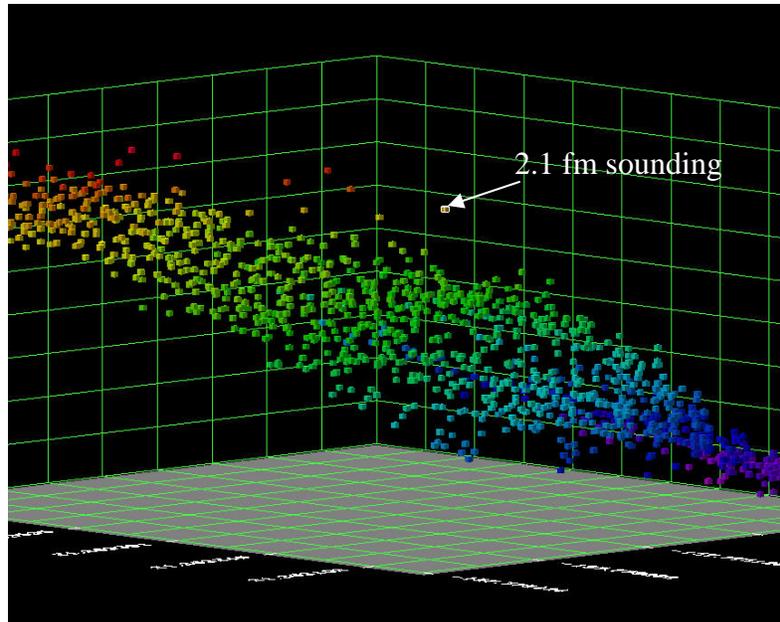
- C. A smooth sheet sounding of 2.1 fms positioned at 21°15'48.45" N, 157°46'29.97" W was located in the vicinity of a charted 5.25-fm sounding. When reviewed in Fledermaus, the validity of the sounding remained uncertain due to the lack of connectivity to the surrounding soundings (Figure 9). The sounding could potentially be a flyer or it could be the least depth of an uncharted obstruction. Due to the uncertainty of the object detection capabilities of LIDAR systems and the lack of denser sounding coverage, it is recommended that the smooth sheet sounding supersede the charted sounding until it can be validated or disproved by future investigation. <sup>22</sup>

**Figure 9.** Image depicting position of 2.1 fm sounding in relation to the surrounding data. Soundings are displayed in Fledermaus 3DEditor and are colored by depth.

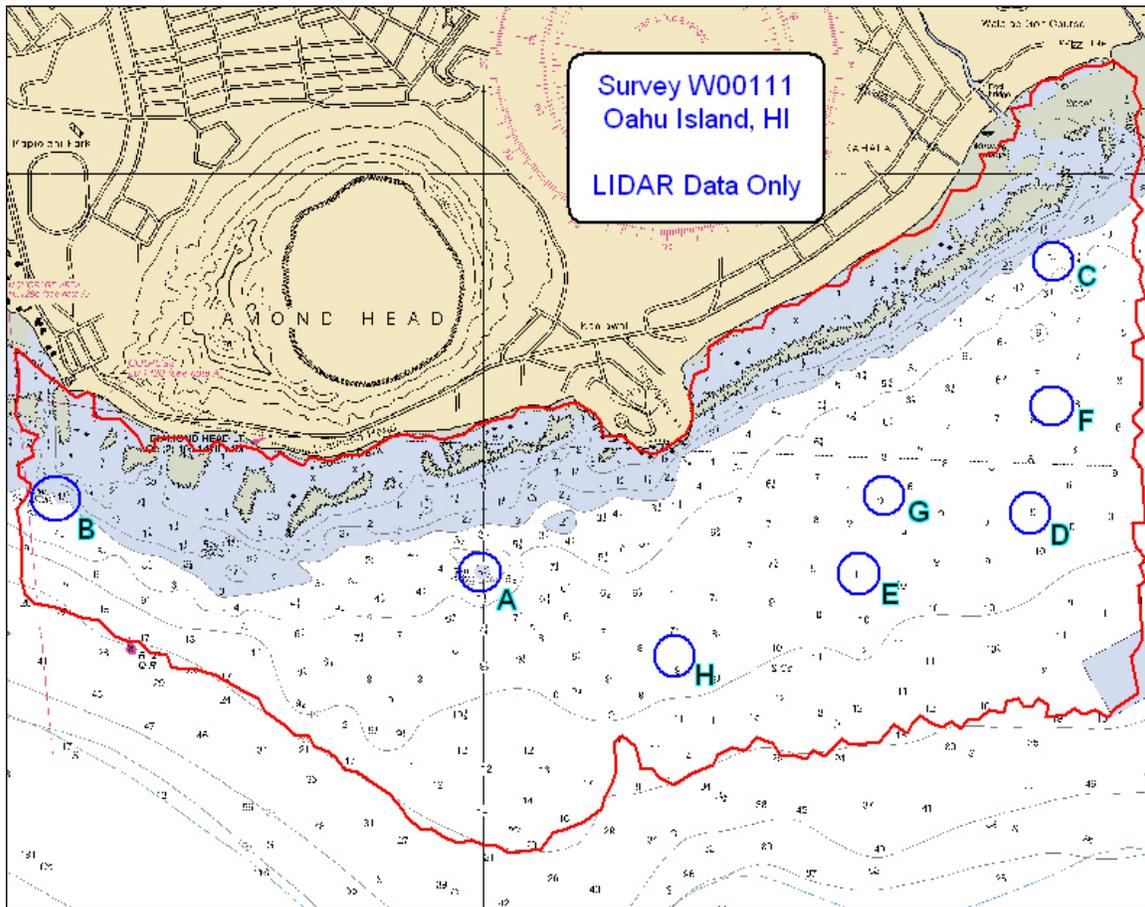
- A. A 5.3-fm sounding was found in the vicinity of a charted 5.25-fm sounding reported in 2000. The charted sounding is located at 21°15'02.44" N, 157°48'01.66" W. It is recommended by the reviewer that the charted sounding be retained and the comment "Rep (2000)" be removed from the chart. <sup>20</sup>
- B. A 1.7-fm sounding was found in the vicinity of a charted 1.75-fm sounding reported in 2000. The charted sounding is located at 21°15'16.92" N, 157°49'09.06" W. It is recommended by the reviewer that the charted sounding be retained and the comment "Rep (2000)" be removed from the chart. <sup>21</sup>

- D. A 7.5-fm sounding positioned at 21°15'10.7" N, 157°46'32.71" W was located in the vicinity of a charted 9-fm sounding. The sounding was reviewed in Fledermaus 3DEditor and appears to be the least depth of a submerged pinnacle with an approximate height of 2 meters. The reviewer recommends charting the obstruction at its least depth position. <sup>23</sup>
- E. A 9.3-fm sounding positioned at 21°15'0.99"N, 157°47'1.51" W was located in the vicinity of a charted 11-fm sounding. The sounding was reviewed in Fledermaus and appears to be a valid depth representing a natural shoaling trend. It is recommended that the smooth sheet sounding supersede the charted sounding. <sup>24</sup>

F/G/H. Three dangers to navigation (dtons) were found by the reviewer for survey W00111. One dton, a submerged obstruction with a least depth of 5.4 fathoms, was located between two 8-fathom charted (19358) soundings. The remaining dtons with depths of 6.9 and 6.6 fathoms are least depth soundings selected from the smooth sheet to identify shoaling trends not represented in the charted (19358) soundings. The 6.9-fm sounding is located between two charted 9-fm soundings and the 6.6-fm sounding is located between two charted soundings of 9.5 and 8.25 fathoms. The positions of the dtons are listed in the table below.

Feature	Depth(fm)	Latitude N	Longitude W
F	5.4 <sup>25</sup>	21°15'25.22"	157°46'28.65"
G	6.9 <sup>26</sup>	21°15'11.58"	157°46'55.92"
H	6.6 <sup>27</sup>	21°14'48.96"	157°47'29.99"

Figure 10. Image depicting data coverage and location of noted features for survey W00111; Chart 19358 is displayed in the background.

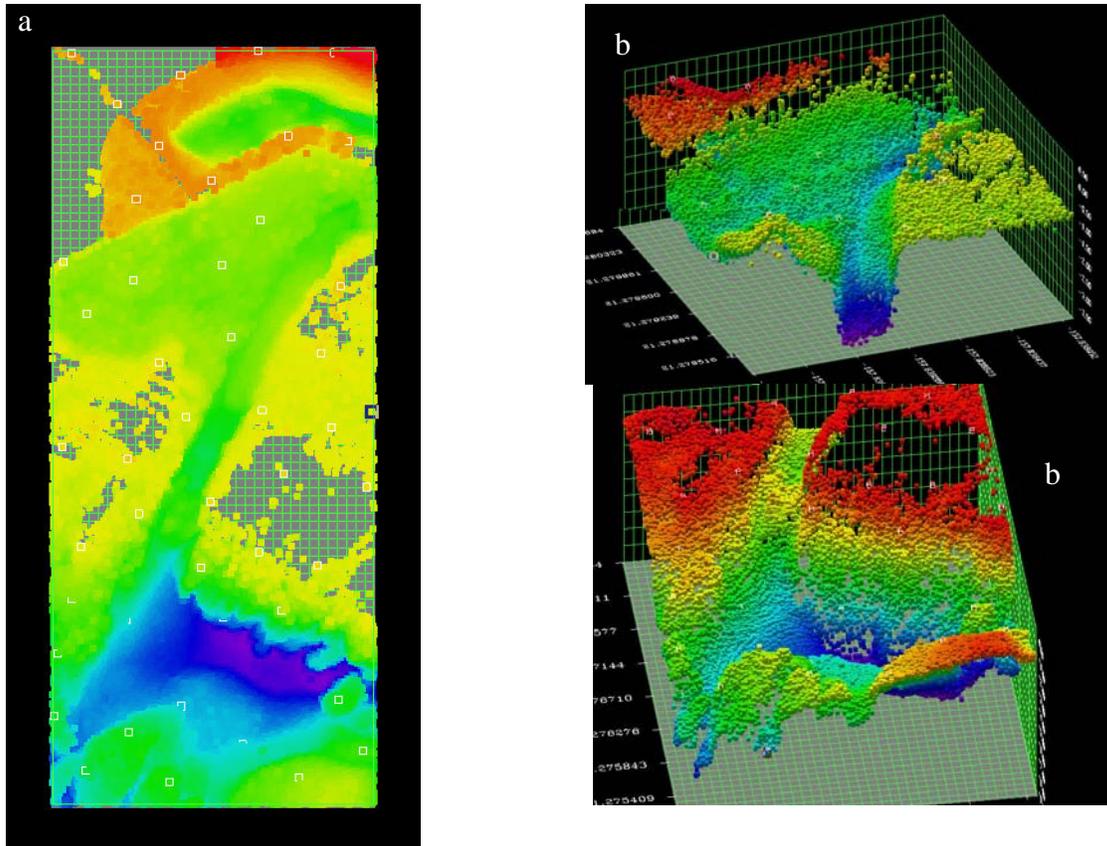
- E. A small lagoon south of Ala Wai Boat Harbor, adjoining a coral reef was charted (19369) as dredged to 5-feet. The depth of the lagoon is not reflected on the NAVOCEANO smooth sheets, but is apparent in the full resolution data set viewed in Fledermaus 3DEditor (Figure 11a, 11b). <sup>35</sup>

**Figure 11.** (a) A DTM of the soundings from the Ala Wai lagoon displayed from above in Fledermaus 3DEditor. Soundings are colored by depth with the white boxes representing soundings selected for the smooth sheet. (b) The topography of the lagoon displayed in Fledermaus 3DEditor, with soundings colored by depth.

The limiting depth at the entrance to the lagoon, through the coral, is 1.21 fms (7.25 ft), positioned at 21°16'38.97" N, 157°50'23.71" W. The following soundings selected from the center of the channel can be used to supplement the smooth sheet soundings (depths are in meters).

and least depth can be determined, the charted note, *5 ft rep*, should be removed and replaced with a note, *2 ft rep 2000*.

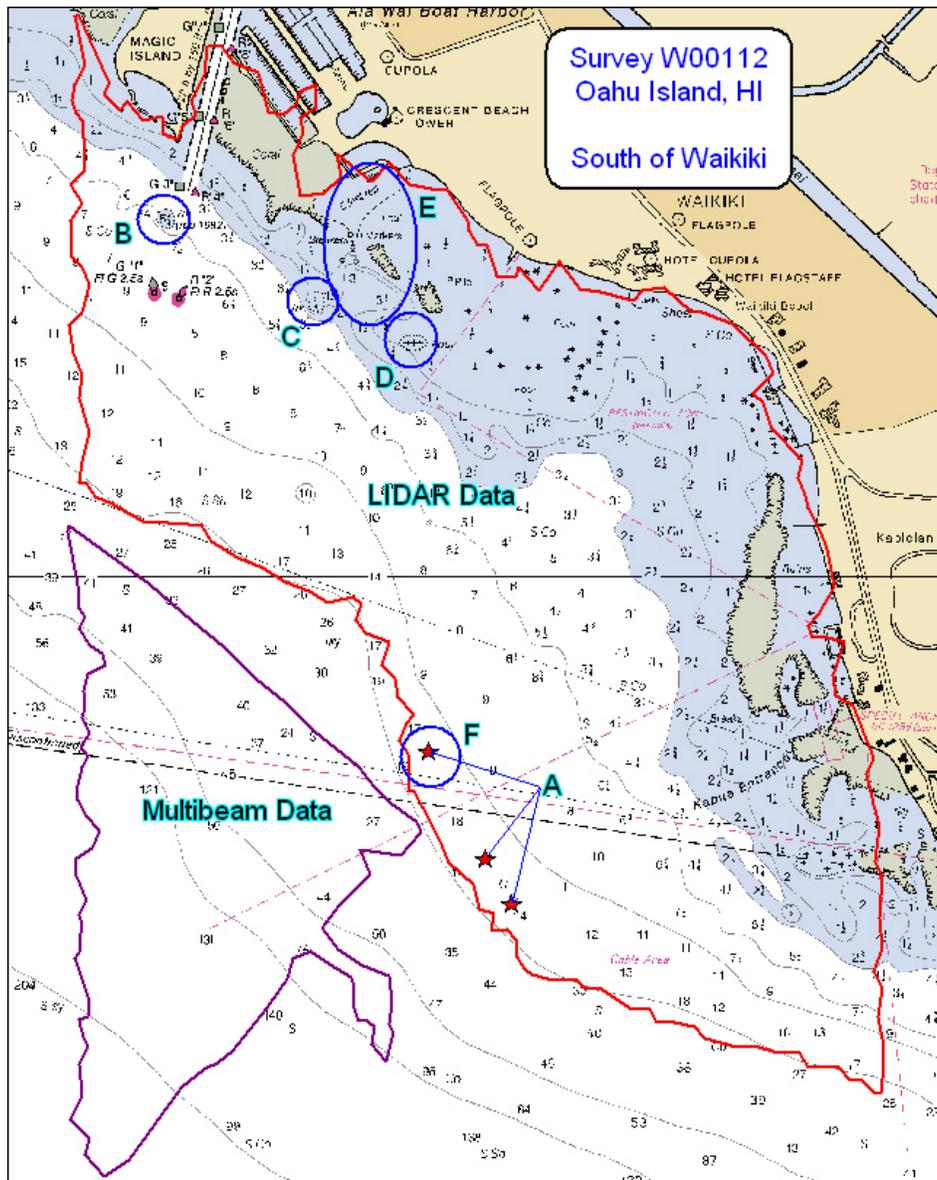
Obstruction 3 appears to have been chosen to represent a submerged obstruction. However, the selected position and depth is not the least depth on this obstruction. The least depth sounding is represented by a 7.9-fm smooth sheet sounding located at 21°15'20.02" N, 157°50'02.72" W. It is recommended by the reviewer that the position and depth for the obstruction selected by NAVOCEANO be replaced by the true least depth of 7.9-fms. It is recommended that the 7.9-fm sounding be charted as an obstruction.<sup>31</sup>

- B. NAVOCEANO reported that a charted (19369) PA Wreck (rep 1982) with a depth of 5.75 fms was not seen in the data, however, suggests that remnants may still exist. The approximate position of the wreck is 21°16'44.0" N, 157°50'48.68" W. A visual inspection in Fledermaus 3DEditor could not confirm the presence of a wreck, as the area was characterized by multiple shoals at the mouth of the canal leading to Magic Island. It is recommended that the PA Wreck be retained as charted and added to the AWOIS database for future investigation. <sup>32</sup>

- C. A charted (19369) wreck with a depth of 0.75 fms located at 21°16'31.75" N, 157°50'28.01" W, was reported as not seen in data by NAVOCEANO, but suggest that remnants may still exist. It is recommended that the charted wreck be retained and added to the AWOIS database for future investigation. <sup>33</sup>

- D. A charted (19369) wreck located approximately at 21°16'28" N, 157°50'15" W was reported as not seen in the data by NAVOCEANO. They report the area as the top of the reef and remnants may still exist, but its existence is doubtful. It is recommended that the charted wreck be retained and added to the AWOIS database for future investigation. <sup>34</sup>

- F. One danger to navigation was found during review of the survey. The dton is a submerged obstruction positioned at 21°15'37.9" N, 157°50'13.1" W with a least depth of 7.9 fathoms located between 10 and 20 fathom charted contours.

**Figure 12.** Image depicting data coverage and location of noted features for survey W00112; Chart 19369 is displayed in the background.

- <sup>29</sup> Concur
- <sup>30</sup> Do not concur, chart according to the smooth sheet.
- <sup>31</sup> Concur
- <sup>32</sup> Do not concur, this survey found a shoal depth of 5 fathoms in the approximate position of the charted wreck. Because the location of the wreck could not be determined in the data, it is recommended that the charted wreck be removed and a 5 fathom wreck PA be charted at the location of the shoal depth.

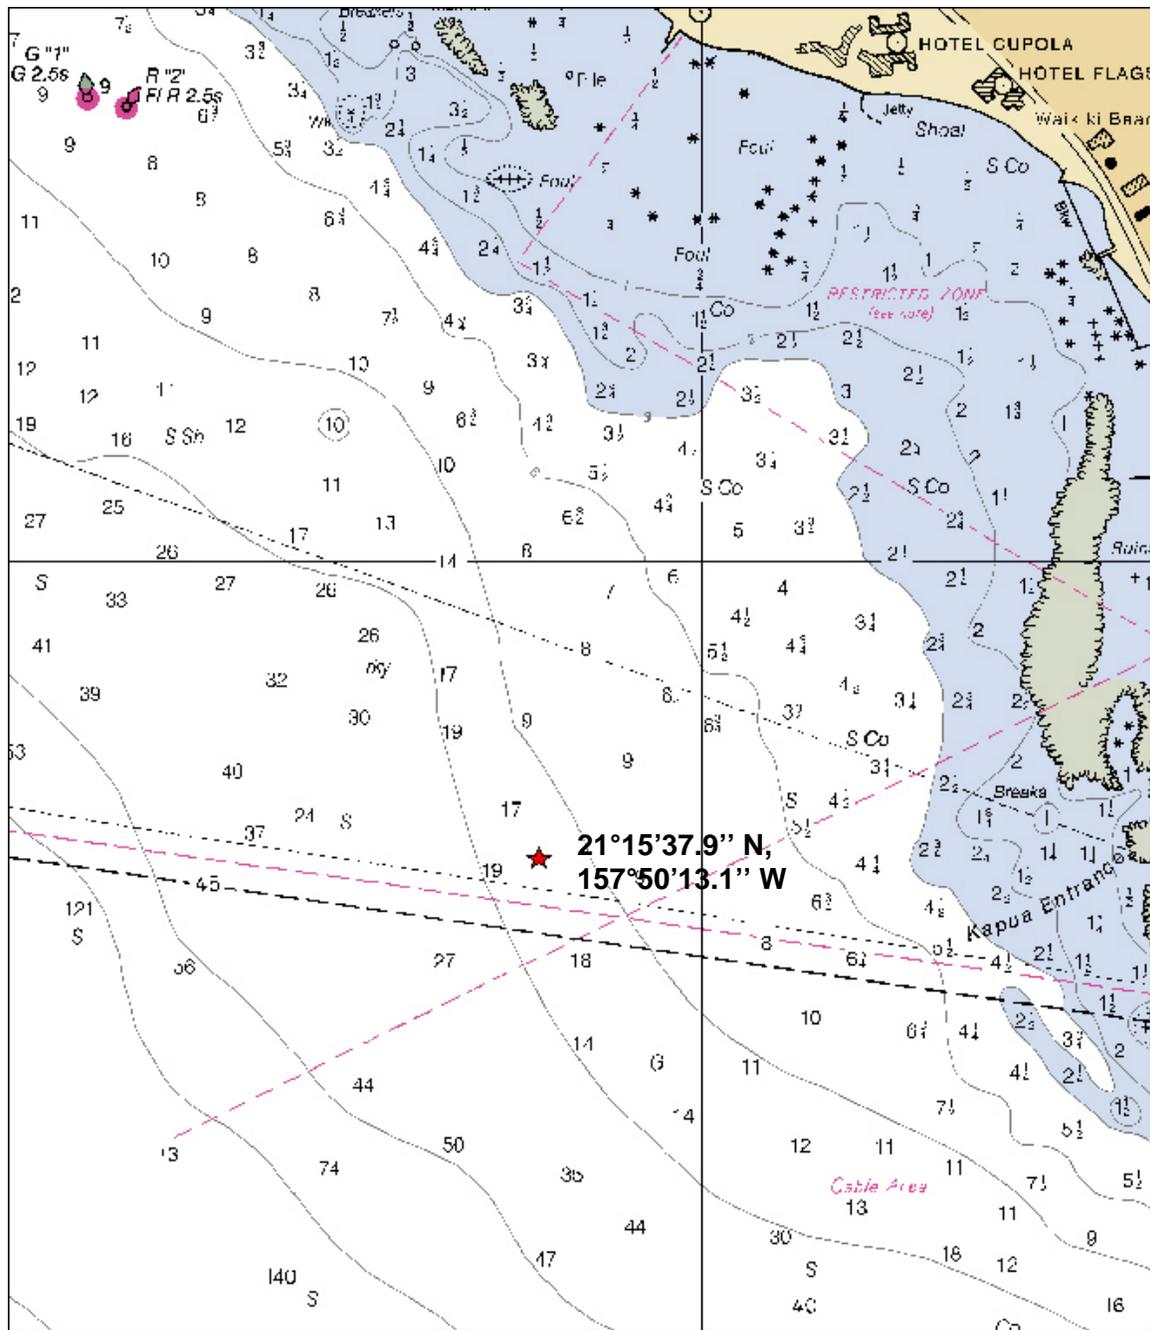
Figure 1. A chartlet depicting the position of the danger to navigation reported for Survey W00112 with NOAA Chart 19369 as the background.

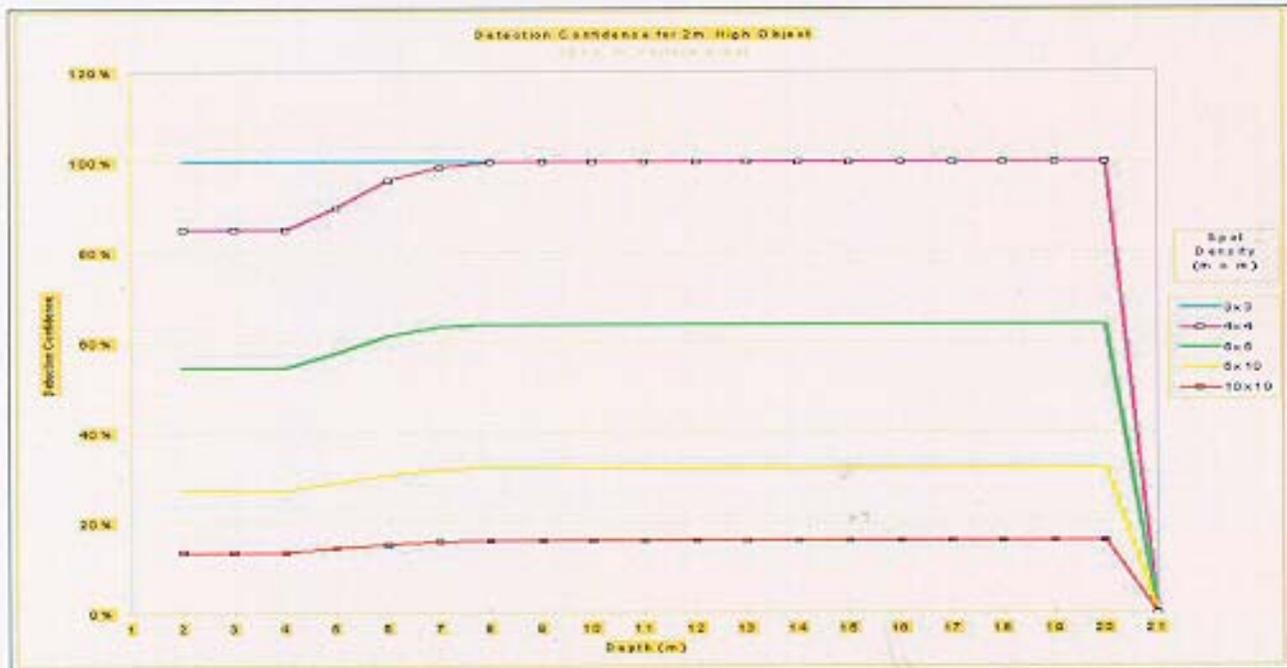
Figure 1. Target detection confidence

1.4.4 Theoretically, based on target detection probability curves produced by NOAA, Guenther, et al, all Navy areas meet IHO Order 1 target/object detection requirements at the 95% confidence level for depths from 7m to 20m with single-flight coverage. At depths deeper than 20m, signal-to-noise ratio limitations greatly reduce target detection capability, particularly for small objects less than 2 meters (Figure 1). Multiple-flight coverage will theoretically improve the confidence of target detection capability in the depth range of 2m to 7m, and possibly down to 20m.

1.4.5 Subsequent testing of the follow-on CHARTS system, utilizing the same operating principles and algorithms and a lower power laser at 4x4 spot spacing, targets of 2 meters were detected 100% of the time in depths of 5 to 30 meters. Based on these actual tests the LIDAR system meets IHO Order 1 target detection requirements. Multiple coverage provides a degree of redundancy for this capability.

Theoretical detection confidence vs. depth for a 2m target at different laser spot densities.

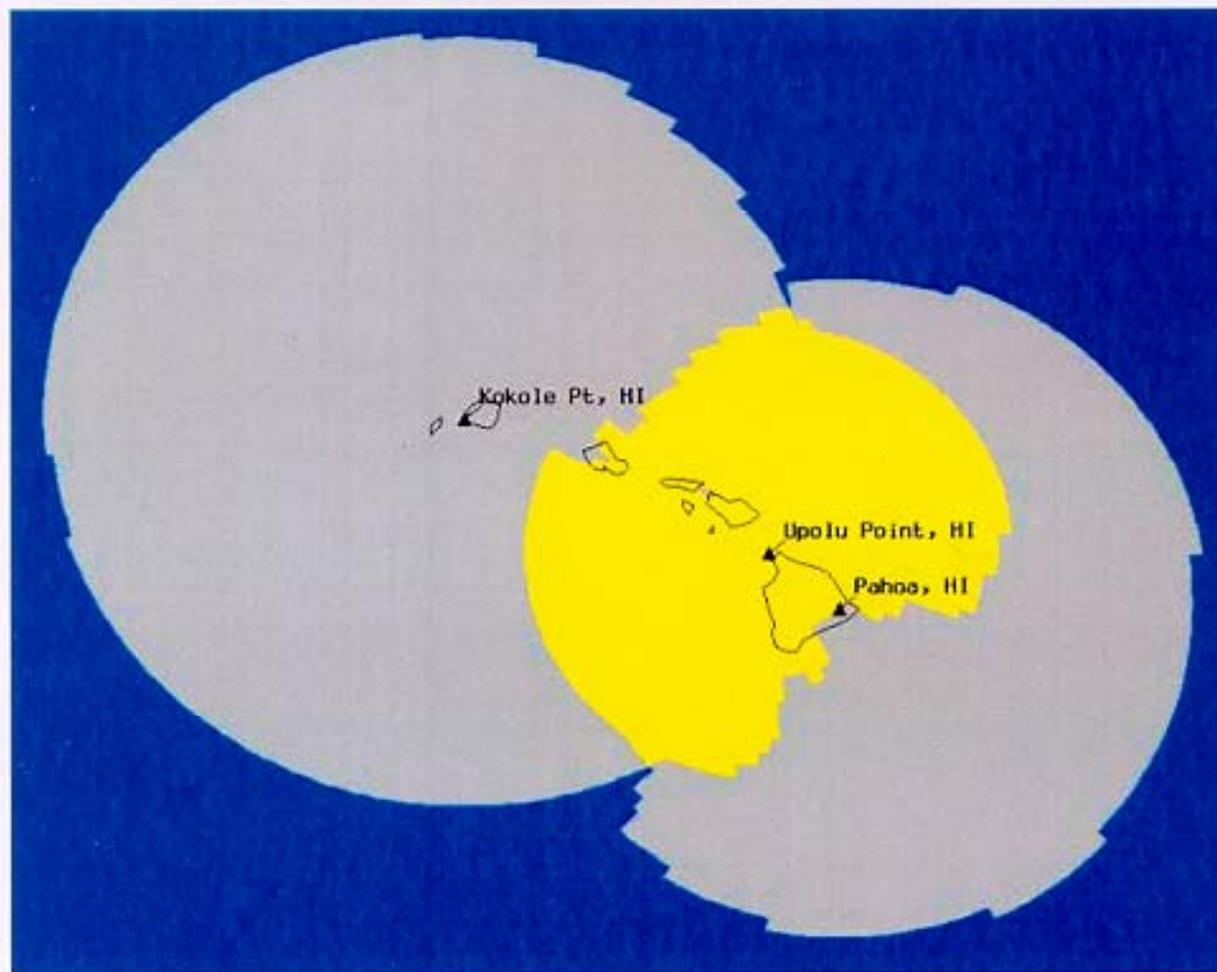
USCG DGPS beacon coverage for Hawaii.

Kokole Point was used for Kauai, and Oahu. Upolu Point was used for Molokai, Maui, Lanai and all but the south shore of Hawaii. Pahoa was used for the south shore of Hawaii.

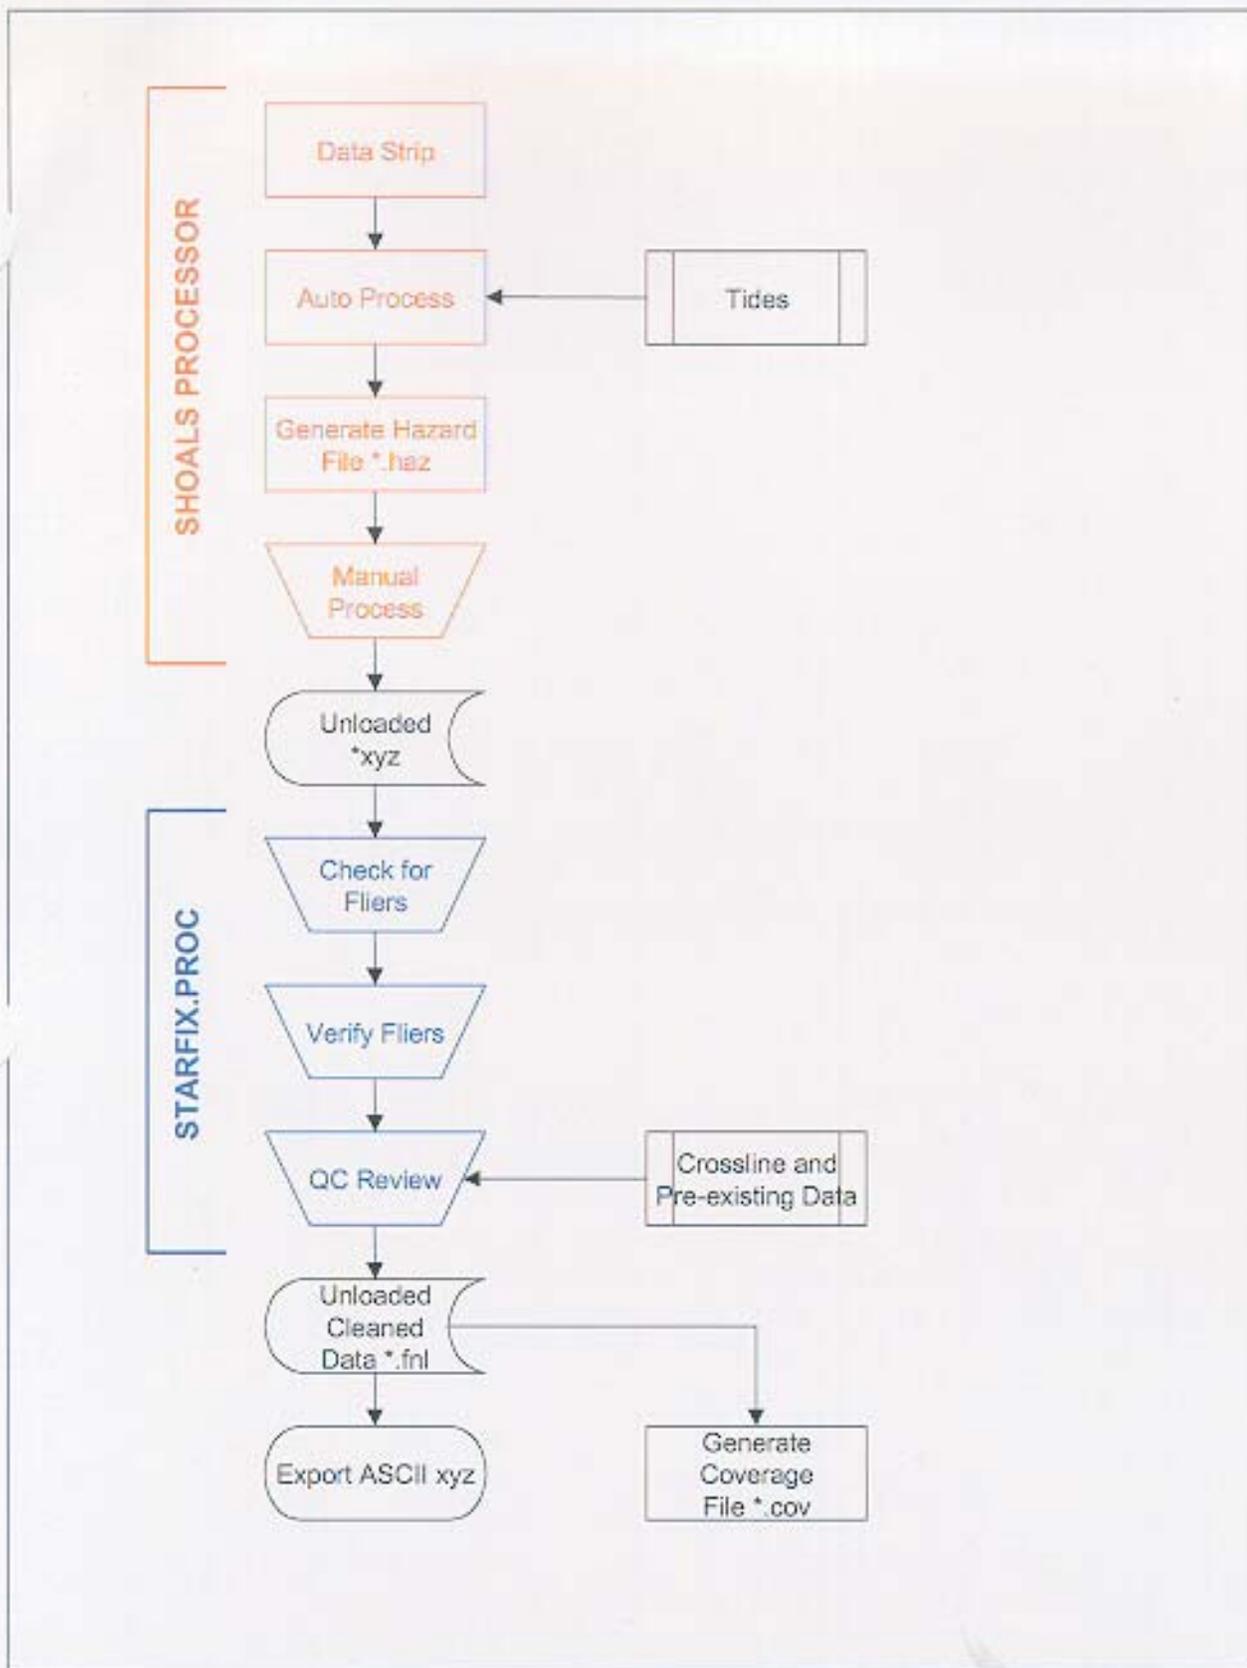
Figure 6: Data Processing Flow

3.5.4 After the data is extracted from the flight tape and input into the database, it is processed by an automated routine consisting of a lidar waveform processor and sounding position determination algorithm. The main function of the automated processor is to obtain inputs from the raw data; calculate depths, positions, and other products; correct for tides and waves; and write the outputs back to file database. It runs at a 1:0.1 time ratio with data collection and data processing.

3.5.5 All data is then manually edited for obvious anomalies. Where such anomalies are clearly due to fish, or similar causes, they will be flagged as invalid returns; any other anomalies resembling bottom hazards will require investigation of the waveform in order to determine whether the feature is real and should be retained in the data set. In cases of doubt, such features will be marked for further investigation through re-flight of the area in question. The processed data is then output as an ASCII (\*.xyz) file which can either be input directly into Hypack, or converted to Fugro Binary Format (\*.fbf) for input into Starfix.Proc for review, QC and ultimately subsequent mapping and product generation. This process is outlined in Figure 6.

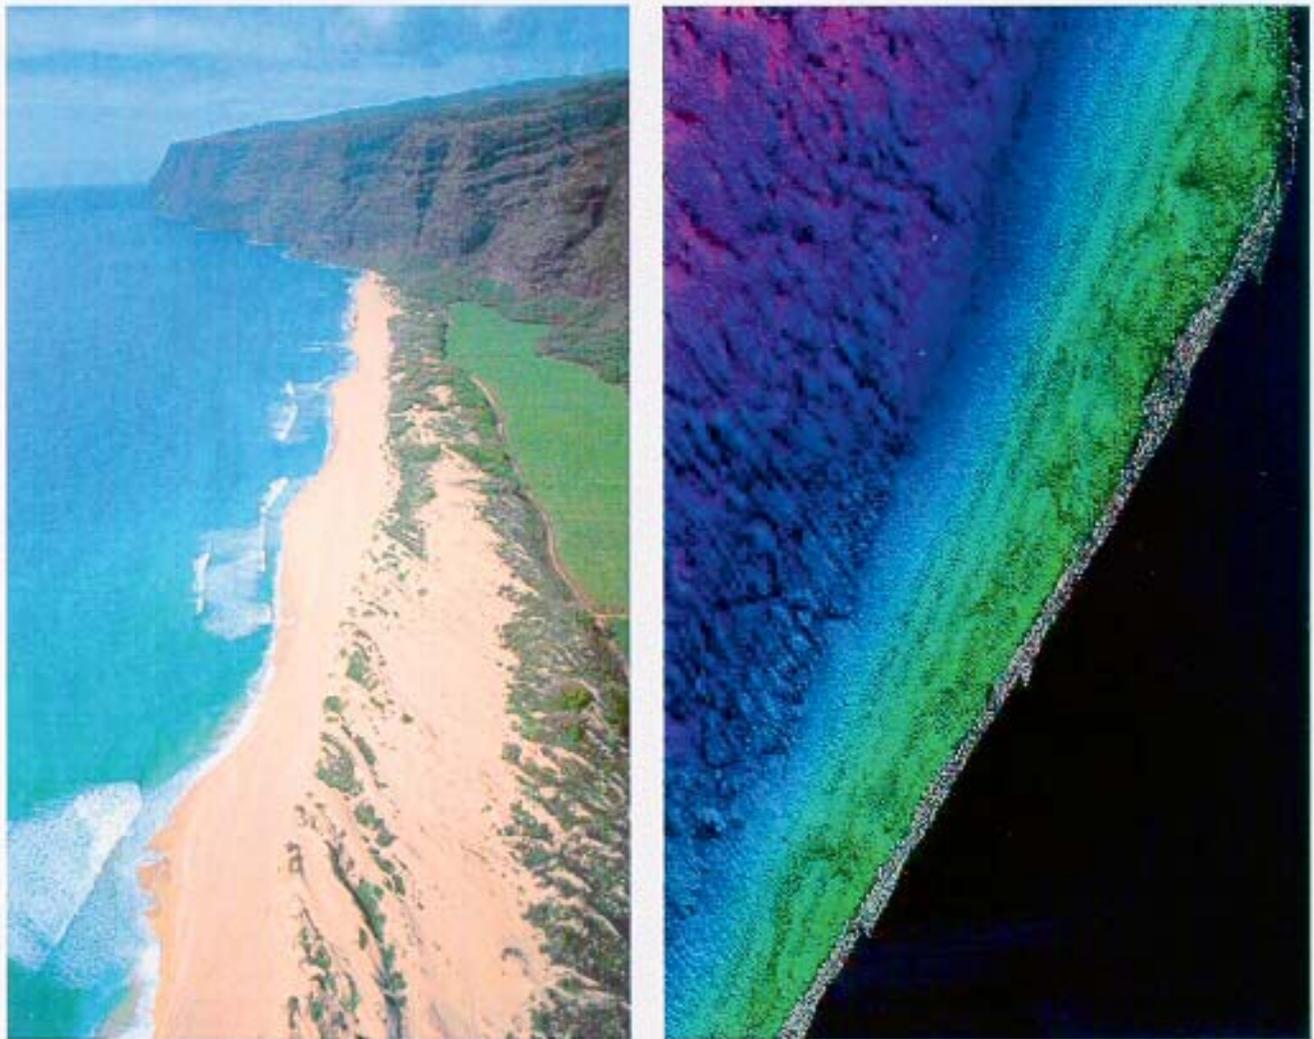
Numerous coastal areas in the Hawaiian Islands are exposed to a Predominately northerly Swell for most of the year. During the winter months the swell becomes quite significant. As a result the beaches and near shore areas are quite dynamic. Oahu north shore beaches undergo re-sculpting during the winter months. The same occurs along the leeward west coast where the beaches and near shore of Makua and Makaha are significantly altered. Along Kauai's northwest Na Pali coast the beaches completely erode in winter, then reappear in the spring. Along Barking Sands, and Majors Bay (Waiokapua Bay) Kauai, north and south of PMRF, beaches and near shore are quite dynamic during any time of high swell and rough surf.

Figure 7. Barking Sands, Kauai. Near shore seabed topography.
