## DESCRIPTIVE REPORT

*Type of Survey* ..... HYDROGRAPHIC .....

*Registry No.* ..... W00105 - W00112 .....

*Sublocality* ..... South Coast of Oahu .....

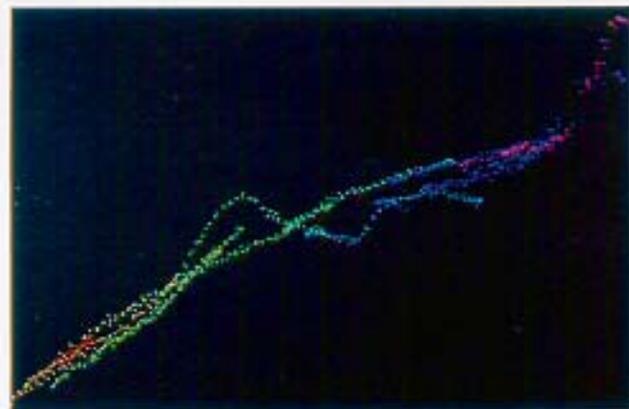
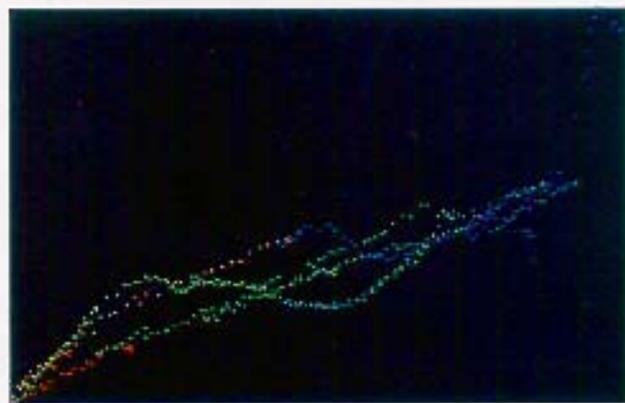
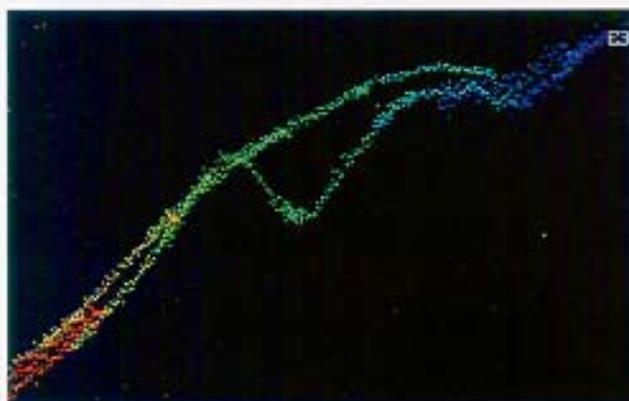
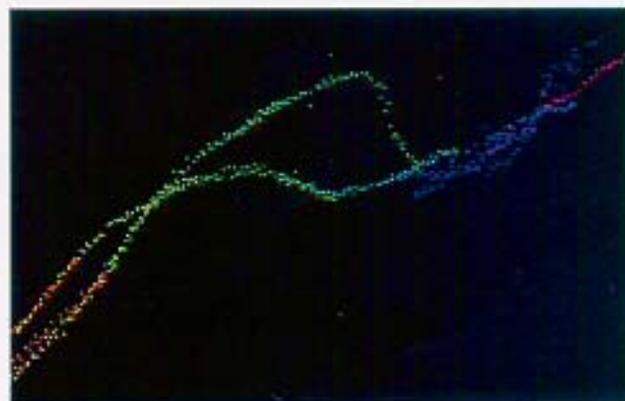
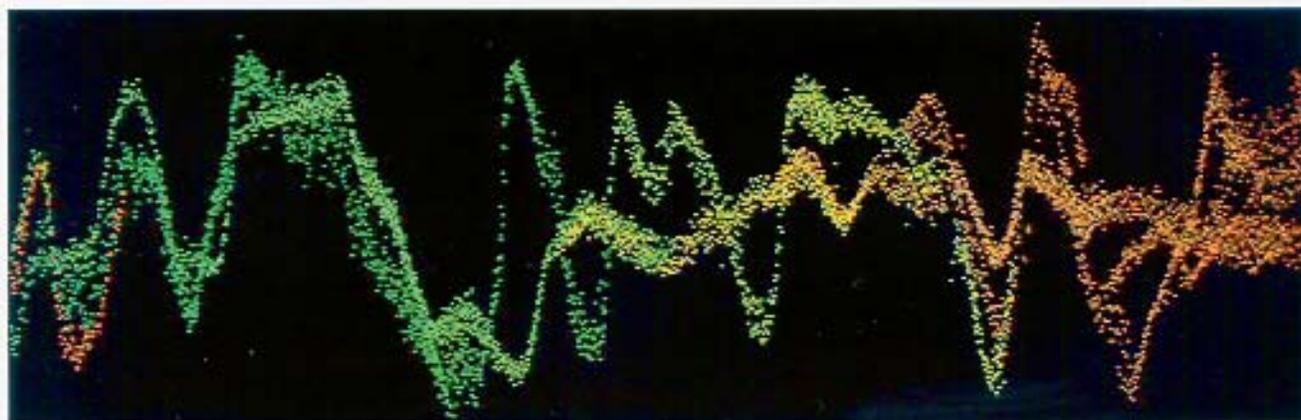
Figure 8. Series of near shore seabed to beach profiles from the area of Barking Sands, Kauai depicted in Figure 7. Insets a-d are west to east cross sections. Inset e is from the north east to southwest along the full length of the near shore.

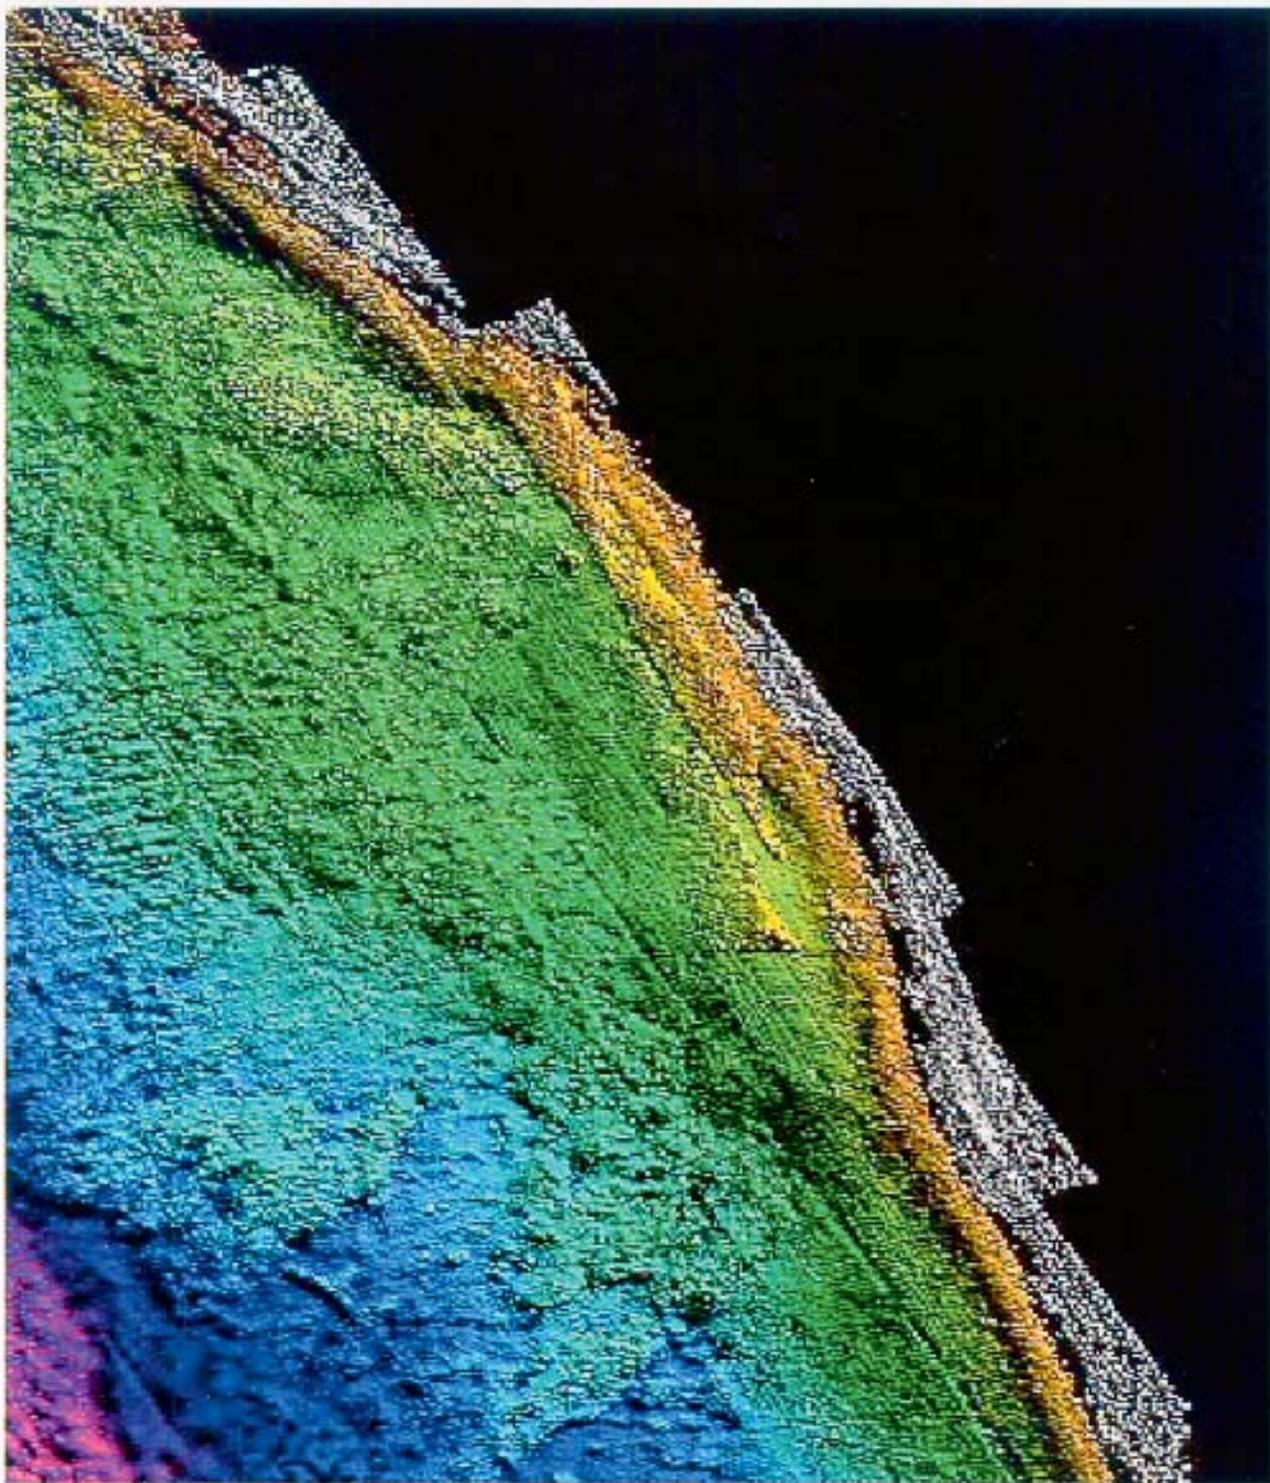
Figure 9. Majors Bay (Waiokapua Bay) Kauai showing near the shore seabed.

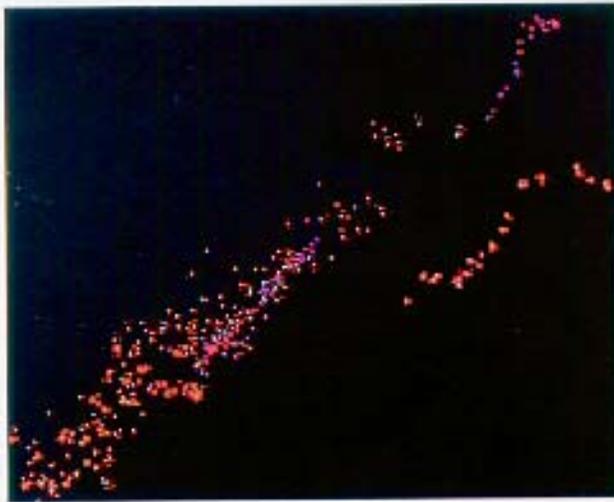
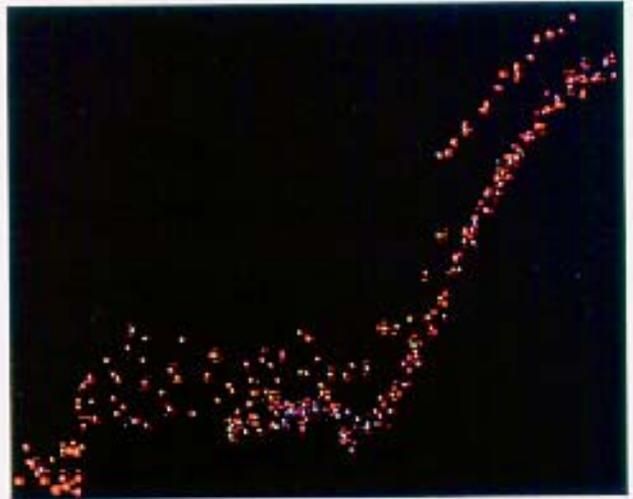
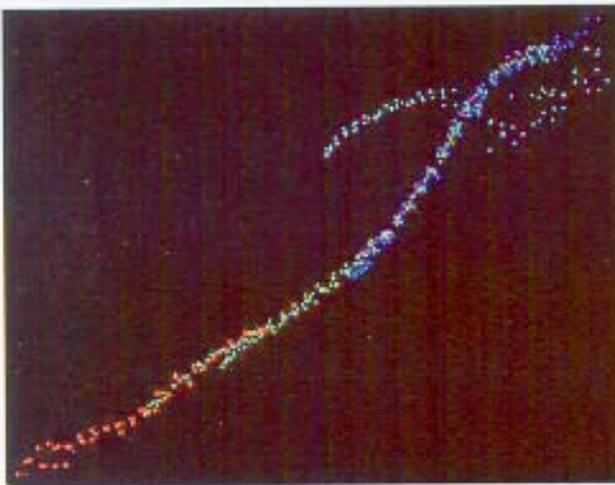
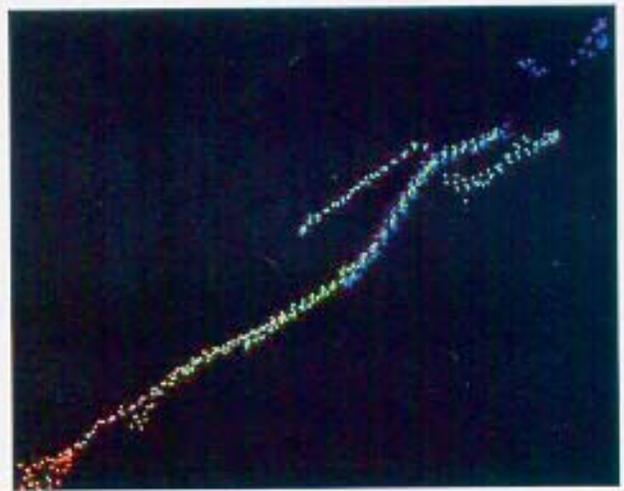
Figure 10. Series of near shore seabed to beach profiles from the area of Majors Bay (Waiokapua Bay) Kauai depicted in Figure 9. Insets a-d are west to east cross sections. Colors represent datasets from different days. These cross sections cover a time span of 6 weeks.

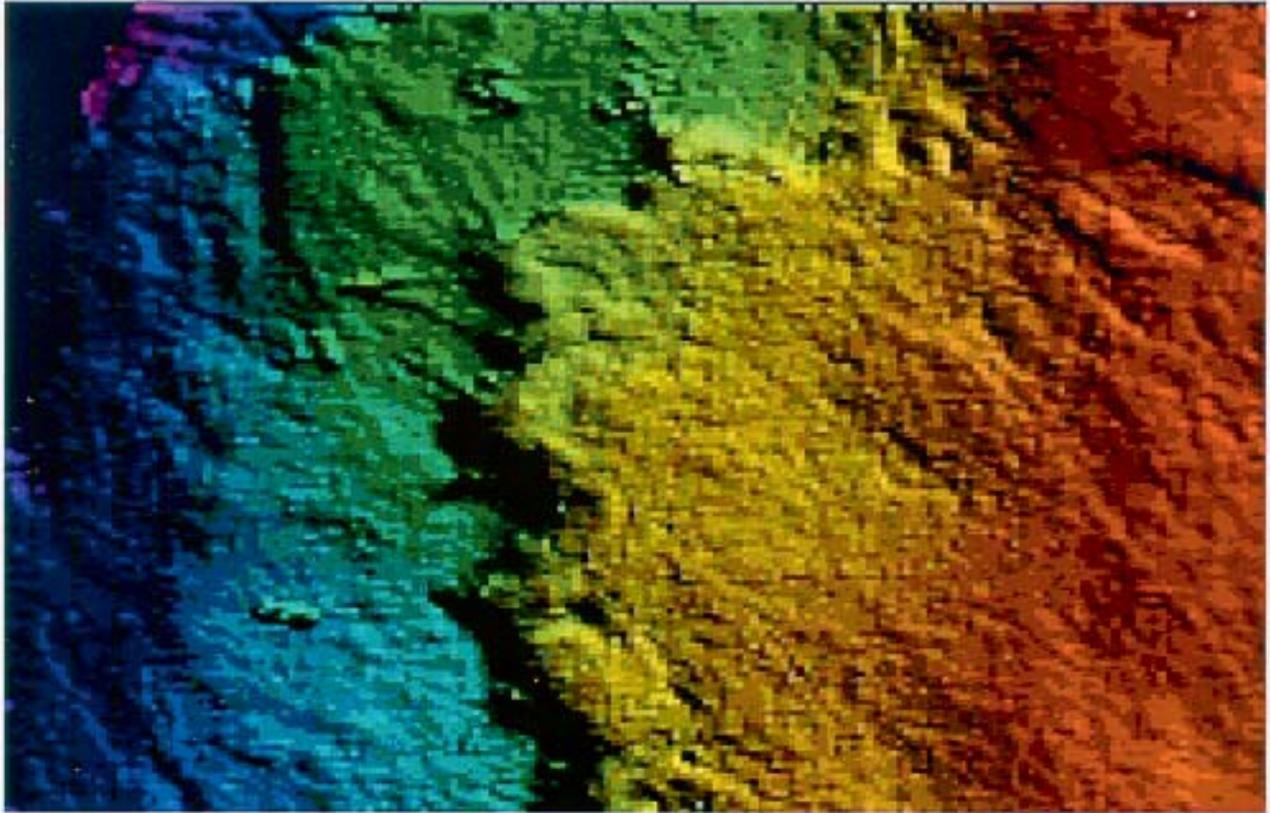
Figure 11. Wrecks and wreckage off Oahu's leeward west coast between Maili Pt. and Waianaae. Charted as fish haven and wrecks. One of these is believed to be the "Mali", a popular dive spot.

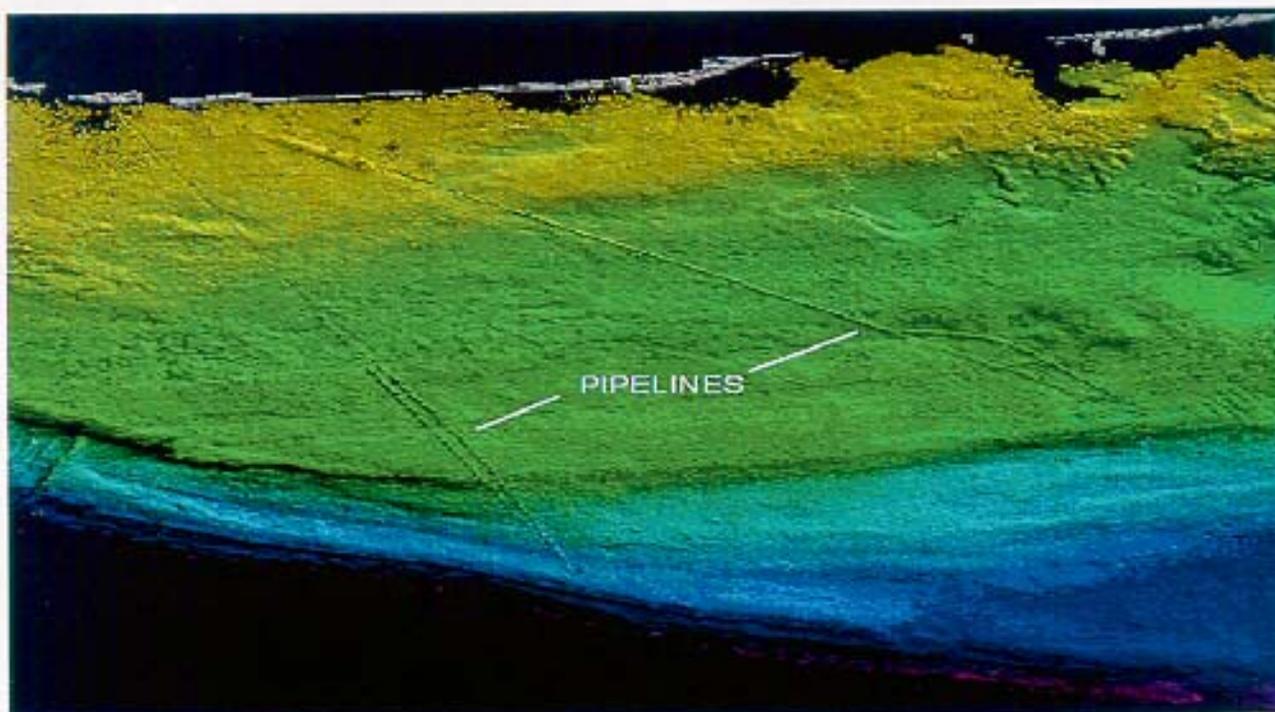
Figure 12. Offshore oil terminal pipelines off Barbers Pt, Oahu.

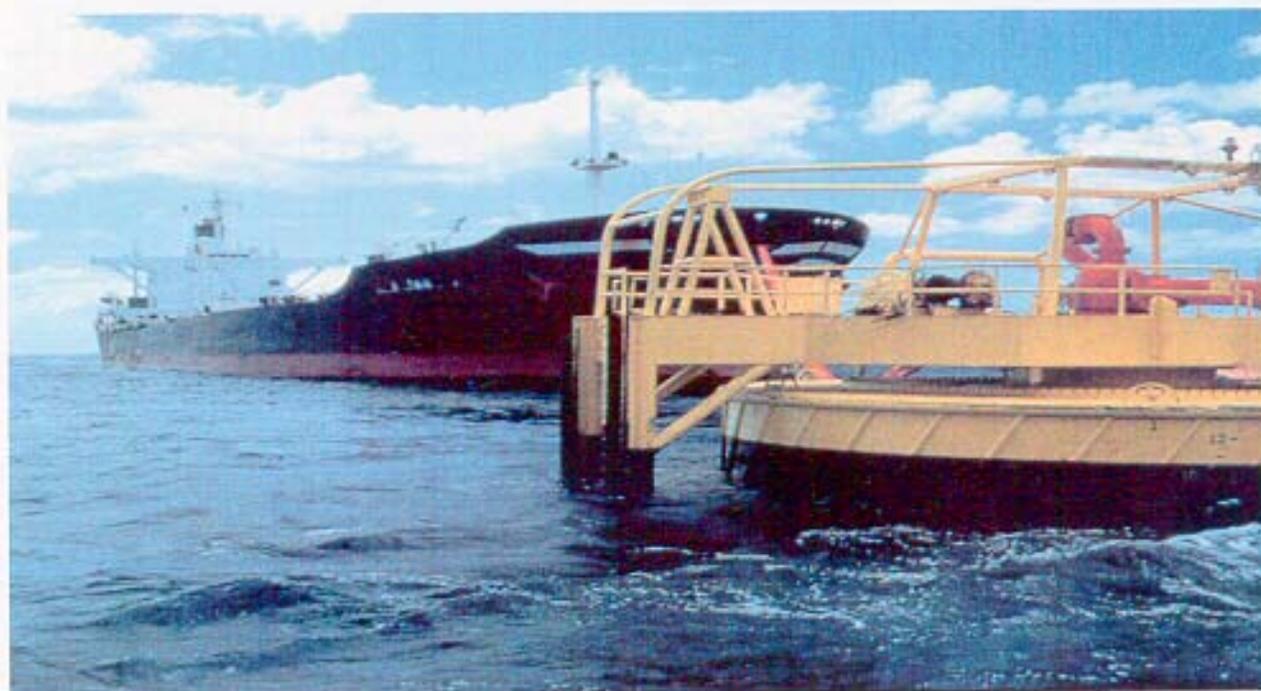
Figure 13. Barbers Pt, Oahu. Offshore oil terminal
