## DESCRIPTIVE REPORT

*Registry No.* ..... W00129 - W00133 .....

*General Locality* ..... South Coast of Molokai .....

*Sublocality* ..... Haleolono Point to Pukoo .....

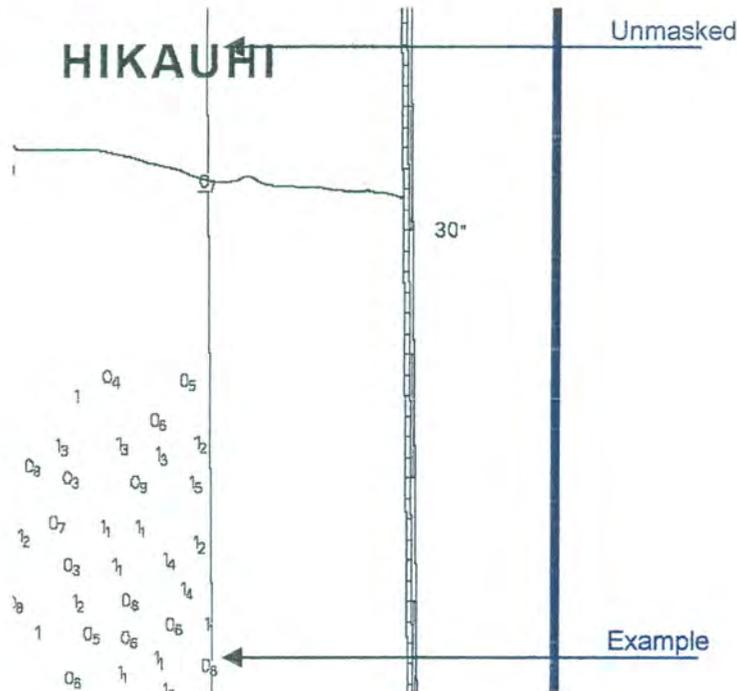
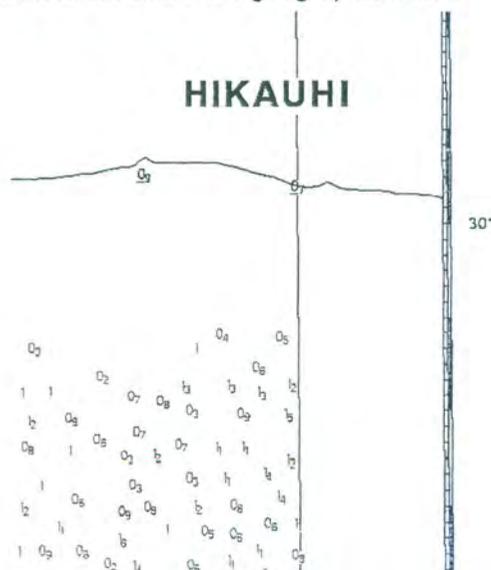
**Sheet 00602:**

- No content errors were observed.
- Only one cosmetic error exists. A small portion of the graticule was not masked over a geographic name.

RESOLUTION: Graticule now masked over geographic name.

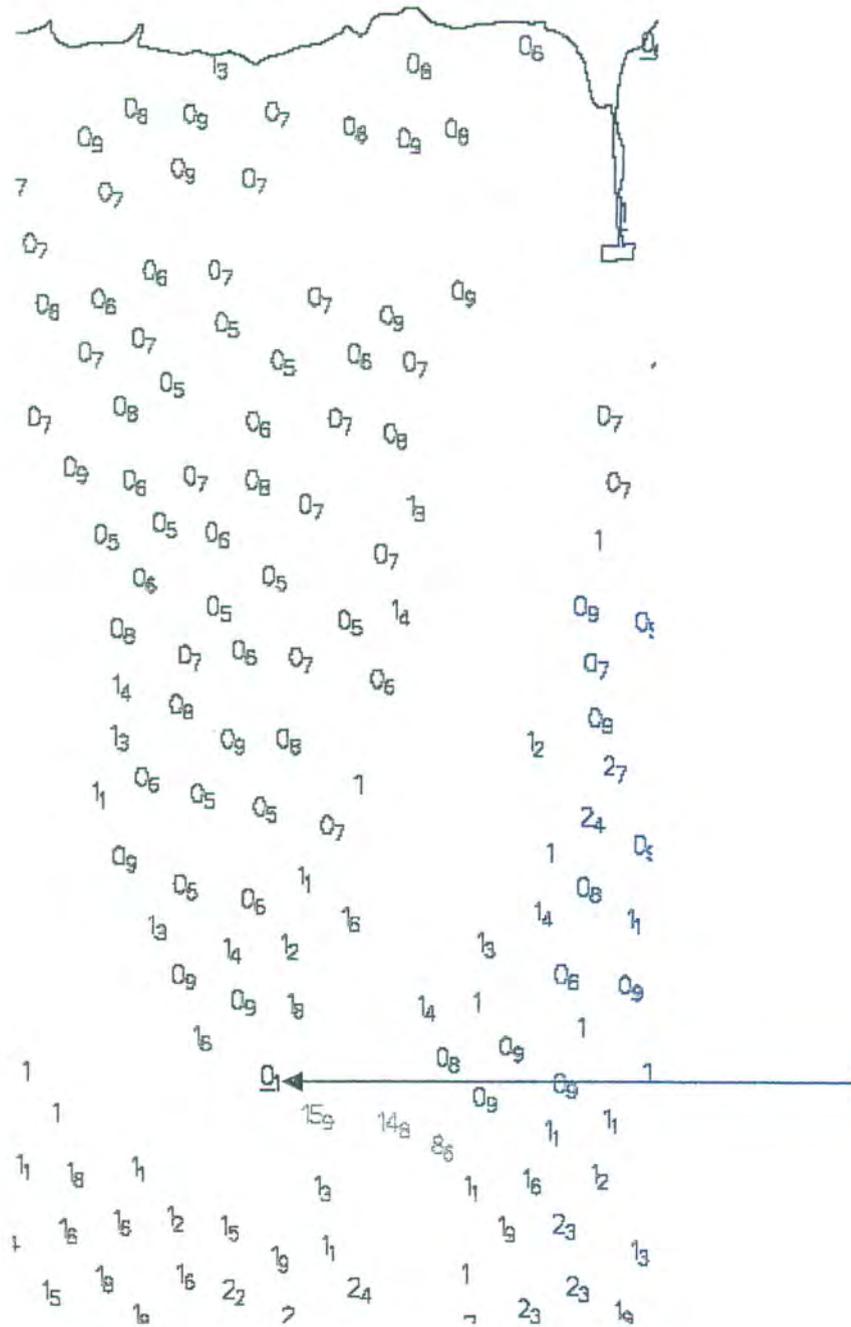
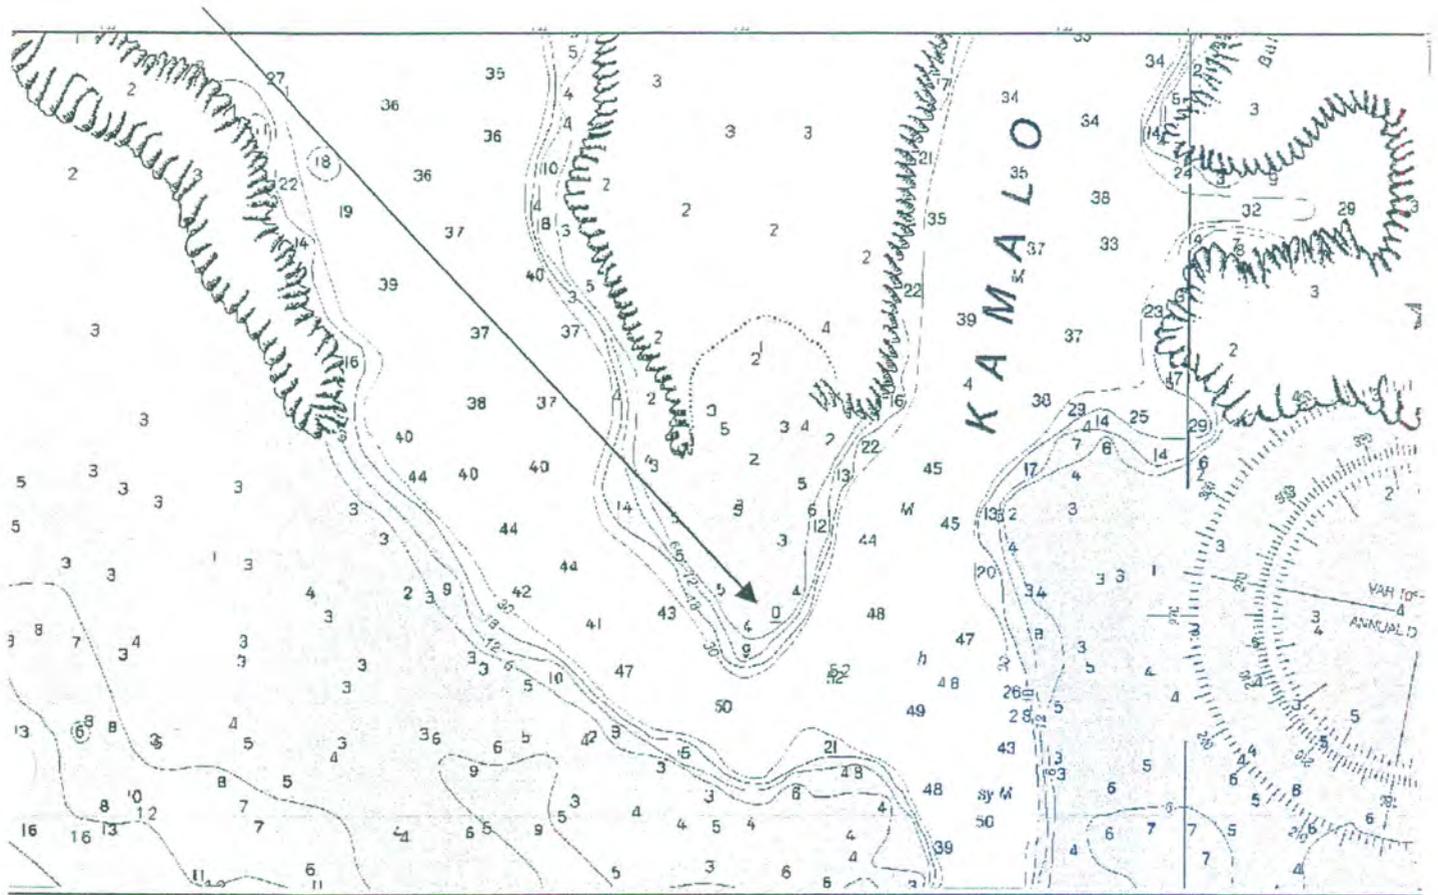
Sheet 00608:

-A drying height of 0.1m can be found at a small distance offshore. This drying height is surrounded by soundings ranging from 0.9m to 15.9m. A recommendation first would be to investigate if this sounding were valid by looking for evidence of existence. If it were a correct sounding and not an editing mistake, the next recommendation would be to add the Chart No. 1 symbol for obstruction, accompanied by the label "Obstr".

RESOLUTION: Review of PFM files and comparison with chart 19353 (12<sup>th</sup> Ed.) could not disprove sounding.

4. Page 4, continuation of “Smooth Sheet Production.” Sheet 00608 is survey W00131. Do not concur with reviewer charting recommendation. The 0.1m sounding shown on the graphic was submitted as a 0 ft Danger to Navigation, Latitude 21° 2’ 14.99”N, Longitude 156° 52’ 40.28”W, see W00129\_133DTON2.doc, Kamalo Harbor, attached to this report. PHB review of the data found the 0.1m sounding to be a flyer. See “PHB Comments for *Quality Review Summary of the Approaches to Molokai, Hawaii*,” attached to this report. It is recommended that the -0.1m (0 ft) sounding not be charted. Chart vicinity according to the Hdrawing.

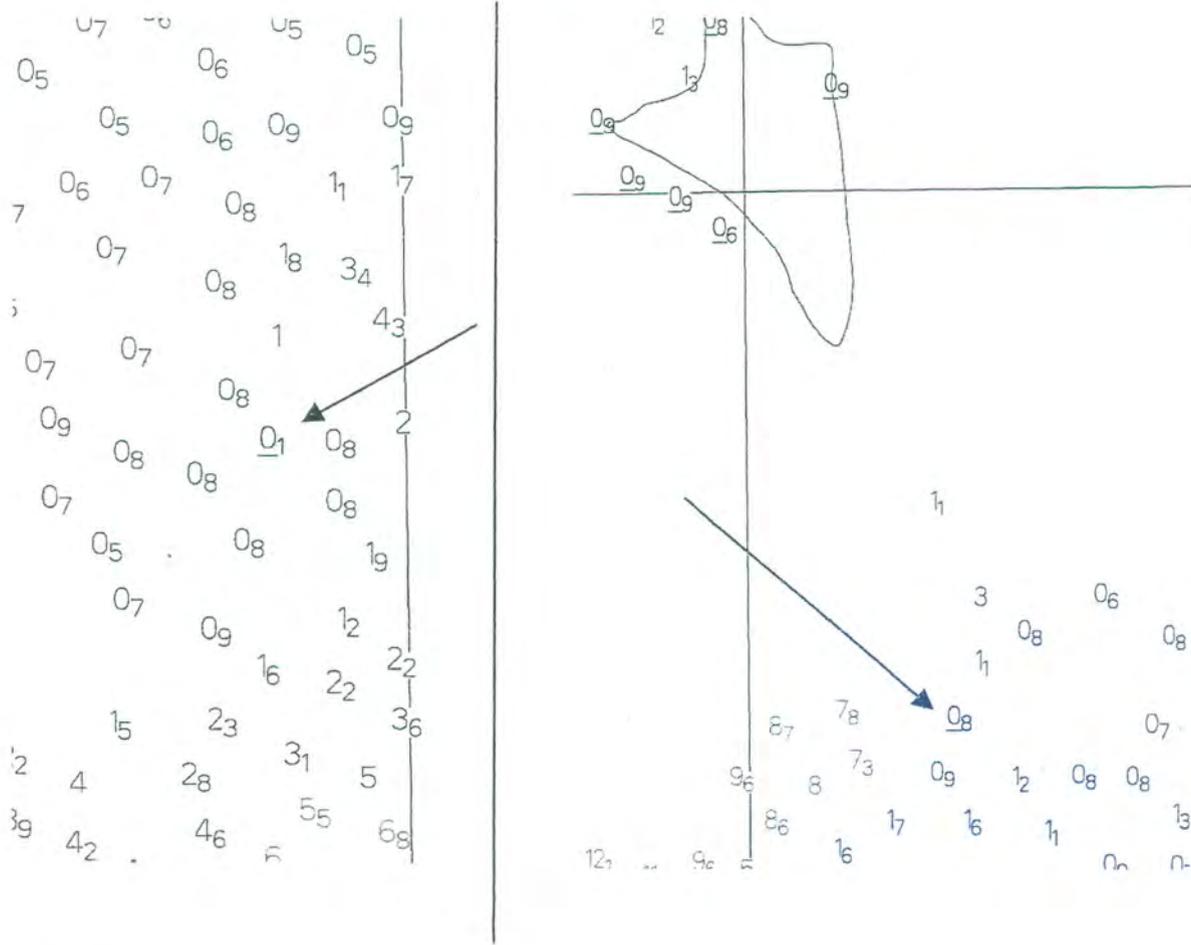
Sheet 00609:

-Two drying heights were observed in areas offshore on opposite ends of the smoothsheet. These may require further symbolization. A recommendation first would be to investigate if this sounding were valid by looking for evidence of existence. If it were a correct sounding and not an editing mistake, the next recommendation would be to add the Chart No. 1 symbol for obstruction, accompanied by the label "Obstr".

5. Page 6, continuation of “Smooth Sheet Production.” Sheet 00609 is survey W00132. Do not concur with reviewer charting recommendation. The -0.1m sounding shown on the left-side graphic and the -0.8m sounding shown on the right-side graphic are discussed in “PHB Comments for *Quality Review Summary of the Approaches to Molokai, Hawaii*,” attached to this report. Both soundings were found by the reviewer to be flyers. It is recommended that the soundings not be charted.

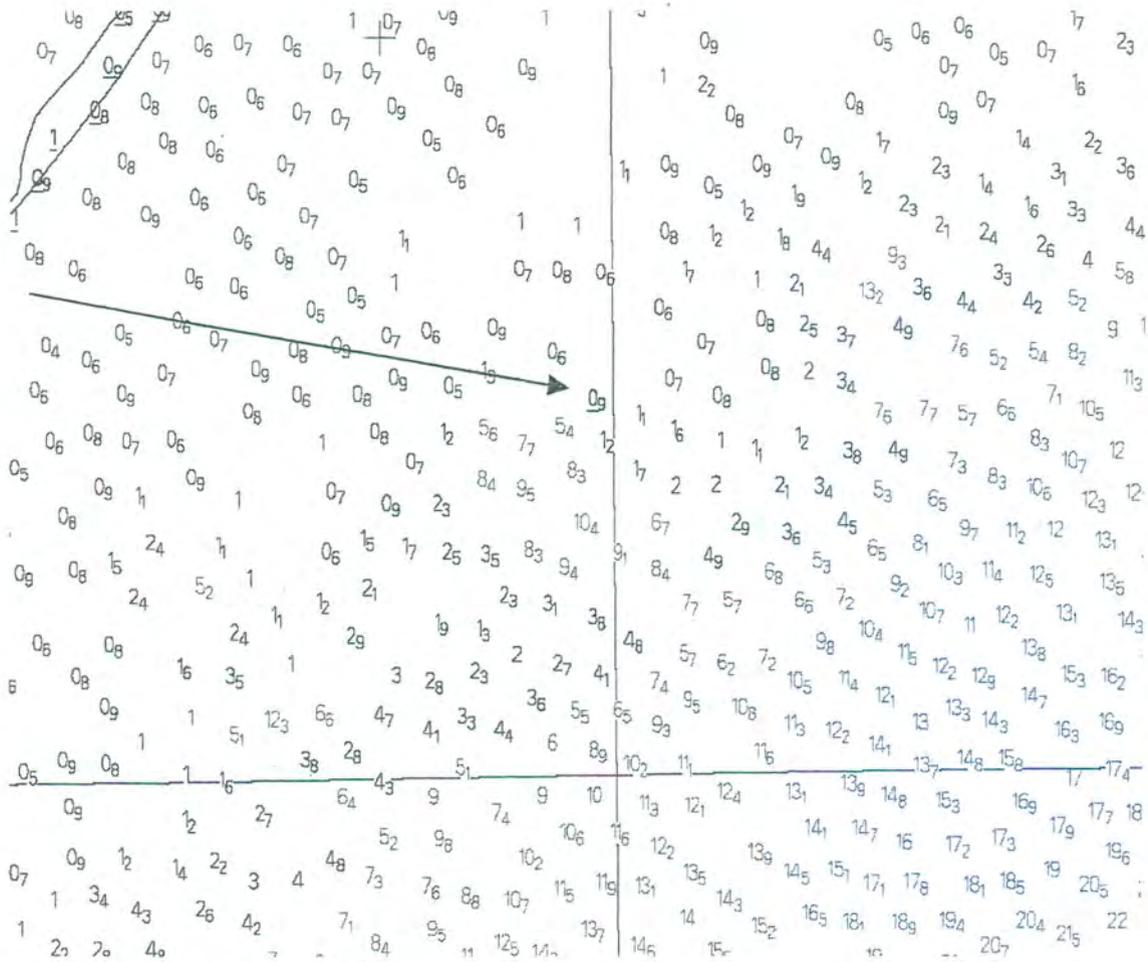
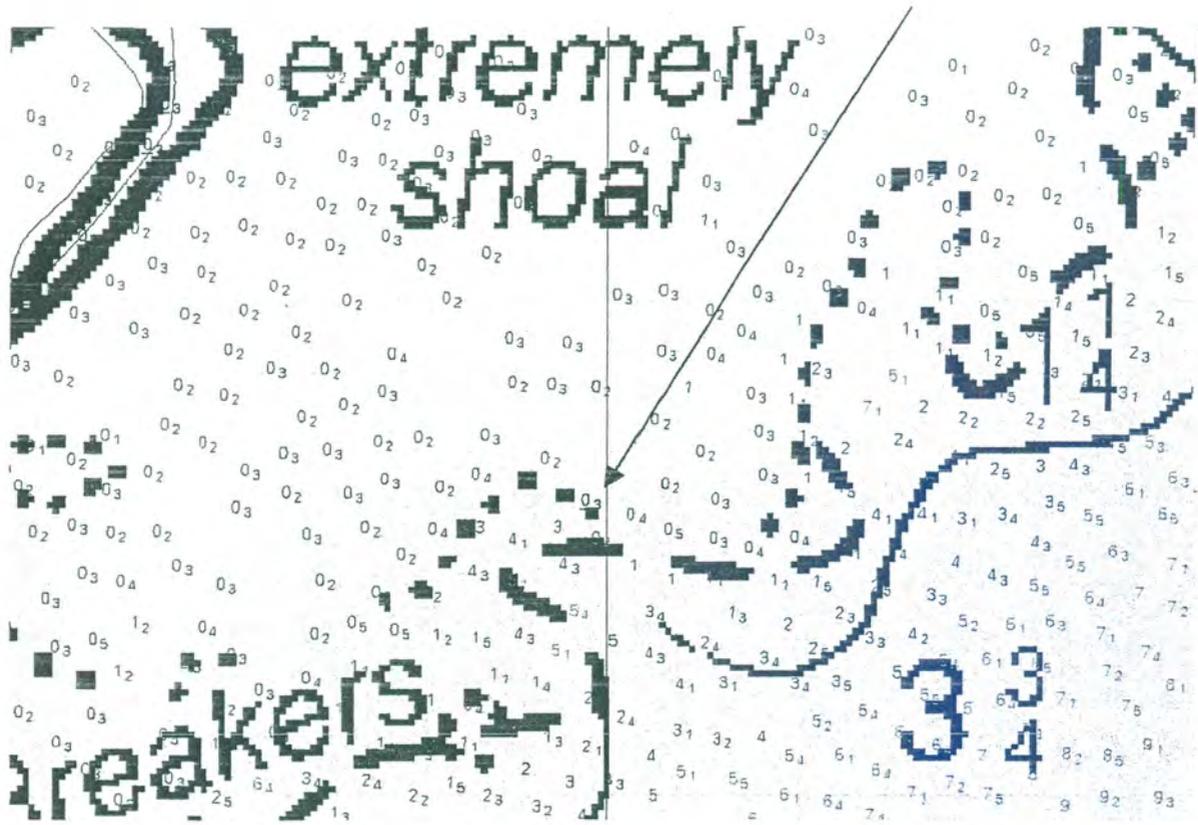
Sheet 00610:

-One drying height was observed in an offshore area. A recommendation first would be to investigate if this sounding were valid by looking for evidence of existence. If it were a correct sounding and not an editing mistake, the next recommendation would be to add the Chart No. 1 symbol for obstruction, accompanied by the label "Obstr".

RESOLUTION: Review of PFM files and comparison with chart 19347 (17<sup>th</sup> Ed.) could not disprove sounding.

7. Page 8, continuation of “Smooth Sheet Production.” Sheet 00610 is survey W00133. Do not concur with reviewer charting recommendation. The -0.9m sounding shown on the graphic is discussed in “PHB Comments for *Quality Review Summary of the Approaches to Molokai, Hawaii*,” attached to this report. The sounding was found by the reviewer to be a flyer. It is recommended that the sounding not be charted.

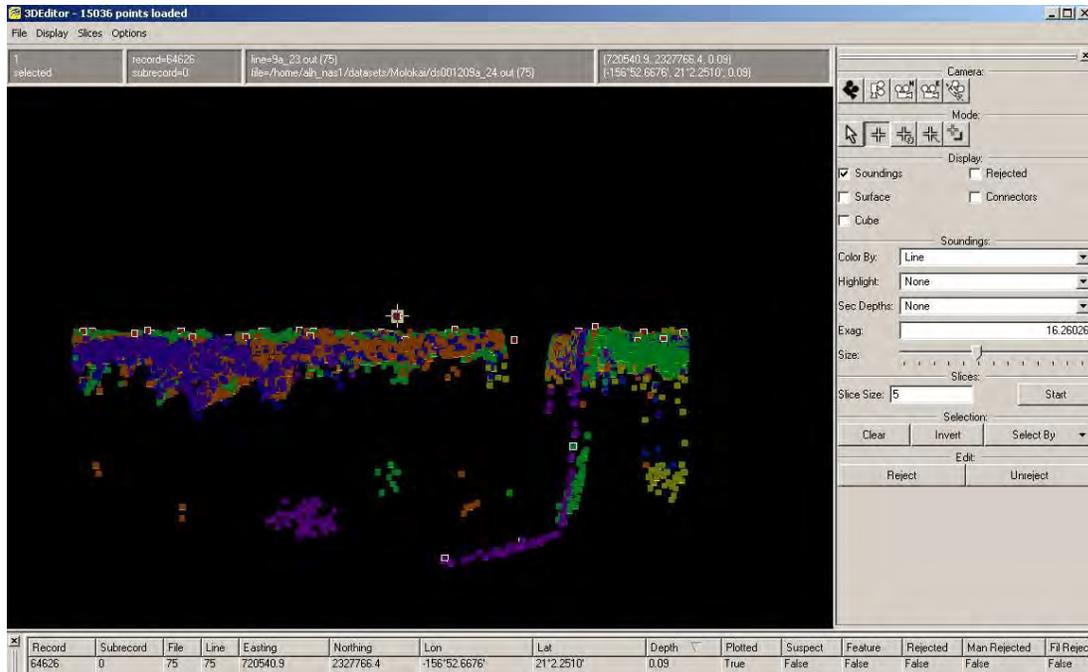
W00131 (00608)

-0.1 meter sounding at 21 02.2510N, -156 52.6676W: Sounding is a single hit from a line not represented in the surrounding data from 4 other lines within 2 meters of the sounding. The surrounding data from the other lines show depths of approximately 1.5m. Based on the review of this data the reviewer does not recommend charting this negative sounding.<sup>1</sup>

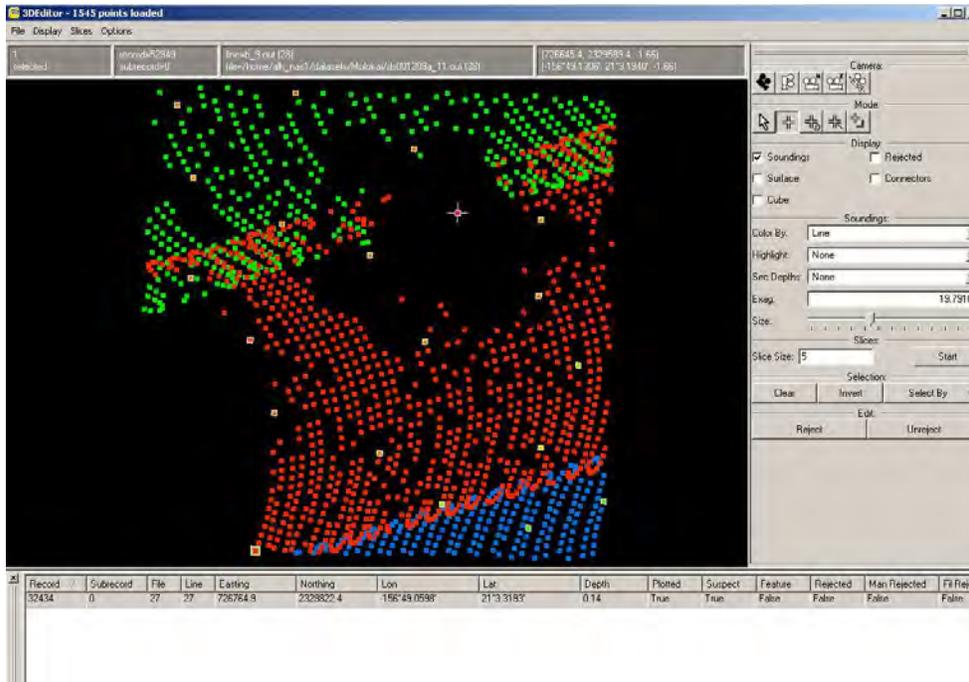
-0.1 meter sounding at 21 03.3193N, -156 49.0598W: Sounding is alone in an approximate 50m-radius area of no coverage. Other plotted soundings in the area have better coverage and show depths of 1 to 1.5 meters. There are rejected sounding from the same line and two others in the surrounding data but no rejected sounding in the area of no coverage. As this sounding has no supporting data in the vicinity, the reviewer does not recommend charting a feature based on this sounding. 3

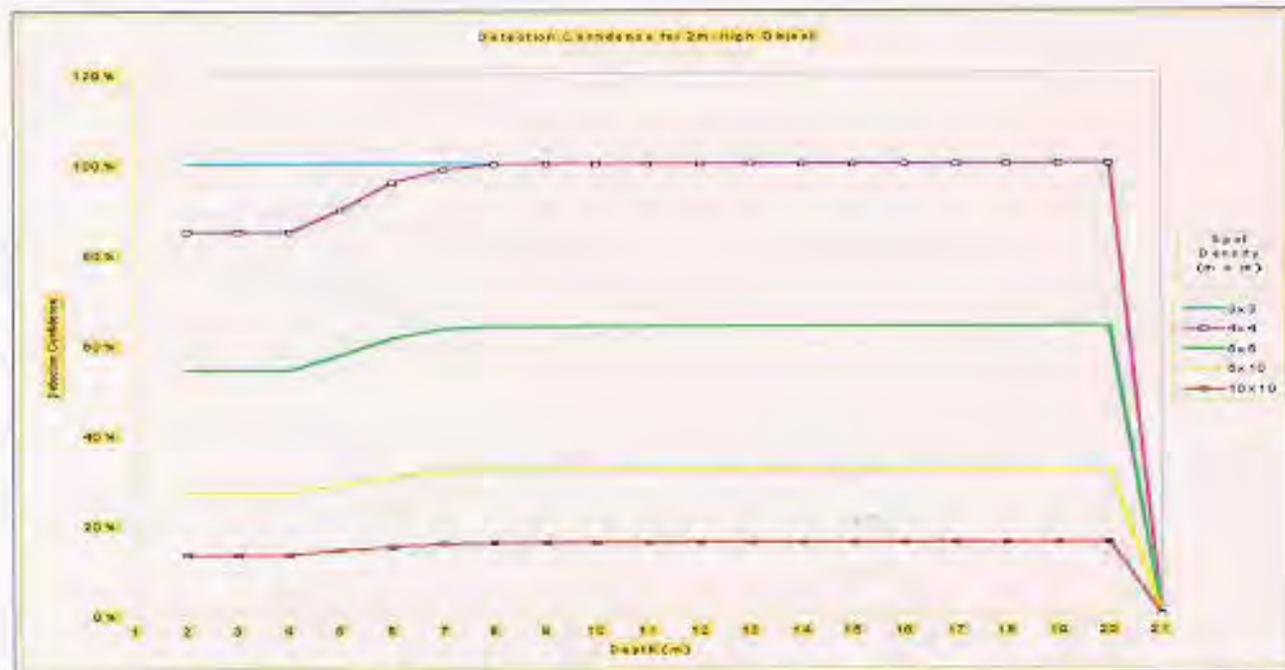
Figure 1. Target detection confidence

1.4.5 Subsequent testing of the follow-on CHARTS system, utilizing the same operating principles and algorithms and a lower power laser at 4x4 spot spacing, targets of 2 meters were detected 100% of the time in depths of 5 to 30 meters. Based on these actual tests the LIDAR system meets IHO Order 1 target detection requirements. Multiple coverage provides a degree of redundancy for this capability.

Theoretical detection confidence vs. depth for a 2m target at different laser spot densities.

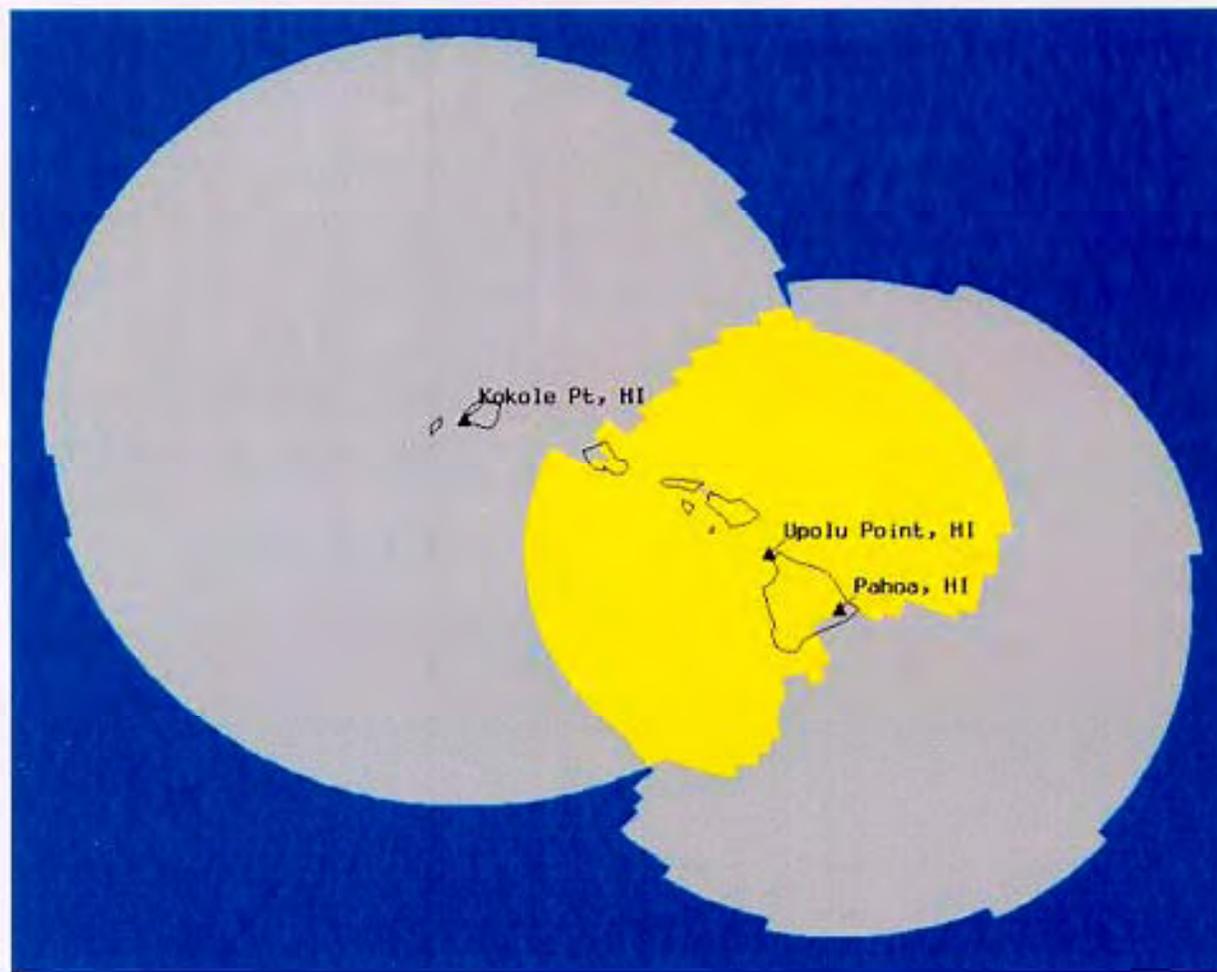
USCG DGPS beacon coverage for Hawaii.

Kokole Point was used for Kauai, and Oahu. Upolu Point was used for Molokai, Maui, Lanai and all but the south shore of Hawaii. Pahoa was used for the south shore of Hawaii.

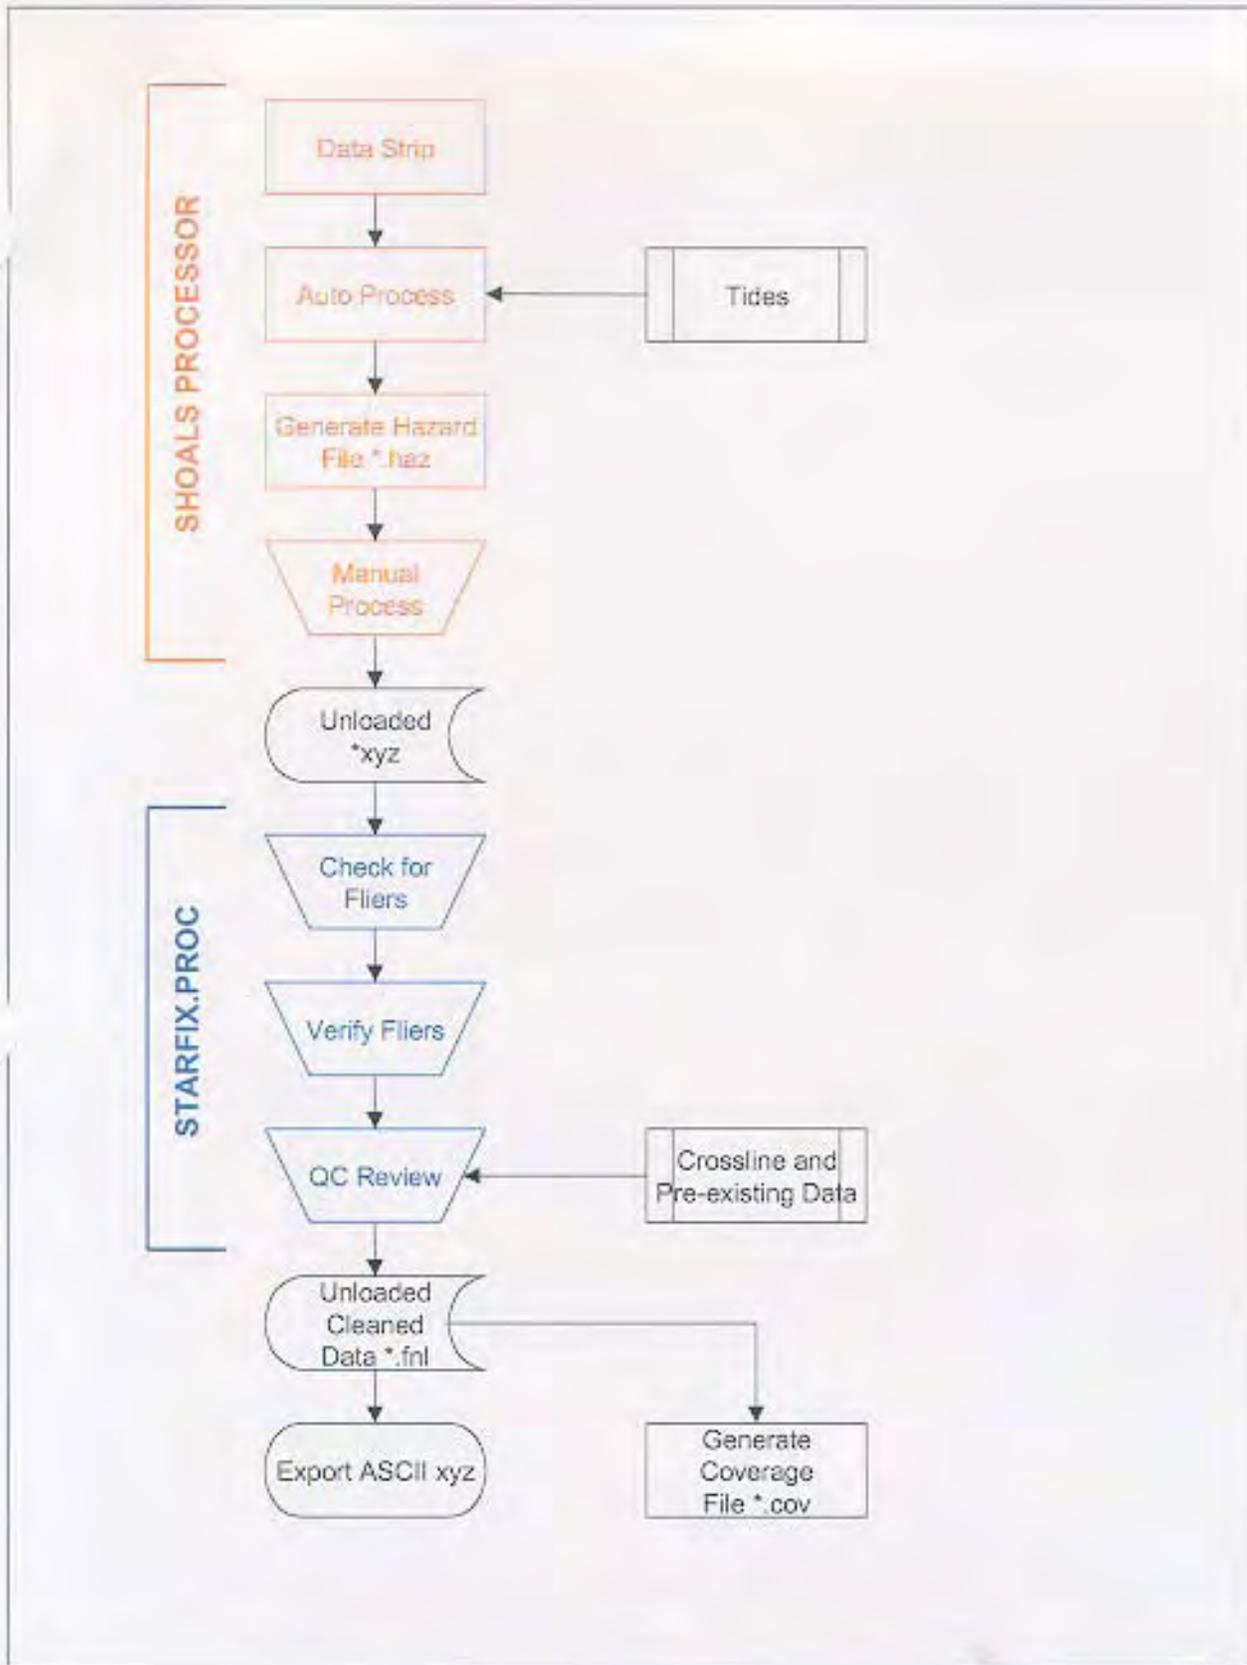
Figure 6: Data Processing Flow

3.5.5 All data is then manually edited for obvious anomalies. Where such anomalies are clearly due to fish, or similar causes, they will be flagged as invalid returns; any other anomalies resembling bottom hazards will require investigation of the waveform in order to determine whether the feature is real and should be retained in the data set. In cases of doubt, such features will be marked for further investigation through re-flight of the area in question. The processed data is then output as an ASCII (\*.xyz) file which can either be input directly into Hypack, or converted to Fugro Binary Format (\*.fbf) for input into Starfix.Proc for review, QC and ultimately subsequent mapping and product generation. This process is outlined in Figure 6.

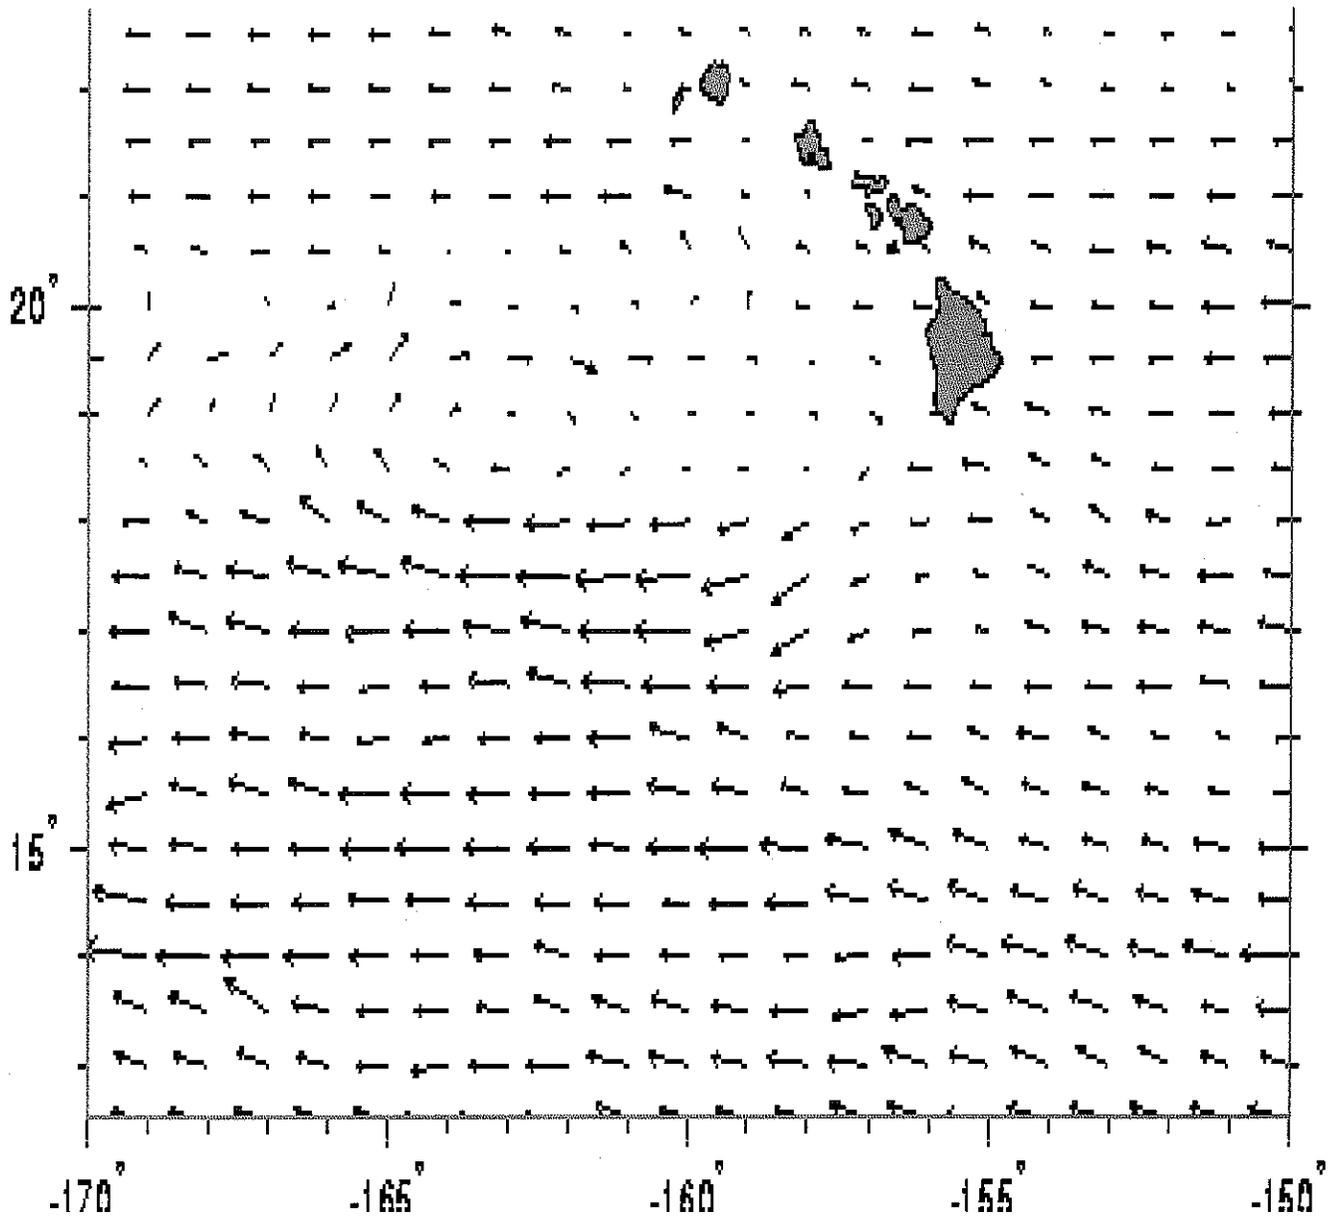
South of Hawaii, the surface North Equatorial Current (NEC) reaches an average westward speed 0.35 knot at 13 N, and gradually decreases towards the islands. Between 18 N and 22 N, the currents are strongly influenced by the islands. The NEC forks at Hawaii; the northern branch becomes the North Hawaiian Ridge Current (NHRC), and intensifies near the islands with a typical speed of 0.5 knots. West of the islands, two elongated circulations appear. A clockwise circulation is centered at 19 N, merging to the south with the southern branch of the NEC. A counter-clockwise circulation is centered at 20-30 N. Between them is the narrow Hawaiian Lee Counter

Figure 2. Large-scale ocean circulation around the Hawaiian Islands.

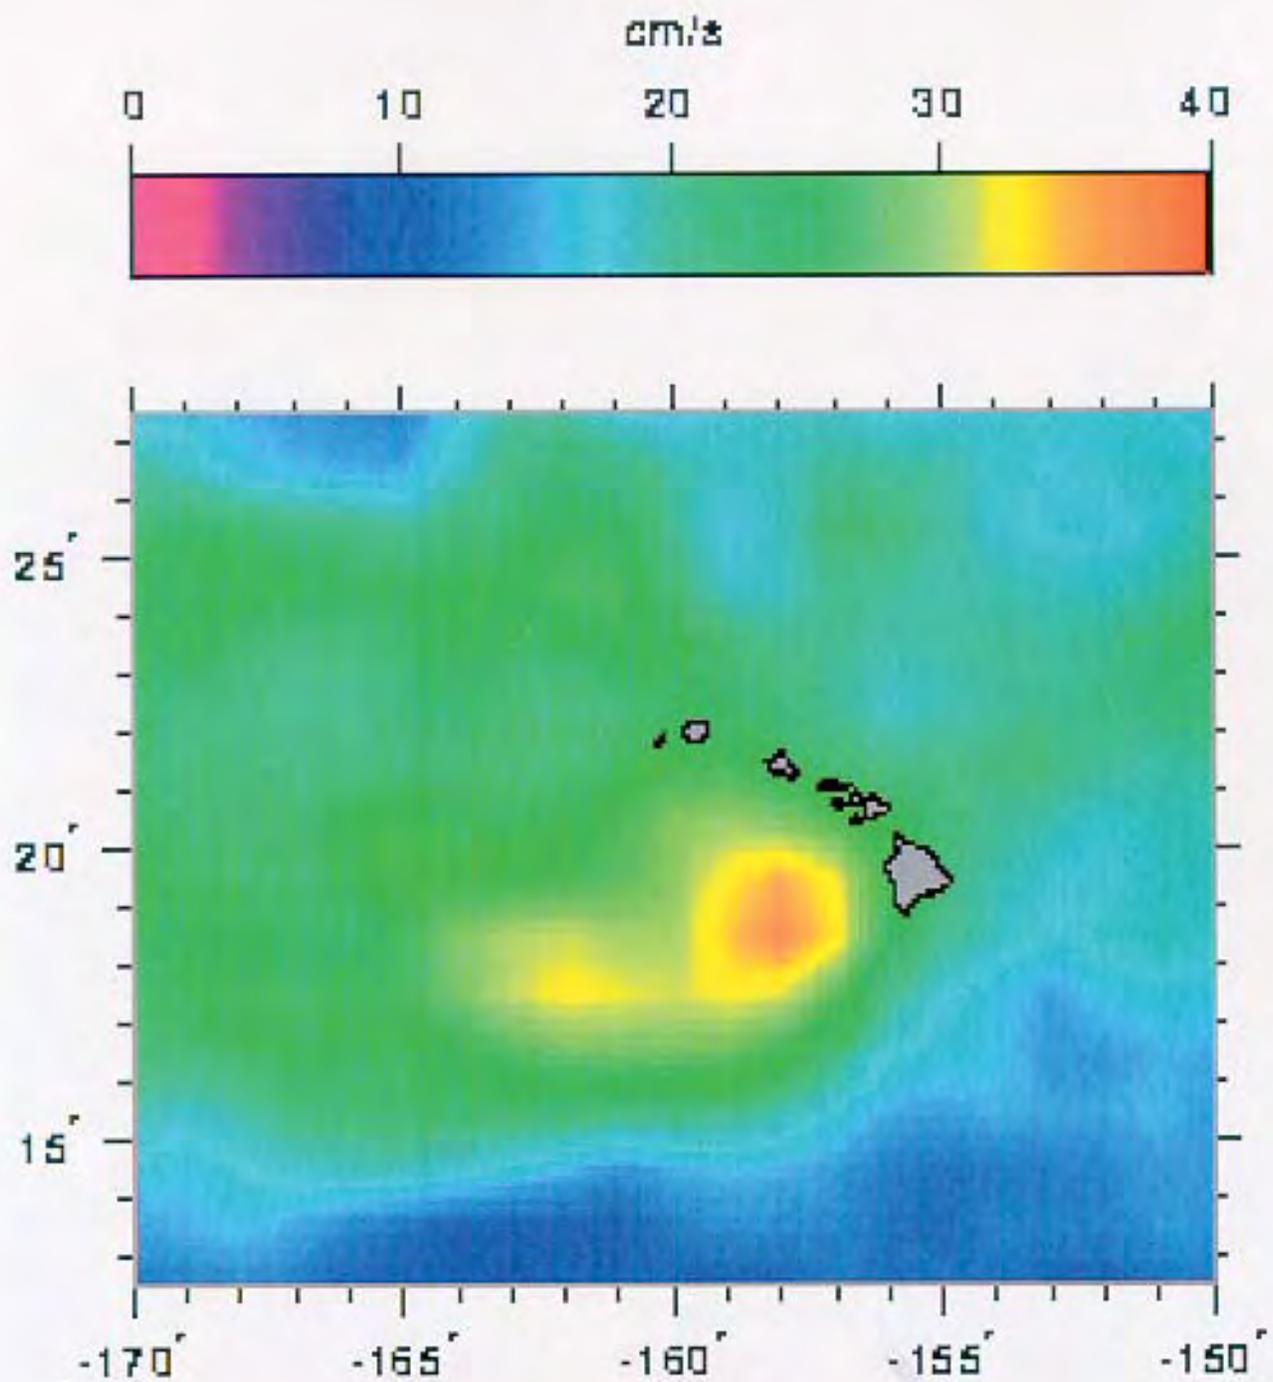
Figure 3. Large-scale ocean circulation variability around Hawaii indicates numerous eddies and swirls which obliterate slower average circulation.

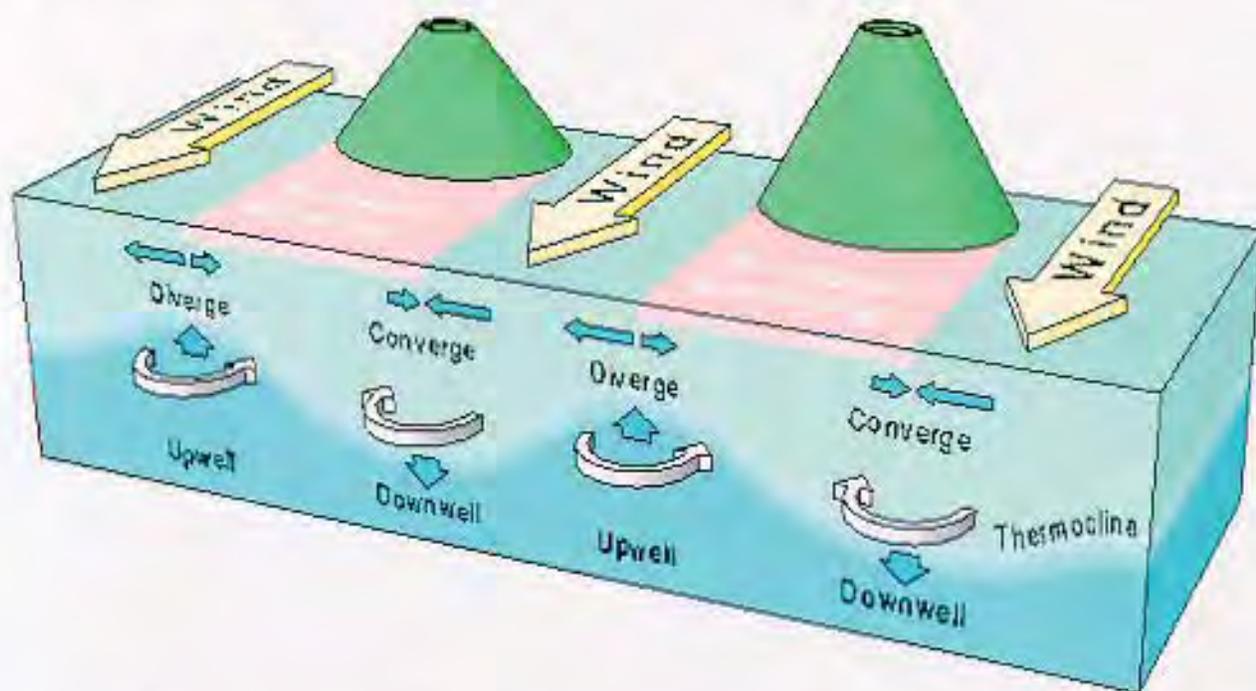
Figure 4. Regional current formation due to the modifying effect of land masses on large-scale circulation.

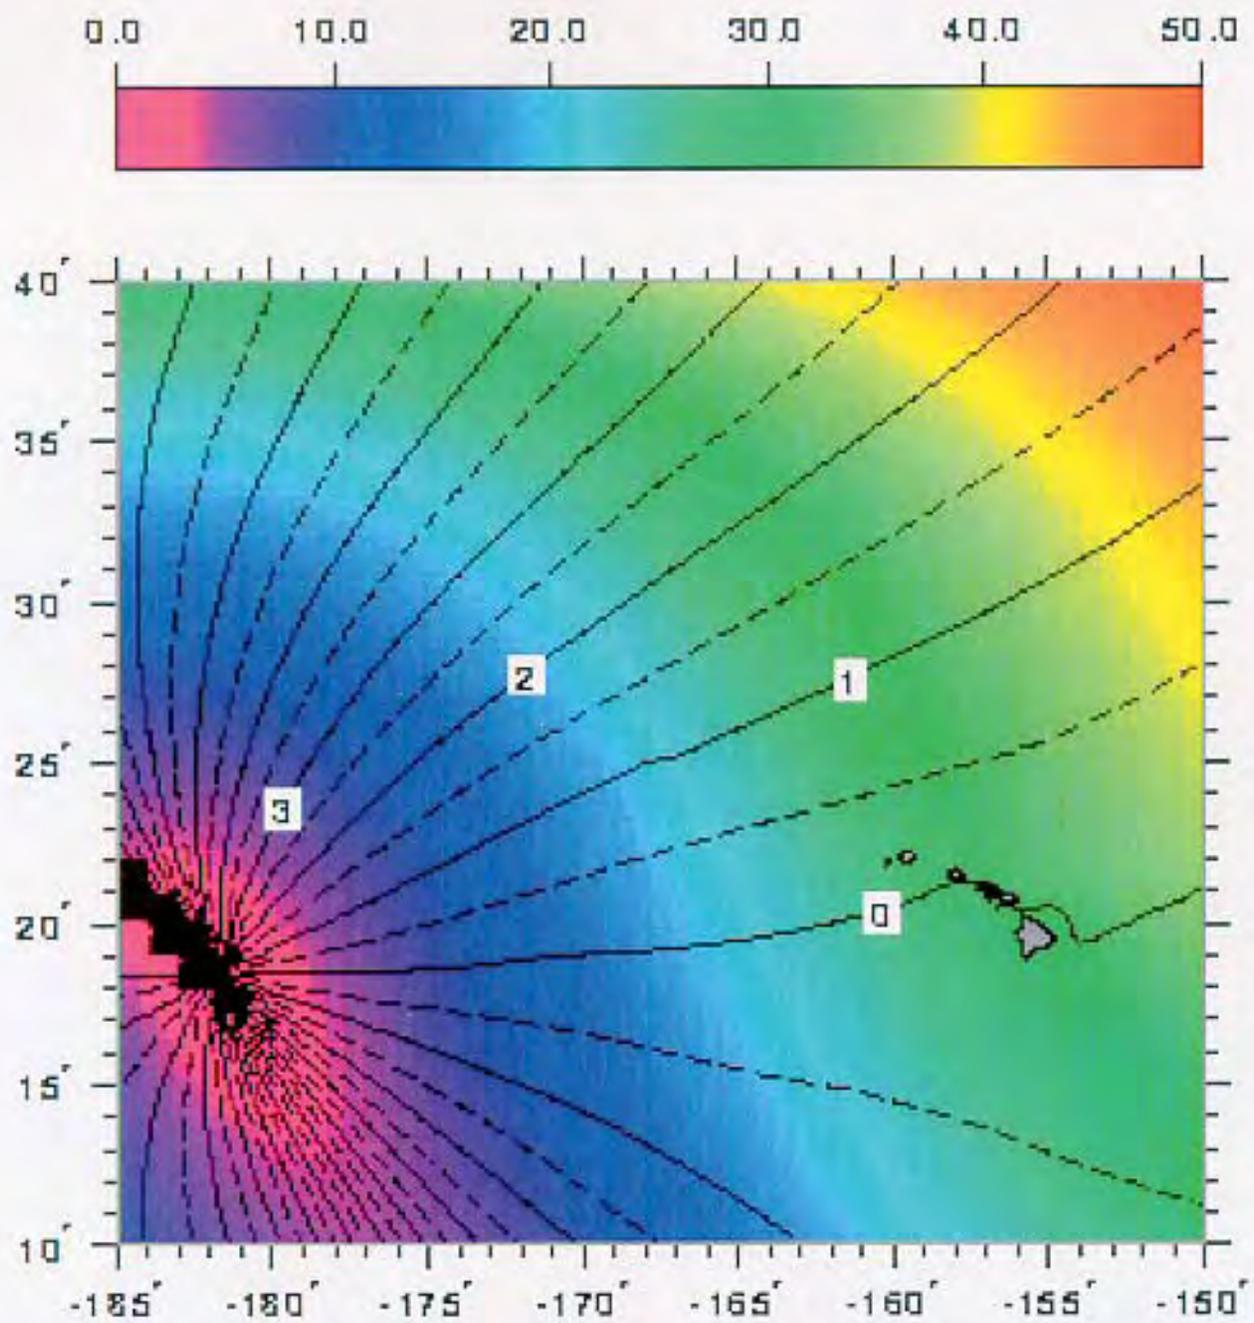
Figure 5. Response of the North Pacific to the longest duration tidal component (23h 56m) and the effect of the Hawaiian land mass.
