## DESCRIPTIVE REPORT

*Registry No.* ..... W00129 - W00133 .....

*General Locality* ..... South Coast of Molokai .....

*Sublocality* ..... Haleolono Point to Pukoo .....

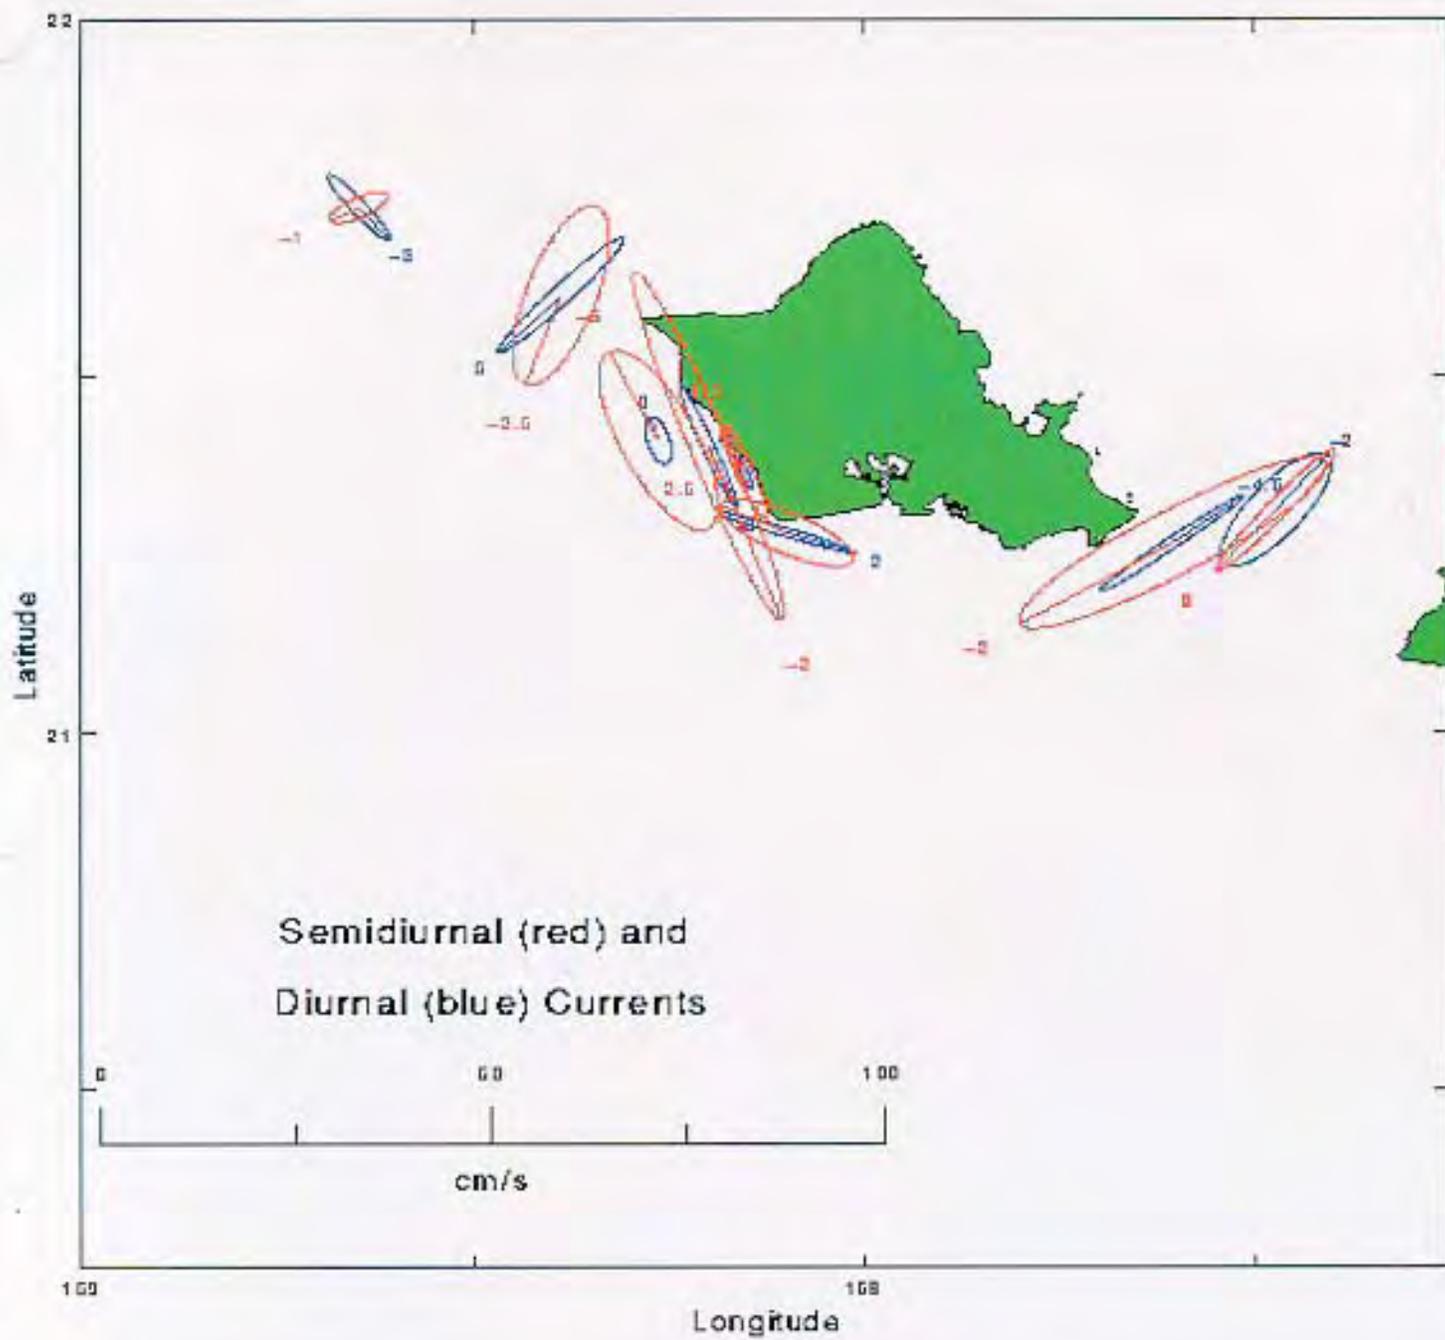
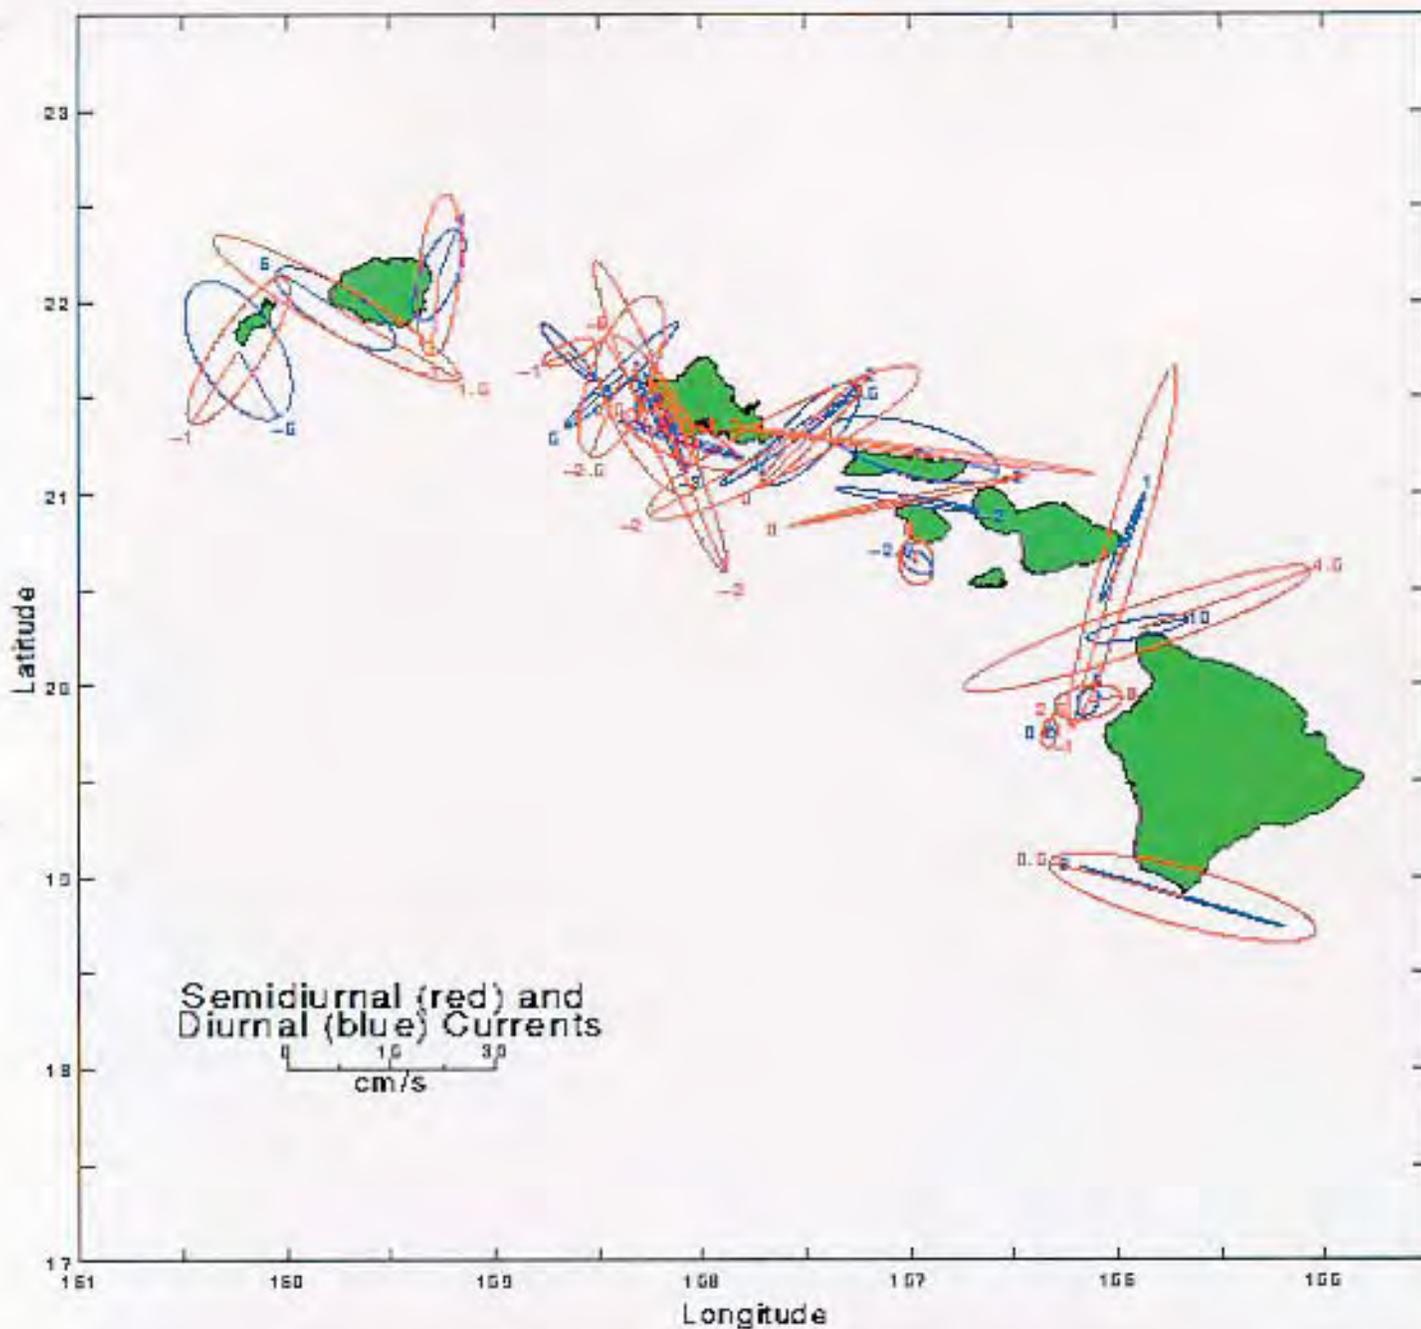
Figure 6a. Representative tidal current flow around the Hawaiian Islands. Diurnal and semi-diurnal tidal flows tend to be aligned with the shoreline. Strong eddies are often found around points and headlands.

Figure 6b. Representative tidal current flow around the Hawaiian Islands. Diurnal and semi-diurnal tidal flows tend to be aligned with the shoreline. Strong eddies are often found around points and headlands.

Due to high variability of tidal currents around the islands, however, this statistical representation may not correspond to the flow at a particular time -- tidal currents cannot be predicted as precisely as sea level. Strong swirls often result from tidal currents flowing around points and headlands, and present hazards to divers.

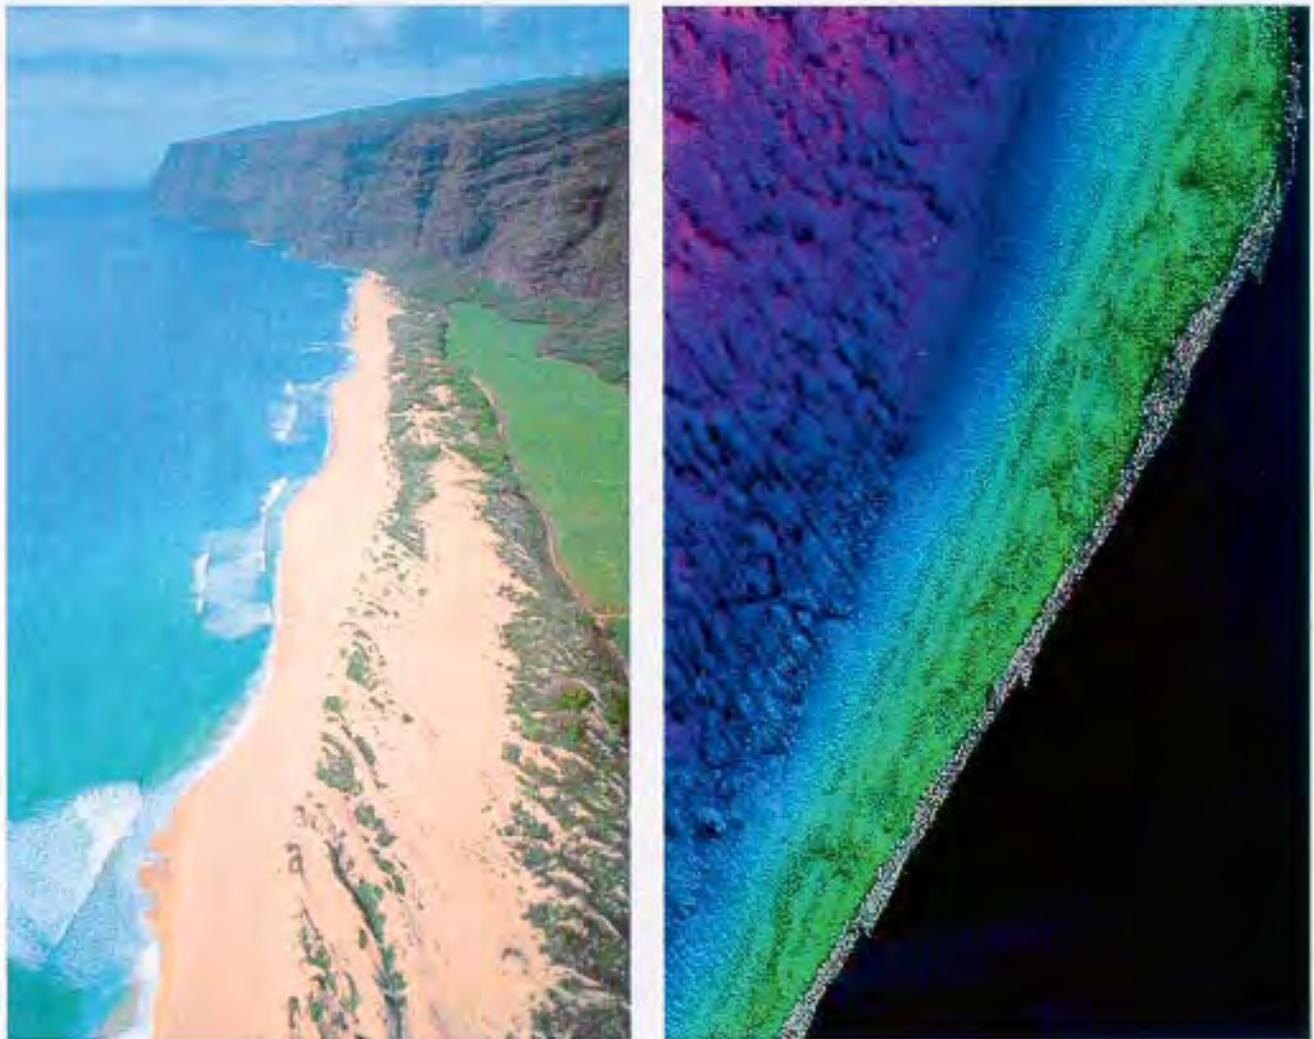
Figure 7. Barking Sands, Kauai. Near shore seabed topography.

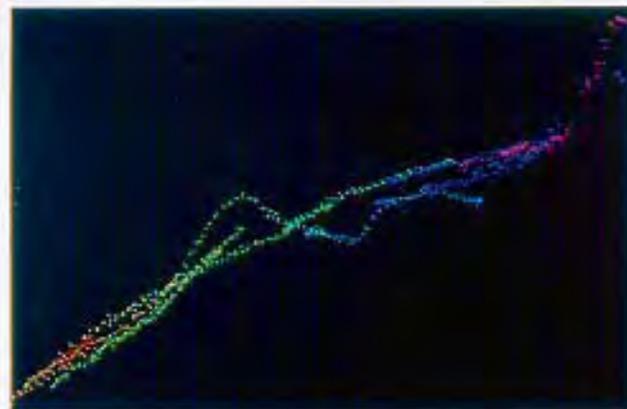
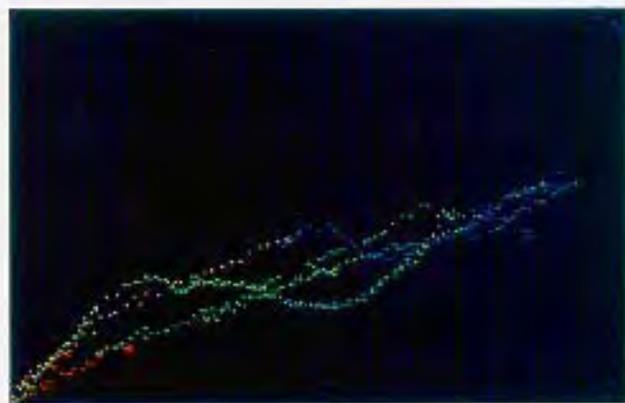
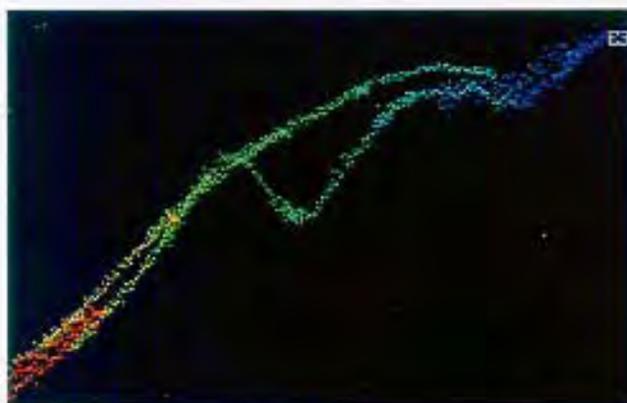
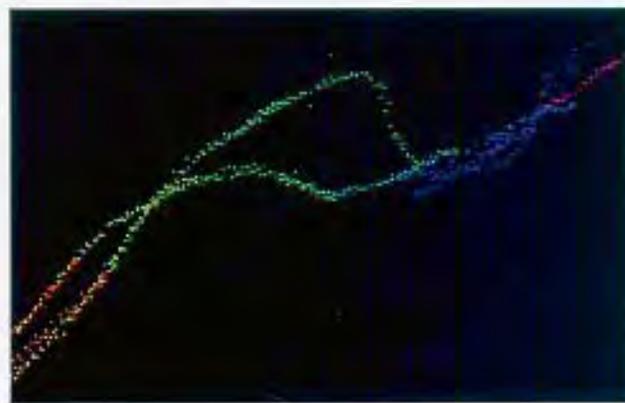
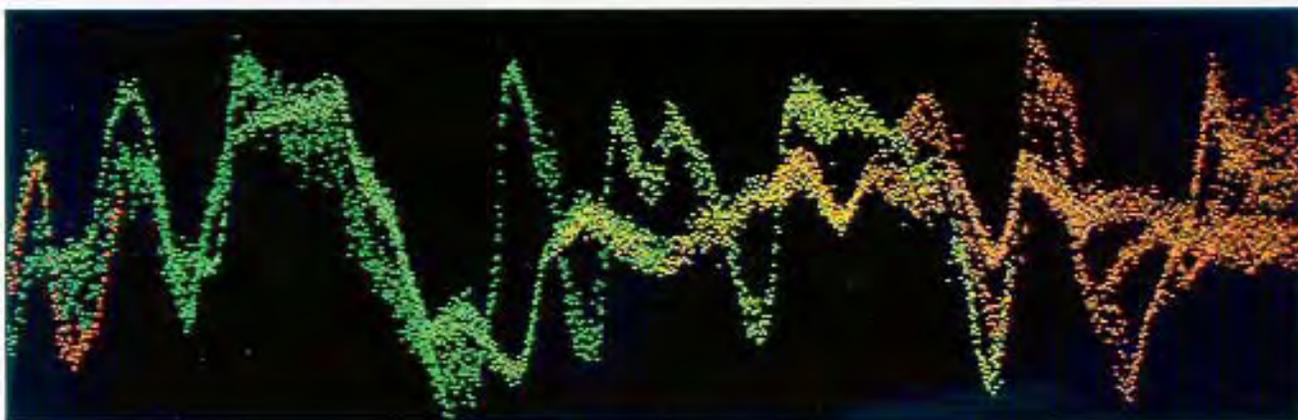
Figure 8. Series of near shore seabed to beach profiles from the area of Barking Sands, Kauai depicted in Figure 7. Insets a-d are west to east cross sections. Inset e is from the north east to southwest along the full length of the near shore.

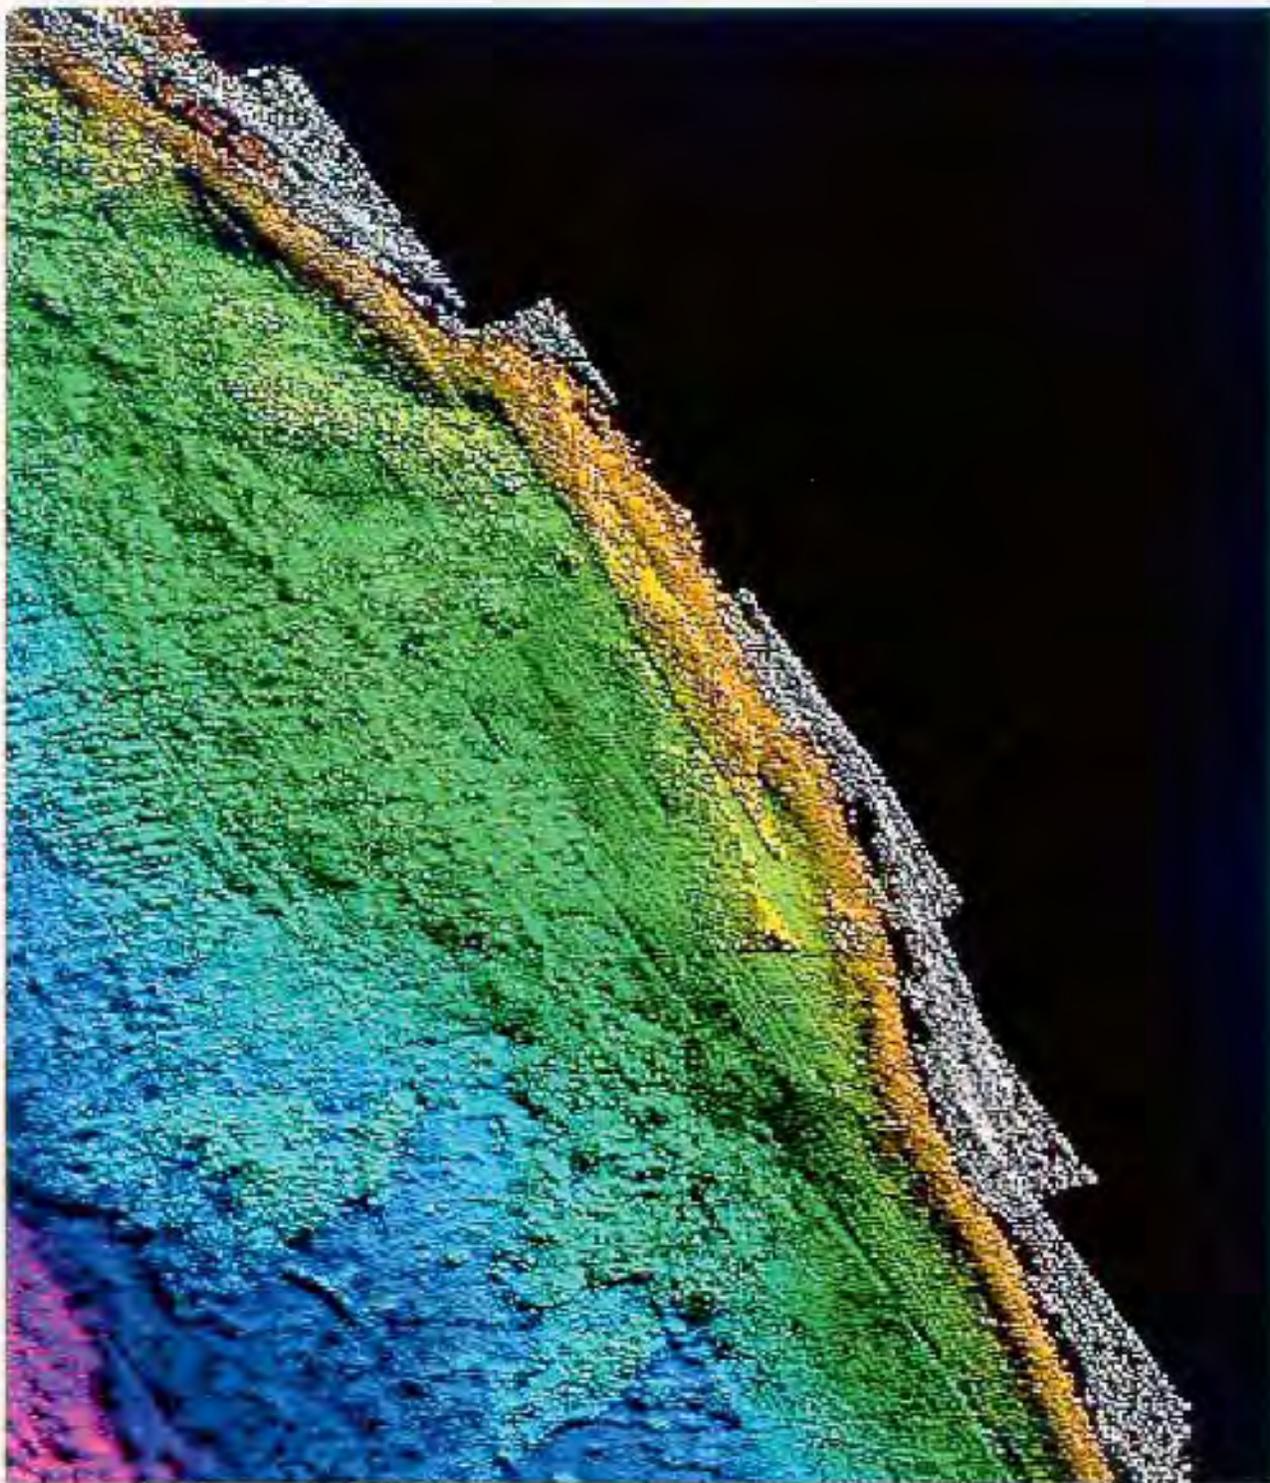
Figure 9. Majors Bay (Waiokapua Bay) Kauai showing near the shore seabed.

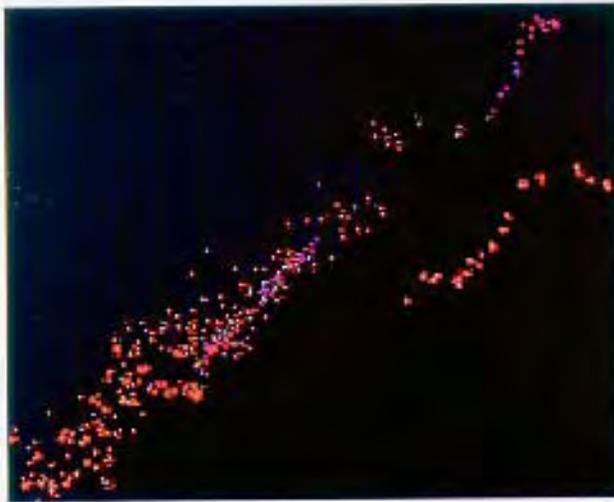
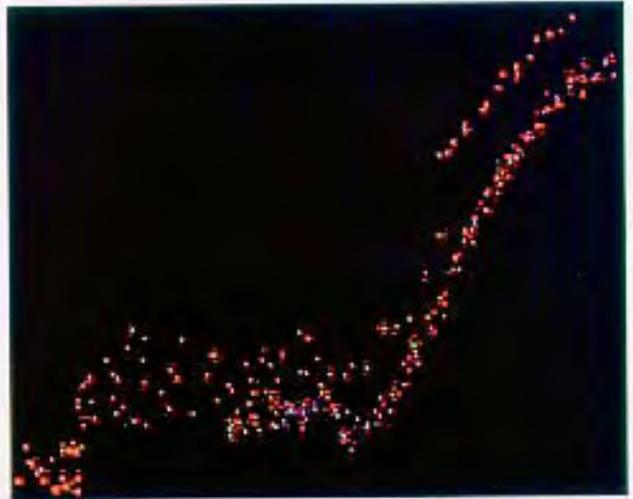
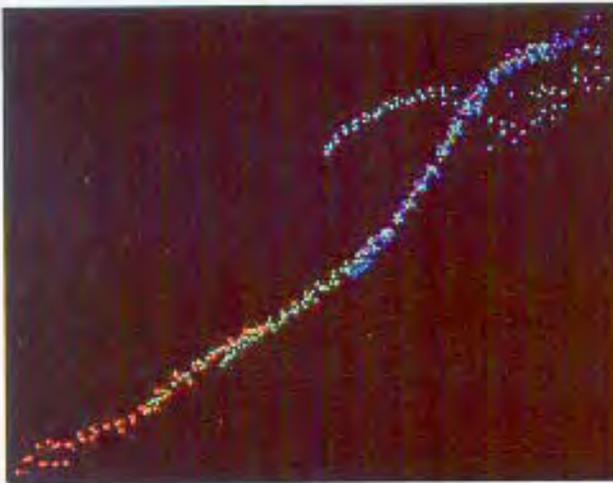
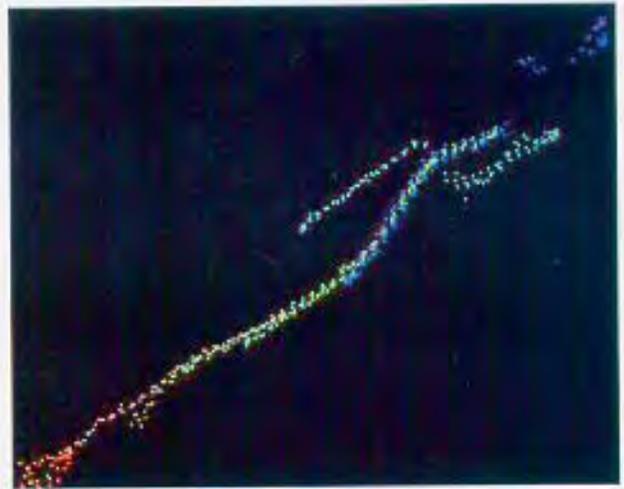
Figure 10. Series of near shore seabed to beach profiles from the area of Majors Bay (Waiokapua Bay) Kauai depicted in Figure 9. Insets a-d are west to east cross sections. Colors represent datasets from different days. These cross sections cover a time span of 6 weeks.

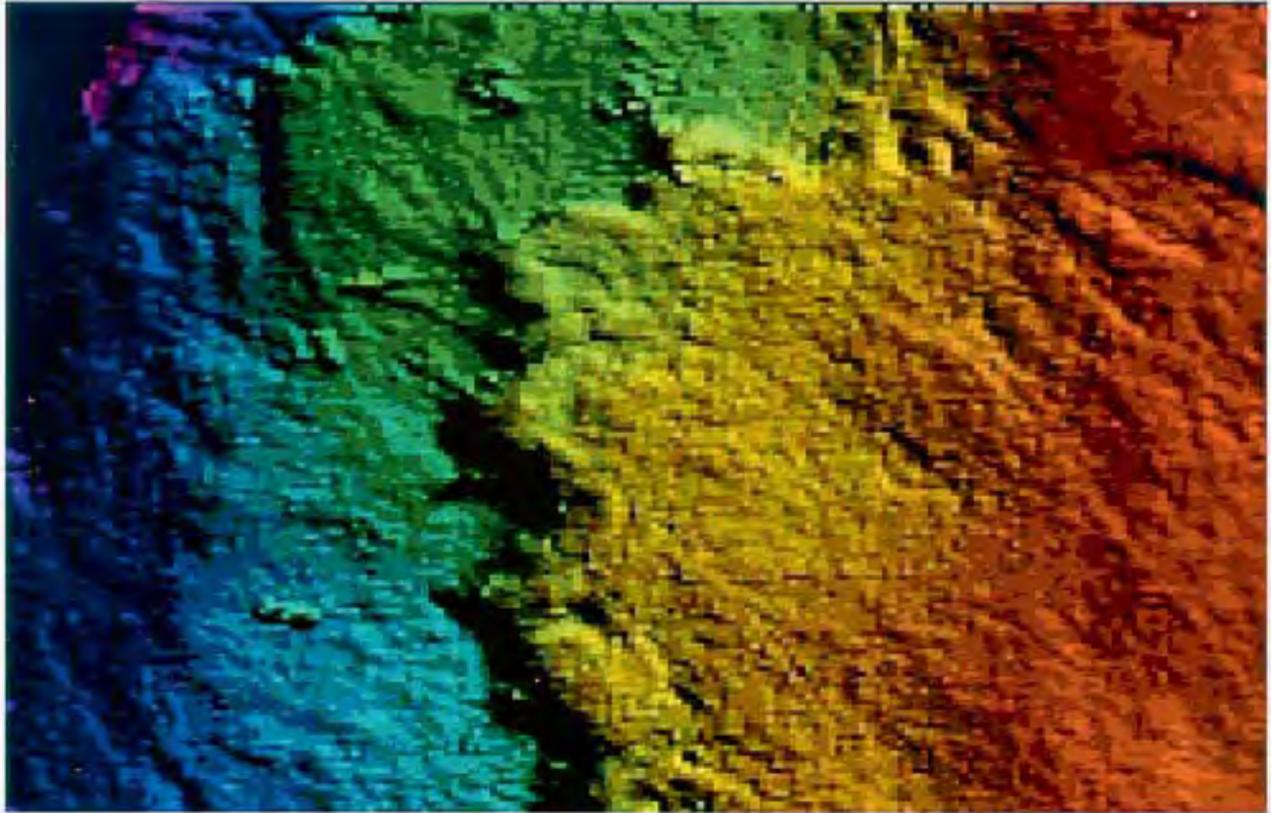
Figure 11. Wrecks and wreckage off Oahu's leeward west coast between Maili Pt. and Waianaae. Charted as fish haven and wrecks. One of these is believed to be the "Mali", a popular dive spot.

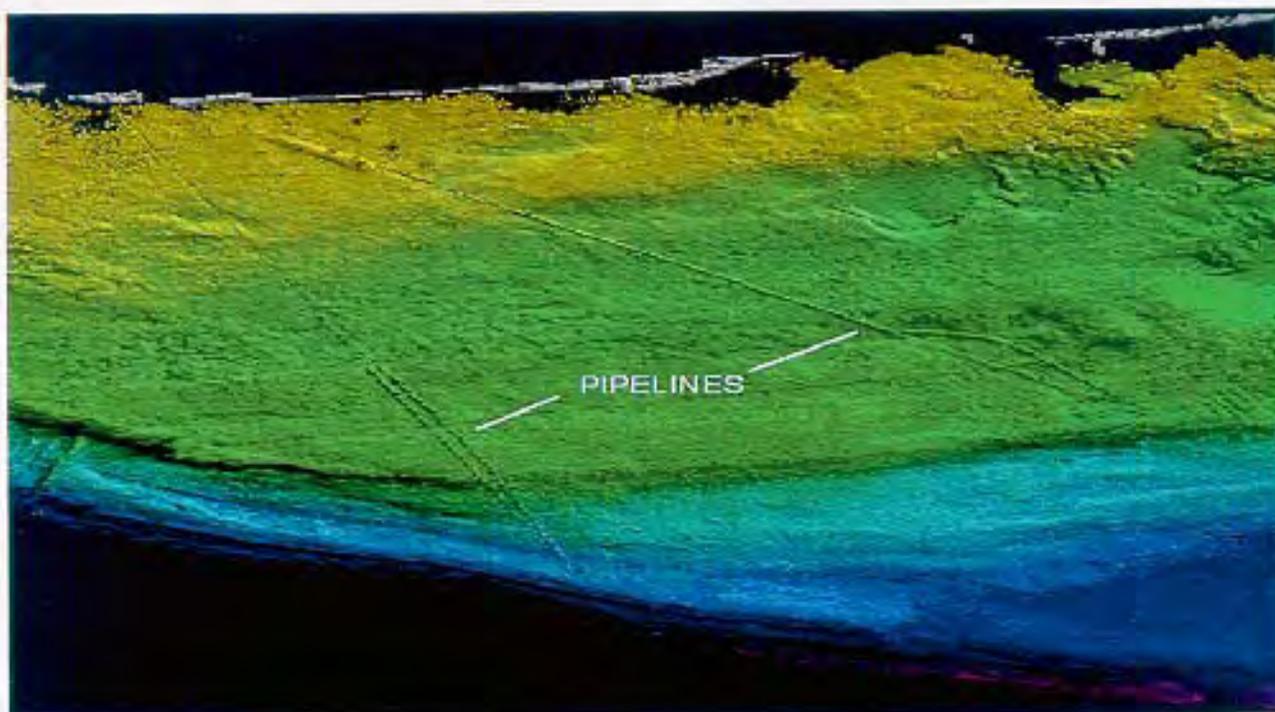
Figure 12. Offshore oil terminal pipelines off Barbers Pt. Oahu.

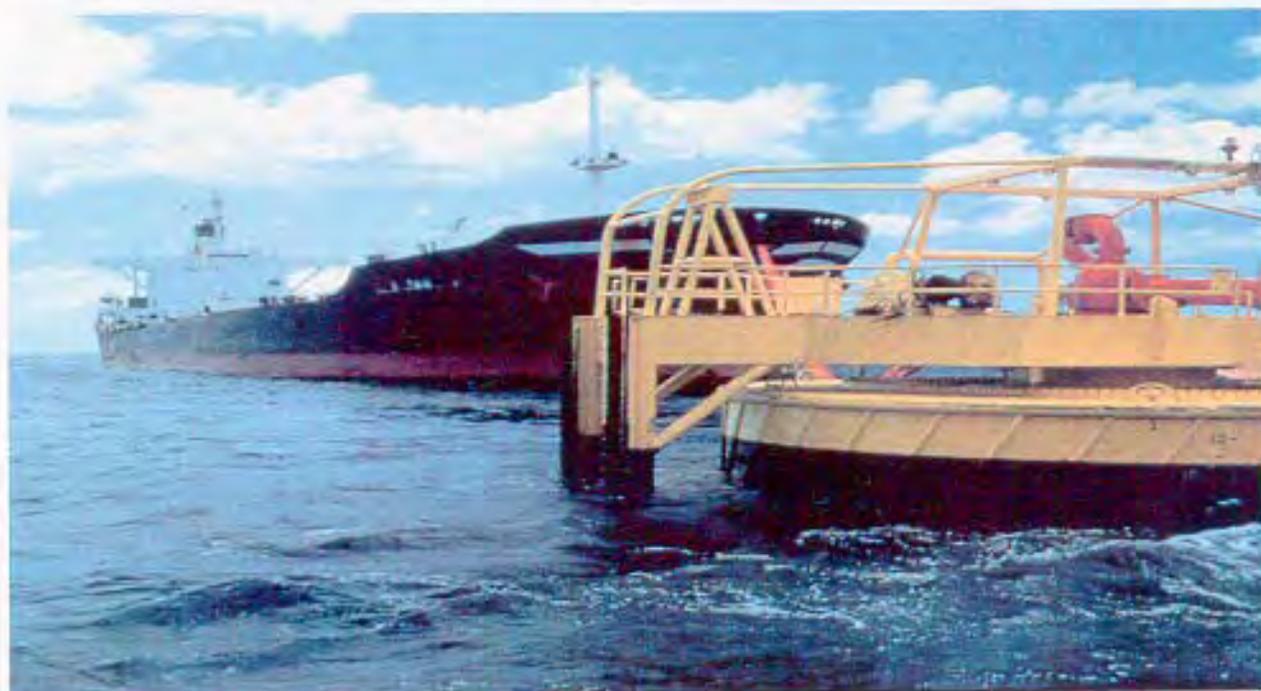
Figure 13. Barbers Pt. Oahu. Offshore oil terminal
