DESCRIPTIVE REPORT

Registry Number: **W00181**

Southern Merrimack Embayment Multibeam Survey

Survey Report

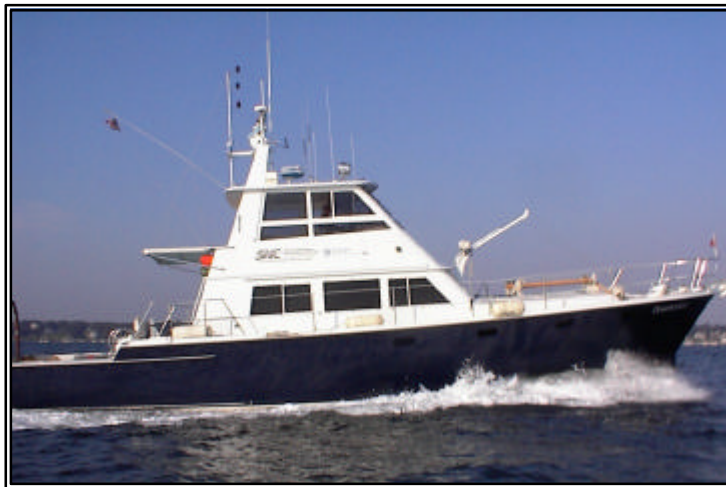
Figure 2. The *R/V OceanExplorer*

SAIC used the *R/V OceanExplorer*, operated by Northeast Marine Services, as the survey vessel during the performance of this survey. Table 1 tabulates the vessel characteristics for the *R/V OceanExplorer* shown in Figure 2.

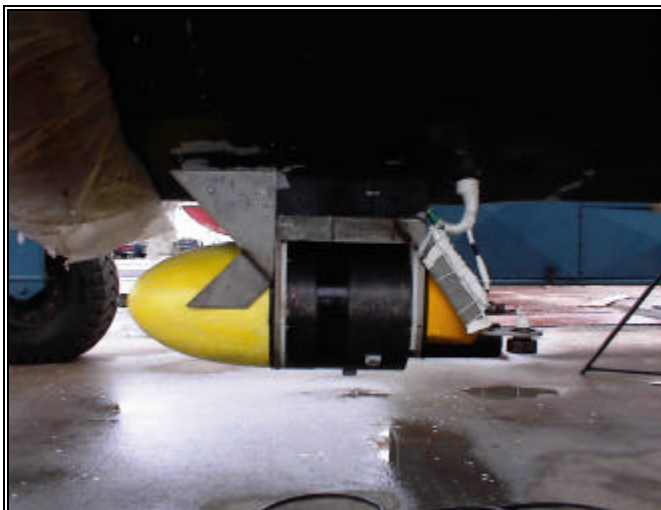
Figure 3. Reson 8101 Installation on the R/V OceanExplorer

The main cabin of the vessel was configured as the data collection center. A POS/MV position and attitude sensor was used to provide vessel position and attitude data, while a Reson 8101 Multibeam Depth Sounder was used to acquire bathymetric and acoustic backscatter data. The Inertial Motion Unit (IMU) was mounted on the vessel centerline just forward and above the Reson 8101 multibeam transducer, below the main deck. The multibeam transducer was mounted on the keel, as shown in Figure 3. A Brooke Ocean Technology Moving Vessel Profiler (MVP) was used to provide sound velocity profiles while underway.

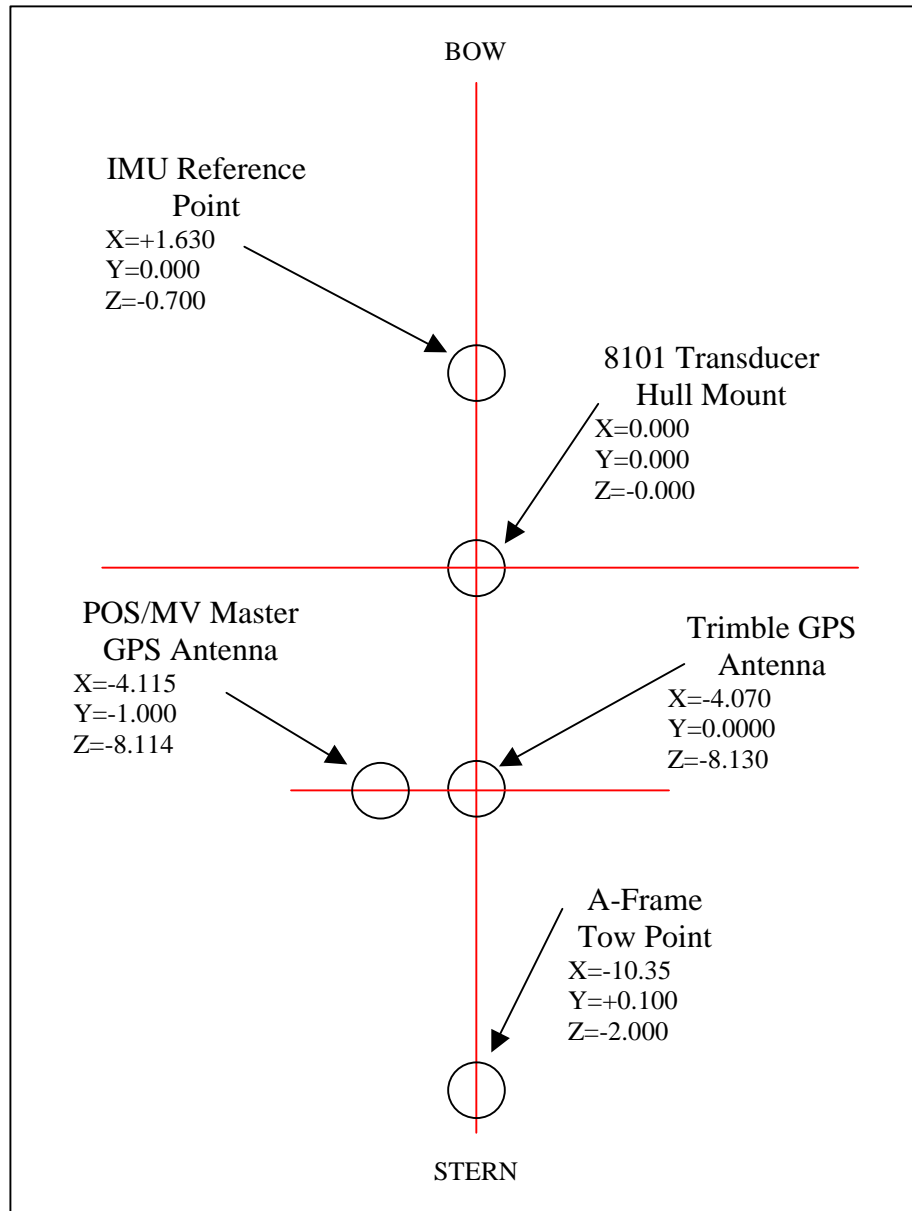
Figure 4. Equipment Locations on the R/V OceanExplorer, Meters

During SAIC's preparation for the 2003 survey season the acquisition system configuration aboard the *R/V OceanExplorer* was measured in reference to the IMU and converted to be relative to the Reson 8101 transducer, Figure 4.

The SAIC Integrated Survey System (ISS2000) and the Reson 8101 multibeam system utilize different coordinate systems. The ISS2000 considers "z" to be positive down, while both the Reson and POS/MV consider "z" positive up. Both the ISS2000 and POS/MV consider "x" positive forward, the Reson considers "x" as positive athwart ships to starboard. The SAIC ISS2000 considers "y" positive athwart ships to starboard, the POS/MV considers "y" positive athwart ships to port and the Reson considers "y" as positive forward. These differences are fully accounted for in the ISS2000 software.

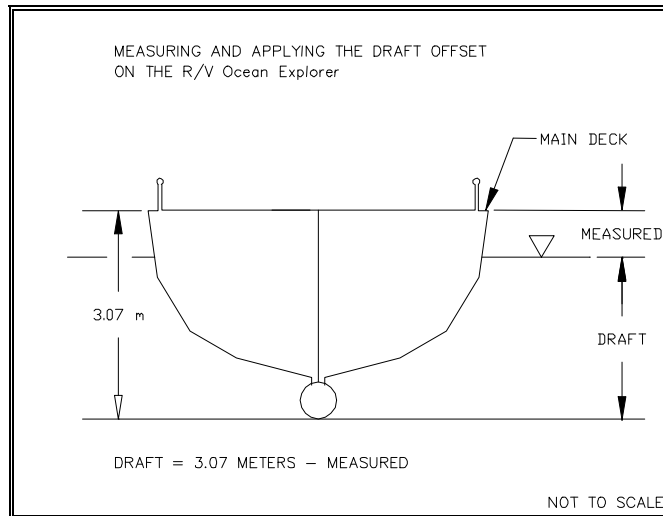
Figure 5. R/V OceanExplorer Draft Determination

Figure 5 shows the draft calculations for the *R/V OceanExplorer*. Depth of the transducer below the deck was determined from measurements made while the boat was hauled in May 2000 and confirmed when the vessel was hauled in July 2002. The transducer depth was recorded as 3.07 meters below the vessel's main deck. The distance below the boat deck to the water surface was measured and subtracted from the transducer hull depth to determine the draft of the transducer's electronic center.

The static draft was observed at the beginning and end of each survey leg, by measuring from the main deck to the waterline and subtracting that measurement from the transducer distance below the deck. The measured static draft value was recorded in the real time Watchstander Log, refer to APPENDIX B. If the static draft value changed from the previously noted value, the new value was entered into the ISS2000 system. Draft was interpolated to derive daily correctors, applied during post processing, as discussed in Section 4.1.2.

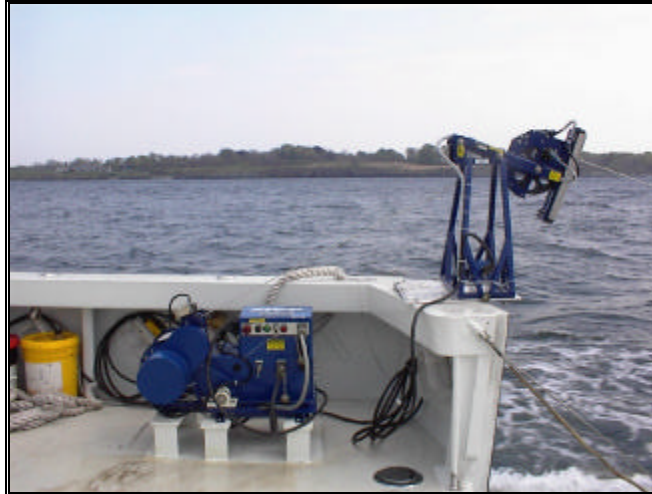
Figure 6. MVP Installation on the R/V OceanExplorer

A Brooke Ocean Technology Ltd. Moving Vessel Profiler (MVP), with an Applied Microsystems, Ltd. Smart Sound Velocity & Pressure sensor was used to determine Sound Velocity Profile (SVP) for corrections to multibeam sonar soundings. Serial numbers and calibration dates for the SVP sensors are presented in Table 3. The system is mounted on the starboard stern of the vessel, as shown in Figure 6.

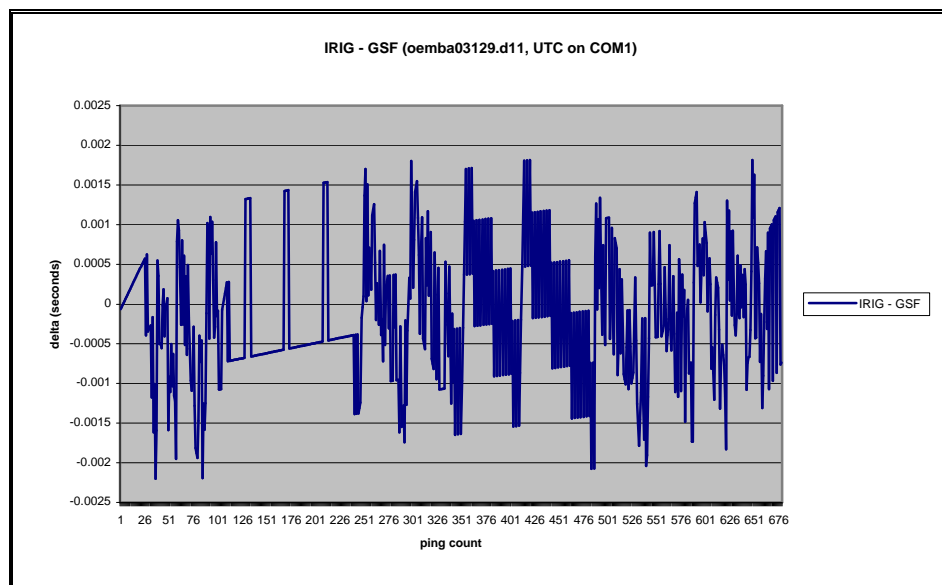
Figure 7. Timing Test Results (9 May 2003)

A ping-timing test was completed on May 9, 2003 to verify there were no time latencies occurring in ISS2000. To perform this test, the user logs ping times from an IRIG-B timing card triggered from the Reson 81P ping trigger. A standard multibeam file is logged simultaneously. While logging, the ping rate is slowly increased from 1 ping/sec to 14.9 pings/sec. The times in each file are compared. The difference in like time tags was no more than 3 milliseconds. Timing tests of ISS2000 were successfully completed prior to any other calibration tests.

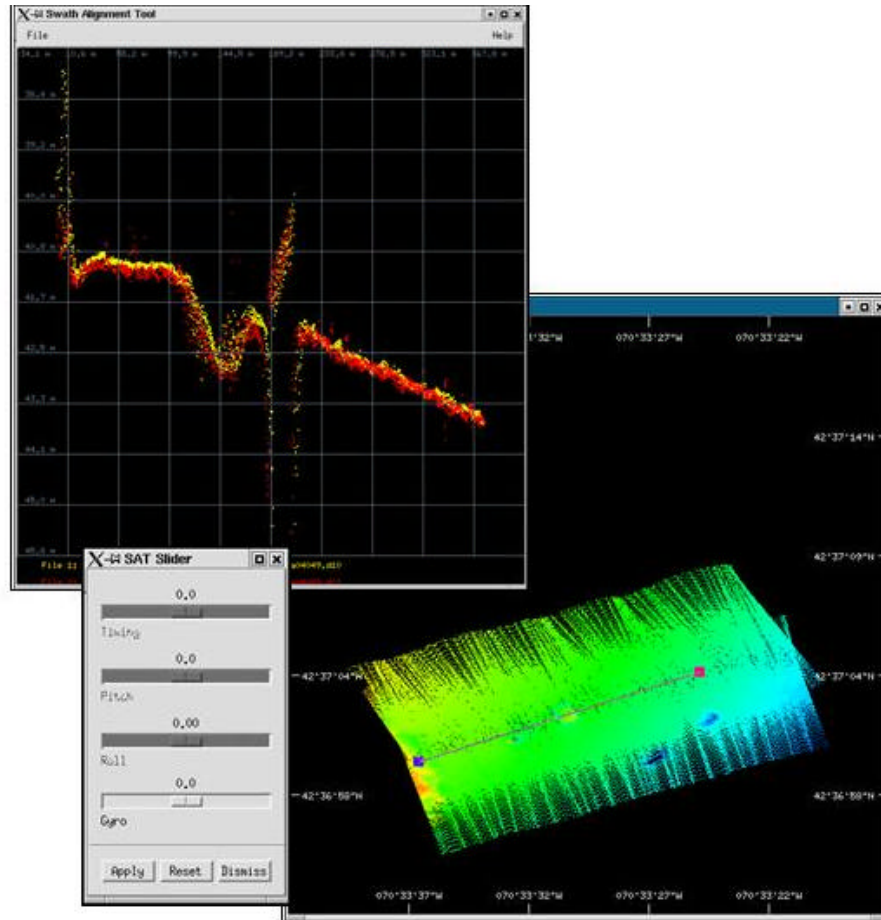
Figure 10. *Swath Alignment Tool: Gyro Bias = +0.8°*

Heading alignment data were collected with a $+0.8^\circ$ entered into the acquisition system. Survey lines were run on either side of the wreck in opposite directions. Multibeam files oemba04049.d10 and oemba04049.d11 were used to determine the input bias was correct for gyro. The following are images of the SABER: Swath Alignment Tool depicting data with $+0.8^\circ$ gyro bias entered in the ISS2000 system; therefore the indicated bias shown is set to 0.0° .

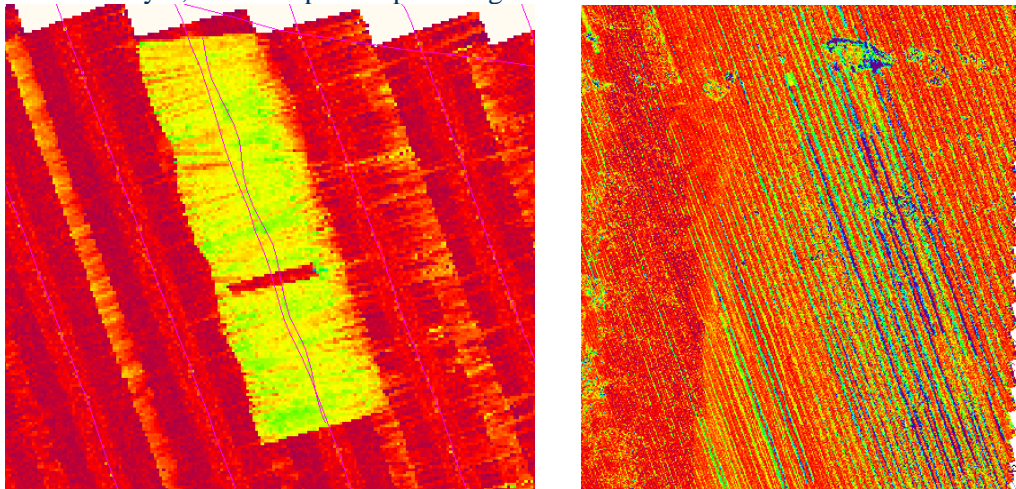
Figure 1. Standard deviation child layer of W00181.

These two were the worst areas of standard deviation, and can be accepted within the IHO order 1.

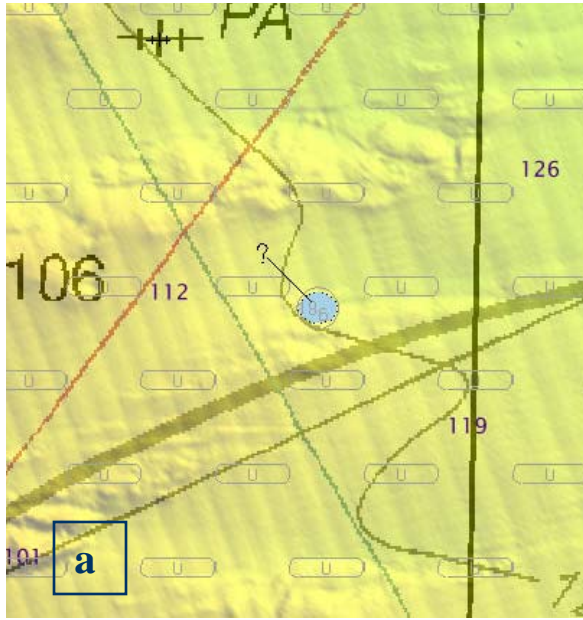
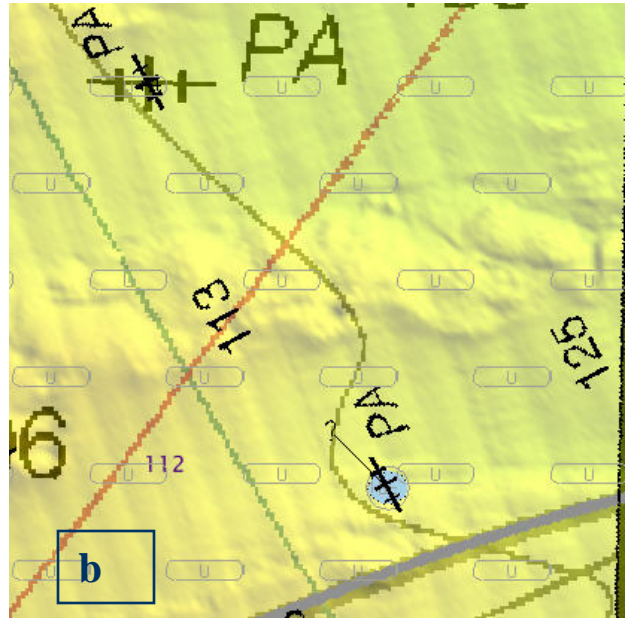
Figure 2. Wreck brought in from ENC, feature is not charted on Chart 13278, edition 26, 20050601(a). The same feature is located on Chart 13274, edition 27, 200706(b).

Figure 2 depicts a wreck that is not charted on 13278, it is found on Chart 13274; the latter chart is at a 1:40000 scale.
