Type of Survey HYDROGRAPHIC
Field No.
Registry No. H11859

Descriptive Report to Accompany Hydrographic Survey H11859

Project *OPR-N338-KR-08*

Columbia River, Oregon

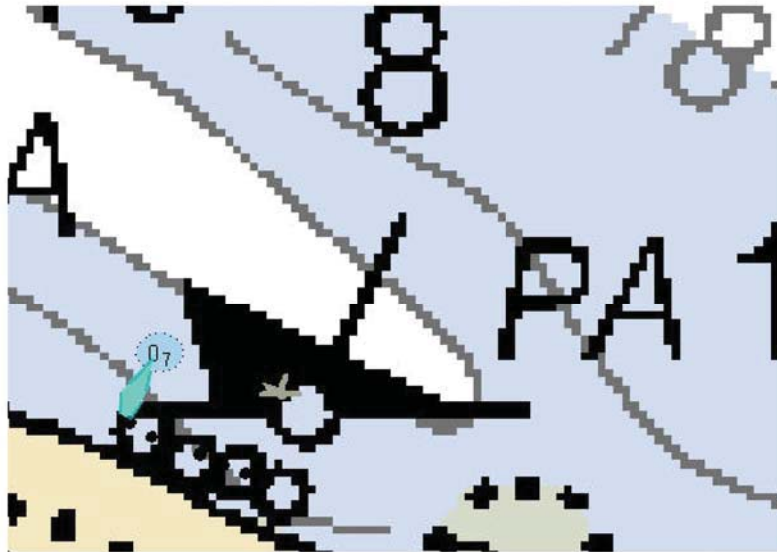
Figure 11. Charted PA Wreck Located by H11859

The charted Wreck PA at 45-36-41.8N, 122-41-49.5W was disproved with 100% multibeam. A wreck area is shown on ENC US5OR15M approximately 100-feet (36m) down river (Figure 11). H11859 located a new seaward extent and least depth of 2.39-feet (0.73 m) on this wreck. The hydrographer recommends removing the charted PA wreck and annotation and charting the surveyed wreck on both versions of the chart as depicted in the S-57 feature file.³¹
